ASBESTOS SURVEY REPORT FOR HOLLEY PARK ACADEMY, WASHINGTON

**HOLLEY PARK ACADEMY SCHOOL,
WASHINGTON**

Date: 5th July 2024

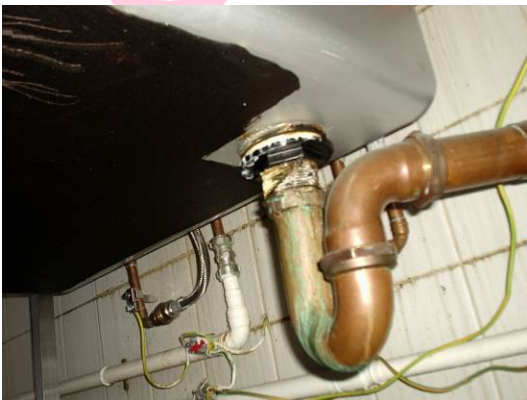
Item 3 - Ref: JP0545/07

The sink pad in the kitchen (Rm 0/8) does not contain asbestos.

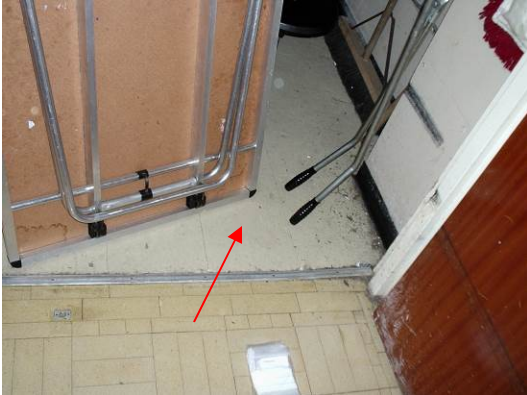
Item 4 - Ref: JP0546/07

The cream vinyl floor tiles to the store (Rm 0/11) contain asbestos.

Any change in its appearance should be recorded and passed to Property Services.

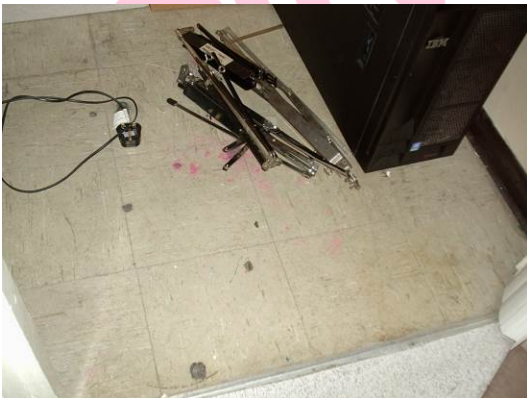
Item 6 – As JP0546/07

The vinyl floor tiles to the cleaners cupboard (Rm 0/16) contain asbestos.

Any change in its appearance should be recorded and passed to Property Services.

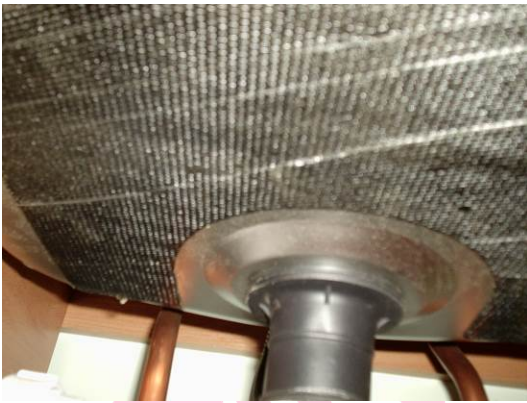
Item 8 - Ref: JP0549/07

The sink pad to classroom year 5 (Rm 0/21) does not contain asbestos.

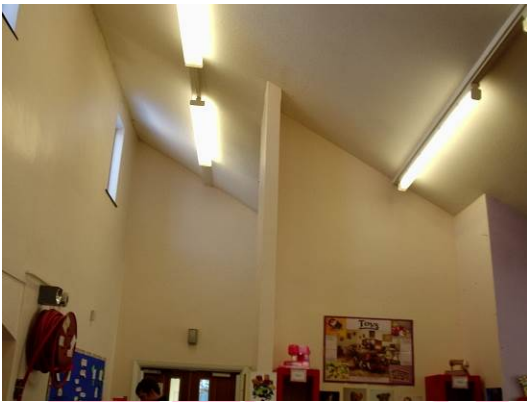
Item 20 - Ref: JP0556/07

The decorative finish to the ceiling of the corridor and practical area (Rm 0/37) does not contain asbestos.

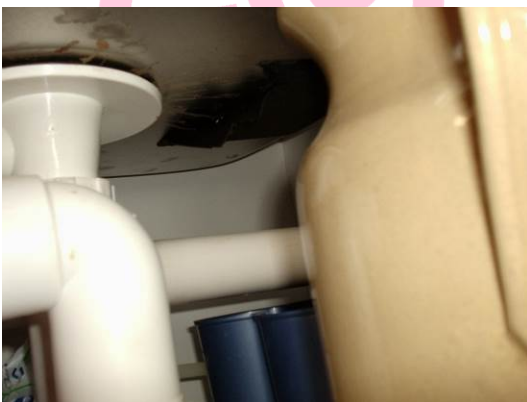
Item 21 - Ref: JP0558/07

The sink pad to the staff room (Rm 0/42) does not contain asbestos.

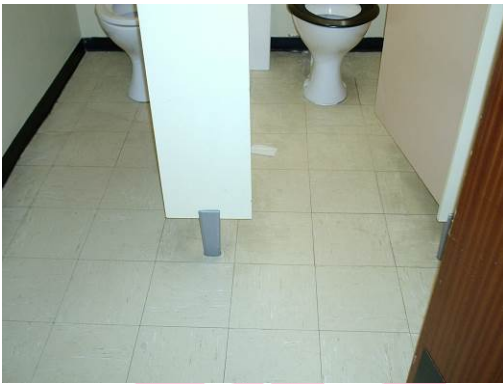
Item 23 – As JP0546/07

The cream floor tiles to the female toilets (Rm 0/44) contained asbestos.

These have now been removed.

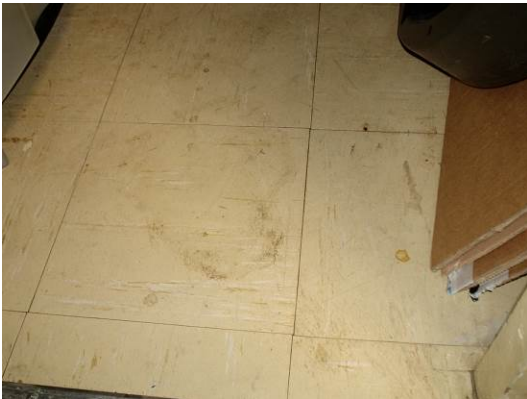
Item 26 – As JP0546/07

The cream floor tiles to the store room (Rm 0/51) contain asbestos.

Any change in its appearance should be recorded and passed to Property Services.

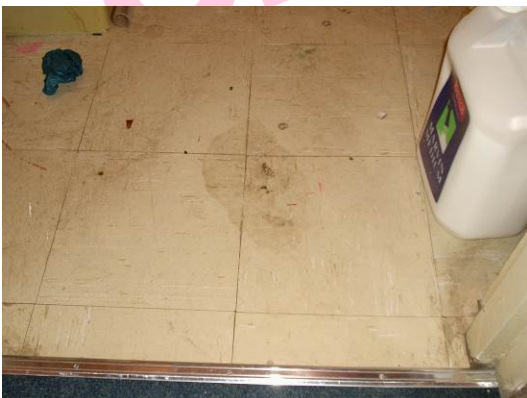
Item 27 – As JP0546/07

The cream floor tiles to the store room (Rm 0/52) contain asbestos.

Any change in its appearance should be recorded and passed to Property Services.

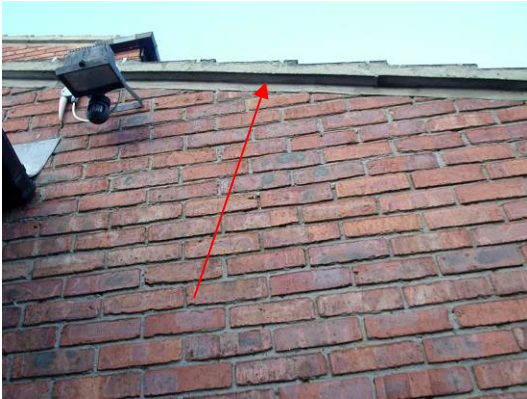
Item 28 - Ref: JP0544/07

The undercloak to the external of the school contains asbestos.

Any change in its appearance should be recorded and passed to Property Services.

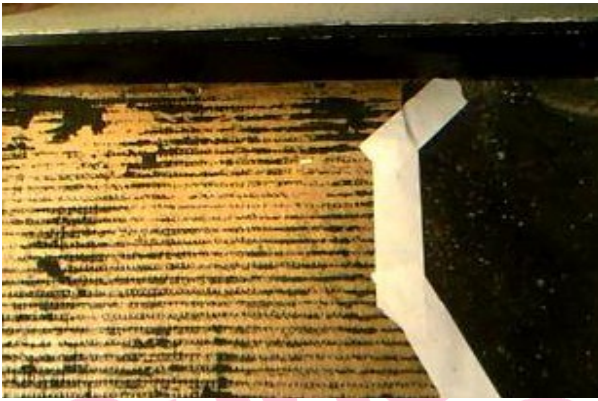
Item 32 - Ref: BB002525

The lino and screed below in the Key Stage 1 Cloaks does not contain asbestos.
