ASBESTOS SURVEY REPORT FOR HUDSON ROAD PRIMARY SCHOOL –VILLIERS STREET SOUTH, SUNDERLAND

Asbestos Register for Hudson Road Primary School

Date: 01 August 2025

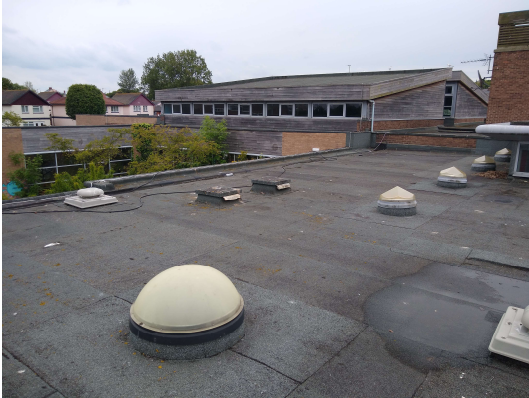
Item 1 Ref: 332593-1

The roof felt to Roof 1 (Nursery) does not contain asbestos.

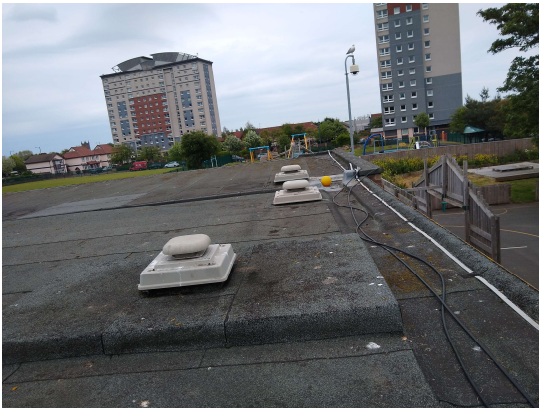
Item 2 Ref: 332593-2

The roof felt to Roof 1 (Nursery) does not contain asbestos.

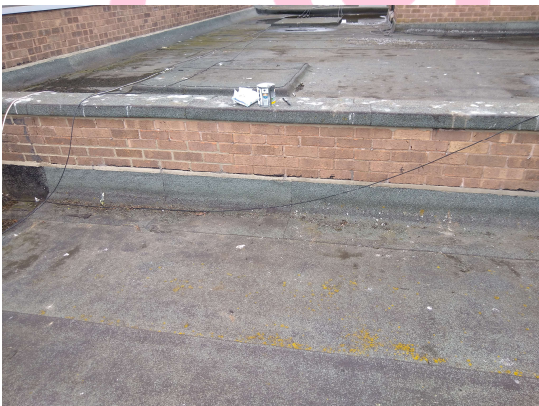
Item 3 Ref: As 3325*93-4

The damp proof course to flashing to Roof 1 (Nursery) does not contain asbestos.

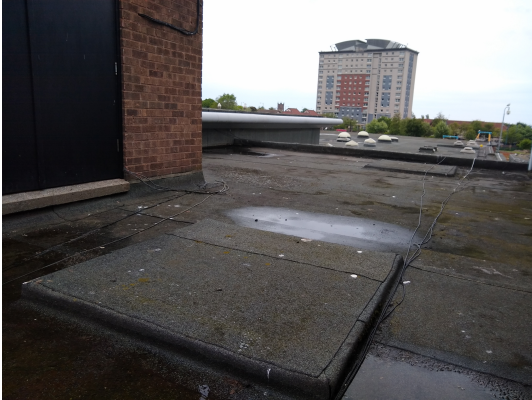
Item 4 Ref: 332593-3

The roof felt to Roof 3 (Nursery) does not contain asbestos.

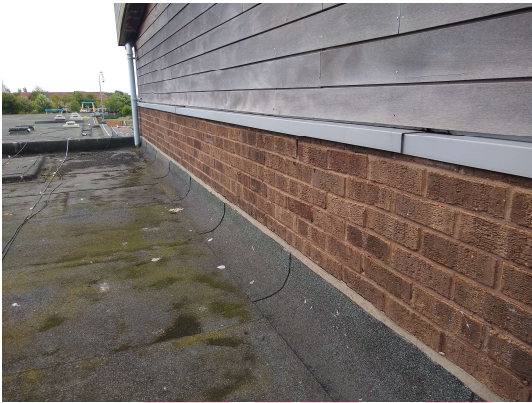
Item 5 Ref: 332593-4

The damp proof course to flashing to Roof 3 (Nursery) does not contain asbestos.

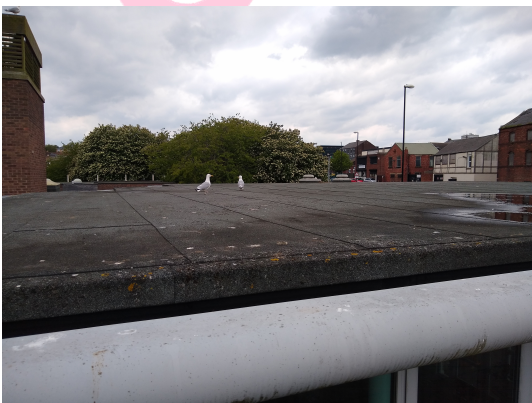
Item 6 Ref: 332593-7

The roof felt to Roof 3 (Nursery) does not contain asbestos.

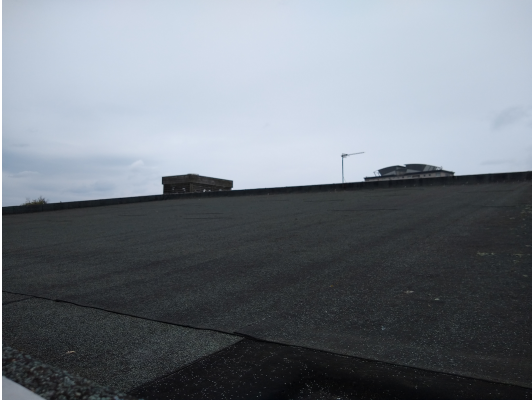
Item 7 Ref: 332593-5

The roof felt to Roof 4 (Nursery) does not contain asbestos.

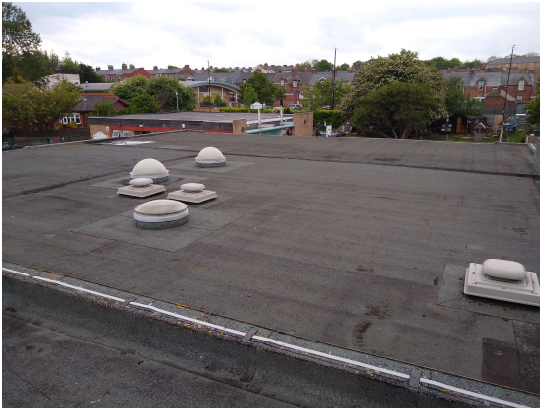
Item 13 Ref: 332593-10

The roof felt to Roof 8 (Nursery) does not contain asbestos.

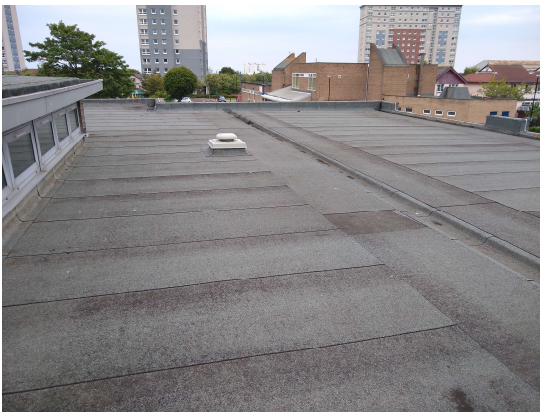
Item 14 Ref: 332593-11

The roof felt to Roof 9 (Nursery) does not contain asbestos.

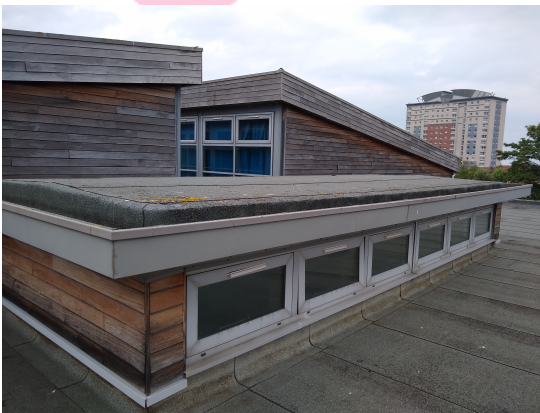
Item 15 Ref: 332593-12

The roof felt to Roof 10 (Nursery) does not contain asbestos.

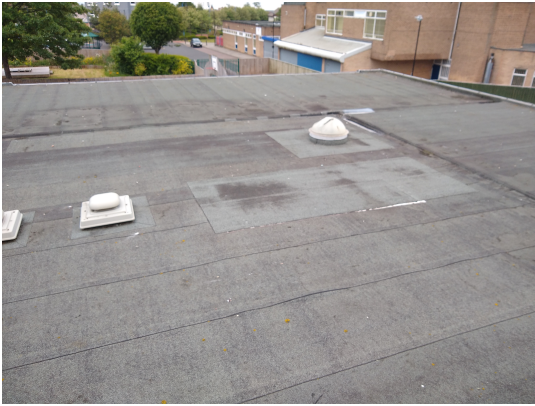
Item 16 Ref: 332593-13

The roof felt to Roof 11 (Nursery) does not contain asbestos.

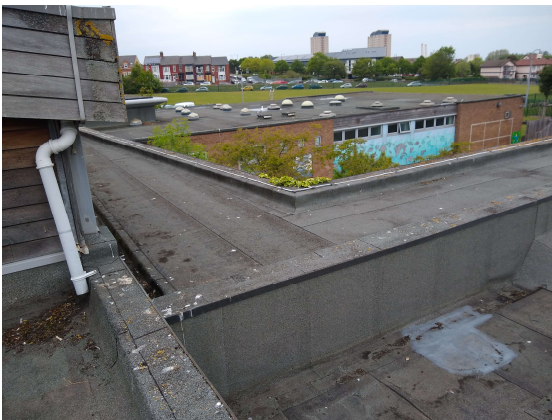
Item 17 Ref: 332593-14

The roof felt to Roof 12 (Nursery) does not contain asbestos.

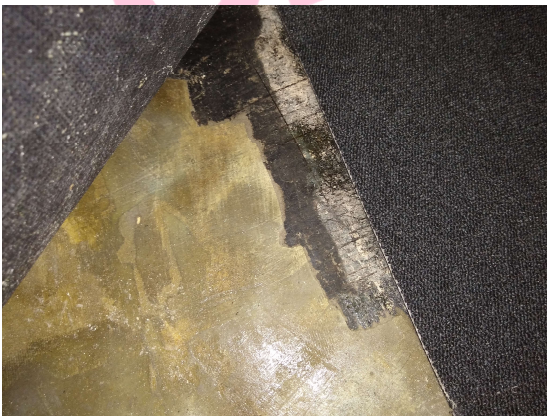
Item 18 Ref: As 343523-13

The Floor screed (014/office 074) does not contain asbestos.

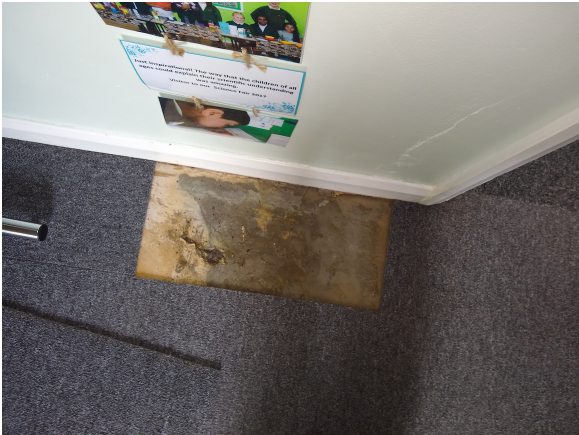
Item 19 Ref: 343523-13

The Floor screed
(015+106/meeting room)
(075+076 now one room) does
not contain asbestos.

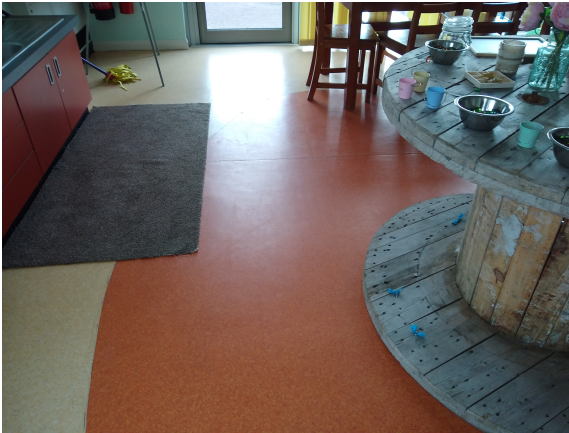
Item 20 Ref: 343523-12

The Floor screed
(024/childcare 087) does not
contain asbestos.

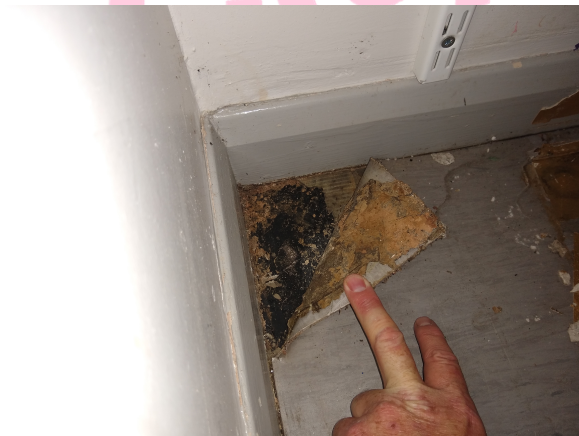
Item 21 Ref: As 343523-12

The Floor screed (025/store
084) does not contain
asbestos.

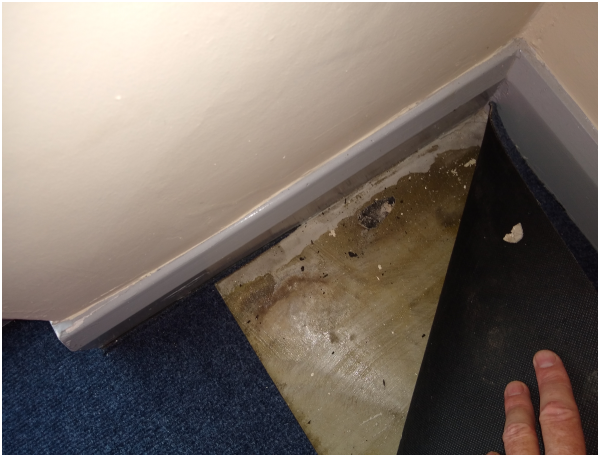
Item 22 Ref: As 343523-12

The Floor screed (027/playroom 088) does not contain asbestos.

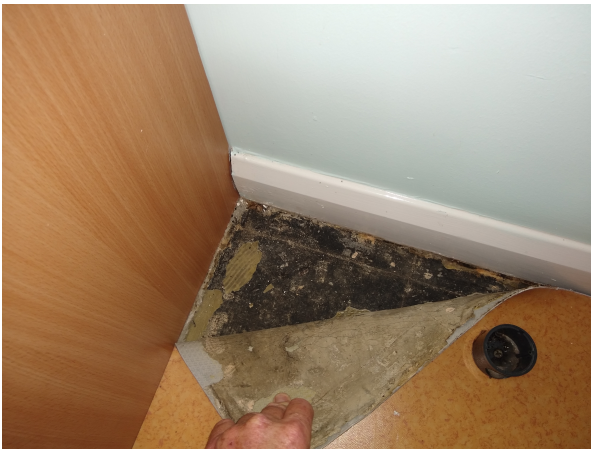
Item 23 Ref: As 343523-12

The Floor screed (028/kitchen 090) does not contain asbestos.

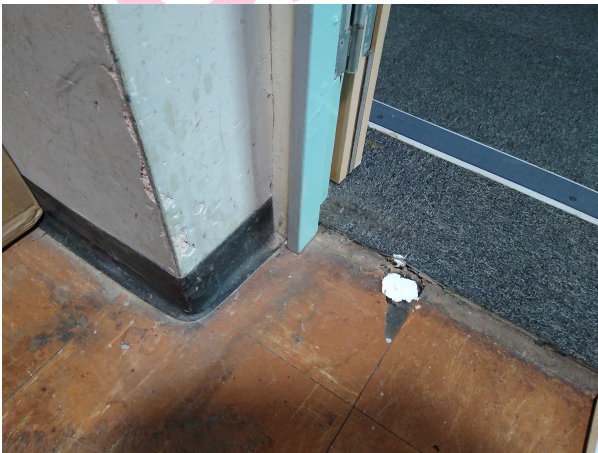
Item 24 Ref: 343523-16

- (Item 23) Ref: As 343523-12 Floor screed (028/kitchen 090) – No Risk
- (Item 24) Ref: 343523-16 Floor covering (031/electric cupboard 064) – Very Low Risk

The Floor covering (031/electric cupboard 064) contains asbestos.

Any change in appearance should be reported to Property Services.

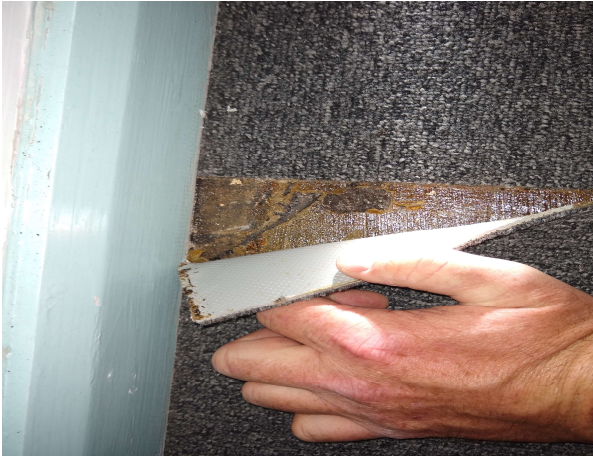
Item 25 Ref: 343523-10

The Floor screed (032/corridor 061) does not contain asbestos.

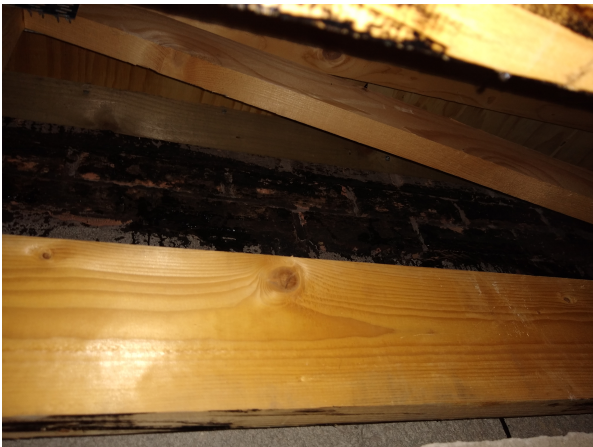
Item 26 Ref: 192371-3

The Remnant debris to former ceiling line (035/corridor-ceiling void) does not contain asbestos.

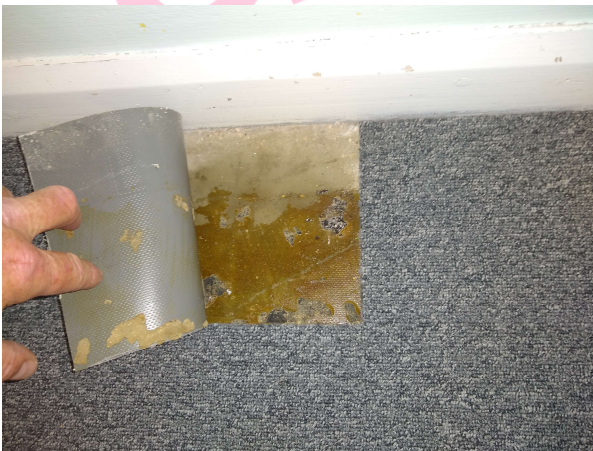
Item 27 Ref: 343523-9

The Floor screed (038/classroom 059) does not contain asbestos.

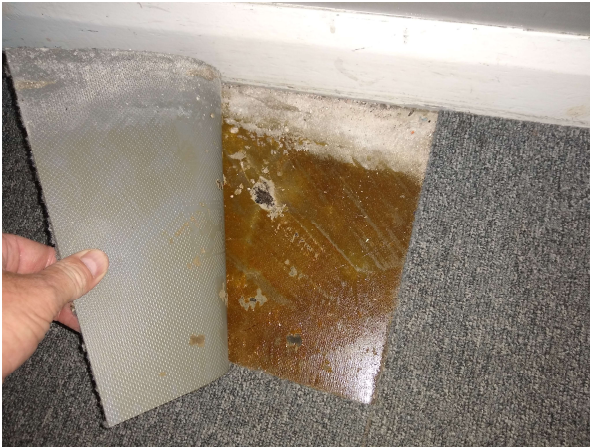
Item 28 Ref: 343523-8

The Floor screed
(040/classroom 057) does not
contain asbestos.

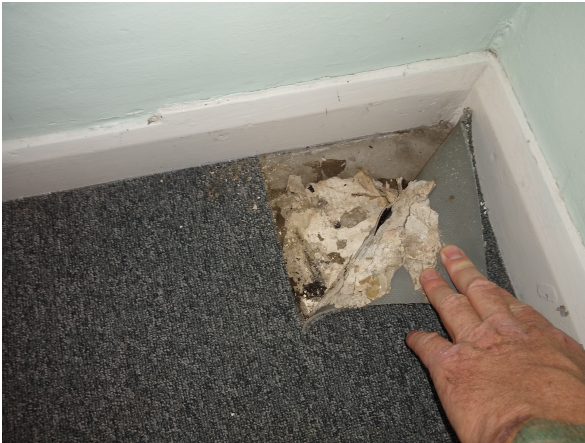
Item 29 Ref: As 343523-8

The Floor screed
(042/classroom 054) does not
contain asbestos.

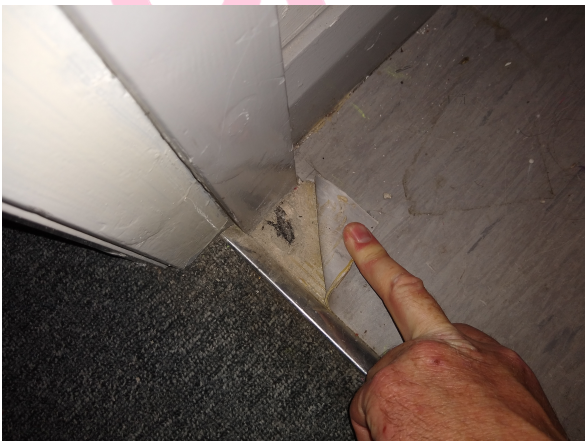
Item 30 Ref: As 343523-9

The Floor screed
(048/classroom 055) does not
contain asbestos.

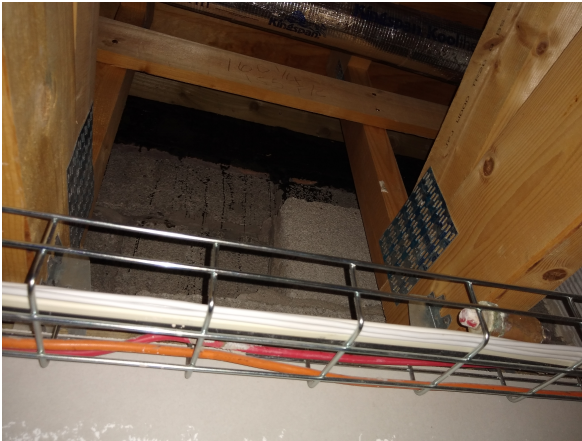
Item 31 Ref: 343523-7

The Remains of old roof line (048/corridor 060-ceiling void) does not contain asbestos.

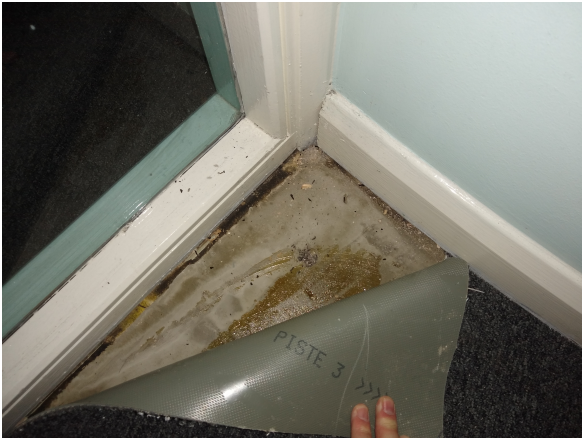
Item 32 Ref: 343523-6

The Screed (049/IT Suite 046) does not contain asbestos.

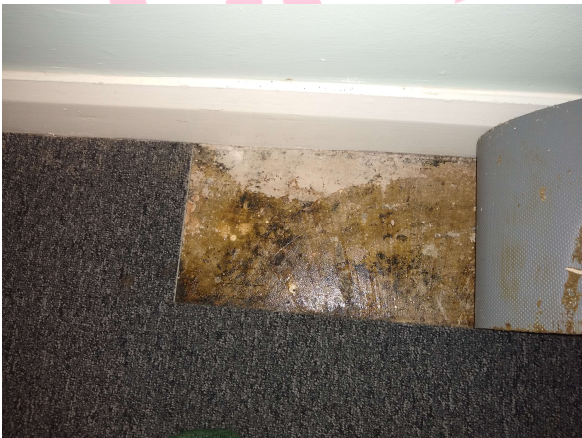
Item 33 Ref: 343523-8

The Floor screed (053/classroom 044) does not contain asbestos.

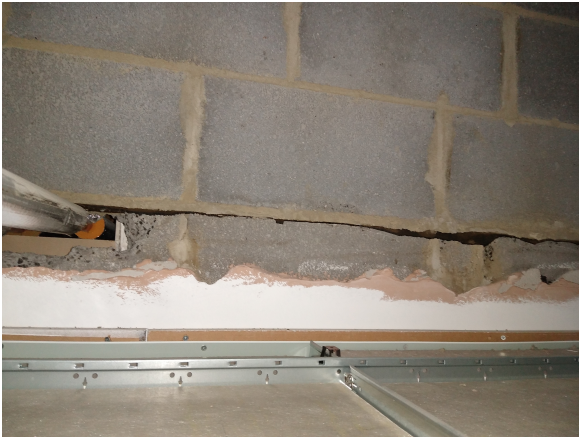
Item 34 Ref: 343523-7

The Old roof felt (060/corridor 26-ceiling void) does not contain asbestos.

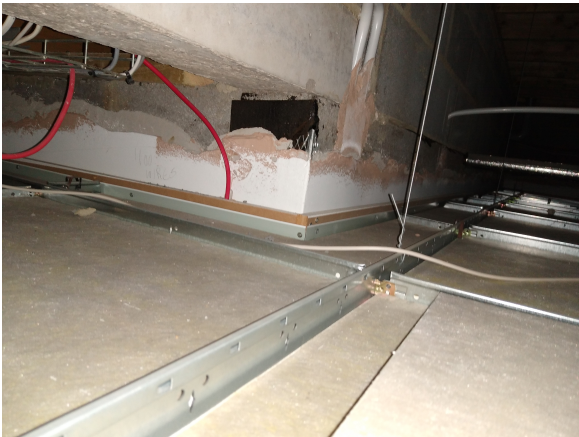
Item 35 Ref: As 343523-5

The Packer to wall at external corner (060/corridor 26-ceiling void) does not contain asbestos.

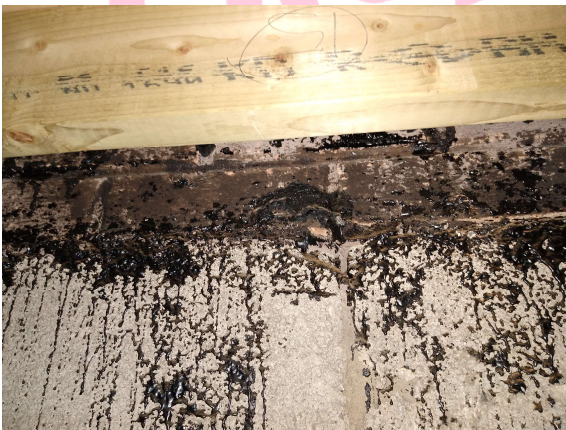
Item 36 Ref: As 343523-7

The Damp proof course (060/corridor 26-ceiling void) does not contain asbestos.

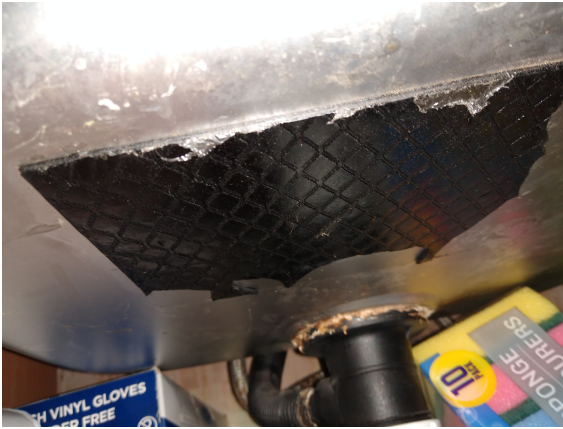
Item 37 Ref: 343523-3

The Sink pad (064/classroom 23) does not contain asbestos.

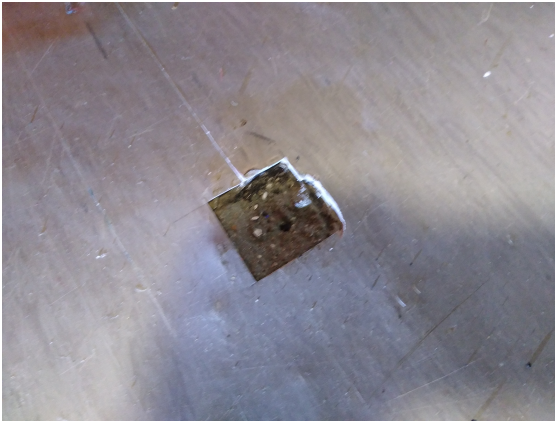
Item 38 Ref: 343523-4

The Screed (056/classroom store 24) does not contain asbestos.

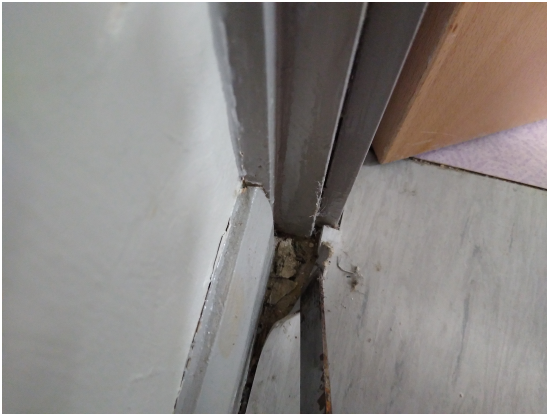
Item 40 Ref: As 343523-1

The Screed (067/classroom 022) does not contain asbestos.

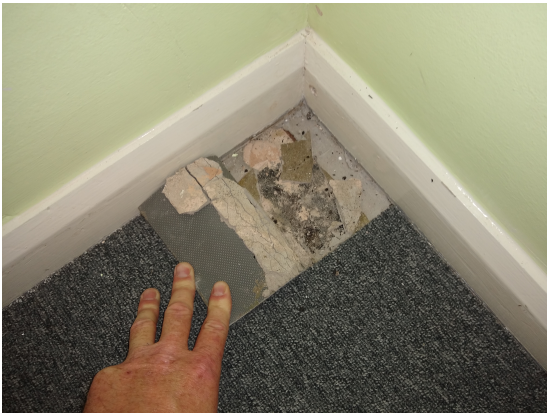
Item 41 Ref: 343523-2

- (Item 40) Ref: As 343523-1 Screed (067/classroom 022) – No Risk
- (Item 41) Ref: 343523-2 Screed (068/classroom) – Very Low Risk

The Screed (068/classroom) contains asbestos.

Any change in appearance should be reported to Property Services.

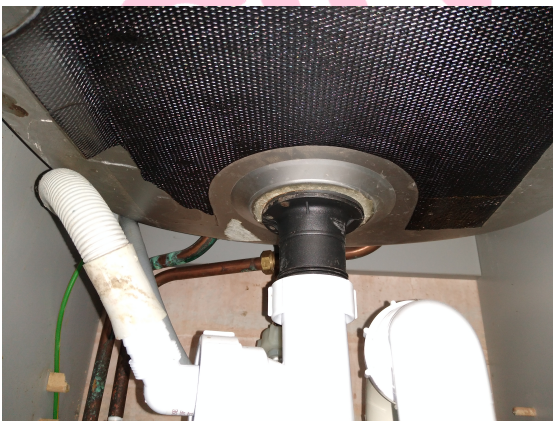
Item 42 Ref: As 343523-5

The Sink pad (088/kitchen 009) does not contain asbestos.

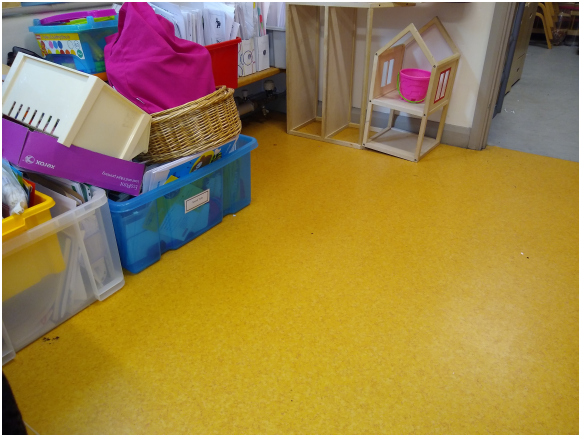
Item 43 Ref: 343523-11

The Floor screed (090/store 003) does not contain asbestos.

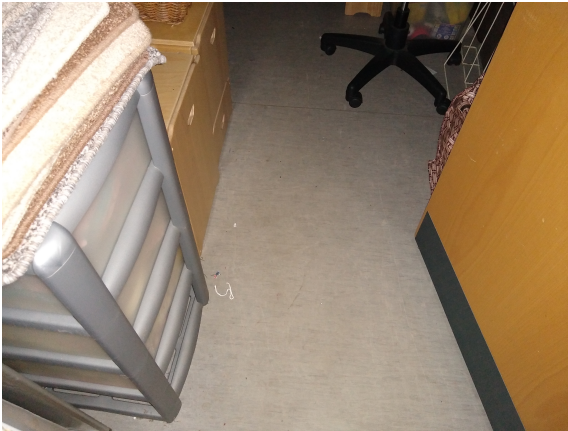
Item 44 Ref: As 343523-11

The Floor screed (091/boiler cupboard 004) does not contain asbestos.

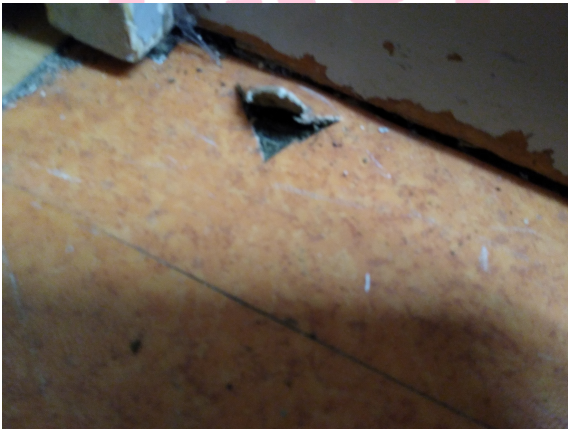
Item 45 Ref: 343523-17

The Screed (100/PE store 39) does not contain asbestos.

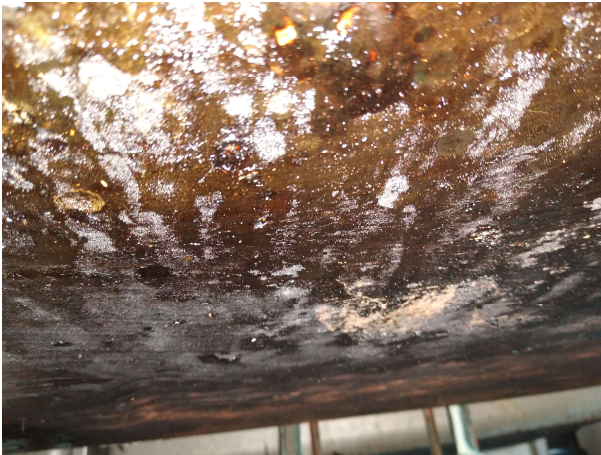
Item 47 Ref: 343523-18

The Sink pad paint
(103/kitchen 036) does not
contain asbestos.

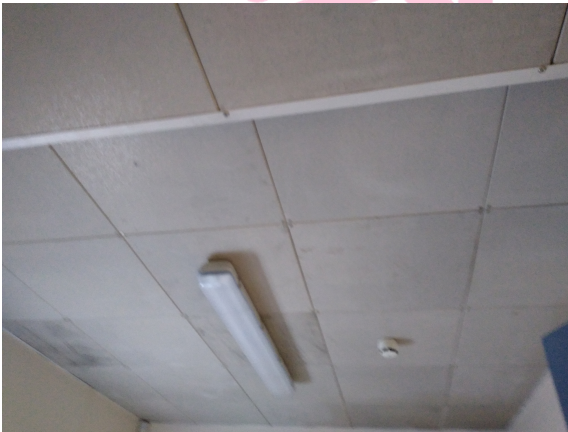
Item 48 Ref: 192371-6

The Suspended ceiling
(111/kitchen office 034)
previously room 106 does not
contain asbestos.

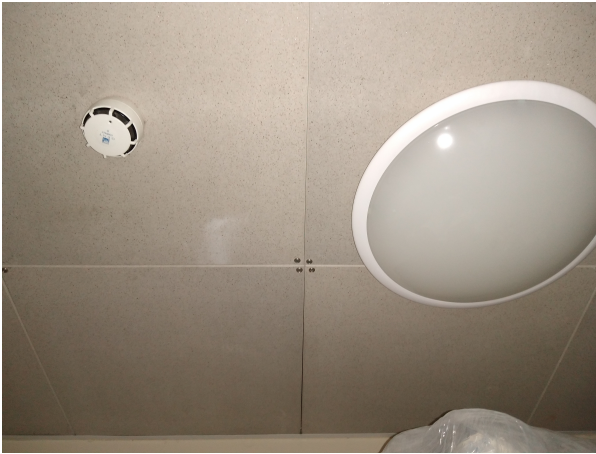
Item 49 Ref: As 192371-6

The Suspended ceiling
(112/kitchen store 035)
previously room 107 does not
contain asbestos.

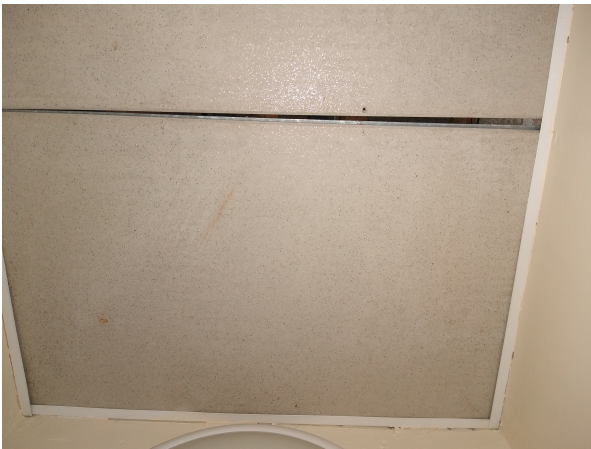
Item 50 Ref: As 192371-6

The Suspended ceiling
(115/kitchen wc lobby 032)
previously room 105 does not
contain asbestos.

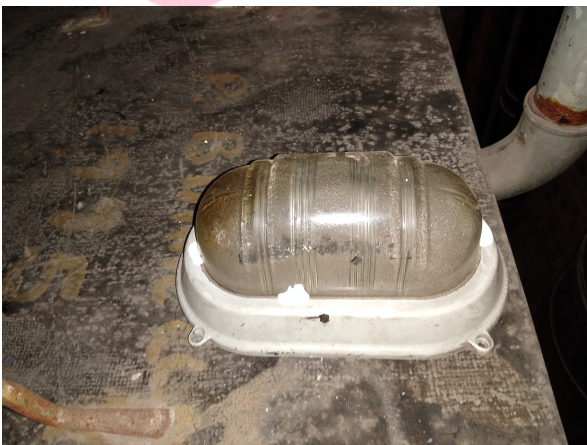
Item 51 Ref: 343523-19

The Sealant to loose lying bulk
head on top of tank (110/tank
room) contains asbestos.

Item 50	No asbestos	Is present		
Item 51	Sealant to loose lying bulk head on top of tank (110/tank room)	Very Low		Removed July 2023
Item 52	No asbestos	Is present

Removed July 2023

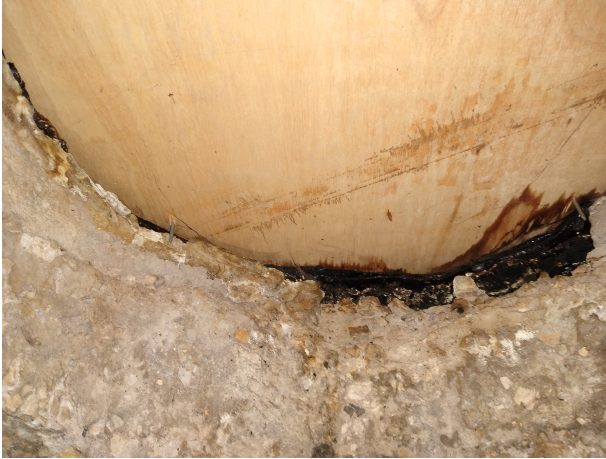
Item 52 Ref: 343523-20

The Roofing felt to old penetration (110/tank room) does not contain asbestos.

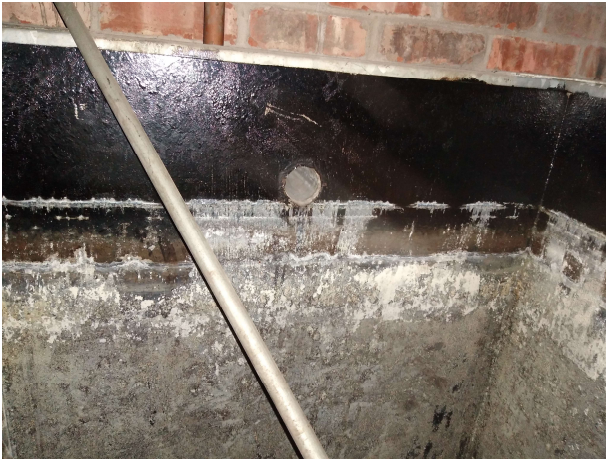
Item 53 Ref: 343523-21

The Coating to inside of tank (110/tank room) does not contain asbestos.

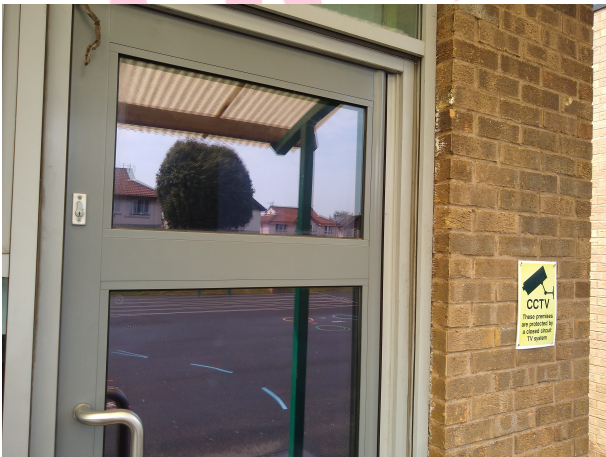
Item 54 Ref: 343523-14

- (Item 54) **Ref: 343523-14 Old mastic to external door of 0/064 (externals) – Very Low Risk**
- (Item 55) **Ref: 343523-15 Old mastic to external door of 038+040 (externals) – Very Low Risk**

The Old mastic to external door of 0/064 (externals) contains asbestos.

Any change in appearance should be reported to Property Services.

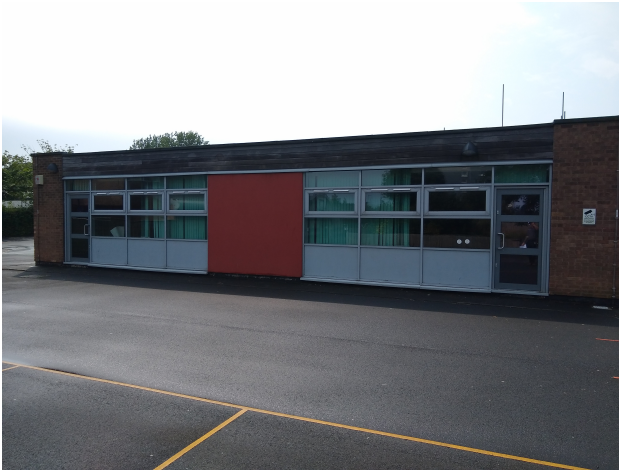
Item 55 Ref: 343523-15

The Old mastic to external door of 038+040 (externals) does contain asbestos.

Any change in appearance should be reported to Property Services.

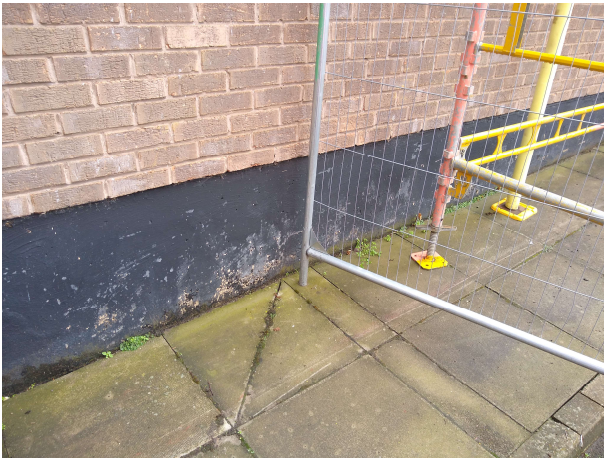
Item 56 Ref: 343523-23

The Paint to concrete slab (externals) does not contain asbestos.

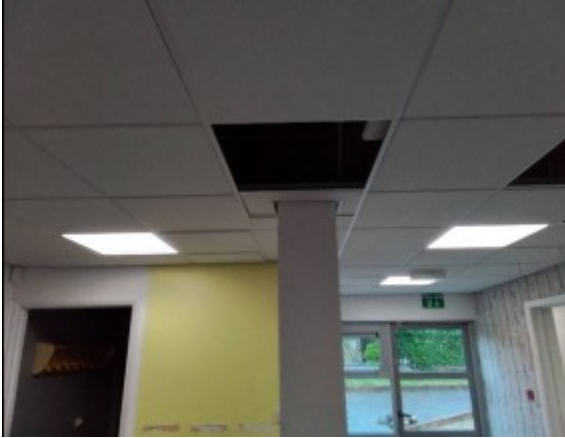
Item 58 Ref: OQ000231

The column cladding – inner layer in the Large Room (Rm G/002) does not contain asbestos.

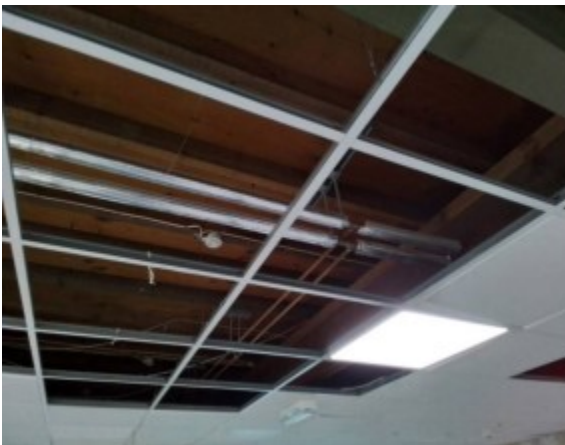
Item 59 Ref: OQ000232

The ceiling void – pipe insulation in the Large Room (Rm G/002) does not contain asbestos.

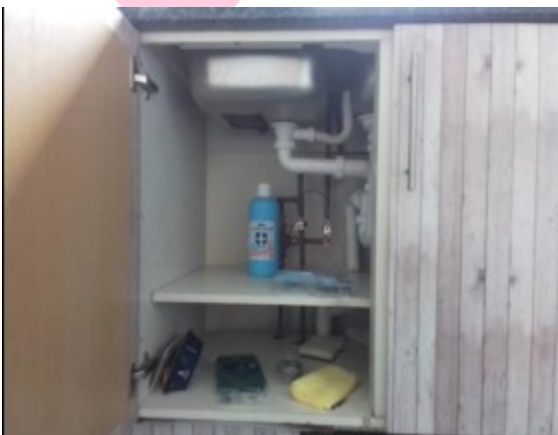
Item 60 Ref: OQ000233

The under sink mat in the Kitchen (Rm G/003) does not contain asbestos.

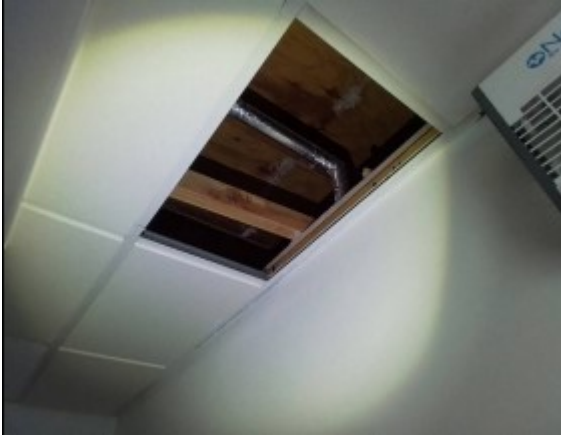
Item 61 Ref: OQ000234

The ceiling void - debris in the Kitchen (Rm G/003) does not contain asbestos.

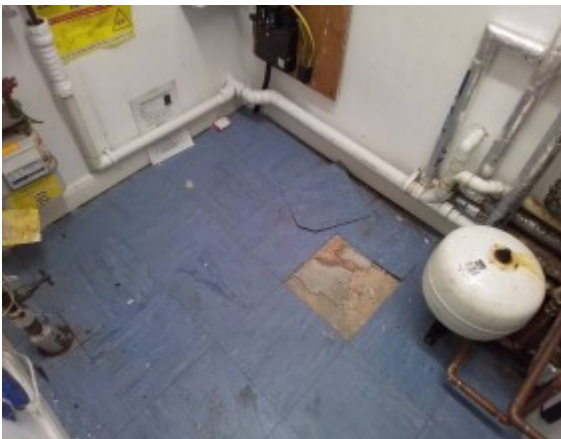
Item 62 Ref: OQ000235

The floor tile in the Plant Room (Rm G/006) does not contain asbestos.

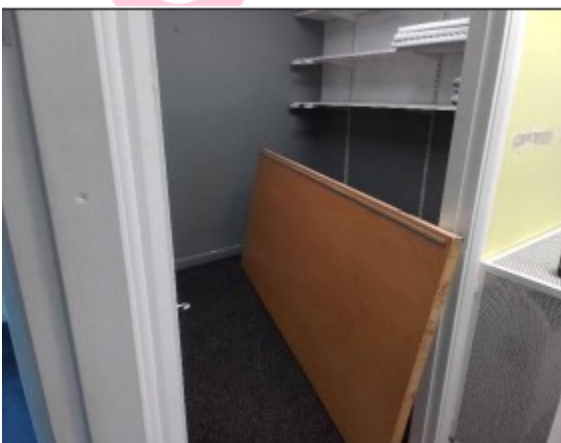
Item 63 Ref: OQ000236

The door – fire door/inner lining – sampled via pre existing holes in the Store Room (Rm G/009) does not contain asbestos.

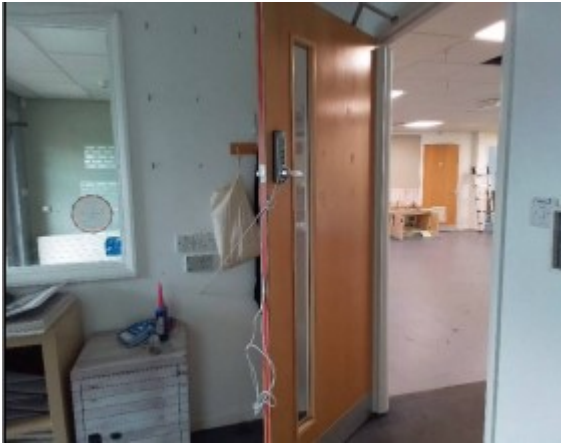
Item 64 Ref: As OQ000236

The door – fire door/inner lining in the Office (Rm G/011) does not contain asbestos.

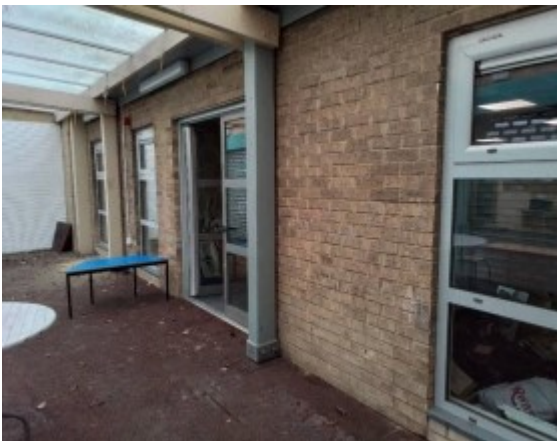
Item 65 Ref: OQ000237

The window putty/seal to frame/wall in the Outhouse (Rm G/013) does not contain asbestos.

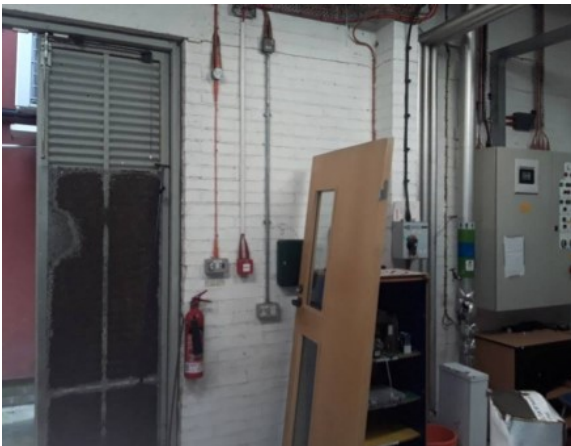
Item 66 Ref: NZ001229

The debris/residue to door wall in the Boiler Room (G/001) does not contain asbestos.

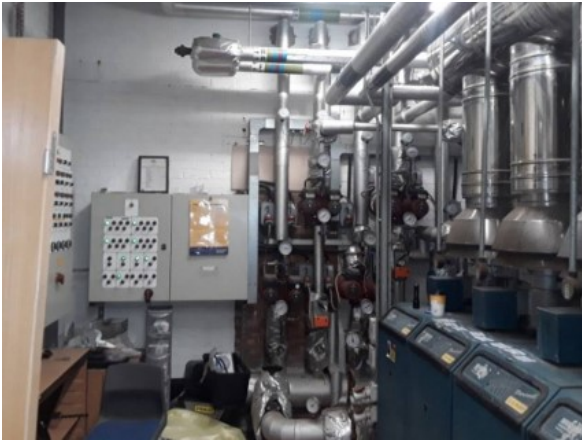
Item 67 Ref: NZ001230

The debris/residue to left hand wall in the Boiler Room (G/001) does not contain asbestos.

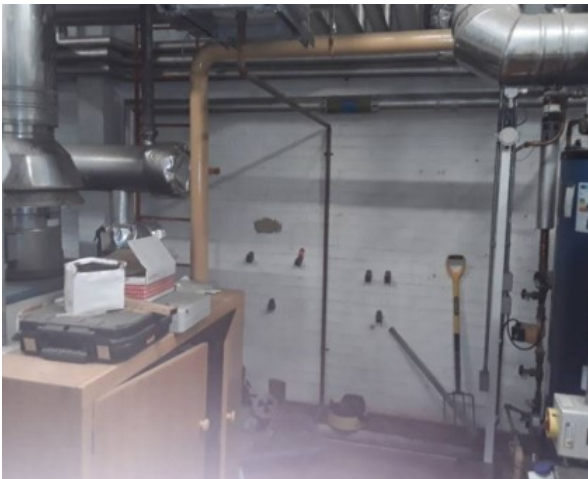
Item 68 Ref: NZ001231

The debris/residue to rear wall behind boilers in the Boiler Room (G/001) does not contain asbestos.

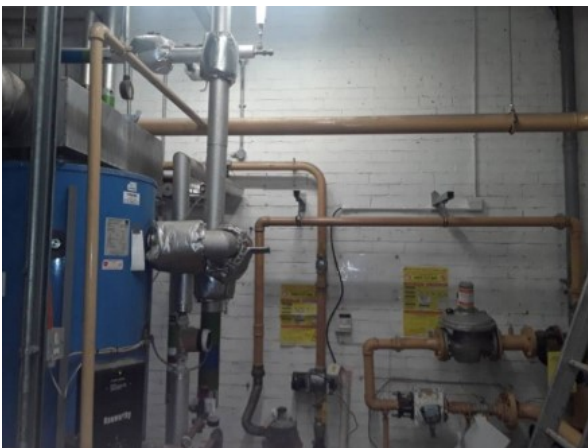
Item 69 Ref: NZ001232

The debris/residue to the right hand wall in the Boiler Room (G/001) does not contain asbestos.

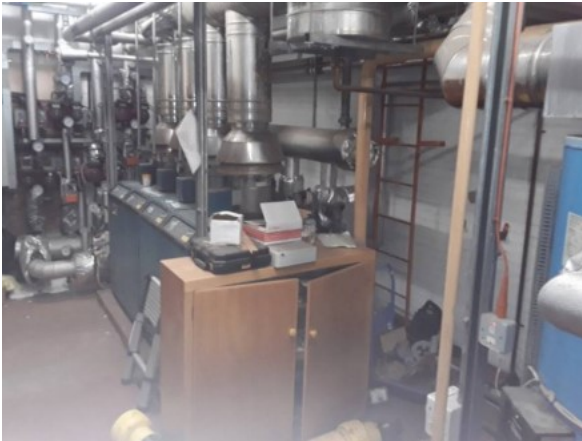
Item 70 Ref: NZ001233

The debris/residue to floor rear of boilers in the Boiler Room (G/001) does not contain asbestos.

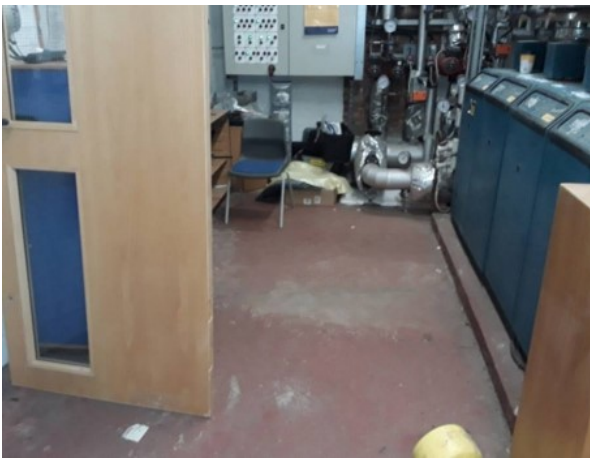
Item 71 Ref: NZ001234

The debris/residue to floor front of boilers in the Boiler Room (G/001) does not contain asbestos.

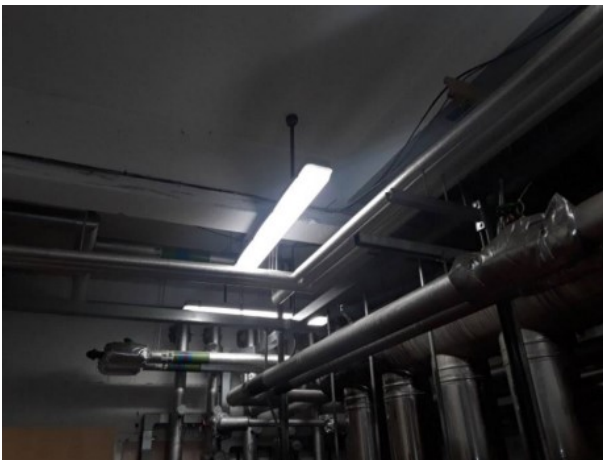
Item 72 Ref: NZ001235

The debris/residue to the ceiling in the Boiler Room (G/001) does not contain asbestos.

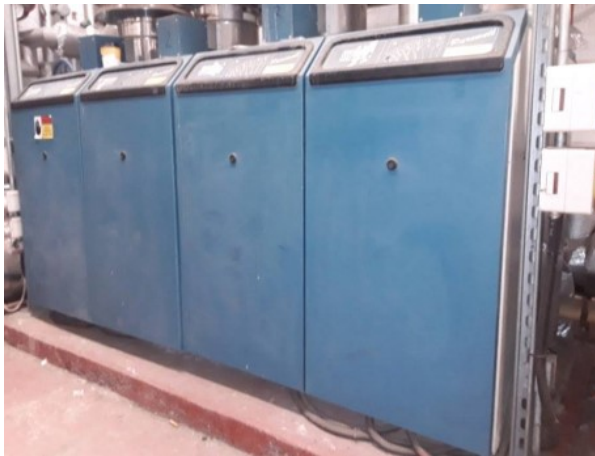
Item 73 Ref: NZ001236

The boiler insulation rope packing to joints x 4 boilers in the Boiler Room (G/001) does not contain asbestos.

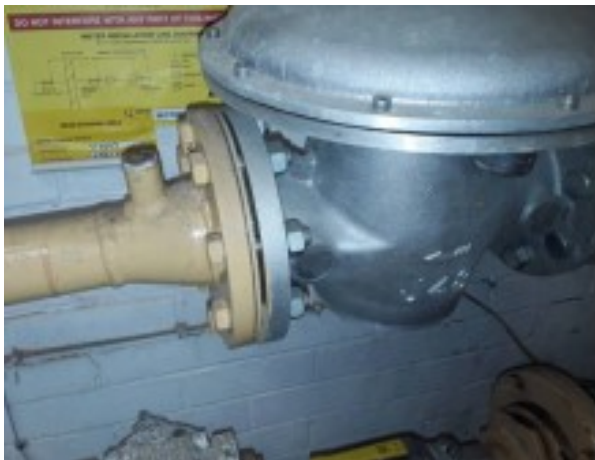
Item 74 Ref: NZ001237

The pipework gaskets to yellow gas pipe in the Boiler Room (G/001) does contain asbestos.

Any change in appearance should be reported to Property Services.

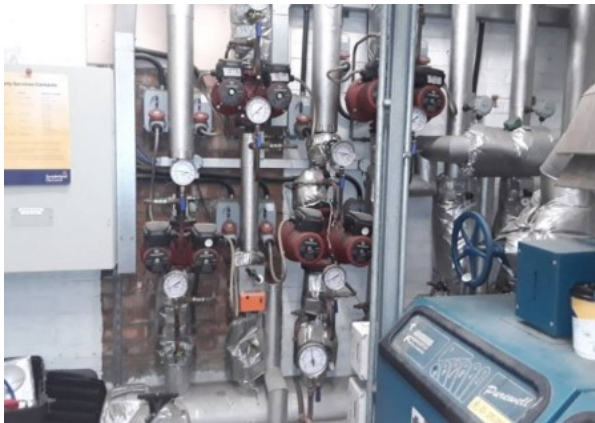
Item 75 Ref: NZ001238

The pipework gaskets to boiler pipework in the Boiler Room (G/001) does not contain asbestos.

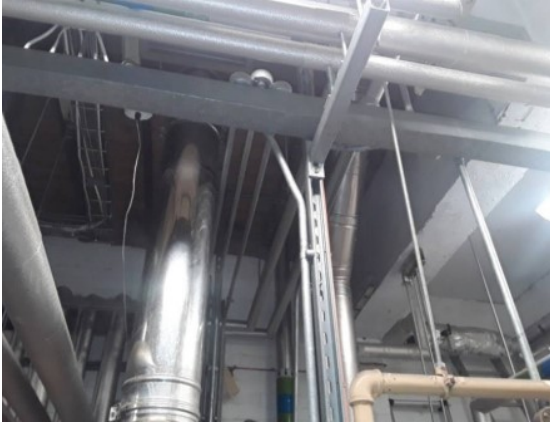
Item 76 Ref: As NZ001239

The debris/residue to pipe hangers below tank room area in the Boiler Room (G/001) does not contain asbestos.

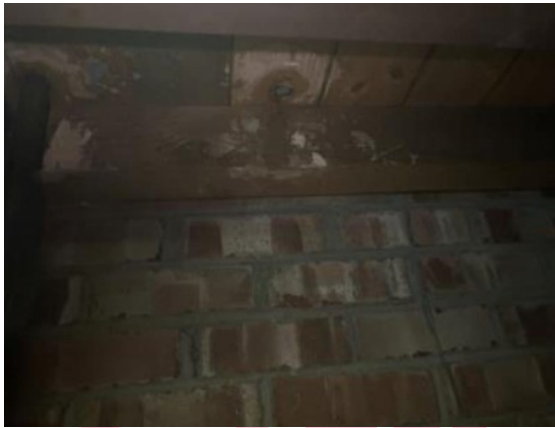
Item 77 Ref: NZ001239

The debris/residue to wall, ceiling penetrations and joists in the Boiler Room (G/001) does not contain asbestos.
