### ASBESTOS SURVEY REPORT FOR HUDSON ROAD PRIMARY SCHOOL –VILLIERS STREET SOUTH, SUNDERLAND

## **Asbestos Register for Hudson Road Primary School**

**Date: 06 July 2026**

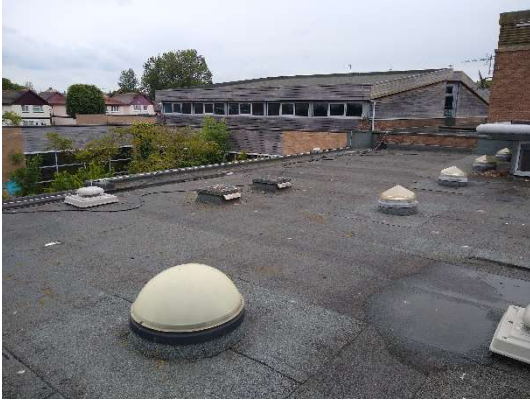
### **Item 1 Ref: 332593-1**

The roof felt to Roof 1 (Nursery) does not contain asbestos.

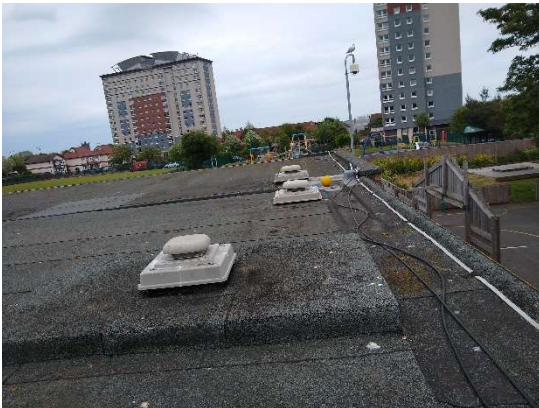
### **Item 2 Ref: 332593-2**

The roof felt to Roof 1 (Nursery) does not contain asbestos.

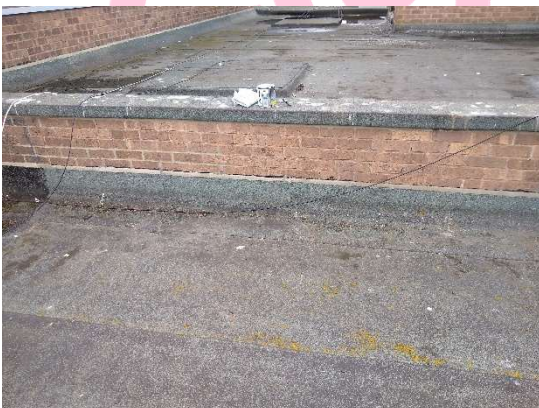
### **Item 3 Ref: As 3325\*93-4**

The damp proof course to flashing to Roof 1 (Nursery) does not contain asbestos.

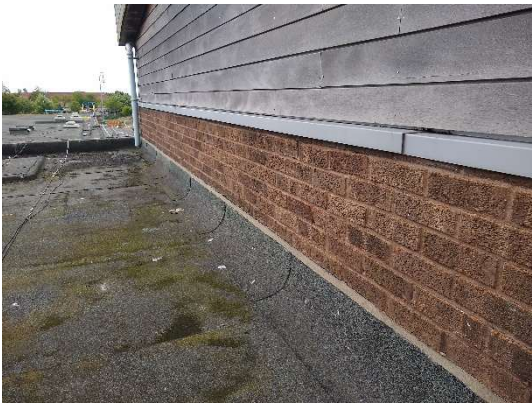
**Item 5 Ref: 332593-4**

The damp proof course to flashing to Roof 3 (Nursery) does not contain asbestos.

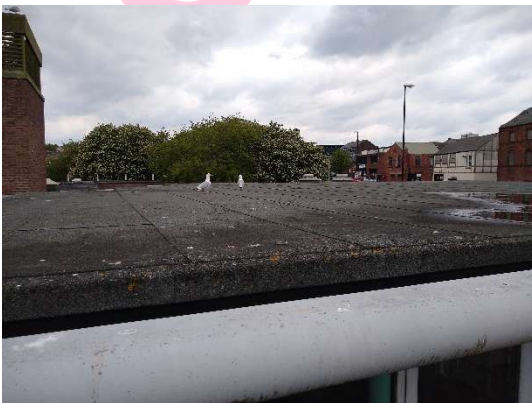
**Item 6 Ref: 332593-7**

The roof felt to Roof 3 (Nursery) does not contain asbestos.

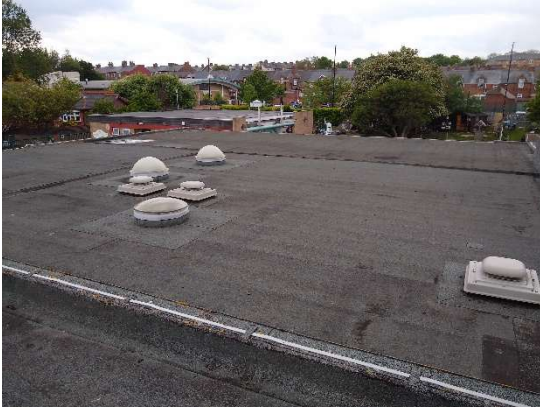
### **Item 13 Ref: 332593-10**

The roof felt to Roof 8 (Nursery) does not contain asbestos.

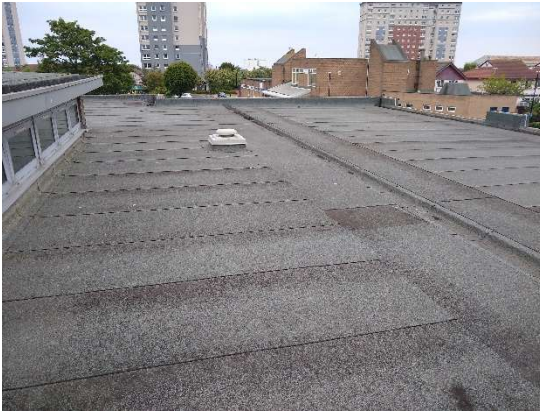
### **Item 14 Ref: 332593-11**

The roof felt to Roof 9 (Nursery) does not contain asbestos.

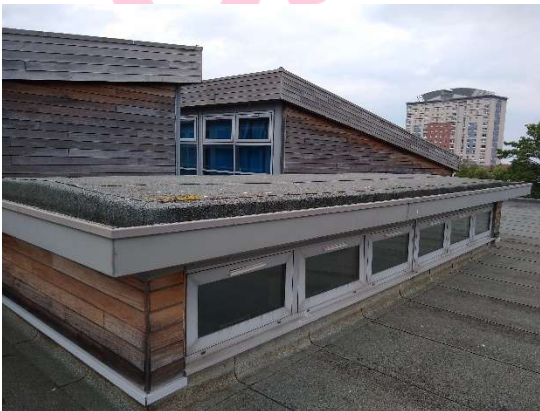
### **Item 15 Ref: 332593-12**

The roof felt to Roof 10 (Nursery) does not contain asbestos.

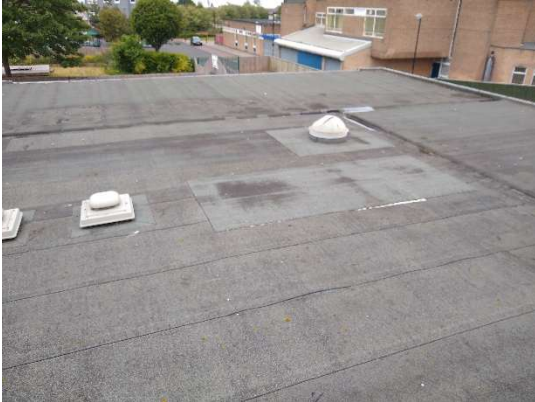
### **Item 16 Ref: 332593-13**

The roof felt to Roof 11 (Nursery) does not contain asbestos.

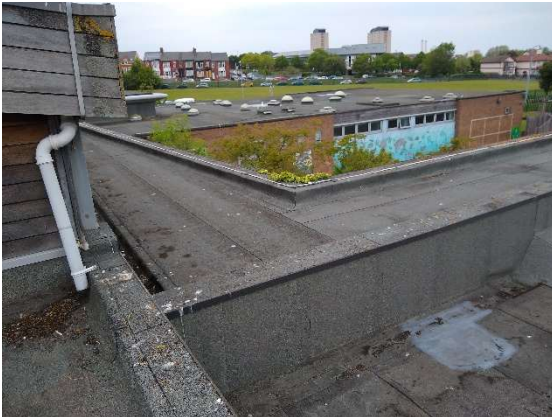
### **Item 17 Ref: 332593-14**

The roof felt to Roof 12 (Nursery) does not contain asbestos.

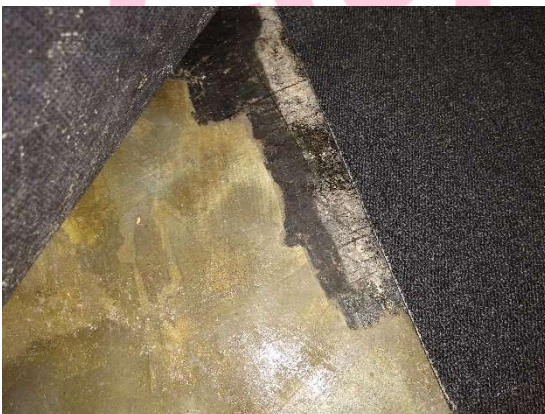
### **Item 18 Ref: As 343523-13**

The Floor screed (014/office 074) does not contain asbestos.

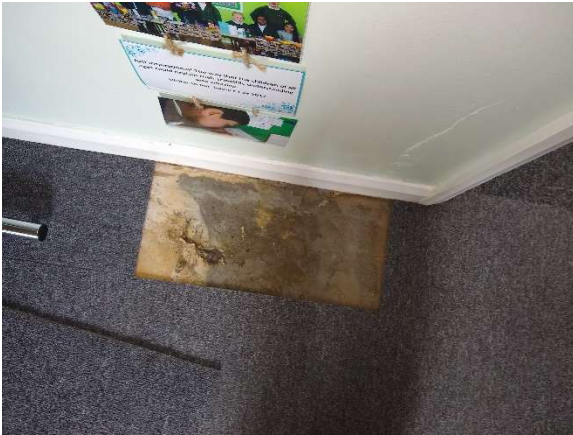
### **Item 19 Ref: 343523-13**

The Floor screed  
(015+106/meeting room)  
(075+076 now one room) does  
not contain asbestos.

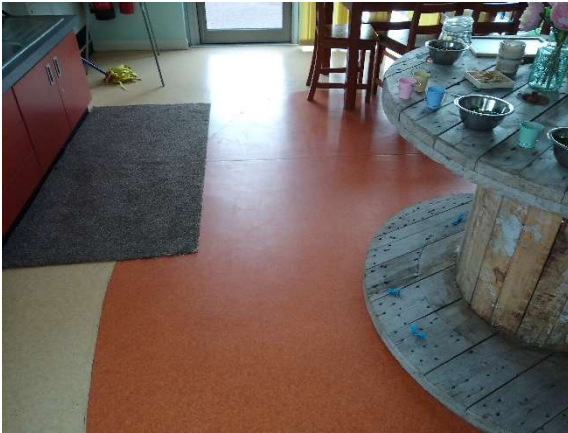
### **Item 20 Ref: 343523-12**

The Floor screed  
(024/childcare 087) does not  
contain asbestos.

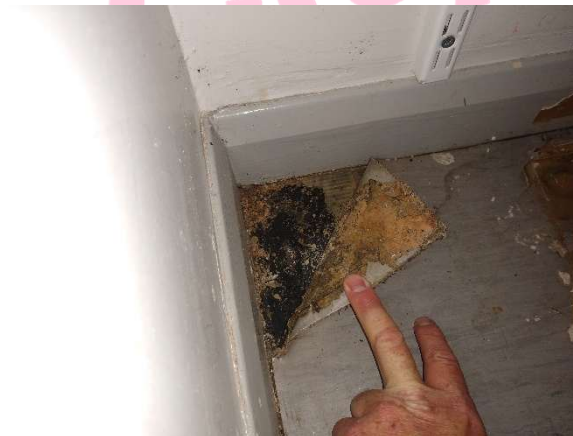
### **Item 21 Ref: As 343523-12**

The Floor screed (025/store  
084) does not contain  
asbestos.

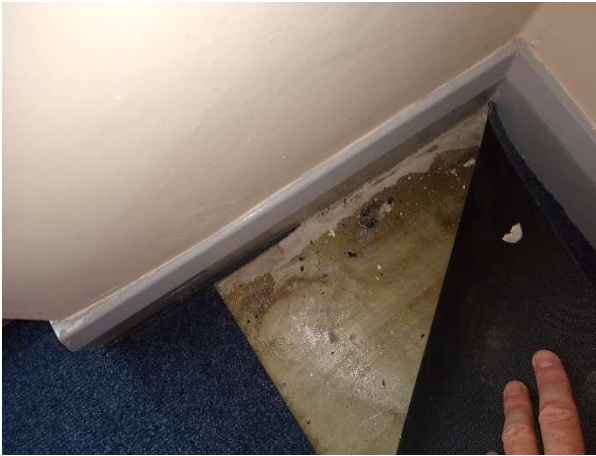
### **Item 22 Ref: As 343523-12**

The Floor screed (027/playroom 088) does not contain asbestos.

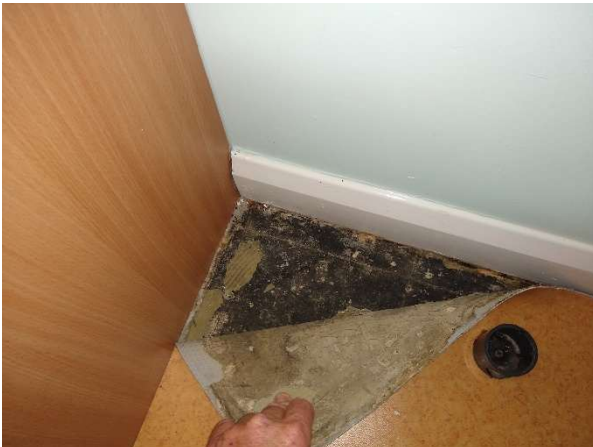
### **Item 23 Ref: As 343523-12**

The Floor screed (028/kitchen 090) does not contain asbestos.

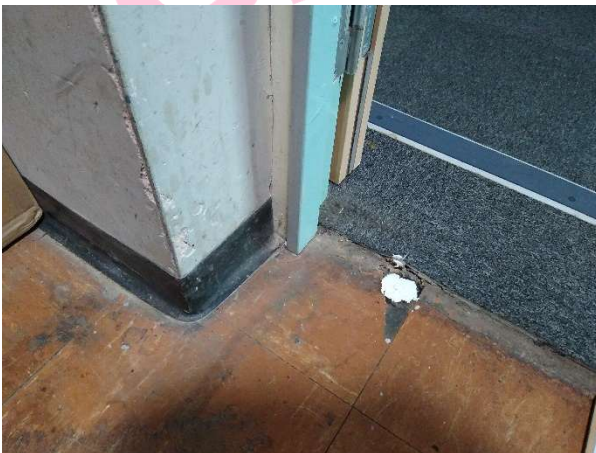
### **Item 24 Ref: 343523-16**

- (Item 23) Ref: As 343523-12 Floor screed (028/kitchen 090) – No Risk
- (Item 24) Ref: 343523-16 Floor covering (031/electric cupboard 064) – Very Low Risk

The Floor covering (031/electric cupboard 064) contains asbestos.

Any change in appearance should be reported to Property Services.

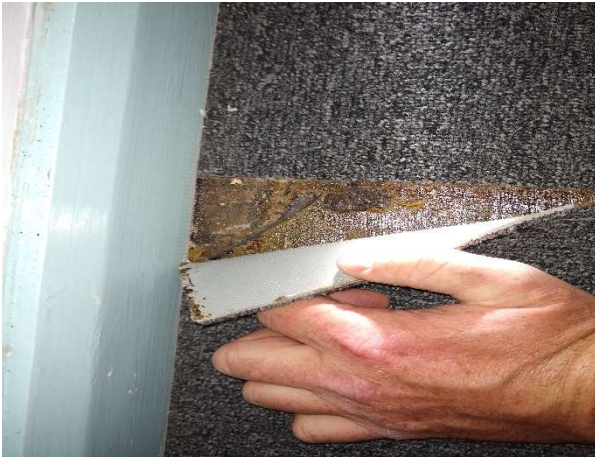
### **Item 25 Ref: 343523-10**

The Floor screed (032/corridor 061) does not contain asbestos.

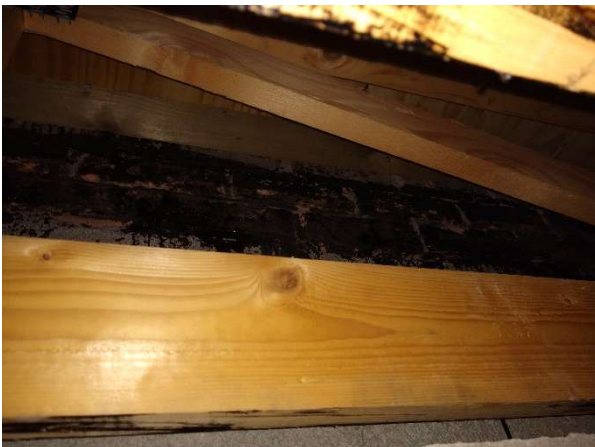
### **Item 26 Ref: 192371-3**

The Remnant debris to former ceiling line (035/corridor-ceiling void) does not contain asbestos.

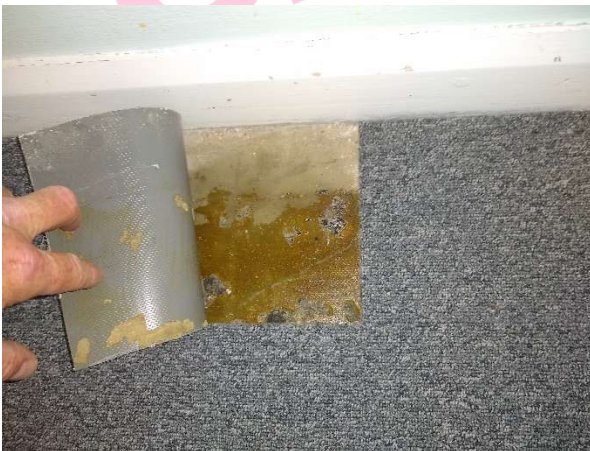
### **Item 27 Ref: 343523-9**

The Floor screed (038/classroom 059) does not contain asbestos.

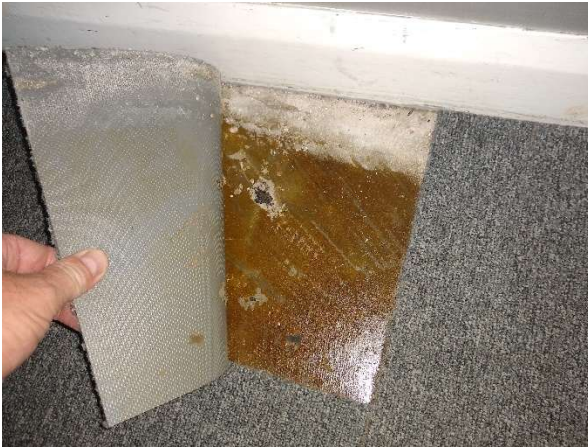
**Item 28 Ref: 343523-8**

The Floor screed  
(040/classroom 057) does not  
contain asbestos.

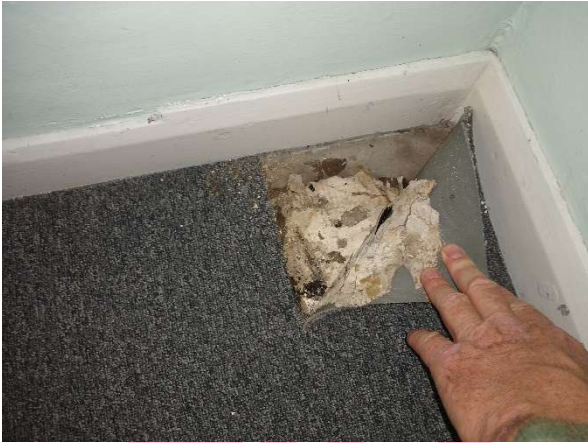
**Item 29 Ref: As 343523-8**

The Floor screed  
(042/classroom 054) does not  
contain asbestos.

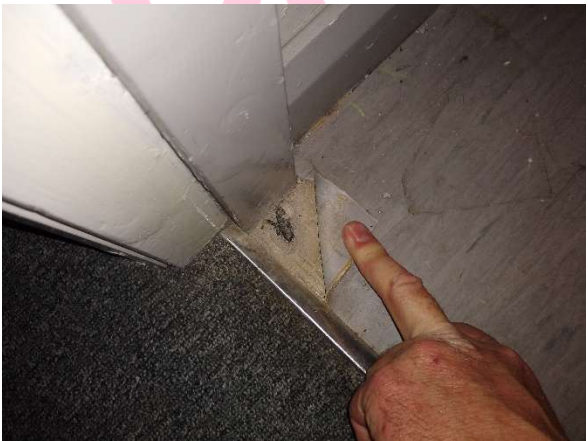
**Item 30 Ref: As 343523-9**

The Floor screed  
(048/classroom 055) does not  
contain asbestos.

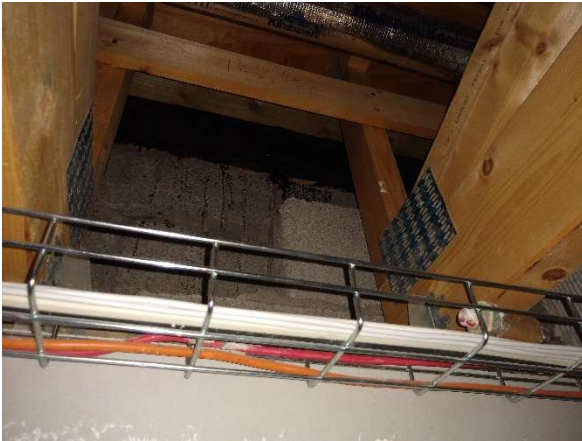
### **Item 31 Ref: 343523-7**

The Remains of old roof line (048/corridor 060-ceiling void) does not contain asbestos.

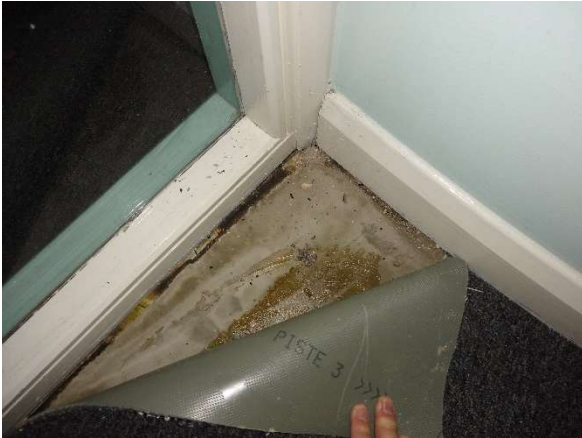
### **Item 32 Ref: 343523-6**

The Screed (049/IT Suite 046) does not contain asbestos.

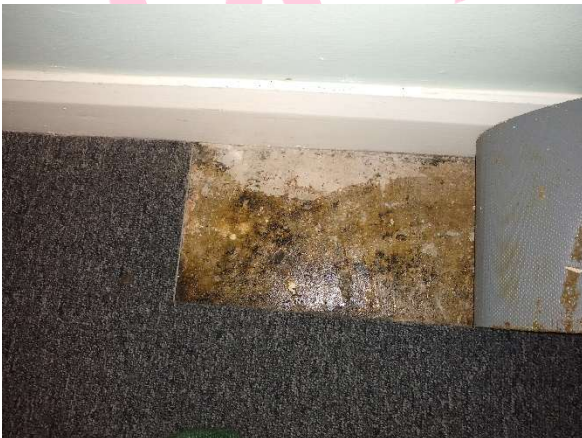
### **Item 33 Ref: 343523-8**

The Floor screed (053/classroom 044) does not contain asbestos.

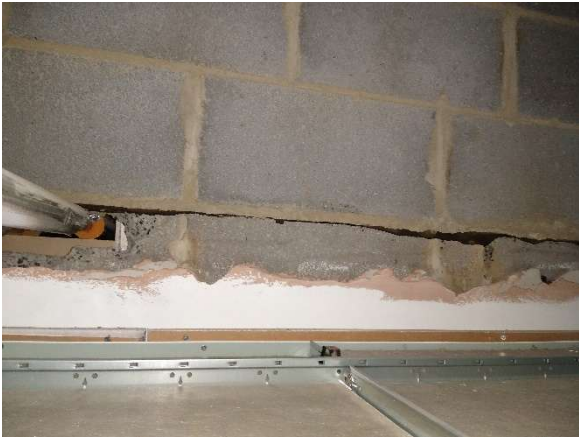
### **Item 34 Ref: 343523-7**

The Old roof felt (060/corridor 26-ceiling void) does not contain asbestos.

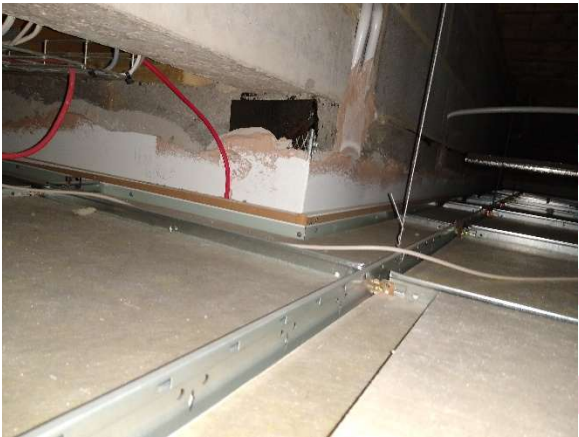
### **Item 35 Ref: As 343523-5**

The Packer to wall at external corner (060/corridor 26-ceiling void) does not contain asbestos.

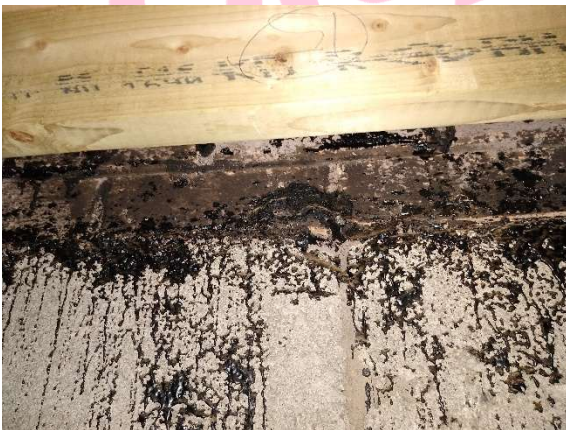
### **Item 36 Ref: As 343523-7**

The Damp proof course (060/corridor 26-ceiling void) does not contain asbestos.

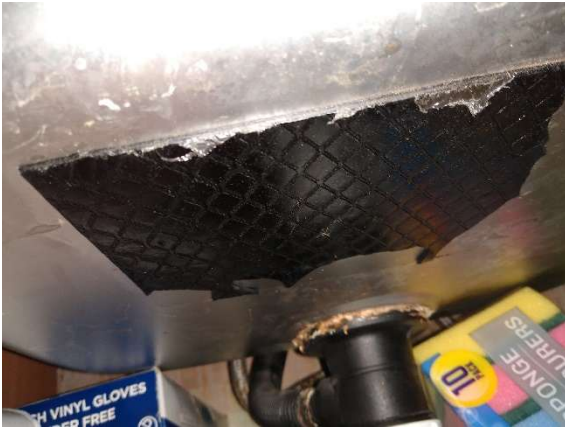
### **Item 37 Ref: 343523-3**

The Sink pad (064/classroom 23) does not contain asbestos.

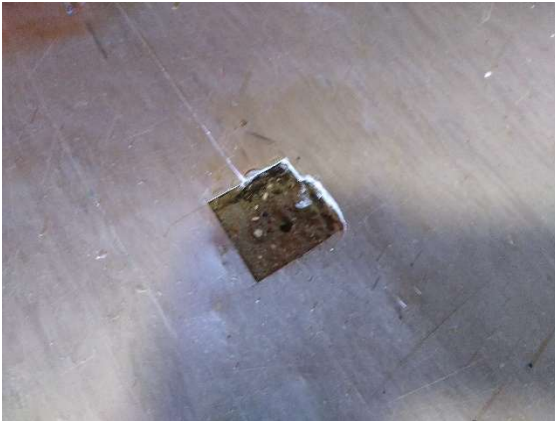
### **Item 38 Ref: 343523-4**

The Screed (056/classroom store 24) does not contain asbestos.

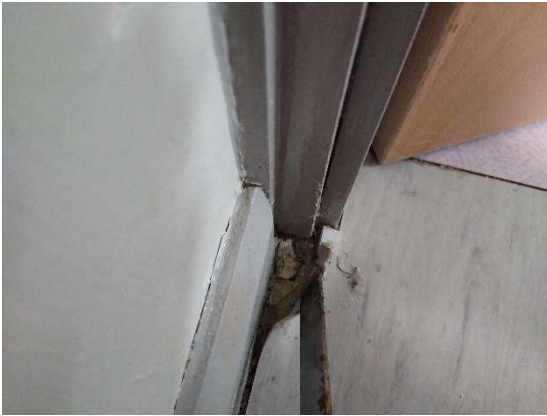
### **Item 40 Ref: As 343523-1**

The Screed (067/classroom 022) does not contain asbestos.

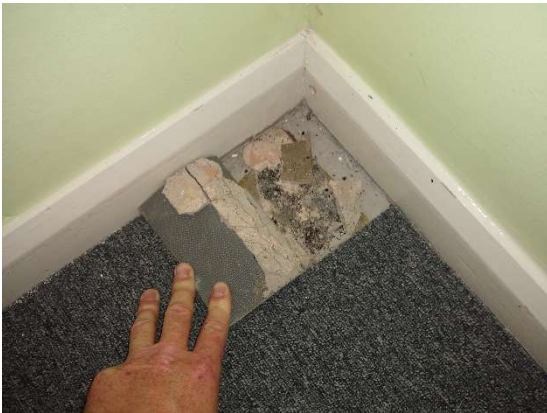
### **Item 41 Ref: 343523-2**

- (Item 40) Ref: As 343523-1 Screed (067/classroom 022) – No Risk
- (Item 41) Ref: 343523-2 Screed (068/classroom) – Very Low Risk

The Screed (068/classroom) contains asbestos.

Any change in appearance should be reported to Property Services.

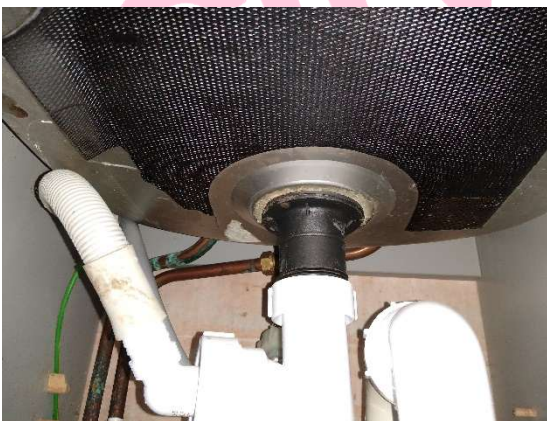
### **Item 42 Ref: As 343523-5**

The Sink pad (088/kitchen 009) does not contain asbestos.

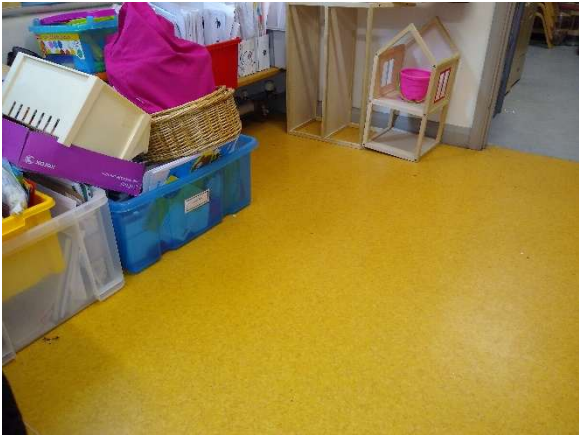
### **Item 43 Ref: 343523-11**

The Floor screed (090/store 003) does not contain asbestos.

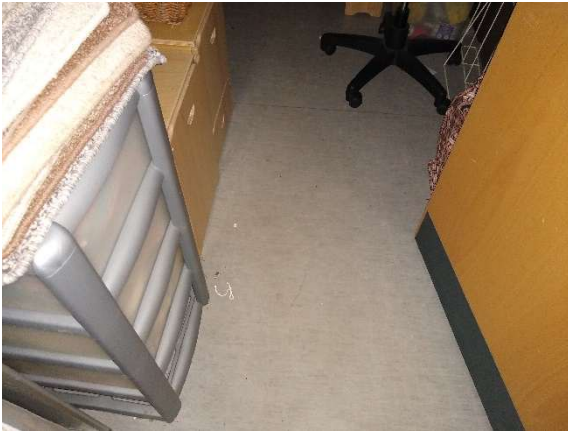
### **Item 44 Ref: As 343523-11**

The Floor screed (091/boiler cupboard 004) does not contain asbestos.

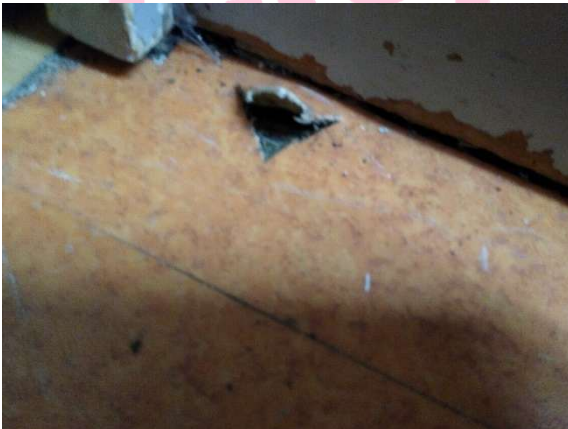
### **Item 45 Ref: 343523-17**

The Screed (100/PE store 39) does not contain asbestos.

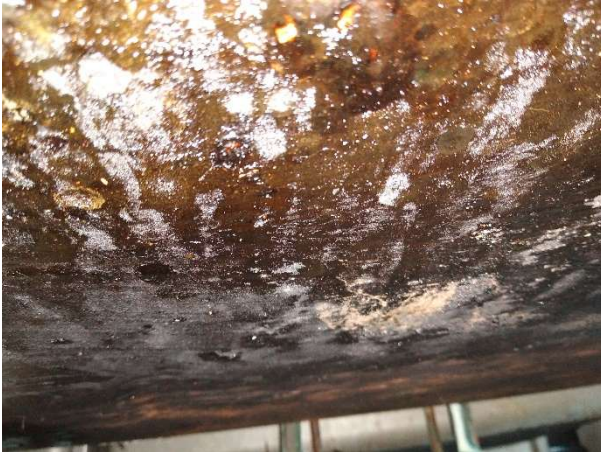
**Item 47 Ref: 343523-18**

The Sink pad paint  
(103/kitchen 036) does not  
contain asbestos.

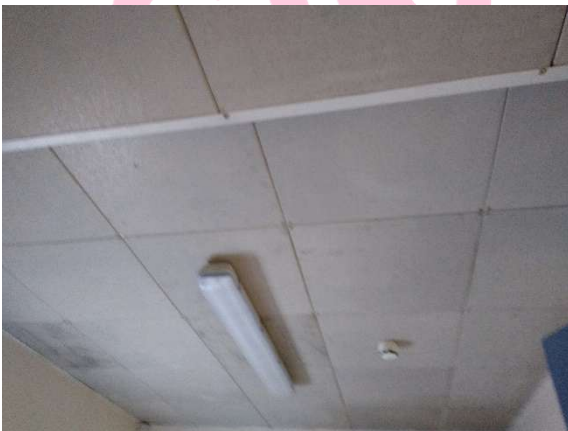
**Item 48 Ref: 192371-6**

The Suspended ceiling  
(111/kitchen office 034)  
previously room 106 does not  
contain asbestos.

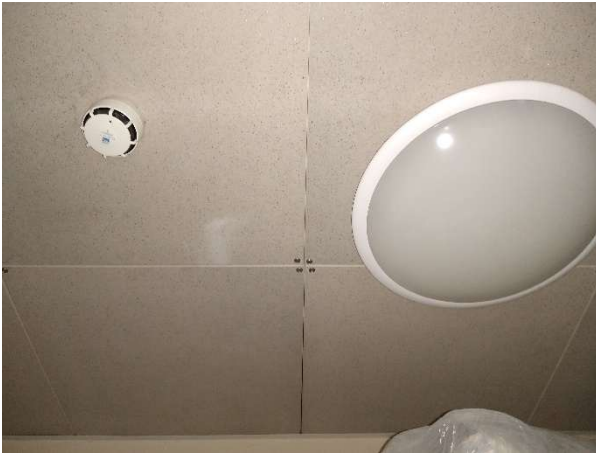
**Item 49 Ref: As 192371-6**

The Suspended ceiling  
(112/kitchen store 035)  
previously room 107 does not  
contain asbestos.

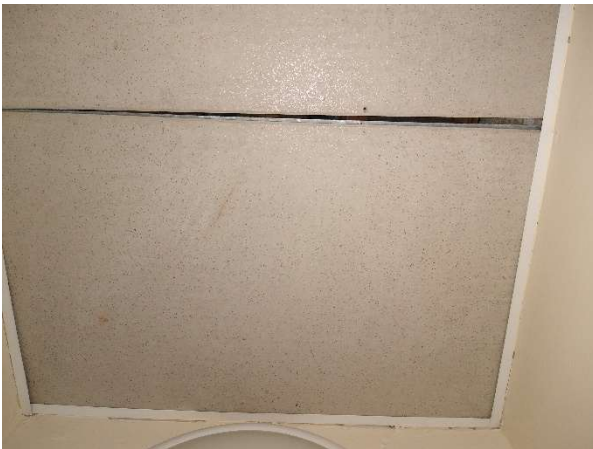
**Item 50 Ref: As 192371-6**

The Suspended ceiling  
(115/kitchen wc lobby 032)  
previously room 105 does not  
contain asbestos.

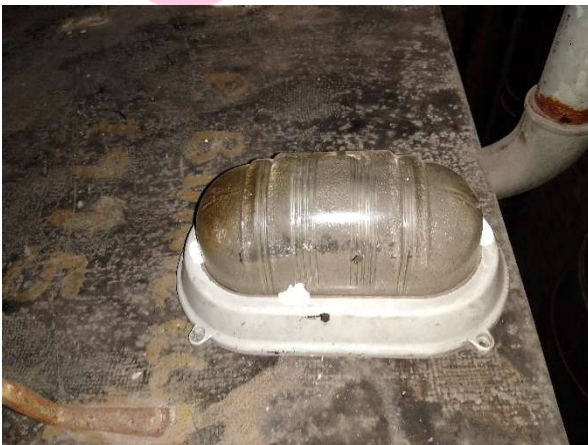
**Item 51 Ref: 343523-19**

The Sealant to loose lying bulk  
head on top of tank (110/tank  
room) contains asbestos.

*Removed July 2023*

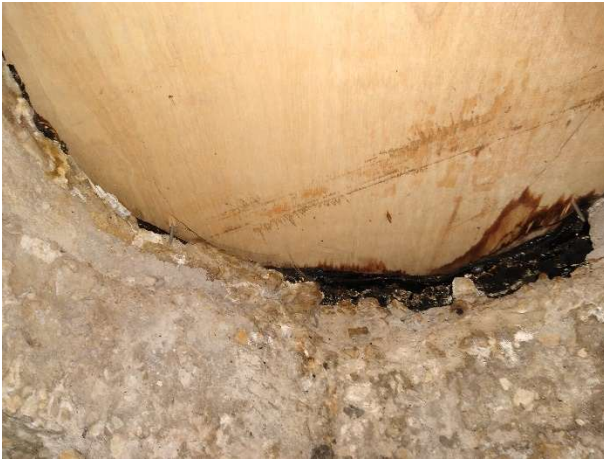
### **Item 52 Ref: 343523-20**

The Roofing felt to old penetration (110/tank room) does not contain asbestos.

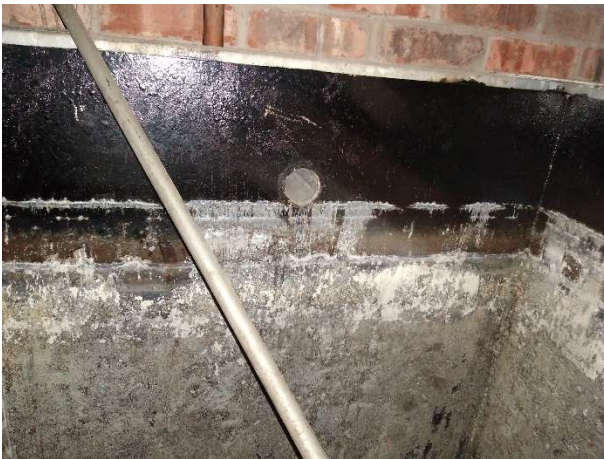
### **Item 53 Ref: 343523-21**

The Coating to inside of tank (110/tank room) does not contain asbestos.

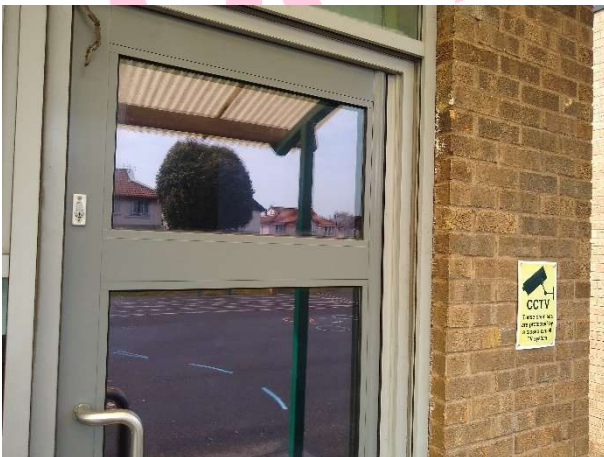
### **Item 54 Ref: 343523-14**

- (Item 54) Ref: 343523-14 Old mastic to external door of 0/064 (externals) – Very Low Risk
- (Item 55) Ref: 343523-15 Old mastic to external door of 038+040 (externals) – Very Low Risk

The Old mastic to external door of 0/064 (externals) contains asbestos.

Any change in appearance should be reported to Property Services.

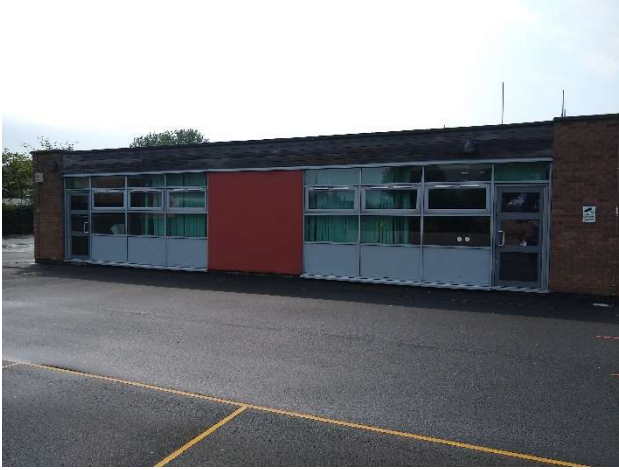
### **Item 55 Ref: 343523-15**

The Old mastic to external door of 038+040 (externals) does contain asbestos.

Any change in appearance should be reported to Property Services.

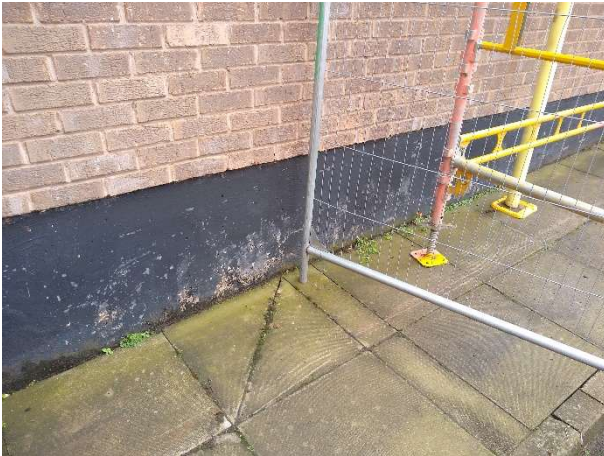
### **Item 56 Ref: 343523-23**

The Paint to concrete slab (externals) does not contain asbestos.

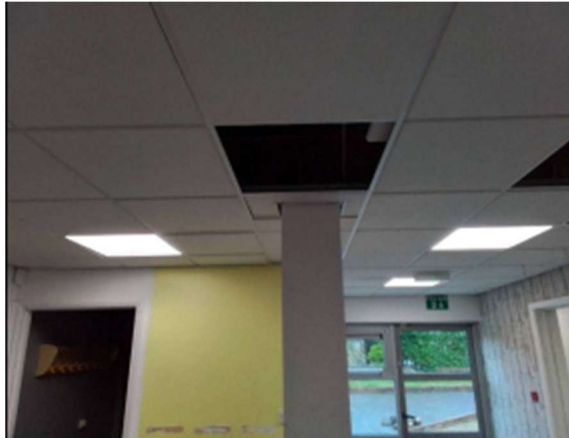
### **Item 58 Ref: OQ000231**

The column cladding – inner layer in the Large Room (Rm G/002) does not contain asbestos.

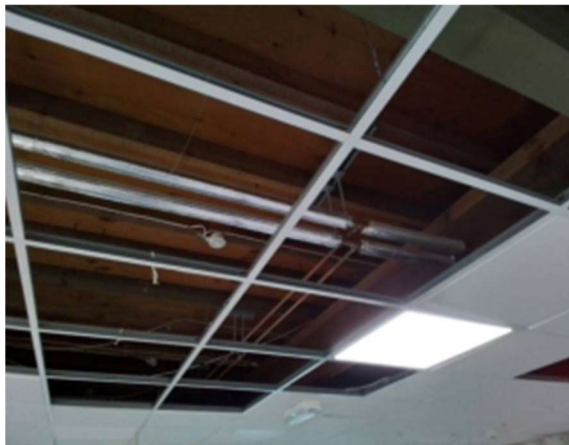
### **Item 59 Ref: OQ000232**

The ceiling void – pipe insulation in the Large Room (Rm G/002) does not contain asbestos.

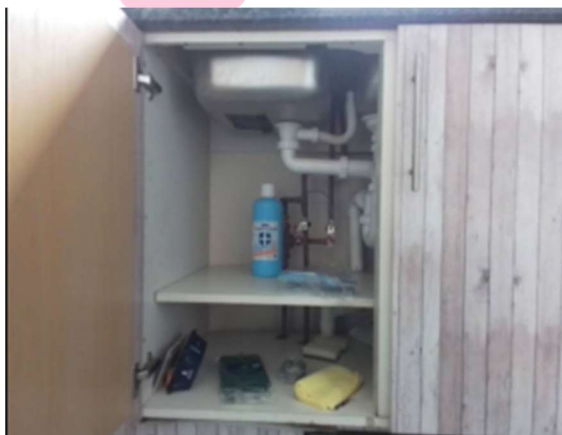
### **Item 60 Ref: OQ000233**

The under sink mat in the Kitchen (Rm G/003) does not contain asbestos.

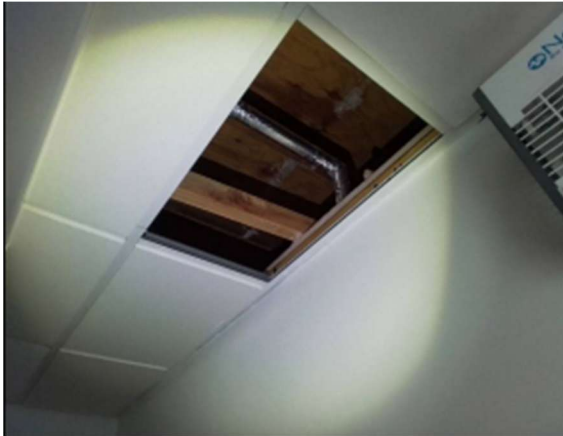
### **Item 61 Ref: OQ000234**

The ceiling void - debris in the Kitchen (Rm G/003) does not contain asbestos.

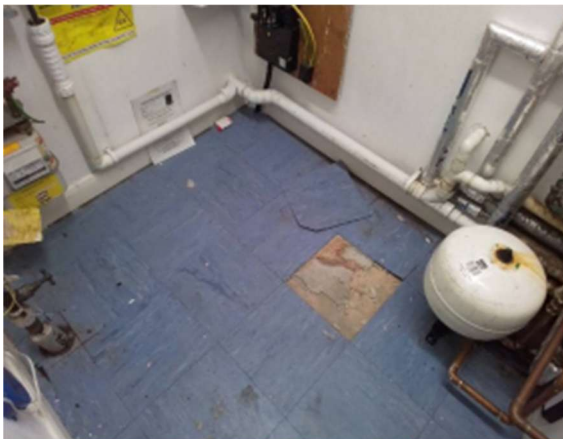
### **Item 62 Ref: OQ000235**

The floor tile in the Plant Room (Rm G/006) does not contain asbestos.

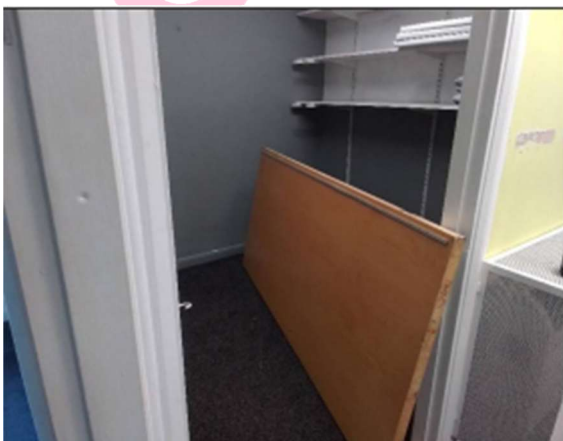
### **Item 63 Ref: OQ000236**

The door – firedoor/inner lining – sampled via pre existing holes in the Store Room (Rm G/009) does not contain asbestos.

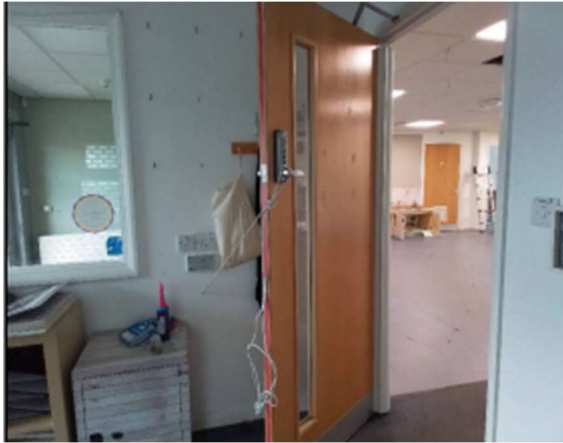
### **Item 64 Ref: As OQ000236**

The door – fire door/inner lining in the Office (Rm G/011) does not contain asbestos.

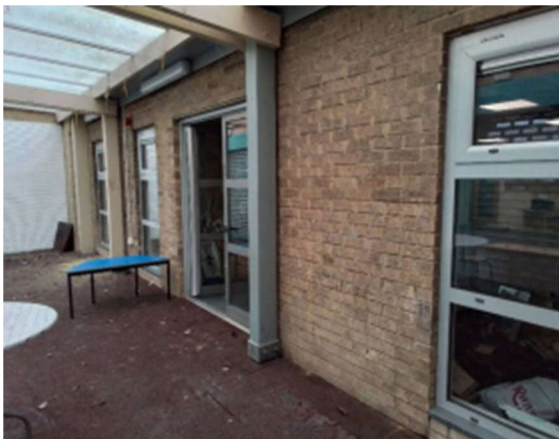
### **Item 65 Ref: OQ000237**

The window putty/seal to frame/wall in the Outhouse (Rm G/013) does not contain asbestos.

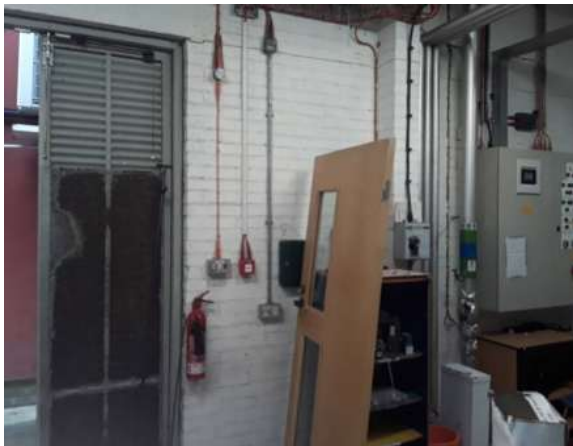
### **Item 66 Ref: NZ001229**

The debris/residue to door wall in the Boiler Room (G/001) does not contain asbestos.

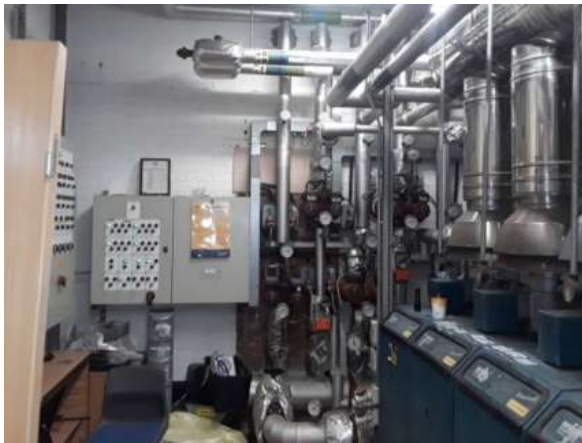
### **Item 67 Ref: NZ001230**

The debris/residue to left hand wall in the Boiler Room (G/001) does not contain asbestos.

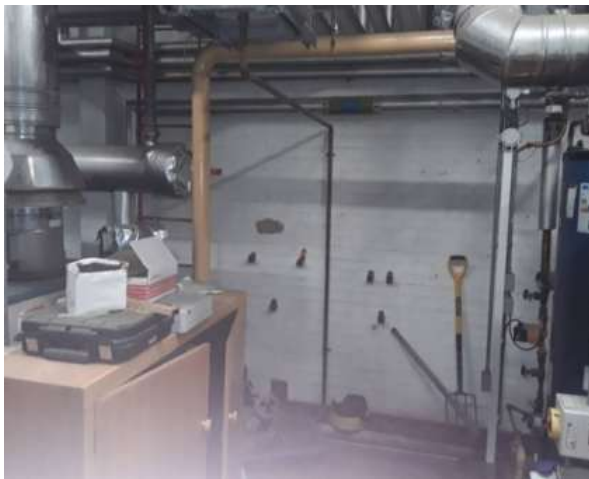
### **Item 68 Ref: NZ001231**

The debris/residue to rear wall behind boilers in the Boiler Room (G/001) does not contain asbestos.

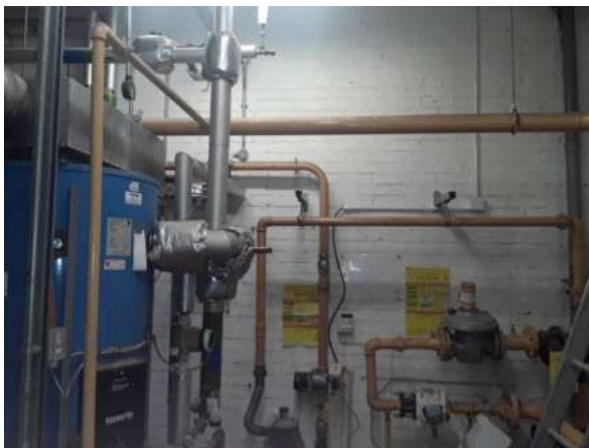
### **Item 69 Ref: NZ001232**

The debris/residue to the right hand wall in the Boiler Room (G/001) does not contain asbestos.

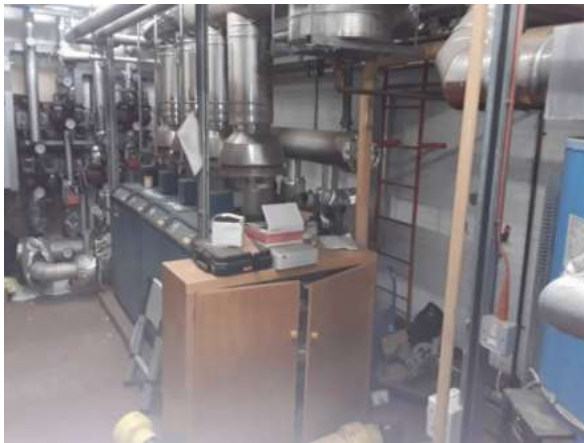
### **Item 70 Ref: NZ001233**

The debris/residue to floor rear of boilers in the Boiler Room (G/001) does not contain asbestos.

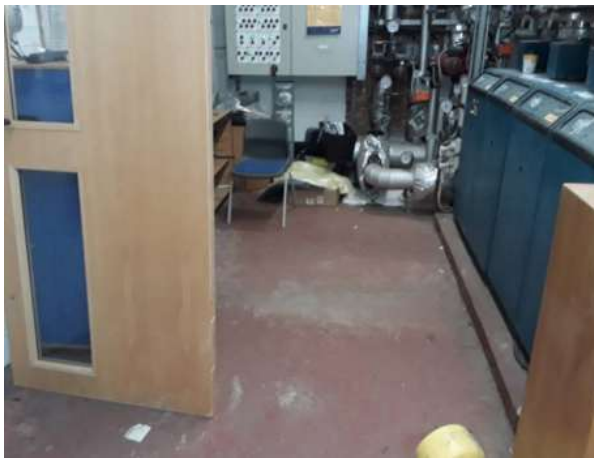
### **Item 71 Ref: NZ001234**

The debris/residue to floor front of boilers in the Boiler Room (G/001) does not contain asbestos.

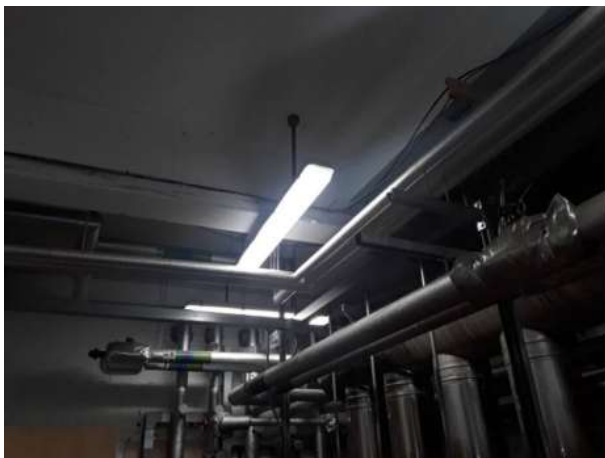
### **Item 72 Ref: NZ001235**

The debris/residue to the ceiling in the Boiler Room (G/001) does not contain asbestos.

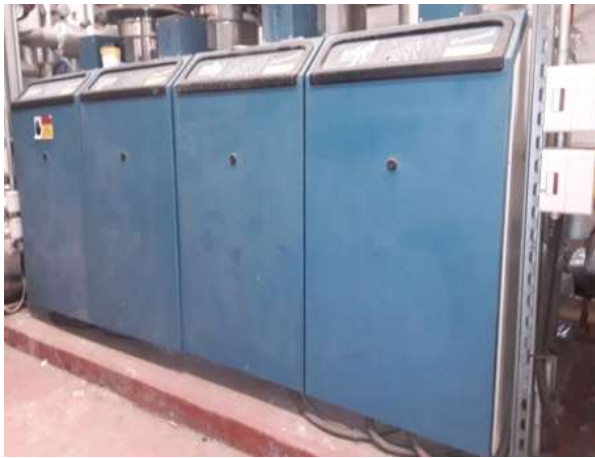
### **Item 73 Ref: NZ001236**

The boiler insulation rope packing to joints x 4 boilers in the Boiler Room (G/001) does not contain asbestos.

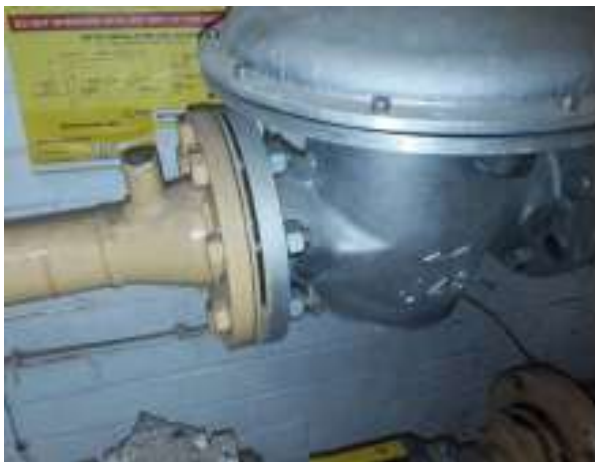
### **Item 74 Ref: NZ001237**

The pipework gaskets to yellow gas pipe in the Boiler Room (G/001) does contain asbestos.

Any change in appearance should be reported to Property Services.

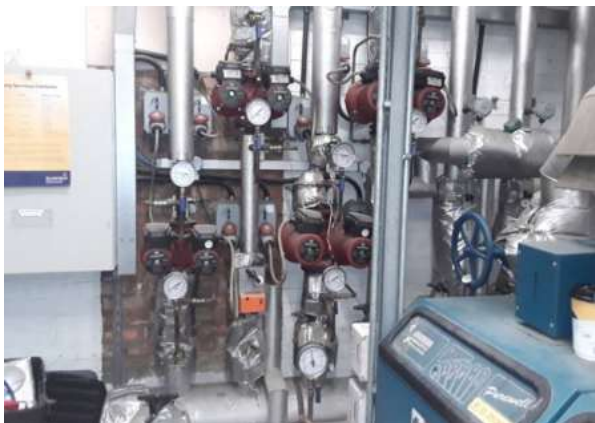
### **Item 75 Ref: NZ001238**

The pipework gaskets to boiler pipework in the Boiler Room (G/001) does not contain asbestos.

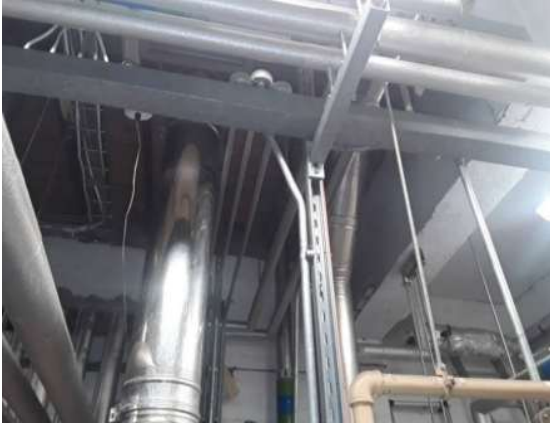
### **Item 76 Ref: As NZ001239**

The debris/residue to pipe hangers below tank room area in the Boiler Room (G/001) does not contain asbestos.

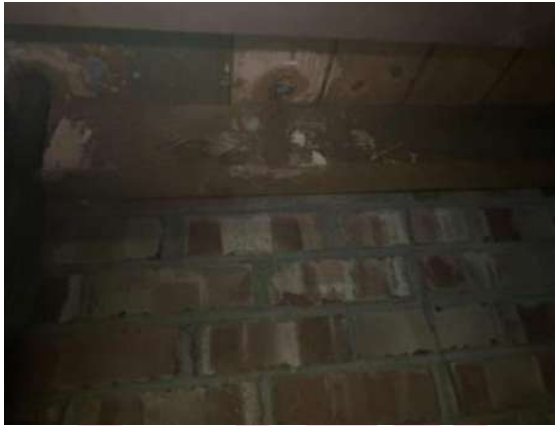
### **Item 77 Ref: NZ001239**

The debris/residue to wall, ceiling penetrations and joists in the Boiler Room (G/001) does not contain asbestos.

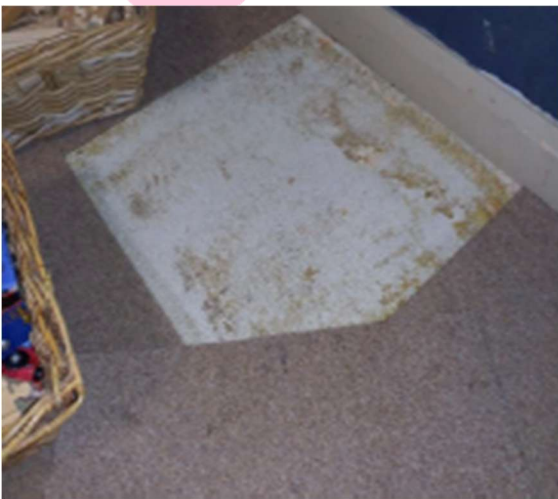
### **Item 78 Ref: RO002961**

The adhesive to the floor in the Reception Reading Room (G/001) does not contain asbestos.

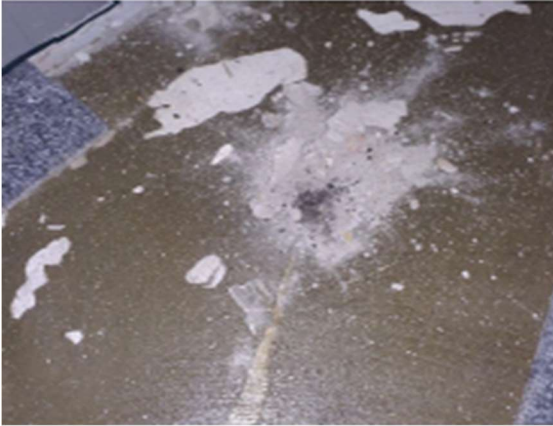
**Item 79 Ref: RO002962**

The bitumen screed to the floor in Nursery Quiet Room (G/002) does not contain asbestos.
