ASBESTOS SURVEY REPORT FOR HUDSON ROAD PRIMARY SCHOOL –VILLIERS STREET SOUTH, SUNDERLAND

Asbestos Register for Hudson Road Primary School

Date: 10 September 2024

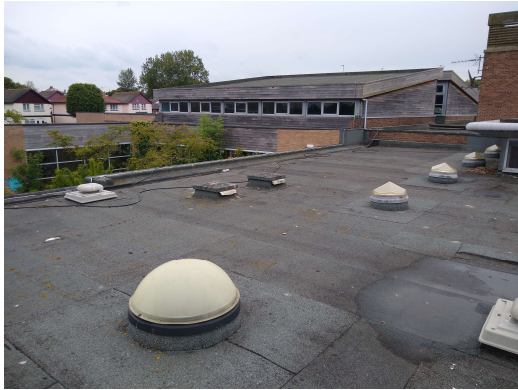
Item 1 Ref: 332593-1

The roof felt to Roof 1 (Nursery) does not contain asbestos.

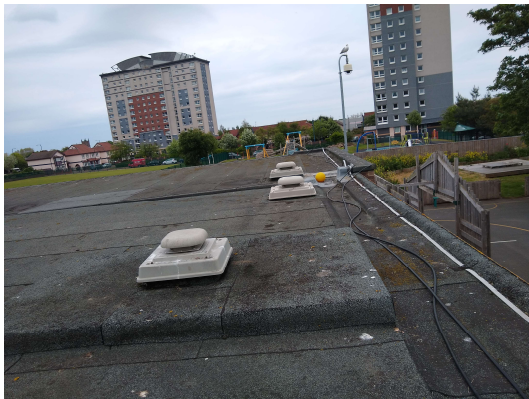
Item 2 Ref: 332593-2

The roof felt to Roof 1 (Nursery) does not contain asbestos.

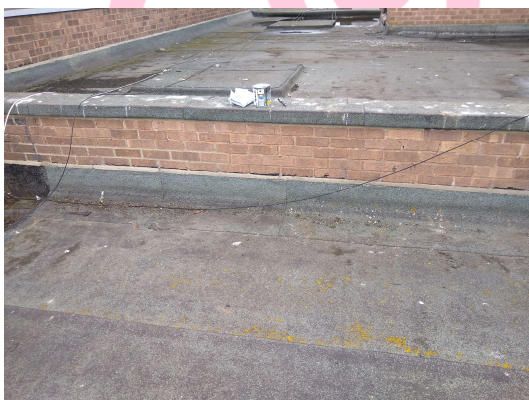
Item 3 Ref: As 3325*93-4

The damp proof course to flashing to Roof 1 (Nursery) does not contain asbestos.

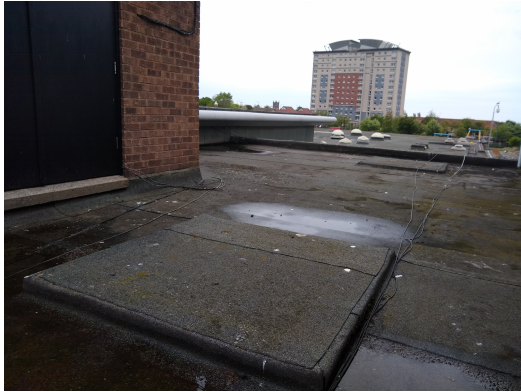
Item 4 Ref: 332593-3

The roof felt to Roof 3 (Nursery) does not contain asbestos.

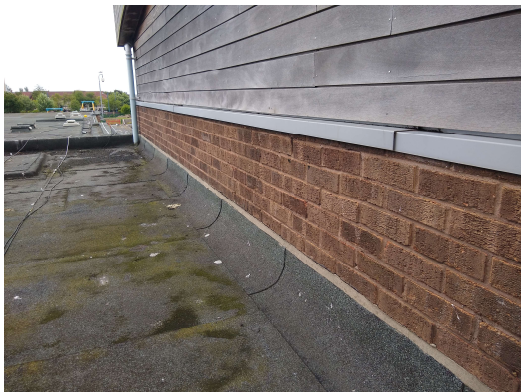
Item 5 Ref: 332593-4

The damp proof course to flashing to Roof 3 (Nursery) does not contain asbestos.

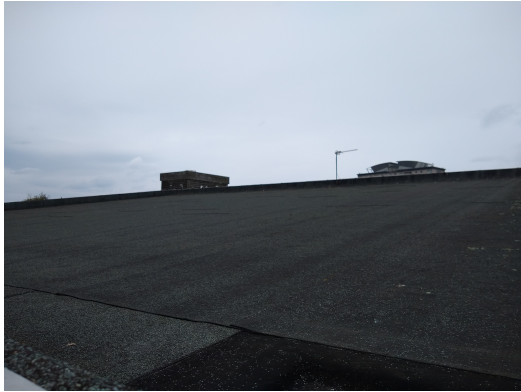
Item 7 Ref: 332593-5

The roof felt to Roof 4 (Nursery) does not contain asbestos.

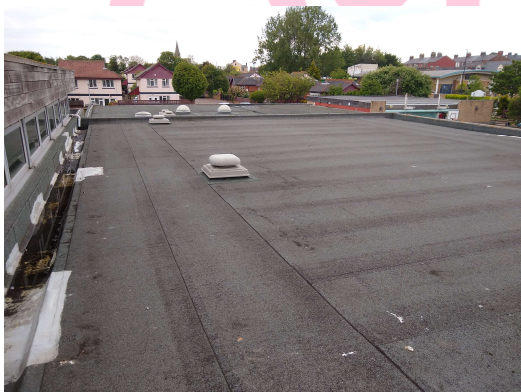
Item 12 Ref: 332593-9

The roof felt to Roof 7 (Nursery) does not contain asbestos.

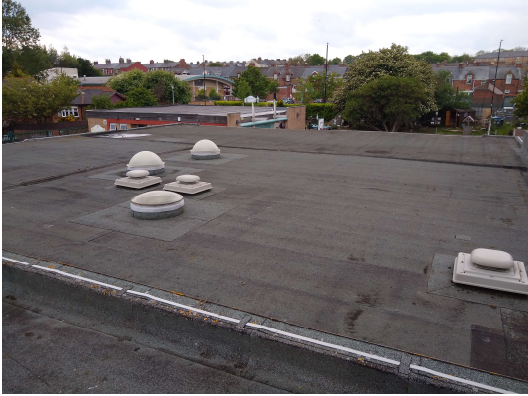
Item 13 Ref: 332593-10

The roof felt to Roof 8 (Nursery) does not contain asbestos.

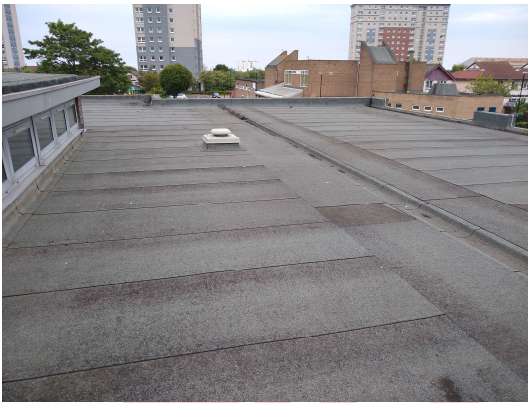
Item 14 Ref: 332593-11

The roof felt to Roof 9 (Nursery) does not contain asbestos.

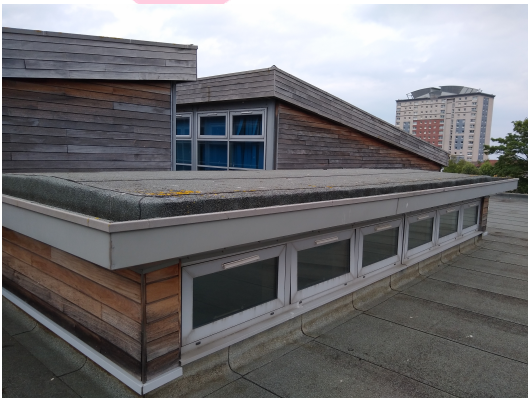
Item 15 Ref: 332593-12

The roof felt to Roof 10 (Nursery) does not contain asbestos.

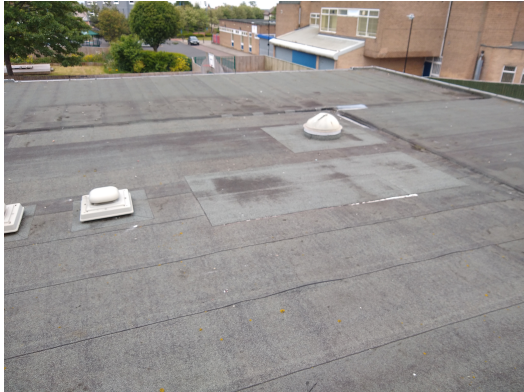
Item 16 Ref: 332593-13

The roof felt to Roof 11 (Nursery) does not contain asbestos.

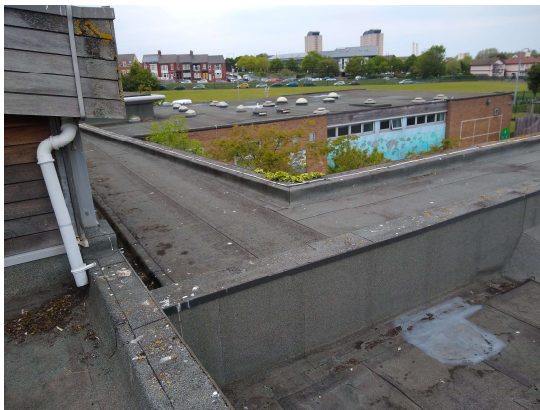
Item 17 Ref: 332593-14

The roof felt to Roof 12 (Nursery) does not contain asbestos.

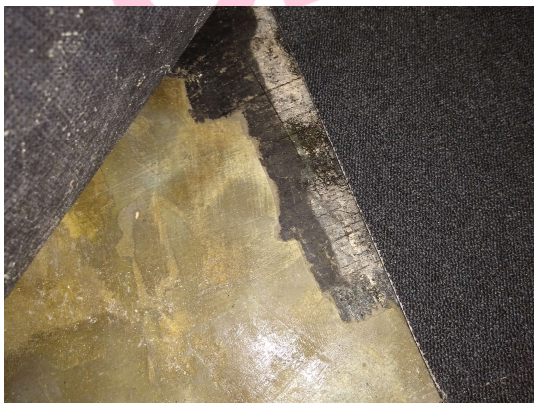
Item 18 Ref: As 343523-13

The Floor screed (014/office 074) does not contain asbestos.

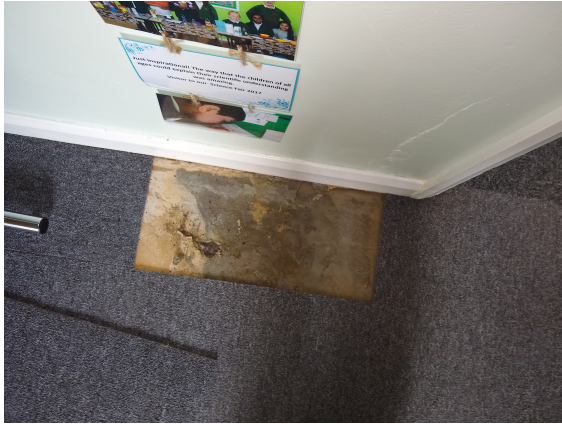
Item 19 Ref: 343523-13

The Floor screed
(015+106/meeting room)
(075+076 now one room) does
not contain asbestos.

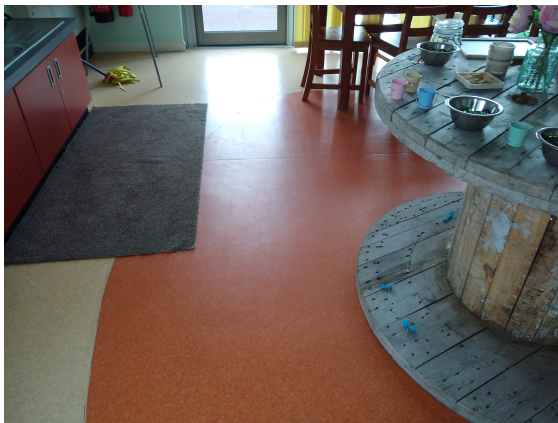
Item 20 Ref: 343523-12

The Floor screed
(024/childcare 087) does not
contain asbestos.

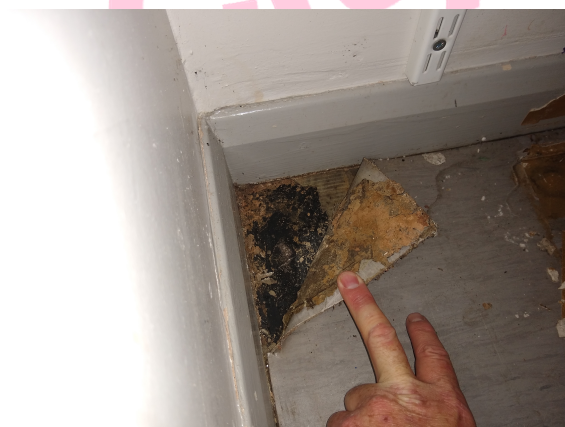
Item 21 Ref: As 343523-12

The Floor screed (025/store
084) does not contain
asbestos.

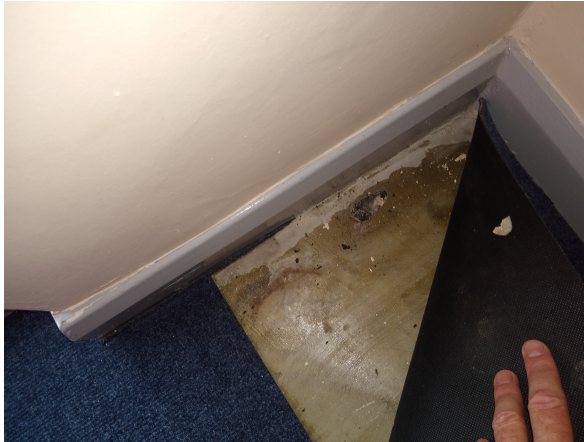
Item 22 Ref: As 343523-12

The Floor screed (027/playroom 088) does not contain asbestos.

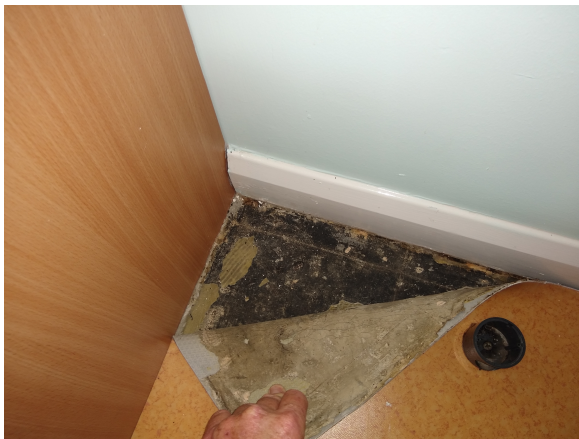
Item 23 Ref: As 343523-12

The Floor screed (028/kitchen 090) does not contain asbestos.

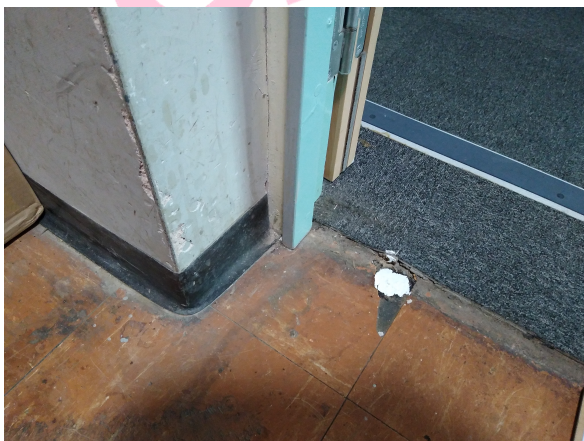
Item 24 Ref: 343523-16

The Floor covering (031/electric cupboard 064) contains asbestos.

Any change in appearance should be reported to Property Services.

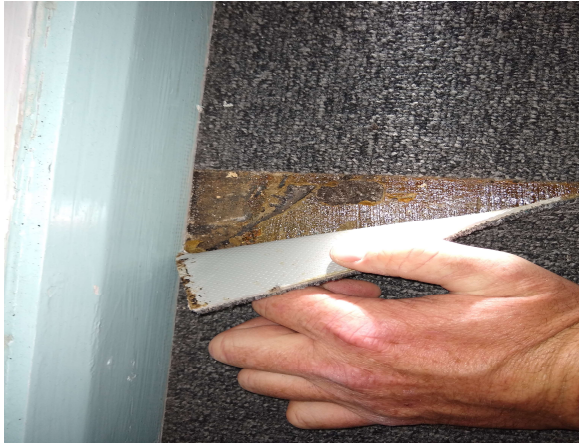
Item 25 Ref: 343523-10

The Floor screed (032/corridor 061) does not contain asbestos.

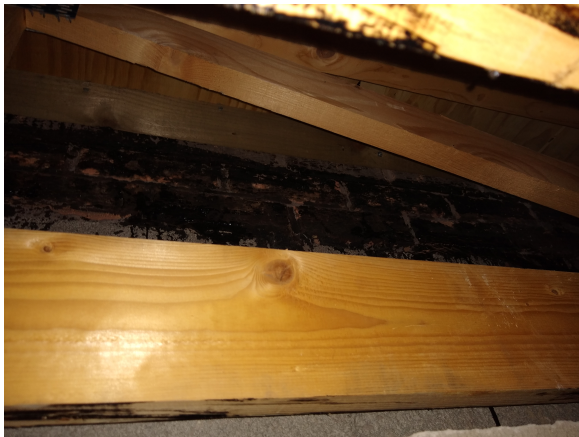
Item 26 Ref: 192371-3

The Remnant debris to former ceiling line (035/corridor-ceiling void) does not contain asbestos.

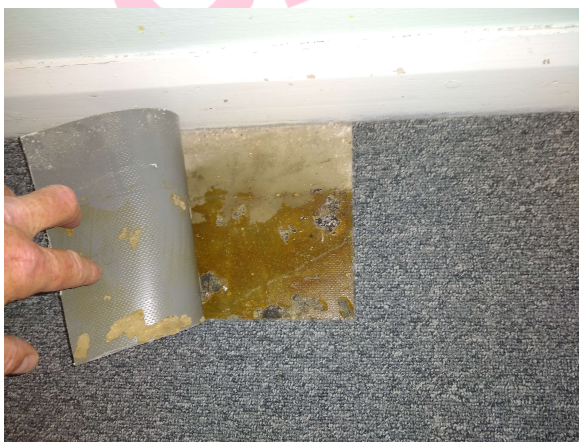
Item 27 Ref: 343523-9

The Floor screed (038/classroom 059) does not contain asbestos.

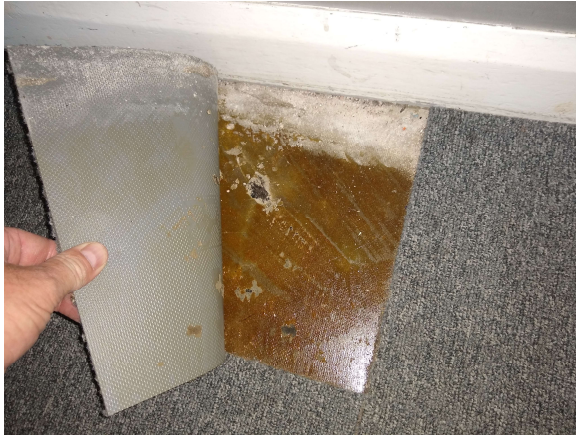
Item 28 Ref: 343523-8

The Floor screed
(040/classroom 057) does not
contain asbestos.

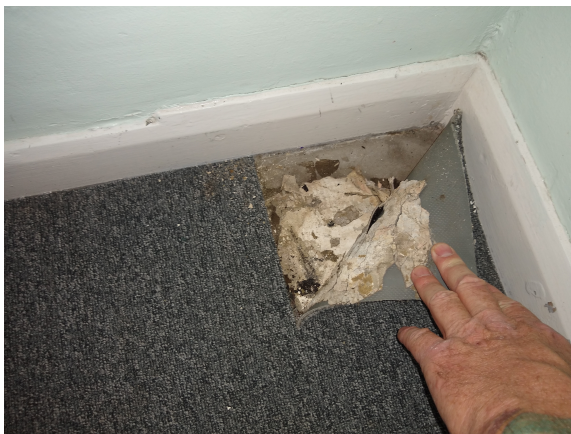
Item 29 Ref: As 343523-8

The Floor screed
(042/classroom 054) does not
contain asbestos.

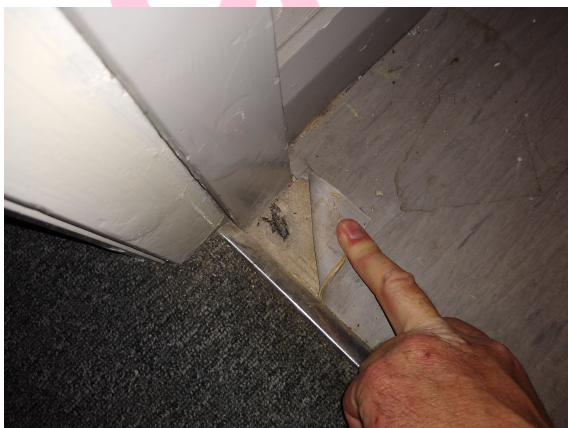
Item 30 Ref: As 343523-9

The Floor screed
(048/classroom 055) does not
contain asbestos.

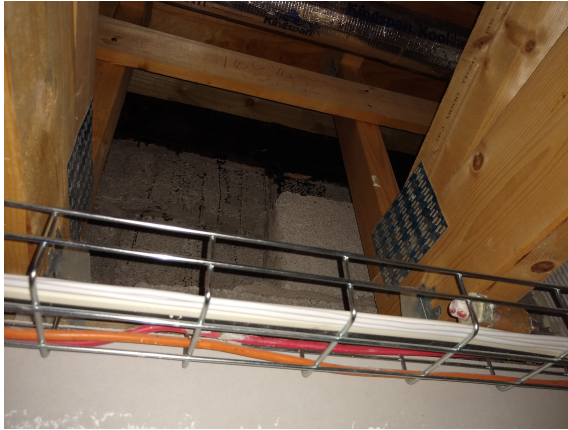
Item 31 Ref: 343523-7

The Remains of old roof line (048/corridor 060-ceiling void) does not contain asbestos.

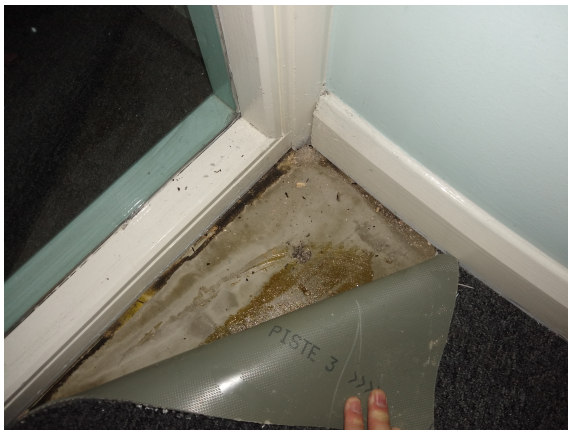
Item 32 Ref: 343523-6

The Screed (049/IT Suite 046) does not contain asbestos.

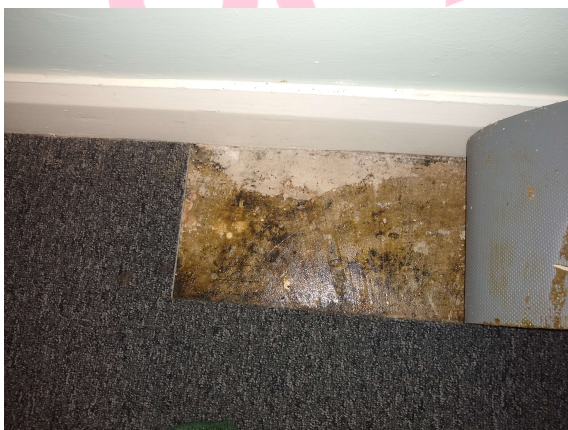
Item 33 Ref: 343523-8

The Floor screed (053/classroom 044) does not contain asbestos.

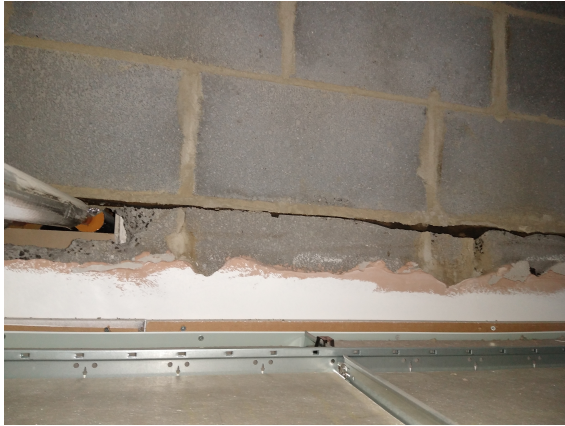
Item 34 Ref: 343523-7

The Old roof felt (060/corridor 26-ceiling void) does not contain asbestos.

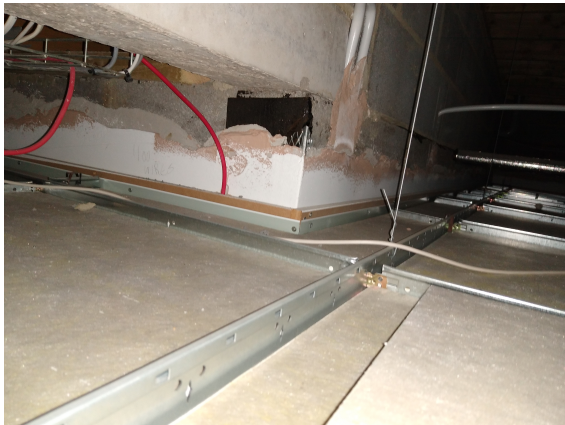
Item 35 Ref: As 343523-5

The Packer to wall at external corner (060/corridor 26-ceiling void) does not contain asbestos.

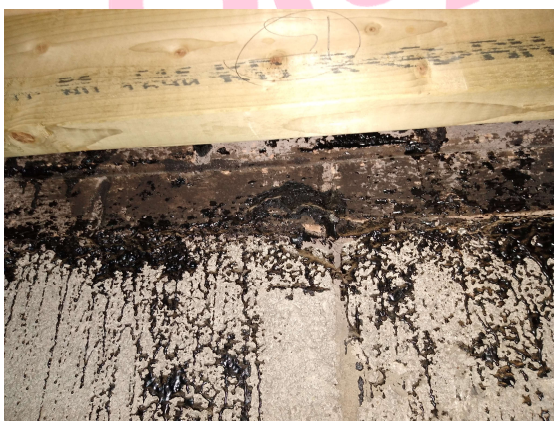
Item 36 Ref: As 343523-7

The Damp proof course (060/corridor 26-ceiling void) does not contain asbestos.

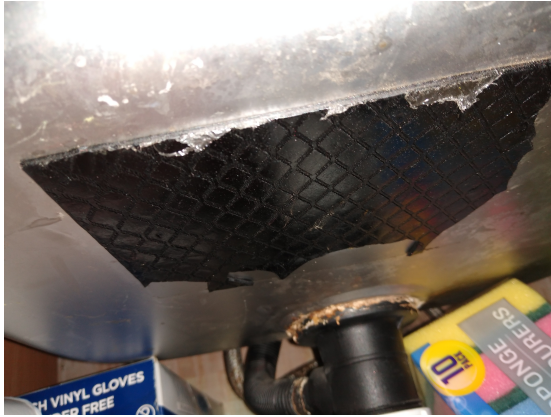
Item 37 Ref: 343523-3

The Sink pad (064/classroom 23) does not contain asbestos.

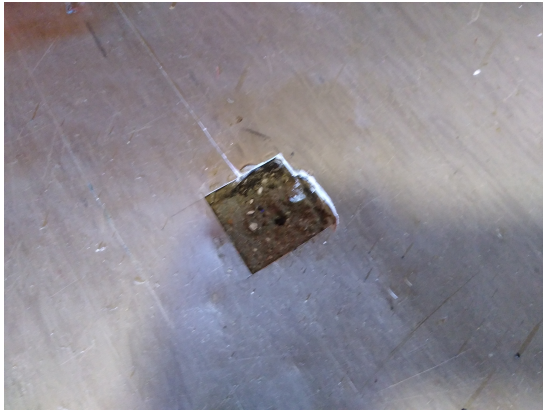
Item 38 Ref: 343523-4

The Screed (056/classroom store 24) does not contain asbestos.

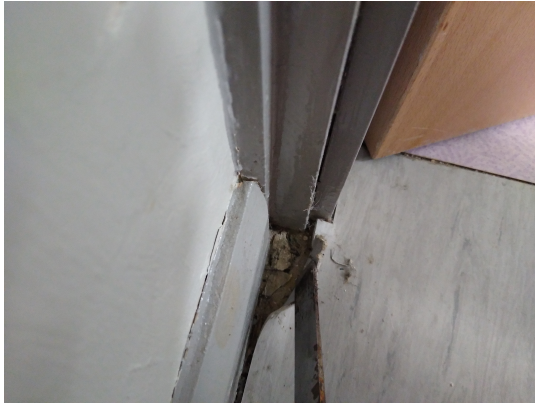
Item 40 Ref: As 343523-1

The Screed (067/classroom 022) does not contain asbestos.

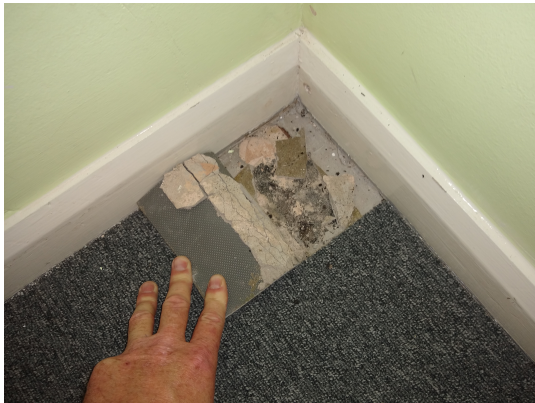
Item 41 Ref: 343523-2

(Item 40) Ref: As 343523-1 Screed (067/classroom 022) – No Risk
(Item 41) Ref: 343523-2 Screed (068/classroom) – Very Low Risk

The Screed (068/classroom) contains asbestos.

Any change in appearance should be reported to Property Services.

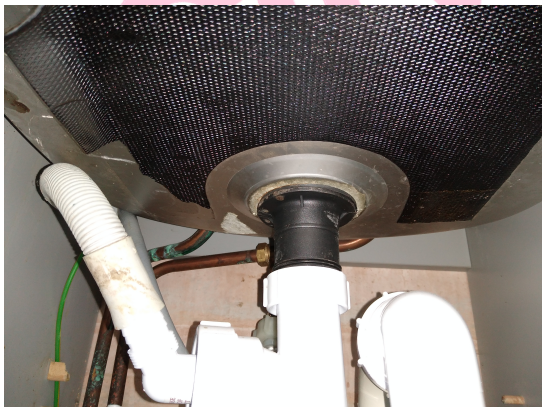
Item 42 Ref: As 343523-5

The Sink pad (088/kitchen 009) does not contain asbestos.

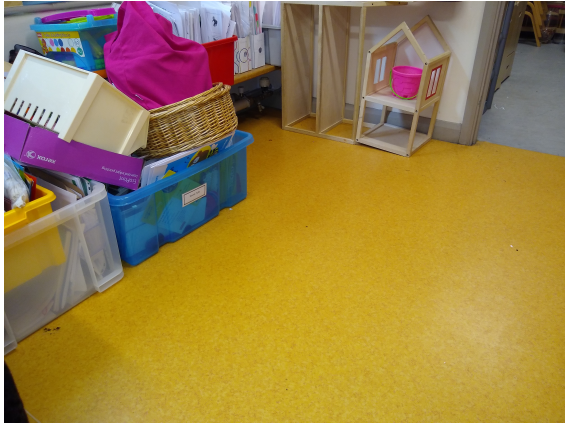
Item 43 Ref: 343523-11

The Floor screed (090/store 003) does not contain asbestos.

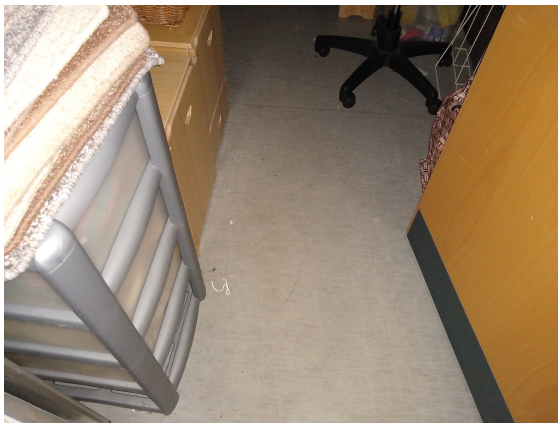
Item 44 Ref: As 343523-11

The Floor screed (091/boiler cupboard 004) does not contain asbestos.

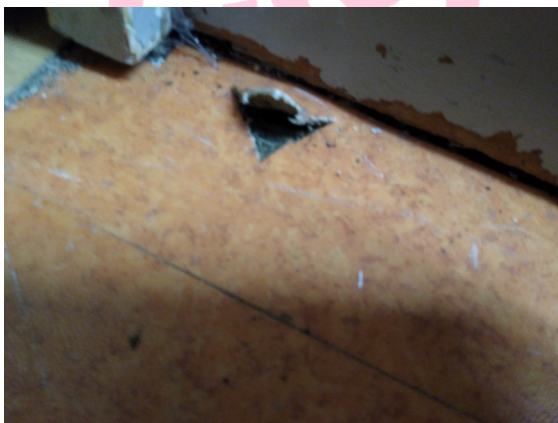
Item 45 Ref: 343523-17

The Screed (100/PE store 39) does not contain asbestos.

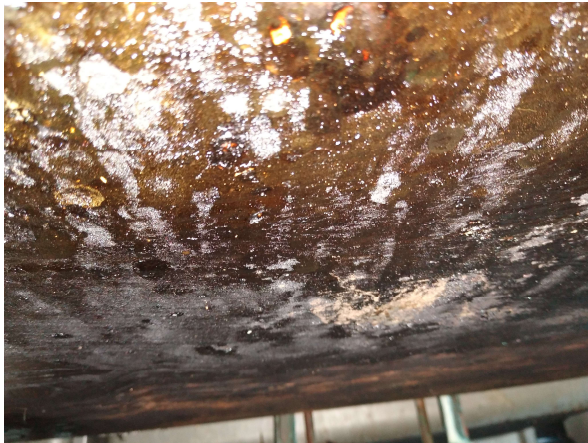
Item 47 Ref: 343523-18

The Sink pad paint
(103/kitchen 036) does not
contain asbestos.

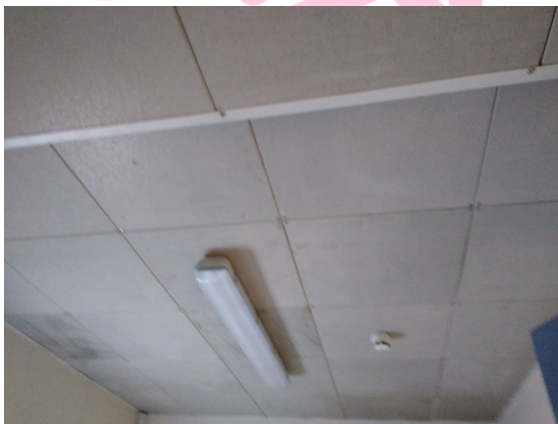
Item 48 Ref: 192371-6

The Suspended ceiling
(111/kitchen office 034)
previously room 106 does not
contain asbestos.

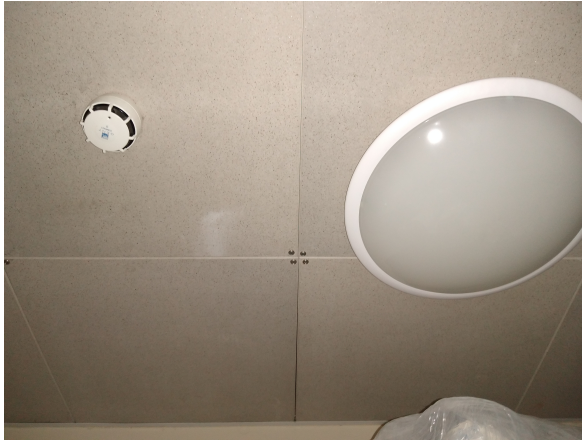
Item 49 Ref: As 192371-6

The Suspended ceiling
(112/kitchen store 035)
previously room 107 does not
contain asbestos.

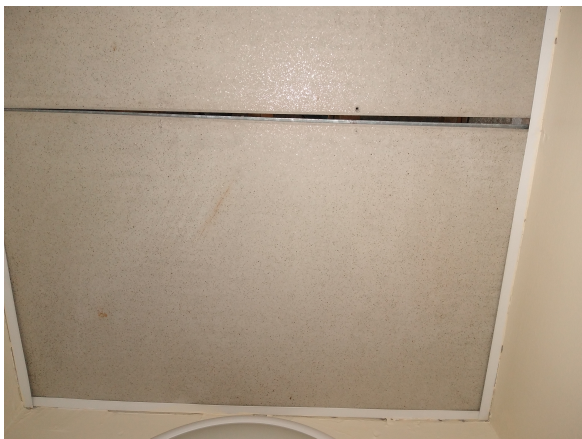
Item 50 Ref: As 192371-6

The Suspended ceiling
(115/kitchen wc lobby 032)
previously room 105 does not
contain asbestos.

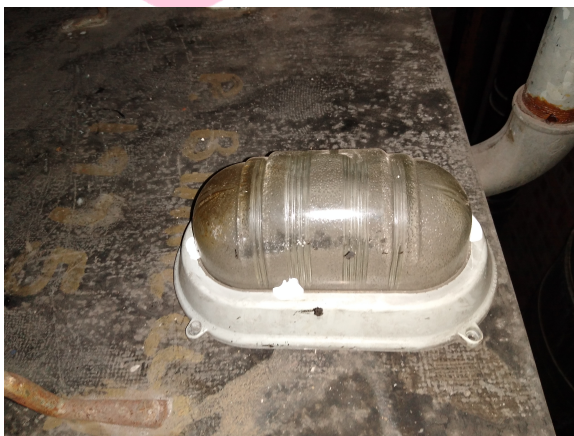
Item 51 Ref: 343523-19

The Sealant to loose lying bulk
head on top of tank (110/tank
room) contains asbestos.

Item 50	No asbestos	Is present		
Item 51	Sealant to loose lying bulk head on top of tank (110/tank room)	Very Low		Removed July 2023
Item 52	No asbestos	Is present

Removed July 2023

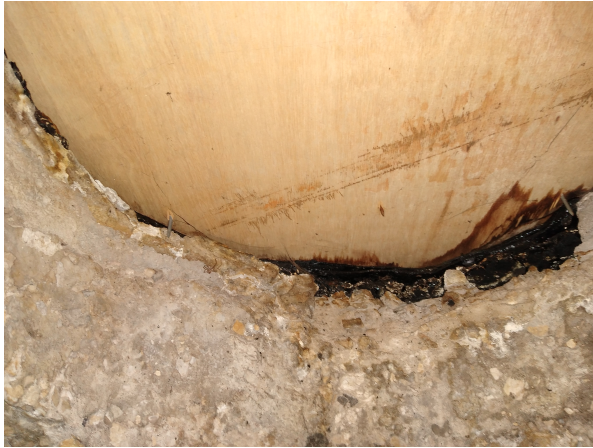
Item 52 Ref: 343523-20

The Roofing felt to old penetration (110/tank room) does not contain asbestos.

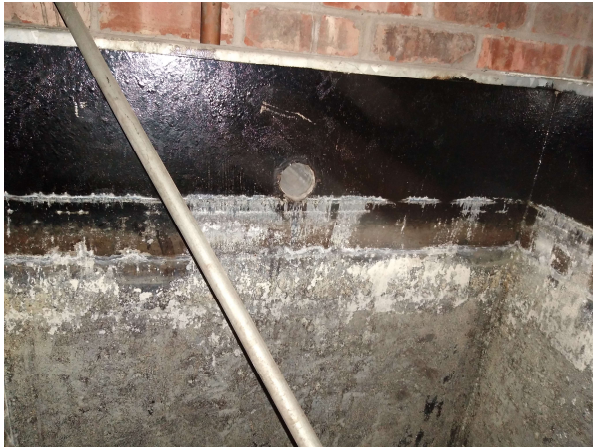
Item 53 Ref: 343523-21

The Coating to inside of tank (110/tank room) does not contain asbestos.

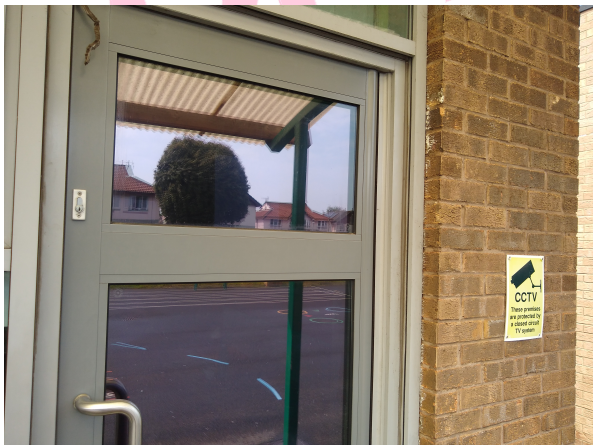
Item 54 Ref: 343523-14

- (Item 54) Ref: 343523-14 Old mastic to external door of 0/064 (externals) – Very Low Risk
- (Item 55) Ref: 343523-15 Old mastic to external door of 038+040 (externals) – Very Low Risk

The Old mastic to external door of 0/064 (externals) contains asbestos.

Any change in appearance should be reported to Property Services.

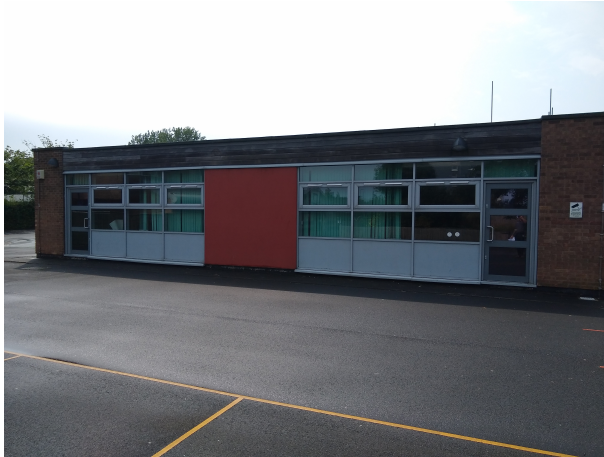
Item 55 Ref: 343523-15

The Old mastic to external door of 038+040 (externals) does contain asbestos.

Any change in appearance should be reported to Property Services.

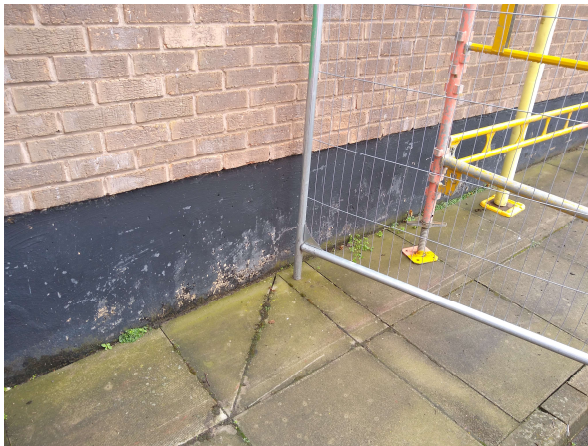
Item 56 Ref: 343523-23

The Paint to concrete slab (externals) does not contain asbestos.

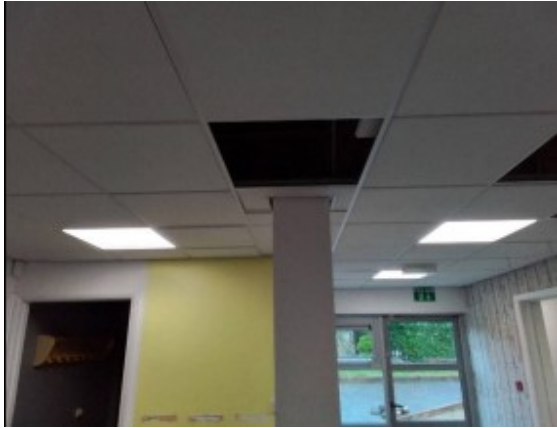
Item 58 Ref: OQ000231

The column cladding – inner layer in the Large Room (Rm G/002) does not contain asbestos.

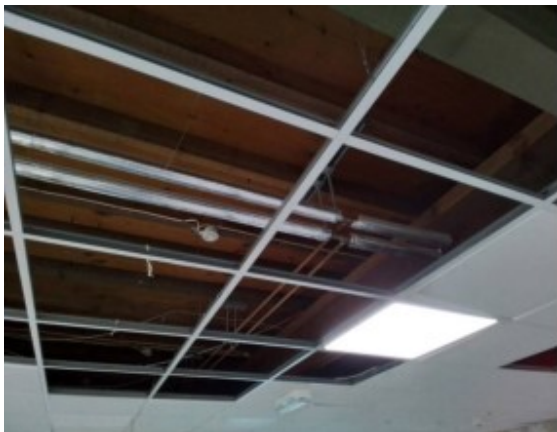
Item 59 Ref: OQ000232

The ceiling void – pipe insulation in the Large Room (Rm G/002) does not contain asbestos.

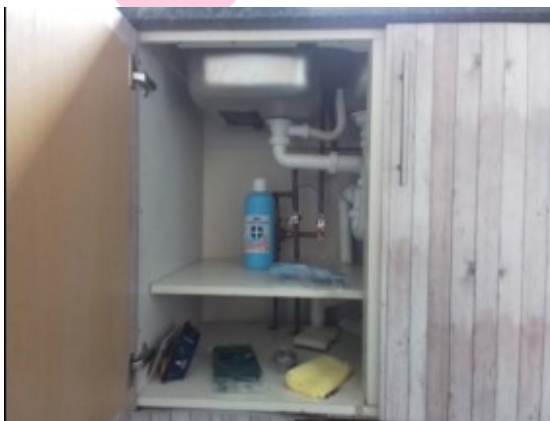
Item 60 Ref: OQ000233

The under sink mat in the Kitchen (Rm G/003) does not contain asbestos.

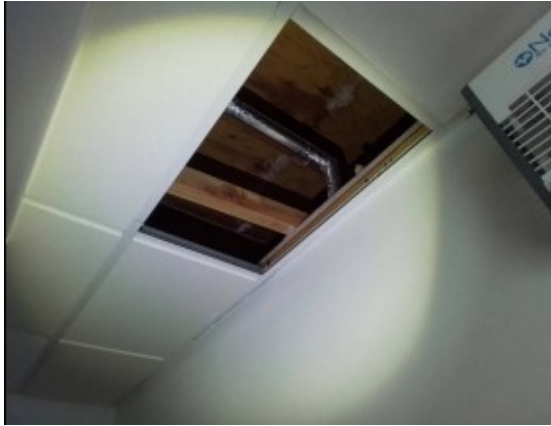
Item 61 Ref: OQ000234

The ceiling void - debris in the Kitchen (Rm G/003) does not contain asbestos.

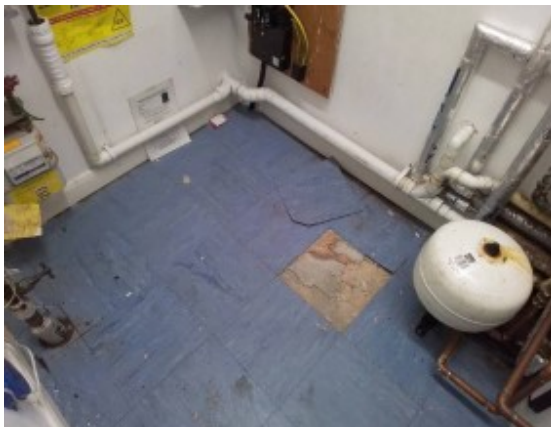
Item 62 Ref: OQ000235

The floor tile in the Plant Room (Rm G/006) does not contain asbestos.

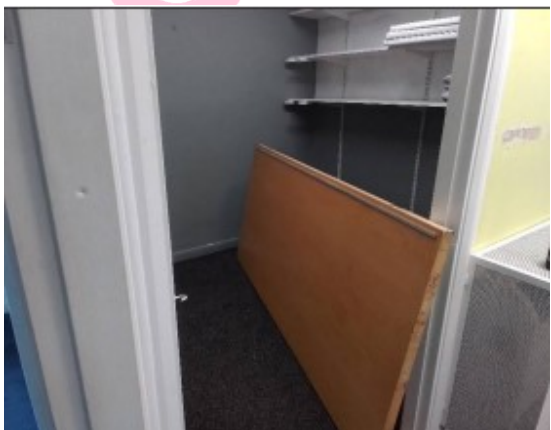
Item 63 Ref: OQ000236

The door – fire door/inner lining – sampled via pre existing holes in the Store Room (Rm G/009) does not contain asbestos.

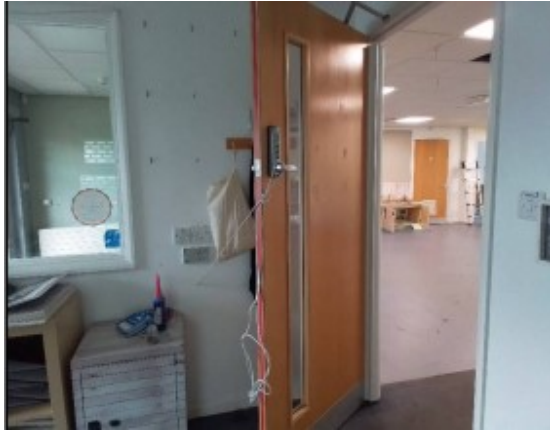
Item 64 Ref: As OQ000236

The door – fire door/inner lining in the Office (Rm G/011) does not contain asbestos.

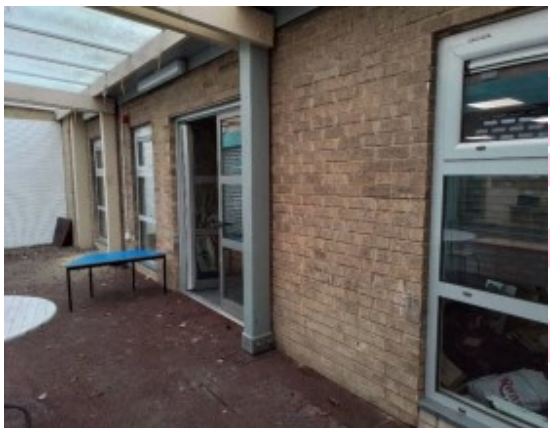
Item 65 Ref: OQ000237

The window putty/seal to frame/wall in the Outhouse (Rm G/013) does not contain asbestos.

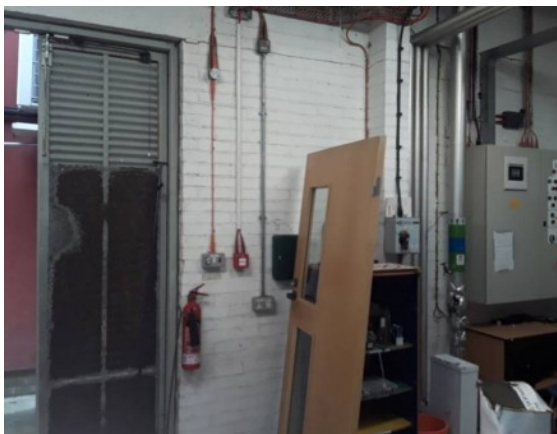
Item 66 Ref: NZ001229

The debris/residue to door wall in the Boiler Room (G/001) does not contain asbestos.

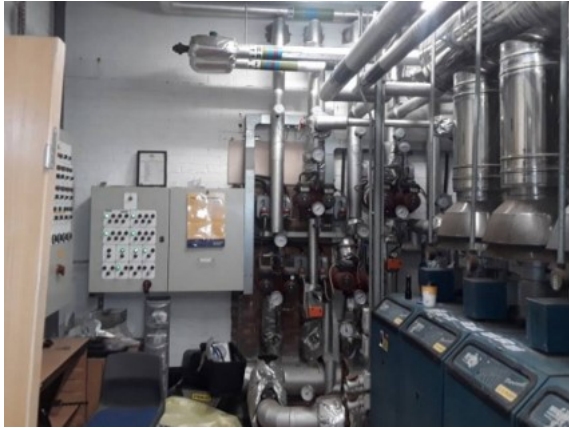
Item 67 Ref: NZ001230

The debris/residue to left hand wall in the Boiler Room (G/001) does not contain asbestos.

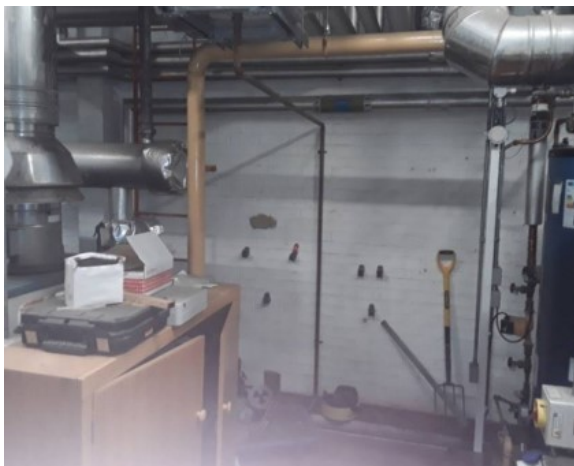
Item 68 Ref: NZ001231

The debris/residue to rear wall behind boilers in the Boiler Room (G/001) does not contain asbestos.

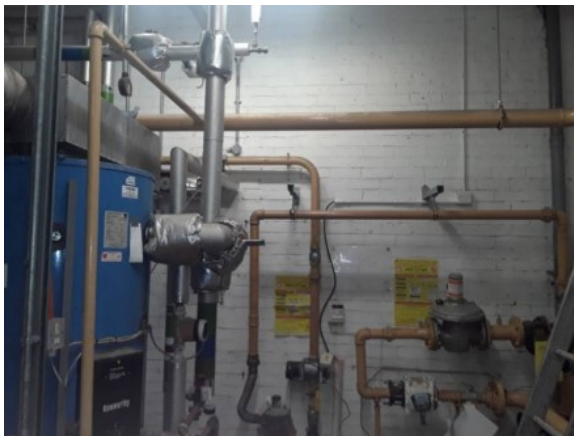
Item 69 Ref: NZ001232

The debris/residue to the right hand wall in the Boiler Room (G/001) does not contain asbestos.

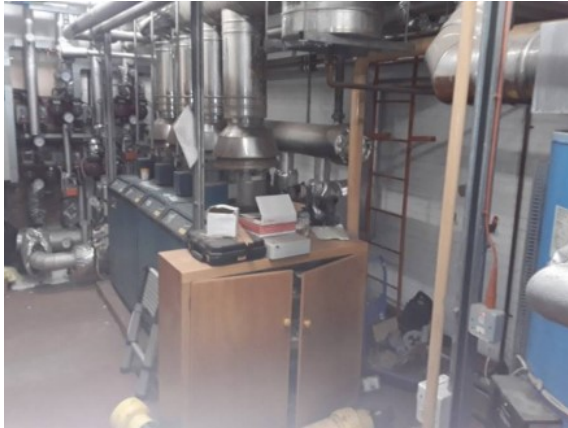
Item 70 Ref: NZ001233

The debris/residue to floor rear of boilers in the Boiler Room (G/001) does not contain asbestos.

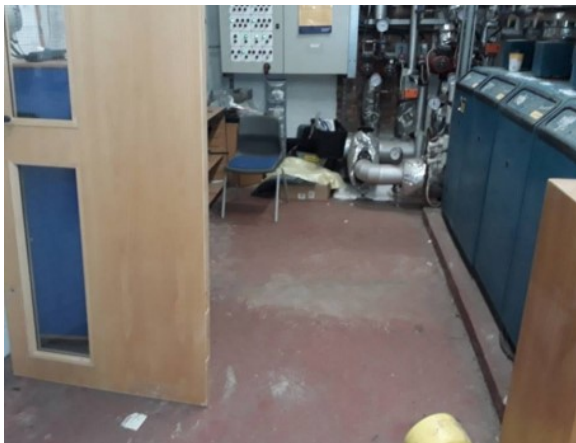
Item 71 Ref: NZ001234

The debris/residue to floor front of boilers in the Boiler Room (G/001) does not contain asbestos.

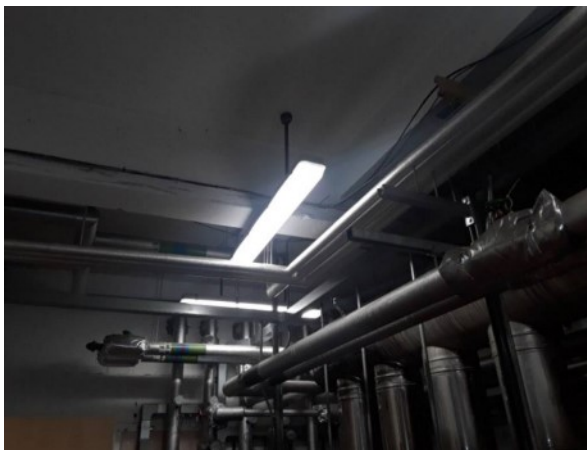
Item 72 Ref: NZ001235

The debris/residue to the ceiling in the Boiler Room (G/001) does not contain asbestos.

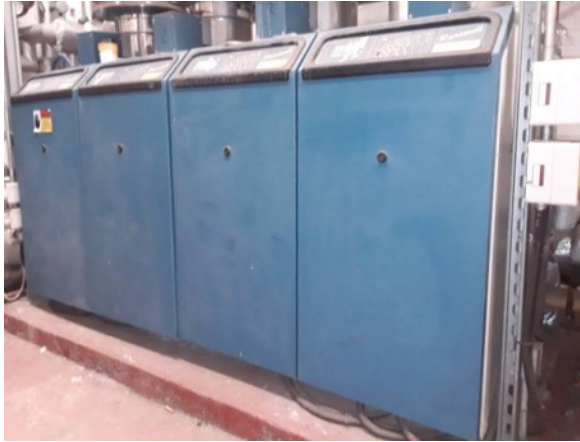
Item 73 Ref: NZ001236

The boiler insulation rope packing to joints x 4 boilers in the Boiler Room (G/001) does not contain asbestos.

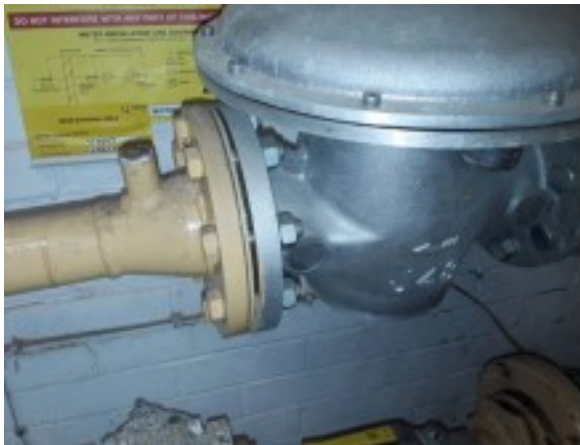
Item 74 Ref: NZ001237

- (Item 73) Ref: NZ001236 – Boiler insulation rope packing to joints x 4 boilers (Boiler Room G/001) – No Risk
- (Item 74) Ref: NZ001237 – Pipework gaskets to yellow gas pipe (Boiler Room G/001) - Very Low Risk

The pipework gaskets to yellow gas pipe in the Boiler Room (G/001) does contain asbestos.

Any change in appearance should be reported to Property Services.

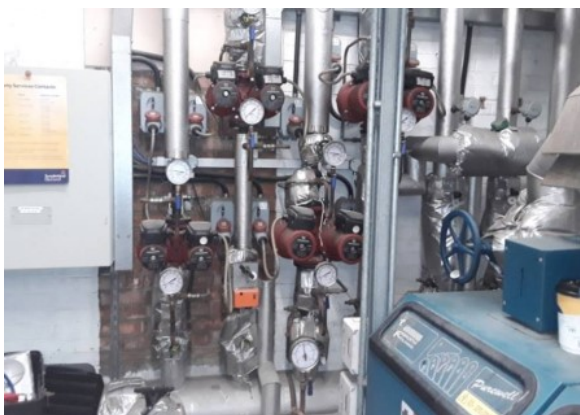
Item 75 Ref: NZ001238

The pipework gaskets to boiler pipework in the Boiler Room (G/001) does not contain asbestos.

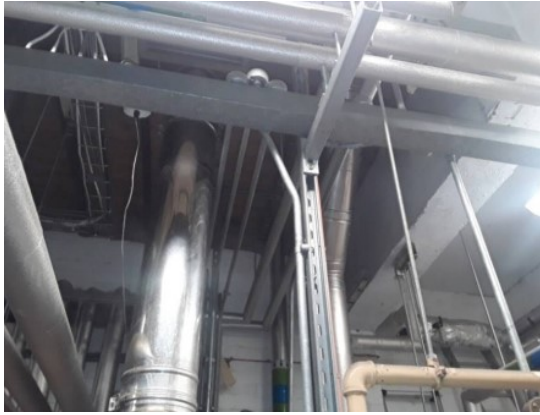
Item 76 Ref: As NZ001239

The debris/residue to pipe hangers below tank room area in the Boiler Room (G/001) does not contain asbestos.

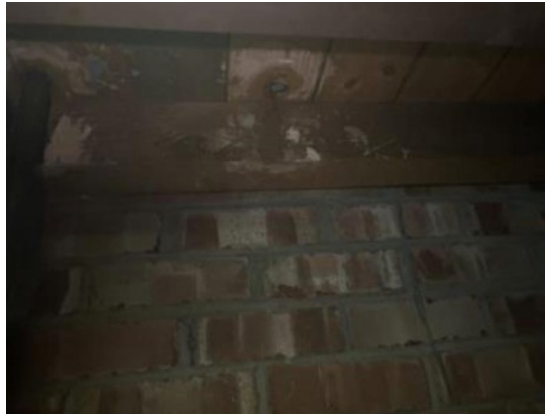
Item 77 Ref: NZ001239

The debris/residue to wall, ceiling penetrations and joists in the Boiler Room (G/001) does not contain asbestos.
