ASBESTOS SURVEY REPORT FOR HYLTON REDHOUSE NURSERY,  
ROTHERHAM ROAD, SUNDERLAND, SR5 5QL

**Hylton Redhouse Nursery, Rotherham Road,  
Sunderland, SR5 5QL**

**Date: 17 February 2025**

## Photographs of Areas Sampled

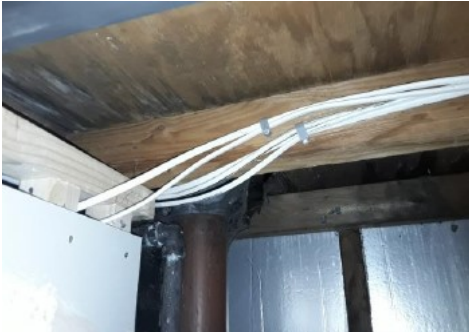
### **Item 1 Ref: 21-35336-1**

The felt to downpipes penetration (Area 2/Play Area) does not contain asbestos.

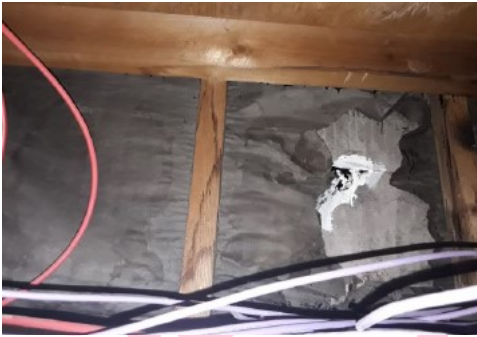
### **Item 2 Ref: Presumed**

The cement fascia (Area 2/Play Area) is presumed to contain asbestos.

**Confirmed as positive see item 23**

Any change in its appearance should be recorded and passed to Property Services.

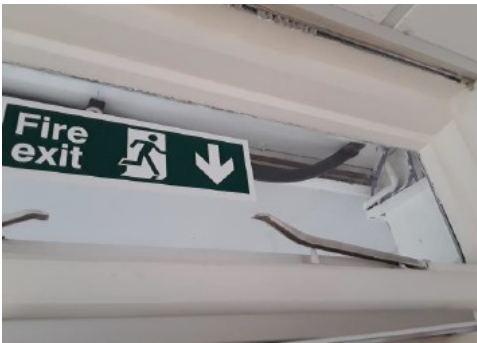
### **Item 3 Ref: 21-35336-2**

The original cement fascia boards (Area 3/Corridor & Staffroom) contain asbestos.

**Duplicate item see item 40**

Any change in its appearance should be recorded and passed to Property Services.

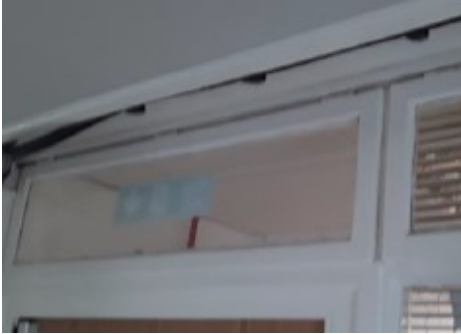
### **Item 4 Ref: 21-35336-7**

The putty to internal wood windows (Area 3/Corridor and Staffroom) does not contain asbestos.

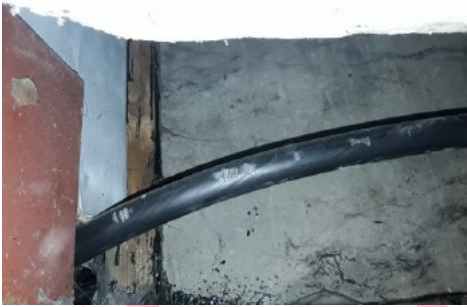
### **Item 5 Ref: Presumed**

The original cement fascia boards (Area 6/Store Room) is presumed to contain asbestos.

Any change in its appearance should be recorded and passed to Property Services.

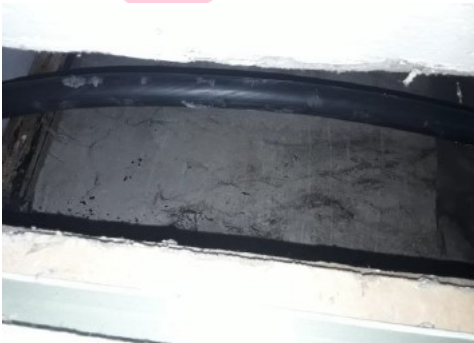
### **Item 6 Ref: Presumed**

The original cement fascia boards (Area 6/Store Room) is presumed to contain asbestos.

Any change in its appearance should be recorded and passed to Property Services.

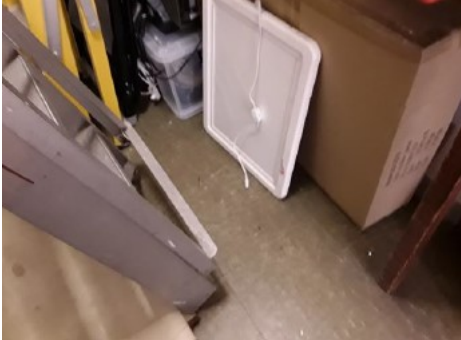
### **Item 7 Ref: 21-35336-3**

The floor tiles and adhesive (Area 6/Store Room) contain asbestos.

Any change in its appearance should be recorded and passed to Property Services.

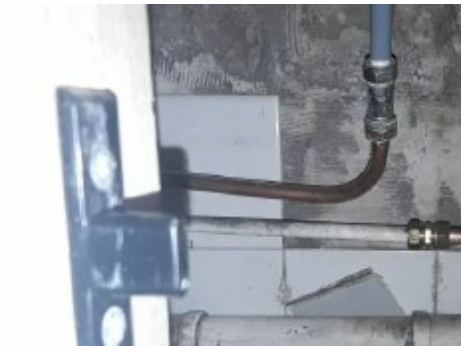
### **Item 8 Ref: 21-35336-4**

The adhesive to ceramic tiles to wall (Area 10/Toilet) does not contain asbestos.

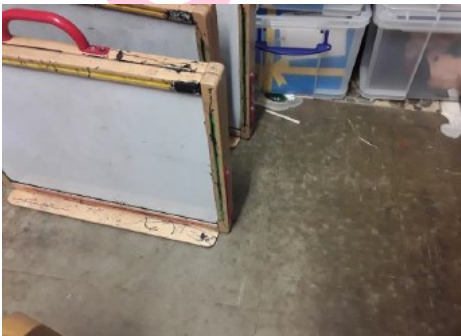
### **Item 9 Ref: 21-35336-3**

The floor tiles and adhesive (Area 11/Store Room) contain asbestos.

Any change in its appearance should be recorded and passed to Property Services.

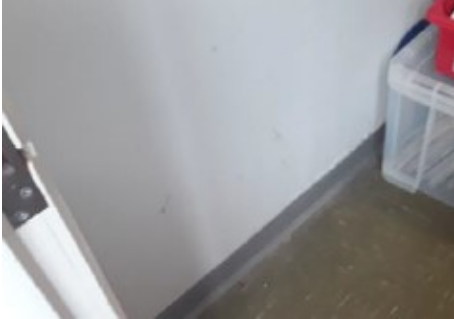
### **Item 10 Ref: 21-35336-3**

The floor tiles and adhesive (Area 12/Store Room) contain asbestos.

Any change in its appearance should be recorded and passed to Property Services.

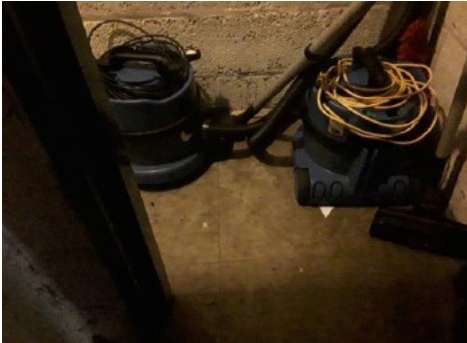
### **Item 11 Ref: 21-35336-3**

The floor tiles and adhesive (Area 24/Boiler Room) contain asbestos.

Any change in its appearance should be recorded and passed to Property Services.

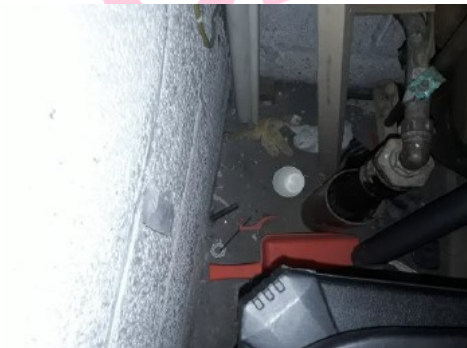
### **Item 12 Ref: 21-35336-5**

The debris to floor (Area 24/Boiler Room) does not contain asbestos.

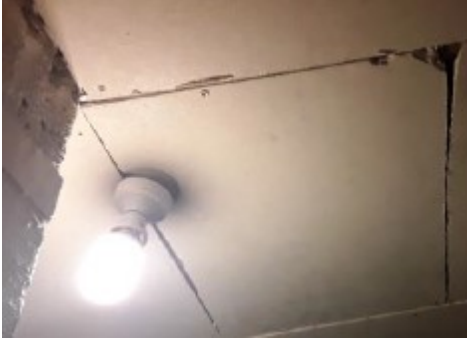
### **Item 13 Ref: 21-35336-6**

The ceiling (Area 24/Boiler Room) does not contain asbestos.

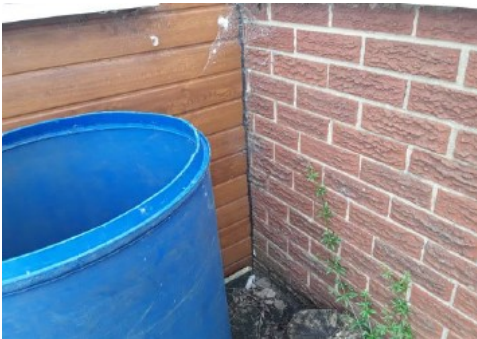
### **Item 14 Ref: 21-35336-10**

The expansion joint putty (Area 25/External) does not contain asbestos.

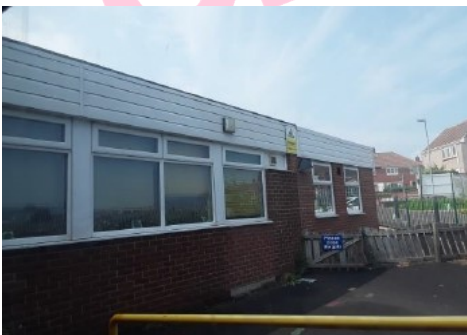
### **Item 15 Ref: Presumed**

The fascia behind new PVC fascia boards (Area 25/External) is presumed to contain asbestos.

Any change in its appearance should be recorded and passed to Property Services.

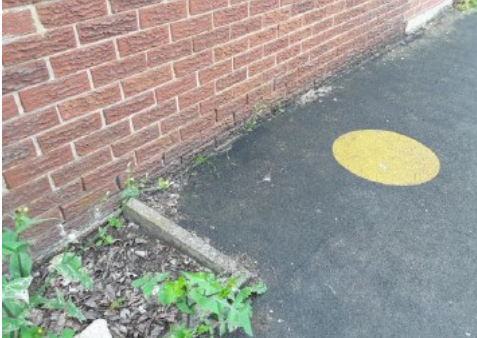
**Item 16 Ref: 21-35336-8**

The damp proof course (Area 25/External) contains asbestos.

Any change in its appearance should be recorded and passed to Property Services.

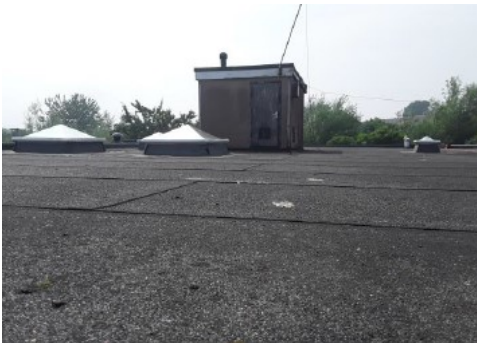
**Item 17 Ref: 21-35336-9**

The bitumen roof (Area 25/External) does not contain asbestos.

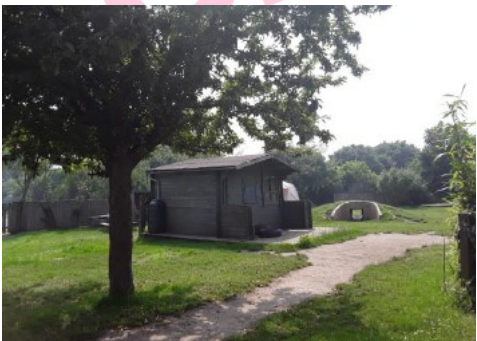
**Item 18 Ref: 21-35336-11**

The bitumen roof (Area 27/Shed 1) does not contain asbestos.

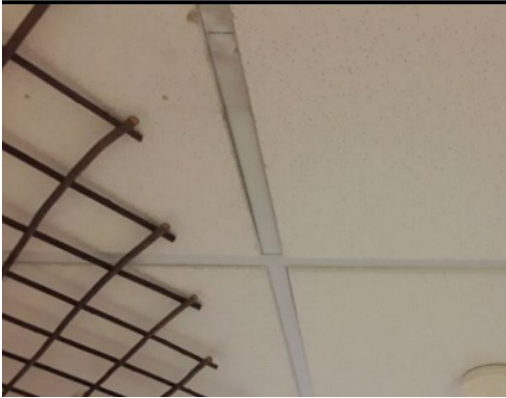
### **Item 19 Ref: NZ000213**

The roof lining in the Entrance Hall/Foyer/Lobby (Room G001) does not contain asbestos.

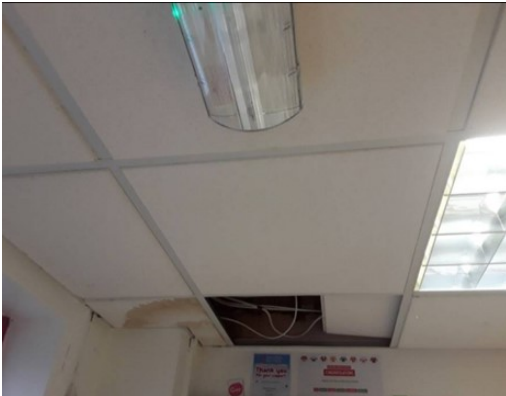
### **Item 20 Ref: NZ000214**

The felt debris to beams from over spill from roof in the Entrance Hall/Foyer/Lobby (Room G001) does not contain asbestos.

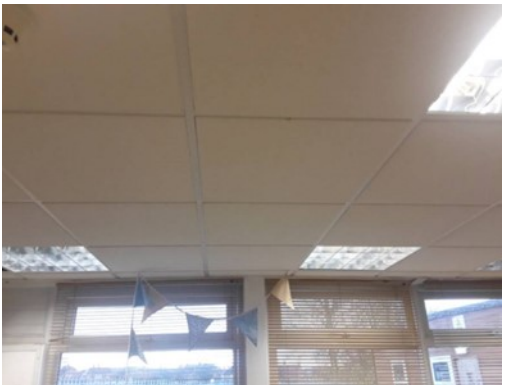
### **Item 21 Ref: NZ000215**

The roof felt around rainwater penetrations in the Classroom (G002) does not contain asbestos.

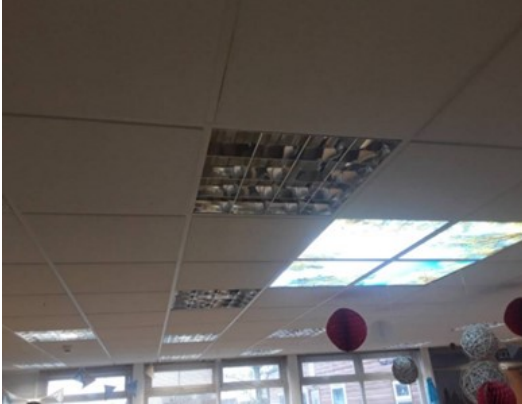
### **Item 22 Ref: NZ000214**

The felt debris to beams from over spill from roof in the Classroom (G002) does not contain asbestos.

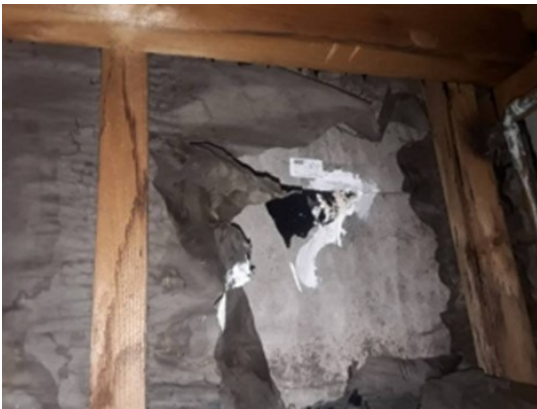
### **Item 23 Ref: NZ000216**

The fascias above door to new extension in Classroom (G002) do contain asbestos.

Any change in its appearance should be recorded and passed to Property Services.

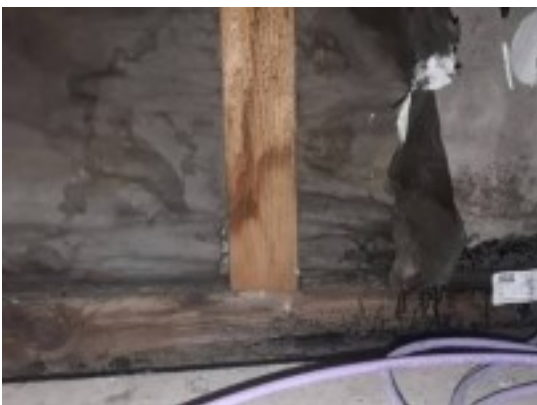
### **Item 24 Ref: NZ000217**

The debris from the damaged fascias above door in Classroom (G002) do contain asbestos.

Removed June 2023.

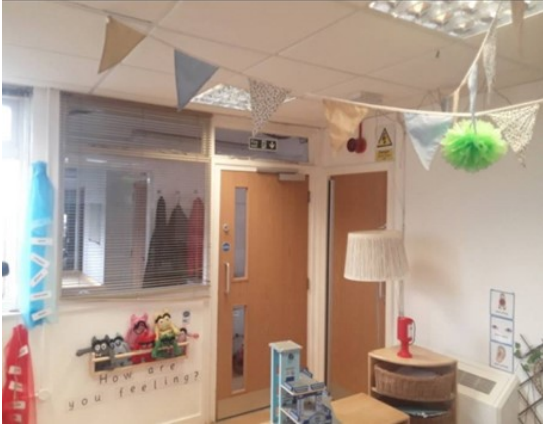
### **Item 25 Ref: NZ000218**

The wall lining above the door to new extension in Classroom (G002) does not contain asbestos.

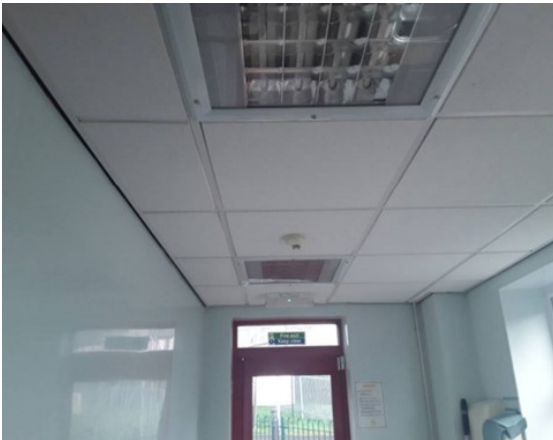
### **Item 26 Ref: NZ000214**

The felt debris to beams from over spill from roof in Kitchen Room 005) does not contain asbestos.

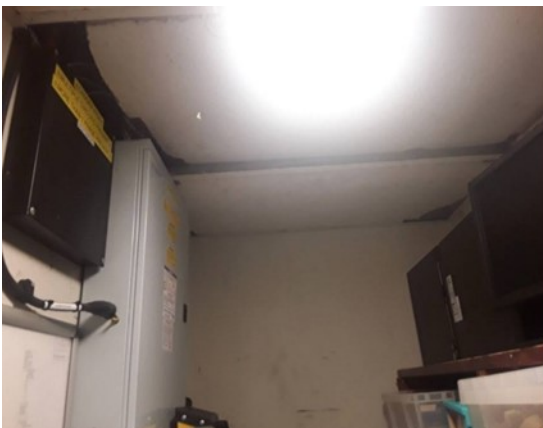
### **Item 27 Ref: NZ000214**

The felt debris to beams from over spill from roof in Electrical Cupboard (Room 006) does not contain asbestos.

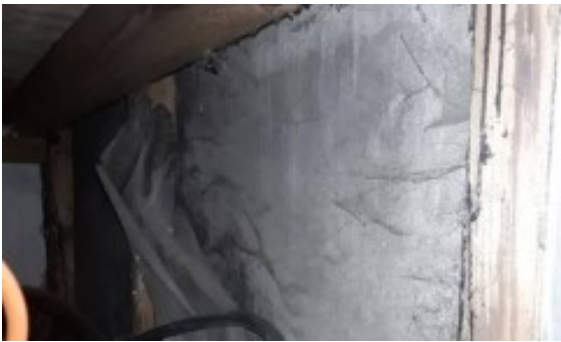
### **Item 28 Ref: NZ000216**

The fascias above new door to extension in the electrical cupboard (Room 006) does contain asbestos.

Any change in its appearance should be recorded and passed to Property Services.

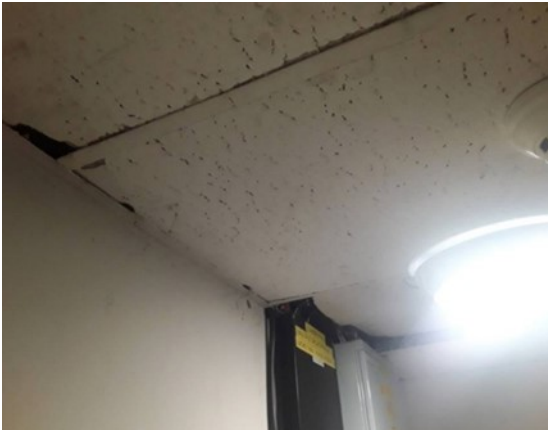
### **Item 29 Ref: NZ000218**

The wall lining in the electrical cupboard (G006) does not contain asbestos.

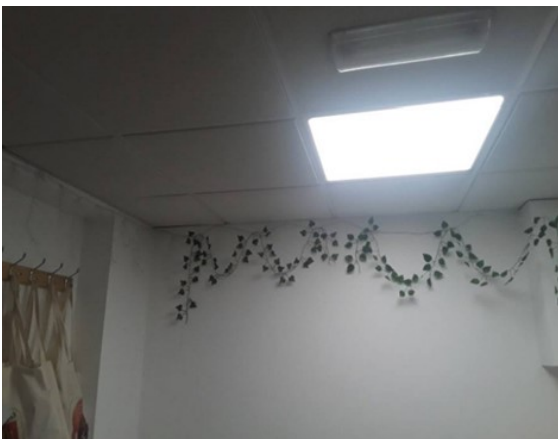
### **Item 30 Ref: NZ000219**

The felt debris to beams from over spill from roof in the Classroom (Room G007) does not contain asbestos.

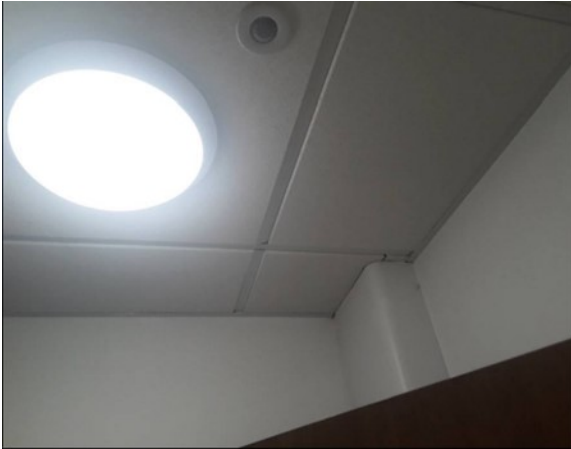
**Item 31 Ref: NZ000219**

The felt debris to beams from over spill from roof in the Toilets (Room G008) does not contain asbestos.

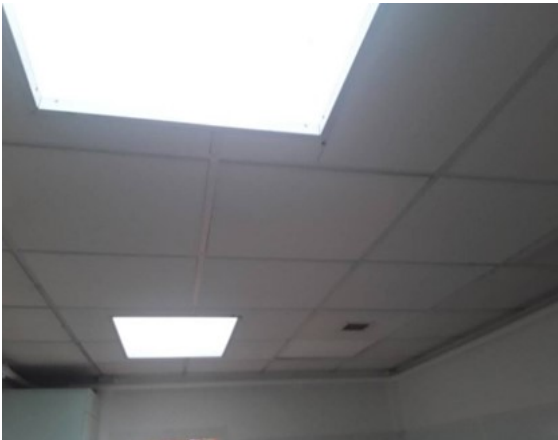
**Item 32 Ref: NZ000219**

The felt debris to beams from over spill from roof in the Toilets (Room G009) does not contain asbestos.

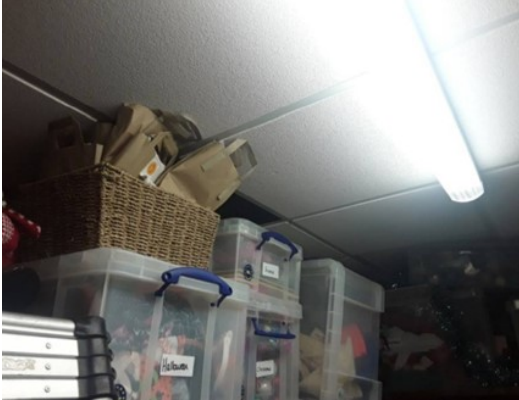
### **Item 33 Ref: NZ000219**

The felt debris to beams from over spill from roof in the Store (Room G010) does not contain asbestos.

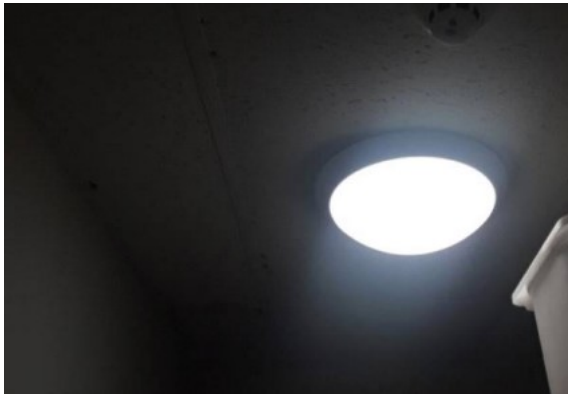
### **Item 34 Ref: NZ000219**

The felt debris to beams from over spill from roof in the Store (Room G011) does not contain asbestos.

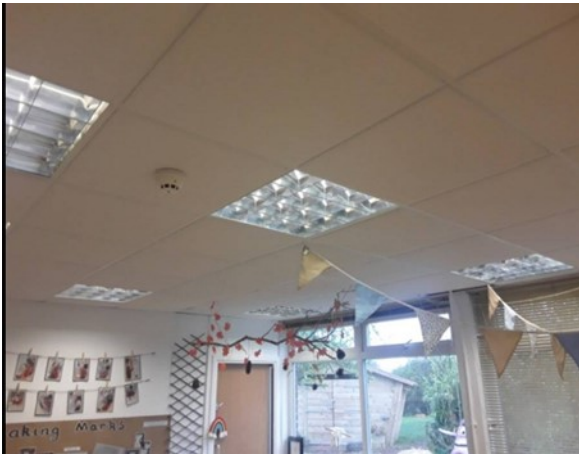
### **Item 35 Ref: NZ000219**

The felt debris to beams from over spill from roof in the Classroom (Room G012) does not contain asbestos.

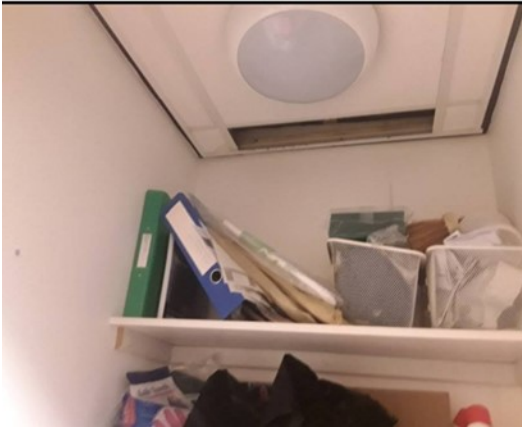
**Item 37 Ref: NZ000219**

The felt debris to beams from over spill from roof in the Cleaners Cupboard (Room G014) does not contain asbestos.

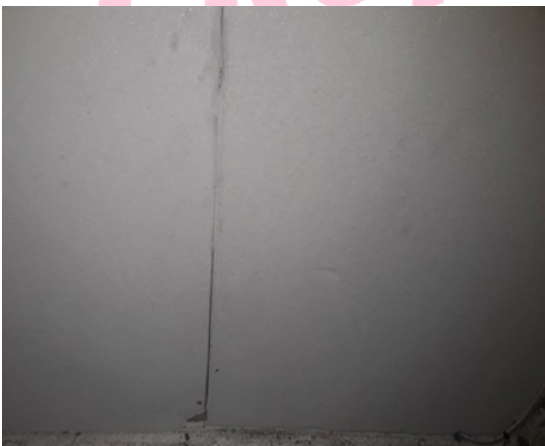
**Item 38 Ref: NZ000220**

The ceiling in the Entrance Hall/Foyer/Lobby to Boiler Room (G019) does not contain asbestos.

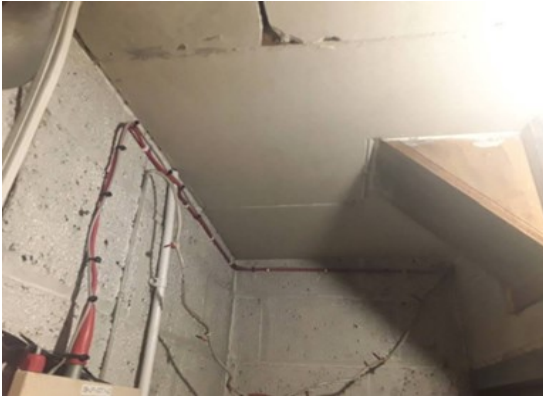
### **Item 39 Ref: NZ000220**

The ceiling in the Entrance Boiler Room to Boiler Room (G020) does not contain asbestos.

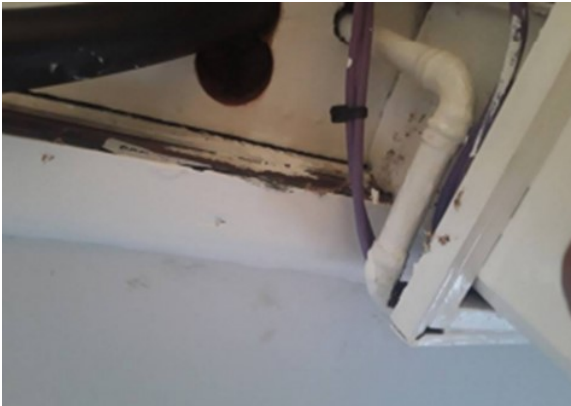
### **Item 40 Ref: NZ000221**

The fascias above the door to the new extension in the entrance hall/foyer/lobby within the new extension (G021) does contain asbestos.

Any change in its appearance should be recorded and passed to Property Services.

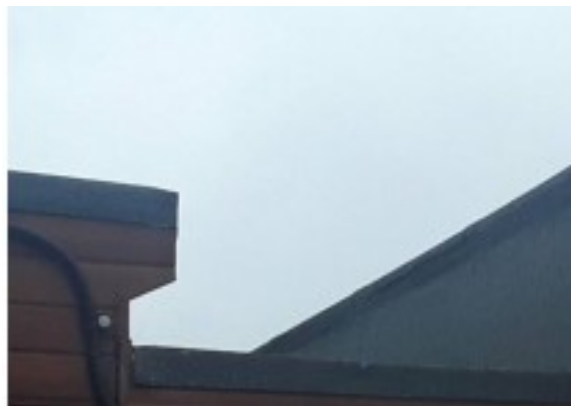
### **Item 41 Ref: NZ000221**

The fascias between main school and extension behind modern roof felt old fascias (External above extension only G025) does contain asbestos.

Any change in its appearance should be recorded and passed to Property Services.

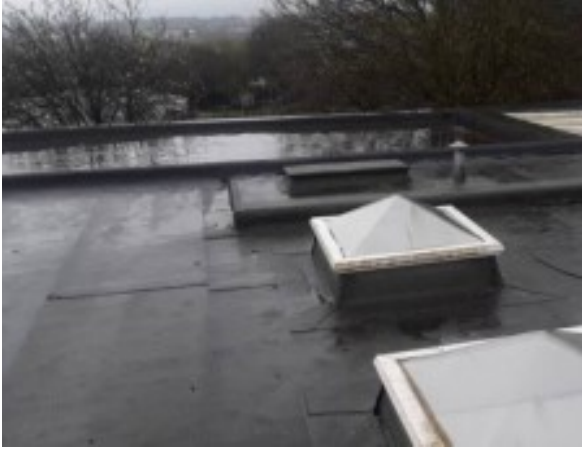
**Item 42 Ref: NZ001201**

The roof felt top layer L/H side of building (E/001) does not contain asbestos.

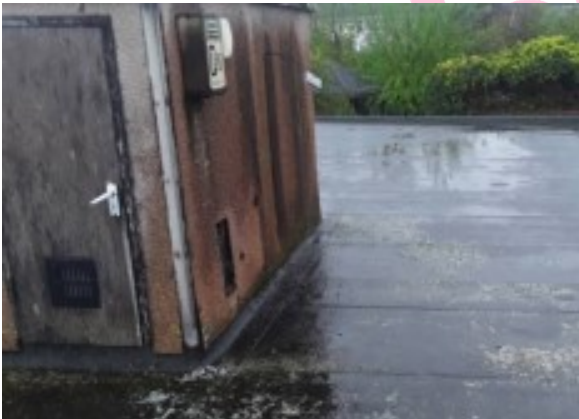
**Item 43 Ref: NZ001202**

The roof felt top layer R/H side of building (E/001) does not contain asbestos.

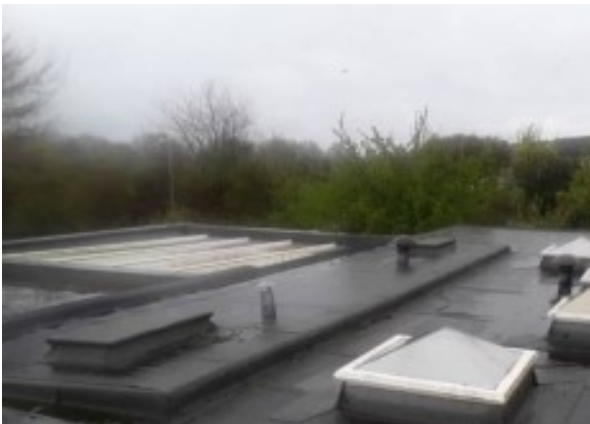
**Item 44 Ref: NZ001203**

The roof felt bottom layer L/H side of building (E/001) does not contain asbestos.

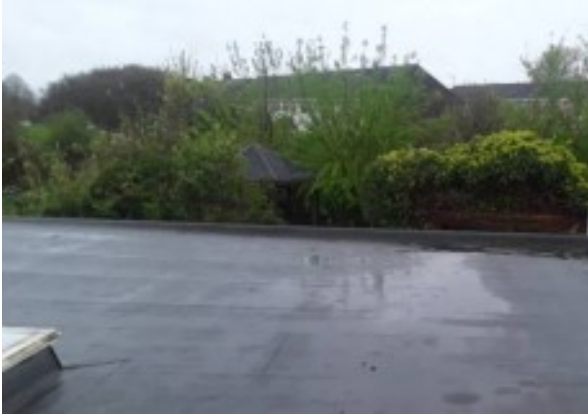
### **Item 45 Ref: NZ001204**

The roof felt bottom layer L/H side of building (E/001) does not contain asbestos.

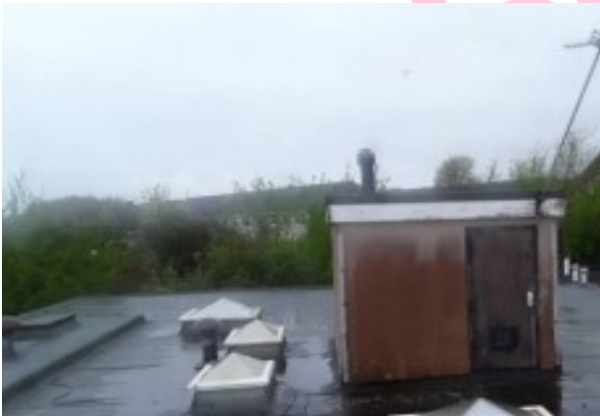
### **Item 46 Ref: NZ001205**

The roof felt to tank room roof (E/001) does not contain asbestos.

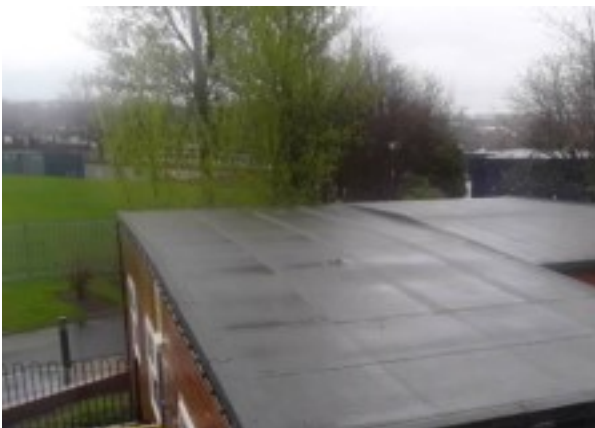
### **Item 47 Ref: NZ001206**

The roof felt to dismountable classrooms (E/001) does not contain asbestos.

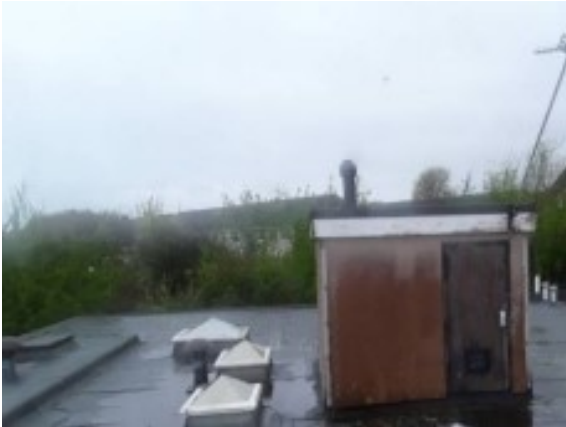
**Item 48 Ref: NZ001207**

The wall jointing compound to tank room walls (E/001) does not contain asbestos.

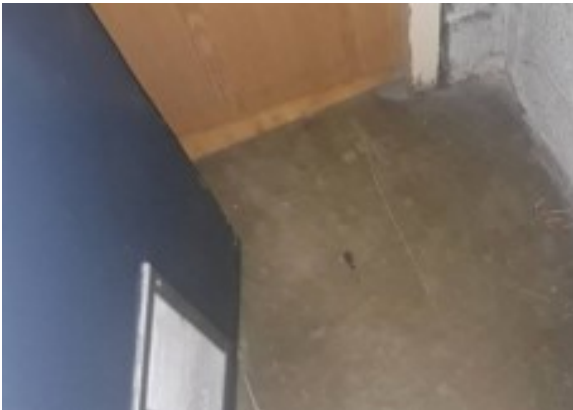
**Item 49 Ref: NZ001574**

The floor tiles to the Entrance Hall/Foyer/Lobby to boiler room (G/001) does contain asbestos.

Any change in appearance should be reported to Property Services.

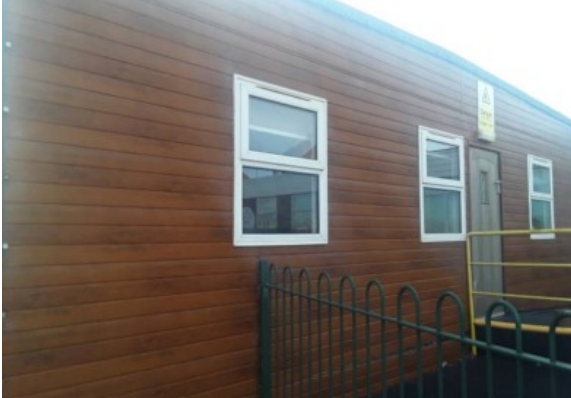
### **Item 51 Ref: NZ002354**

The wall coating timber behind wall sheet cladding to demountable unit (External E/001) does not contain asbestos.

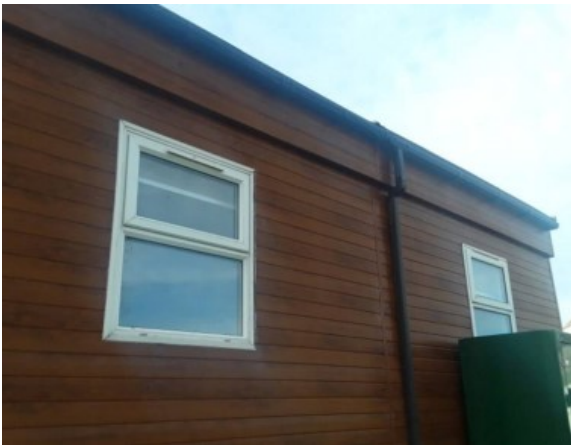
### **Item 52 Ref: NZ002355**

The window putty/seal to frame (External E/001) does not contain asbestos.

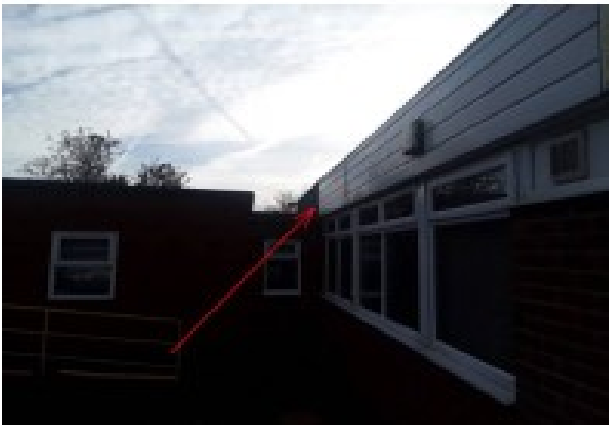
### **Item 53 Ref: As NZ002356**

The wall sheet cladding behind modern roof felt above corridor within demountable unit does contain asbestos.

Any change in appearance should be reported to Property Services.
