### ASBESTOS SURVEY REPORT FOR JOHN F KENNEDY PRIMARY SCHOOL, WASHINGTON

*Control of Asbestos  
Regulations 2012*

### JOHN F KENNEDY PRIMARY SCHOOL, WASHINGTON

**Date: 04 June 2026**

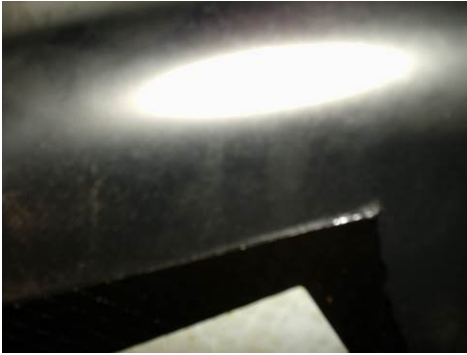
### **Item 4 - Ref: JP0652/07**

The sink pad to the classroom (Room 0/21) does not contain asbestos.

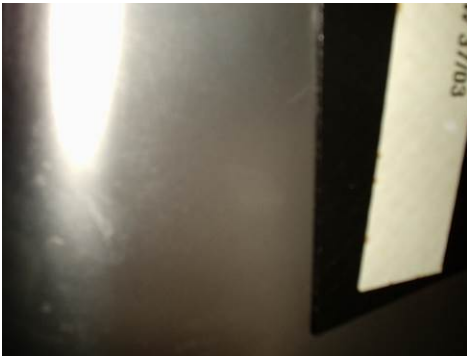
### **Item 5 - Ref: JP0653/07**

The sink pad to the classroom (Room 0/22) does not contain asbestos.

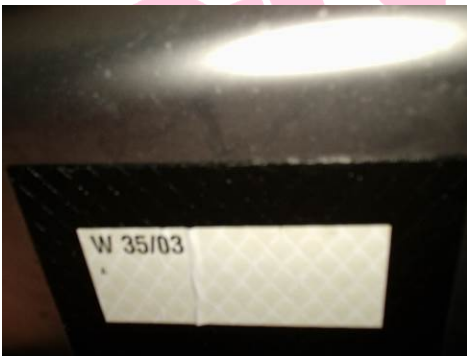
### **Item 6 - Ref: JP0654/07**

The sink pad to the classroom (Room 0/27) does not contain asbestos.

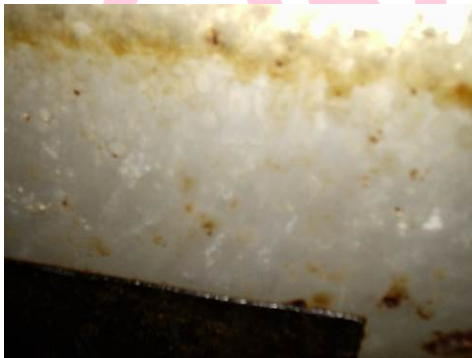
### **Item 9 - Ref: JP0657/07**

The sink pad to the kitchen (Room 0/36) does not contain asbestos.

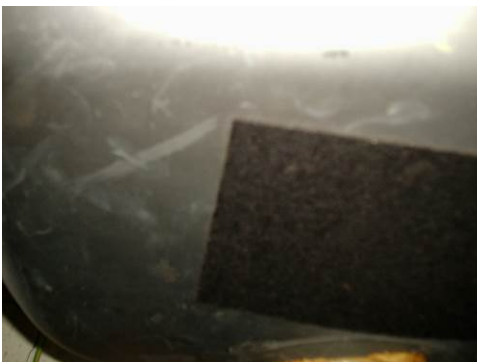
**Item 12 - Ref: JP0660/07**

The sink pad to the classroom (Room 0/58) does not contain asbestos

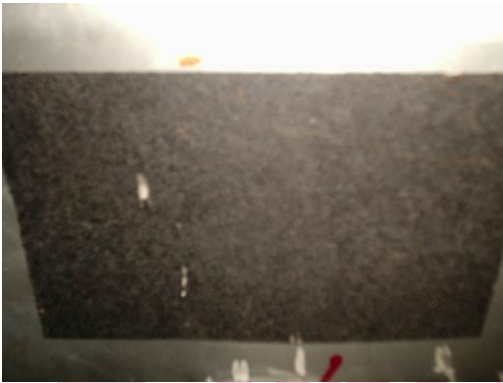
**Item 14 - Ref:JP0662/07**

The sink pad to the classroom (Room 0/61) does not contain asbestos

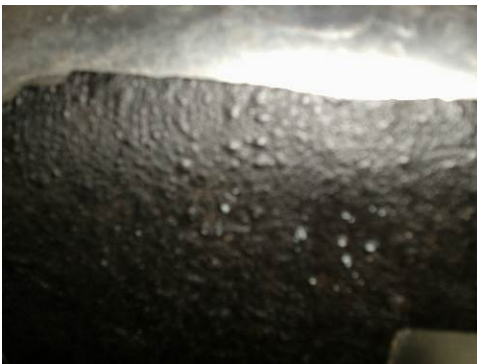
**Item 17 - Ref: JP0665/07**

The sink pad to the classroom (Room 0/65) contained asbestos.

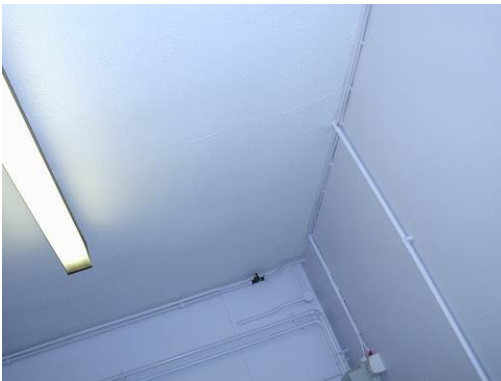
### **Item 20 - Ref:JP0668/07**

The textured coating to the ceiling in the corridor (Room 0/76) does not contain asbestos.

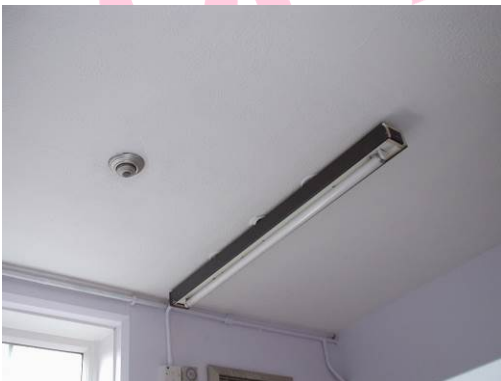
### **Item 21 - Ref:JP0669/07**

The textured coating to the ceiling in the female WC (Room 0/77) does not contain asbestos.

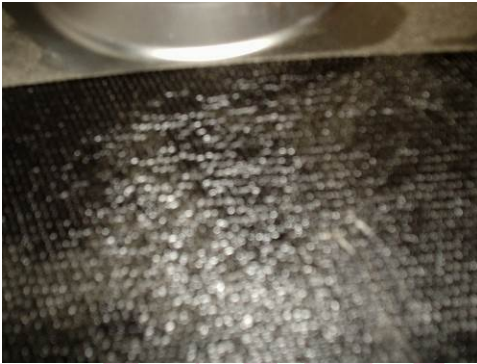
### **Item 23 - Ref:JP0671/07**

The sink pad in the classroom (Room 0/79) does not contain asbestos.

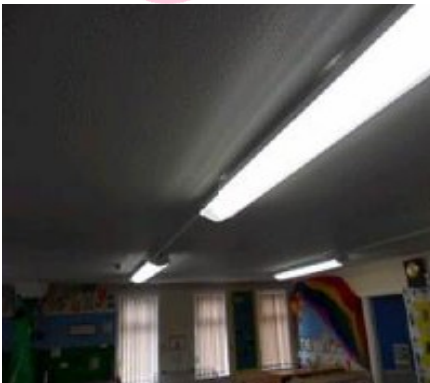
### **Item 24: Ref: VP003646**

*The textured coating to the ceiling within the nursery contains asbestos.*

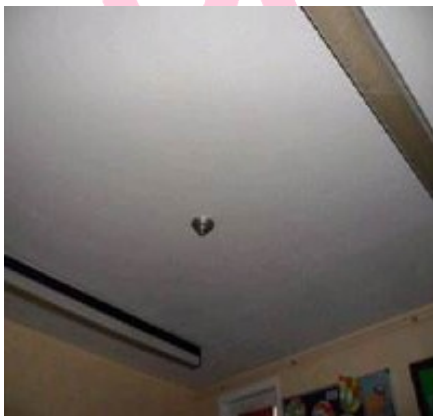
**Item 27: As VP003646**

*The textured coating to the ceiling within the adjacent room within the nursery contains asbestos.*

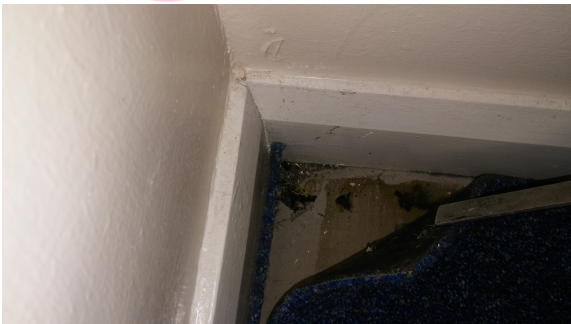
### **Item 36 Ref: As 415279-2**

The remnant floor adhesive beneath screed in Rm 0/033 Classroom contains asbestos.

Any change in its appearance should be recorded and passed to Property Services.

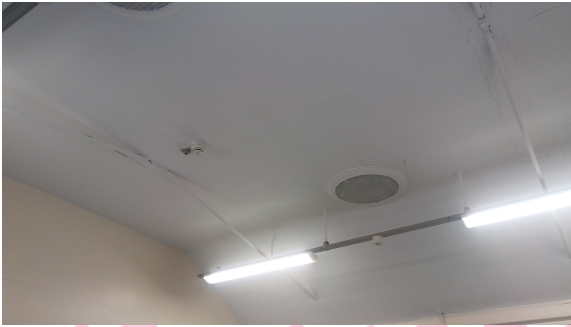
### **Item 38 Ref: As 415279-1**

The ceiling in Rm 0/033 Classroom does not contain asbestos.

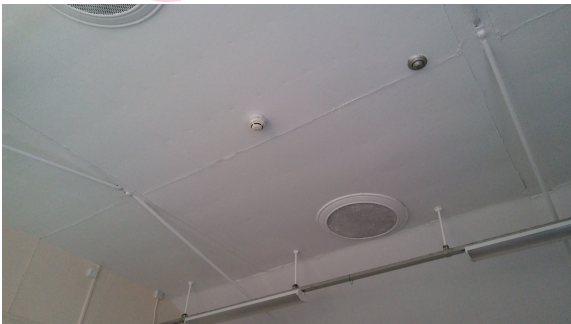
### **Item 39 Ref: 415279-1**

The ceiling in Rm 0/034 Classroom does not contain asbestos.

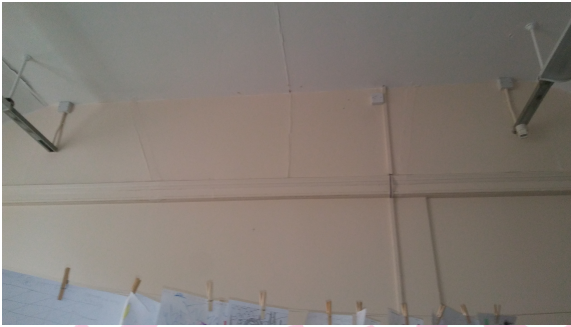
### **Item 41 Ref: As 415279-1**

The high level panels in Rm 0/034 Classroom do not contain asbestos.

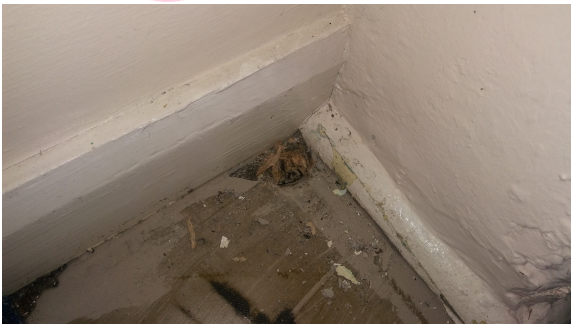
### **Item 42 Ref: 415279-3**

The remnant floor adhesive in Rm 0/035 Classroom does not contain asbestos.

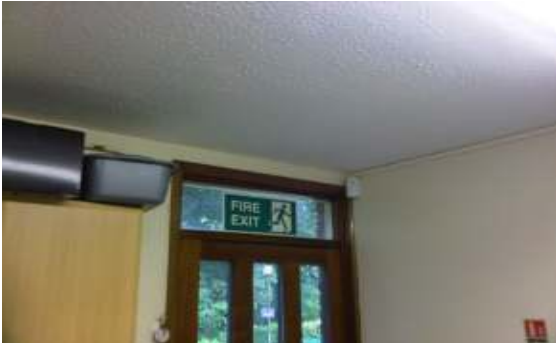
**Item 46 Ref: IC11-493**

The textured coating to ceiling above door (Door A) does not contain asbestos.

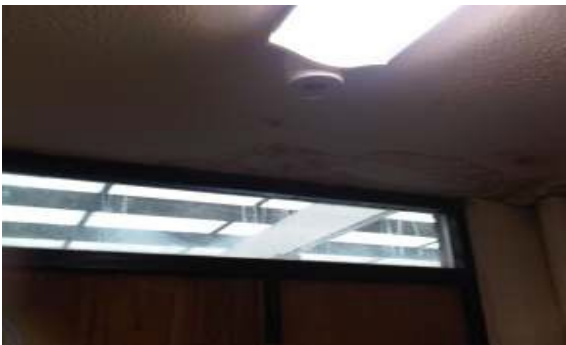
**Item 47 Ref: As IC11-493**

The textured coating to ceiling above door (Door B) does not contain asbestos.

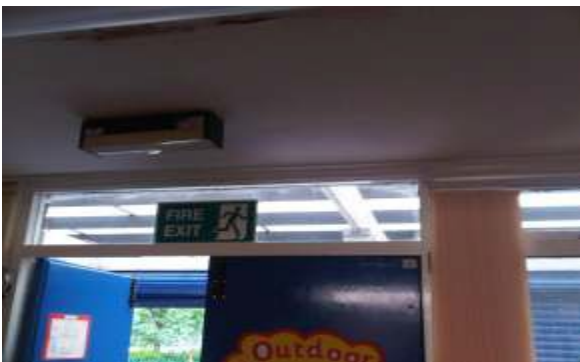
**Item 48 Ref: As IC11-493**

The textured coating to ceiling above door (Door C) does not contain asbestos.

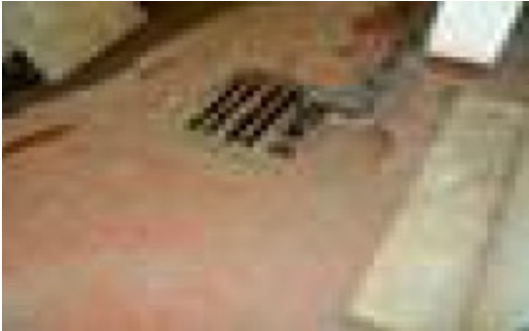
**Item 55 Ref: BS004221**

The Debris to floor (Boiler Room 1) does not contain asbestos.

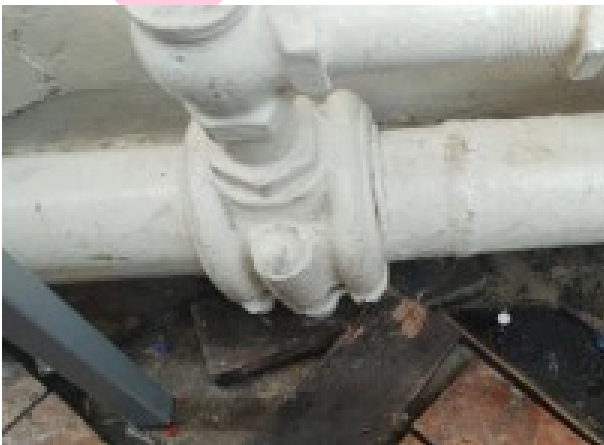
**Item 141 Ref: 21-32784-1**

The bitumen to the floor in Year 6 Classroom (Area 1) does not contain asbestos.

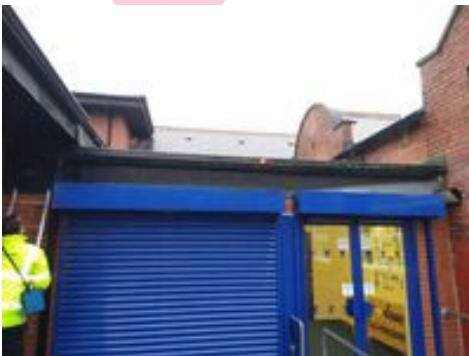
**Item 144 Ref: 451175-4**

The roof covering (External Roof 6) does not contain asbestos.

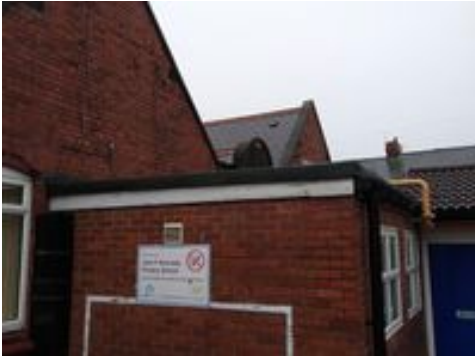
**Item 145 Ref: 451175-2**

The roof covering (External Roof 7) does not contain asbestos.

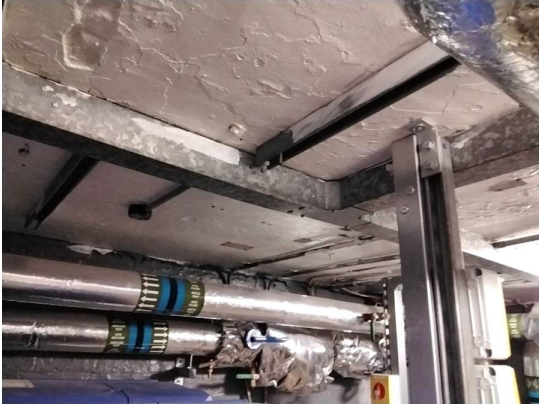
### **Item 151 Ref: Presumed**

Presumed – Debris/Residue to ceiling (Boiler Room Plant Room 2 Z1/001) (Item 151) – Medium Risk  
Presumed – Debris/Residue to walls (Boiler Room Plant Room 2 Z1/001) (Item 152) – Medium Risk  
Presumed – Debris/Residue to wall opposite door, paint degraded (Boiler Room Plant Room 2 Z1/001) (Item 153) – Medium Risk  
KX001875 – Debris/Residue to floor (Boiler Room Plant Room 2 Z1/001) (Item 154) – No Risk  
KX001876 – Debris/Residue to floor (Boiler Room Plant Room 2 Z1/001) (Item 155) – Medium Risk  
KX001877 – Debris/Residue within pipe penetration (Boiler Room Plant Room 2 Z1/001) (Item 156) – No Risk

The Debris/Residue to ceiling (Boiler Room Plant Room 2 Z1/001) is presumed to contain asbestos.

Any change in its appearance should be recorded and passed to Property Services.

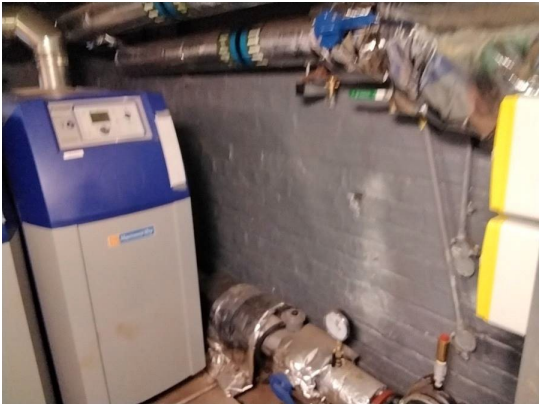
### **Item 152 Ref: Presumed**

The Debris/Residue to walls (Boiler Room Plant Room 2 Z1/001) is presumed to contain asbestos.

Any change in its appearance should be recorded and passed to Property Services.

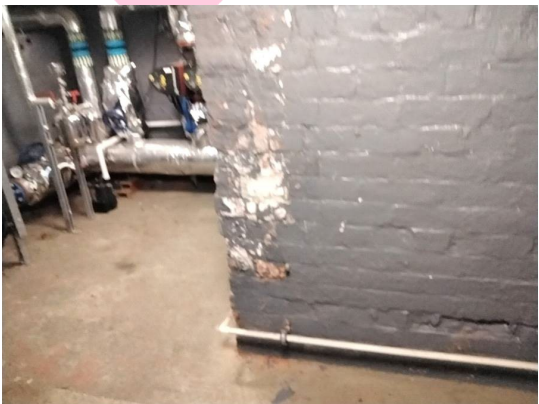
### **Item 153 Ref: Presumed**

The Debris/Residue to wall opposite door, paint degraded (Boiler Room Plant Room 2 Z1/001) is presumed to contain asbestos.

Any change in its appearance should be recorded and passed to Property Services.

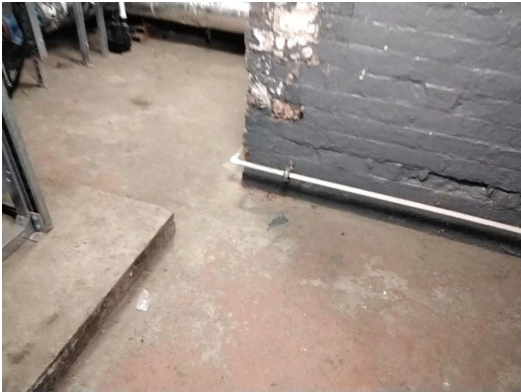
**Item 154 Ref: KX001875**

The Debris/Residue to floor (Boiler Room Plant Room 2 Z1/001) does not contain asbestos.

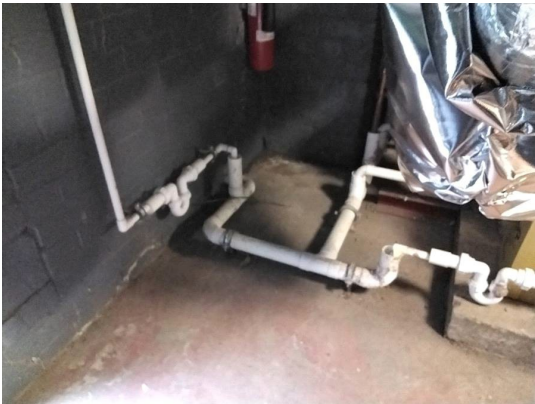
**Item 155 Ref: KX001876**

The Debris/Residue to floor (Boiler Room Plant Room 2 Z1/001) contains asbestos.

Any change in its appearance should be recorded and passed to Property Services.

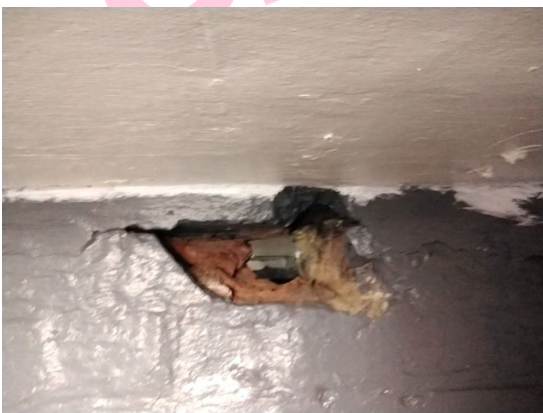
**Item 156 Ref: KX001877**

The Debris/Residue within pipe penetration (Boiler Room Plant Room 2 Z1/001) does not contain asbestos.

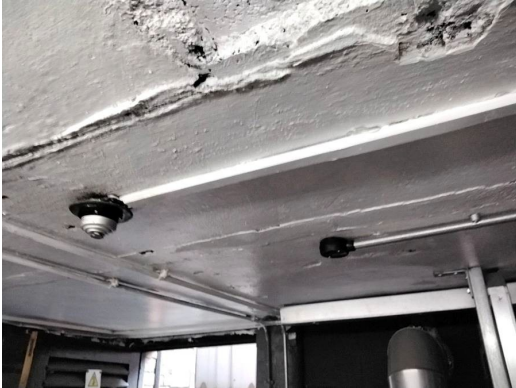
### **Item 157 Ref: Presumed**

Presumed – Debris/Residue to ceiling (Boiler Room Plant Room 3 Z1/002) (Item 157) – Medium Risk  
Presumed – Debris/Residue to walls (Boiler Room Plant Room 3 Z1/002) (Item 158) – Medium Risk  
Presumed – Debris/Residue to wall in corner, paint degraded (Boiler Room Plant Room 3 Z1/002) (Item 159) – Medium Risk  
KX001878 – Debris/Residue to floor (Boiler Room Plant Room 3 Z1/002) (Item 160) – No Risk  
KX001879 – Debris/Residue to floor (Boiler Room Plant Room 3 Z1/002) (Item 161) – No Risk  
KX001883 – Debris/Residue to corner penetration (Boiler Room Plant Room 1 Z1/003) (Item 162) – No Risk  
KX001882 – Debris/Residue to floor (Boiler Room Plant Room 1 Z1/003) (Item 163) – No Risk  
KX001880 – Debris/Residue to ceiling penetrations (Boiler Room Plant Room 1 Z1/003) (Item 164) – No Risk  
KX001881 – Debris/Residue within pipe penetrations to rear wall (Boiler Room Plant Room 1 Z1/003) (Item 165) – No Risk

The Debris/Residue to ceiling (Boiler Room Plant Room 3 Z1/002) is presumed to contain asbestos.

Any change in its appearance should be recorded and passed to Property Services.

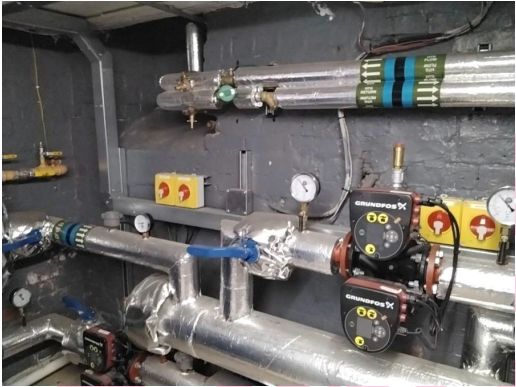
### **Item 158 Ref: Presumed**

The Debris/Residue to walls (Boiler Room Plant Room 3 Z1/002) is presumed to contain asbestos.

Any change in its appearance should be recorded and passed to Property Services.

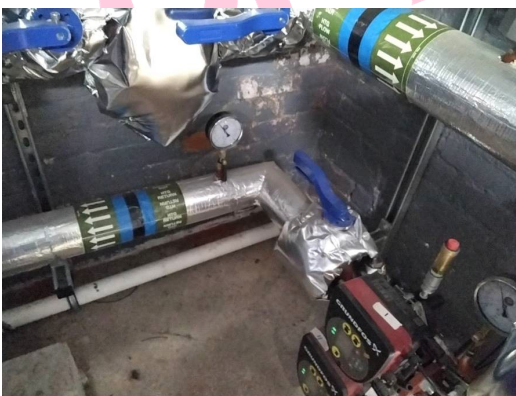
### **Item 159 Ref: Presumed**

The Debris/Residue to wall in corner, paint degraded (Boiler Room Plant Room 3 Z1/002) is presumed to contain asbestos.

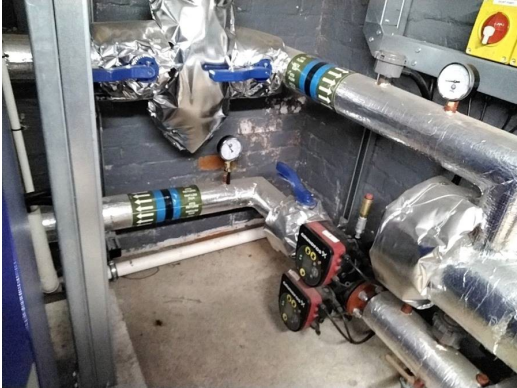
**Item 160 Ref: KX001878**

The Debris/Residue to floor (Boiler Room Plant Room 3 Z1/002) does not contain asbestos.

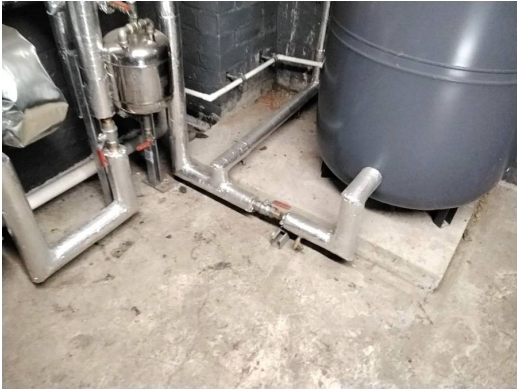
**Item 161 Ref: KX001879**

The Debris/Residue to floor (Boiler Room Plant Room 3 Z1/002) does not contain asbestos.

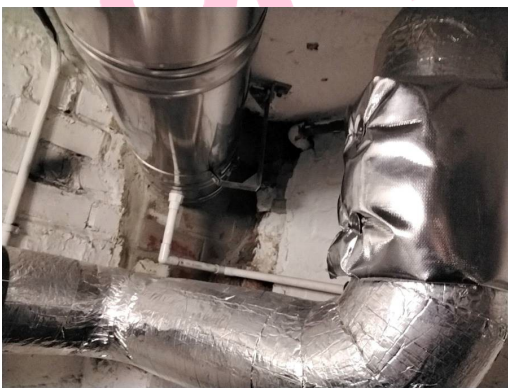
**Item 162 Ref: KX001883**

The Debris/Residue to corner penetration (Boiler Room Plant Room 1 Z1/003) does not contain asbestos.

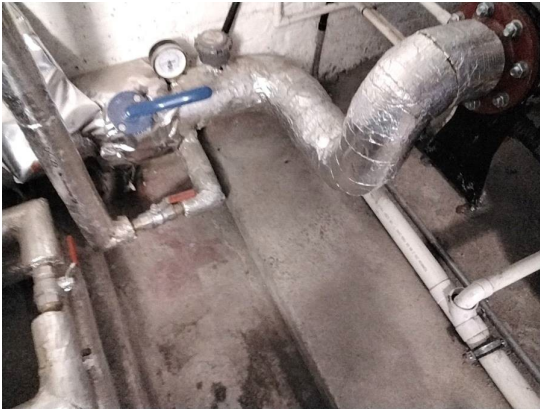
**Item 163 Ref: KX001882**

The Debris/Residue to floor (Boiler Room Plant Room 1 Z1/003) does not contain asbestos.

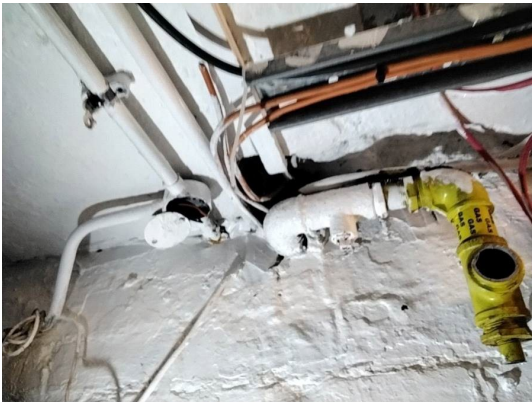
**Item 164 Ref: KX001880**

The Debris/Residue to ceiling penetrations (Boiler Room Plant Room 1 Z1/003) does not contain asbestos.

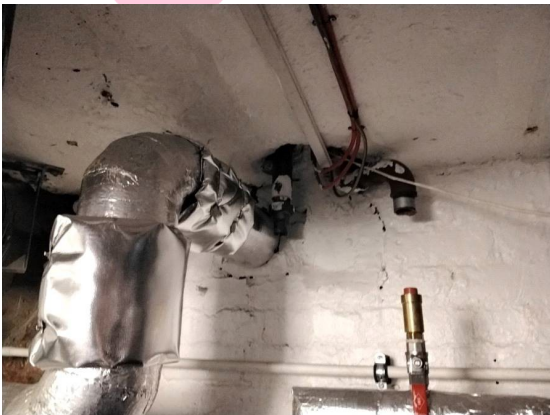
**Item 165 Ref: KX001881**

The Debris/Residue within pipe penetrations to rear wall (Boiler Room Plant Room 1 Z1/003) does not contain asbestos.

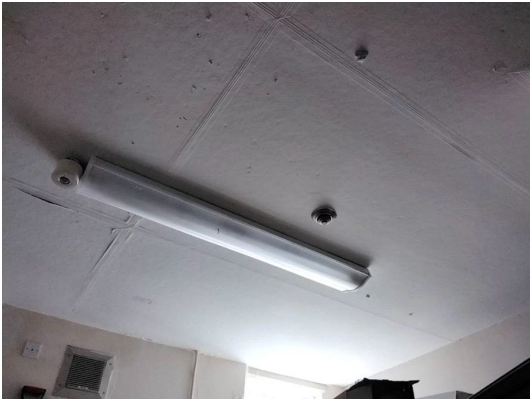
**Item 166 Ref: KX001872**

The Ceiling (Male Toilets G/002) does not contain asbestos.

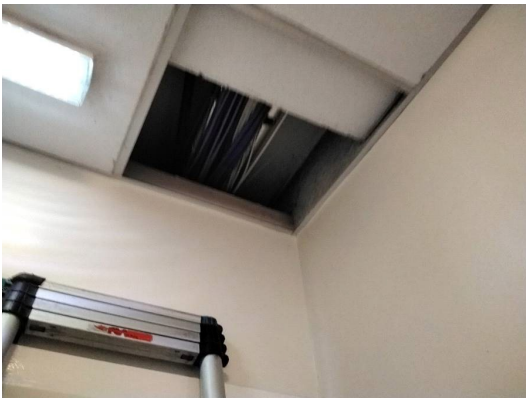
**Item 167 Ref: As KX001872**

The Ceiling (Corridor G/003) does not contain asbestos.

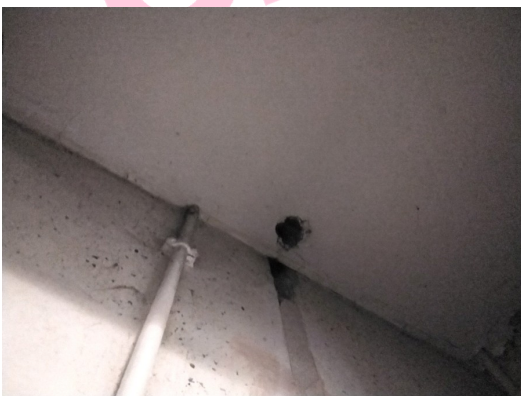
**Item 168 Ref: As KX001872**

The Ceiling (Corridor G/004) does not contain asbestos.

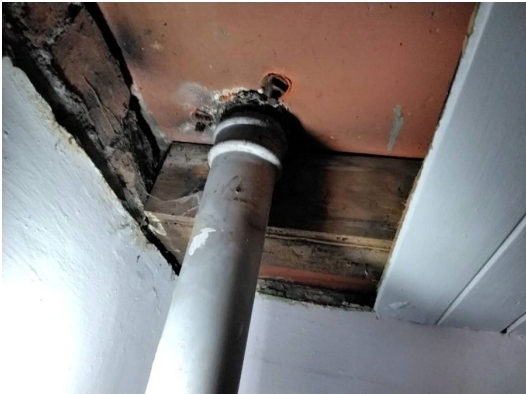
**Item 169 Ref: KX001873**

The Pipe joints  
Caulking/packing drainpipe  
joint to tank (Cupboard G/007)  
does not contain asbestos.

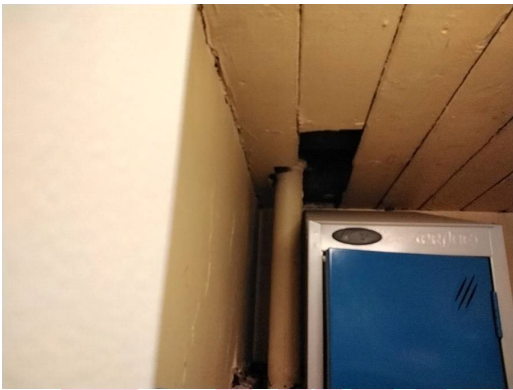
**Item 170 Ref: As KX001873**

The Pipe joints  
Caulking/packing drainpipe  
joint to tank (Cupboard G/016)  
does not contain asbestos.

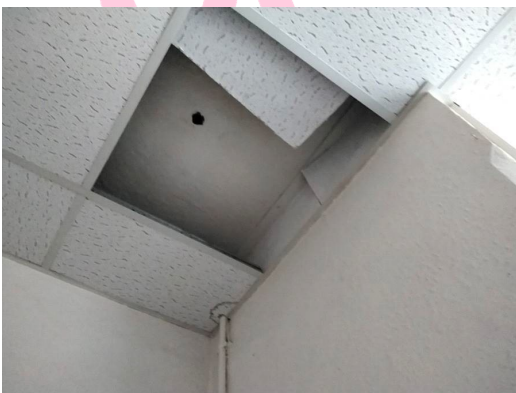
**Item 171 Ref: KX001874**

The Ceiling (Store Room  
G/017) does not contain  
asbestos.

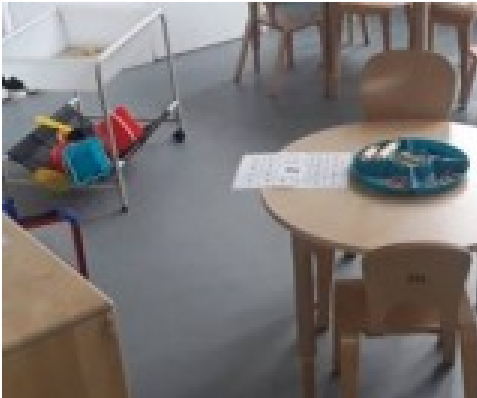
### **Item 172 Ref: NZ001548**

The Floor parquet tiles (Classroom Hedgehog Room G/001) does not contain asbestos.

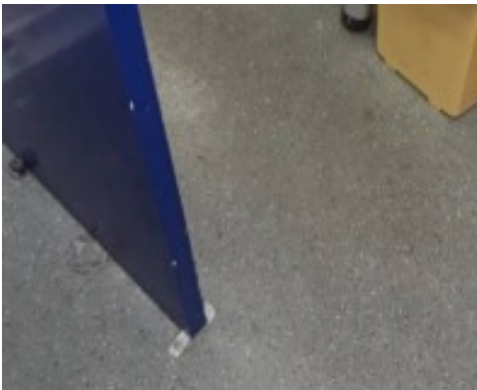
### **Item 173 Ref: NZ001549**

The Floor tile with adhesive (Kitchen G/003) does not contain asbestos.

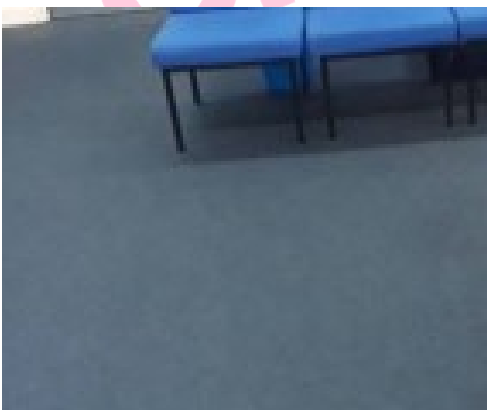
### **Item 174 Ref: NZ001550**

The Floor screed (Staff Room G/004) does not contain asbestos.

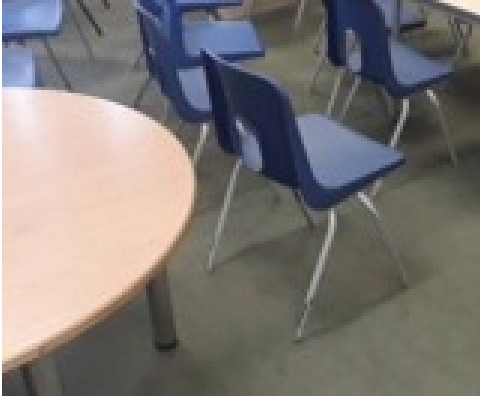
### **Item 175 Ref: As NZ001550**

The Floor screed (Classroom proposed after school club G/005) does not contain asbestos.

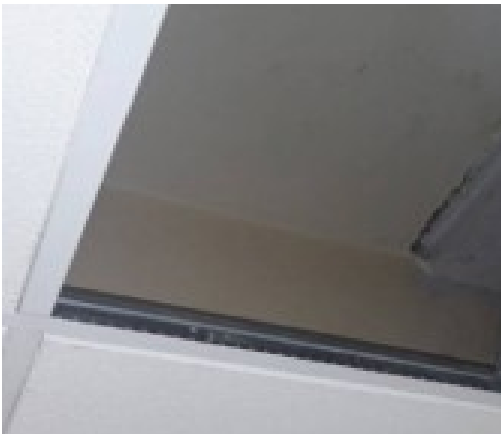
### **Item 176 Ref: NZ001551**

The Ceiling void ceiling above (Toilets staff adjacent caretakes room G/006) does not contain asbestos.

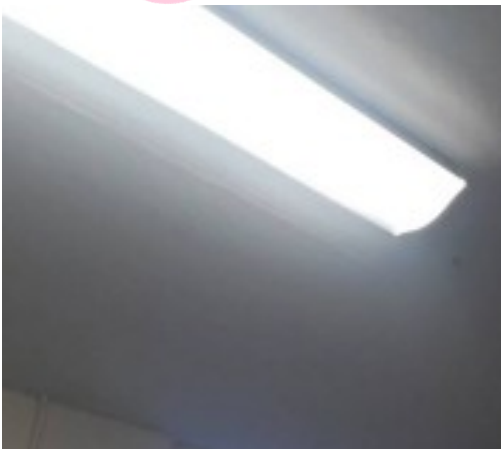
### **Item 177 Ref: As NZ001551**

The Ceiling (Caretakes room adjacent staff toilet G/007) does not contain asbestos.

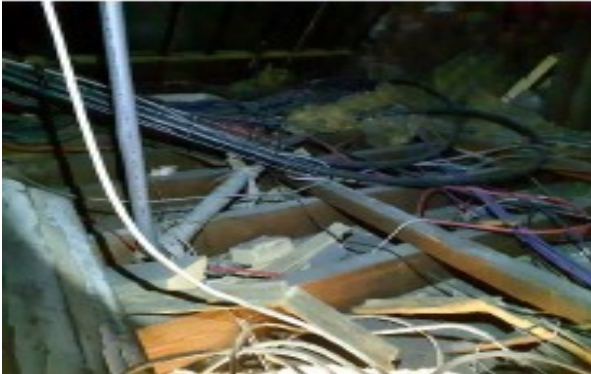
### **Item 178 Ref: RO001518**

The insulation debris in the roof void (PPA Room G/01) does not contain asbestos.

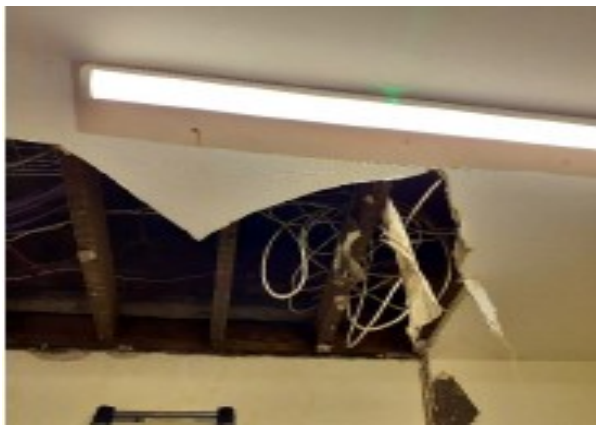
### **Item 179 Ref: RO001519**

The plasterboard ceiling in (PPA Room G/01) does not contain asbestos.

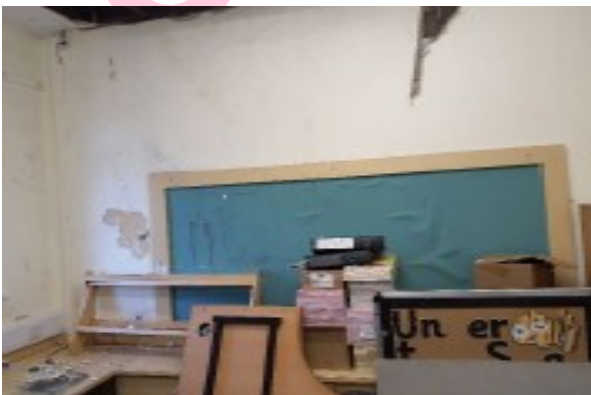
### **Item 180 Ref: RO001520**

The plastered masonry wall in (PPA Room G/01) does not contain asbestos.

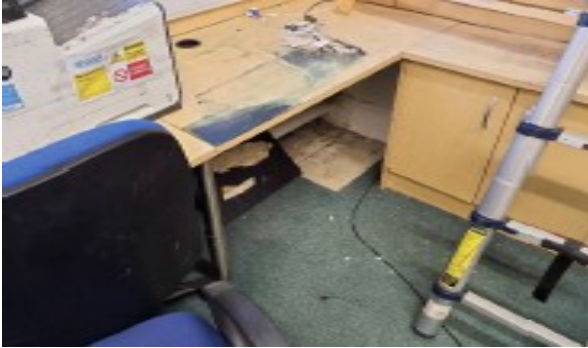
**Item 181 Ref: RO001520**

The bitumen adhesive to floor in (PPA Room G/01) does not contain asbestos.
