ASBESTOS SURVEY REPORT FOR JOHN F KENNEDY PRIMARY SCHOOL, WASHINGTON

Asbestos Register for

JOHN F KENNEDY PRIMARY SCHOOL, WASHINGTON

Date: 26 September 2024

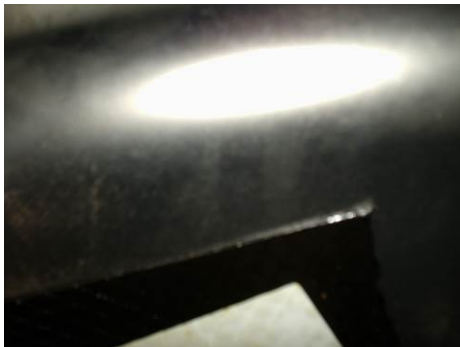
Item 4 - Ref: JP0652/07

The sink pad to the classroom (Room 0/21) does not contain asbestos.

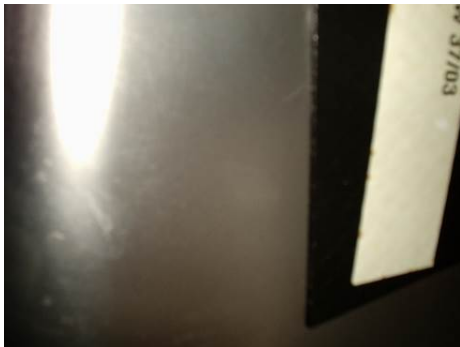
Item 5 - Ref: JP0653/07

The sink pad to the classroom (Room 0/22) does not contain asbestos.

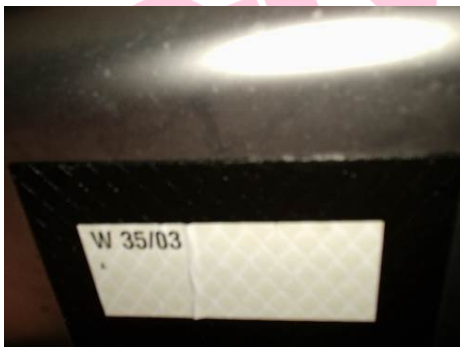
Item 6 - Ref: JP0654/07

The sink pad to the classroom (Room 0/27) does not contain asbestos.

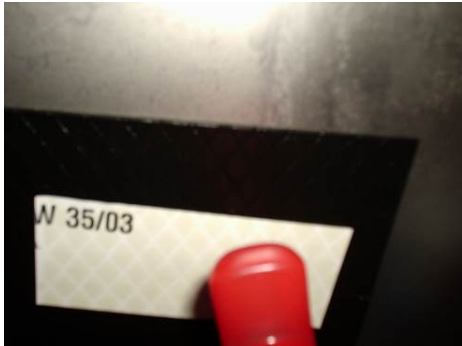
Item 7 - Ref: JP0655/07

The sink pad to the classroom (Room 0/28) does not contain asbestos.

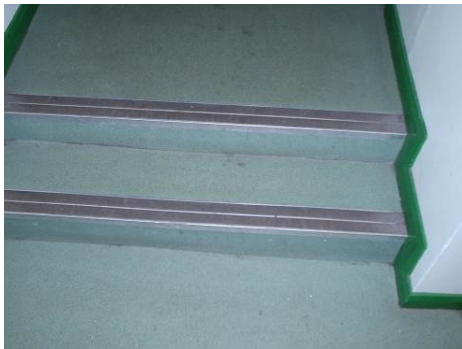
Item 8 - Ref: JP0656/07

The nosing to the stairs in the corridor (Room 0/33) does not contain asbestos.

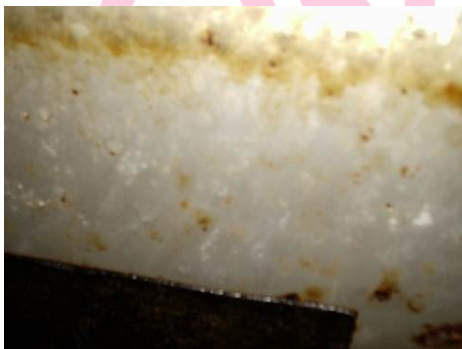
Item 9 - Ref: JP0657/07

The sink pad to the kitchen (Room 0/36) does not contain asbestos.

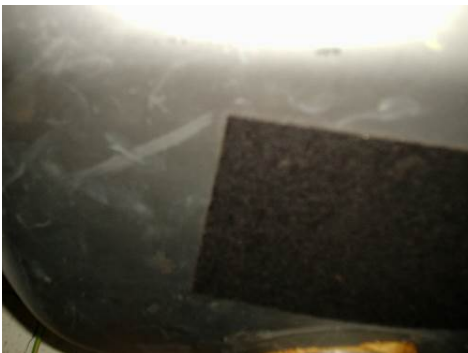
Item 12 - Ref: JP0660/07

The sink pad to the classroom (Room 0/58) does not contain asbestos

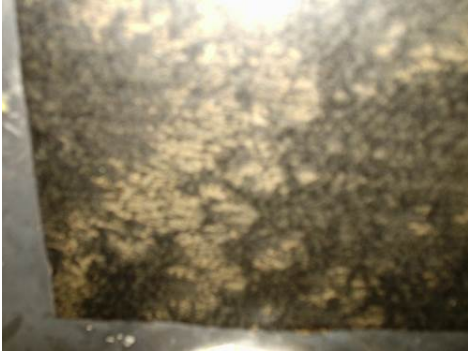
Item 13 - Ref:JP0661/07

The sink pad to the classroom (Room 0/59) does not contain asbestos

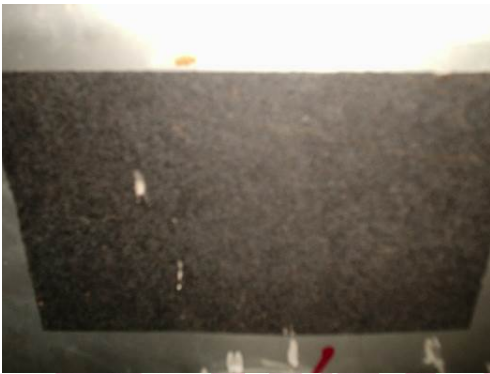
Item 14 - Ref:JP0662/07

The sink pad to the classroom (Room 0/61) does not contain asbestos

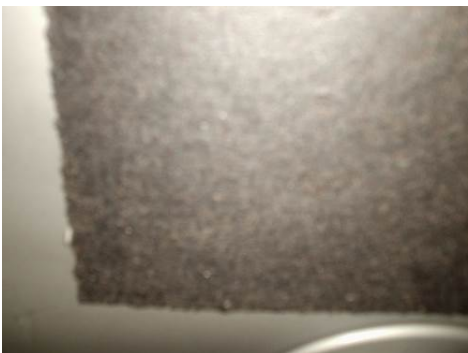
Item 15 - Ref:JP0663/07

The sink pad to the classroom (Room 0/62) does not contain asbestos

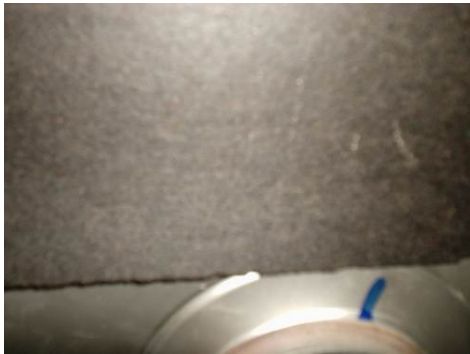
Item 16 - Ref: JP0664/07

The sink pad to the classroom (Room 0/63) does not contain asbestos

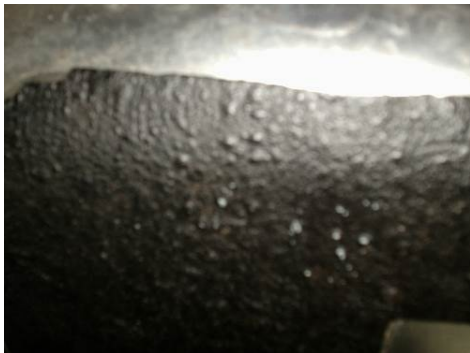
Item 17 - Ref: JP0665/07

The sink pad to the classroom (Room 0/65) contained asbestos.

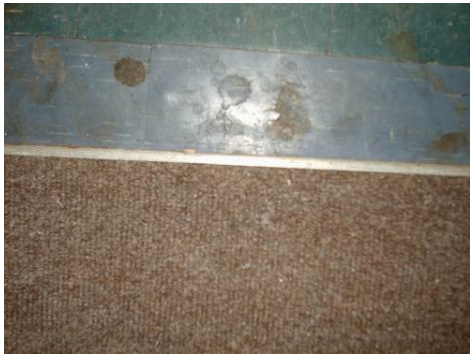
Item 19 - Ref:JP0667/07

The blue floor tiles to the caretakers office (Room 0/74) contains asbestos.

Any change in its appearance should be recorded, and passed to Property Services.

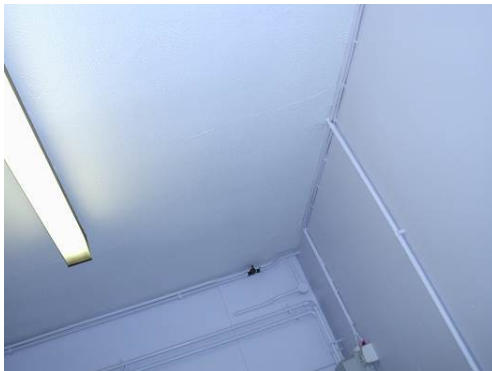
Item 20 - Ref:JP0668/07

The textured coating to the ceiling in the corridor (Room 0/76) does not contain asbestos.

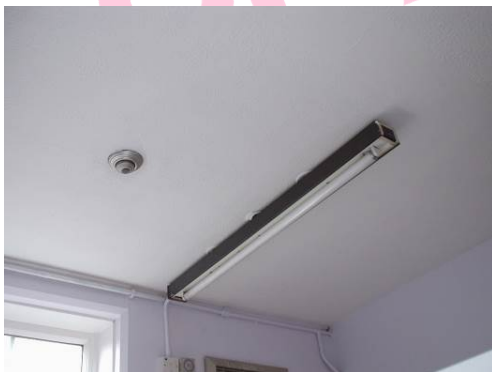
Item 21 - Ref:JP0669/07

The textured coating to the ceiling in the female WC (Room 0/77) does not contain asbestos.

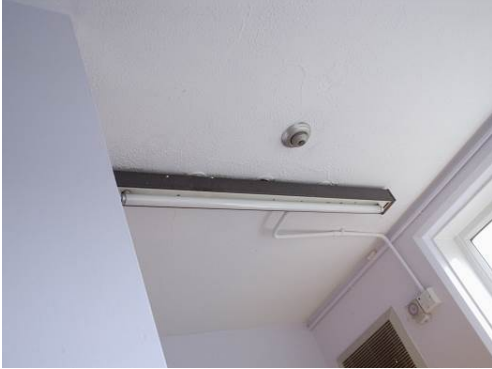
Item 22 - Ref:JP0670/07

The textured coating to the ceiling in the male WC (Room 0/78) does not contain asbestos.

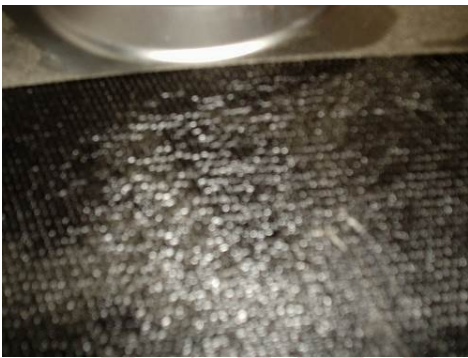
Item 23 - Ref:JP0671/07

The sink pad in the classroom (Room 0/79) does not contain asbestos.

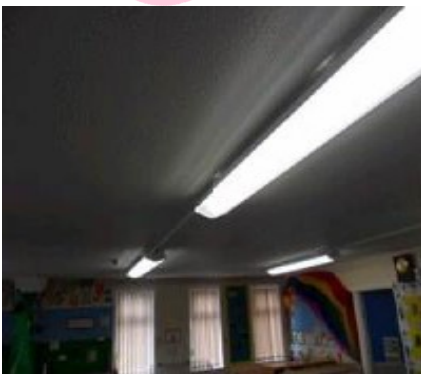
Item 24: Ref: VP003646

The textured coating to the ceiling within the nursery contains asbestos.

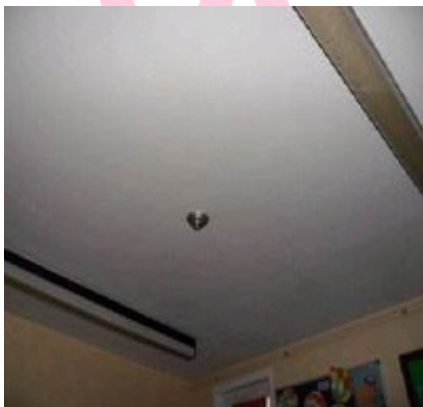
Item 27: As VP003646

The textured coating to the ceiling within the adjacent room within the nursery contains asbestos.

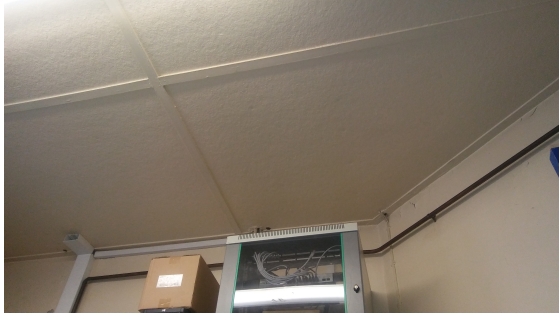
Item 34 Ref: As 415279-5

The ceiling in Rm 0/031 Caretakers Room does not contain asbestos.

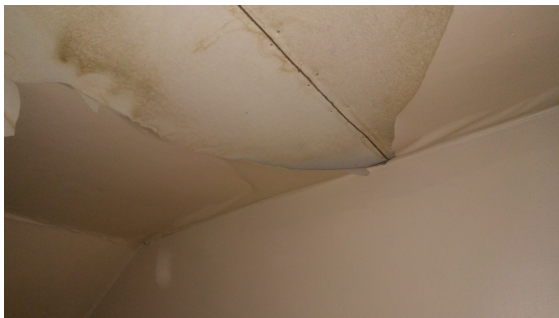
Item 35 Ref: As 415279-1

The ceiling in Rm 0/032 Classroom void above does not contain asbestos.

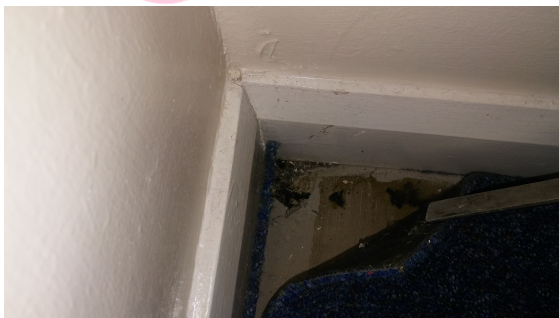
Item 36 Ref: As 415279-2

The remnant floor adhesive beneath screed in Rm 0/033 Classroom contains asbestos.

Any change in its appearance should be recorded and passed to Property Services.

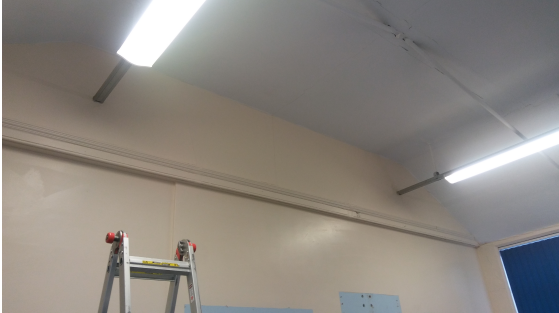
Item 37 Ref: As 415279-1

The high level panels in Rm 0/033 Classroom do not contain asbestos.

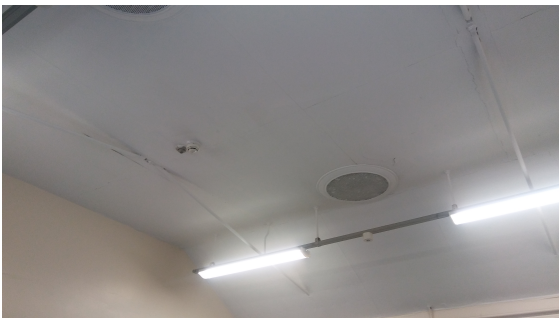
Item 38 Ref: As 415279-1

The ceiling in Rm 0/033 Classroom does not contain asbestos.

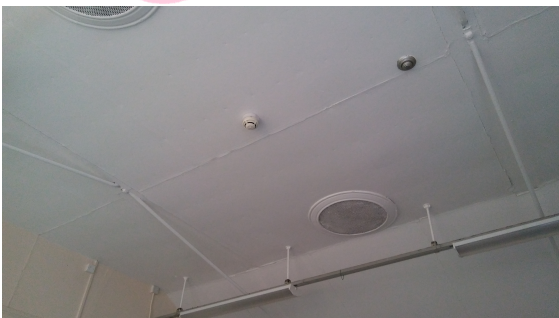
Item 39 Ref: 415279-1

The ceiling in Rm 0/034 Classroom does not contain asbestos.

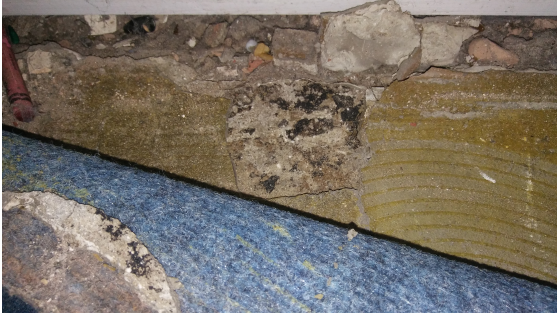
Item 40 Ref: 415279-2

The remnant floor adhesive beneath screed in Rm 0/034 Classroom contains asbestos.

Any change in its appearance should be recorded and passed to Property Services.

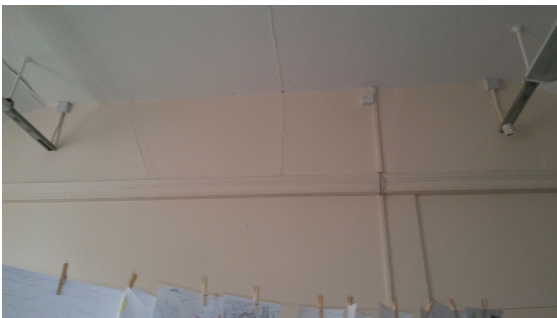
Item 41 Ref: As 415279-1

The high level panels in Rm 0/034 Classroom do not contain asbestos.

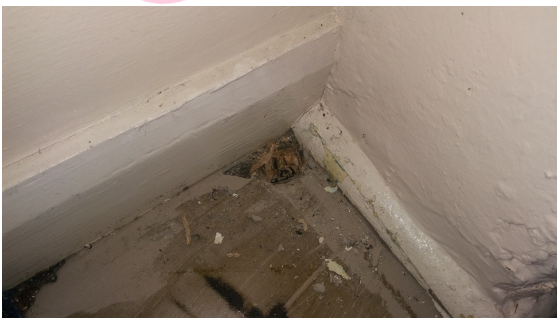
Item 42 Ref: 415279-3

The remnant floor adhesive in Rm 0/035 Classroom does not contain asbestos.

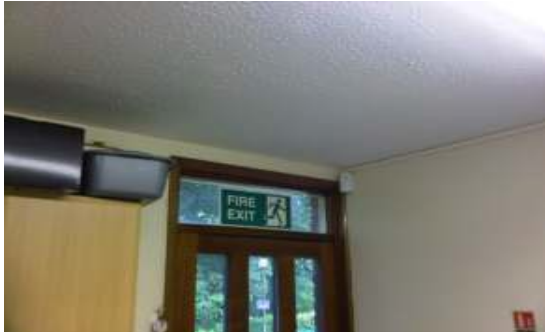
Item 46 Ref: IC11-493

The textured coating to ceiling above door (Door A) does not contain asbestos.

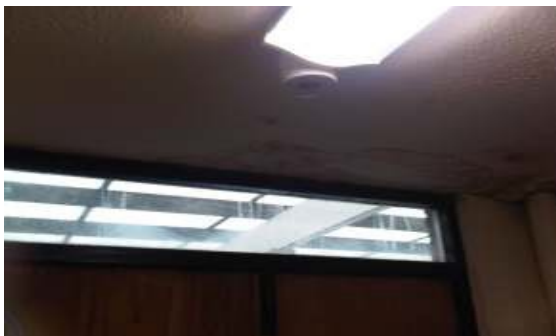
Item 47 Ref: As IC11-493

The textured coating to ceiling above door (Door B) does not contain asbestos.

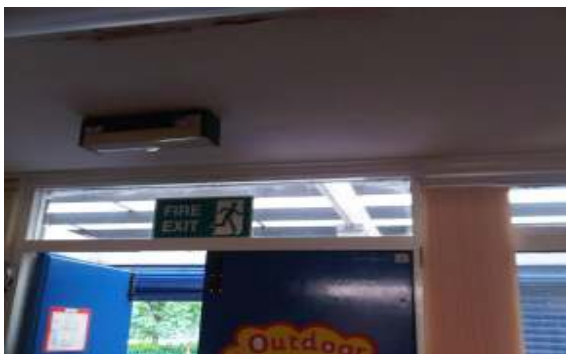
Item 48 Ref: As IC11-493

The textured coating to ceiling above door (Door C) does not contain asbestos.

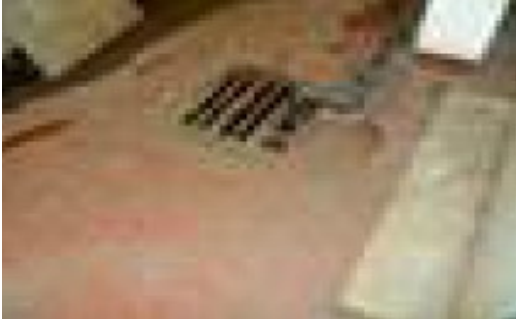
Item 55 Ref: BS004221

The Debris to floor (Boiler Room 1) does not contain asbestos.

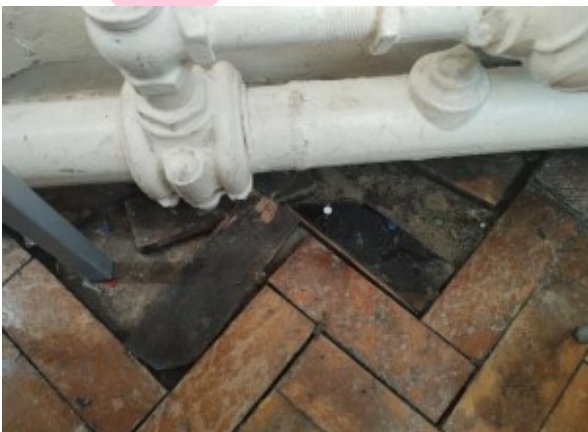
Item 141 Ref: 21-32784-1

The bitumen to the floor in Year 6 Classroom (Area 1) does not contain asbestos.

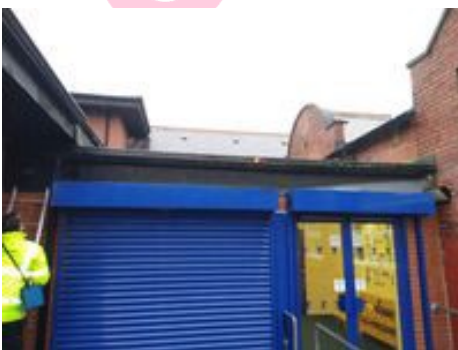
Item 144 Ref: 451175-4

The roof covering (External Roof 6) does not contain asbestos.

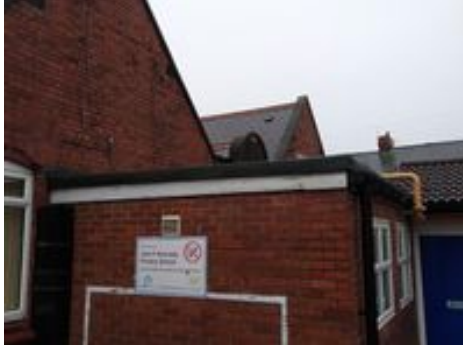
Item 145 Ref: 451175-2

The roof covering (External Roof 7) does not contain asbestos.

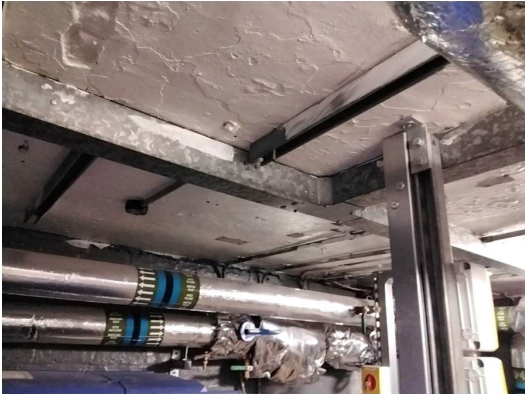
Item 151 Ref: Presumed

The Debris/Residue to ceiling (Boiler Room Plant Room 2 Z1/001) is presumed to contain asbestos.

Any change in its appearance should be recorded and passed to Property Services.

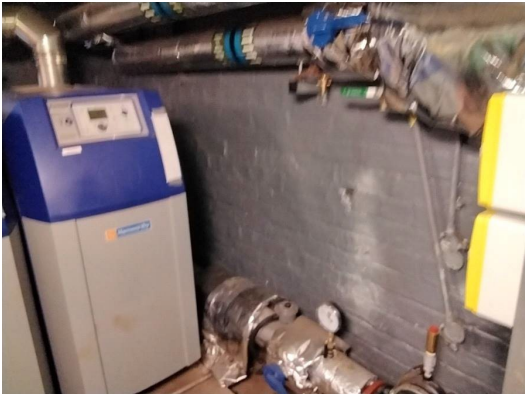
Item 152 Ref: Presumed

The Debris/Residue to walls (Boiler Room Plant Room 2 Z1/001) is presumed to contain asbestos.

Item 152	Debris/Residue to walls (Boiler Room Plant Room 2 Z1/001)	Medium Risk		03.12.2024
Item 153	Debris/Residue to wall opposite door, paint degraded (Boiler Room Plant Room 2 Z1/001)	Medium Risk		03.12.2024

Any change in its appearance should be recorded and passed to Property Services.

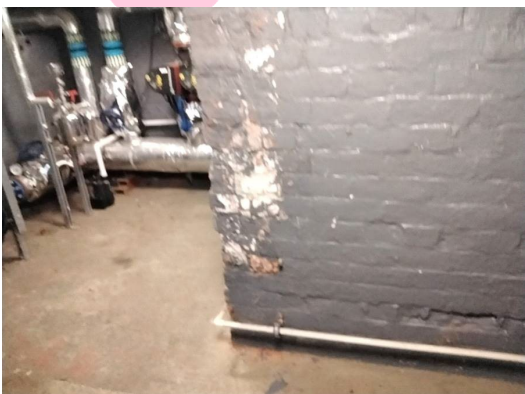
Item 153 Ref: Presumed

The Debris/Residue to wall opposite door, paint degraded (Boiler Room Plant Room 2 Z1/001) is presumed to contain asbestos.

Any change in its appearance should be recorded and passed to Property Services.

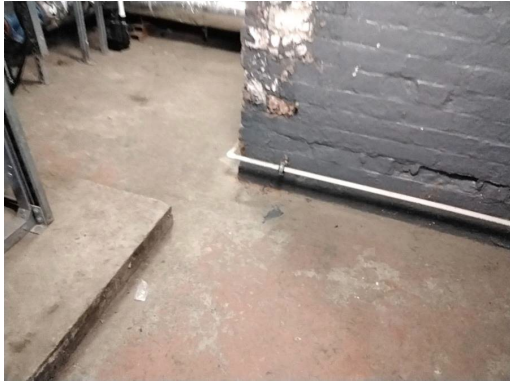
Item 154 Ref: KX001875

The Debris/Residue to floor (Boiler Room Plant Room 2 Z1/001) does not contain asbestos.

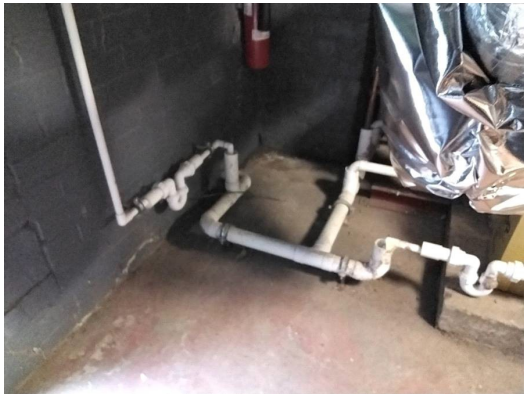
Item 155 Ref: KX001876

The Debris/Residue to floor (Boiler Room Plant Room 2 Z1/001) contains asbestos.

Any change in its appearance should be recorded and passed to Property Services.

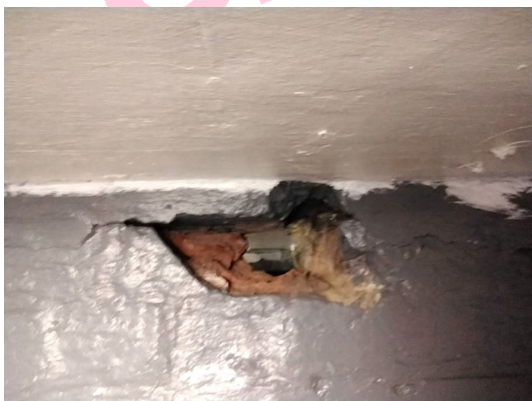
Item 156 Ref: KX001877

The Debris/Residue within pipe penetration (Boiler Room Plant Room 2 Z1/001) does not contain asbestos.

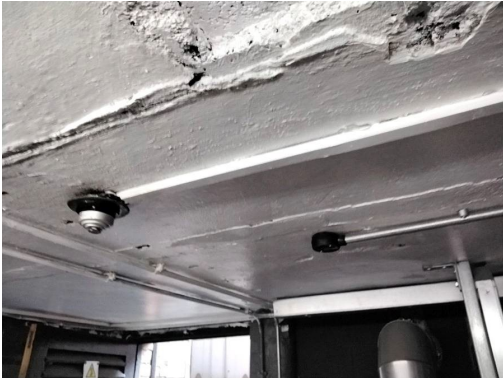
Item 157 Ref: Presumed

The Debris/Residue to ceiling (Boiler Room Plant Room 3 Z1/002) is presumed to contain asbestos.

Any change in its appearance should be recorded and passed to Property Services.

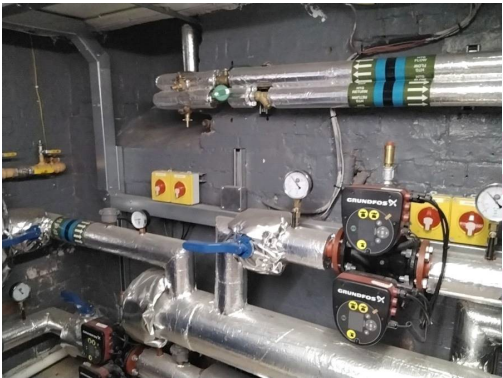
Item 158 Ref: Presumed

The Debris/Residue to walls (Boiler Room Plant Room 3 Z1/002) is presumed to contain asbestos.

Any change in its appearance should be recorded and passed to Property Services.

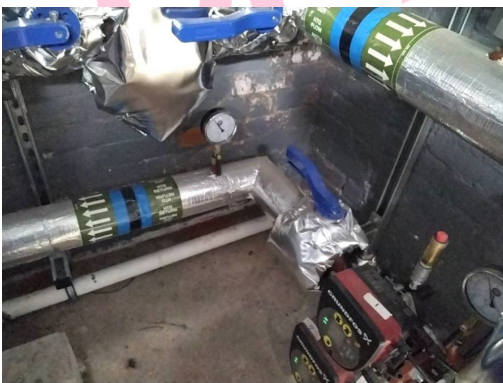
Item 159 Ref: Presumed

The Debris/Residue to wall in corner, paint degraded (Boiler Room Plant Room 3 Z1/002) is presumed to contain asbestos.

Any change in its appearance should be recorded and passed to Property Services.

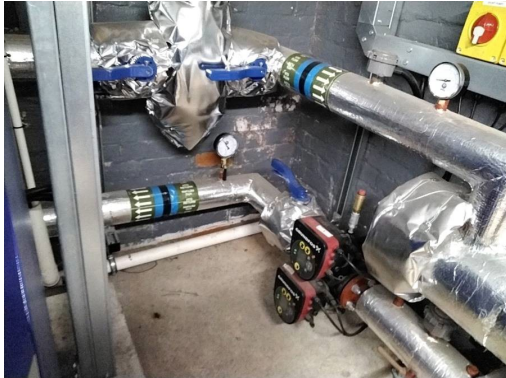
Item 160 Ref: KX001878

The Debris/Residue to floor (Boiler Room Plant Room 3 Z1/002) does not contain asbestos.

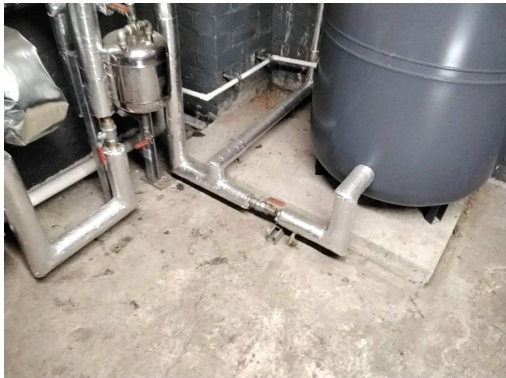
Item 161 Ref: KX001879

The Debris/Residue to floor (Boiler Room Plant Room 3 Z1/002) does not contain asbestos.

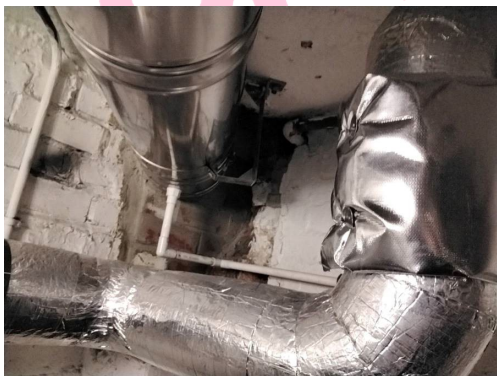
Item 162 Ref: KX001883

The Debris/Residue to corner penetration (Boiler Room Plant Room 1 Z1/003) does not contain asbestos.

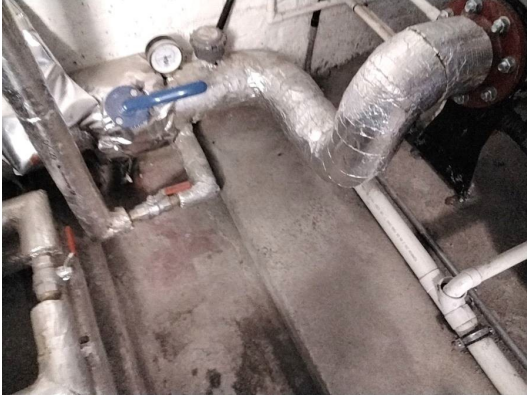
Item 163 Ref: KX001882

The Debris/Residue to floor (Boiler Room Plant Room 1 Z1/003) does not contain asbestos.

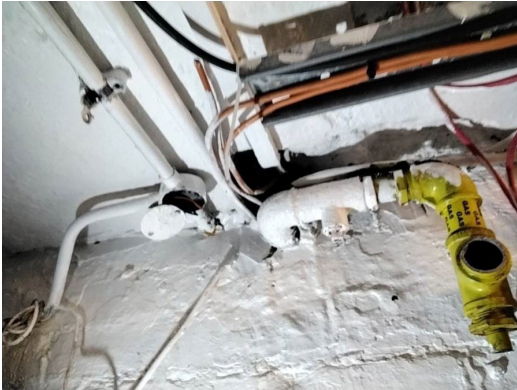
Item 164 Ref: KX001880

The Debris/Residue to ceiling penetrations (Boiler Room Plant Room 1 Z1/003) does not contain asbestos.

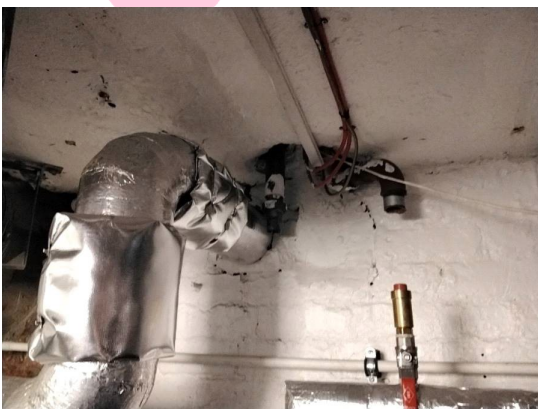
Item 165 Ref: KX001881

The Debris/Residue within pipe penetrations to rear wall (Boiler Room Plant Room 1 Z1/003) does not contain asbestos.

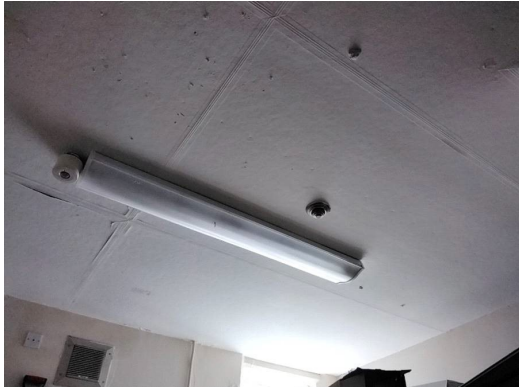
Item 166 Ref: KX001872

The Ceiling (Male Toilets G/002) does not contain asbestos.

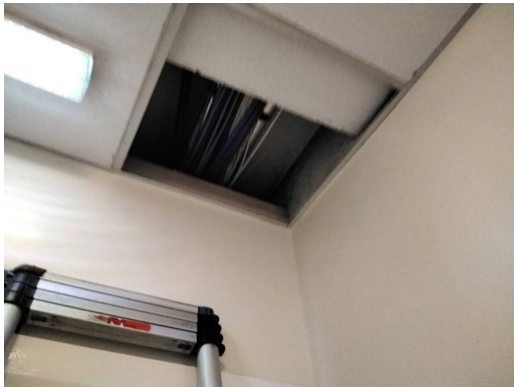
Item 167 Ref: As KX001872

The Ceiling (Corridor G/003) does not contain asbestos.

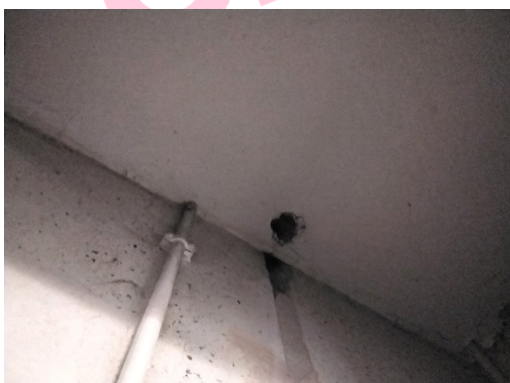
Item 168 Ref: As KX001872

The Ceiling (Corridor G/004) does not contain asbestos.

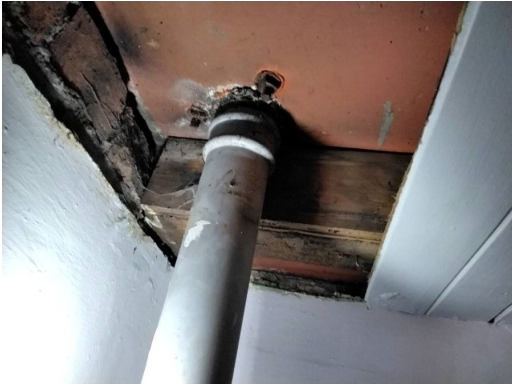
Item 169 Ref: KX001873

The Pipe joints
Caulking/packing drainpipe
joint to tank (Cupboard G/007)
does not contain asbestos.

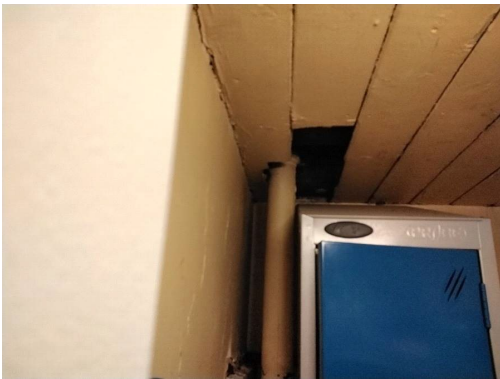
Item 170 Ref: As KX001873

The Pipe joints
Caulking/packing drainpipe
joint to tank (Cupboard G/016)
does not contain asbestos.

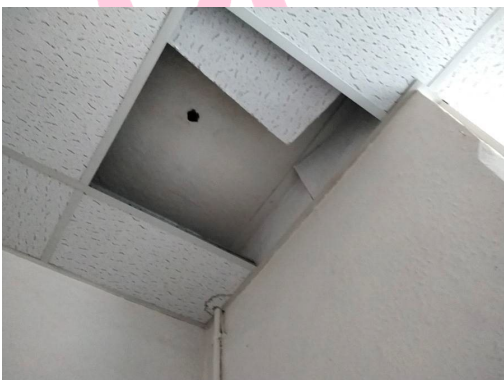
Item 171 Ref: KX001874

The Ceiling (Store Room
G/017) does not contain
asbestos.

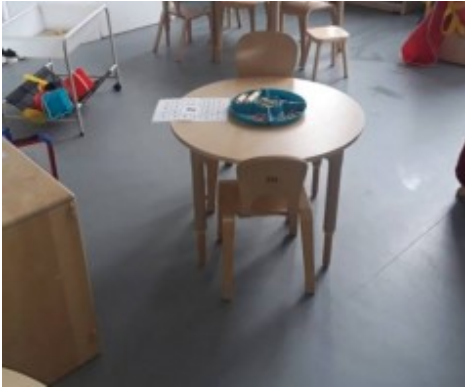
Item 172 Ref: NZ001548

The Floor parquet tiles (Classroom Hedgehog Room G/001) does not contain asbestos.

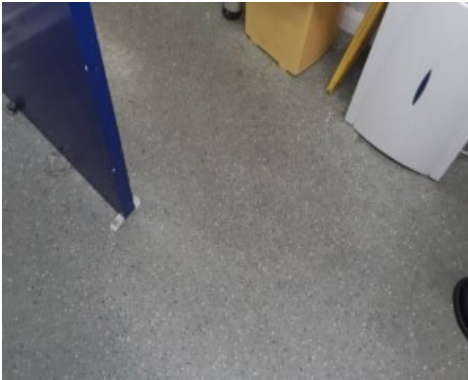
Item 173 Ref: NZ001549

The Floor tile with adhesive (Kitchen G/003) does not contain asbestos.

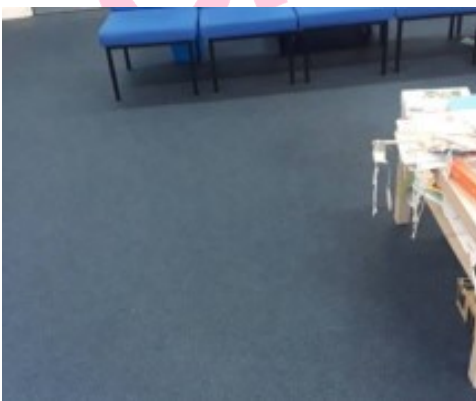
Item 174 Ref: NZ001550

The Floor screed (Staff Room G/004) does not contain asbestos.

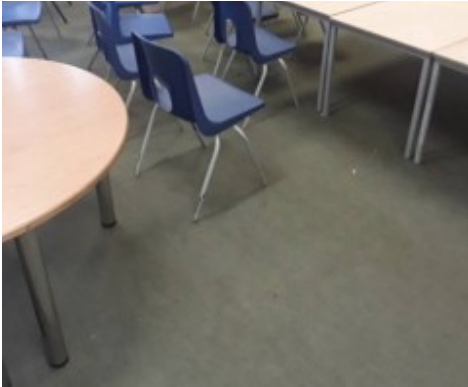
Item 175 Ref: As NZ001550

The Floor screed (Classroom proposed after school club G/005) does not contain asbestos.

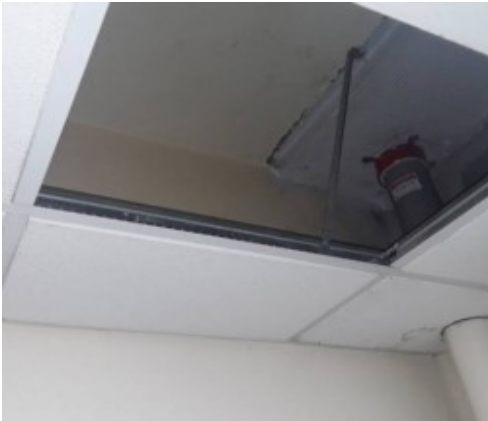
Item 176 Ref: NZ001551

The Ceiling void ceiling above (Toilets staff adjacent caretakes room G/006) does not contain asbestos.

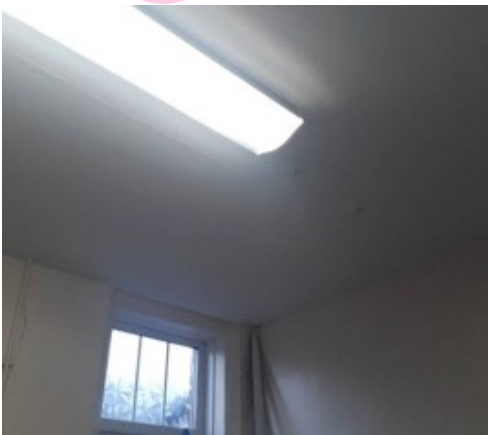
Item 177 Ref: As NZ001551

The Ceiling (Caretakes room adjacent staff toilet G/007) does not contain asbestos.
