ASBESTOS SURVEY REPORT FOR MILL HILL NURSERY SCHOOL,
TORPHIN HILL DRIVE, SUNDERLAND, SR3 2LE.

MILL HILL NURSERY SCHOOL

Date: 5th February 2024

Mill Hill Nursery - Last updated 26/09/2024 – Version 2

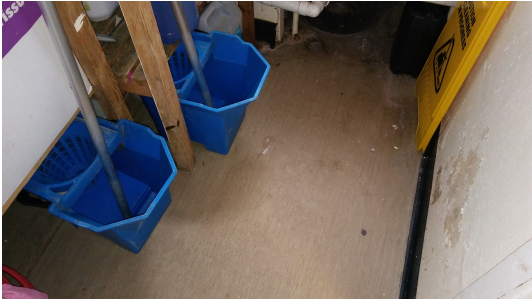
Item 1 Ref: 254938-4

The Floor covering in 010/Cleaners contains asbestos.

Any change in its appearance should be noted and reported to Property Services.

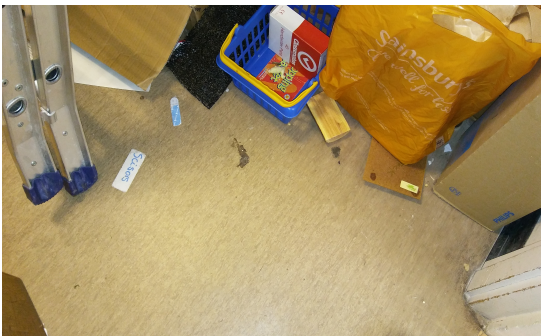
Item 2 Ref: As 254938-4

The Floor covering in 012/Store void above contains asbestos.

Any change in its appearance should be noted and reported to Property Services.

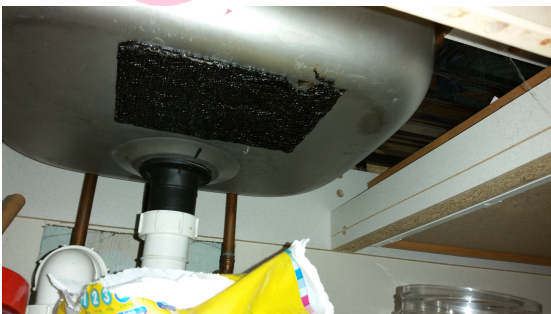
Item 3 Ref: 254938-5

The Sink Pad in 014/Nursery does not contain asbestos.

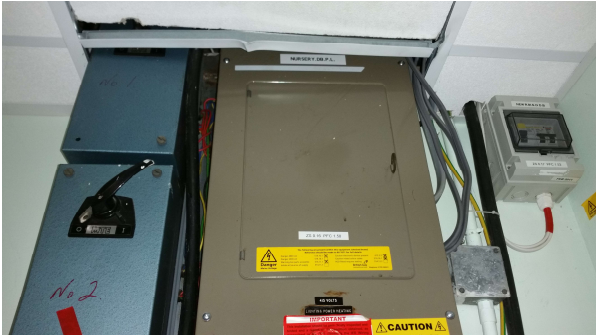
Item 4 Ref: Presumed

The Electrics NURSERY.DB.P.L. woven product in 014A/Electric Cupboard contains asbestos.

Any change in its appearance should be noted and reported to Property Services.

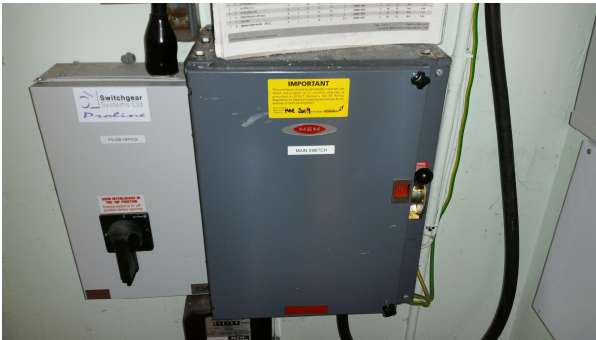
Item 5 Ref: Presumed

The Electrics MAIN SWITCH woven product in 014A/Electric Cupboard contains asbestos.

Any change in its appearance should be noted and reported to Property Services.

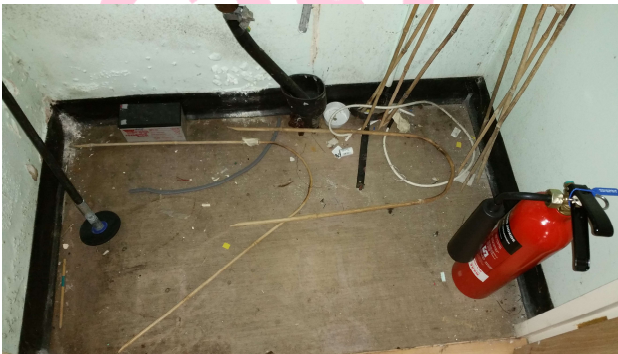
Item 6 Ref: As 254938-4

The Floor covering in 014A/Electric Cupboard contains asbestos.

Any change in its appearance should be noted and reported to Property Services.

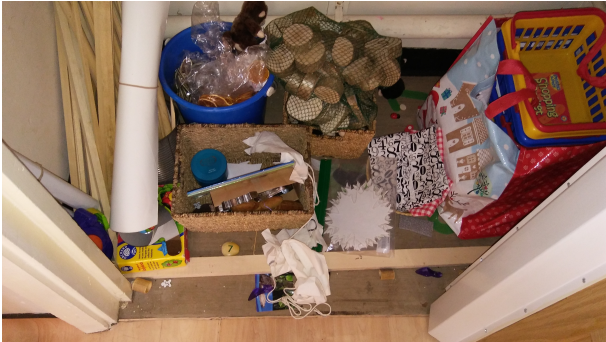
Item 7 Ref: As 254938-4

The Floor covering in 014B/Cupboard contains asbestos.

Any change in its appearance should be noted and reported to Property Services.

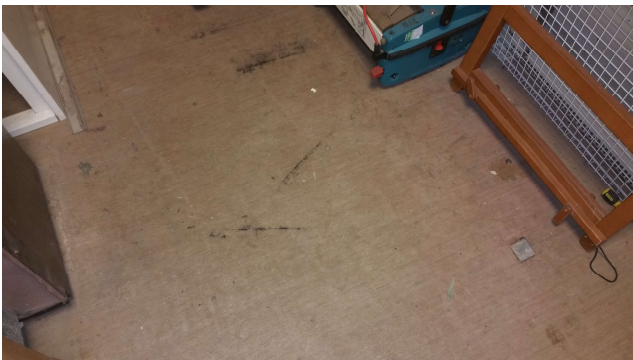
Item 8 Ref: As 254938-4

The Floor covering in 015/Plant Room contains asbestos.

Any change in its appearance should be noted and reported to Property Services.

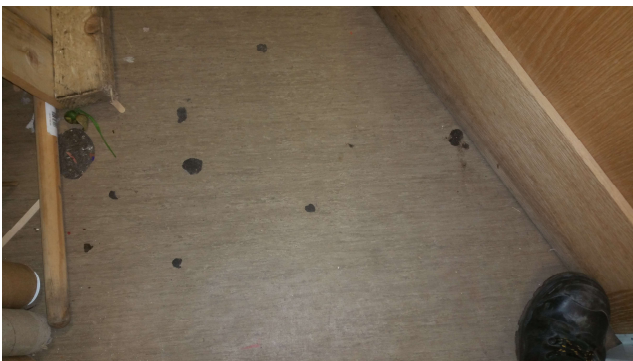
Item 9 Ref: As 254938-4

The Floor covering in 016/Store Room contains asbestos.

Any change in its appearance should be noted and reported to Property Services.

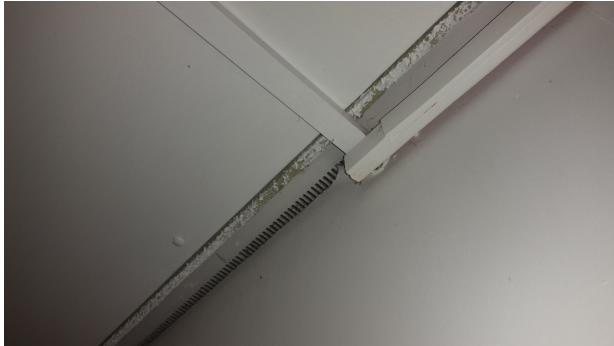
Item 10 Ref: 254938-3

The Textured Coating in 023/Entrance Lobby does not contain asbestos.

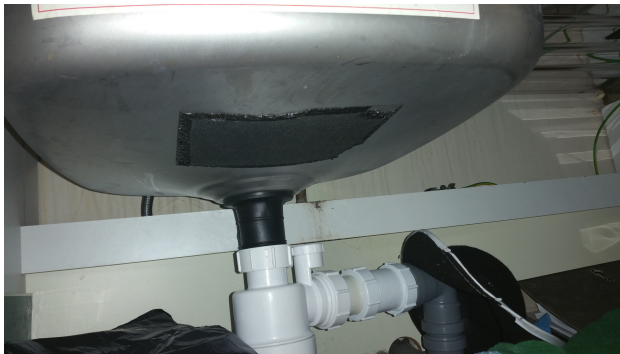
Item 11 Ref: 254938-2

The Sink Pad in 025/Staff area does not contain asbestos.

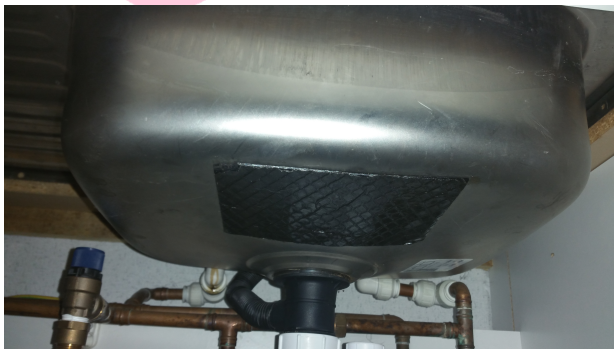
Item 12 Ref: 254938-1

The Sink Pad in 028/Nursery does not contain asbestos.

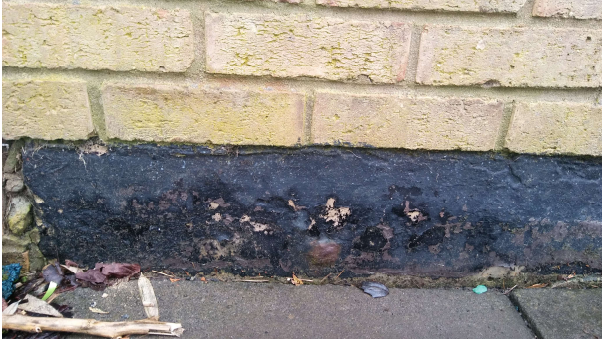
Item 13 Ref: 254938-5

The Damp Proof Course -
External does not contain
asbestos.

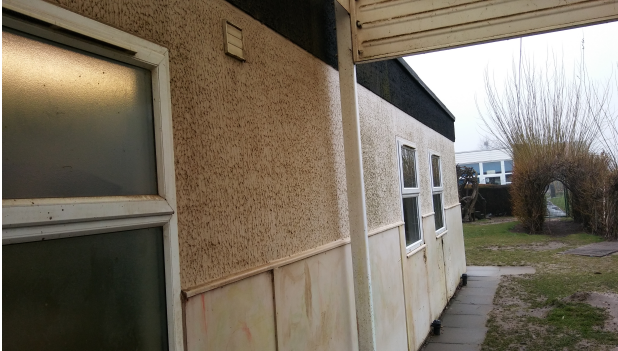
Item 14 Ref: As 254938-3

The Textured Coating -External
does not contain asbestos.

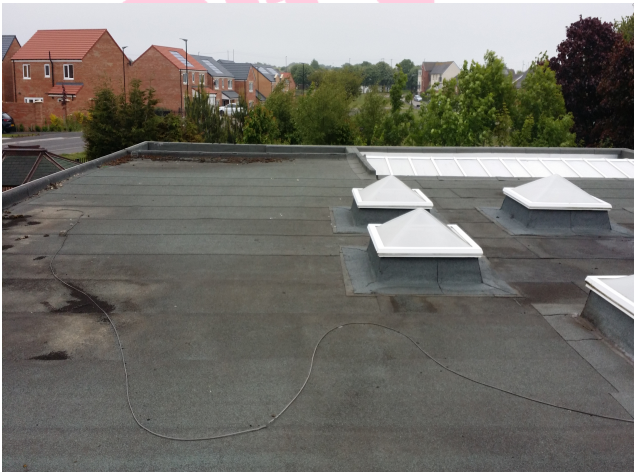
Item 15 Ref: 266111-1

The roof area 2 covering
does not contain asbestos.

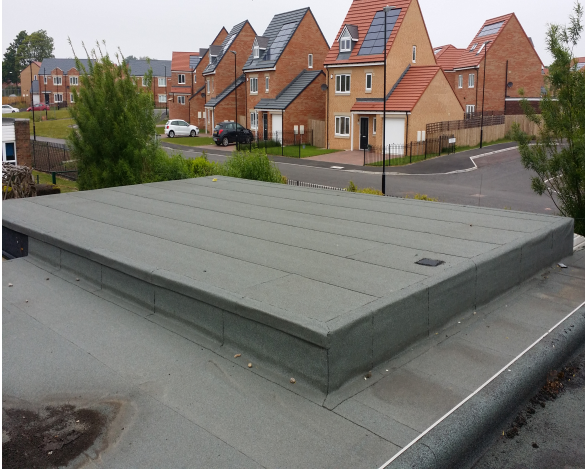
Item 16 Ref: 266111-3

The roof area 1 covering does not contain asbestos.

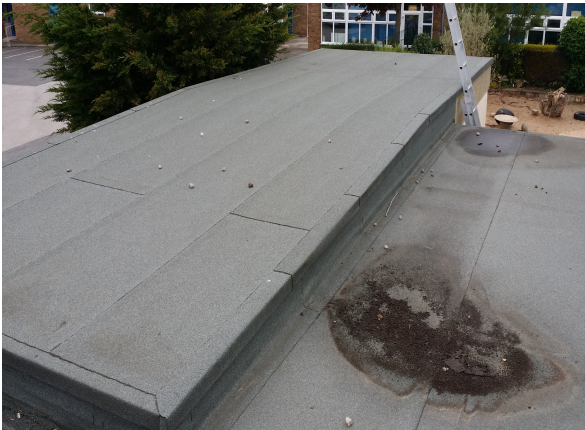
Item 17 Ref: 266111-4

The roof area 1 covering does not contain asbestos

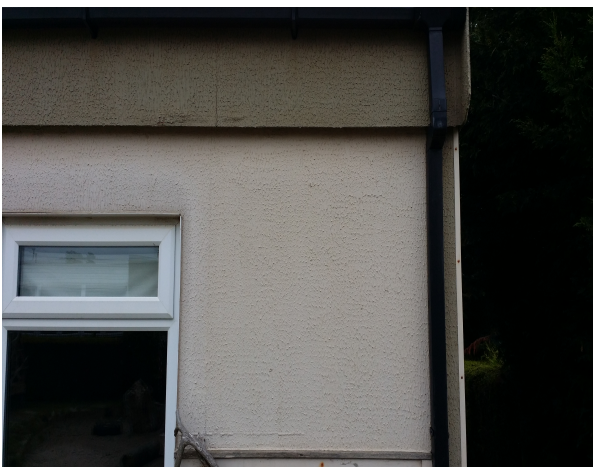
Item 18 Ref: 266111-5

The covering to wood pre-fab walls does not contain asbestos

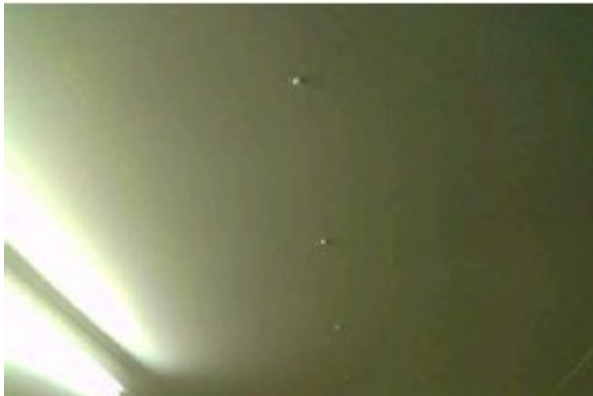
Item 19 Ref: AD001983

The ceiling in Room 1 Meeting Room does not contain asbestos.

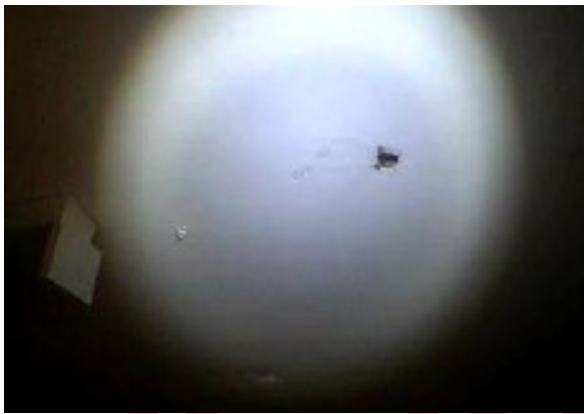
Item 20 Ref: AD001984

The ceiling in Room 2 Lunch Room does not contain asbestos.
