ASBESTOS SURVEY REPORT FOR MILL HILL NURSERY SCHOOL,  
TORPHIN HILL DRIVE, SUNDERLAND, SR3 2LE.

## **Asbestos Register for MILL HILL NURSERY SCHOOL**

**Date: 27<sup>th</sup> January 2025**

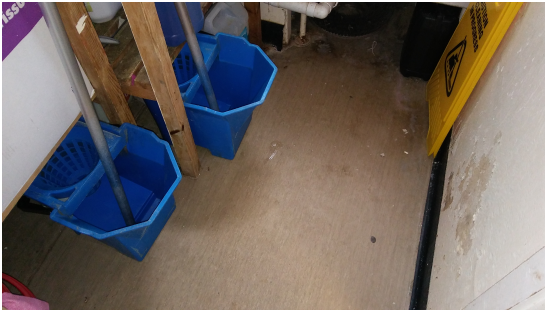
### **Item 1 Ref: 254938-4**

The Floor covering in 010/Cleaners contains asbestos.

Removed August 2024

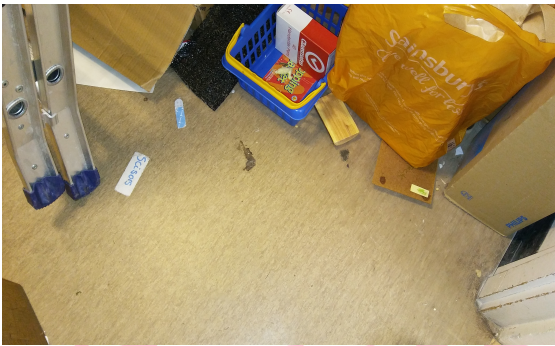
### **Item 2 Ref: As 254938-4**

The Floor covering in 012/Store void above contains asbestos.

Any change in its appearance should be noted and reported to Property Services.

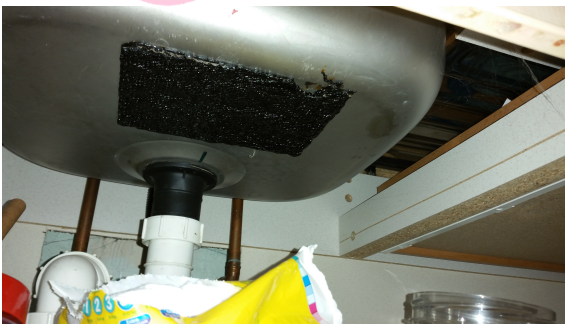
### **Item 3 Ref: 254938-5**

The Sink Pad in 014/Nursery does not contain asbestos.

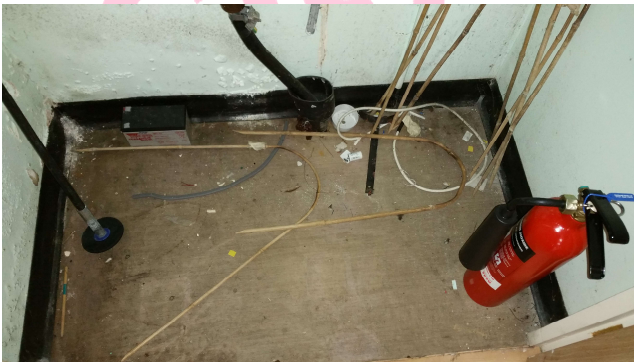
### **Item 6 Ref: As 254938-4**

The Floor covering in  
014A/Electric Cupboard  
contains asbestos.

Any change in its appearance  
should be noted and reported  
to Property Services.

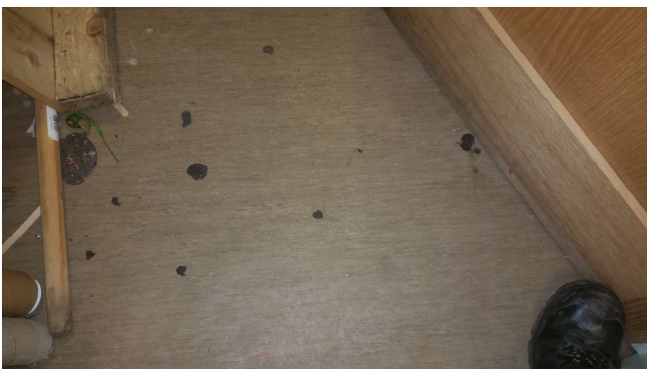
### **Item 9 Ref: As 254938-4**

The Floor covering in 016/Store Room contains asbestos.

Any change in its appearance should be noted and reported to Property Services.

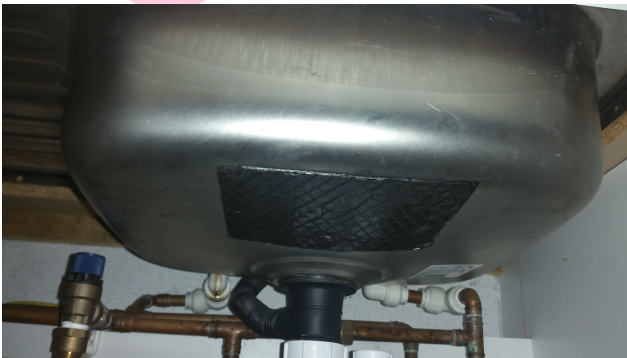
### **Item 12 Ref: 254938-1**

The Sink Pad in 028/Nursery does not contain asbestos.

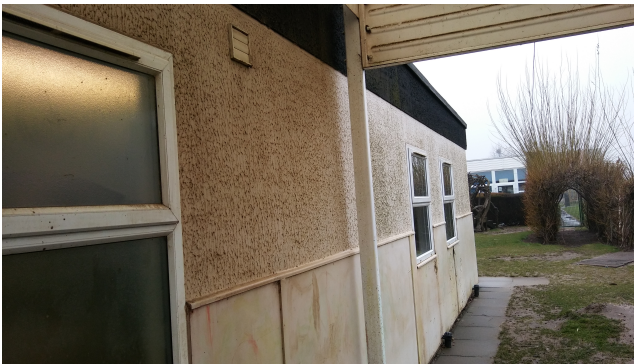
### **Item 14 Ref: As 254938-3**

The Textured Coating -External  
does not contain asbestos.

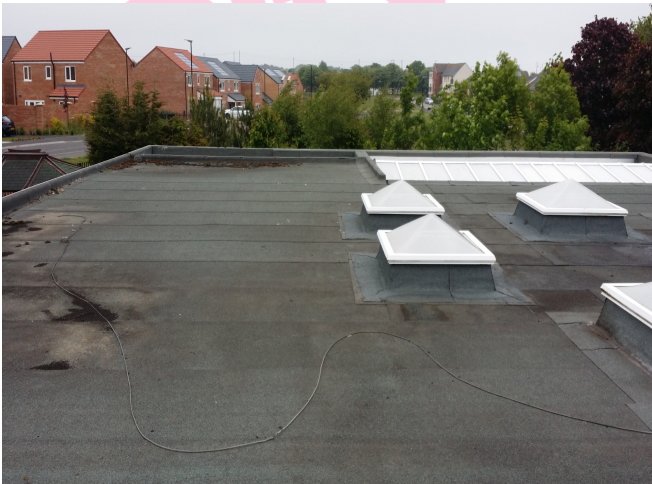
### **Item 15 Ref: 266111-1**

The roof area 2 covering  
does not contain asbestos.

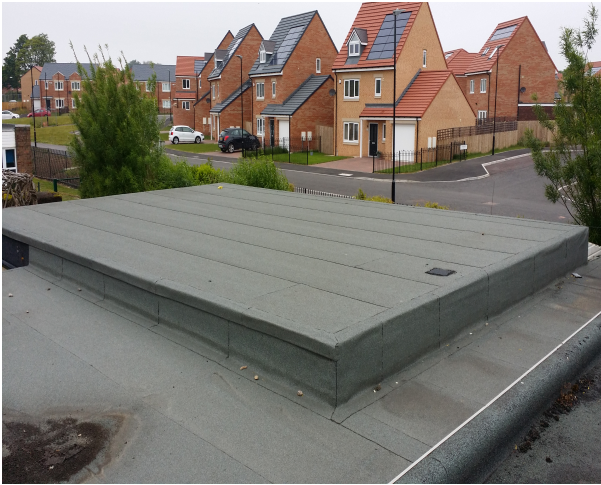
**Item 16 Ref: 266111-3**

The roof area 1 covering  
does not contain asbestos.
