ASBESTOS SURVEY REPORT FOR MILL HILL PRIMARY SCHOOL,
DOXFORD PARK, SUNDERLAND SR3 2PJ.

Asbestos Register for

Mill Hill Primary School, Doxford Park, SR3 2PJ

Date: 26 June 2026

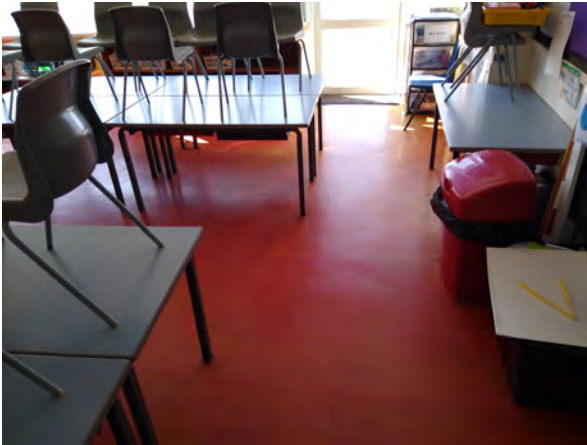
Item 1 Ref: As 412662-2

The floor covering in Rm 0/001 Classroom does not contain asbestos.

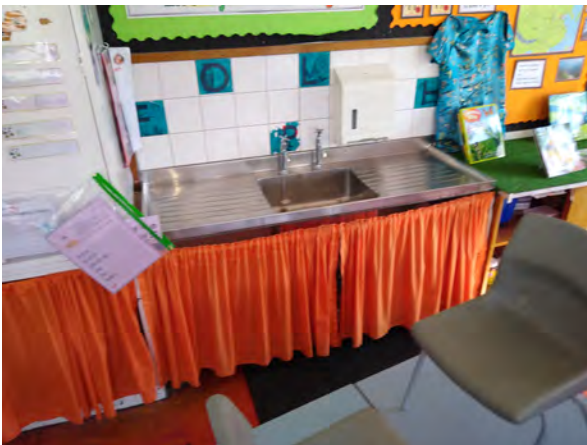
Item 2 Ref: As 412662-4

The sink pad in Rm 0/001 Classroom contains asbestos.

Any change in its appearance should be recorded and passed to Property Services.

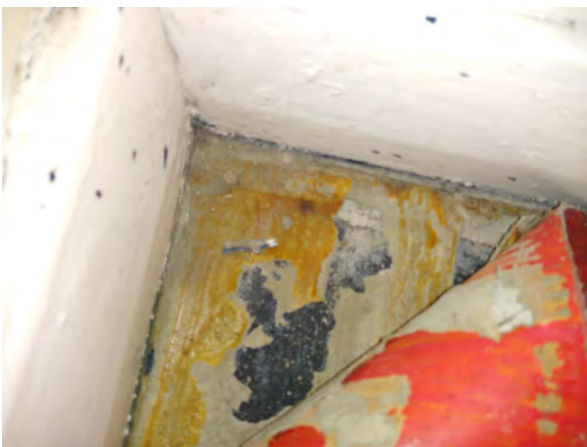
Item 3 Ref: As 412662-3

The remnant screed beneath lino in Rm 0/001 Classroom contains asbestos.

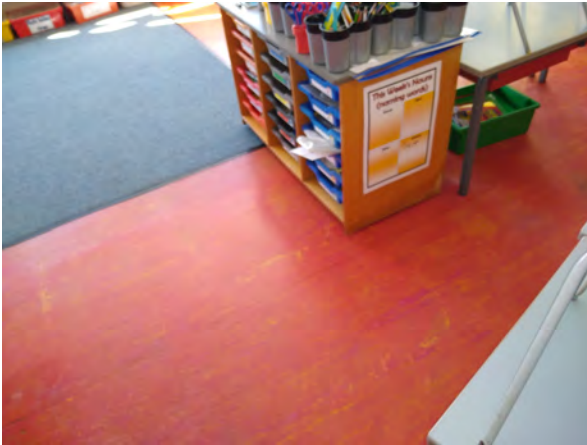
Item 4 Ref: As 412662-2

The floor covering in Rm 0/002 Classroom does not contain asbestos.

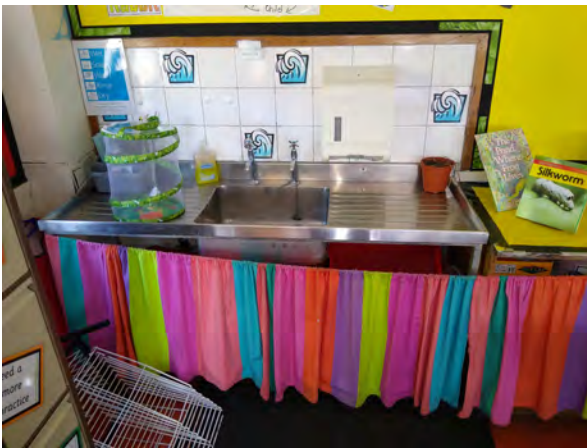
Item 5 Ref: As 412662-4

The sink pad in Rm 0/002 Classroom contains asbestos.

Any change in its appearance should be recorded and passed to Property Services.

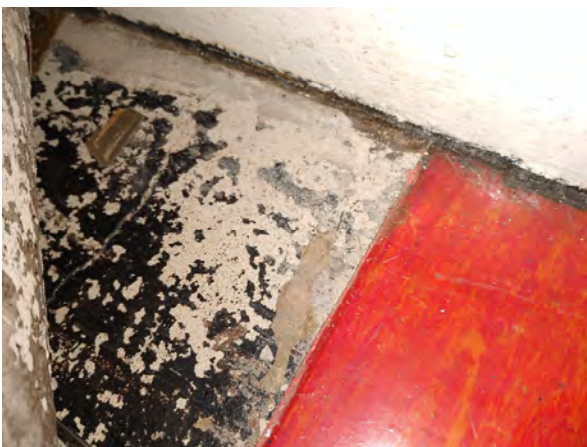
Item 6 Ref: As 412662-3

The remnant screed beneath lino in Rm 0/002 Classroom contains asbestos.

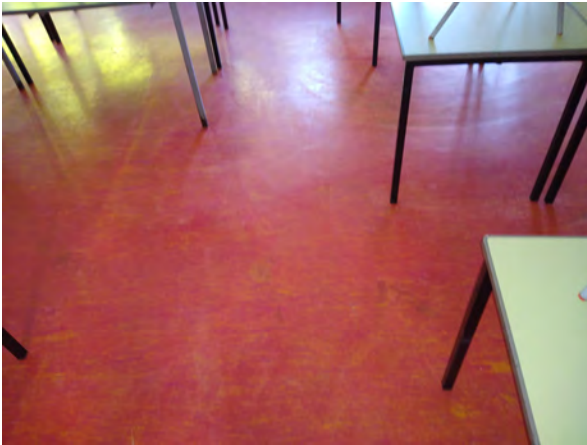
Item 7 Ref: As 412662-2

The floor covering in Rm 0/003 Classroom does not contain asbestos.

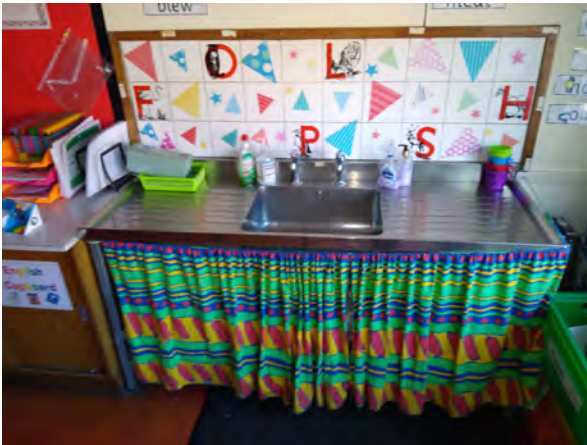
Item 8 Ref: As 412662-4

The sink pad in Rm 0/003 Classroom contains asbestos.

Any change in its appearance should be recorded and passed to Property Services.

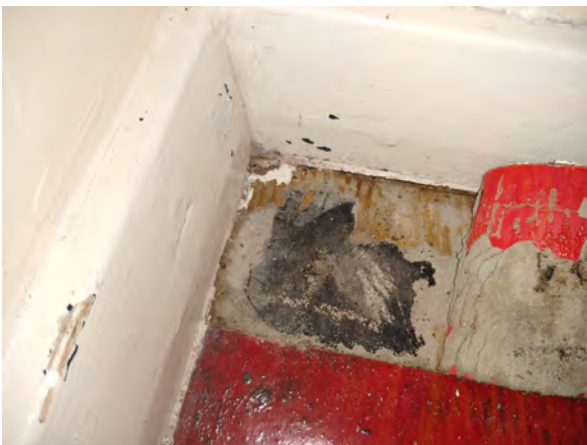
Item 9 Ref: As 412662-3

The remnant screed beneath lino in Rm 0/003 Classroom contains asbestos.

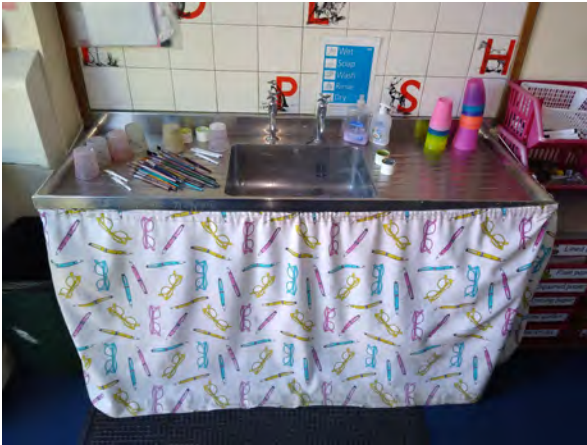
Item 10 Ref: As 412662-4

The sink pad in Rm 0/004 Classroom contains asbestos.

Any change in its appearance should be recorded and passed to Property Services.

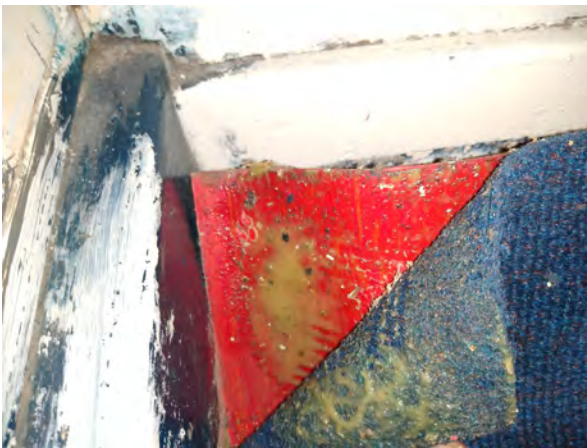
Item 11 Ref: As 412662-2

The red lino floor covering below carpet in Rm 0/004 Classroom does not contain asbestos.

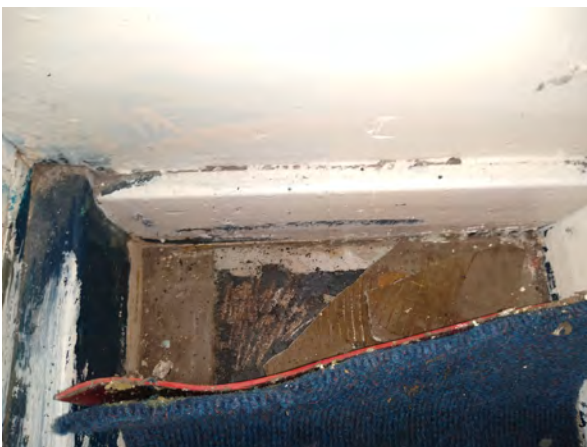
Item 12 Ref: 412662-5

The floor covering below red lino adjacent convector heater in Rm 0/004 Classroom contains asbestos.

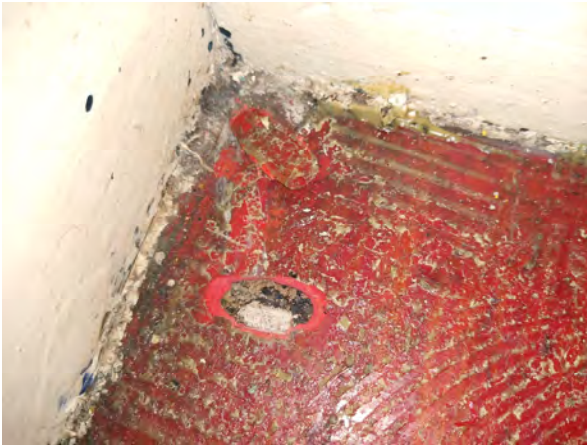
Item 13 Ref: As 412662-3

The remnant screed beneath lino in Rm 0/004 Classroom contains asbestos.

Any change in its appearance should be recorded and passed to Property Services.

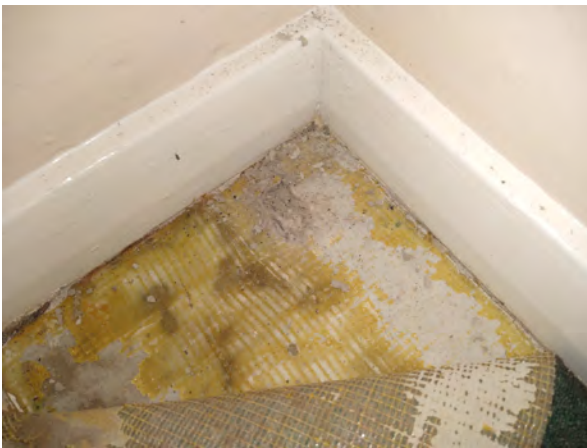
Item 14 Ref: 412662-3

The remnant bitumen adhesive below carpet in 0/005 Library contains asbestos.

Any change in its appearance should be recorded and passed to Property Services.

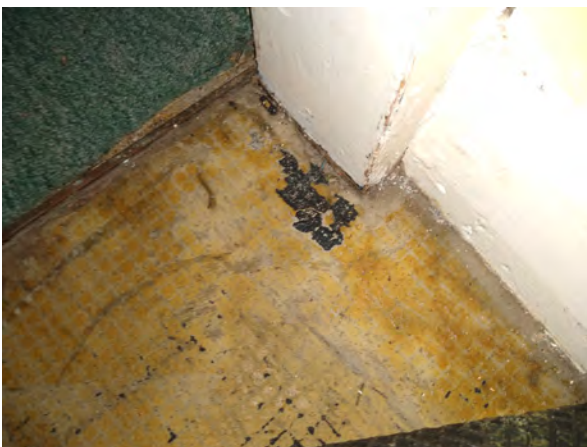
Item 15 Ref: As 412662-3

The remnant bitumen adhesive below carpet in 0/005a Library contains asbestos.

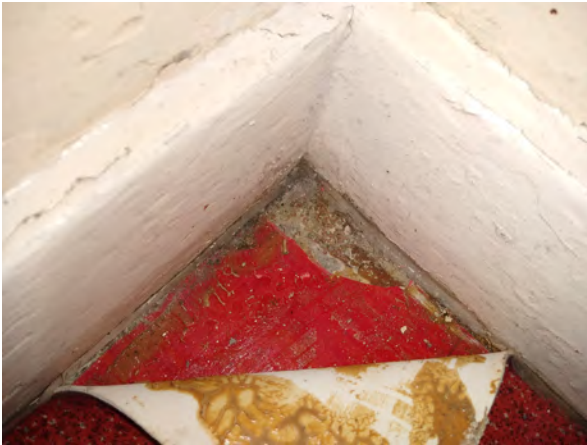
Item 16 Ref: 412662-2

The subfloor in Rm 0/009 Corridor does not contain asbestos.

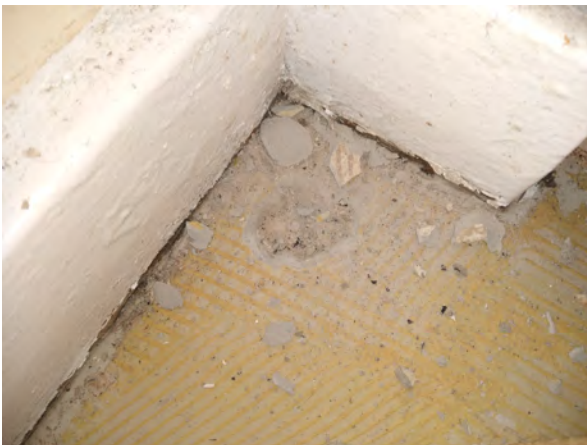
Item 17 Ref: 412662-1

The remnant bitumen adhesive below modern lino and remnant parquet flooring in Rm 0/10 Junior Dining Hall contains asbestos.

Any change in its appearance should be recorded and passed to Property Services.

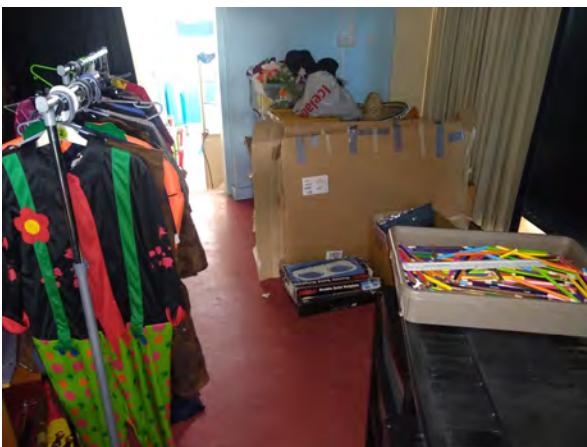
Item 18 Ref: 412662-15

The floor covering in Rm 0/011b Stage does not contain asbestos.

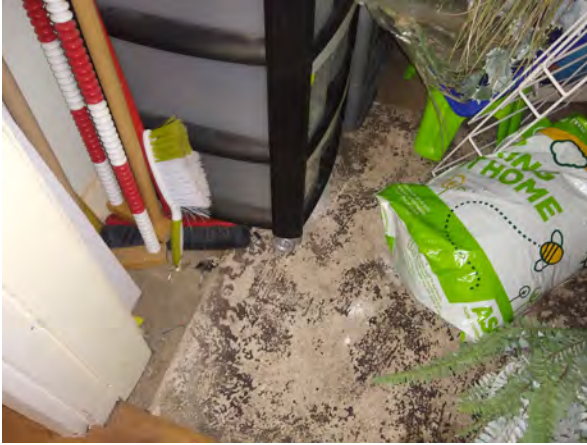
Item 19 Ref: 412662-16

The remnant floor covering in Rm 0/12a Store contains asbestos.

Removed June 2020.

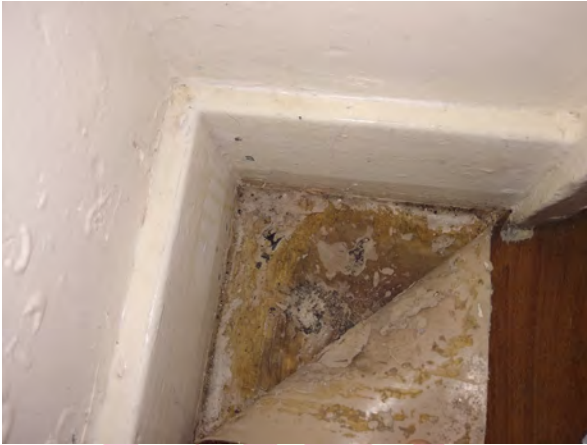
Item 20 Ref: 412662-17

The remnant adhesive to floor beneath screed in Rm 0/13 Classroom contains asbestos.

Any change in its appearance should be recorded and passed to Property Services.

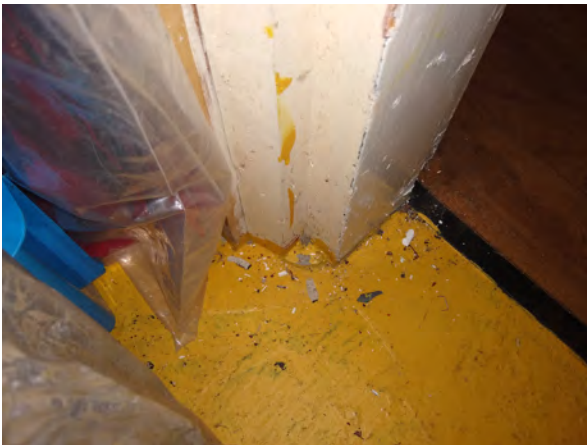
Item 21 Ref: As 412662-16

The remnant floor covering in Rm 0/13a Store contains asbestos.

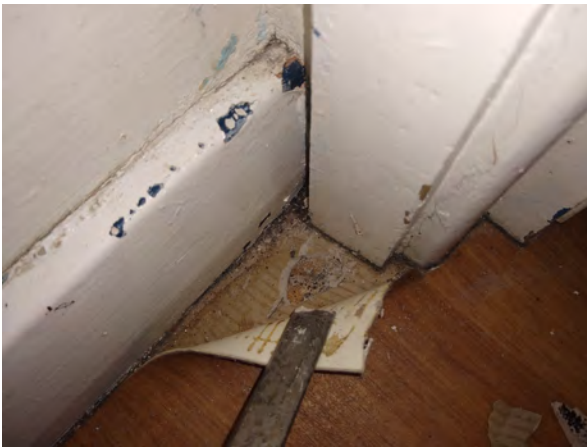
Item 22 Ref: As 412662-18

The remnant adhesive to floor beneath screed in Rm 0/23 Art Prep contains asbestos.

Any change in its appearance should be recorded and passed to Property Services.

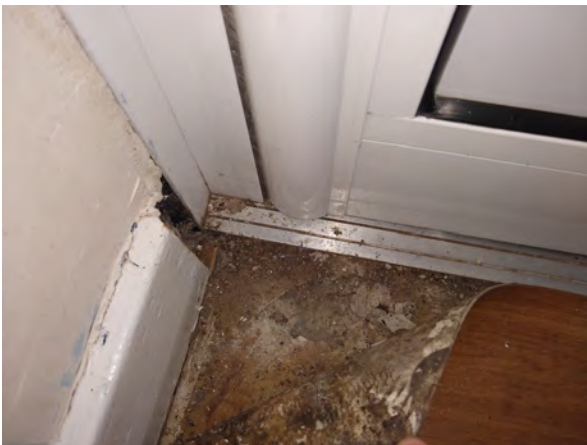
Item 23 Ref: As 412662-18

The remnant adhesive to floor beneath screed in Rm 0/25 Classroom contains asbestos.

Any change in its appearance should be recorded and passed to Property Services.

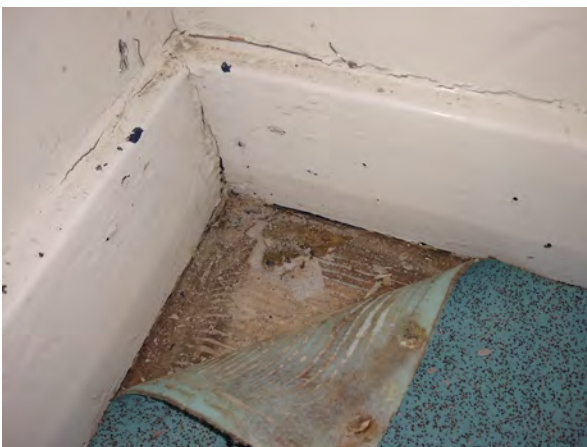
Item 24 Ref: As 412662-18

The remnant adhesive to floor beneath screed in Rm 0/25a Classroom contains asbestos.

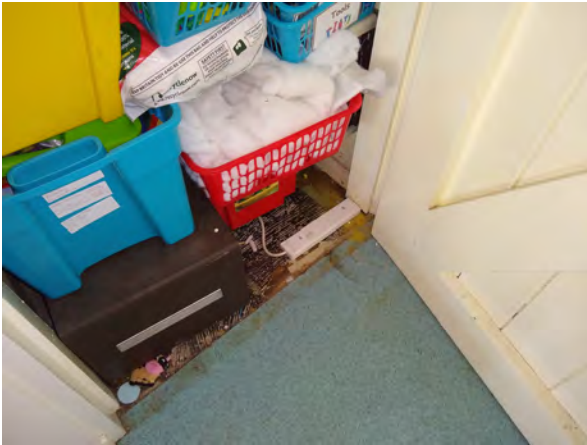
Item 25 Ref: 412662-19

The remnant floor covering in Rm 0/25b Cupboard contains asbestos.

Any change in its appearance should be recorded and passed to Property Services.

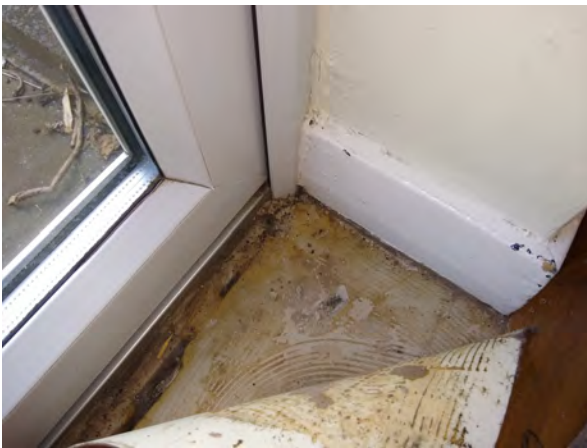
Item 26 Ref: As 412662-18

The remnant adhesive to floor beneath screed in Rm 0/26 Classroom contains asbestos.

Any change in its appearance should be recorded and passed to Property Services.

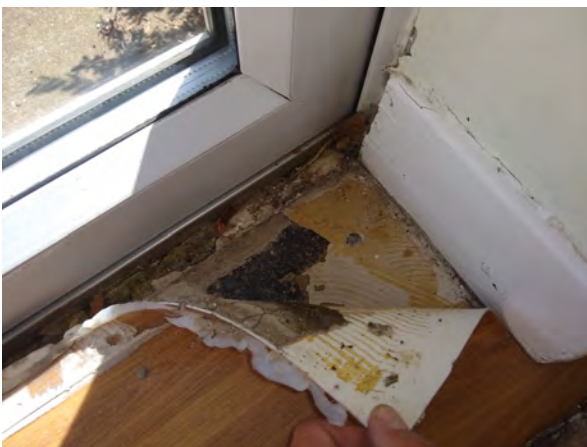
Item 27 Ref: As 412662-18

The remnant adhesive to floor beneath screed in Rm 0/27 Classroom contains asbestos.

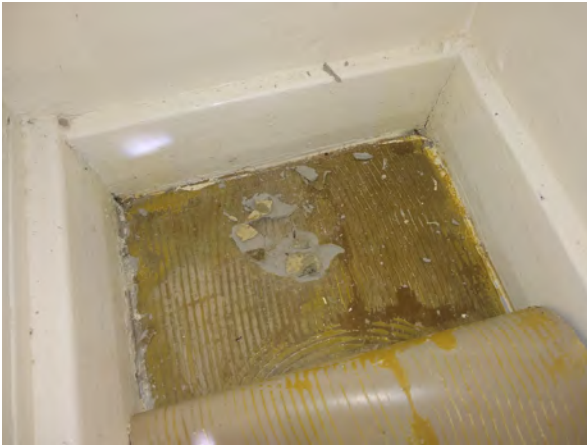
Item 28 Ref: 412662-18

The remnant adhesive to floor beneath screed in Rm 0/28 Classroom contains asbestos.

Any change in its appearance should be recorded and passed to Property Services.

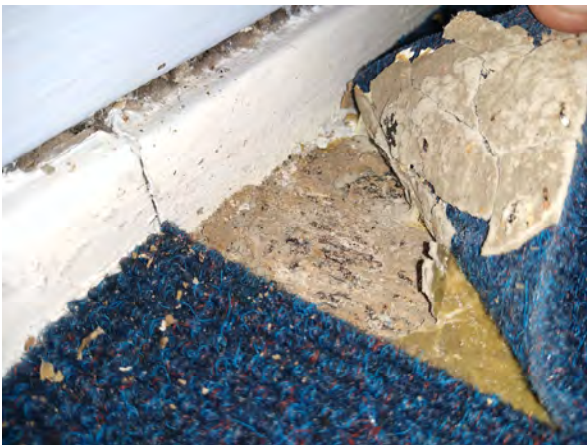
Item 29 Ref: 412662-7

The remnant bitumen adhesive below floor coverings in Rm 0/29 Corridor contains asbestos.

Any change in its appearance should be recorded and passed to Property Services.

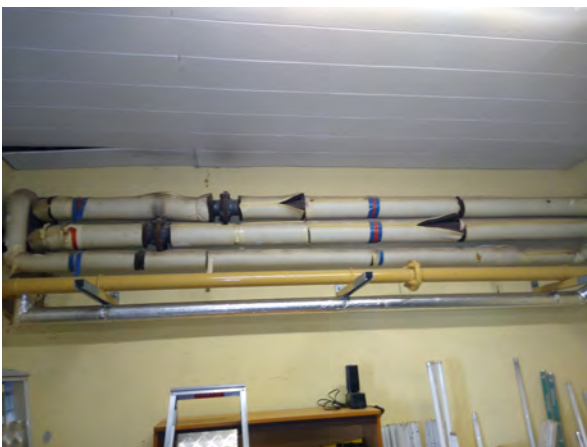
Item 30 Ref: 412662-6

The pipework flange gasket in Rm 0/29a Store does not contain asbestos.

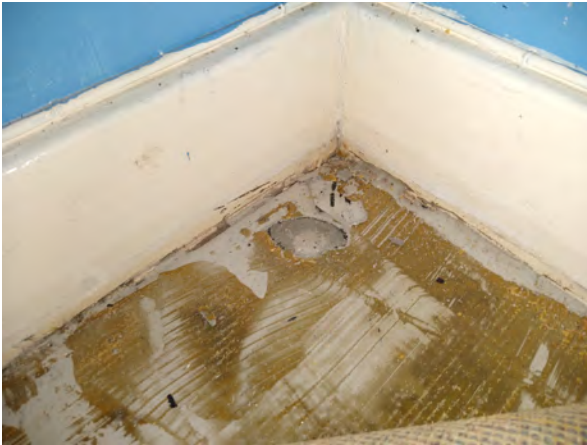
Item 31 Ref: 412662-9

The remnant bitumen adhesive below carpet in Rm 0/29c ICT Suite contains asbestos.

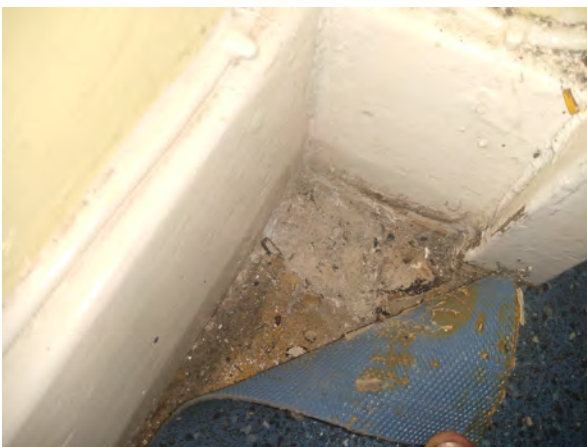
Item 33 Ref: 412662-10

- (Item 32) Ref: 412662-8 – Packers to wood joists topside of metal beam (0/29c ICT Suite void above) – Very Low Risk
- (Item 33) Ref: 412662-10 – Subfloor covering below modern lino (0/29d Medical Room) – Very Low Risk

The subfloor covering below modern lino in Rm 0/29d Medical Room contains asbestos.

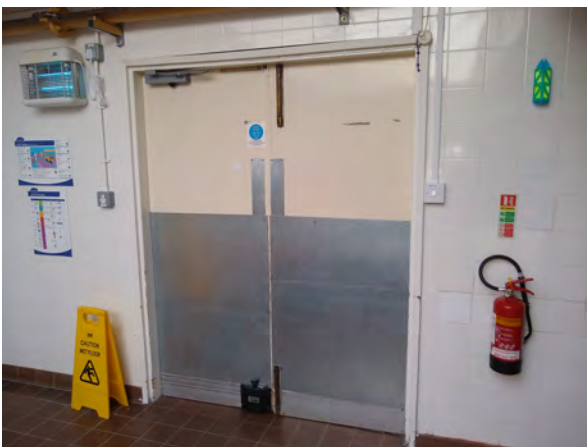
Item 36 Ref: 412662-20

The lining within doors to 0/017a in Rm 0/30 Kitchen contains asbestos.

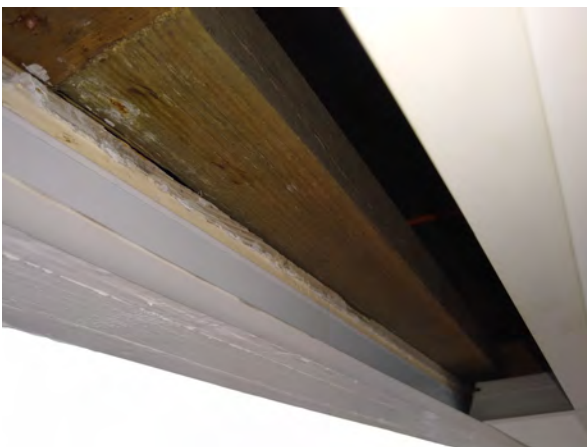
Item 42 Ref: 412662-24

The debris to skylight surround framework at former ceiling height in Rm 0/30 Kitchen void above contains asbestos.

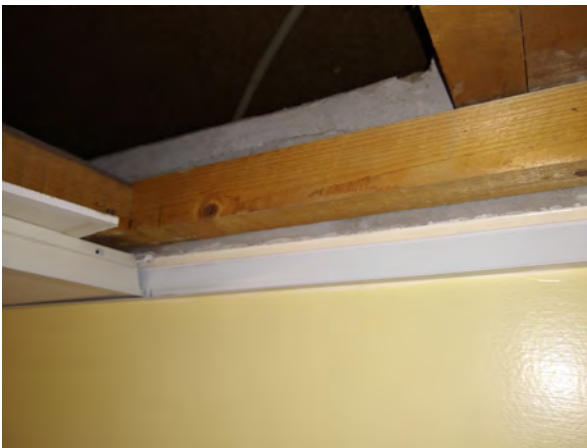
Item 44 Ref: 412662-30

The debris to walls at former ceiling height in Rm 0/31 Office void above contains asbestos.

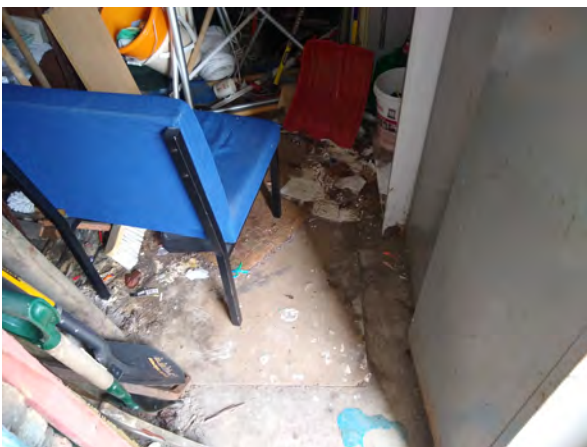
Item 48 Ref: 412662-29

The floor covering in Rm 0/32d Store does not contain asbestos.

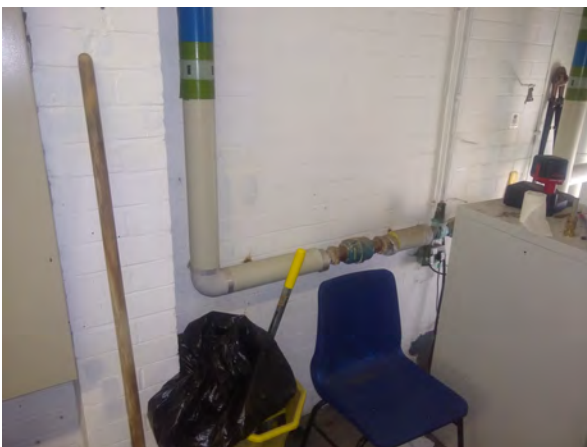
Item 51 Ref: 412662-36

The encapsulated insulation debris to wall (East) in Rm 0/33 Boiler Room contains asbestos.

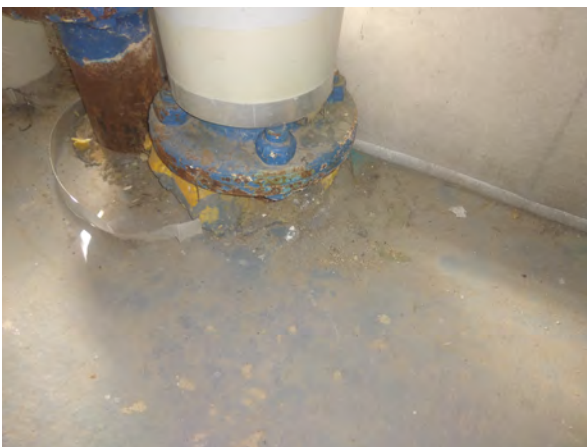
Item 54 Ref: 412662-39

The debris to floor in Rm 0/33 Boiler Room contains asbestos.

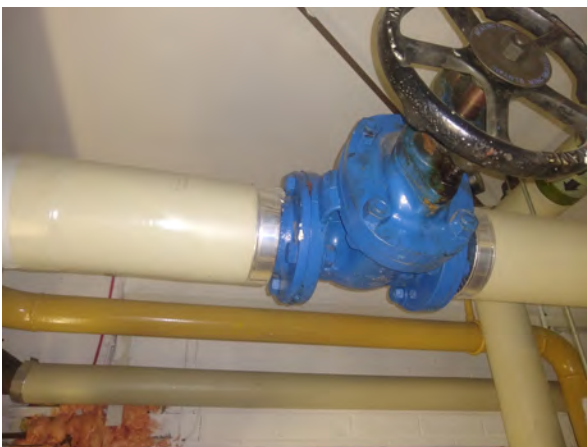
Item 57 Ref: 412662-42

The debris to original gate valve at high level in Rm 0/33 Boiler Room contains asbestos.

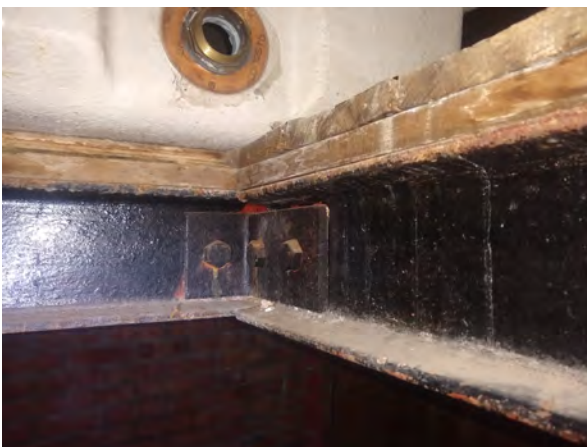
Item 63 Ref: 412662-48

The loose debris to beams in Rm 0/33 Boiler Room tank room above contains asbestos.

Item 62	Debris to walls (0/33 Boiler Room tank room above)	Medium Risk	3 monthly	Removed June 2020
Item 63	Loose debris to beams (0/33 Boiler Room tank room above)	Medium Risk	3 monthly	Removed June 2020

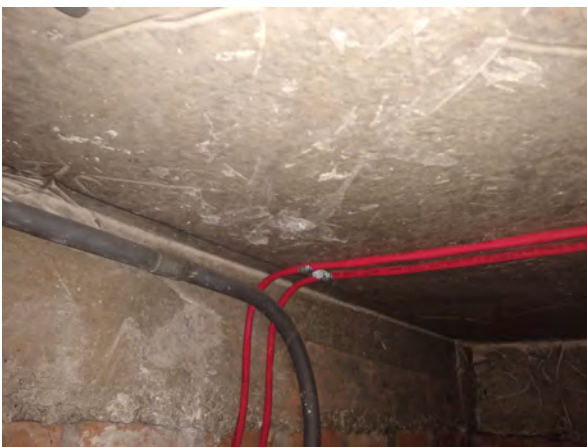
Item 66 Ref: 412662-53

The debris to underside of roof in Rm 0/33 Boiler Room tank room above contains asbestos.

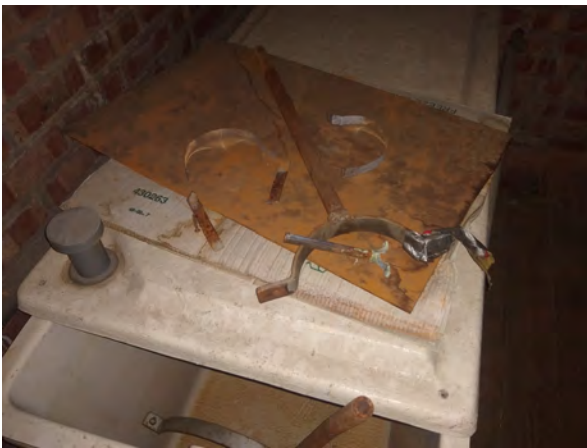
Item 68 Ref: 412662-55

- (Item 68) Ref: 412662-55 – Debris to loose lying pipe hangers (0/33 Boiler Room tank room above) – Removed June 2020
- (Item 69) Ref: 412662-56 – Gasket to fibreglass tank (0/33 Boiler Room tank room above) – No Risk

The debris to loose lying pipe hangers in Rm 0/33 Boiler Room tank room above contains asbestos.

Removed June 2020

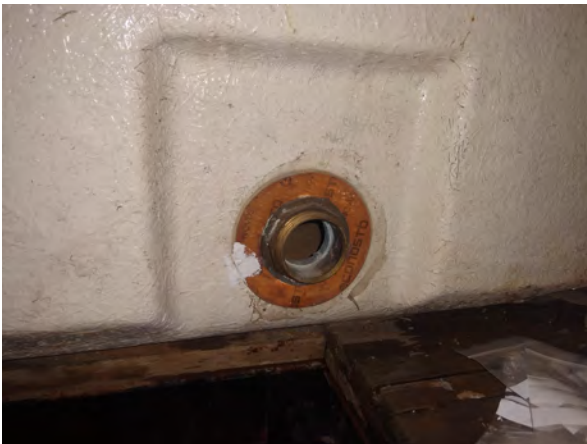
Item 69 Ref: 412662-56

The gasket to fibreglass tank in Rm 0/33 Boiler Room tank room above does not contain asbestos.

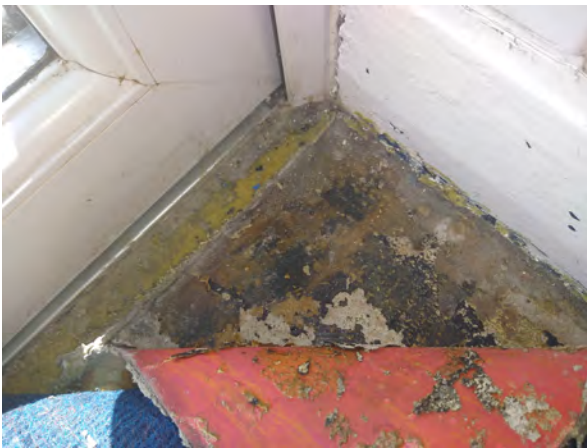
Item 71 Ref: As 412662-9

The remnant screed beneath lino in Rm 0/37 Classroom contains asbestos.

Any change in its appearance should be recorded and passed to Property Services.

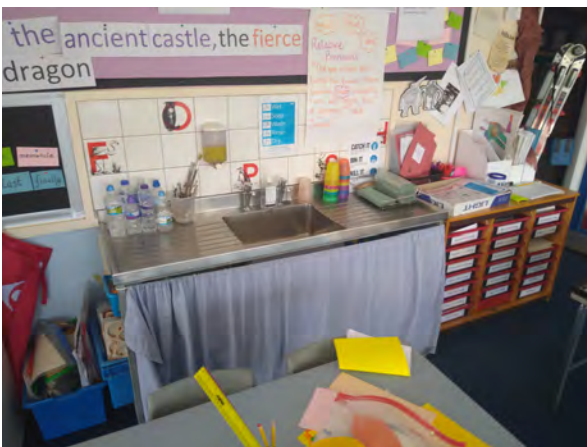
Item 72 Ref: As 412662-11

The sink pad in Rm 0/37 Classroom contains asbestos.

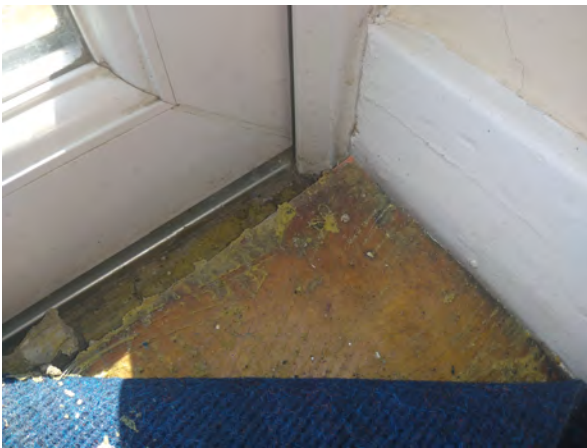
Item 74 Ref: As 412662-2

The sub floor covering below carpet in Rm 0/38 Classroom does not contain asbestos.

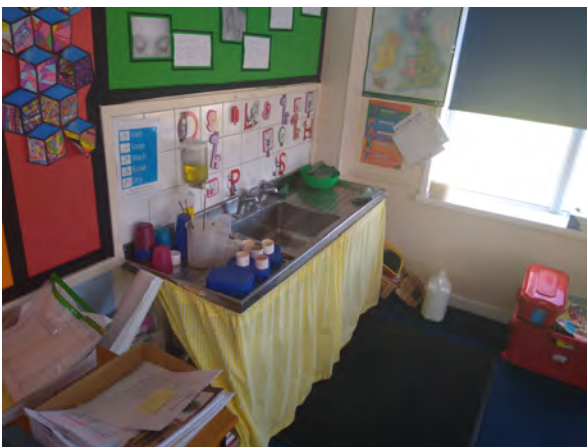
Item 75 Ref: As 412662-11

The sink pad in Rm 0/38 Classroom contains asbestos.

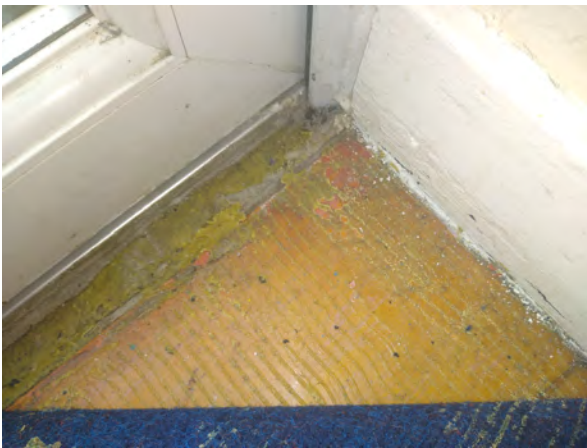
Item 77 Ref: As 412662-2

The sub floor covering below carpet in Rm 0/39 Classroom does not contain asbestos.

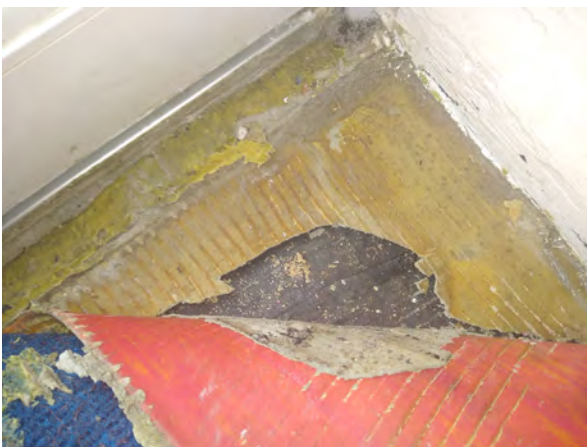
Item 78 Ref: As 412662-9

The remnant screed beneath lino in Rm 0/39 Classroom contains asbestos.

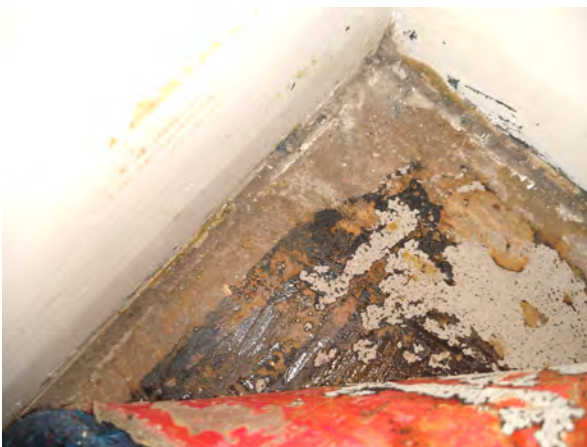
Item 81 Ref: As 412662-9

The remnant screed beneath lino in Rm 0/40 Classroom contains asbestos.

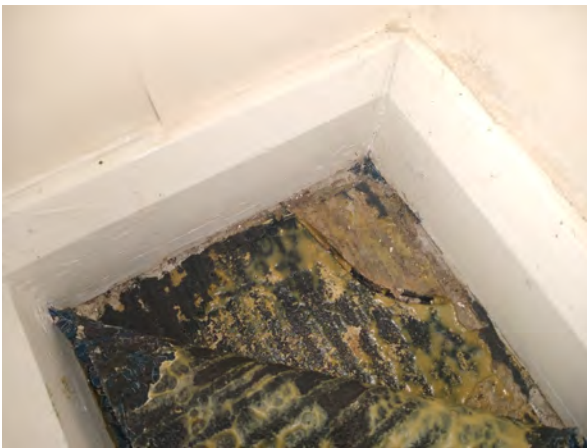
Item 83 Ref: As 412662-14

The screed to floor below carpet in Rm 0/42 Entrance Lobby does not contain asbestos.

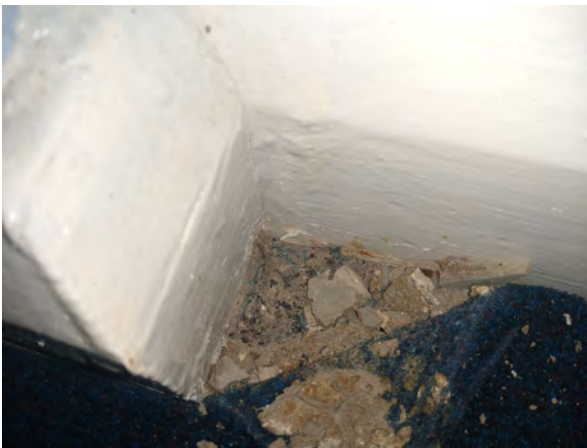
Item 86 Ref: 412662-13

The sub floor covering below carpet adjacent location 0/29 in Rm 0/43 Corridor contains asbestos.

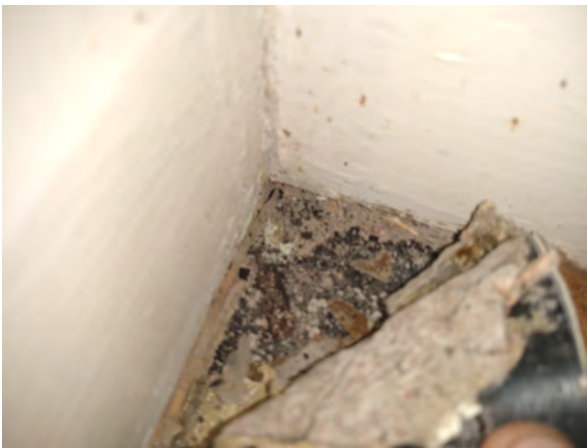
Item 89 Ref: As 412662-14

The screed to floor below modern lino in Rm 0/45 Staff Room does not contain asbestos.

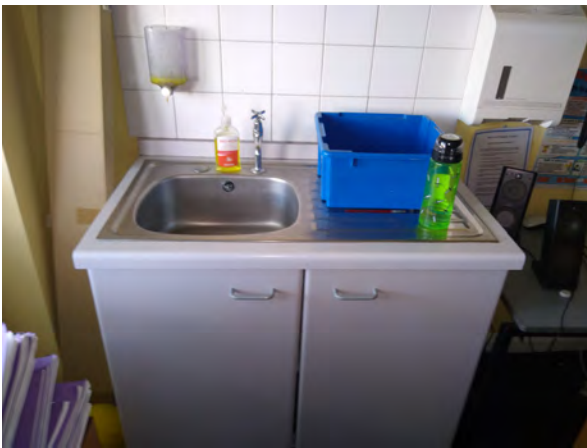
Item 92 Ref: As 412662-52

The sink pad in Rm 0/47 Classroom does not contain asbestos.

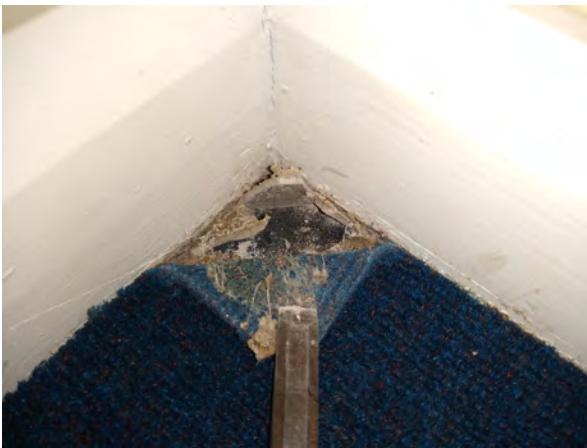
Item 95 Ref: As 412662-51

The screed to floor below carpet in Rm 0/48 Classroom does not contain asbestos.

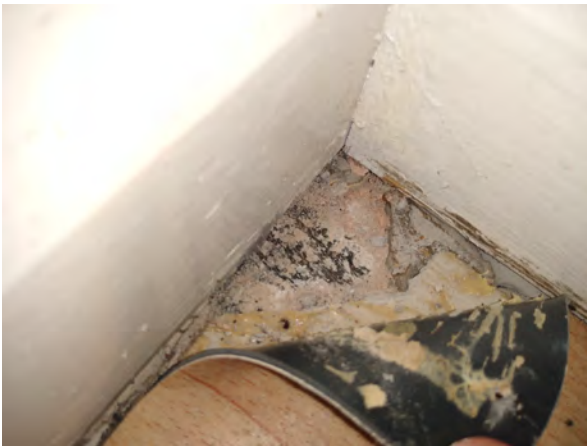
Item 96 Ref: As 412662-51

The screed to floor below carpet in Rm 0/49 After School Club does not contain asbestos.

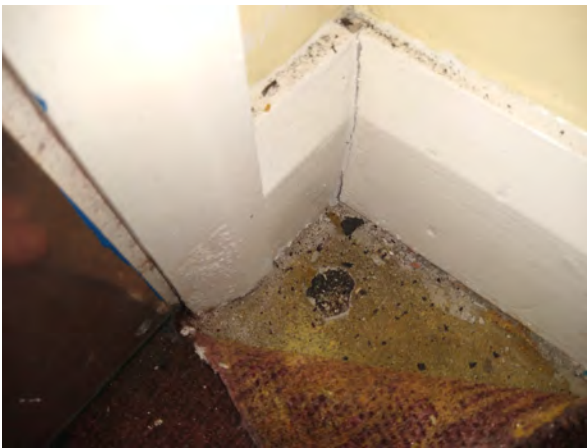
Item 98 Ref: As 412662-51

The screed to floor below carpet in Rm 0/50 Classroom does not contain asbestos.

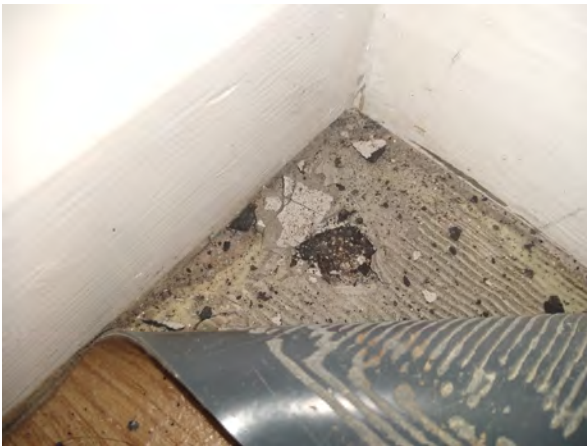
Item 99 Ref: As 412662-14

The screed to floor below modern lino in Rm 0/51 Community Room does not contain asbestos.

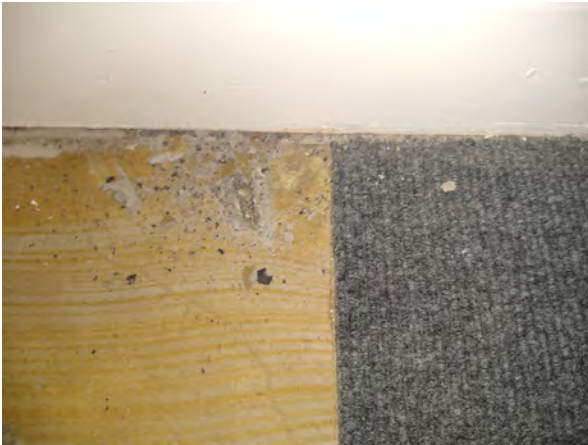
Item 100 Ref: As 412662-14

The screed to floor below carpet in Rm 0/52 Head teacher does not contain asbestos.

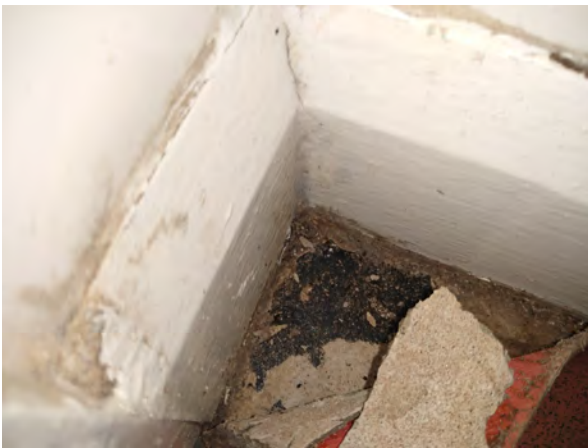
Item 101 Ref: As 412662-51

The screed to floor in Rm 0/53 Male toilets does not contain asbestos.

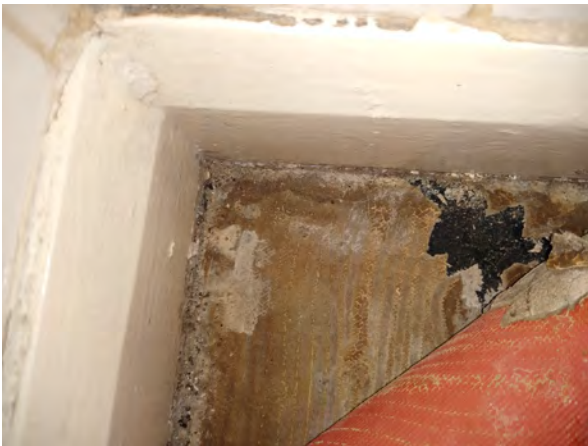
Item 102 Ref: As 412662-51

The screed to floor below modern lino in Rm 0/54 Female toilets does not contain asbestos.

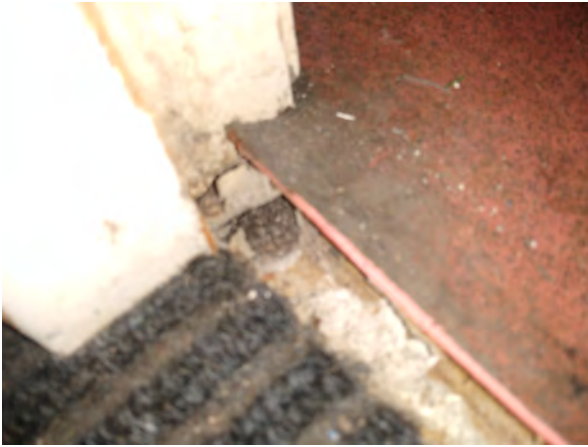
Item 106 Ref: As 412662-51

The screed to floor below modern lino in Rm 0/58 Cleaners Cupboard does not contain asbestos.

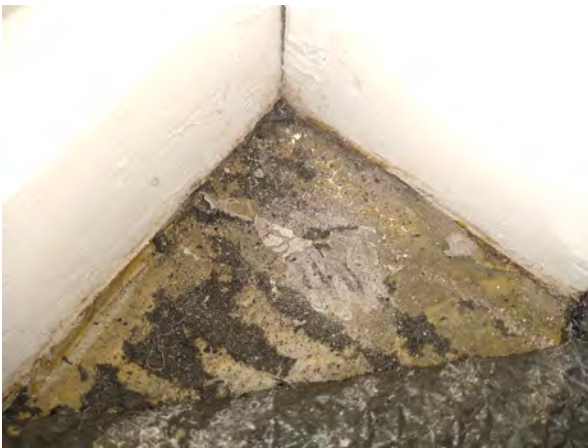
Item 107 Ref: As 412662-51

The screed to floor below modern lino in Rm 0/59 Corridor does not contain asbestos.

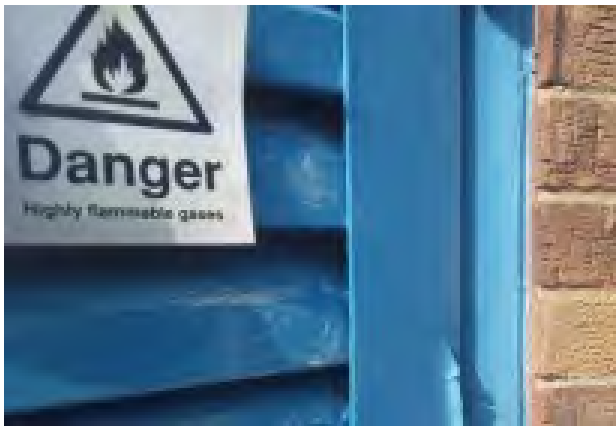
Item 112 Ref: 21-31964-3

The mastic to the door frame of the Boiler room (0/33) does not contain asbestos.

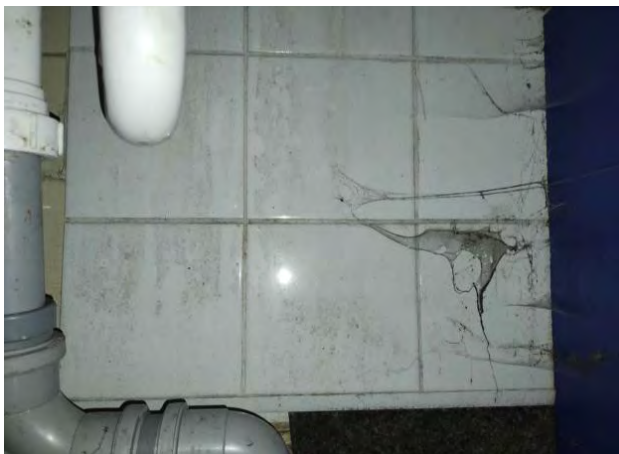
Item 113 Ref: 21-33323-5

The adhesive behind ceramic tiles (Area 7/Boys WC) does not contain asbestos.
