ASBESTOS SURVEY REPORT FOR OXCLOSE NURSERY, BRANCEPETH ROAD, WASHINGTON, TYNE AND WEAR, NE38 0LA

Asbestos Register for

Oxclose Nursery, Brancepeth Road, Washington

Date: 08 June 2025

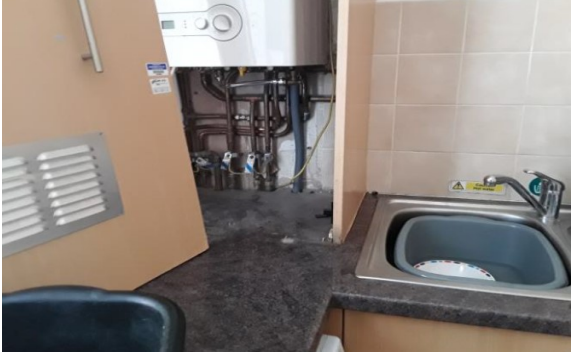
Item 1 Ref: 21-35338-1

- (Item 1) Ref: 21-35338-1 – Adhesive to ceramic tiles to walls (Area 2/Kitchen) – No Risk
- (Item 2) Ref: 21-35338-2 – Floor above area 8 behind plastic membrane and polystyrene insulation (Area 5/Ceiling void above areas 1, 2, 3, 6, 7 and 8) – Low Risk

The adhesive to ceramic tiles to walls (Area 2 / Kitchen) does not contain asbestos.

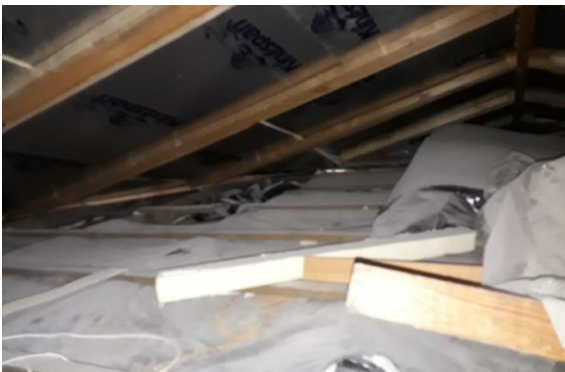
Item 2 Ref: 21-35338-2

The floor above area 8 behind plastic membrane and polystyrene insulation (Area 5 / Ceiling void above areas 1, 2, 3, 6, 7 and 8) does contain asbestos.

Any change in its appearance should be recorded and passed to property services.

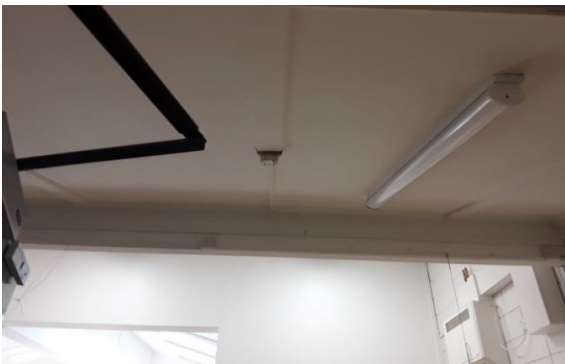
Item 3 Ref: 21-35338-2

- (Item 3) Ref: 21-35338-2 – Ceiling insulating board (Area 8/Main nursery and wet play area) – Medium Risk
- (Item 4) Ref: 21-35338-3 – Ceiling insulating board (Area 8/Main nursery and wet play area) – Medium Risk

The insulating board ceiling (Area 8 / Main Nursery and Wet play area) does contain asbestos.

Any change in its appearance should be recorded and passed to property services.

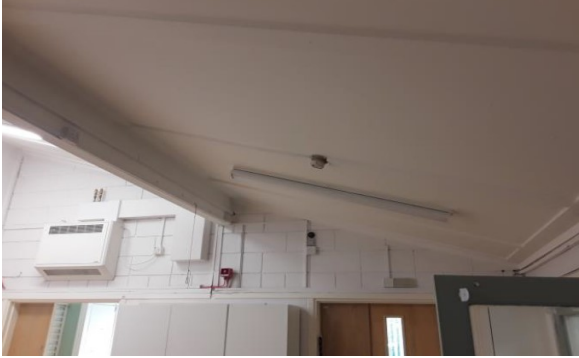
Item 4 Ref: 21-35338-3

The insulating board ceiling (Area 8 / Main Nursery and Wet play area) does contain asbestos.

Any change in its appearance should be recorded and passed to property services.

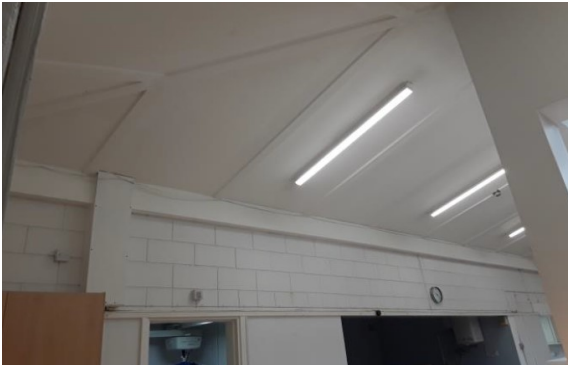
Item 5 Ref: 21-35338-4

- (Item 5) Ref: 21-35338-4 – Ceiling insulating board (Area 8/Main nursery and wet play area) – Medium Risk
- (Item 6) Ref: 21-35338-5 – Ceiling insulating board (Area 8/Main nursery and wet play area) – Medium Risk

The insulating board ceiling (Area 8 / Main Nursery and Wet play area) does contain asbestos.

Any change in its appearance should be recorded and passed to property services.

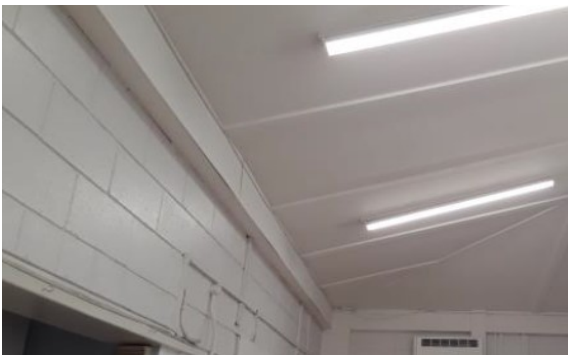
Item 6 Ref: 21-35338-5

The insulating board ceiling (Area 8 / Main Nursery and Wet play area) does contain asbestos.

Any change in its appearance should be recorded and passed to property services.

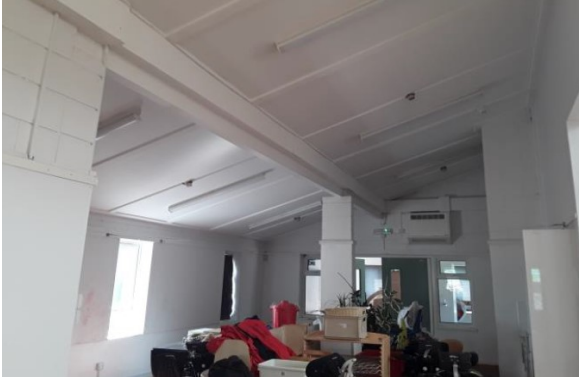
Item 7 Ref: 21-35338-6

- (Item 7) Ref: 21-35338-6 – Ceiling insulating board (Area 8/Main nursery and wet play area) – Medium Risk
- (Item 8) Ref: 21-35338-7 – Floor tiles and adhesive (Area 9/Store Cupboard) – No Risk

The insulating board ceiling (Area 8 / Main Nursery and Wet play area) does contain asbestos.

Any change in its appearance should be recorded and passed to property services.

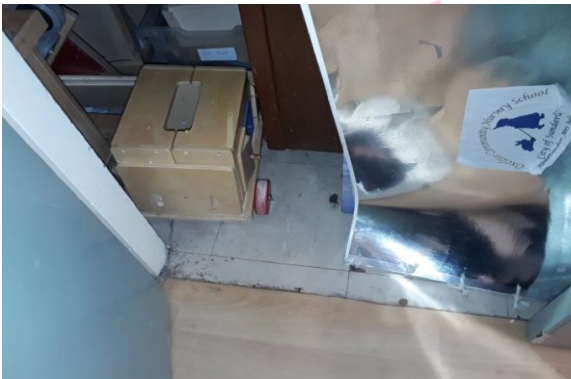
Item 8 Ref: 21-35338-7

The tiles and adhesive to floor (Area 9 / Store Cupboard) does not contain asbestos.

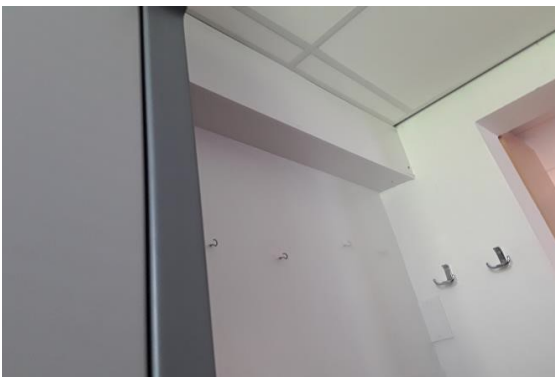
Item 9 Ref: 21-35338-8

- (Item 9) Ref: 21-35338-8 – Boxing (Area 10/Office) – No Risk
- (Item 10) Ref: 21-35338-9 – Walls (Area 10/Office) – No Risk
- (Item 11) Ref: 21-35338-10 – Residual debris to nails to wood joists (Area 11/Ceiling voids above area 10 office and area 11 disabled toilets/shower) – No Risk

The boxing (Area 10 / Office) does not contain asbestos.

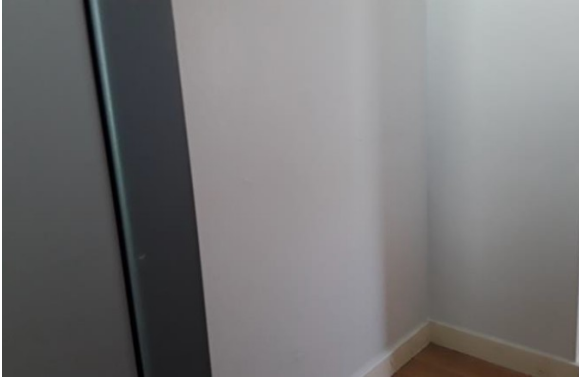
Item 10 Ref: 21-35338-9

The walls (Area 10 / Office) do not contain asbestos.

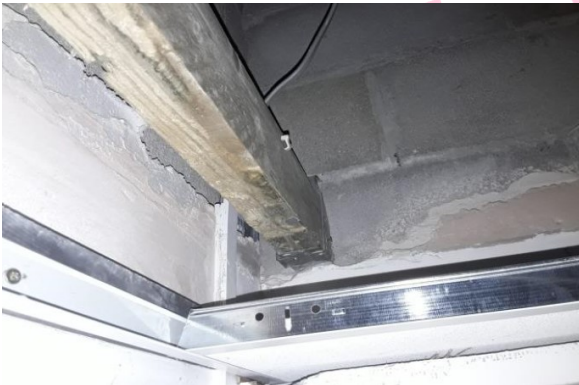
Item 11 Ref: 21-35338-10

The residual insulation debris to nails in wood joists (Area 11 / Ceiling void above area 10 office and area 11 disabled toilets / shower) does not contain asbestos.

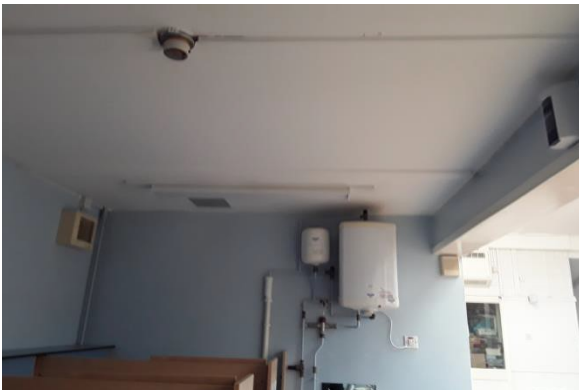
Item 12 Ref: 21-35338-11

- (Item 12) Ref: 21-35338-11 – Ceiling insulating board (Area 13/Main nursery toilets) – Medium Risk
- (Item 13) Ref: 21-35338-12 – Residual adhesive beneath screed to floor (Area 17/Storeroom) – No Risk

The insulating board ceiling (Area 13 / Main nursery toilet) does contain asbestos.

Any change in its appearance should be recorded and passed to property services.

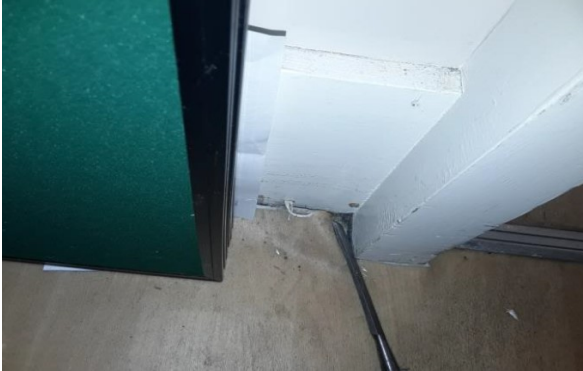
Item 13 Ref: 21-35338-12

The residual bitumen adhesive beneath screed to floor (Area 17 / Store Room) does not contain asbestos.

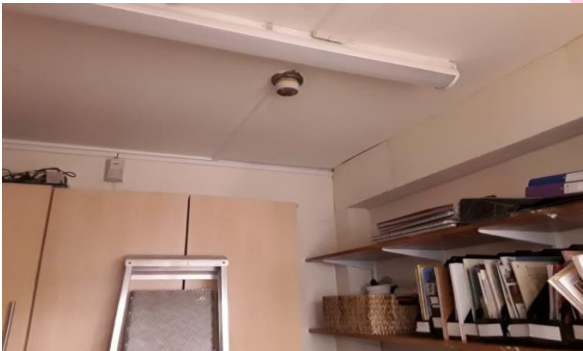
Item 14 Ref: 21-35338-13

- (Item 14) Ref: 21-35338-13 – Ceiling insulating board (Area 17/Storeroom) – Low Risk
- (Item 15) Ref: 21-35338-9 – Walls (Area 17/Storeroom) – No Risk

The insulating board ceiling (Area 17 / Store room) does contain asbestos.

Any change in its appearance should be recorded and passed to property services.

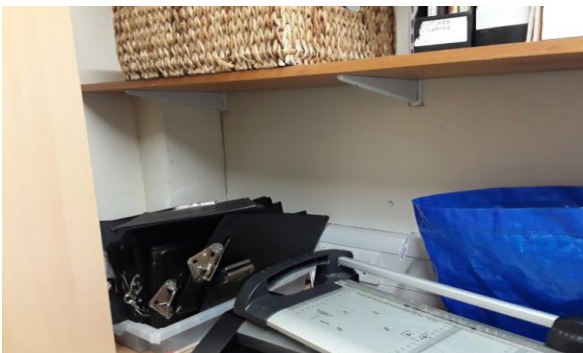
Item 15 Ref: 21-35338-9

The walls (Area 17 / Store room) do not contain asbestos.

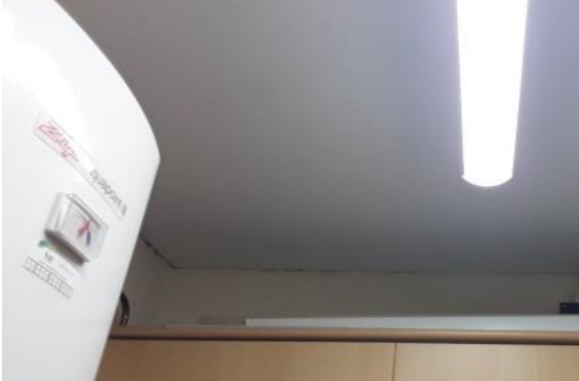
Item 16 Ref: 21-35338-16

- (Item 16) Ref: 21-35338-16 – Ceiling insulating board (Area 18/Cleaners store) – Low Risk
- (Item 17) Ref: 21-35338-14 - Ceiling insulating board (Area 19/Store cupboard) – Low Risk

The insulating board ceiling (Area 18 / Cleaners Store) does contain asbestos.

Any change in its appearance should be recorded and passed to property services.

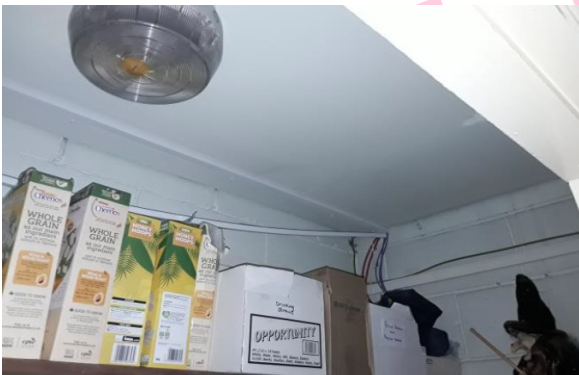
Item 17 Ref: 21-35338-14

The insulating board ceiling (Area 19 / Store cupboard) does contain asbestos.

Any change in its appearance should be recorded and passed to property services.

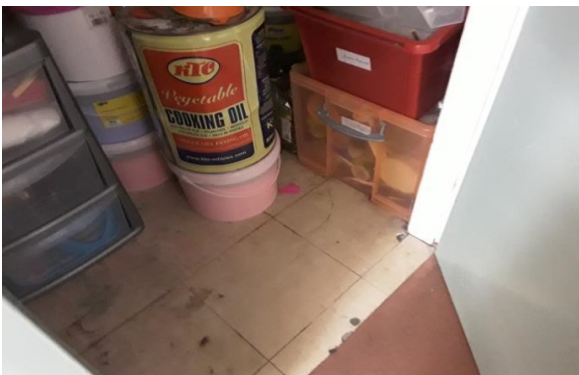
Item 18 Ref: 21-35338-15

- (Item 18) Ref: 21-35338-15 – Floor tiles and adhesive (Area 19/Store cupboard) – No Risk
- (Item 19) Ref: 21-35338-18 – Undercloaks to roof (Area 25/External) – No Risk

The tiles and adhesive to floor (Area 19 / Store cupboard) does not contain asbestos.

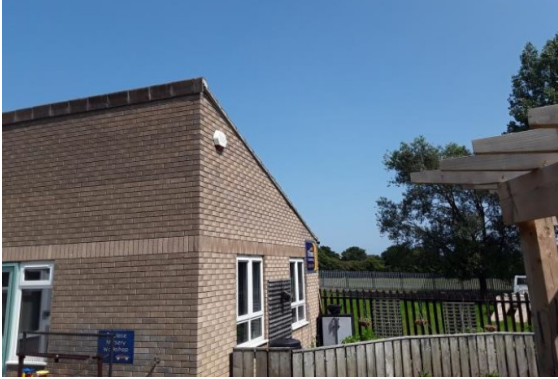
Item 19 Ref: 21-35338-18

The cement undercloaks to roof (Area 25 / External) does not contain asbestos.

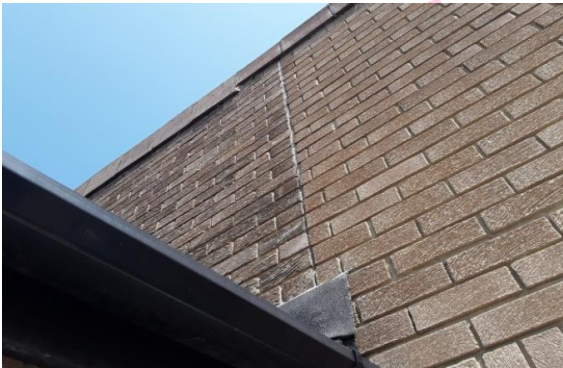
Item 20 Ref: 21-35338-19

- (Item 20) Ref: 21-35338-19 – Putty to expansion joints on wall (Area 25/External) – No Risk
- (Item 21) Ref: Presumed – Cement infill panels to roof (Area 25/External) – Very Low Risk

The putty to expansion joints (Area 25 / External) does not contain asbestos.

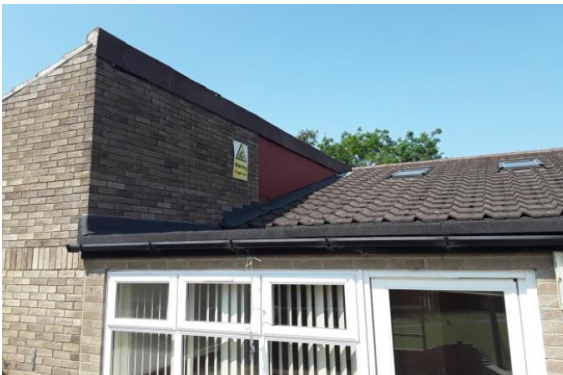
Item 21 Ref: Presumed

The infill panels to roof (Area 25 / External) are presumed to contain asbestos.

Any change in its appearance should be recorded and passed to property services.

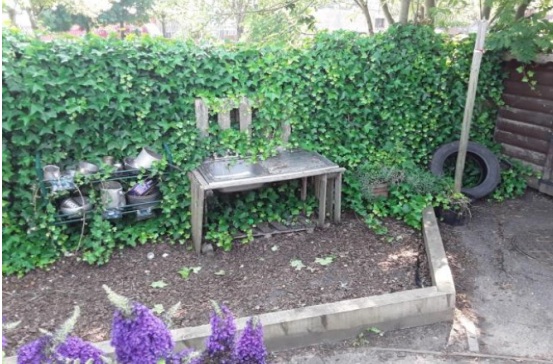
Item 22 Ref: 21-35338-21

- (Item 22) Ref: 21-35338-21 – Sink pad to external garden sink pad and drainer pad (Area 25/External) – No Risk
- (Item 23) Ref: 21-35338-17 – Damp proof course (Area 30/Photocopy room and cupboard) – No Risk

The sink pad to external garden sink (Area 25 / External) does not contain asbestos.

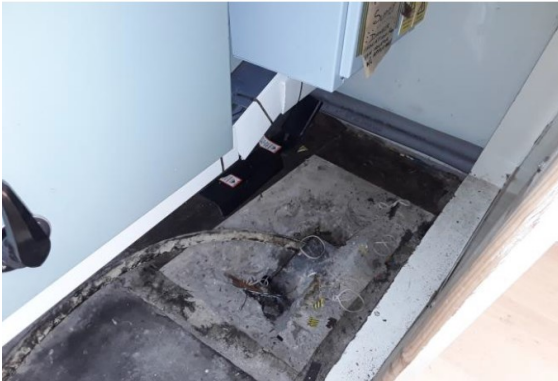
Item 23 Ref: 21-35338-17

The damp proof course (Area 30 / Photocopy room and cupboard) does not contain asbestos.
