### **ASBESTOS SURVEY REPORT FOR OXCLOSE VILLAGE PRIMARY, WASHINGTON**

### **OXCLOSE VILLAGE PRIMARY ACADEMY SCHOOL, WASHINGTON**

**Date: 22 August 2024**

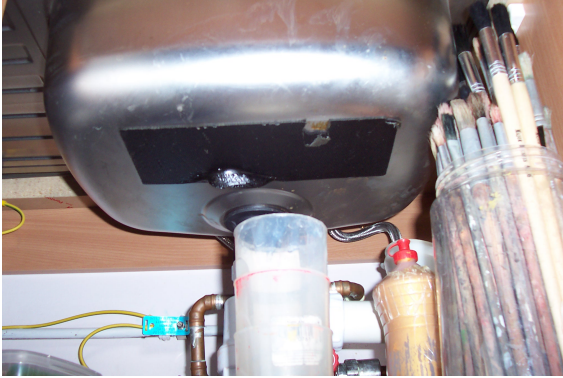
### **Various - Ref: DM06/1304**

The sink pad in the classroom (Area 25) does not contain asbestos.

Similar sink pads are located in areas 24, 23, 37, 38, 53 and 72.

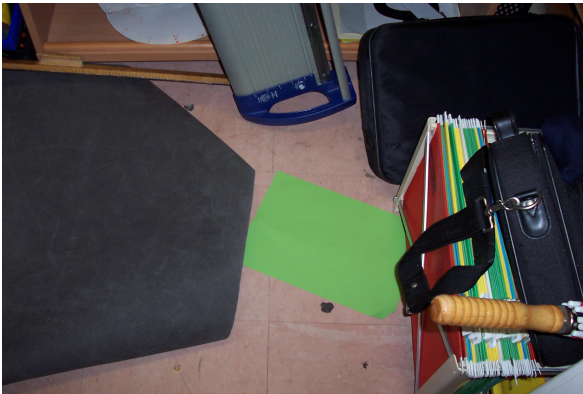
### **Various - Ref: DM06/1305**

The floor tiles (beige) to the store (Area 25a) do not contain asbestos.

Similar floor tiles are located in areas 24a, 23a, 40, and 79.

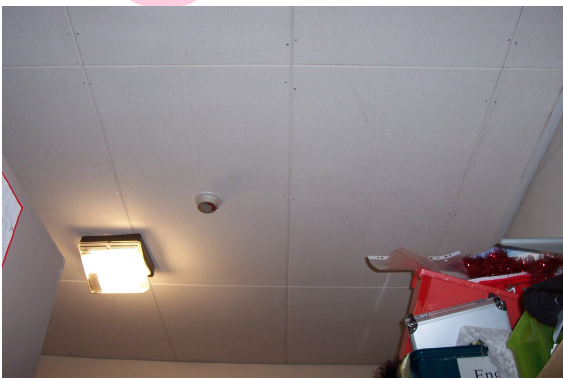
### **Various – Ref:DM06/1306**

The ceiling tiles to the PE store (Area 8) do not contain asbestos.

Similar ceiling tiles are located in area 7 (Art store).

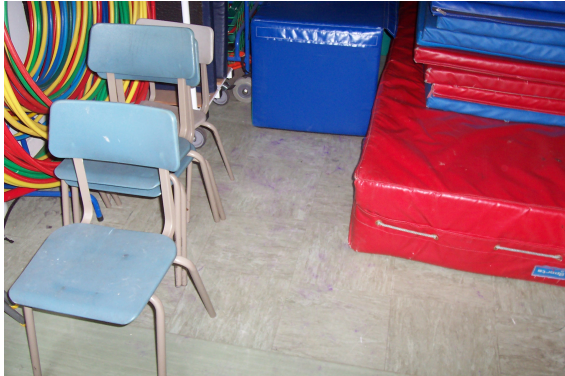
### **Item 13 - Ref: DM06/1307**

The floor tiles (Green) to the hall store (Area 6) do not contain asbestos.

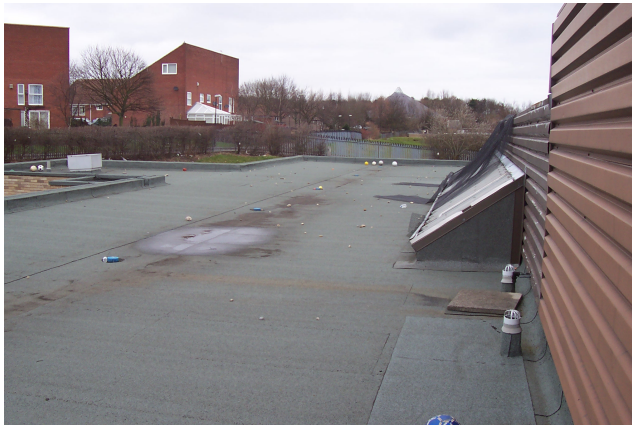
### **Item 18 - Ref: DM06/1309**

The roofing felt to the entire roof does not contain asbestos.

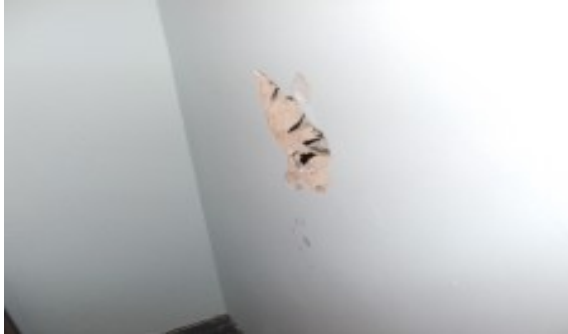
### **Item 20 - Ref: Sample 1**

The partition wall in the Physical Therapy Area (survey ref: FP10-0168) does not contain asbestos.

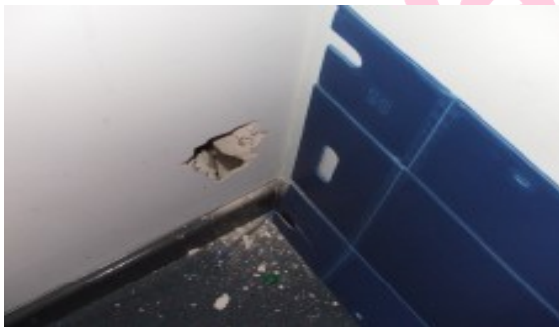
### **Item 21 - Ref: Sample 2**

The partition adjacent to sink in the Physical Therapy Area (survey ref: FP10-0168) does not contain asbestos.

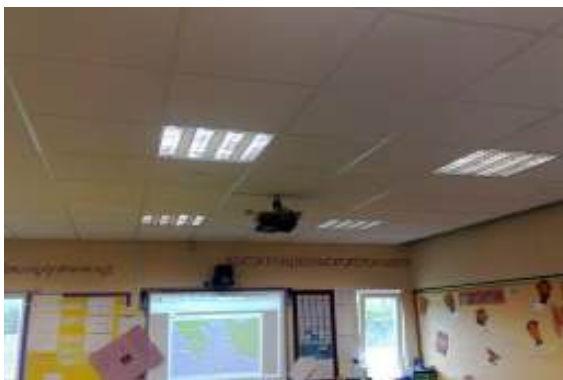
### **Item 22 - Ref: IC10/963**

The suspended ceiling tiles in Area CB6 do not contain asbestos.

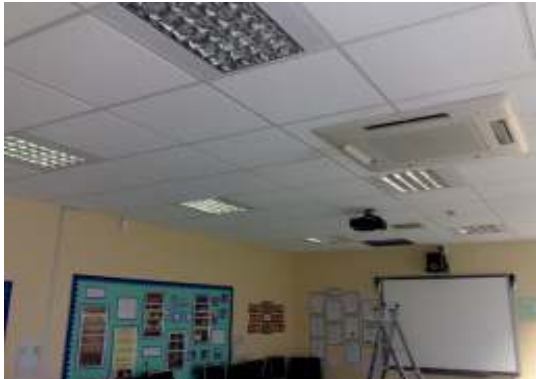
### **Item 23 - Ref: IC10/964**

The suspended ceiling tiles in Area ICT do not contain asbestos.

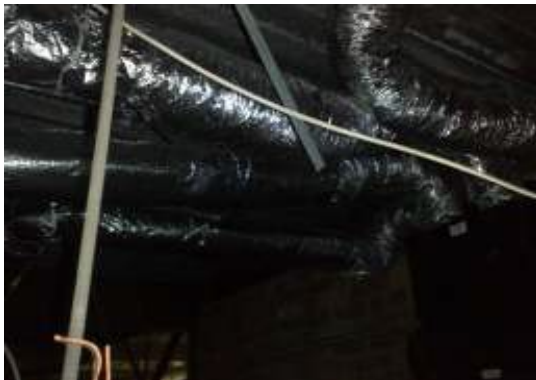
### **Item 24 - Ref: IC10/965**

The lagging to ducting in the ICT-ceiling void above does not contain asbestos.

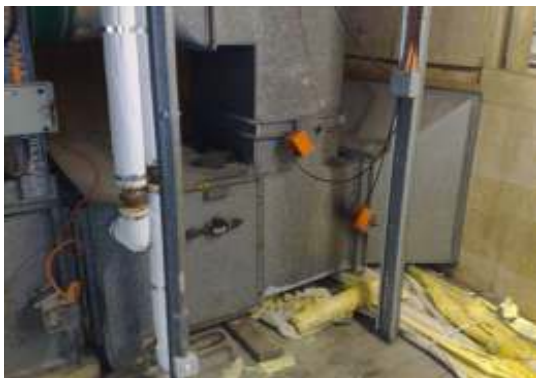
### **Item 25 - Ref: AL09/1100**

The pipe insulation in the Tank Room does not contain asbestos.

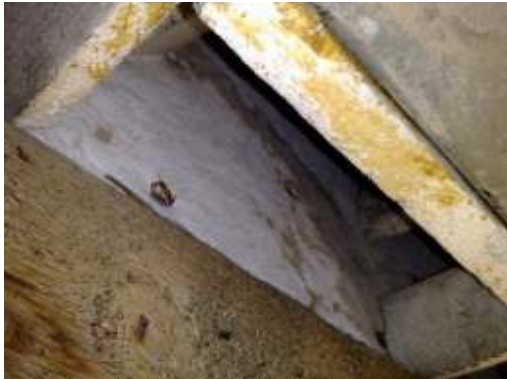
**Item 26 - Ref: AL09/1101**

The cloaking boards around tanks in the Tank Room do not contain asbestos.

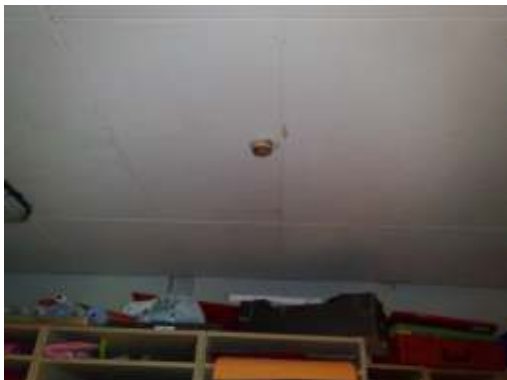
**Item 27 - Ref: AL09/1102**

The ceiling tiles in Area 1 Store 1 do not contain asbestos.

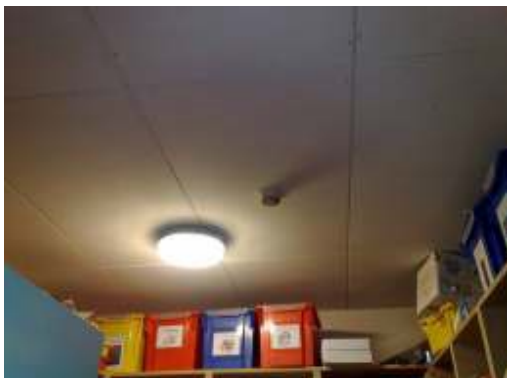
**Item 28 - Ref: AL09/1103**

The ceiling tiles in Area 1 Store 2 do not contain asbestos.

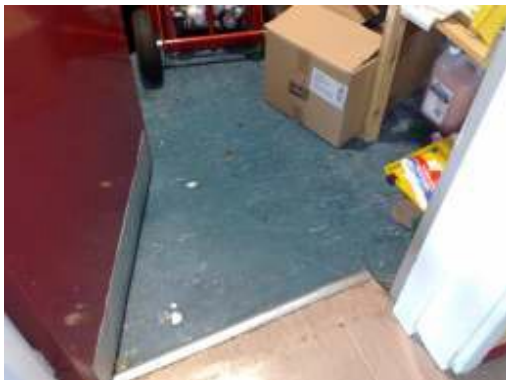
### Item 30 - Ref: AL09/1105

The flooring material in the Dining room chemical store does not contain asbestos.

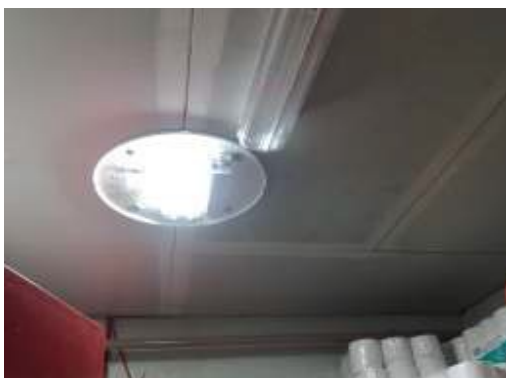
### Item 31 - Ref: AL09/1106

*The ceiling tiles in the Dining room chemical store contained asbestos.*

*Removed 2010*

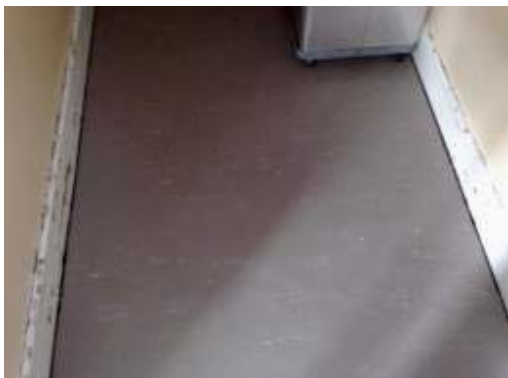
### **Item 32 - Ref: AL09/1107**

The flooring material in the Main Area Kitchen does not contain asbestos.

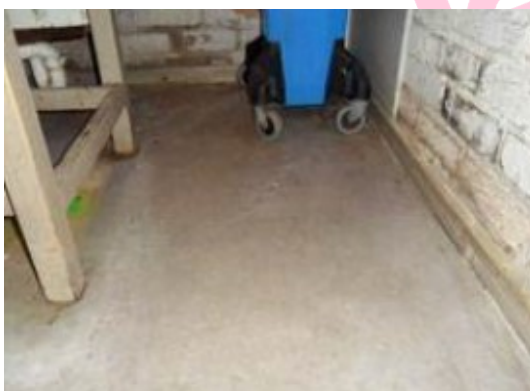
### **Item 33 - Ref: VP004255**

The vinyl floor covering & bitumen adhesive below in room 5 DSR does not contain asbestos.

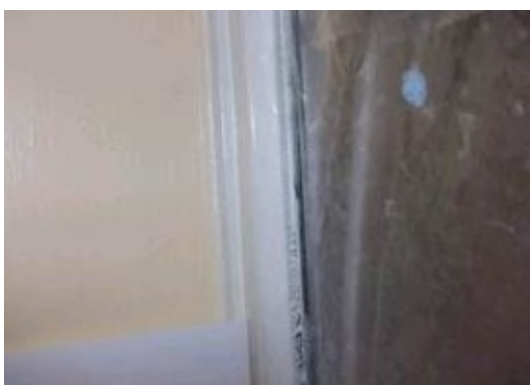
### **Item 34 - Ref: VP002358**

The window putty in Room 1 CB4 does not contain asbestos.

*Removed 2012*

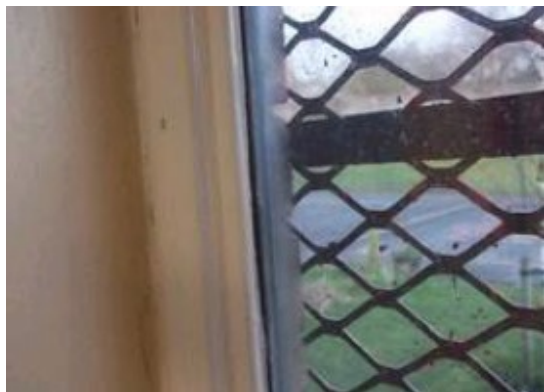
**Item 35 - Ref: VP002359**

The window putty in Room 2  
CB6 does not contain asbestos.

*Removed 2012*

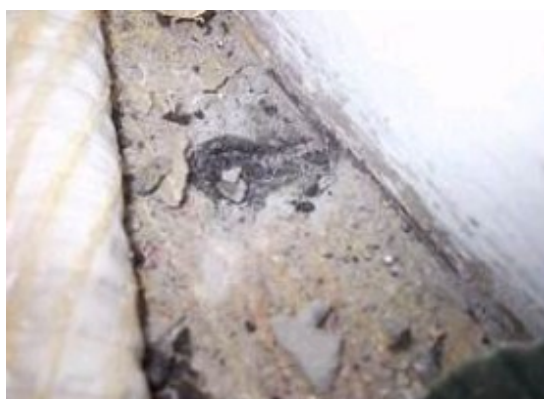
**Item 36 - Ref: VP002360**

The black screed beneath  
cement skim to floor in Room 2  
CB6 does not contain asbestos.

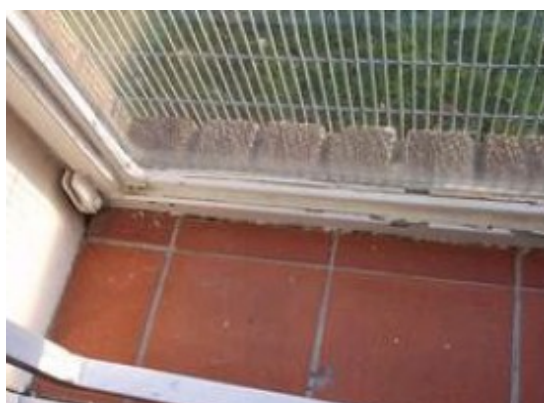
**Item 37 - Ref: VP002361**

The window putty in Room 3  
CB7 does not contain asbestos.

*Removed 2012*

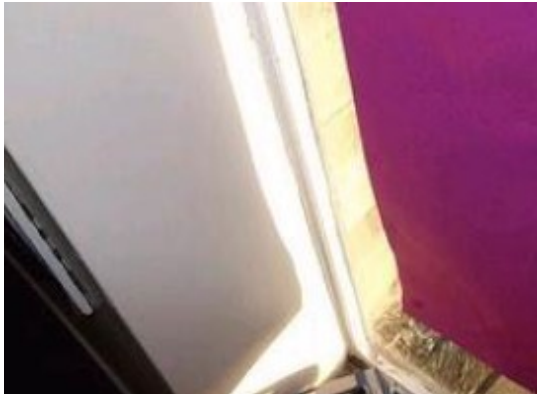
### **Item 38 - Ref: VP002362**

The window putty in Room 4  
CB8 does not contain asbestos.

*Removed 2012*

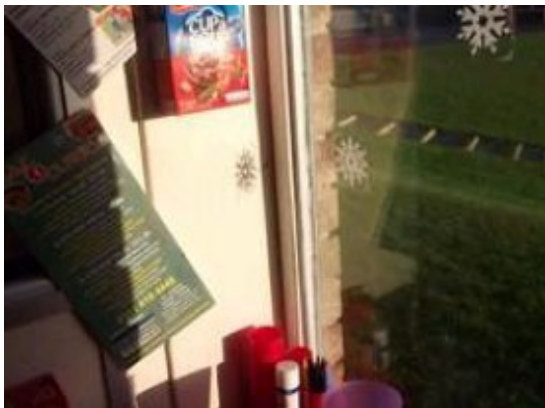
### **Item 39 - Ref: VP002363**

The window putty in Room 5  
Corridor does not contain  
asbestos.

*Removed 2012*

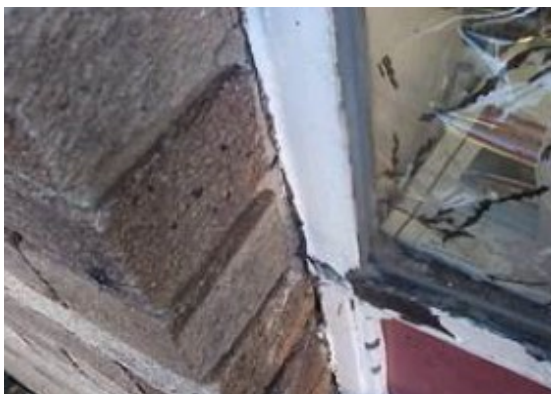
### **Item 40 - Ref: VP002364**

The window putty at CB4 in  
Room 1 external contained  
asbestos.

*Removed 2012 – no removal  
paperwork*

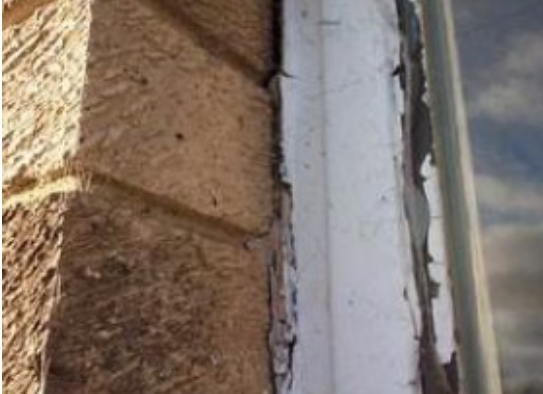
### Item 41 - Ref: VP002365

The window putty at CB7 in Room 1 external does not contain asbestos.

*Removed 2012*

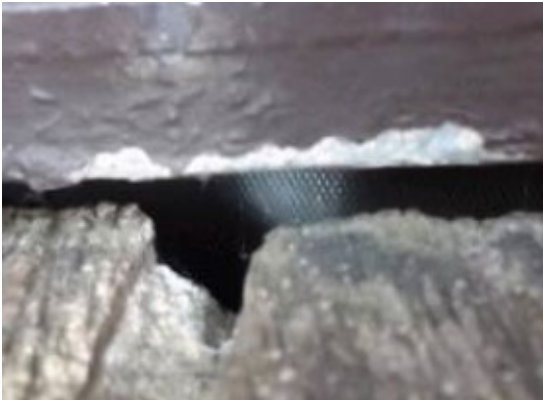
### Item 42 - Ref: VP002366

The damp proof course Room 1 external does not contain asbestos.

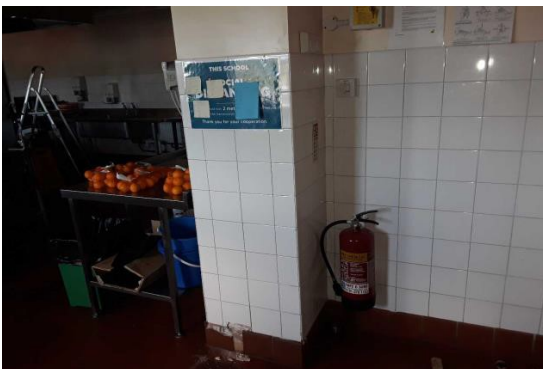
### Item 43 - Ref: 22-50222-1

The walls – ceramic wall tile adhesive (Area 1/Kitchen) do not contain asbestos.

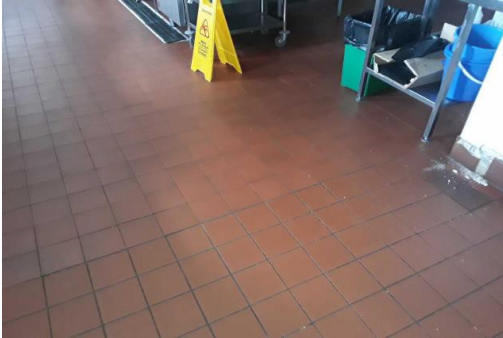
### **Item 44 Ref: 22-50222-2**

The floor – quarry tile and adhesive (Area 1/Kitchen) does not contain asbestos.

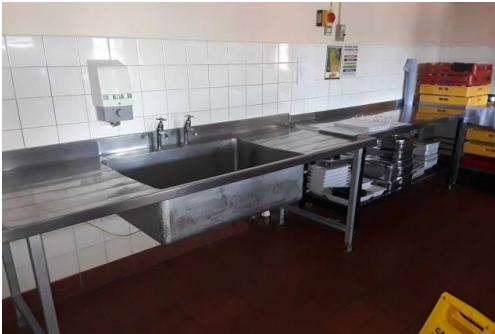
### **Item 45 Ref: 22-50222-4**

The sink pads x5 to sinks and adjacent bench (Area 1/Kitchen) contains asbestos.

Any change in its appearance should be recorded and passed to Property Services.

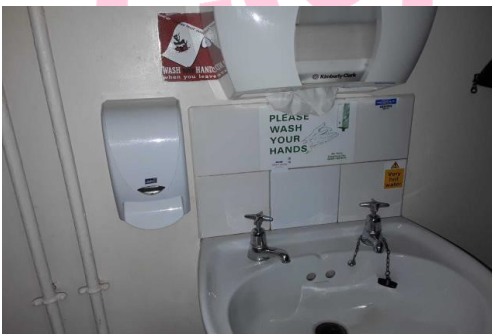
### **Item 46 Ref: 22-50222-1**

The walls – ceramic wall tile adhesive (Area 2/WC) does not contain asbestos.

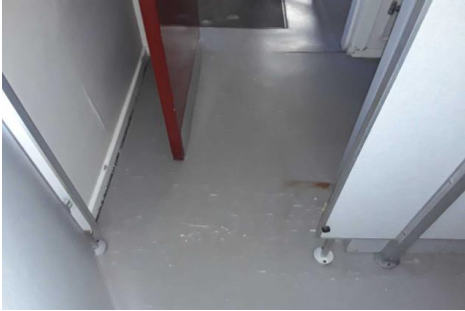
**Item 47 Ref: 22-50222-3**

The floor – vinyl and adhesive (Area 2/WC) does not contain asbestos.

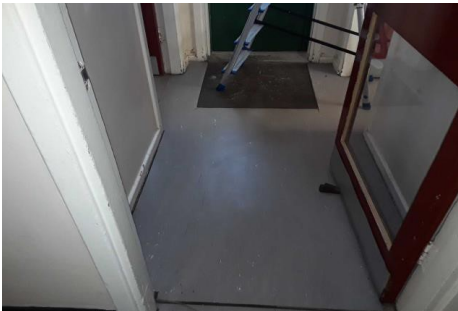
**Item 48 Ref: 22-50222-3**

The floor – vinyl and adhesive (Area 3/Entrance Hall) does not contain asbestos.

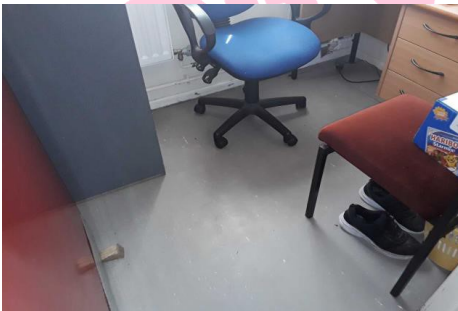
**Item 49 Ref: 22-50222-3**

The floor – vinyl and adhesive (Area 4/Office) does not contain asbestos.

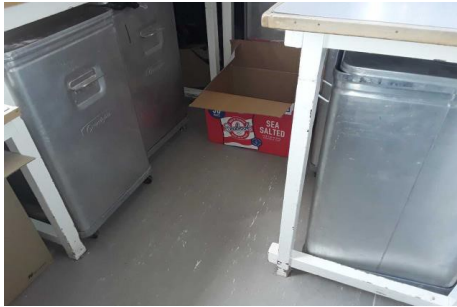
### **Item 50 Ref: 22-50222-3**

The floor – vinyl and adhesive (Area 5/Larder) does not contain asbestos.

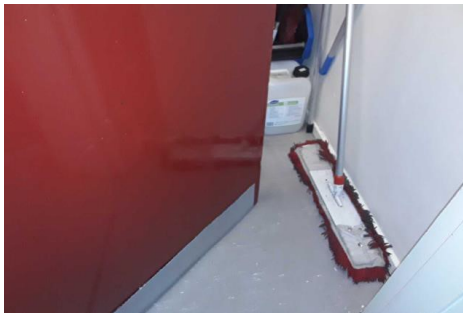
### **Item 51 Ref: 22-50222-3**

The floor – vinyl and adhesive (Area 6/Cleaners Cupboard) does not contain asbestos.

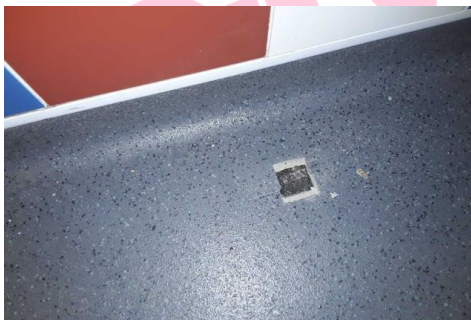
### **Item 52 Ref: 22-50222-5**

The floor – vinyl and adhesive beneath modern vinyl (Area 7/Boys WC) does not contain asbestos.

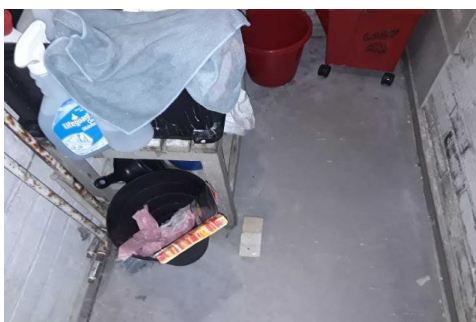
**Item 53 Ref: 22-50222-5**

The floor – vinyl and adhesive (Area 8/Boys WC Cleaners Cupboard) does not contain asbestos.

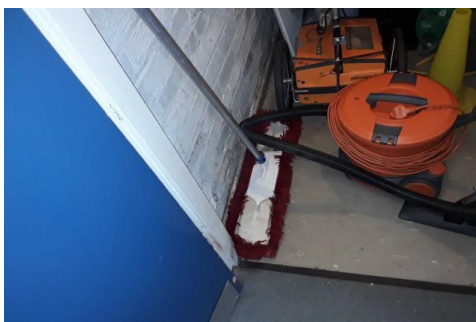
**Item 54 Ref: 22-50222-6**

The floor – vinyl and adhesive beneath modern vinyl (Area 9/Girls WC Cleaners Cupboard) does not contain asbestos.

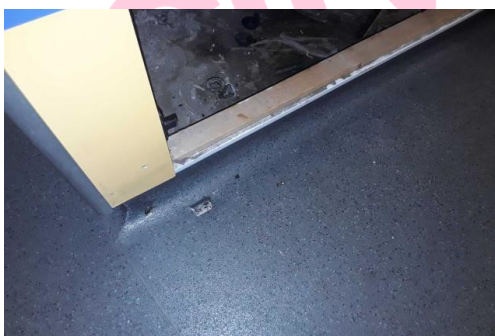
**Item 55 Ref: 22-50222-6**

The floor – vinyl and adhesive beneath modern vinyl (Area 10/Girls WC) does not contain asbestos.
