ASBESTOS SURVEY REPORT FOR OXCLOSE SCHOOL, DILSTON CLOSE, WASHINGTON

Asbestos Register for

**OXCLOSE ACADEMY,
DILSTON CLOSE, WASHINGTON**

Premises Manager / Samo: - Tenant Date: 27 March 2025

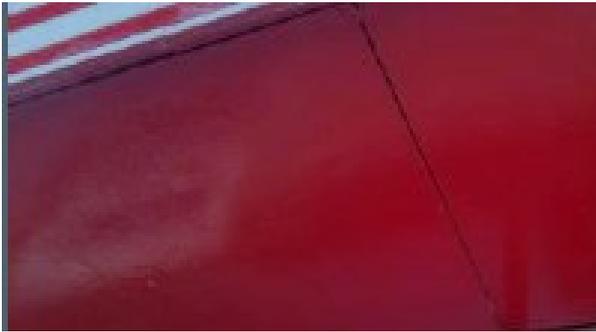
Item 1 Ref: Sample 01

- (Item 1) *Presumed – Soffits to the external – removed August 2018*
- (Item 2) *Presumed – Gasket material (Plant Room) – Very Low Risk*
- (Item 3) *ED04-02 – Wall boards at Height (Plant Room) – Low Risk*

The soffits to the external of the building (around the eaves) contain asbestos. In areas these have been repaired or over clad. Care needs to be taken when accessing these areas.

These were removed August 2018

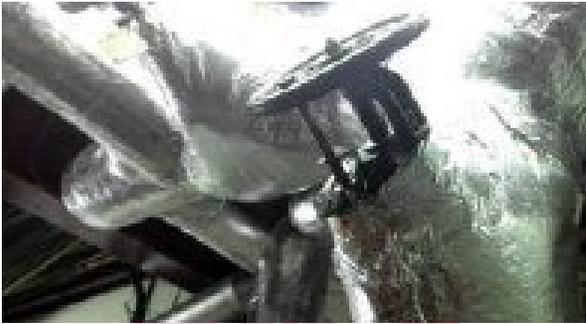
Item 2 - Ref: Presumed

The gaskets to the boiler room are presumed to contain asbestos.

Picture	Location	Risk	Inspection Frequency	Date of return
Item 1	Soffits to external of building	Very Low	Removed	August 2018
Item 2	Gaskets to boiler in Plant Room	Very Low	12 Monthly	01.02.2026

Any change in its appearance should be recorded, and passed to Property Services.

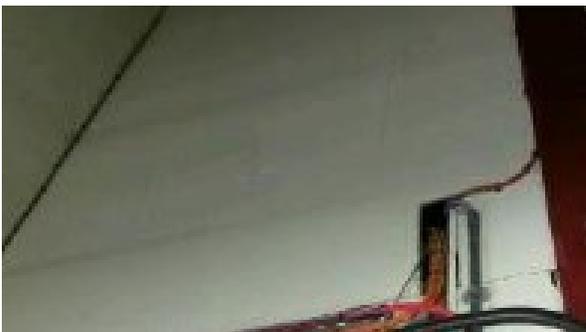
Item 3 - Ref: ED04-2

The wall boards at height in the plant room contain asbestos.

Item 3	Wall boards to wall in plant room	Low	6 Monthly	01.08.2025
Item 4	No asbestos	Is present		
Item 5	No asbestos	Is present		
Item 6	No asbestos	Is present

Any change in its appearance should be recorded, and passed to Property Services.

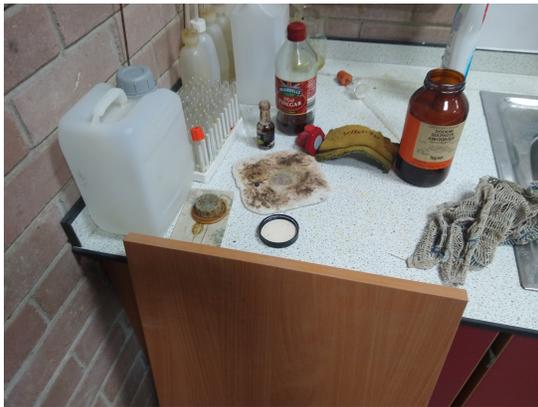
Item 14 - Ref: 330086-1

The Heat pad in Ground Floor Rm 08/Y15 prep room does not contain asbestos.

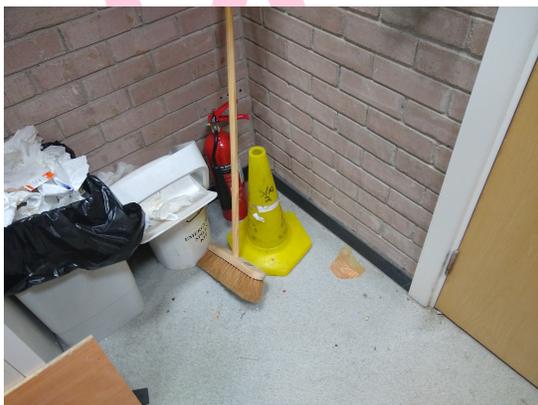
Item 15 - Ref: As 330086-3

The Skirting in Ground Floor Rm 08/Y15 prep room does not contain asbestos.

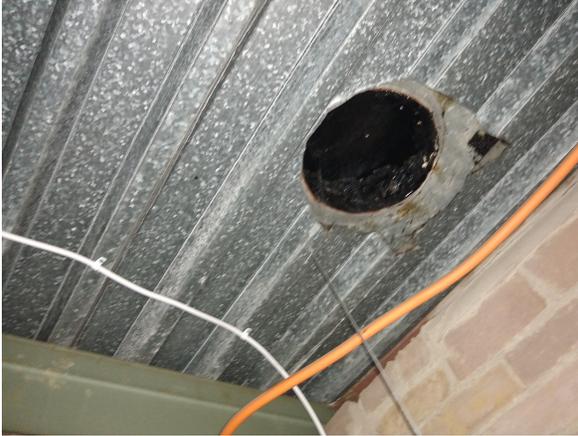
Item 16 - Ref: 330086-2

- (Item 16) *330086-2 – Felt around old pipework penetrations points through the roof (Ground Floor Rm 010/Y16 science classroom – void above) – Low Risk*

The felt around old pipework penetrations points through the roof in ground floor Rm 010/Y16 science classroom (void above) contains asbestos.

Item 12	No asbestos	Is present		
Item 13	No asbestos	Is present		
Item 14	No asbestos	Is present		
Item 15	No asbestos	Is present		
Item 16	Felt around old pipework penetrations points through the roof (Rm 010/Y16 science classroom – void above)	Low	DO NOT	INSPECT

Any change in its appearance should be recorded, and passed to Property Services.

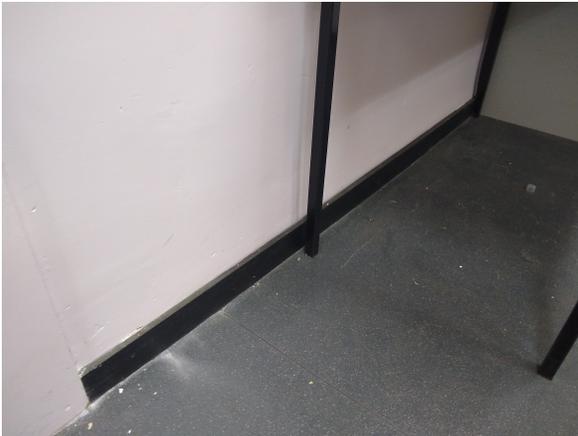
Item 17 - Ref: 330086-3

The Skirting in Ground Floor Rm 011/Y14 science classroom does not contain asbestos.

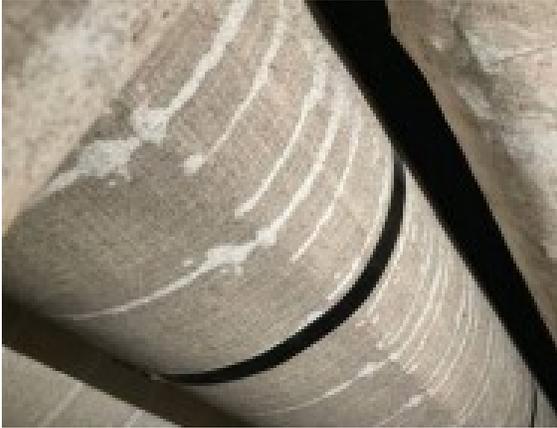
Item 19 - Ref: NG000203

The pipe work throughout ceiling void (Kitchen) does not contain asbestos.

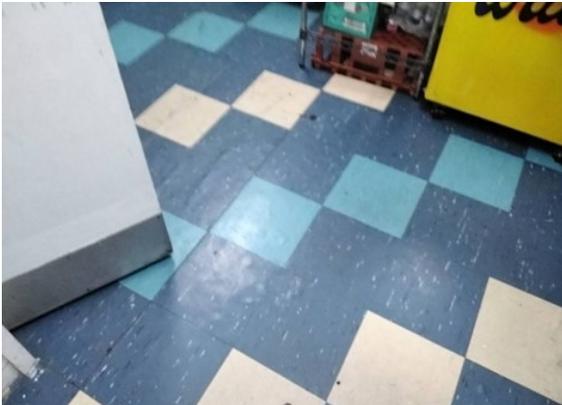
Item 20 - Ref: NG001825

The floor tiles with adhesive in the Store Room (various colours) (G/001) does not contain asbestos.

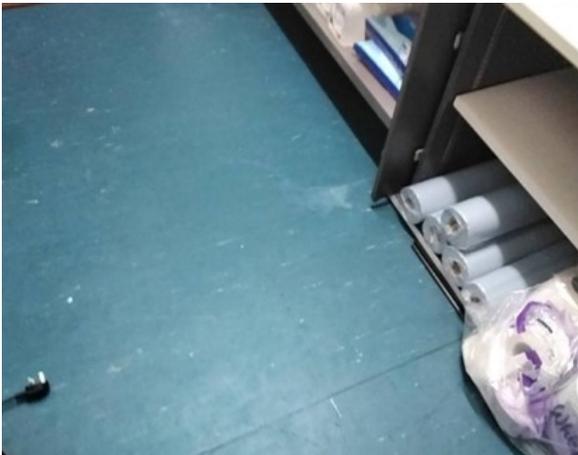
Item 21 - Ref: NG001826

The floor tiles with adhesive in the Store Room (G/002) does not contain asbestos.
