ASBESTOS SURVEY REPORT FOR OXCLOSE SCHOOL, DILSTON CLOSE, WASHINGTON

Asbestos Register for

**OXCLOSE ACADEMY,
DILSTON CLOSE, WASHINGTON**

Oxclose Academy Last updated 09/05/2024 Version 2

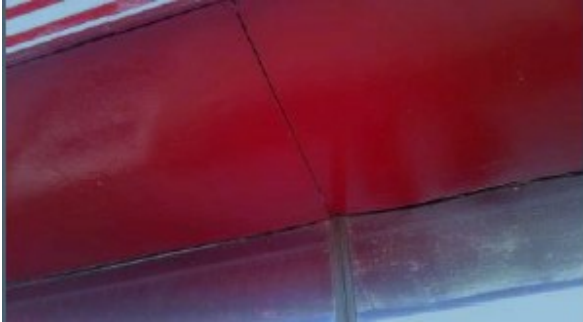
Item 1 Ref: Sample 01

- (Item 1) *Presumed – Soffits to the external – removed August 2018*
- (Item 2) *Presumed – Gasket material (Plant Room) – Very Low Risk*
- (Item 3) *ED04-02 – Wall boards at Height (Plant Room) – Low Risk*

The soffits to the external of the building (around the eaves) contain asbestos. In areas these have been repaired or over clad. Care needs to be taken when accessing these areas.

These were removed August 2018

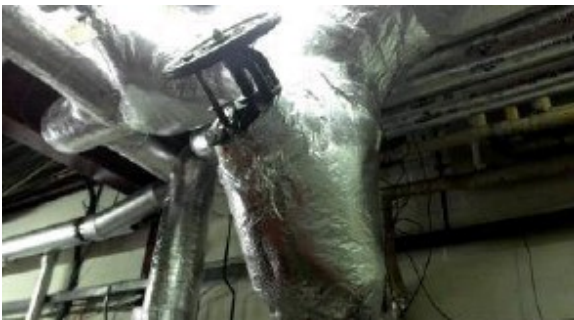
Item 2 - Ref: Presumed

The gaskets to the boiler room are presumed to contain asbestos.

Any change in its appearance should be recorded, and passed to Property Services.

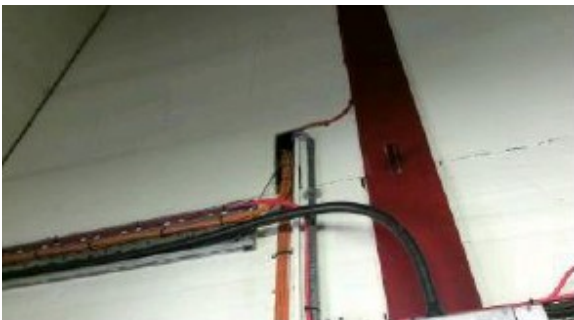
Item 3 - Ref: ED04-2

The wall boards at height in the plant room contain asbestos.

Any change in its appearance should be recorded, and passed to Property Services.

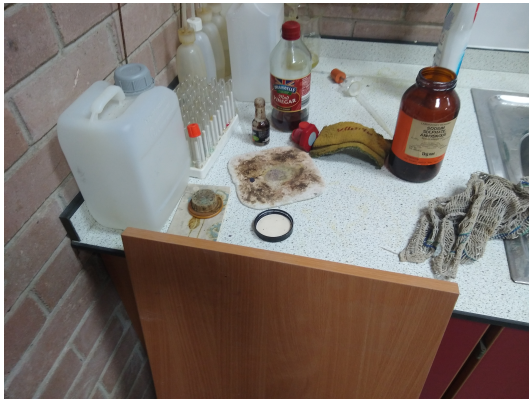
Item 14 - Ref: 330086-1

The Heat pad in Ground Floor Rm 08/Y15 prep room does not contain asbestos.

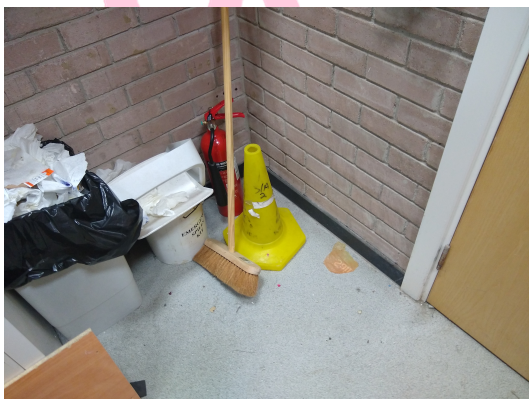
Item 15 - Ref: As 330086-3

The Skirting in Ground Floor Rm 08/Y15 prep room does not contain asbestos.

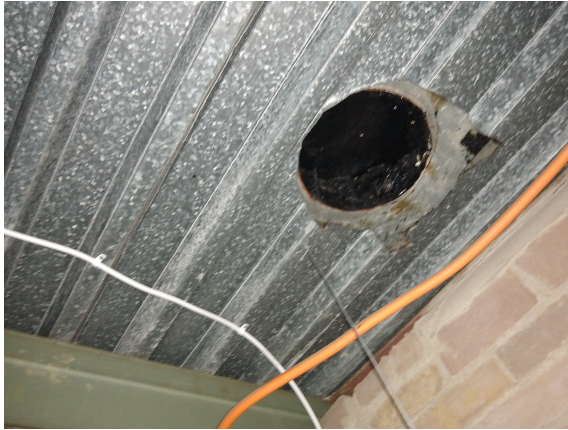
Item 16 - Ref: 330086-2

- (Item 16) *330086-2 – Felt around old pipework penetrations points through the roof (Ground Floor Rm 010/Y16 science classroom – void above) – Low Risk*

The felt around old pipework penetrations points through the roof in ground floor Rm 010/Y16 science classroom (void above) contains asbestos.

Any change in its appearance should be recorded, and passed to Property Services.

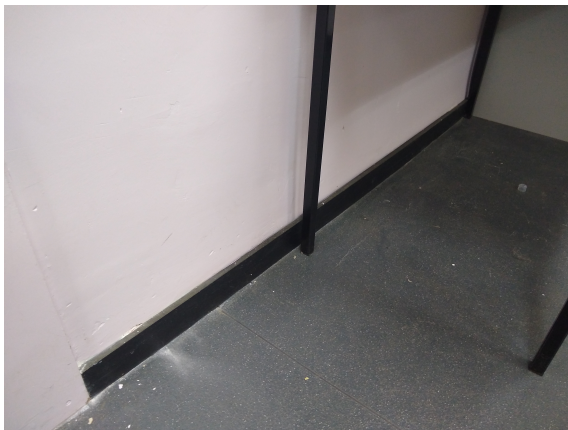
Item 17 - Ref: 330086-3

The Skirting in Ground Floor Rm 011/Y14 science classroom does not contain asbestos.

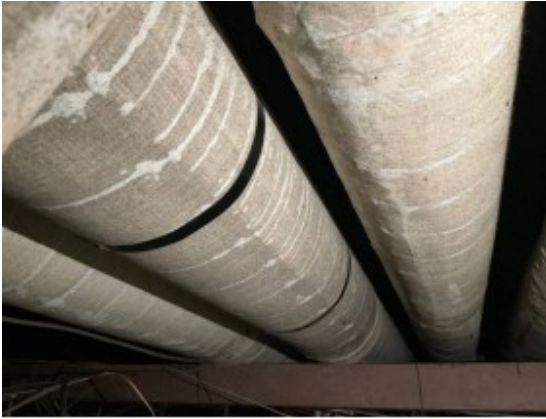
Item 19 - Ref: NG000203

The pipe work throughout ceiling void (Kitchen) does not contain asbestos.

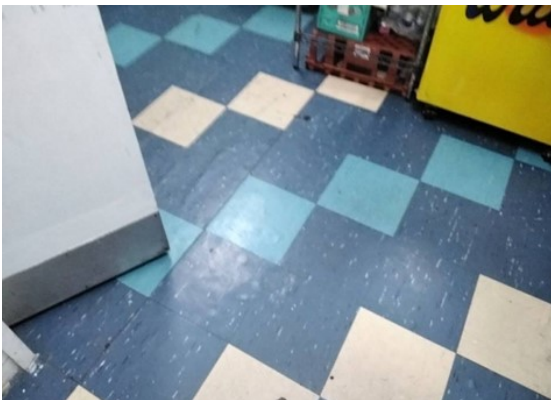
Item 20 - Ref: NG001825

The floor tiles with adhesive in the Store Room (various colours) (G/001) does not contain asbestos.

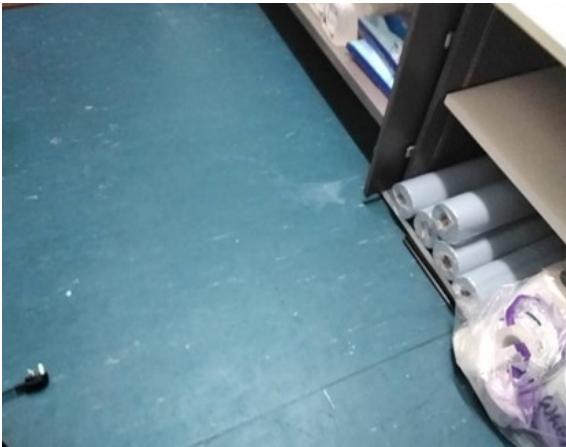
Item 21 - Ref: NG001826

The floor tiles with adhesive in the Store Room (G/002) does not contain asbestos.
