ASBESTOS SURVEY REPORT FOR ST ANNES RC PRIMARY, SUNDERLAND

Asbestos Register for ST ANNES RC PRIMARY, SUNDERLAND

Date: 18 September 2024

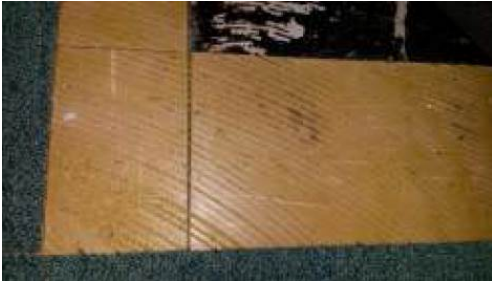
Item 1 Ref: 15-19198/1

- 15-19198/1 – Floor tiles and adhesive (Room 1) (Item 1) – Low Risk
- 15-19198/2 – Floor tiles and adhesive (Room 2) (Item 2) - No Risk
- As 15-19198/2 – Floor tiles and adhesive (Room 4) (Item 3) - No Risk

The floor tiles and the adhesive to the ICT Suite (Room 1) contain asbestos.

Any change in its appearance should be noted and passed to Property Services.

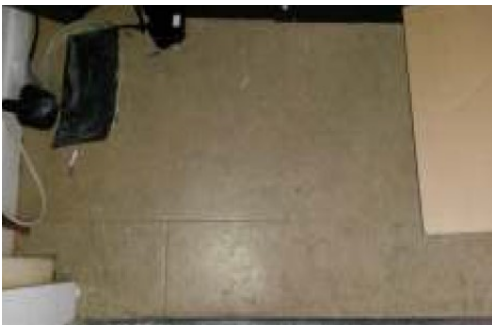
Item 2 Ref: 15-19198/2

The floor tiles and the adhesive to the ICT Suite store (Room 2) do not contain asbestos.

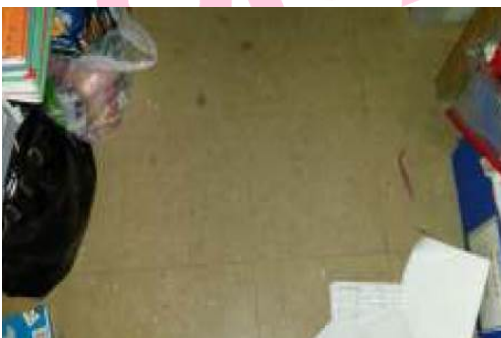
Item 3 As: 15-19198/2

The floor tiles and the adhesive to the year 6 classroom store (Room 4) do not contain asbestos.

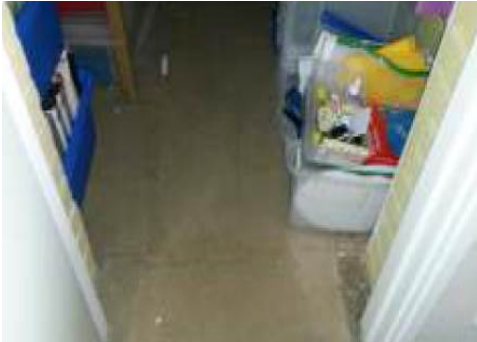
Item 4 As: 15-19198/2

The floor tiles and the adhesive to the year 6 classroom store (Room 6) does not contain asbestos.

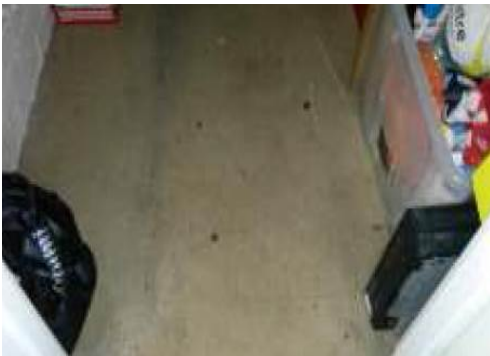
Item 5 Ref: 15-19198/2

The floor tiles and the adhesive to the year 4 classroom store (Room 8) do not contain asbestos.

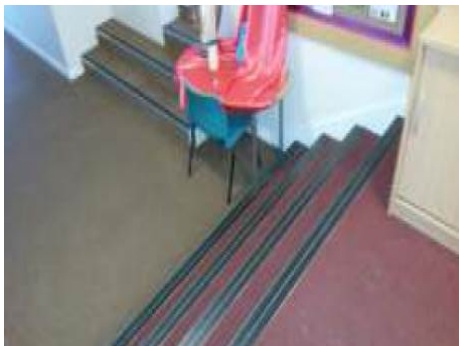
Item 8 Ref: 15-19198/9

The stair nosing to the corridor (Room 22) does not contain asbestos.

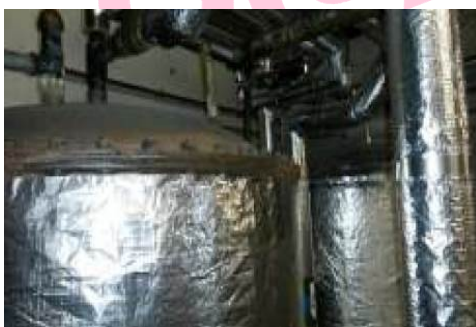
Item 9 Ref: 15-19198/5

The gaskets to the tanks in the boiler house (Room 23) do not contain asbestos.

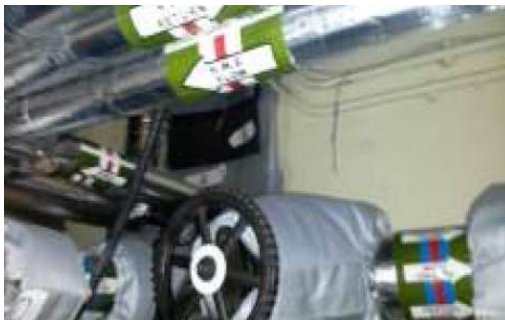
Item 10 Ref: Presumed

The pipe insulation in the sealed duct within the boiler room (Room 23) is presumed to contain asbestos.

Prior to entering the duct, further investigation is required.

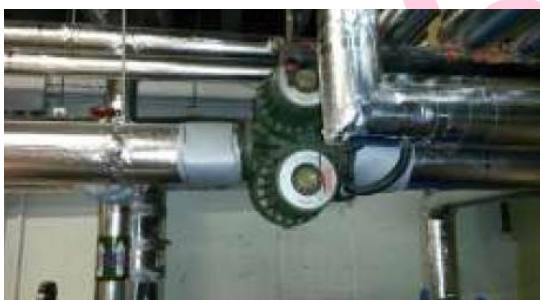
Item 11 Ref: 15-19198/4

The flange gaskets to the boiler room (Room 23) contain asbestos.

Removed Aug 2024 – waiting WCN's

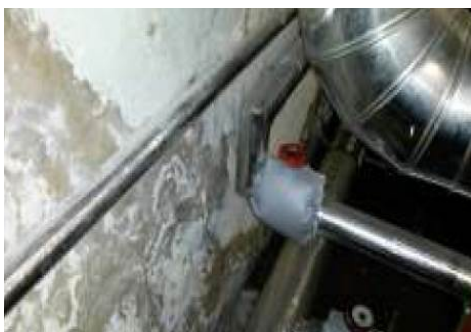
Item 12 Ref: 15-19198/6

The debris to walls removed and walls encapsulated (Room 23) (Item 12) – Aug 2024 – waiting WCN's.

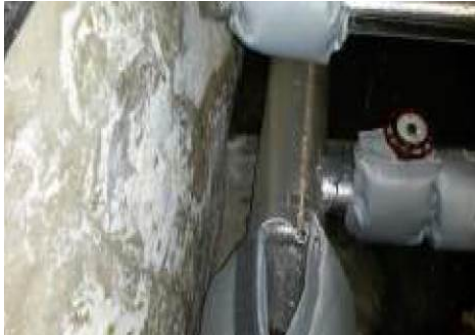
Item 13 Ref: 15-19198/7

The debris to the floor removed and floor encapsulated in the boiler room (Room 23) - August 2024 - waiting WCN's.

Encapsulated - Environmental clean carried out in April 2019 and Aug 2024

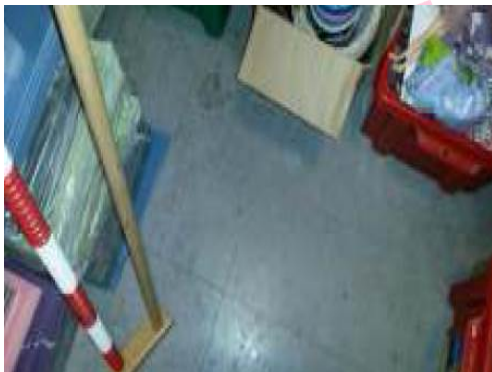
Item 14 Ref: 15-19198/10

The floor tiles and adhesive to the year 3 classroom store (Room 27) contain asbestos.

Any change in its appearance should be noted and passed to Property Services.

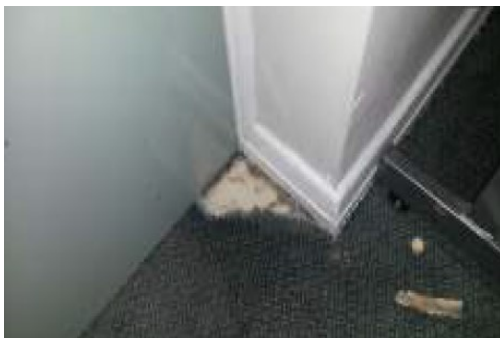
Item 15 Ref: 15-19198/11

The floor tiles and adhesive to the IR Room (Room 28) do not contain asbestos.

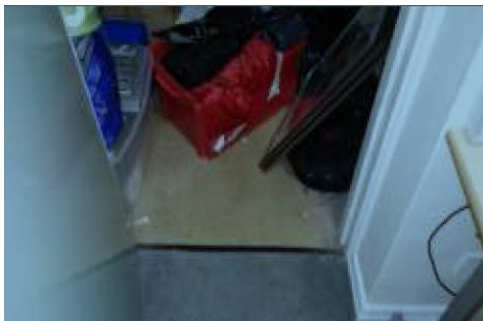
Item 16 Ref: 15-19198/12

The floor tiles and adhesive to the IR Room store (Room 30) do not contain asbestos.

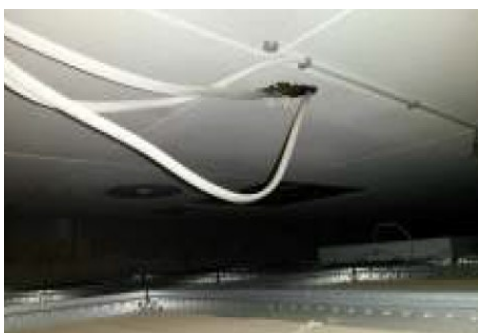
Item 17 Ref: 15-19198/13

The insulation board to the void above the ceiling in the nurture room (Room 31) does not contain asbestos.

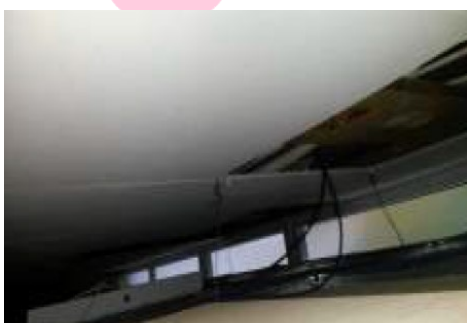
Item 18 Ref: 15-19198/14

The insulation board to the void above the ceiling in the nurture room (Room 31) does not contain asbestos.

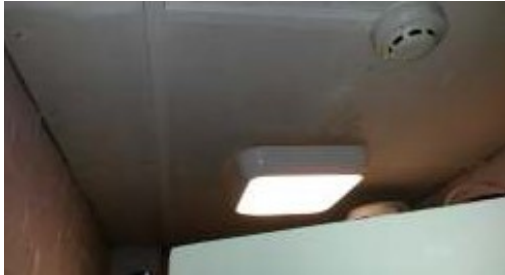
Item 19 Ref: 15-19198/15

The insulation board ceiling to the cleaners cupboard (Room 35) does not contain asbestos.

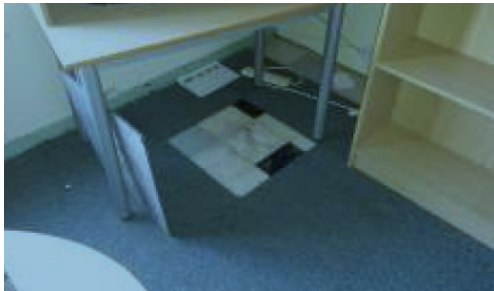
Item 20 Ref: 15-19198/16

The floor tiles and the adhesive to the Rainbow Room (Room 38) contain asbestos.

Any change in its appearance should be recorded and passed to Property Services.

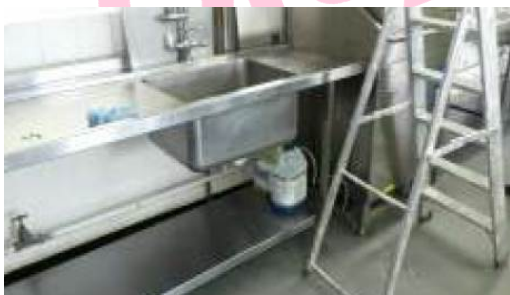
Item 21 Ref: 15-19198/17

The sink pad to the kitchen (Room 42) does not contain asbestos.

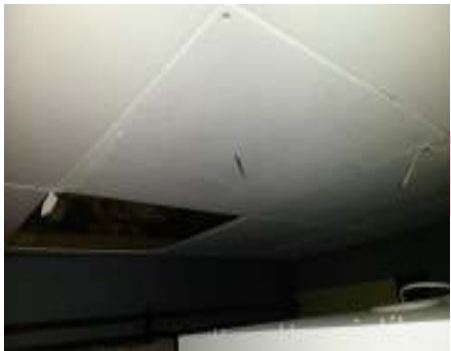
Item 23 Ref: 15-19198/19

The insulation board ceiling to the cleaners' cupboard (Room 48) does not contain asbestos.

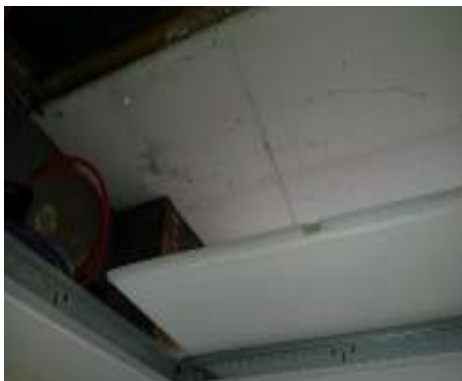
Item 24 Ref: 15-19198/20

The insulation board ceiling to the cleaners' cupboard (Room 51) does not contain asbestos.

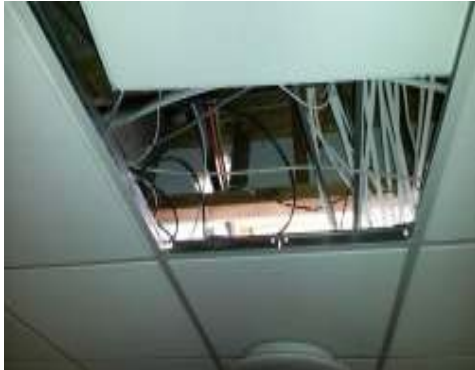
Item 25 Ref: 15-19198/20

The insulation board upstands to the redundant skylight in the void above Room 61 (Room 62) do not contain asbestos.

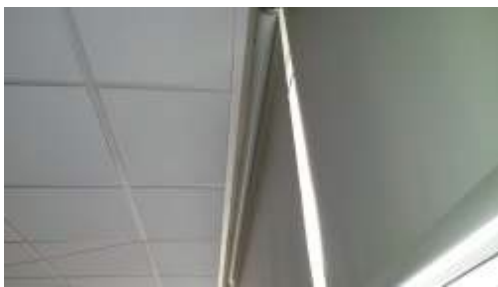
Item 26 Ref: 15-19198/22

The ceiling panels above the windows to the year 2 classroom (Room 73) do not contain asbestos.

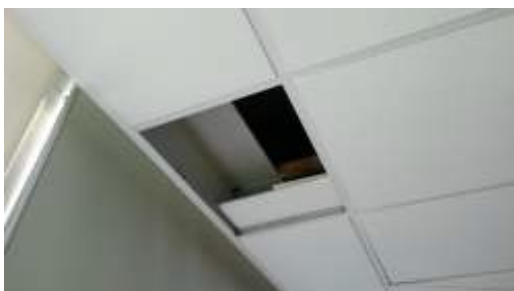
Item 27 Ref: 15-19198/23

The insulation board to the void above year 2 classroom (Room 74) does not contain asbestos.

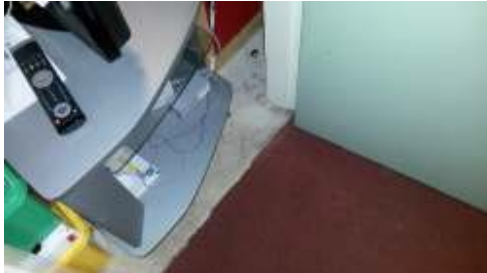
Item 28 Ref: 15-19198/24

The floor tiles and adhesive to the store (Room 82) contain asbestos.

Any change in its appearance should be noted and passed to Property Services.

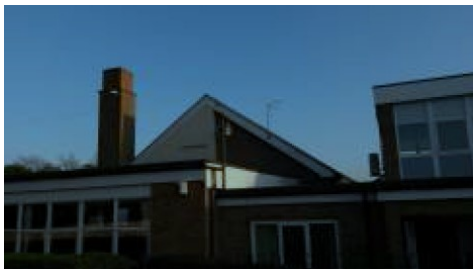
Item 29 Ref: 15-19198/29

The external cement under cloaking contains asbestos.

Any change in its appearance should be noted and passed to Property Services.

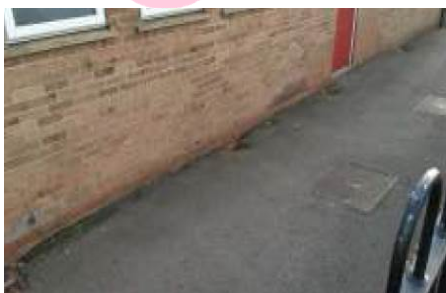
Item 30 Ref: 15-19198/30

The damp proof course to the external contains asbestos.

Any change in its appearance should be noted and passed to Property Services.

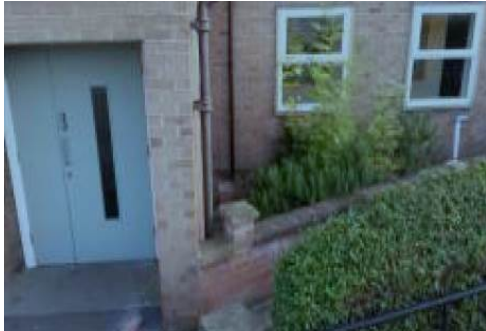
Item 31 Ref: 15-19198/32

The jointing compound to the soil pipe (External) contains asbestos.

Any change in its appearance should be noted and passed to Property Services.

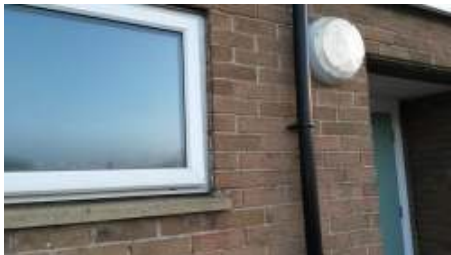
Item 32 Ref: 15-19198/31

The putty to the brickwork (External) does not contain asbestos.

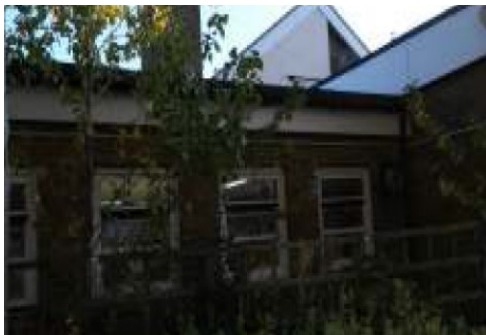
Item 33 Ref: 15-19198/28

The putty to the wood frame (External) does not contain asbestos.

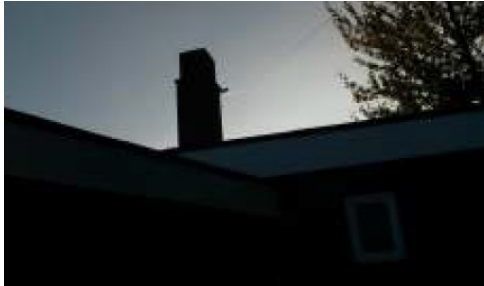
Item 34 Ref: 15-19198/27

The roof felt (external) does not contain asbestos.

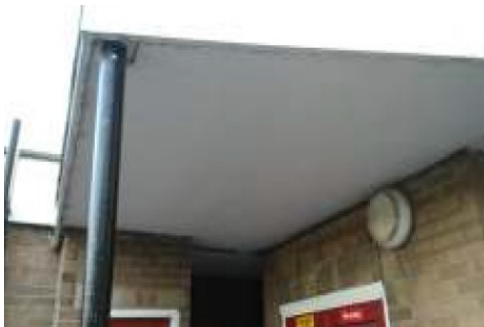
Item 35 Ref: 15-19198/25

The insulation board to the rear canopy outside the kitchen (external) does not contain asbestos.

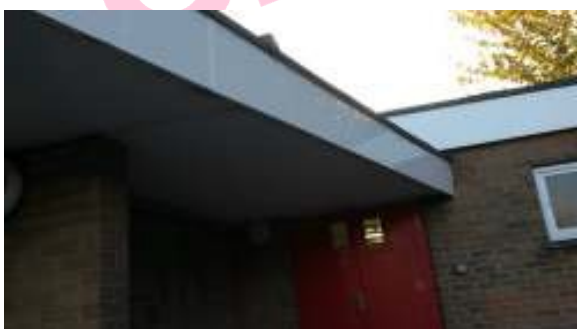
Item 36 Ref: 15-19198/26

The insulation board soffits to the rear canopy outside the kitchen (External) do not contain asbestos.

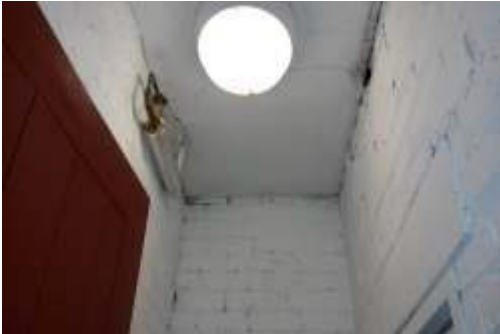
Item 37 Ref: 15-19198/33

The insulation board to the ceiling in the external wc does not contain asbestos.

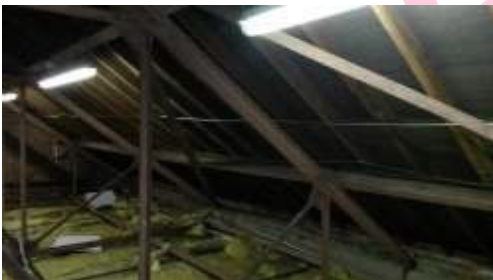
Item 38 Ref: 15-19198/34

The sarking felt to the roof tank room does not contain asbestos.

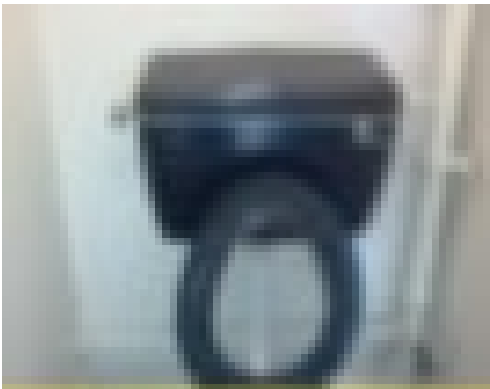
Item 43 Ref: 55377-2

The toilet cistern in the Male WC R13 does contain asbestos.

Removed Sept 2021

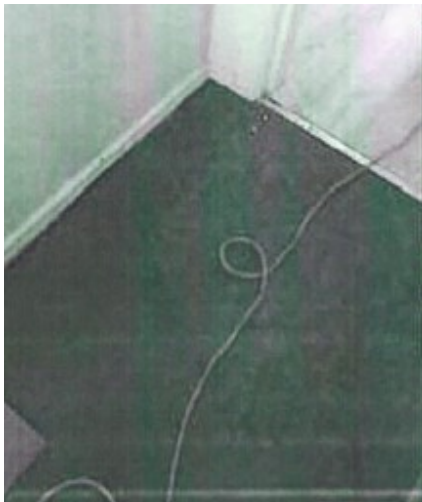
Item 46 Ref: SARCS/001

The vinyl floor covering in the Community Room does contain asbestos.

Any change in appearance should be reported to Property Services.

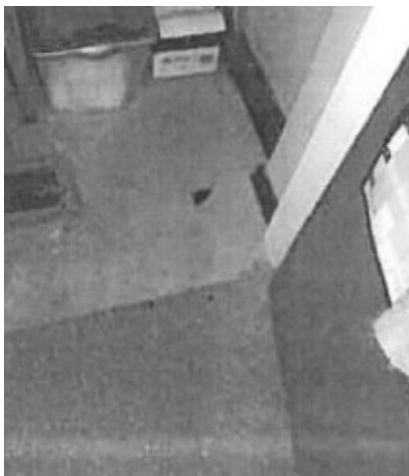
Item 47 Ref: SARCS/003

The vinyl floor tiles in the Community Room cupboard does contain asbestos.

Any change in appearance should be reported to Property Services.

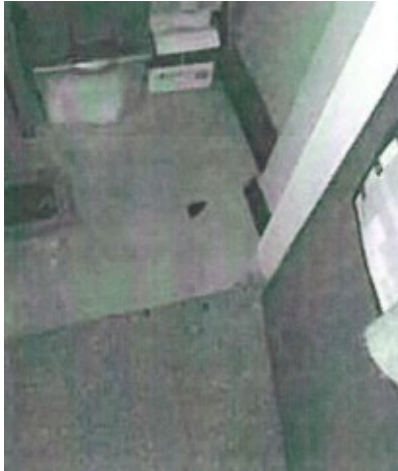
Item 48 Ref: SARCS/004

The vinyl floor tile adhesive in the Community Room cupboard does contain asbestos.

Any change in appearance should be reported to Property Services.

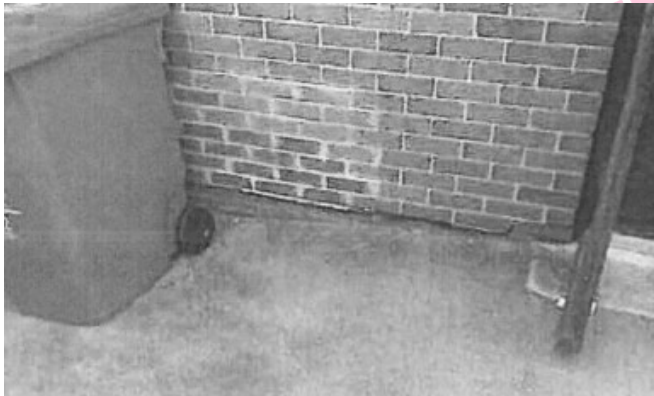
Item 49 Ref: SAS/002

The damp proof course to the external area of the Community Room cupboard does contain asbestos.

Any change in appearance should be reported to Property Services.

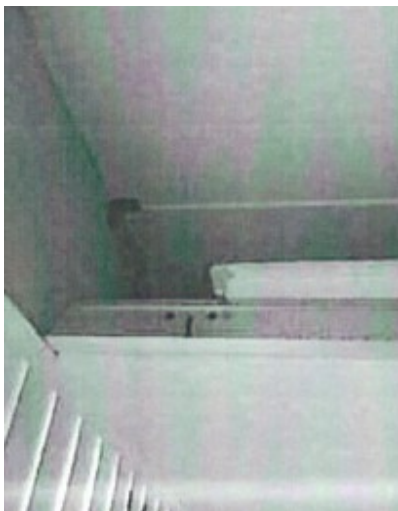
Item 50 Ref: SAS/003

The panels above the windows in the Community Room does not contain asbestos.

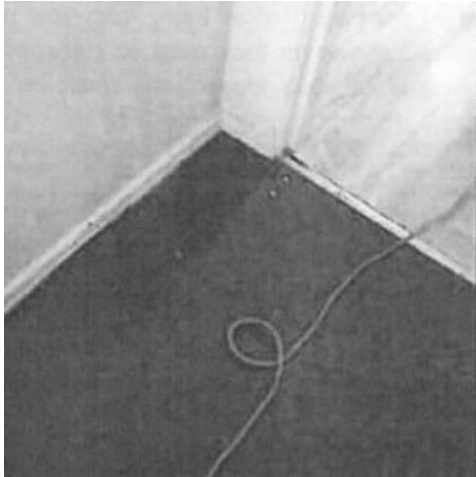
Item 51 Ref: SARCS/002

The floor screed in the Community Room does not contain asbestos.

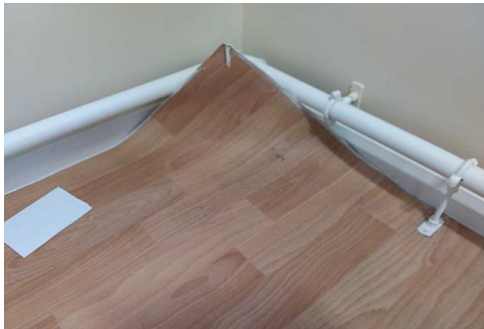
Item 52 Ref: 22-44268-1

The floor (Community Room and Cupboards/Area 1) does not contain asbestos.

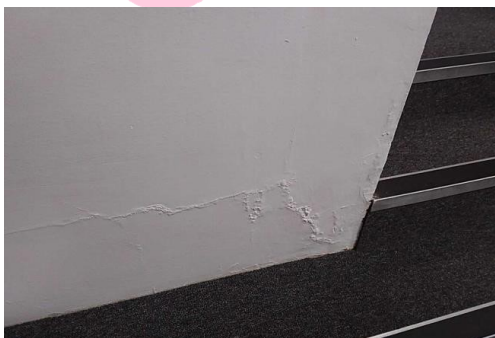
Item 53 Ref: 22-44268-2

The left side of walls (Corridor opposite main hall/Area 2) does not contain asbestos.

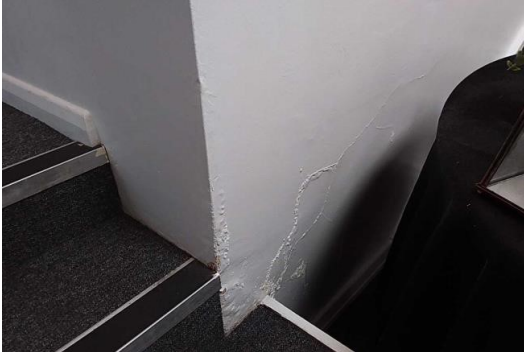
Item 54 Ref: 22-44268-3

The right side of walls (Corridor opposite main hall/Area 2) does not contain asbestos.

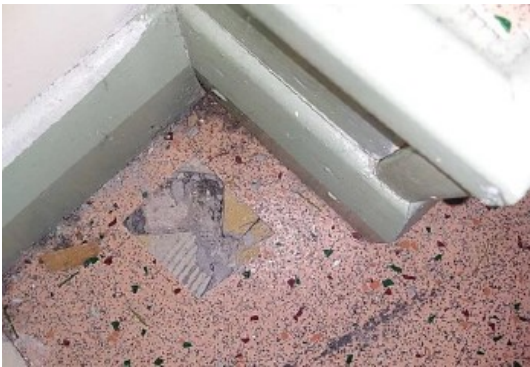
Item 55 Ref: 22-49421-1

The residual adhesive beneath modern vinyl and screed (Early Years WC 2 /Area 2) does contain asbestos.

Removed July 2022

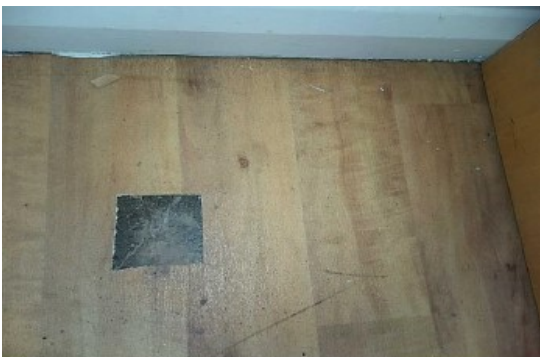
Item 56 Ref: 22-49421-1

The residual adhesive beneath modern vinyl and screed (Nursery /Area 3) does contain asbestos.

Any change in appearance should be reported to Property Services.

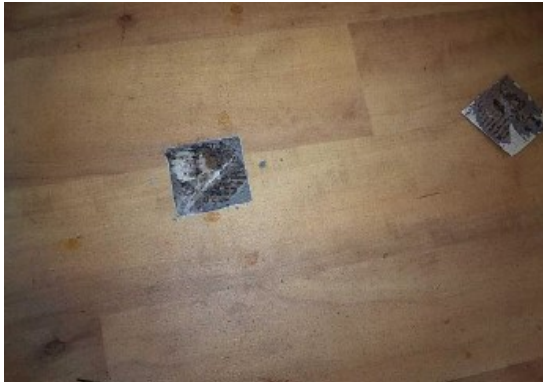
Item 57 Ref: 22-49421-1

The residual adhesive beneath modern vinyl and screed (Fs Unit /Area 4) does contain asbestos.

Any change in appearance should be reported to Property Services.

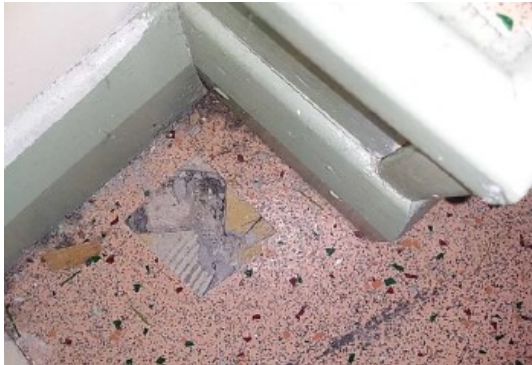
Item 58 Ref: 22-49421-1

The residual adhesive beneath modern vinyl and screed (Reception Class /Area 5) does contain asbestos.

Any change in appearance should be reported to Property Services.

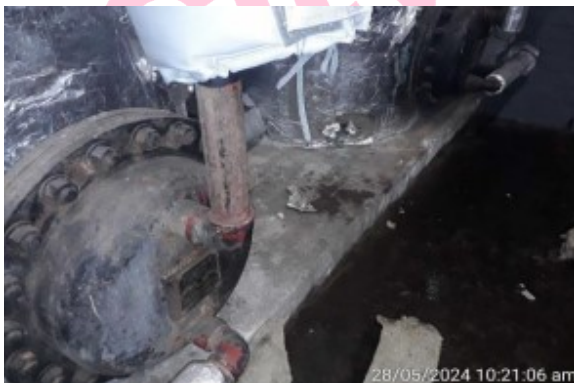
Item 59 Ref: 24-76425-1

The residual insulation to copper tank front flanges x 2 (Boiler Room/Area 001) does contain asbestos.

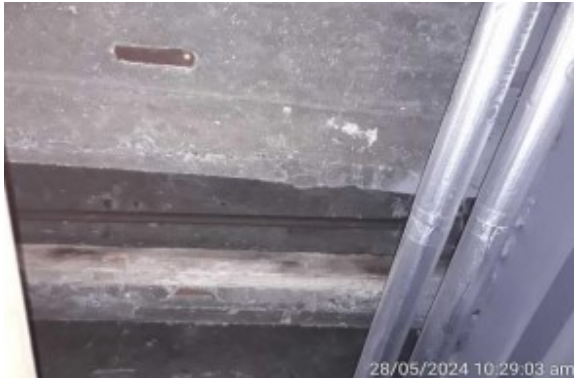
Item 60 Ref: 24-76425-2

The ceiling residual insulation (Boiler Room/Area 001) contains asbestos.

Any change in appearance should be reported to Property Services.

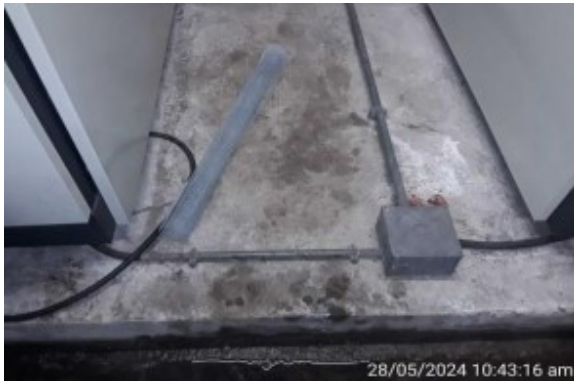
Item 61 Ref: 24-76425-4

The walls residual insulation to boiler plinth (Boiler Room/Area 001) does not contain asbestos.

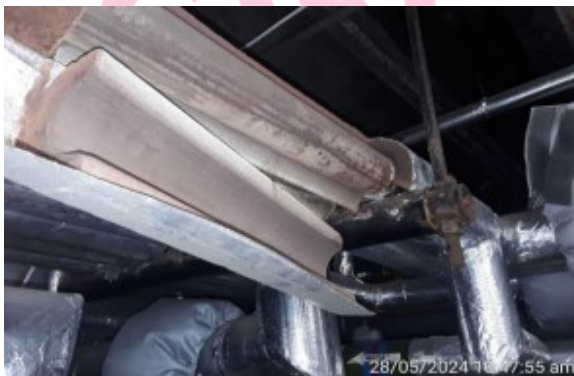
Item 62 Ref: 24-76425-6

The residual insulation to old pipework and hangers beneath foam insulation (Boiler Room/Area 001) contains asbestos.

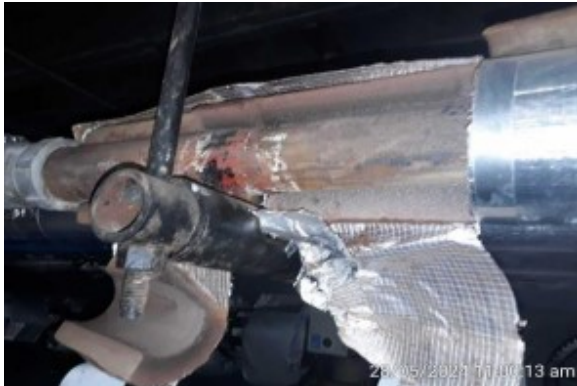
Item 63 Ref: 24-76425-7

The residual insulation to old pipework and hangers beneath foam insulation (Boiler Room/Area 001) contains asbestos.

Any change in appearance should be reported to Property Services.

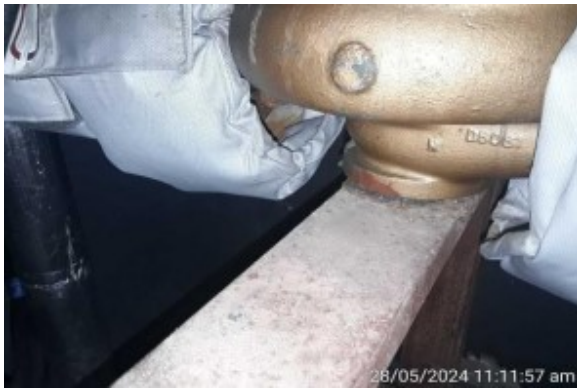
Item 64 Ref: 24-76425-8

The acoustic pads beneath 2 x pumps (Boiler Room/Area 001) do not contain asbestos.

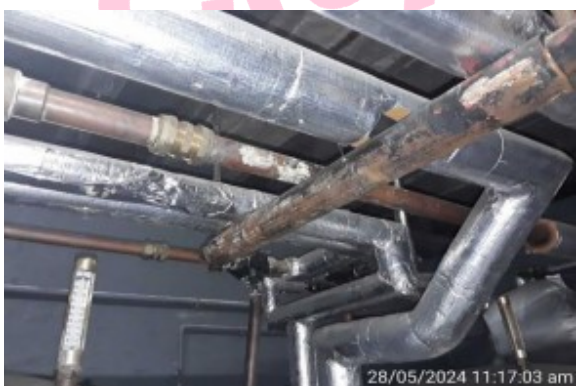
Item 65 Ref: 24-76425-9

The residual insulation to old pipework and hangers beneath foam insulation (Boiler Room/Area 001) contains asbestos.

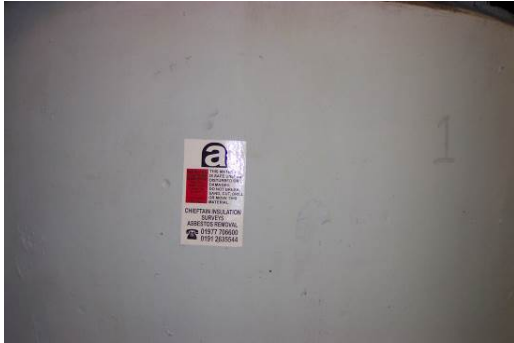
Ref: 037SW1

The insulation to the calorifier in the plant room (Room 23) contained asbestos.

This was removed in February 2014.

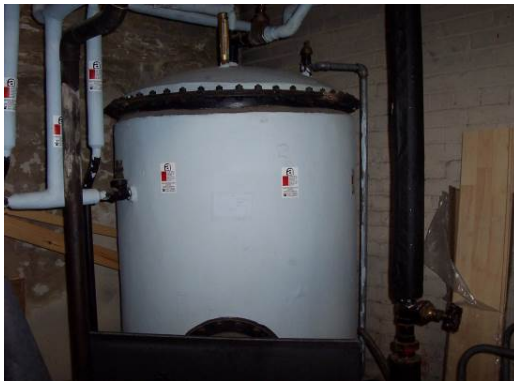
Ref:037SW2

The calorifier insulation in the plant room (Room 23) contained asbestos.

This was removed in February 2014.

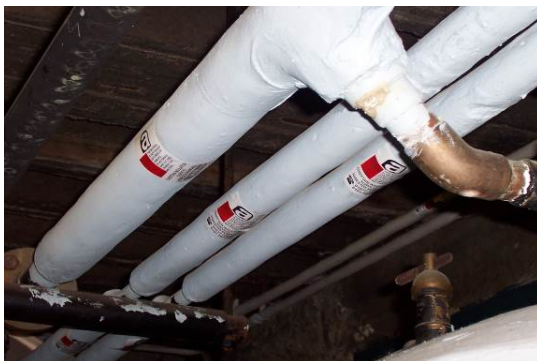
Ref:037SW3

The pipe insulation in the plant room (Room 23) contained asbestos.

This was removed in February 2014.

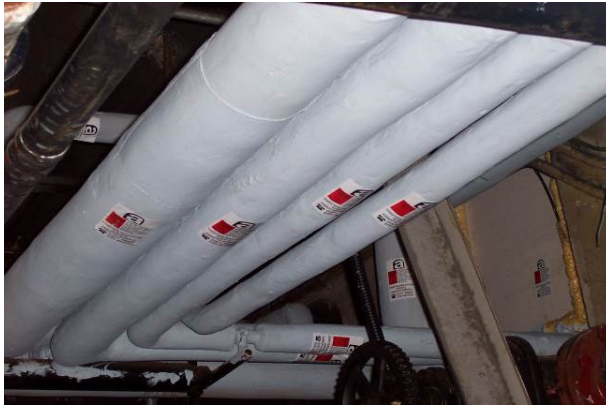
Ref:037SW3 and 037SW6

The pipe insulation in the plant room (Room 23) contained asbestos.

This was removed in February 2014.

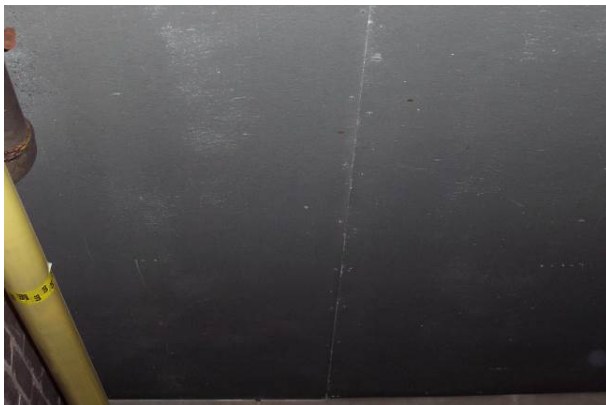
Ref: 037SW8

The ceiling boards to the plant room (Room 23) contained asbestos.

These have since been removed.

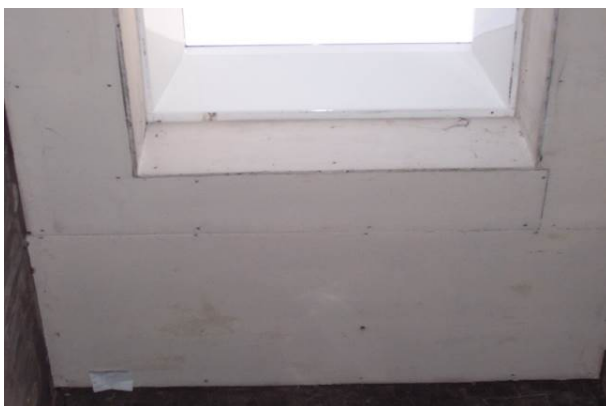
Ref: 037SW9

The ceiling boards to the plant room (Room 23) contained asbestos.

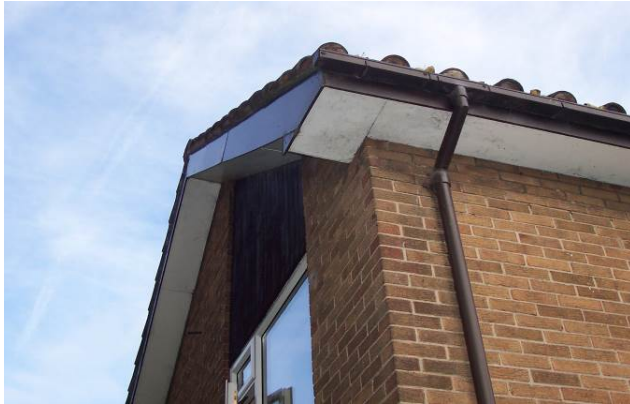
Item 39 - Ref: 037SW13

The soffitt boards to the Caretakers House contain asbestos.

Any change in its appearance should be recorded, and passed to Property Services.

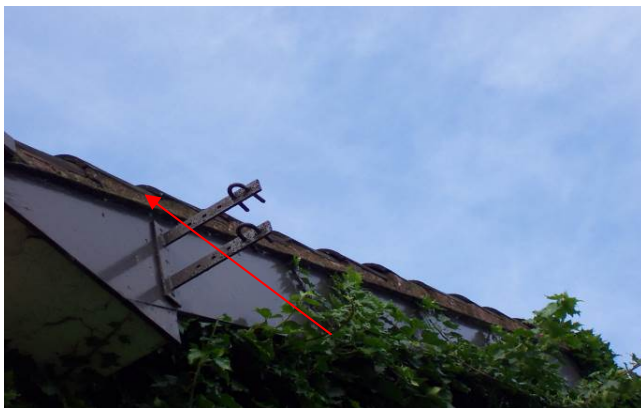
Item 40 - Ref: Presumed

The fillet board to the apex on the Caretakers House is presumed to contain asbestos.
