ASBESTOS SURVEY REPORT FOR ST ANNES RC PRIMARY, SUNDERLAND

Asbestos Register for ST ANNES RC PRIMARY, SUNDERLAND

Date: 22 July 2025

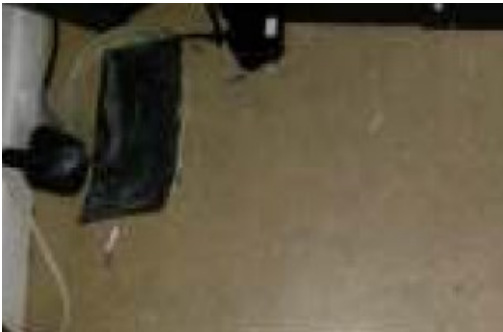
Item 2 Ref: 15-19198/2
cross ref: 25-88025-6

The floor (Tiles & adhesive)
(Room 1/ ICT Suite and
cupboard/Area: 048) contain
asbestos.

Any change in its appearance
should be noted and passed to
Property Services.

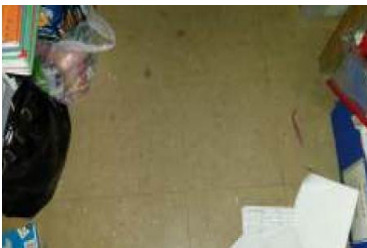
Item 3 As: 15-19198/2

The floor tiles and the
adhesive to the year 6
classroom store (Room 4) do
not contain asbestos.

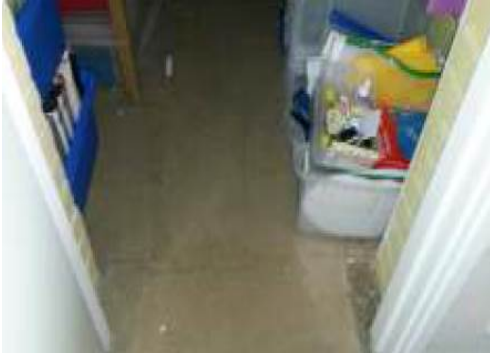
Item 4 As: 15-19198/2

The floor tiles and the adhesive to the year 6 classroom store (Room 6) does not contain asbestos.

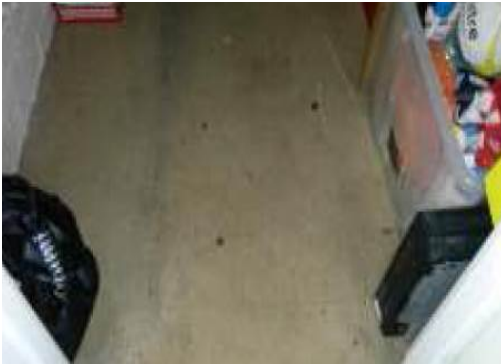
Item 5 Ref: 15-19198/2

The floor tiles and the adhesive to the year 4 classroom store (Room 8) do not contain asbestos.

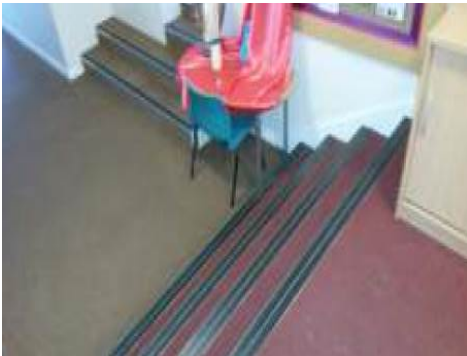
Item 8 Ref: 15-19198/9

The stair nosing to the corridor (Room 22) does not contain asbestos.

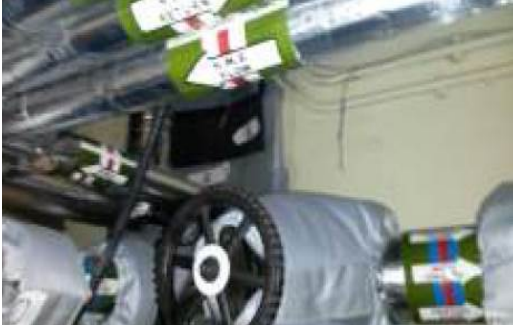
Item 10 Ref: Presumed

The pipe insulation in the sealed duct within the boiler room (Room 23) is presumed to contain asbestos.

Prior to entering the duct, further investigation is required.

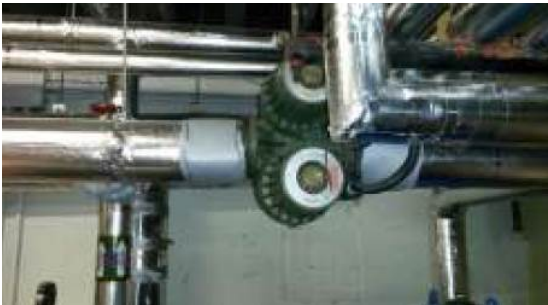
Item 11 Ref: 15-19198/4

The flange gaskets to the boiler room (Room 23) contain asbestos.

Removed Aug 2024 – waiting WCN's

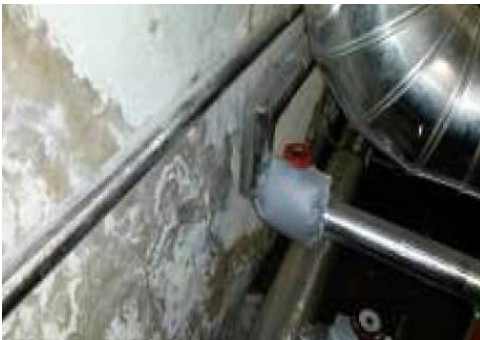
Item 12 Ref: 15-19198/6

The debris to walls removed and walls encapsulated (Room 23) (Item 12) – Aug 2024 – waiting WCN's.

Encapsulated - Environmental clean carried out in April 2019 and Aug 2024

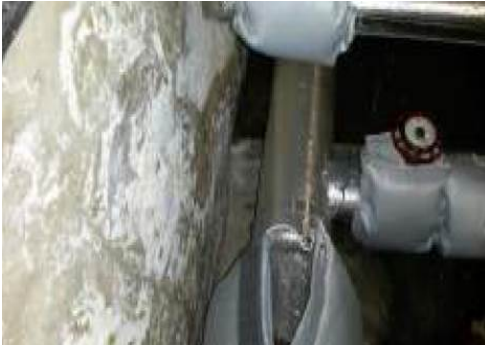
Item 13 Ref: 15-19198/7

The debris to the floor removed and floor encapsulated in the boiler room (Room 23) - August 2024 - waiting WCN's.

Encapsulated - Environmental clean carried out in April 2019 and Aug 2024

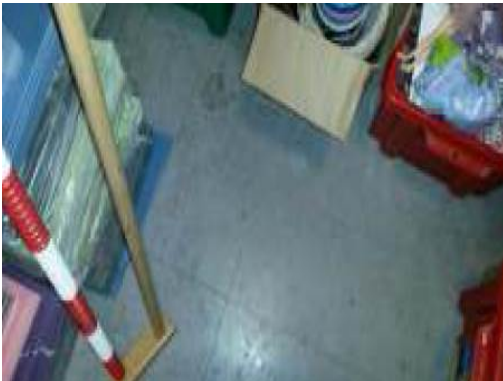
Item 14 Ref: 15-19198/10

The floor tiles and adhesive to the year 3 classroom store (Room 27) contain asbestos.

Any change in its appearance should be noted and passed to Property Services.

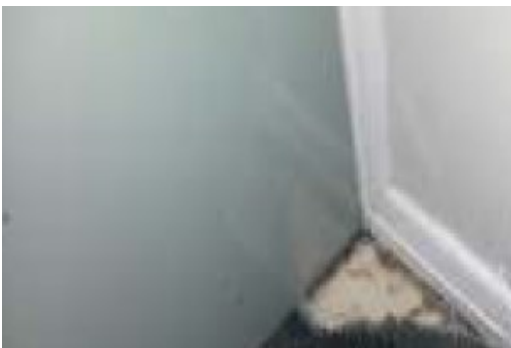
Item 15 Ref: 15-19198/11

The floor tiles and adhesive to the IR Room (Room 28) do not contain asbestos.

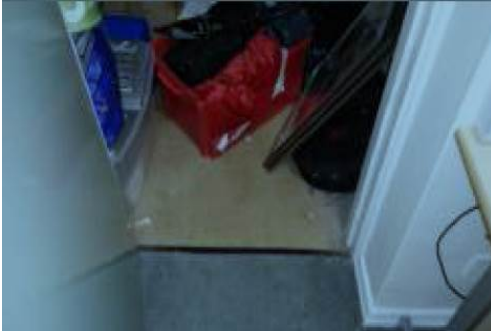
Item 16 Ref: 15-19198/12

The floor tiles and adhesive to the IR Room store (Room 30) do not contain asbestos.

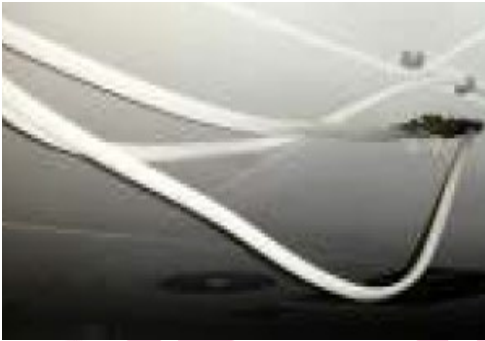
Item 17 Ref: 15-19198/13

The insulation board to the void above the ceiling in the nurture room (Room 31) does not contain asbestos.

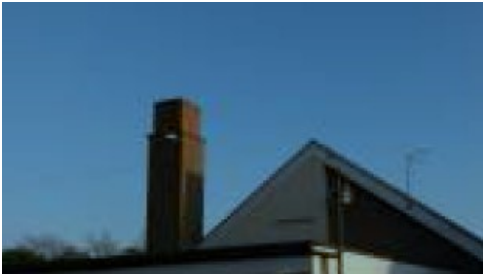
Item 29 Ref: 15-19198/29

The external cement under cloaking contains asbestos.

Any change in its appearance should be noted and passed to Property Services.

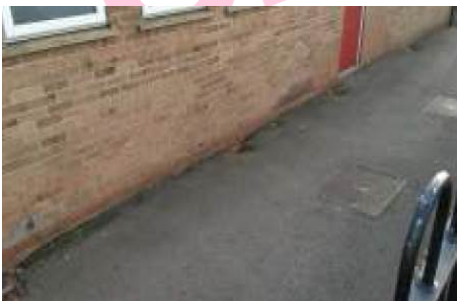
Item 30 Ref: 15-19198/30

The damp proof course to the external contains asbestos.

Any change in its appearance should be noted and passed to Property Services.

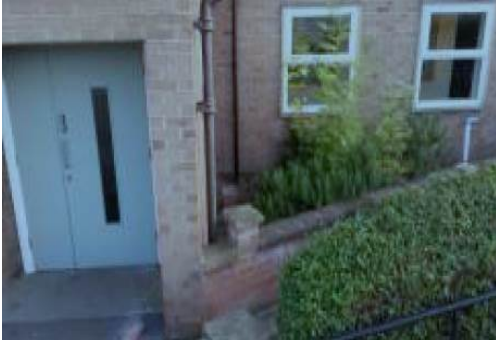
Item 31 Ref: 15-19198/32

The jointing compound to the soil pipe (External) contains asbestos.

Any change in its appearance should be noted and passed to Property Services.

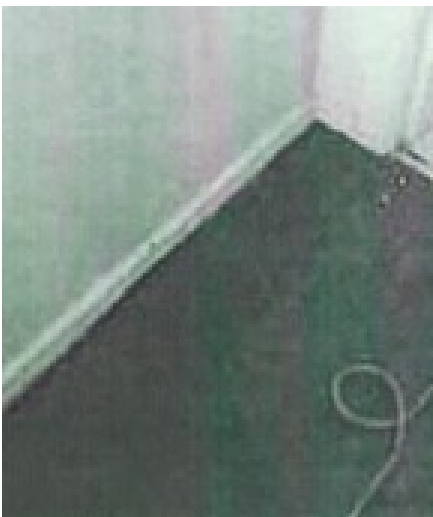
Item 46 Ref: SARCS/001

The vinyl floor covering in the Community Room does contain asbestos.

Any change in appearance should be reported to Property Services.

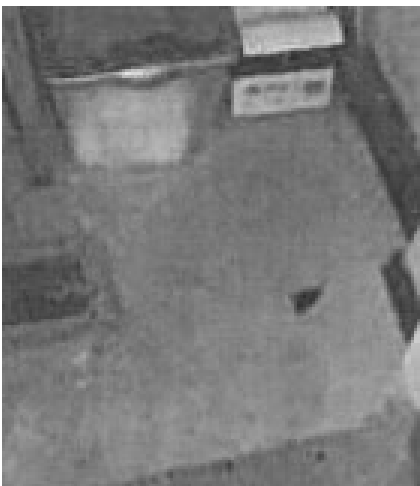
Item 47 Ref: SARCS/003

The vinyl floor tiles in the Community Room cupboard does contain asbestos.

Any change in appearance should be reported to Property Services.

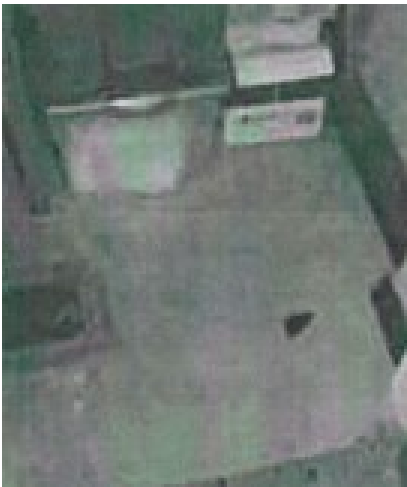
Item 48 Ref: SARCS/004

The vinyl floor tile adhesive in the Community Room cupboard does contain asbestos.

Any change in appearance should be reported to Property Services.

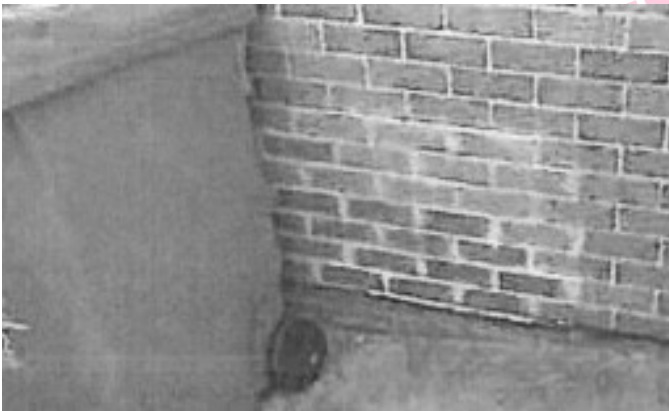
Item 49 Ref: SAS/002

The damp proof course to the external area of the Community Room cupboard does contain asbestos.

Any change in appearance should be reported to Property Services.

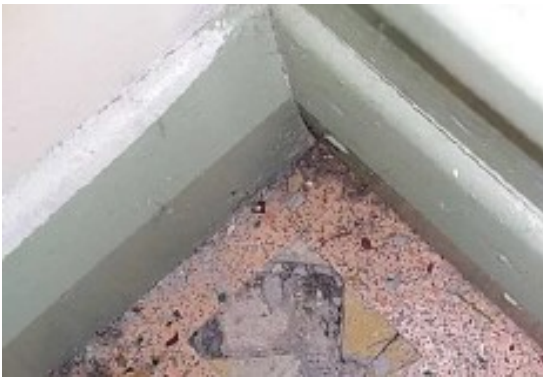
Item 55 Ref: 22-49421-1

The residual adhesive beneath
modern vinyl and screed (Early
Years WC 2 /Area 2) does
contain asbestos.

Removed July 2022

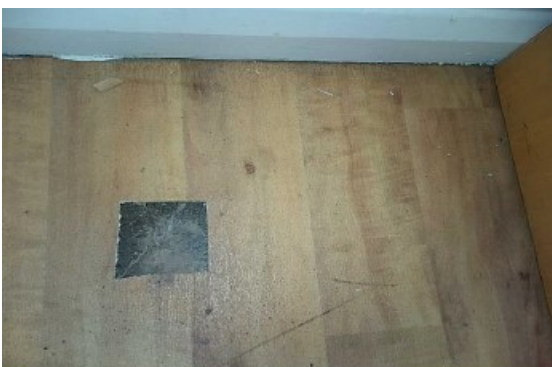
Item 56 Ref: 22-49421-1

The residual adhesive beneath
modern vinyl and screed
(Nursery /Area 3) does contain
asbestos.

Any change in appearance
should be reported to Property
Services.

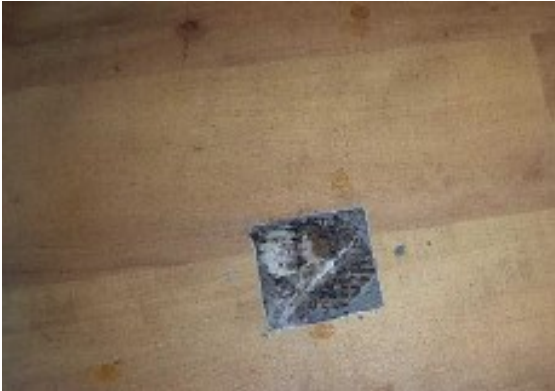
Item 57 Ref: 22-49421-1

The residual adhesive beneath modern vinyl and screed (Fs Unit /Area 4) does contain asbestos.

Any change in appearance should be reported to Property Services.

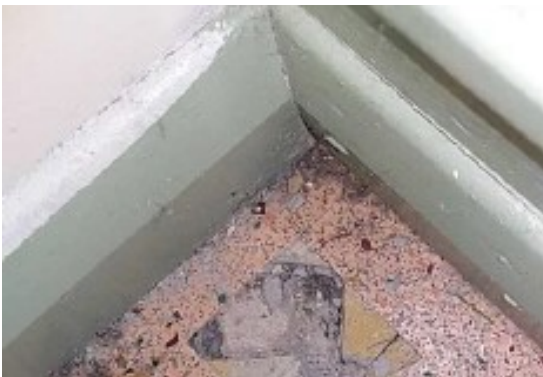
Item 58 Ref: 22-49421-1

The residual adhesive beneath modern vinyl and screed (Reception Class /Area 5) does contain asbestos.

Any change in appearance should be reported to Property Services.

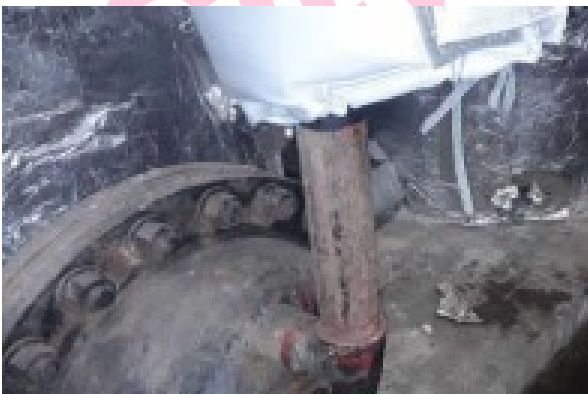
Item 59 Ref: 24-76425-1

The residual insulation to copper tank front flanges x 2 (Boiler Room/Area 001) does contain asbestos.

Any change in appearance should be reported to Property Services.

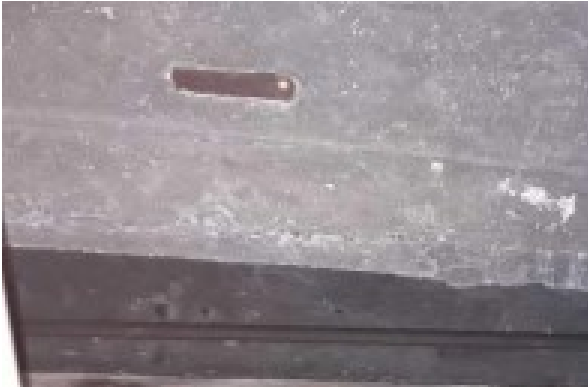
Item 60 Ref: 24-76425-2

The ceiling residual insulation (Boiler Room/Area 001) contains asbestos.

Any change in appearance should be reported to Property Services.

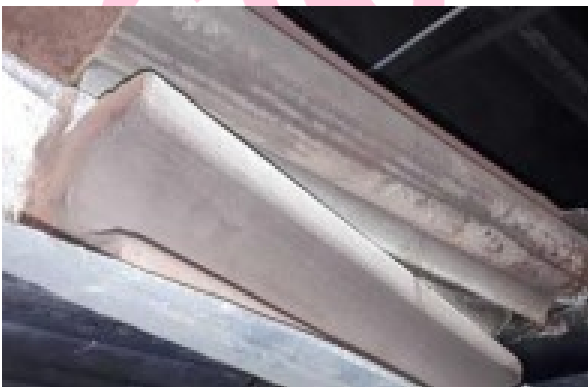
Item 62 Ref: 24-76425-6

The residual insulation to old pipework and hangers beneath foam insulation (Boiler Room/Area 001) contains asbestos.

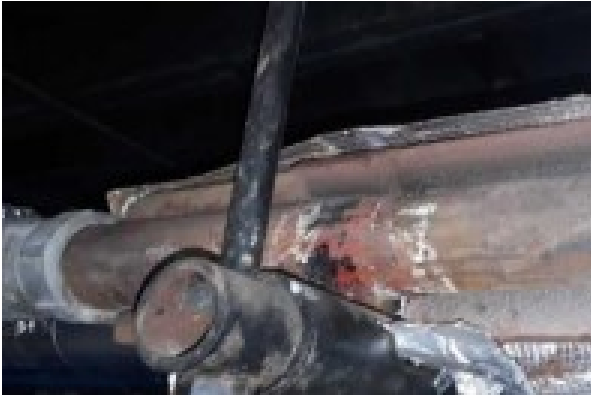
Item 63 Ref: 24-76425-7

The residual insulation to old pipework and hangers beneath foam insulation (Boiler Room/Area 001) contains asbestos.

Any change in appearance should be reported to Property Services.

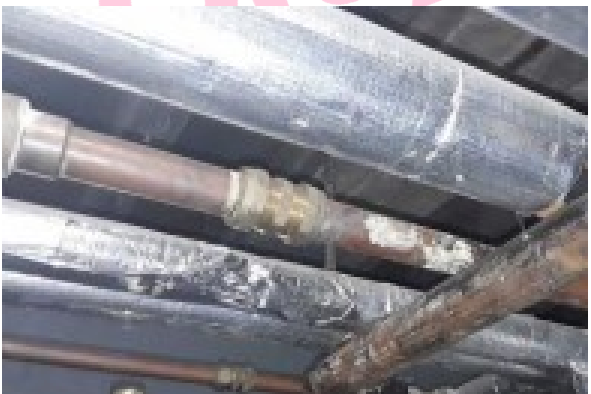
Item 65 Ref: 24-76425-9

The residual insulation to old pipework and hangers beneath foam insulation (Boiler Room/Area 001) contains asbestos.

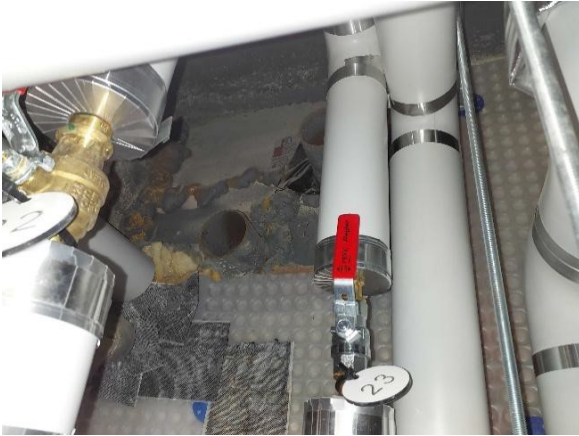
Item 66 Ref: Presumed

The pipes - insulating to pipe inside ducts x 2 (Insulation) (Boiler Room/Area: 001) are presumed to contain asbestos.

Any change in appearance should be reported to Property Services.

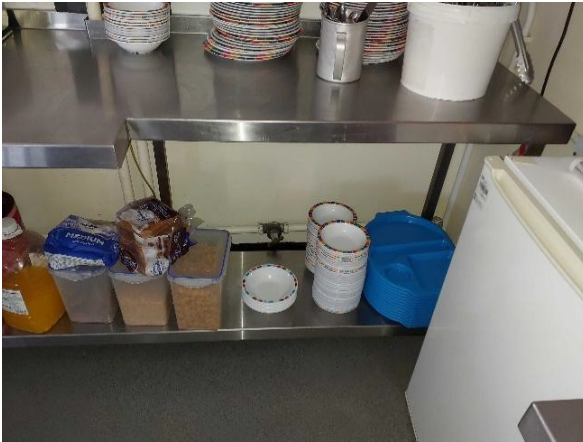
Item 67 Ref: Presumed

The Pipes - stop tap gasket (Gasket) (Kitchen/Area: 002) are presumed to contain asbestos.

Any change in appearance should be reported to Property Services.

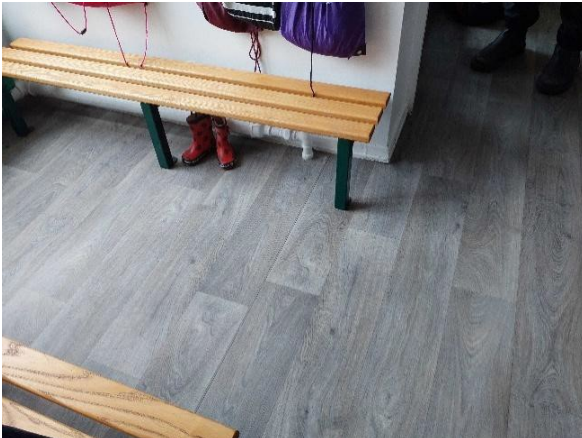
Item 70 Ref: 25-88025-5

The floor - residual adhesive beneath screed (Bitumen) (Cloakroom/Area: 033) contains asbestos.

Any change in appearance should be reported to Property Services.

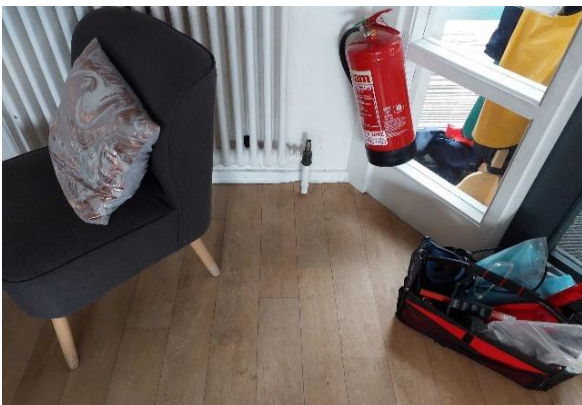
Item 71 Ref: 25-88025-5

The floor - residual adhesive beneath screed (Bitumen) (Reception class/ Area: 034) contains asbestos.

Any change in appearance should be reported to Property Services.

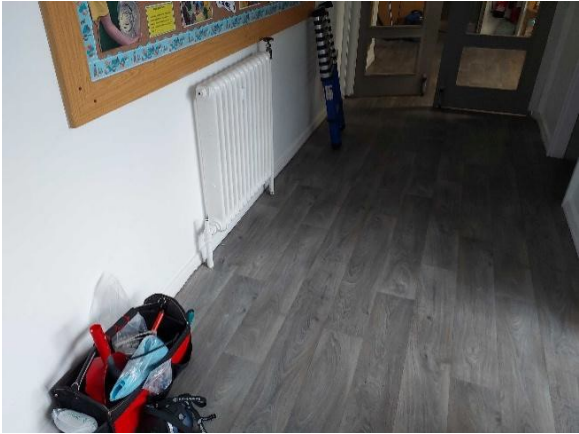
Item 72 Ref: 25-88025-5

The floor - residual adhesive beneath screed (Bitumen) (Corridor 6/ Area: 037) contains asbestos.

Any change in appearance should be reported to Property Services.

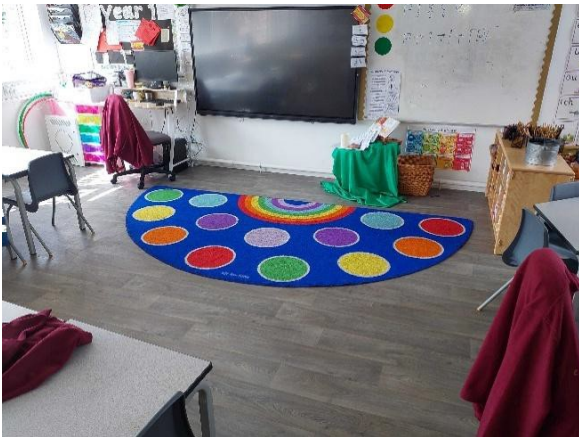
Item 73 Ref: 25-88025-5

The floor - residual adhesive beneath screed (Bitumen) (Year 1 and cupboards/ Area: 040) contains asbestos.

Any change in appearance should be reported to Property Services.

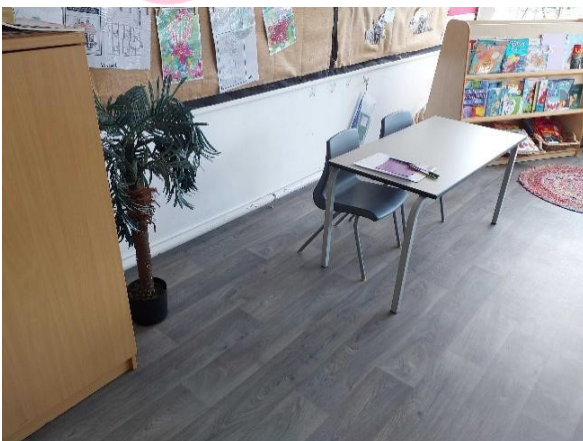
Item 74 Ref: 25-88025-5

The floor - residual adhesive beneath screed (Bitumen) (Year 2 and cupboards/ Area: 041) contains asbestos.

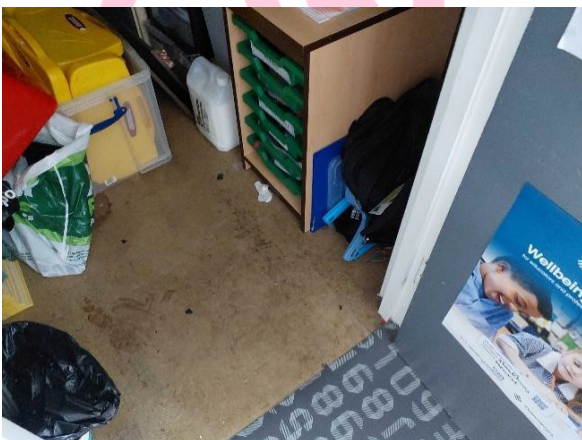
Item 77 Ref: 25-88025-6

The floor (Tiles & adhesive)
(Year 4 Classroom cupboard/Area: 052) contains asbestos.

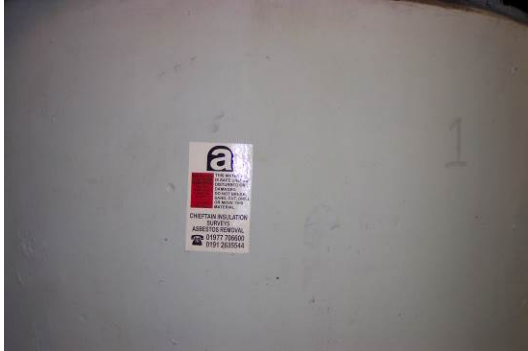
Ref: 037SW1

The insulation to the calorifier in the plant room (Room 23) contained asbestos.

This was removed in February 2014.
