ASBESTOS SURVEY REPORT FOR WESSINGTON PRIMARY SCHOOL  
LANERCOST, WASHINGTON, TYNE AND WEAR, NE38 7QA.

## Asbestos Register for

**Wessington Primary School, Washington,  
NE38 7QA**

**Date: 22 August 2024**

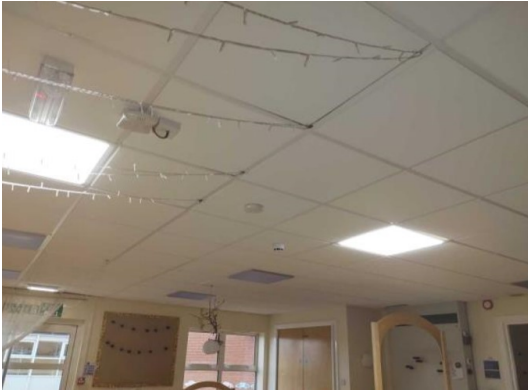
### **Item 1 Ref: 20-28462-2**

The ceiling (Area 1/Nursery Classroom) does not contain asbestos.

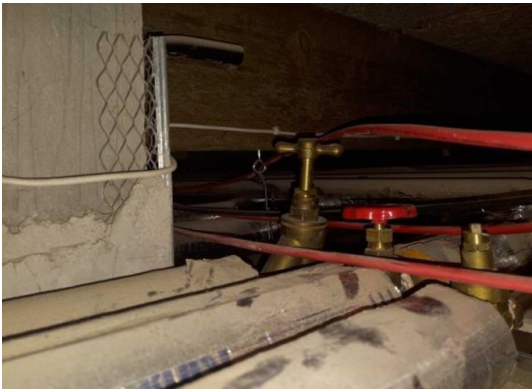
### **Item 2 Ref: 20-28462-3**

The gaskets (Area 1/Nursery Classroom) do not contain asbestos.

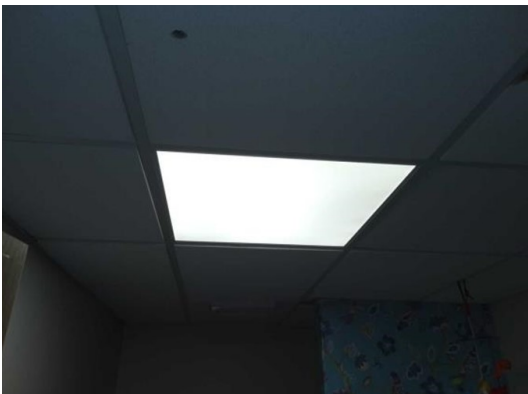
### **Item 3 Ref: 20-28462-2**

The ceiling (Area 7/Shower) does not contain asbestos.

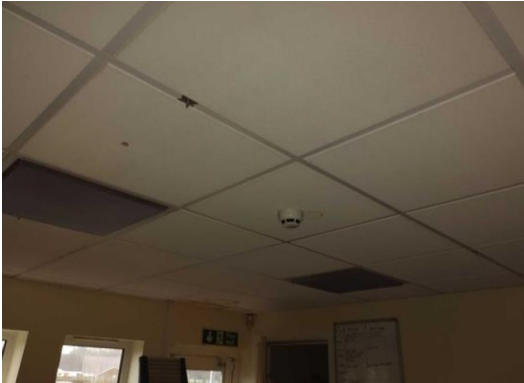
**Item 4 Ref: 20-28462-2**

The ceiling (Area 8/Kitchen and Cupboard) does not contain asbestos.

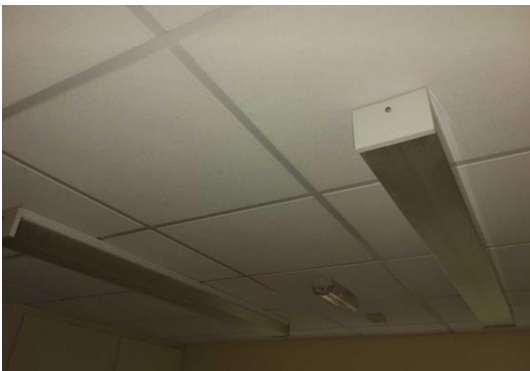
**Item 5 Ref: 20-28462-2**

The ceiling (Area 9/Toilet) does not contain asbestos.

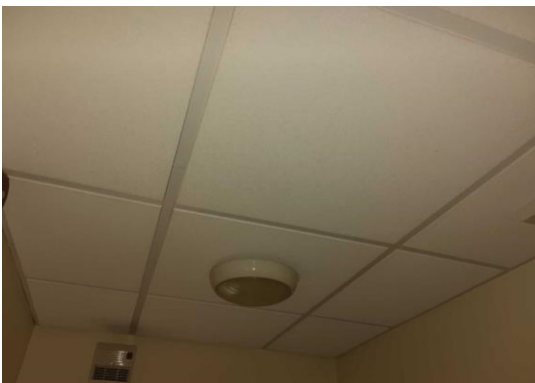
**Item 6 Ref: 20-28462-2**

The ceiling (Area 10/Staff Toilet) does not contain asbestos.

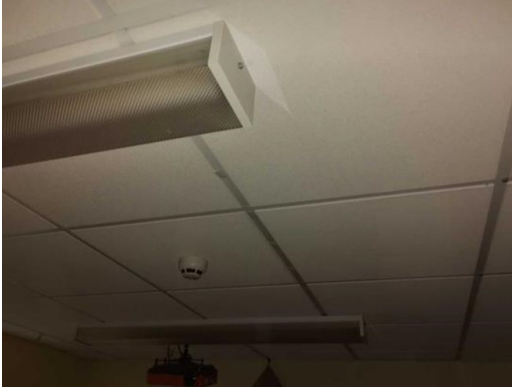
**Item 7 Ref: 20-28462-2**

The ceiling (Area 11/Quiet Room) does not contain asbestos.

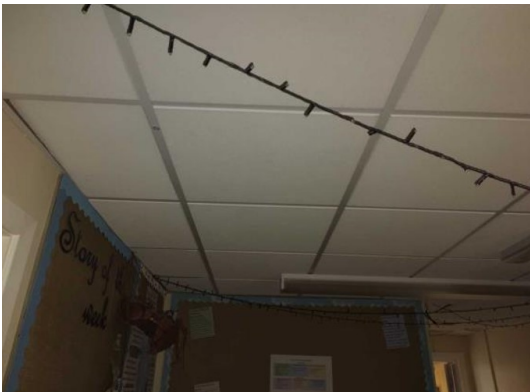
**Item 8 Ref: 20-28462-2**

The ceiling (Area 12/Corridor) does not contain asbestos.

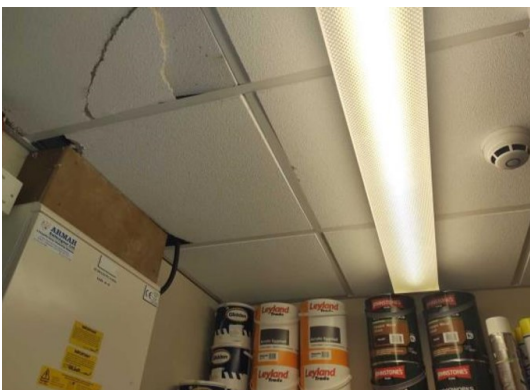
**Item 9 Ref: 20-28462-2**

The ceiling (Area 13/Store) does not contain asbestos.

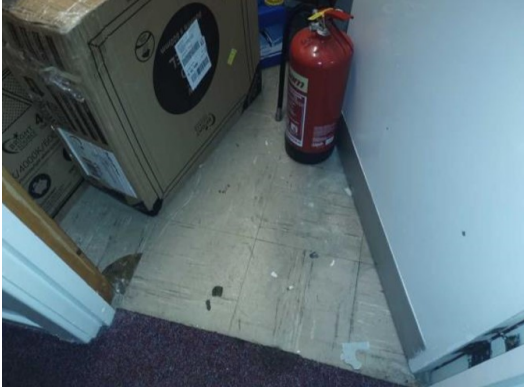
**Item 10 Ref: 20-28462-4**

The floor tiles and adhesive (Area 13/Store) does not contain asbestos.

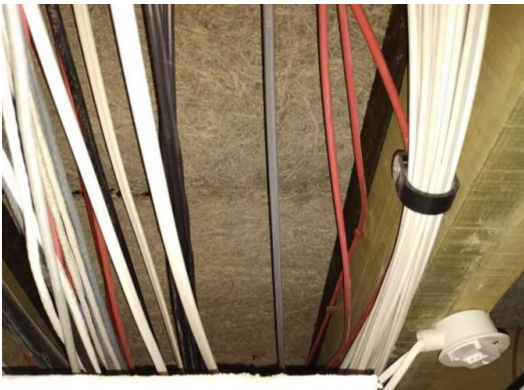
**Item 11 Ref: 20-28462-2**

The ceiling (Area 14/Corridor) does not contain asbestos.

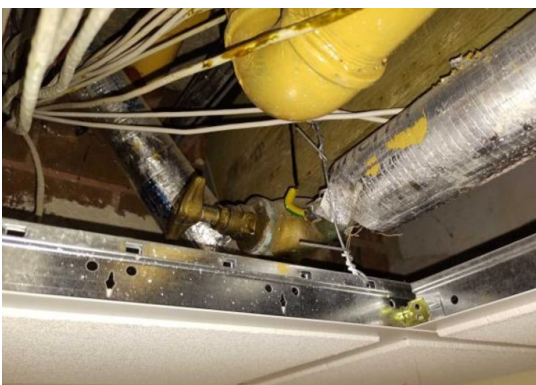
**Item 12 Ref: 20-28462-5**

The gasket (Area 14/Corridor ceiling void) does not contain asbestos.

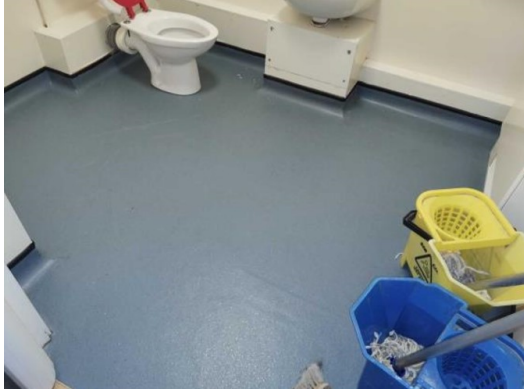
**Item 13 Ref: 20-28462-6**

The floor (Area 18/Disabled toilet) does not contain asbestos.

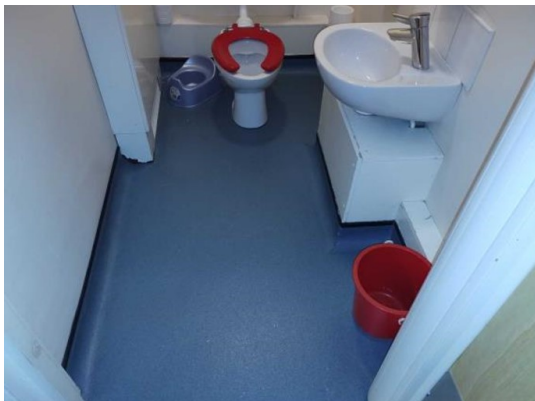
**Item 14 Ref: 20-28462-6**

The floor (Area 19/Toilet) does not contain asbestos.

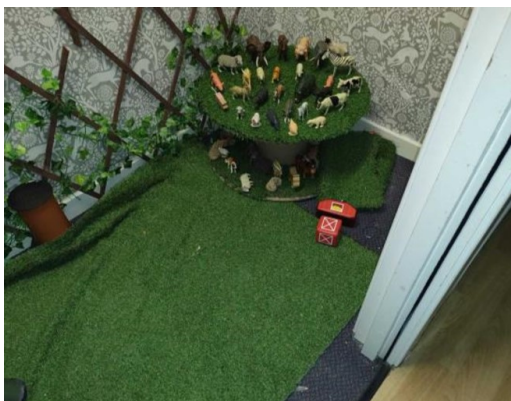
**Item 15 Ref: 20-28462-1**

- (Item 13) Ref: 20-28462-6 – Floor (Area 18/Disabled toilet) – No Risk
- (Item 14) Ref: 20-28462-6 – Floor (Area 19/Toilet) – No Risk
- (Item 15) Ref: 20-28462-1 – Floor (Area 1b/Cupboard) – Very Low Risk

The floor (Area 1b/Cupboard) contains asbestos.

Any change in its appearance should be recorded and passed to Property Services.

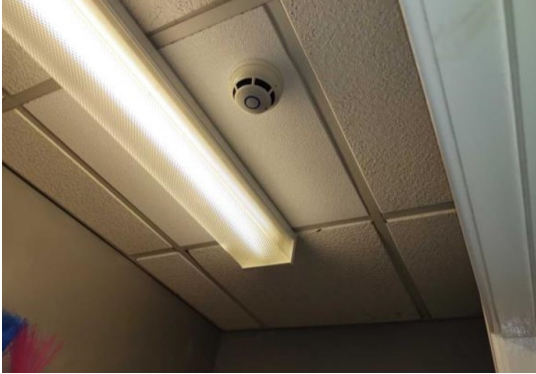
**Item 16 Ref: 20-28462-2**

The ceiling (Area 1b/Cupboard) does not contain asbestos.

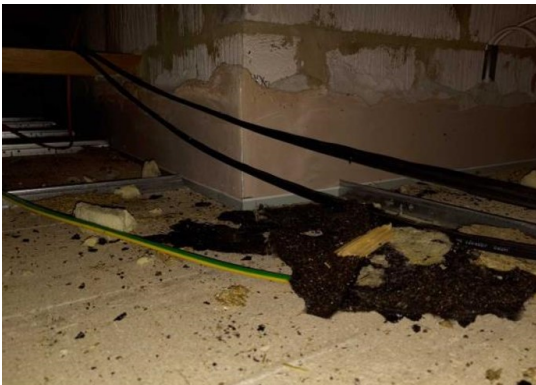
**Item 17 Ref: 20-28462-7**

The ceiling (Area 28/Corridor) does not contain asbestos.

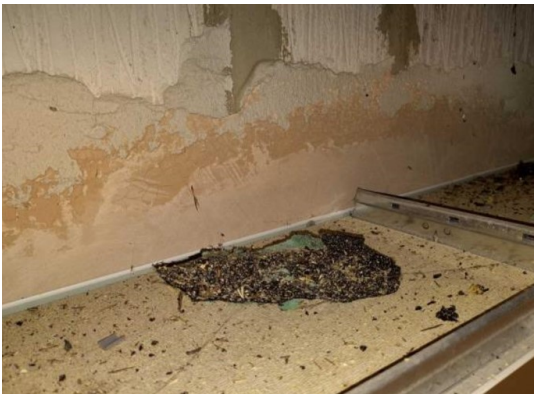
**Item 18 Ref: 20-28462-7**

The ceiling (Area 29/Toilet) does not contain asbestos.

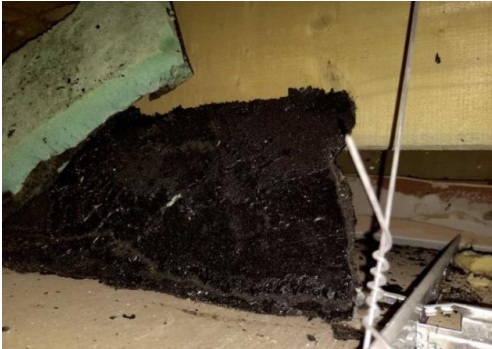
**Item 19 Ref: 20-28462-7**

The ceiling (Area 30/Toilet) does not contain asbestos.

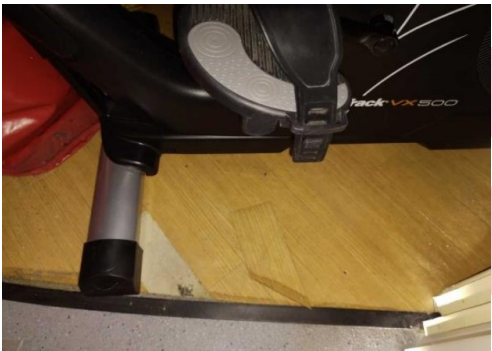
**Item 20 Ref: 20-28462-6**

The floor (Area 35/Cupboard) does not contain asbestos.

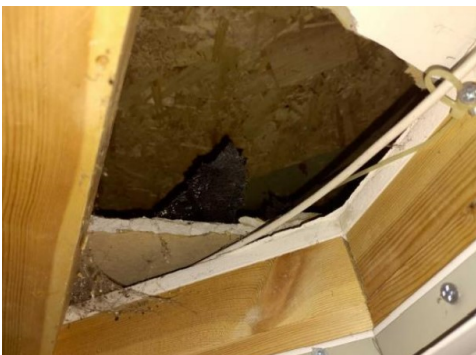
**Item 21 Ref: 20-28462-7**

The ceiling (Area 36/Corridor) does not contain asbestos.

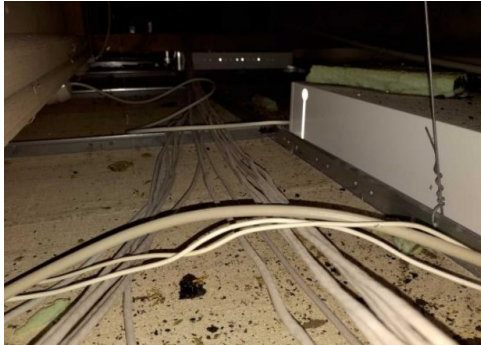
**Item 22 Ref: 20-28462-7**

The ceiling (Area 42/Classroom and cupboard) does not contain asbestos.

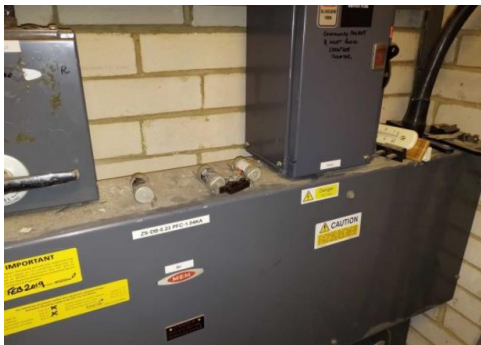
**Item 23 Ref: 20-28462-8**

The electrical equipment (Area 46/Electric meter cupboard) does not contain asbestos.

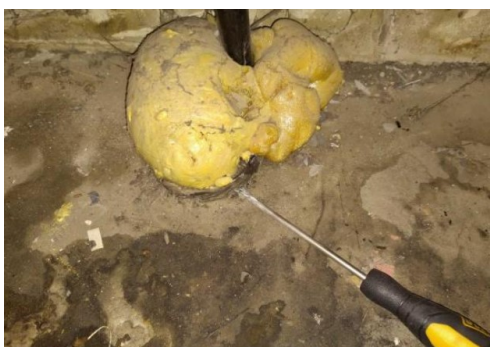
**Item 24 Ref: 20-28462-9**

The cable intrusion sleeve (Area 46/Electric meter cupboard) does not contain asbestos.

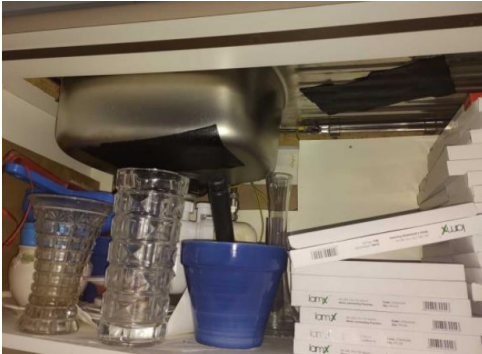
**Item 25 Ref: 20-28462-10**

The sink pad (Area 60/Reprographic Room) does not contain asbestos.

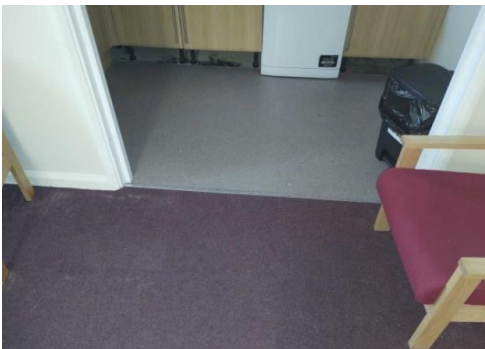
**Item 26 Ref: 20-28462-11**

The floor (Area 70/Staff room and kitchen) does not contain asbestos.

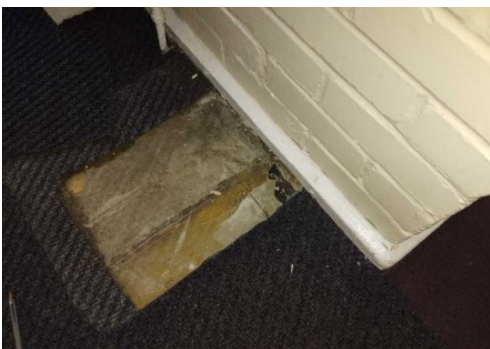
**Item 27 Ref: 20-28462-12**

The floor (Area 72/Corridor) does not contain asbestos.

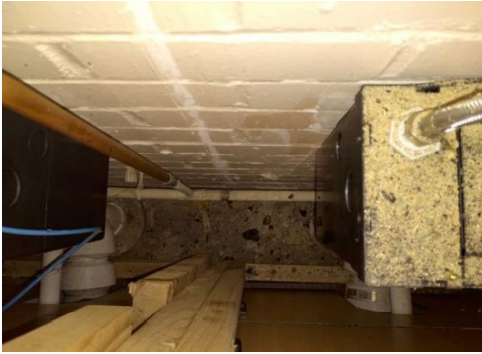
**Item 28 Ref: 20-28462-7**

The ceiling (Area 73/Toilet) does not contain asbestos.

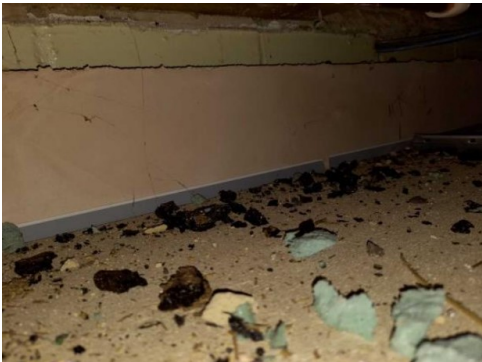
**Item 29 Ref: 20-28462-7**

The ceiling (Area 79/Toilet) does not contain asbestos.

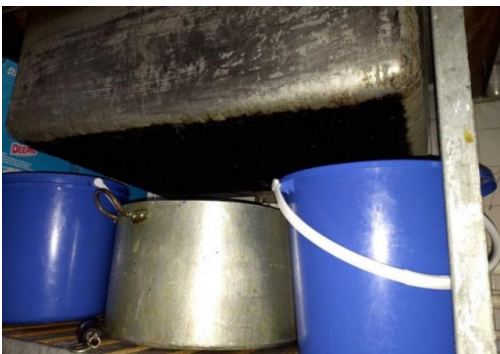
**Item 30 Ref: 20-28462-14**

The sink pad (Area 83/Kitchen) does not contain asbestos.

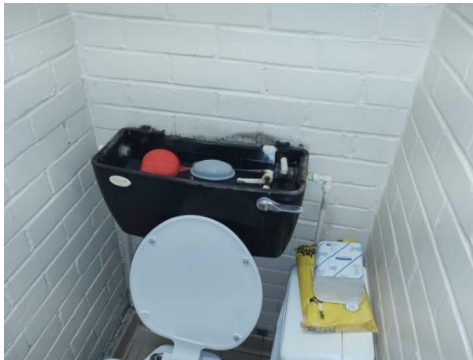
**Item 31 Ref: 20-28462-15**

- (Item 29) Ref: 20-28462-7 – Ceiling (Area 79/Toilet) – No Risk
- (Item 30) Ref: 20-28462-14 – Sink pad (Area 83/Kitchen) – No Risk
- (Item 31) Ref: 20-28462-15 – Toilet Cistern (Area 86/WC) – Low Risk

The toilet cistern (Area 86/WC) contains asbestos.

Any change in its appearance should be recorded and passed to Property Services.

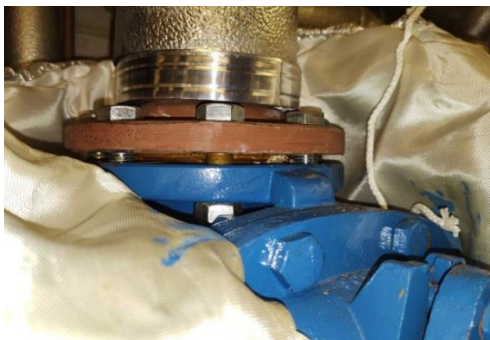
**Item 32 Ref: 20-28462-16**

The flanges throughout gaskets (Area 103/Boiler Room) do not contain asbestos.

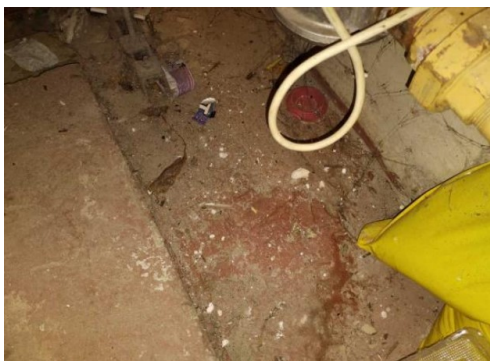
**Item 33 Ref: 20-28462-17**

The debris to floor (Area 103/Boiler Room) does not contain asbestos.

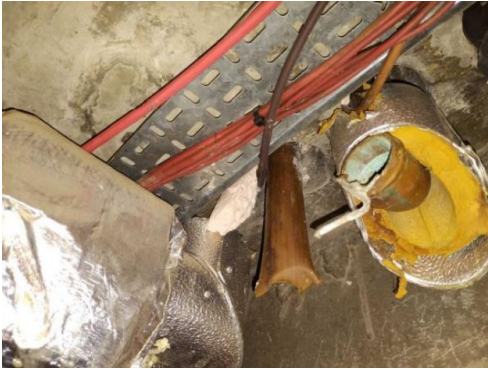
**Item 34 Ref: 20-28462-17**

The ceiling (Area 103/Boiler Room) does not contain asbestos.

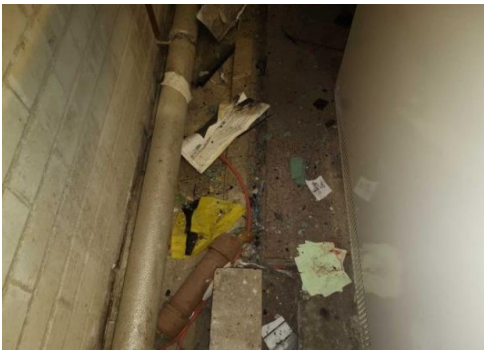
**Item 35 Ref: 20-28462-7**

The felt debris (Area 103/Boiler Room) does not contain asbestos.

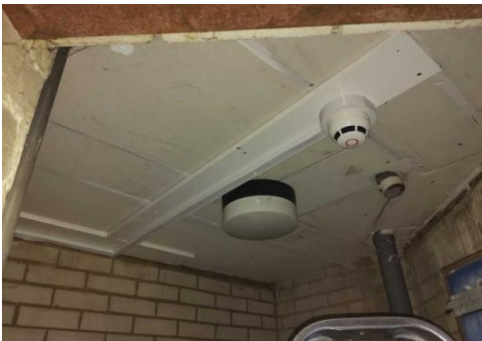
**Item 36 Ref: 20-28462-18**

The ceiling (Area 104/External Store) does not contain asbestos.

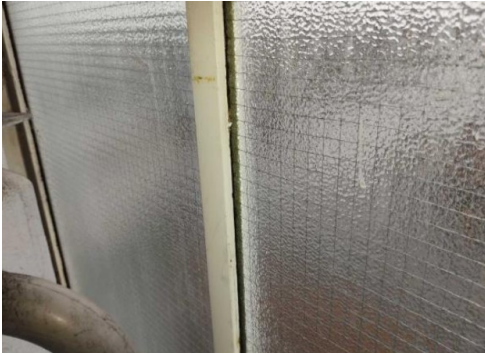
**Item 37 Ref: 20-28462-19**

- (Item 37) Ref: 20-28462-19 – Sealant to glass panes (Area 105/Tank Room) – Very Low Risk
- (Item 38) Ref: 20-28462-20 – Gaskets (Area 105/Tank Room) – No Risk

The sealant to glass panes (Area 105/Tank Room) contains asbestos.

Any change in its appearance should be recorded and passed to Property Services.

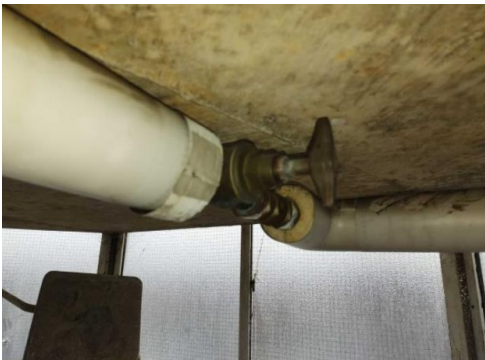
**Item 38 Ref: 20-28462-20**

The gaskets (Area 105/Tank Room) do not contain asbestos.

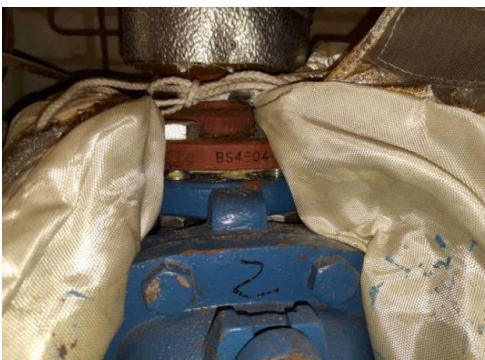
**Item 39 Ref: 20-28462-22**

The gaskets (Area 105/Tank Room) do not contain asbestos.

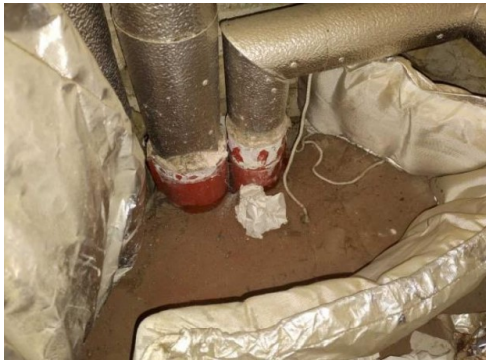
**Item 40 Ref: 20-28462-23**

The pipes (Area 106/Boiler Room) do not contain asbestos.

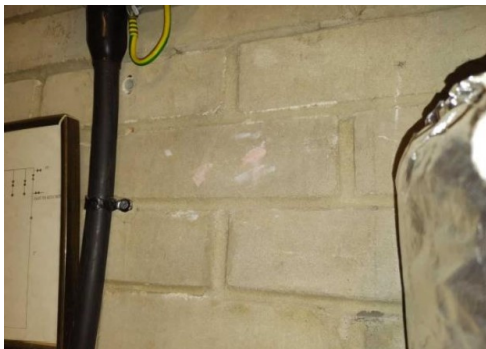
**Item 41 Ref: 20-28462-23**

The debris to walls (Area 106/Boiler Room) does not contain asbestos.

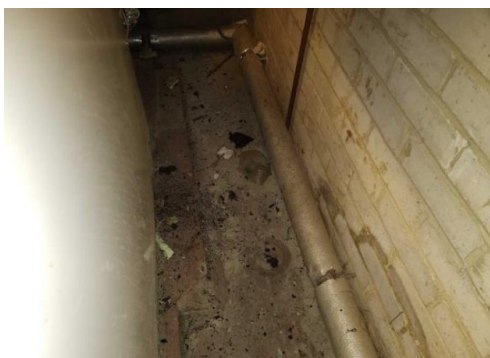
**Item 42 Ref: 20-28462-7**

The felt debris (Area 106/Boiler Room) does not contain asbestos.

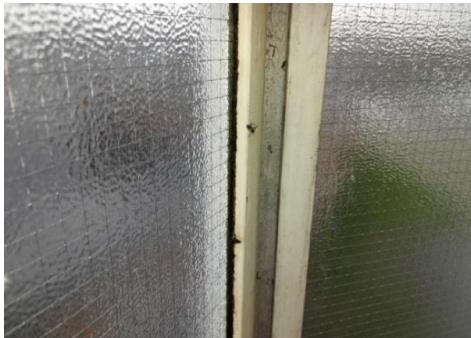
**Item 43 Ref: 20-28462-19**

- (Item 43) Ref: 20-28462-19 – Sealant to glass panes (Area 107/Tank Room) – **Very Low Risk**
- (Item 44) Ref: 20-28462-20 – Gaskets (Area 107/Tank Room) – No Risk

The sealant to glass panes (Area 107/Tank Room) contains asbestos.

Any change in its appearance should be recorded and passed to Property Services.

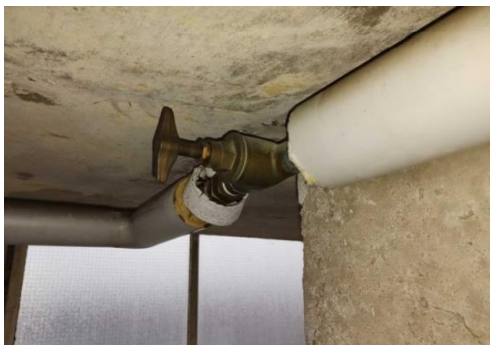
**Item 44 Ref: 20-28462-20**

The gaskets (Area 107/Tank Room) do not contain asbestos.

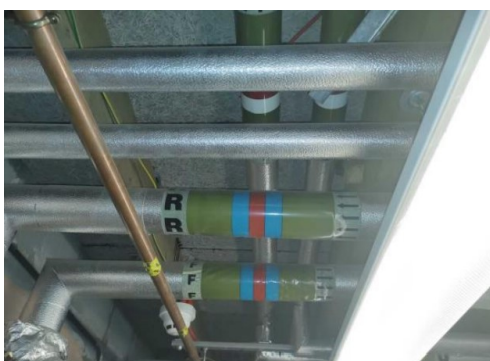
**Item 45 Ref: 20-28462-2**

The ceiling (Area 108/Boiler Room) does not contain asbestos.

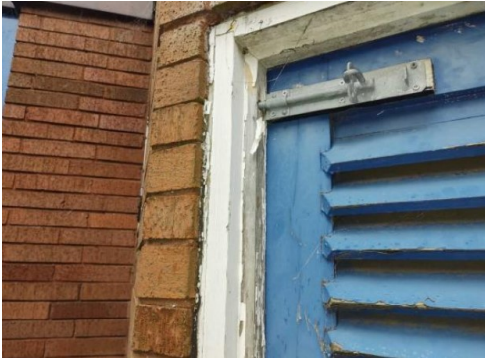
**Item 46 Ref: 20-28462-21**

- (Item 45) Ref: 20-28462-2 – Ceiling (Area 108/Boiler Room) – No Risk
- (Item 46) Ref: 20-28462-21 – Sealant to door frame (Store area 104) (Area 109/External) – **Very Low Risk**

The sealant to door frame (Store area 104) (Area 109/External) contains asbestos.

Any change in its appearance should be recorded and passed to Property Services.

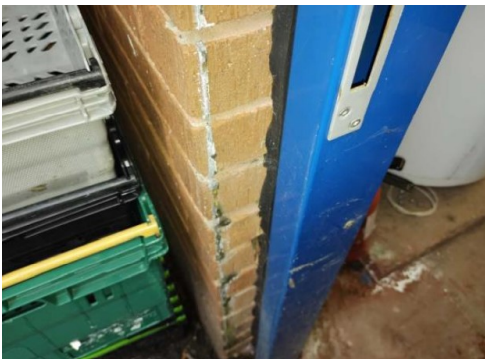
**Item 47 Ref: 20-28462-21**

The sealant to brickwork (Area 109/External) contains asbestos.

Any change in its appearance should be recorded and passed to Property Services.

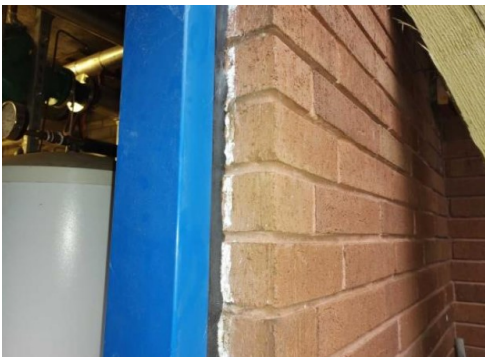
**Item 48 Ref: 20-28462-21**

The sealant to brickwork (Area 109/External) contains asbestos.

Any change in its appearance should be recorded and passed to Property Services.

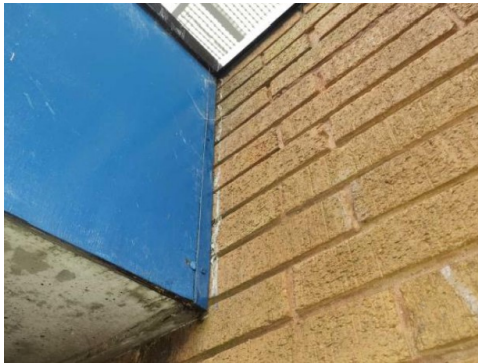
**Item 49 Ref: 20-28462-21**

The sealant to wooden cladding (Area 109/External) contains asbestos.

Any change in its appearance should be recorded and passed to Property Services.

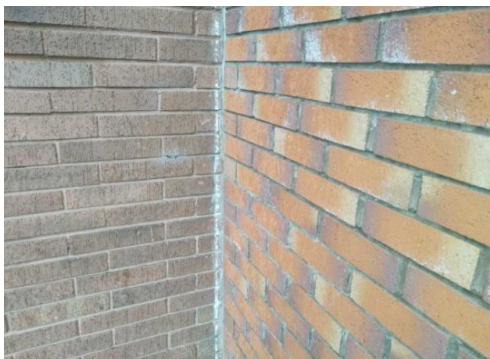
**Item 50 Ref: 20-28462-21**

The sealant to walls (CAMHS Entrance) (Area 109/External) contains asbestos.

Any change in its appearance should be recorded and passed to Property Services.

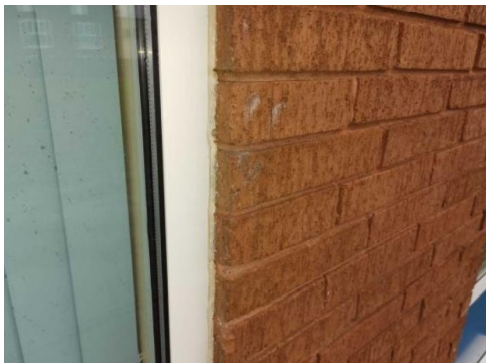
**Item 51 Ref: 20-28462-21**

The sealant to walls (Area 109/External) contains asbestos.

Any change in its appearance should be recorded and passed to Property Services.

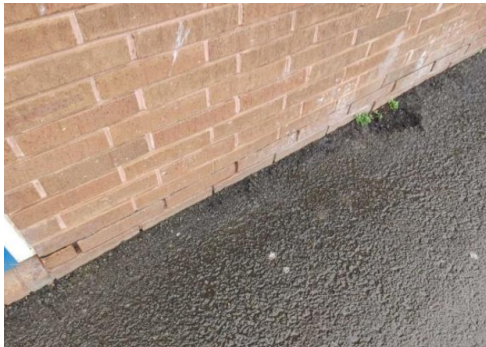
**Item 52 Ref: 20-28462-24**

The damp proof course (Area 109/External) does not contain asbestos.

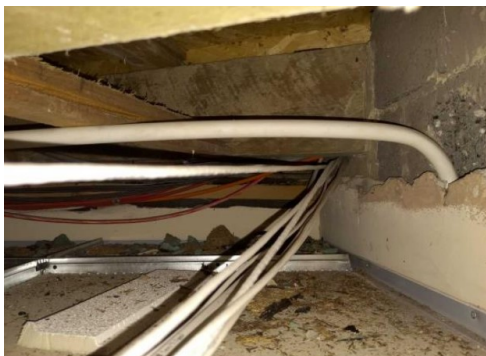
**Item 53 Ref: 20-28462-7**

The ceiling (Area 71a/Corridor) does not contain asbestos.

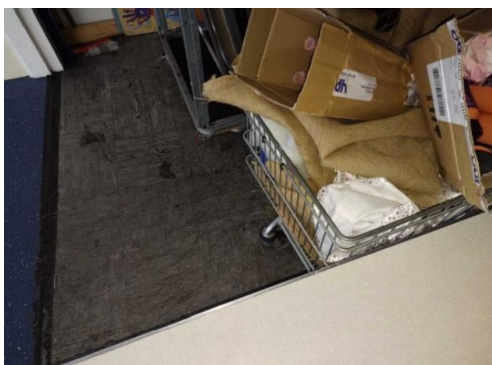
**Item 54 Ref: 20-28462-13**

The floor (Area 82a/Store Cupboards) contains asbestos.

Any change in its appearance should be recorded and passed to Property Services.

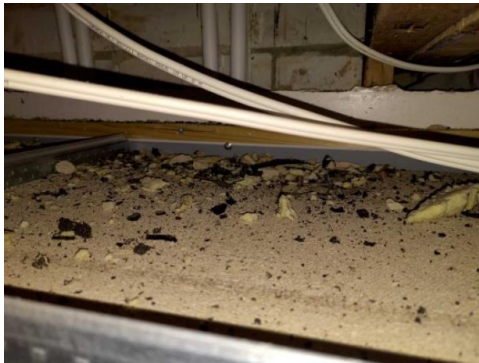
**Item 55 Ref: 20-28462-7**

The ceiling (Area 95a/Kitchen) does not contain asbestos.

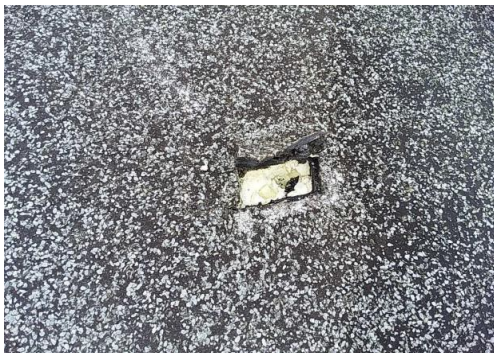
**Item 56 Ref: 22-47238-1**

The bitumen roof felt (Area 1/External) does not contain asbestos.

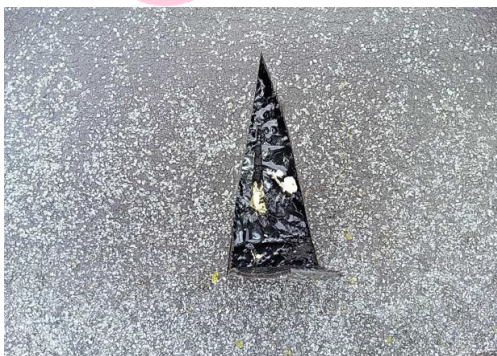
**Item 57 Ref: 22-47238-10**

The bitumen roof felt (Area 1/External) does not contain asbestos.

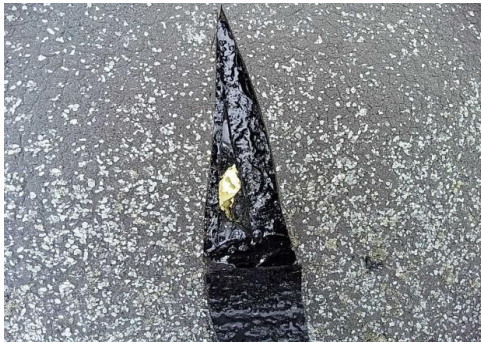
**Item 58 Ref: 22-47238-11**

The bitumen roof felt (Area 1/External) does not contain asbestos.

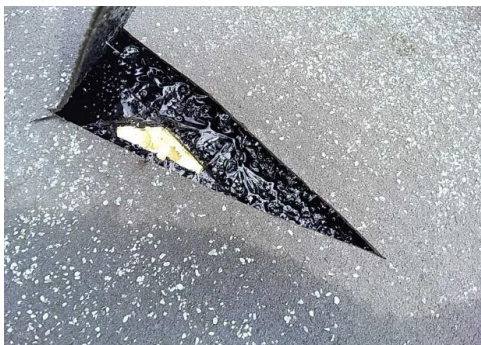
**Item 59 Ref: 22-47238-12**

The bitumen roof felt (Area 1/External) does not contain asbestos.

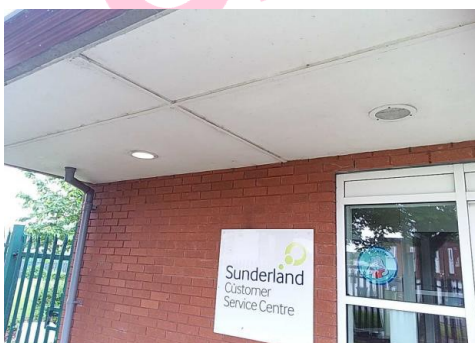
**Item 60 Ref: 22-47238-13**

The ceiling canopy above front entrance (Area 1/External) does not contain asbestos.

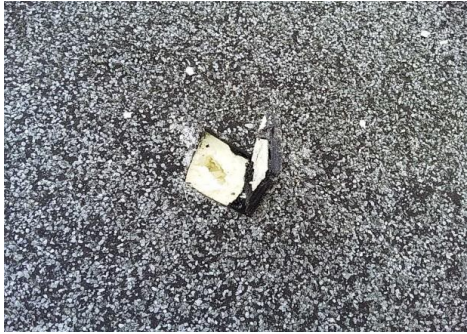
**Item 61 Ref: 22-47238-2**

The bitumen roof felt (Area 1/External) does not contain asbestos.

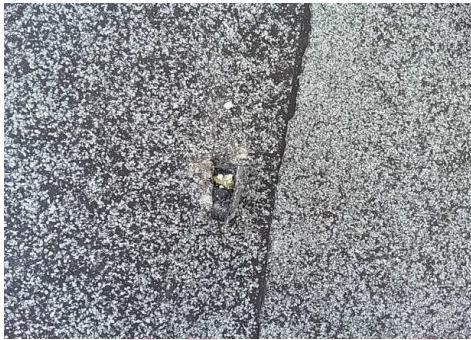
**Item 62 Ref: 22-47238-3**

The bitumen roof felt (Area 1/External) does not contain asbestos.

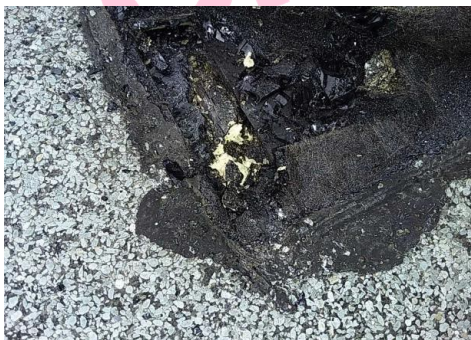
**Item 63 Ref: 22-47238-4**

The bitumen roof felt (Area 1/External) does not contain asbestos.

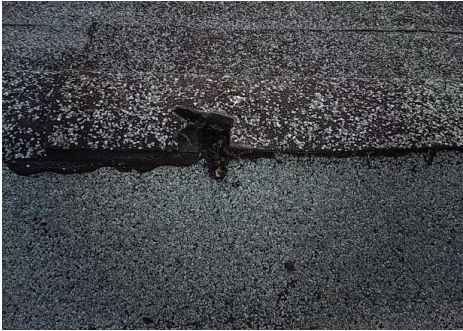
**Item 64 Ref: 22-47238-5**

The bitumen roof felt (Area 1/External) does not contain asbestos.

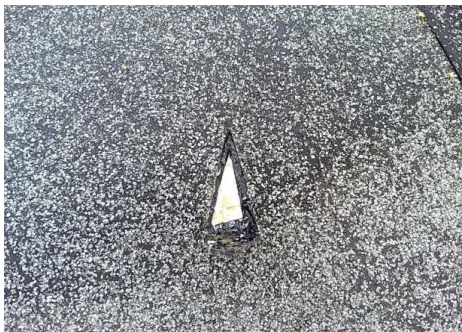
**Item 68 Ref: 22-47238-9**

The bitumen roof felt (Area 1/External) does not contain asbestos.

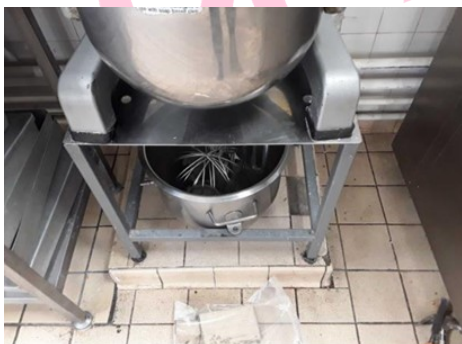
**Item 69 Ref: 22-53635-1**

The floor beneath the ceramic tiles to concrete floor plinth (Area 1: Kitchen) does not contain asbestos.

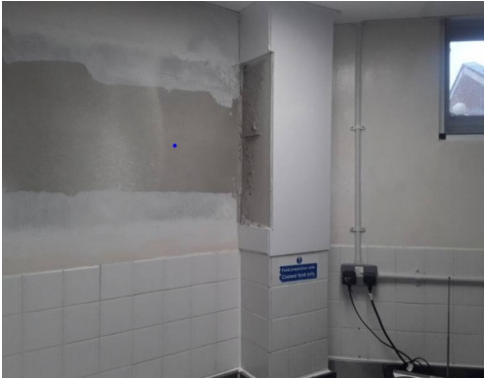
**Item 70 Ref: NZ001182**

The vertical boxing in the Kitchen (Room G/001) does not contain asbestos.

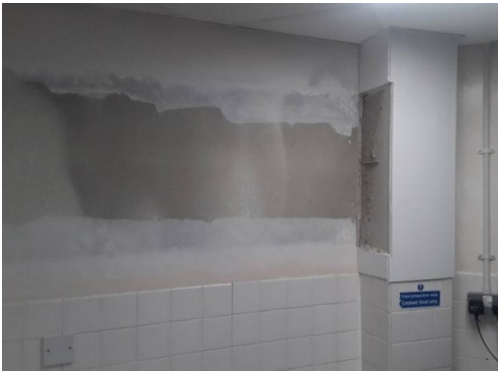
**Item 71 Ref: NZ001183**

The wall coating to the wall and boxing in the Kitchen (Room G/001) does not contain asbestos.
