### **ASBESTOS SURVEY REPORT FOR WESSINGTON PRIMARY SCHOOL LANERCOST, WASHINGTON, TYNE AND WEAR, NE38 7QA.**

## **Asbestos Register for**

**Wessington Primary School, Washington,  
NE38 7QA**

**Date: 01 August 2025**

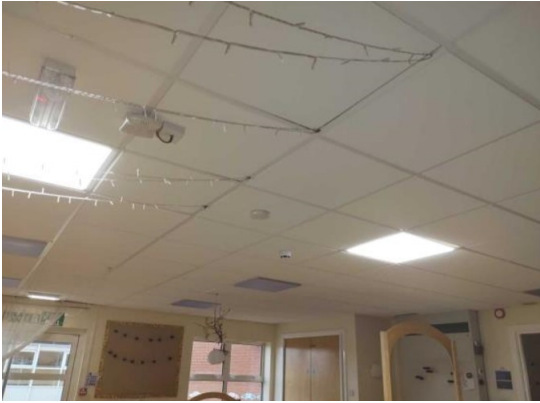
### **Item 1 Ref: 20-28462-2**

The ceiling (Area 1/Nursery Classroom) does not contain asbestos.

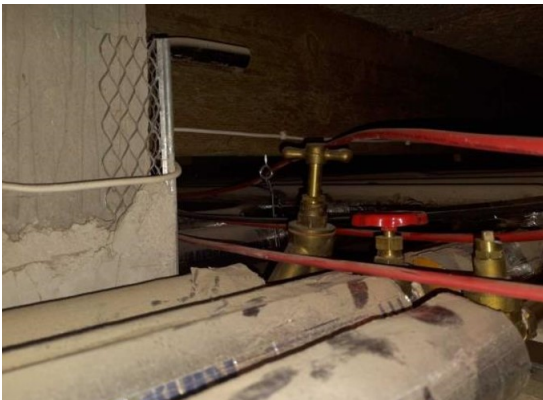
### **Item 2 Ref: 20-28462-3**

The gaskets (Area 1/Nursery Classroom) do not contain asbestos.

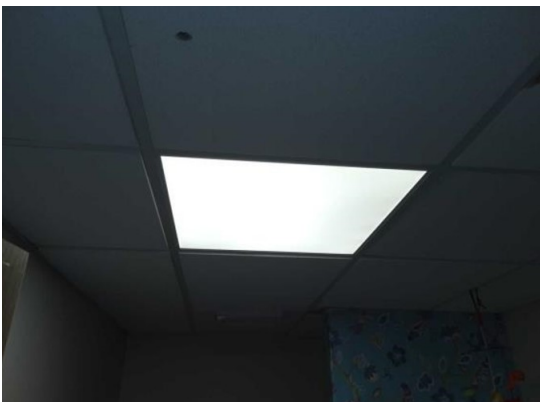
### **Item 3 Ref: 20-28462-2**

The ceiling (Area 7/Shower) does not contain asbestos.

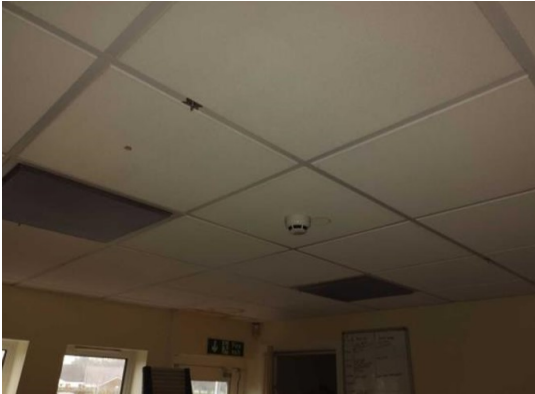
### **Item 4 Ref: 20-28462-2**

The ceiling (Area 8/Kitchen and Cupboard) does not contain asbestos.

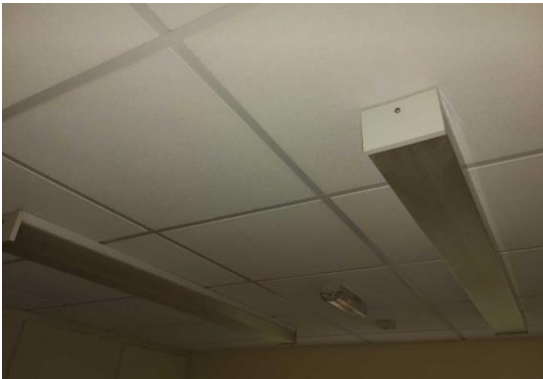
### **Item 5 Ref: 20-28462-2**

The ceiling (Area 9/Toilet) does not contain asbestos.

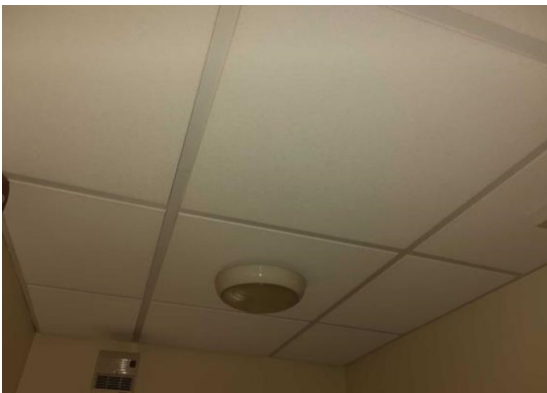
### **Item 6 Ref: 20-28462-2**

The ceiling (Area 10/Staff Toilet) does not contain asbestos.

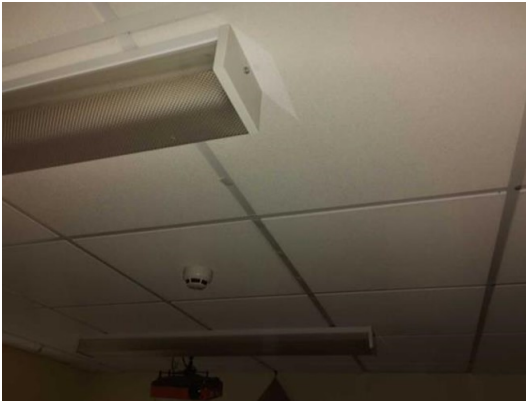
### **Item 7 Ref: 20-28462-2**

The ceiling (Area 11/Quiet Room) does not contain asbestos.

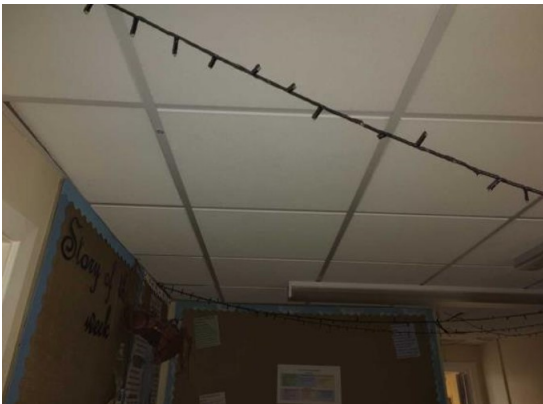
### **Item 8 Ref: 20-28462-2**

The ceiling (Area 12/Corridor) does not contain asbestos.

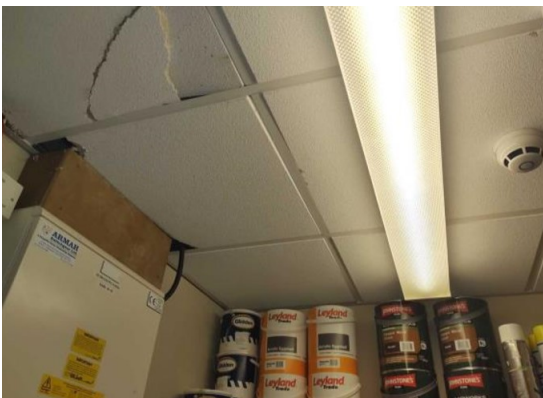
### **Item 9 Ref: 20-28462-2**

The ceiling (Area 13/Store) does not contain asbestos.

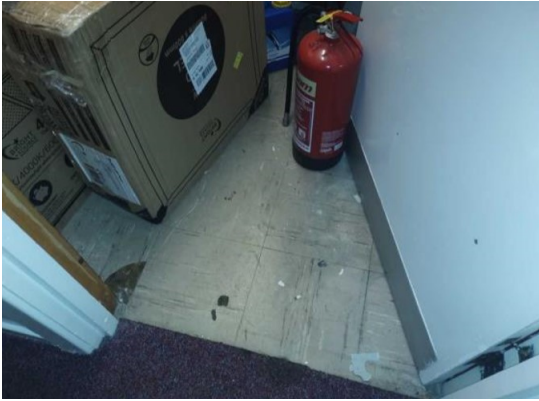
### **Item 10 Ref: 20-28462-4**

The floor tiles and adhesive (Area 13/Store) does not contain asbestos.

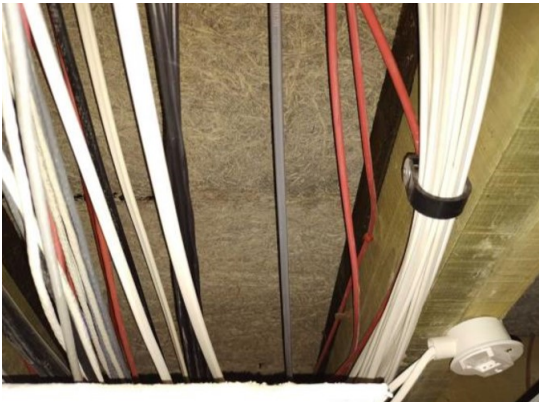
### **Item 11 Ref: 20-28462-2**

The ceiling (Area 14/Corridor) does not contain asbestos.

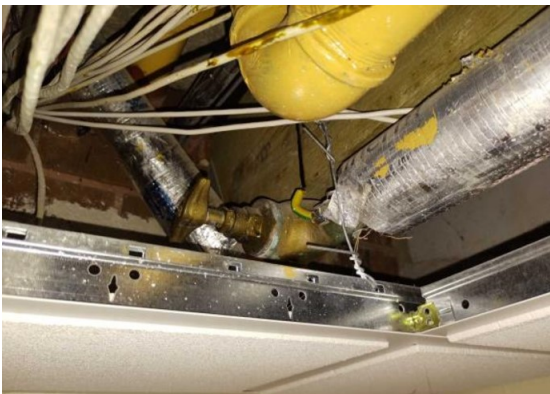
### **Item 12 Ref: 20-28462-5**

The gasket (Area 14/Corridor ceiling void) does not contain asbestos.

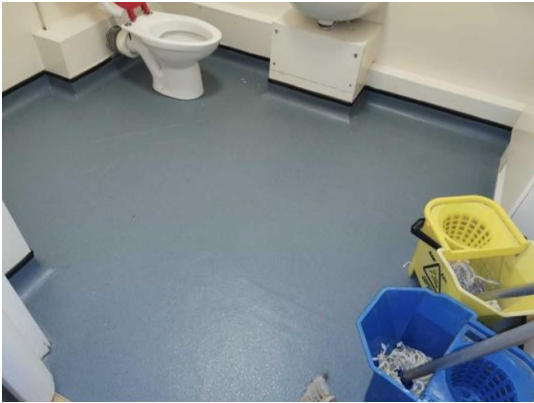
#### **Item 13 Ref: 20-28462-6**

The floor (Area 18/Disabled toilet) does not contain asbestos.

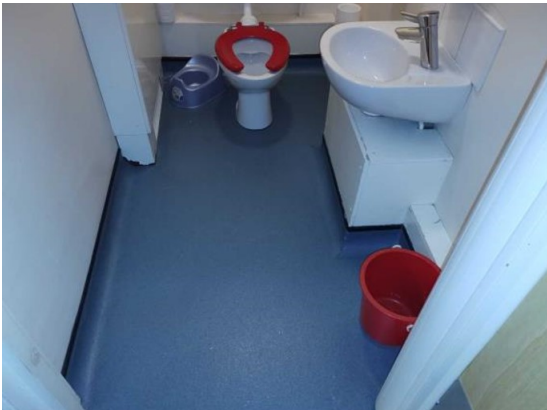
#### **Item 14 Ref: 20-28462-6**

The floor (Area 19/Toilet) does not contain asbestos.

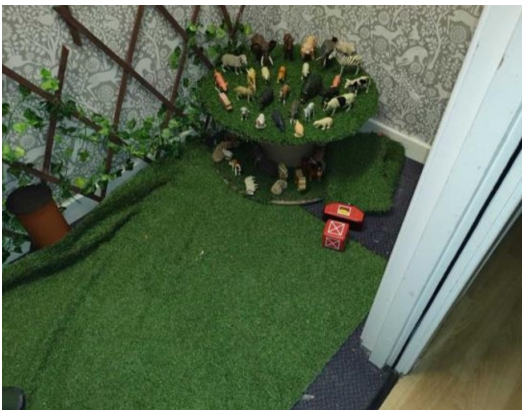
#### **Item 15 Ref: 20-28462-1**

- (Item 13) Ref: 20-28462-6 – Floor (Area 18/Disabled toilet) – No Risk
- (Item 14) Ref: 20-28462-6 – Floor (Area 19/Toilet) – No Risk
- (Item 15) Ref: 20-28462-1 – Floor (Area 1b/Cupboard) – Very Low Risk

The floor (Area 1b/Cupboard) contains asbestos.

Any change in its appearance should be recorded and passed to Property Services.

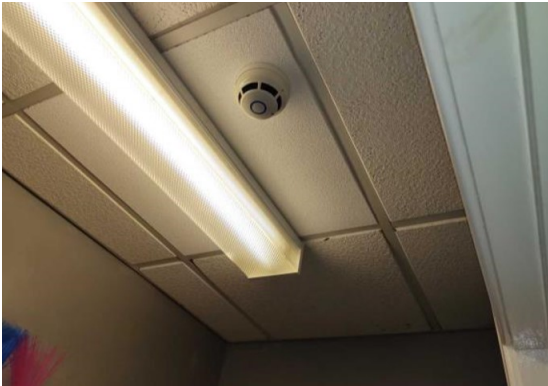
#### **Item 16 Ref: 20-28462-2**

The ceiling (Area 1b/Cupboard) does not contain asbestos.

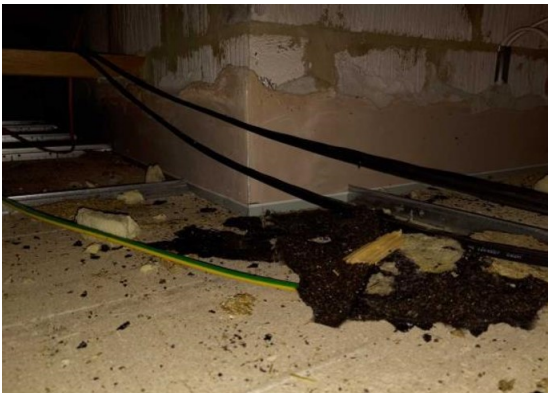
#### **Item 17 Ref: 20-28462-7**

The ceiling (Area 28/Corridor) does not contain asbestos.

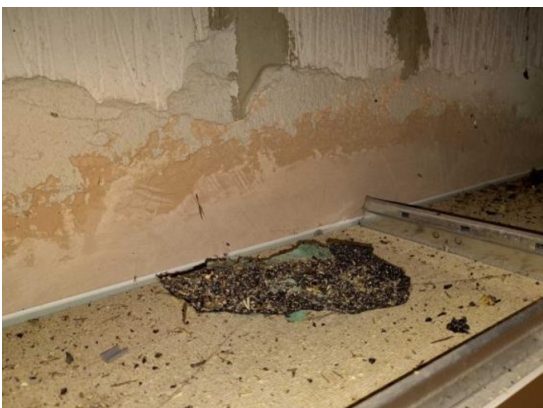
#### **Item 18 Ref: 20-28462-7**

The ceiling (Area 29/Toilet) does not contain asbestos.

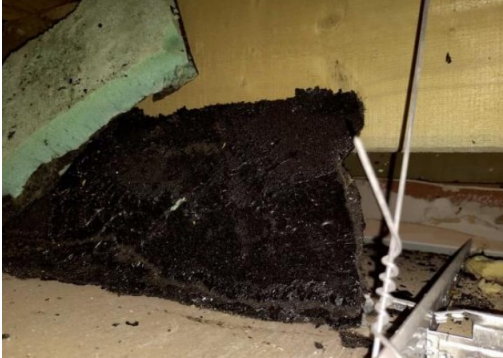
### **Item 19 Ref: 20-28462-7**

The ceiling (Area 30/Toilet)  
does not contain asbestos.

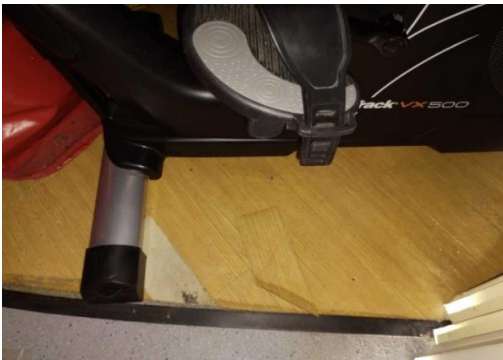
### **Item 20 Ref: 20-28462-6**

The floor (Area 35/Cupboard)  
does not contain asbestos.

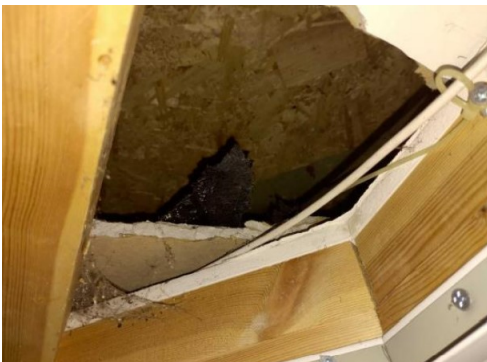
### **Item 21 Ref: 20-28462-7**

The ceiling (Area 36/Corridor)  
does not contain asbestos.

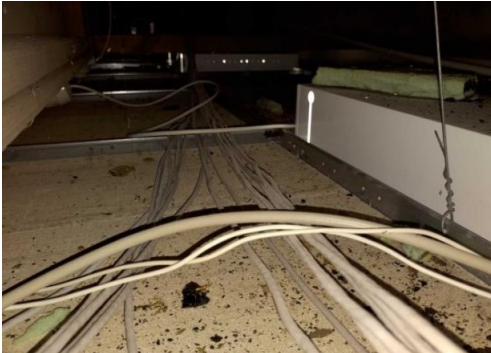
### **Item 22 Ref: 20-28462-7**

The ceiling (Area 42/Classroom and cupboard) does not contain asbestos.

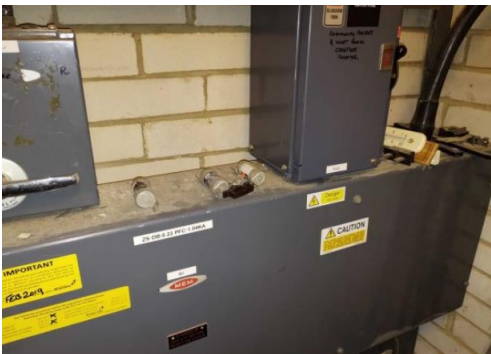
### **Item 23 Ref: 20-28462-8**

The electrical equipment (Area 46/Electric meter cupboard) does not contain asbestos.

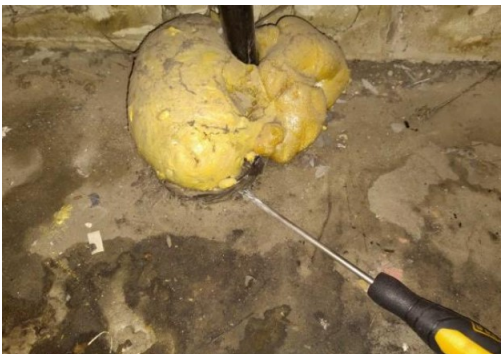
### **Item 24 Ref: 20-28462-9**

The cable intrusion sleeve (Area 46/Electric meter cupboard) does not contain asbestos.

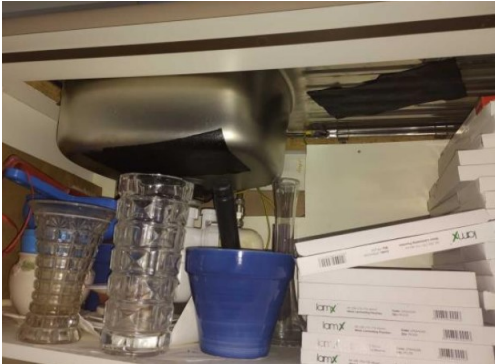
### **Item 25 Ref: 20-28462-10**

The sink pad (Area 60/Reprographic Room) does not contain asbestos.

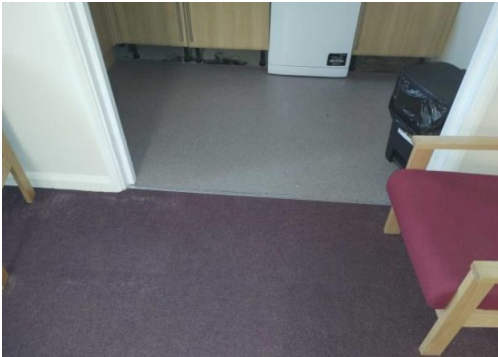
### **Item 26 Ref: 20-28462-11**

The floor (Area 70/Staff room and kitchen) does not contain asbestos.

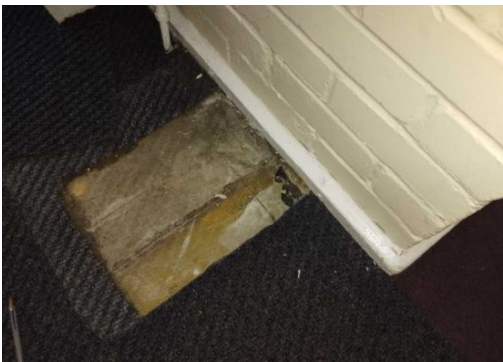
### **Item 27 Ref: 20-28462-12**

The floor (Area 72/Corridor) does not contain asbestos.

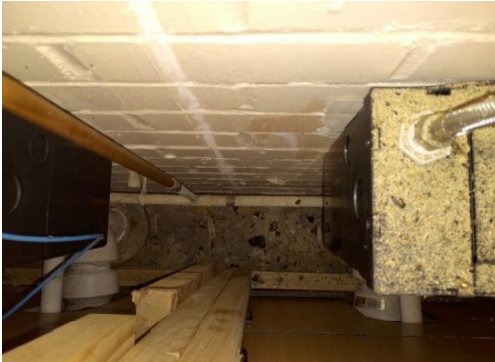
#### **Item 28 Ref: 20-28462-7**

The ceiling (Area 73/Toilet) does not contain asbestos.

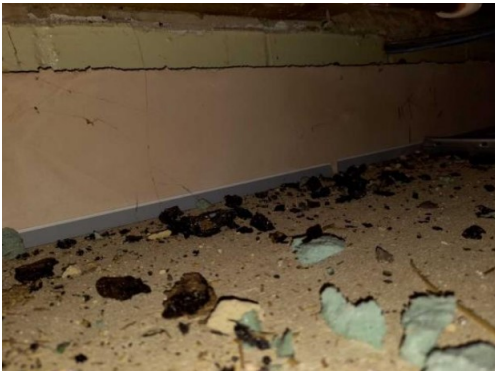
#### **Item 29 Ref: 20-28462-7**

The ceiling (Area 79/Toilet) does not contain asbestos.

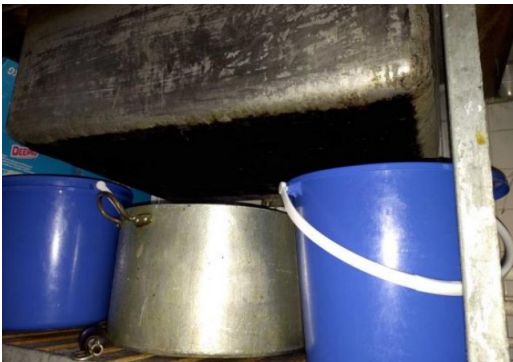
#### **Item 30 Ref: 20-28462-14**

The sink pad (Area 83/Kitchen) does not contain asbestos.

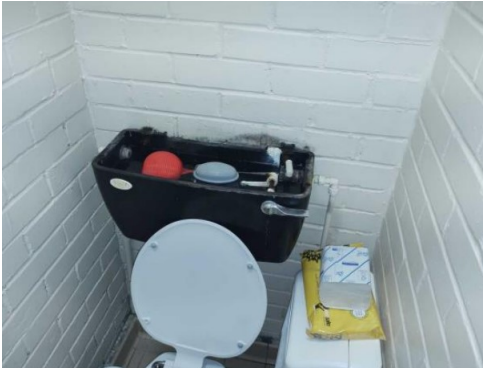
#### **Item 31 Ref: 20-28462-15**

- (Item 29) Ref: 20-28462-7 – Ceiling (Area 79/Toilet) – No Risk
- (Item 30) Ref: 20-28462-14 – Sink pad (Area 83/Kitchen) – No Risk
- (Item 31) Ref: 20-28462-15 – Toilet Cistern (Area 86/WC) – Low Risk

The toilet cistern (Area 86/WC) contains asbestos.

Any change in its appearance should be recorded and passed to Property Services.

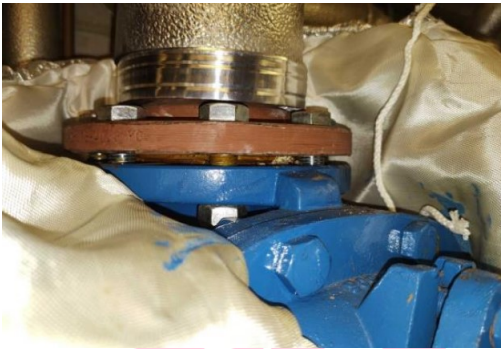
#### **Item 32 Ref: 20-28462-16**

The flanges throughout gaskets (Area 103/Boiler Room) do not contain asbestos.

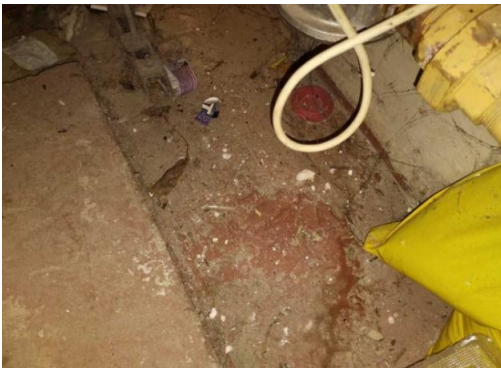
#### **Item 33 Ref: 20-28462-17**

The debris to floor (Area 103/Boiler Room) does not contain asbestos.

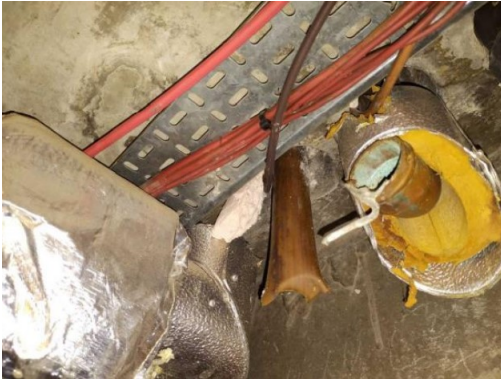
### **Item 34 Ref: 20-28462-17**

The ceiling (Area 103/Boiler Room) does not contain asbestos.

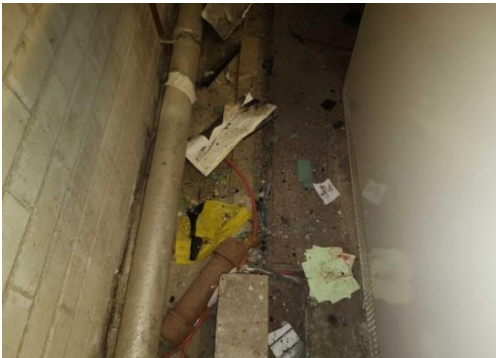
### **Item 35 Ref: 20-28462-7**

The felt debris (Area 103/Boiler Room) does not contain asbestos.

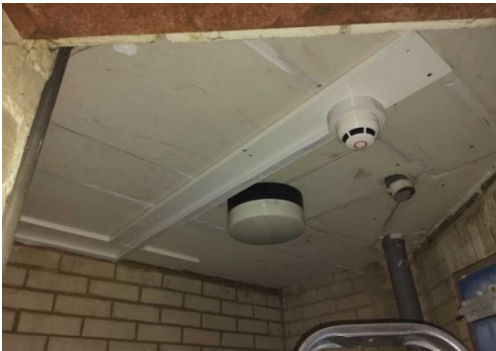
### **Item 36 Ref: 20-28462-18**

The ceiling (Area 104/External Store) does not contain asbestos.

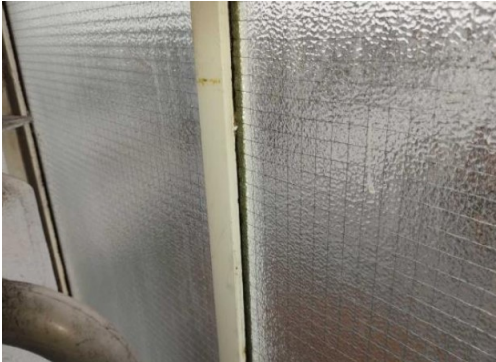
#### **Item 37 Ref: 20-28462-19**

- (Item 37) Ref: 20-28462-19 – Sealant to glass panes (Area 105/Tank Room) – Very Low Risk
- (Item 38) Ref: 20-28462-20 – Gaskets (Area 105/Tank Room) – No Risk

The sealant to glass panes (Area 105/Tank Room) contains asbestos.

Any change in its appearance should be recorded and passed to Property Services.

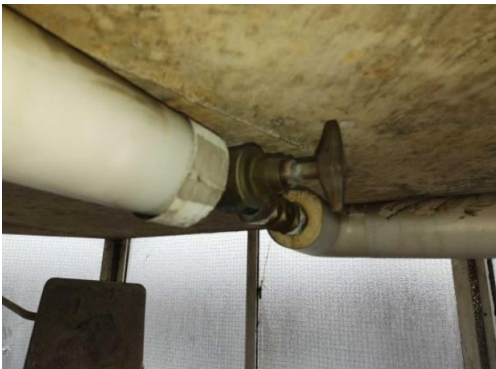
#### **Item 38 Ref: 20-28462-20**

The gaskets (Area 105/Tank Room) do not contain asbestos.

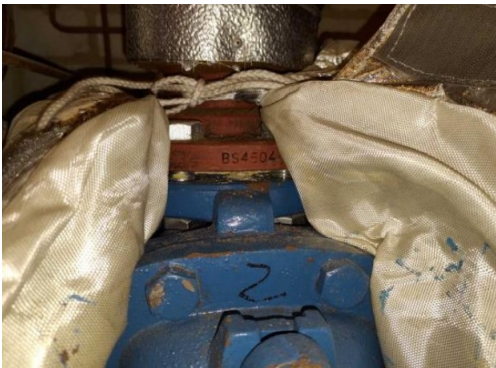
#### **Item 39 Ref: 20-28462-22**

The gaskets (Area 105/Tank Room) do not contain asbestos.

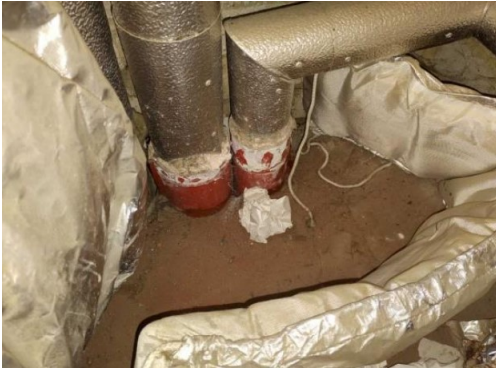
#### **Item 40 Ref: 20-28462-23**

The pipes (Area 106/Boiler Room) do not contain asbestos.

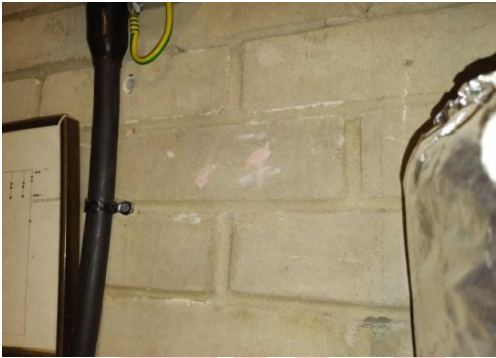
#### **Item 41 Ref: 20-28462-23**

The debris to walls (Area 106/Boiler Room) does not contain asbestos.

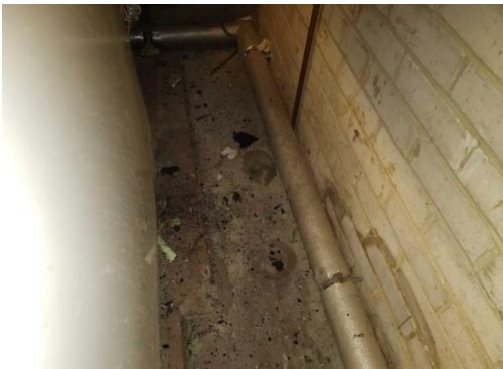
#### **Item 42 Ref: 20-28462-7**

The felt debris (Area 106/Boiler Room) does not contain asbestos.

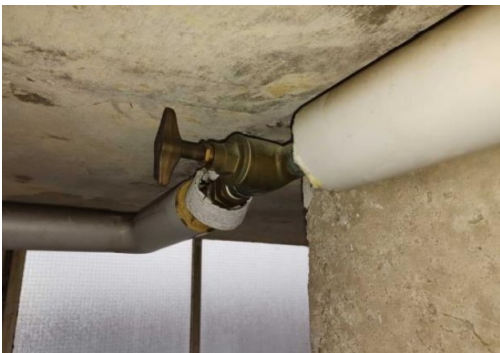
#### **Item 44 Ref: 20-28462-20**

The gaskets (Area 107/Tank Room) do not contain asbestos.

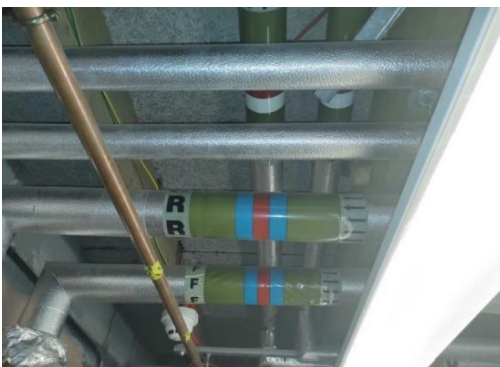
#### **Item 45 Ref: 20-28462-2**

The ceiling (Area 108/Boiler Room) does not contain asbestos.

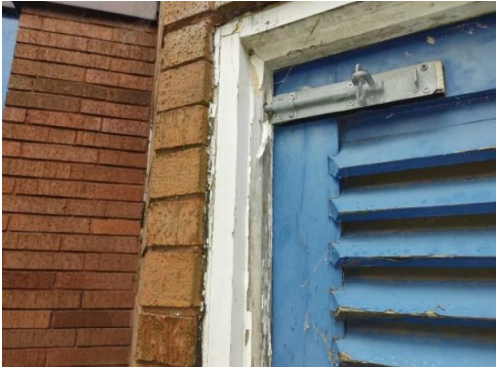
### **Item 46 Ref: 20-28462-21**

The sealant to door frame (Store area 104) (Area 109/External) contains asbestos.

Any change in its appearance should be recorded and passed to Property Services.

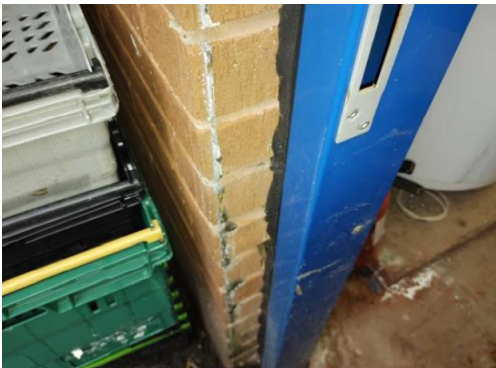
### **Item 47 Ref: 20-28462-21**

The sealant to brickwork (Area 109/External) contains asbestos.

Any change in its appearance should be recorded and passed to Property Services.

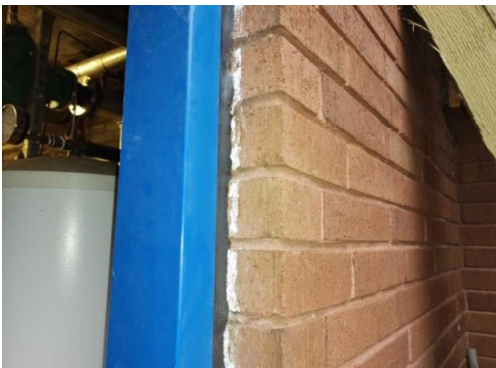
### **Item 48 Ref: 20-28462-21**

The sealant to brickwork (Area 109/External) contains asbestos.

Any change in its appearance should be recorded and passed to Property Services.

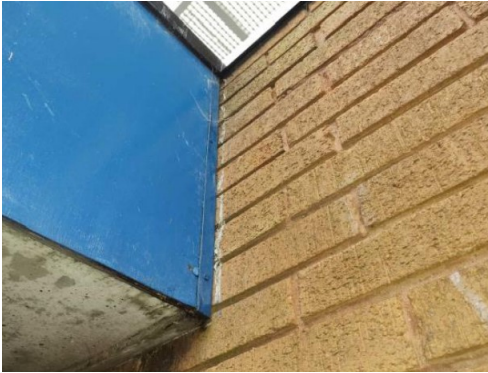
### **Item 49 Ref: 20-28462-21**

The sealant to wooden cladding (Area 109/External) contains asbestos.

Any change in its appearance should be recorded and passed to Property Services.

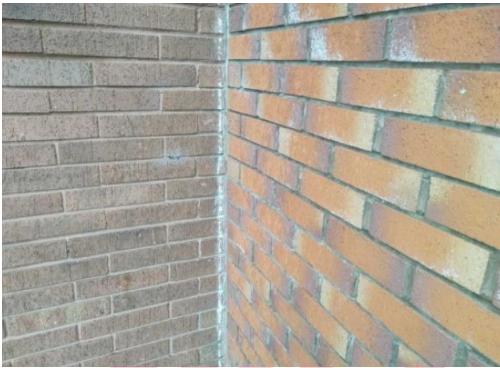
### **Item 50 Ref: 20-28462-21**

The sealant to walls (CAMHS Entrance) (Area 109/External) contains asbestos.

Any change in its appearance should be recorded and passed to Property Services.

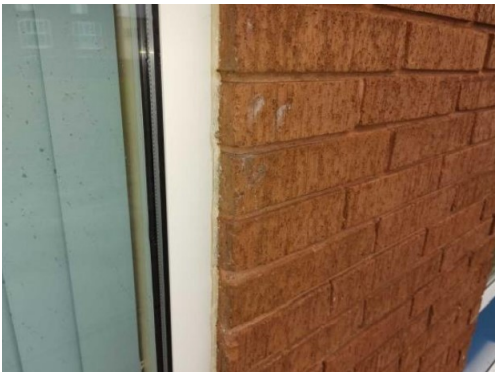
### **Item 51 Ref: 20-28462-21**

The sealant to walls (Area 109/External) contains asbestos.

Any change in its appearance should be recorded and passed to Property Services.

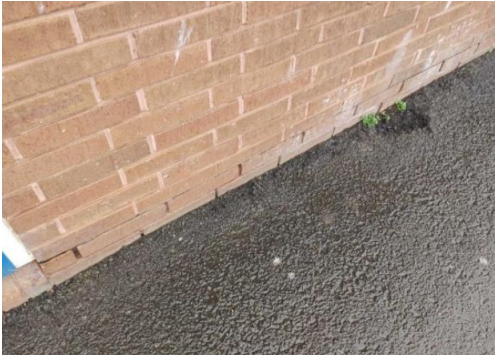
### **Item 52 Ref: 20-28462-24**

The damp proof course (Area 109/External) does not contain asbestos.

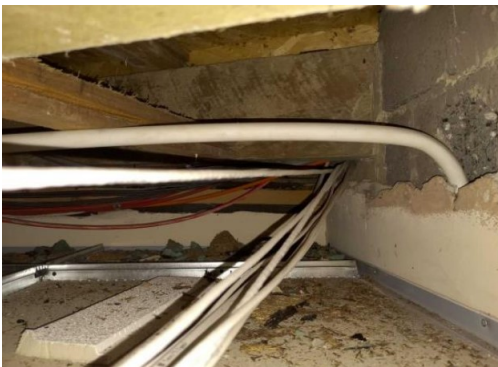
### **Item 53 Ref: 20-28462-7**

The ceiling (Area 71a/Corridor) does not contain asbestos.

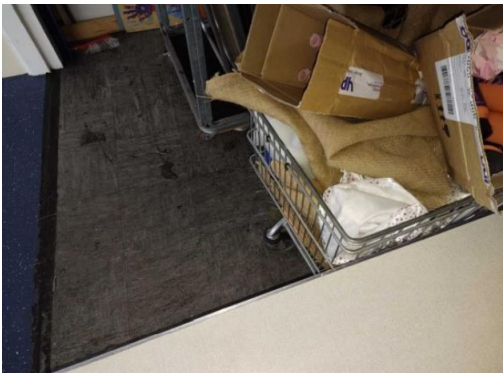
### **Item 54 Ref: 20-28462-13**

The floor (Area 82a/Store Cupboards) contains asbestos.

Any change in its appearance should be recorded and passed to Property Services.

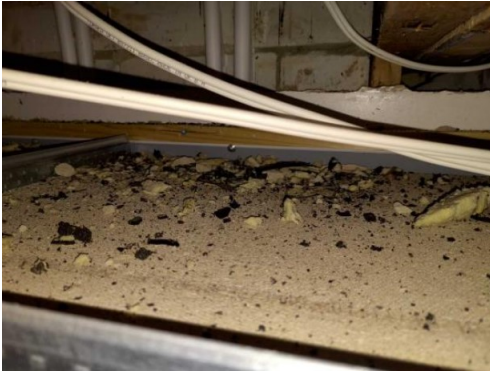
#### **Item 55 Ref: 20-28462-7**

The ceiling (Area 95a/Kitchen) does not contain asbestos.

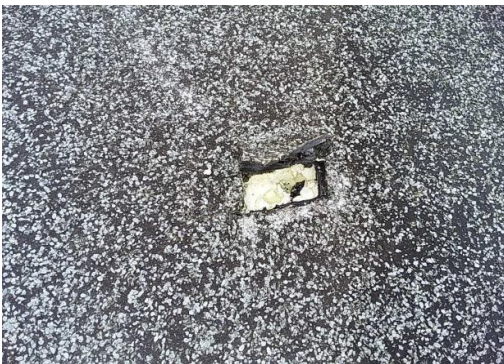
#### **Item 56 Ref: 22-47238-1**

The bitumen roof felt (Area 1/External) does not contain asbestos.

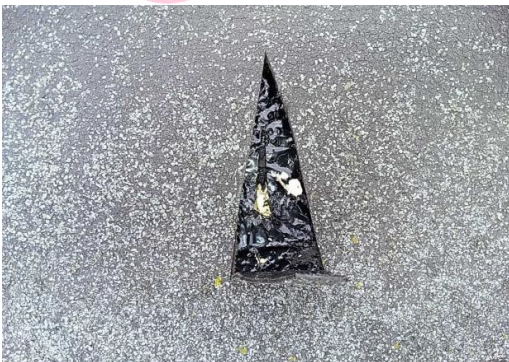
#### **Item 57 Ref: 22-47238-10**

The bitumen roof felt (Area 1/External) does not contain asbestos.

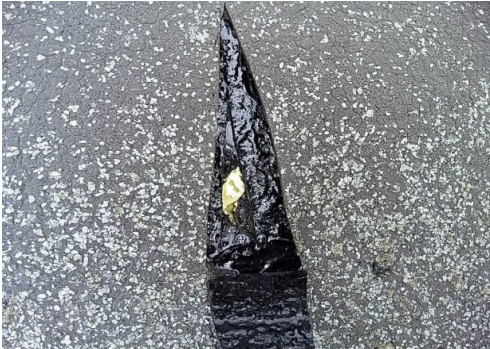
#### **Item 58 Ref: 22-47238-11**

The bitumen roof felt (Area 1/External) does not contain asbestos.

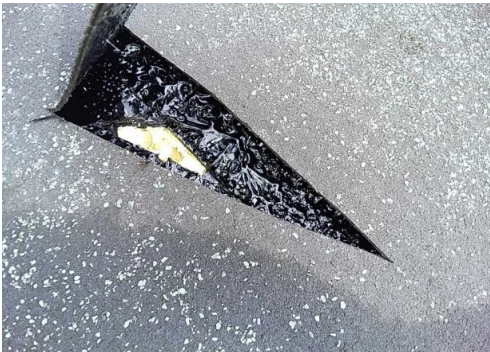
#### **Item 59 Ref: 22-47238-12**

The bitumen roof felt (Area 1/External) does not contain asbestos.

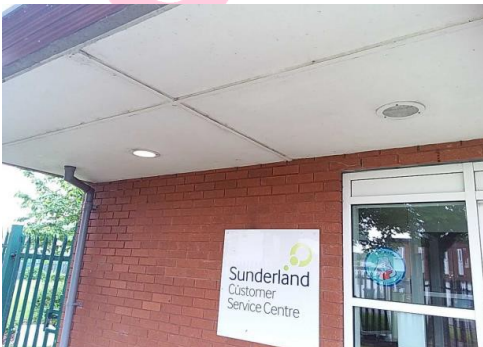
#### **Item 60 Ref: 22-47238-13**

The ceiling canopy above front entrance (Area 1/External) does not contain asbestos.

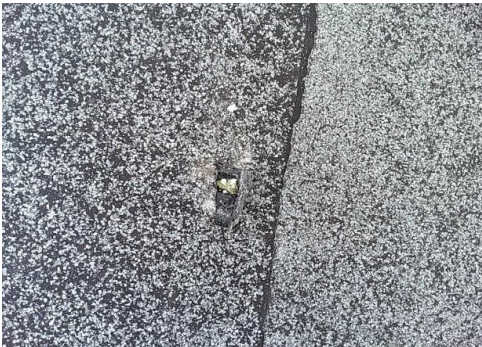
#### **Item 62 Ref: 22-47238-3**

The bitumen roof felt (Area 1/External) does not contain asbestos.

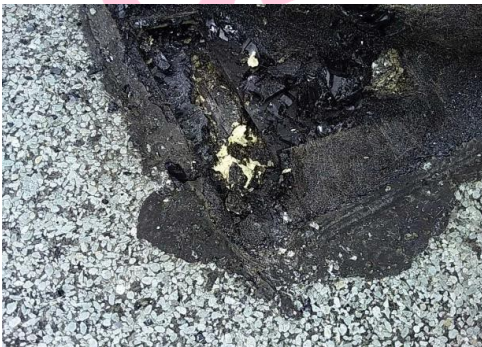
#### **Item 63 Ref: 22-47238-4**

The bitumen roof felt (Area 1/External) does not contain asbestos.

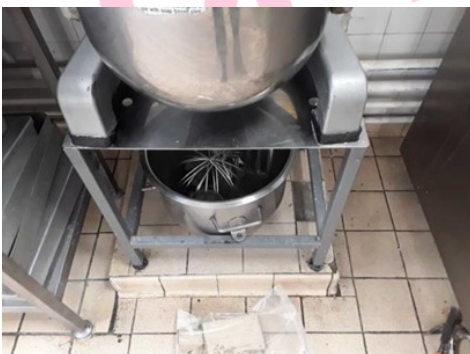
#### **Item 69 Ref: 22-53635-1**

The floor beneath the ceramic tiles to concrete floor plinth (Area 1: Kitchen) does not contain asbestos.

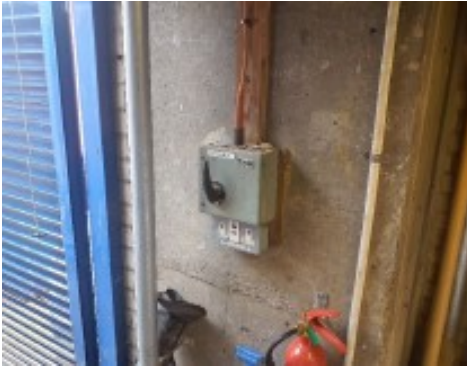
### **Item 70 Ref: Presumed**

The Textiles within ottermill fuse box (Keystage 1 Plant Room G/01) are presumed to contain asbestos.

Any change in appearance should be reported to Property Services.

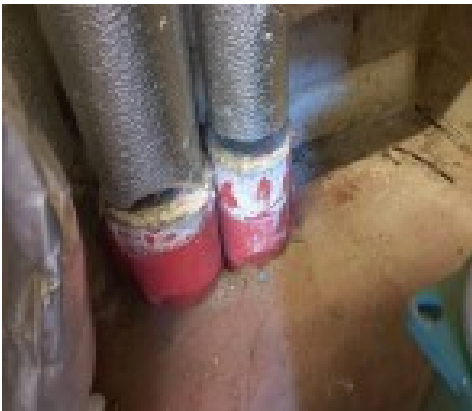
### **Item 71 Ref: RC000278**

The lagging pipework (Keystage 1 Plant Room G/01) does not contain asbestos.

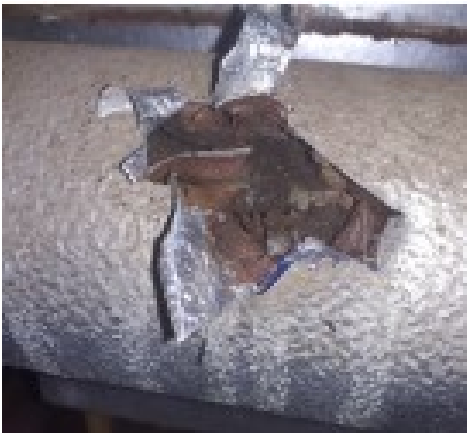
### **Item 72 Ref: RC000279**

The Paper lining – plant pipework behind metal casing (Keystage 1 Plant Room G/01) does not contain asbestos.

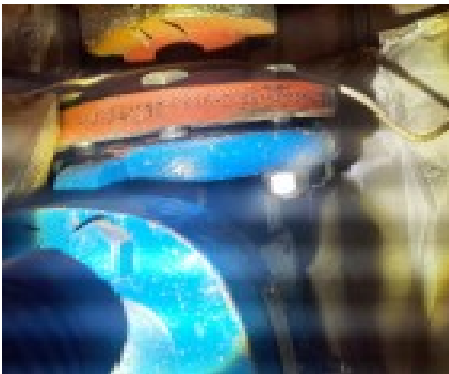
#### **Item 74 Ref: RC000281**

The Gaskets pipework RHS side (Keystage 1 Plant Room G/01) does not contain asbestos.

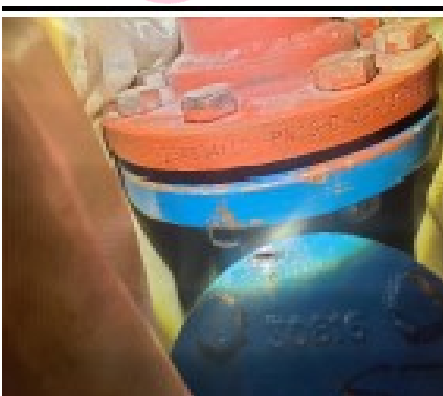
#### **Item 75 Ref: RC000282**

The - Gaskets pipework at high level and behind plant RHS side (Keystage 1 Plant Room G/01) does not contain asbestos.

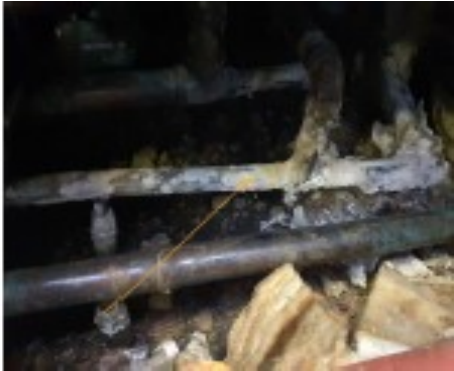
#### **Item 76 Ref: RC000562**

The Lagging residue pipework (Floor duct G/01 Hall KS2) does not contain asbestos.

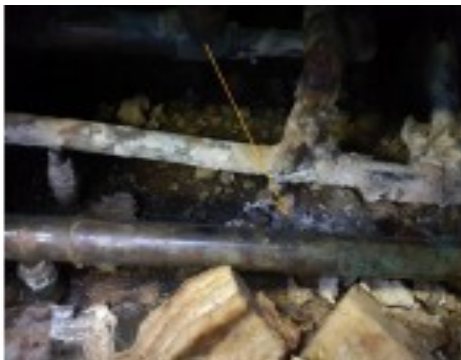
#### **Item 77 Ref: RC000563**

The Debris residue from pipework (Floor duct G/01 Hall KS2) does not contain asbestos.
