ASBESTOS SURVEY REPORT FOR BLOCK 3 EDWARD THOMPSON SITE, RICHMOND STREET, SUNDERLAND, SR5 1BQ

### **Asbestos Register for Block 3 Edward Thompson Site, Richmond Street, Sunderland, SR5 1BQ**

**Date: 18 July 2023**

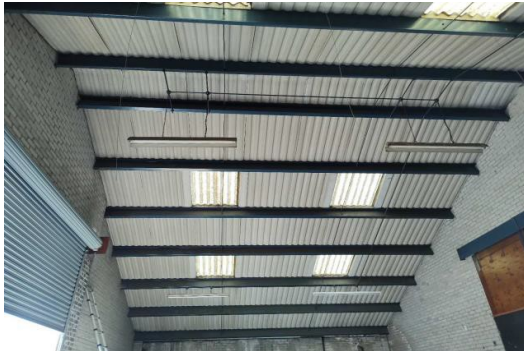
### **Item 1 Ref: 22-47233-1**

- (Item 1) Ref: 22-47233-1 – Ceiling (Cement) (Area:1 Garage) – Very Low Risk
- (Item 2) Ref: 22-47233-2 – Walls – damp proof course to corner brick columns (Bitumen) (Area:1 Garage) – No Risk

The ceiling (Cement) (Area:1 Garage) contains asbestos.

Any change in its appearance should be recorded and passed to Property Services.

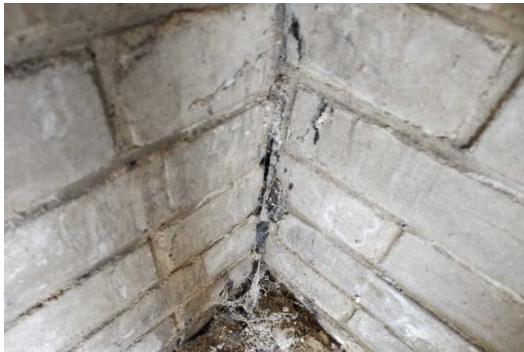
### **Item 2 Ref: 22-47233-2**

The walls – damp proof course to corner brick columns (Bitumen) (Area:1 Garage) do not contain asbestos.

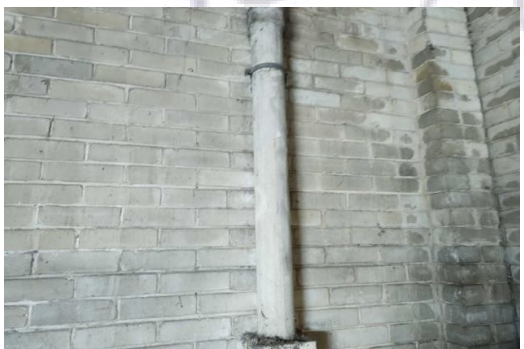
### **Item 3 Ref: 22-47233-3**

- (Item 3) Ref: 22-47233-3 – Downpipes (Cement) (Area:1 Garage) – Very Low Risk
- (Item 4) Ref: 22-47233-4 – Rainwater goods – cement rainwater troughs (Cement) (Area:1 Garage) – Very Low Risk

The downpipes (Cement) (Area:1 Garage) contain asbestos.

Any change in its appearance should be recorded and passed to Property Services.

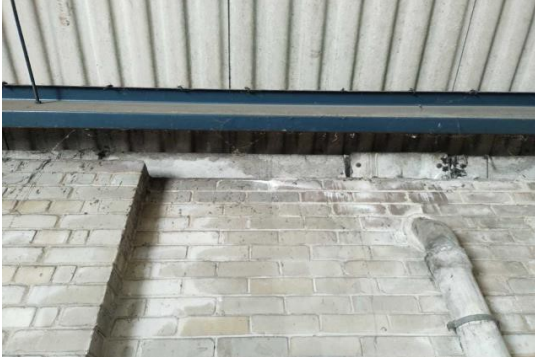
### **Item 4 Ref: 22-47233-4**

The rainwater goods – cement rainwater troughs (Cement) (Area:1 Garage) contain asbestos.

Any change in its appearance should be recorded and passed to Property Services.

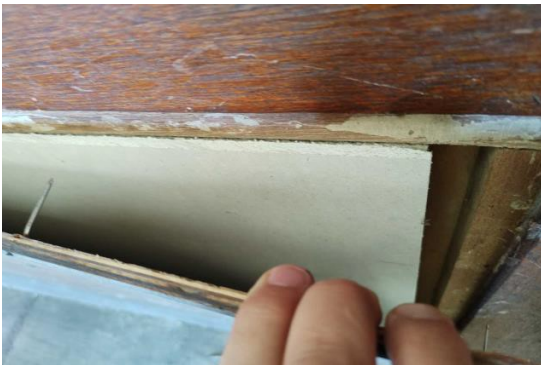
### **Item 5 Ref: 22-47233-5**

- (Item 5) Ref: 22-47233-5 – Door – insulating board firebreak panels within large central roller doors (insulating board) (Area:1 Garage) – Low Risk
- (Item 6) Ref: 22-47233-6 – Window – glazing putty to office window (Putty) (Area:1 Garage) – No Risk

The door – insulating board firebreak panels within large central roller doors (insulating board) (Area:1 Garage) contains asbestos.

Any change in its appearance should be recorded and passed to Property Services.

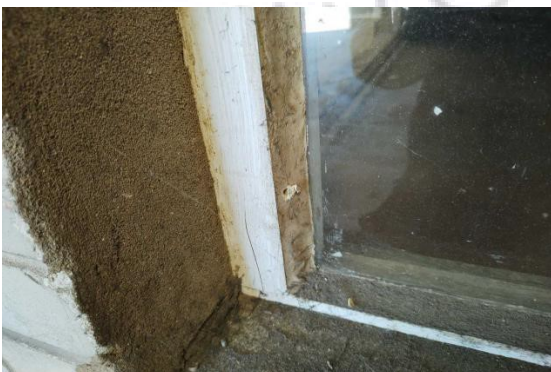
### **Item 6 Ref: 22-47233-6**

The window – glazing putty to office window (Putty) (Area:1 Garage) does not contain asbestos.

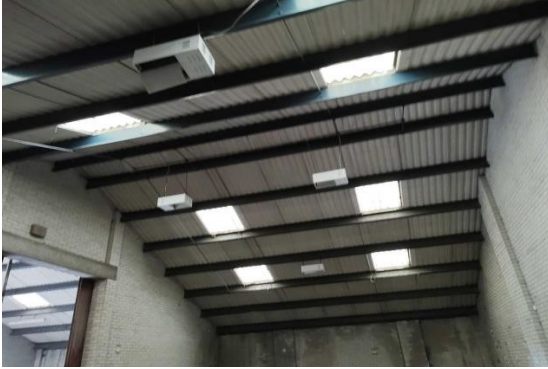
### **Item 7 Ref: 22-47233-1**

- (Item 7) Ref: 22-47233-1 – Ceiling (Cement) (Area:2 Garage 2) – Very Low Risk
- (Item 8) Ref: 22-47233-4 – Rainwater goods – cement rainwater troughs (Cement) (Area:2 Garage 2) – Very Low Risk

The ceiling (Cement) (Area:2 Garage 2) contains asbestos.

Any change in its appearance should be recorded and passed to Property Services.

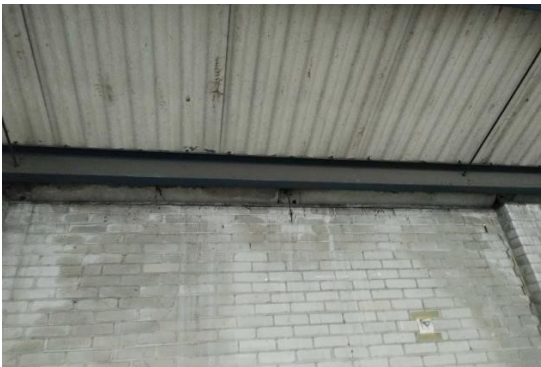
### **Item 8 Ref: 22-47233-4**

The rainwater goods – cement rainwater troughs (Cement) (Area:2 Garage 2) contain asbestos.

Any change in its appearance should be recorded and passed to Property Services.

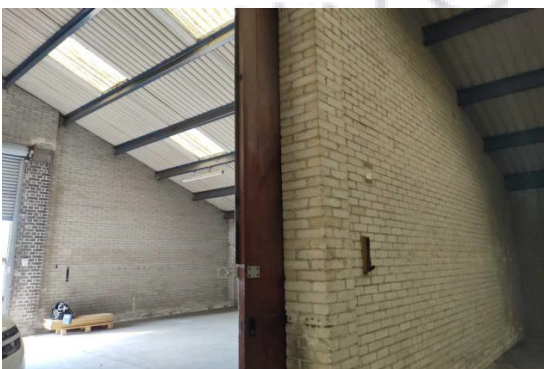
### **Item 9 Ref: 22-47233-5**

- (Item 9) Ref: 22-47233-5 – Door – insulating board firebreak panels within large central roller doors (insulating board) (Area:2 Garage 2) – Low Risk

The door – insulating board firebreak panels within large central roller doors (insulating board) (Area:2 Garage 2) contains asbestos.

Any change in its appearance should be recorded and passed to Property Services.

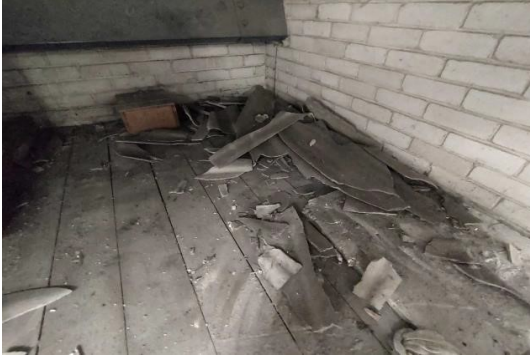
### **Item 10 Ref: 22-47233-7**

- (Item 10) Ref: 22-47233-7 – Broken roof sheets to top of office & WC roof (Cement) (Area:2 Garage 2) – Low Risk
- (Item 11) Ref: 22-47233-10 – Door – panel within door (insulating board) (Area:3 Office) – Low Risk

The broken roof sheets to top of office & WC roof (Cement) (Area:2 Garage 2) contain asbestos.

<b>Item 10</b>	<b>Broken roof sheets to top of office &amp; WC roof (Area:2</b>	<b>Low Risk</b>	<b>6 monthly</b>	<b>24/2/2024</b>

Any change in its appearance should be recorded and passed to Property Services.

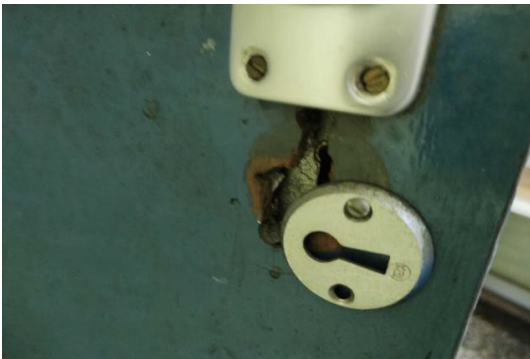
### **Item 11 Ref: 22-47233-10**

The door – panel within door (insulating board) (Area:3 Office) contains asbestos.

Any change in its appearance should be recorded and passed to Property Services.

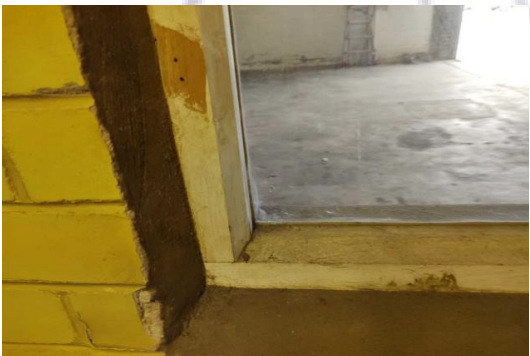
### **Item 12 Ref: 22-47233-6**

The window – glazing putty to office window (Putty) (Area:3 Office) does not contain asbestos.

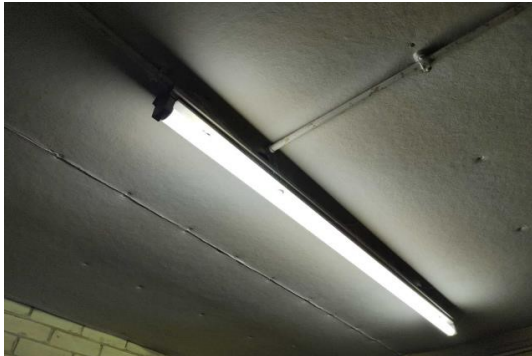
**Item 13 Ref: 22-47233-8**

The ceiling (insulating board) (Area:3 Office) does not contain asbestos.

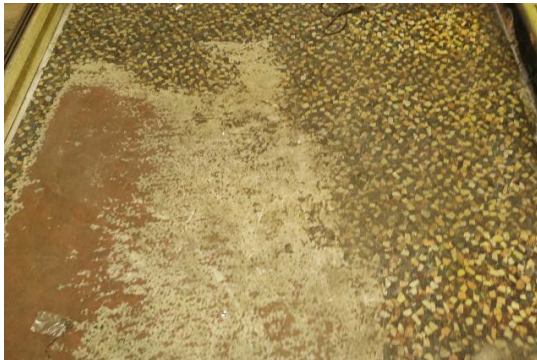
**Item 14 Ref: 22-47233-9**

The floor (Vinyl) (Area:3 Office) does not contain asbestos.

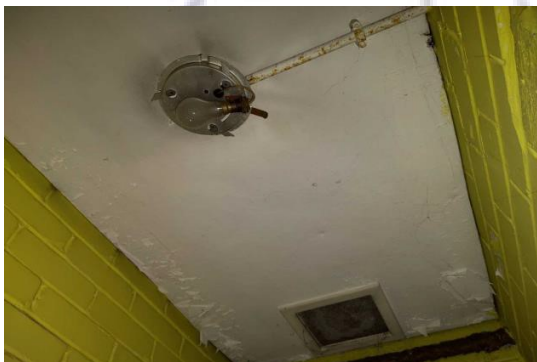
**Item 15 Ref: 22-47233-11**

The ceiling (insulating board) (Area:4 WC) does not contain asbestos.

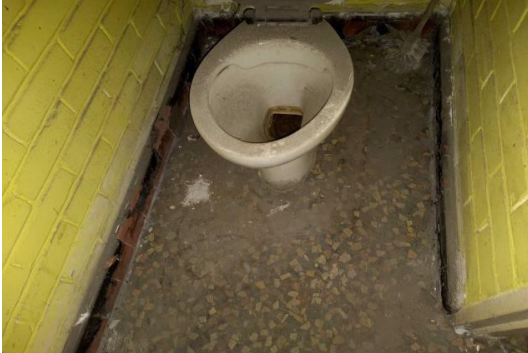
**Item 16 Ref: 22-47233-9**

The floor (Vinyl) (Area:4 WC) does not contain asbestos.

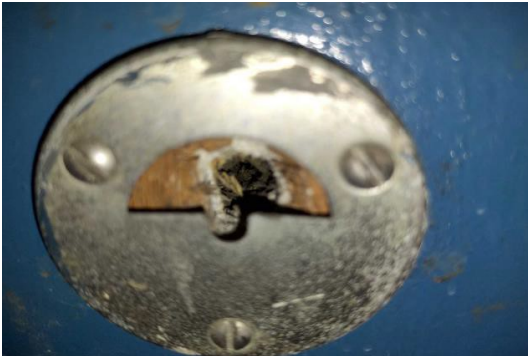
**Item 17 Ref: 22-47233-10**

The door – panel within door (insulating board) (Area:5 Wash Area) contains asbestos.

Any change in its appearance should be recorded and passed to Property Services.

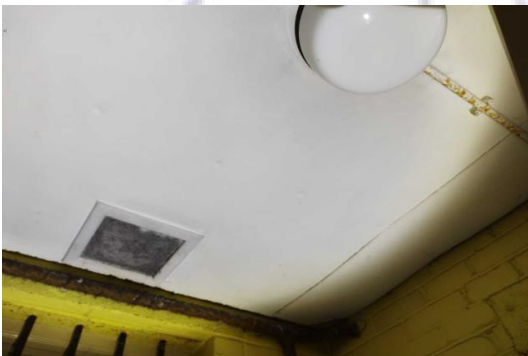
**Item 18 Ref: 22-47233-11**

The ceiling (insulating board) (Area:5 Wash Area) does not contain asbestos.

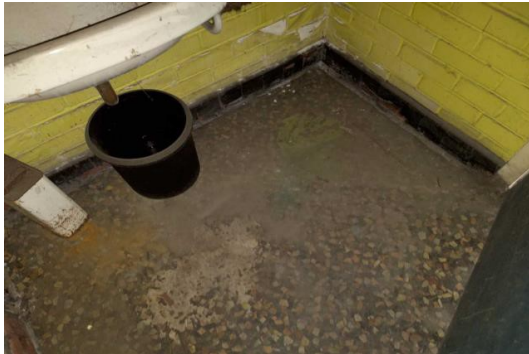
**Item 19 Ref: 22-47233-9**

The floor (Vinyl) (Area:5 Wash Area) does not contain asbestos.

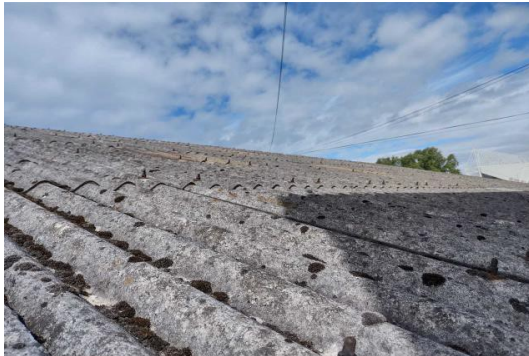
**Item 20 Ref: 22-47233-1**

The roof (Cement) (Area:6 External) contains asbestos.

Any change in its appearance should be recorded and passed to Property Services.

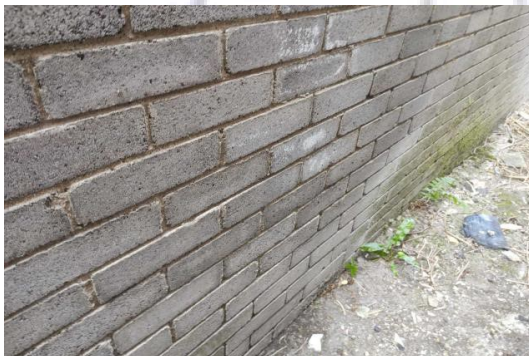
**Item 21 Ref: 22-47233-12**

The damp proof course (Bitumen) (Area:6 External) does not contain asbestos.

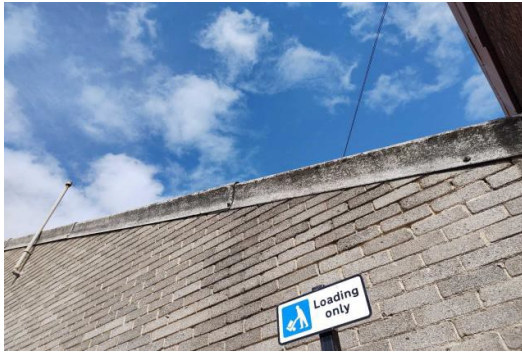
### **Item 22 Ref: 22-47233-13**

The roof (Cement) (Area:6 External) contains asbestos.

Any change in its appearance should be recorded and passed to Property Services.

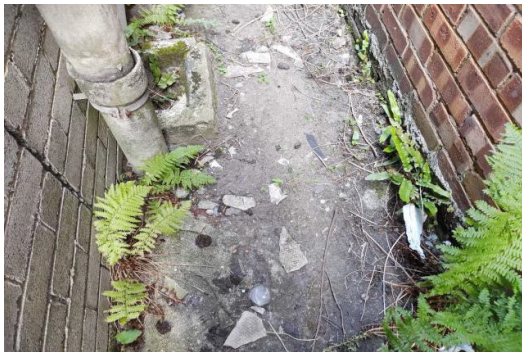
### **Item 23 Ref: 22-47233-14**

- (Item 22) Ref: 22-47233-13 – Roof (Cement) (Area:6 External) – Very Low Risk
- (Item 23) Ref: 22-47233-14 – Debris to perimeter of building (Cement) (Area:6 External) – Low Risk

The debris to perimeter of building (Cement) (Area:6 External) contains asbestos.

Any change in its appearance should be recorded and passed to Property Services.

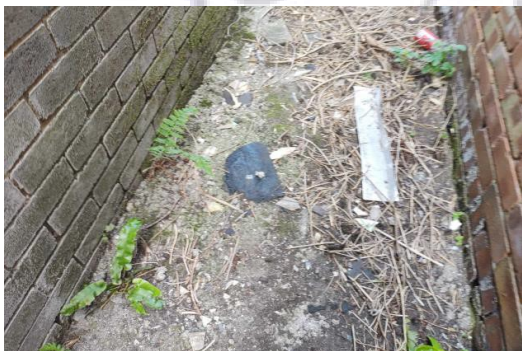
### **Item 24 Ref: 22-47233-15**

The felt to perimeter (Bitumen) (Area:6 External) does not contain asbestos.

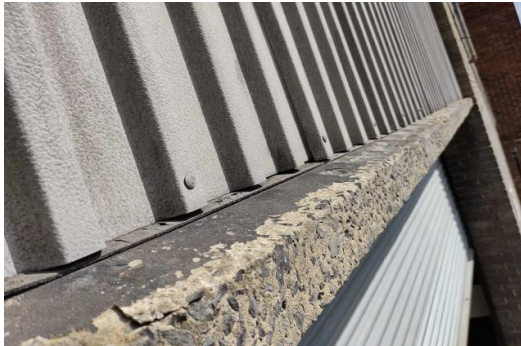
**Item 25 Ref: 22-47233-16**

The walls – damp proof to corrugated metal above door (Bitumen) (Area:6 External) does not contain asbestos.

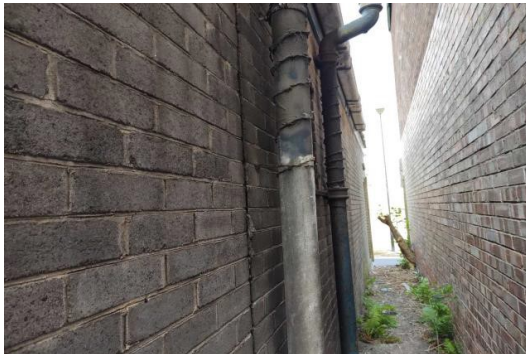
**Item 26 Ref: 22-47233-3**

The downpipes (Cement) (Area:6 External) contain asbestos.

Any change in its appearance should be recorded and passed to Property Services.

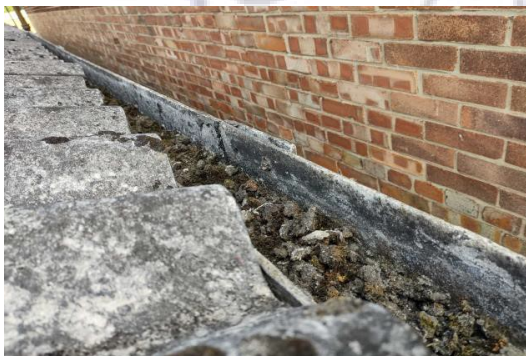
**Item 27 Ref: 22-47233-4**

The rainwater goods – cement rainwater troughs (Cement) (Area:6 External) contain asbestos.

Any change in its appearance should be recorded and passed to Property Services.
