ASBESTOS SURVEY REPORT FOR BARNES JUNIOR SCHOOL, MOUNT ROAD, SUNDERLAND, SR4 7QF.

Asbestos Register for

**Barnes Junior School, Mount Road, Sunderland,
SR4 7QF**

Date: 24 June 2025

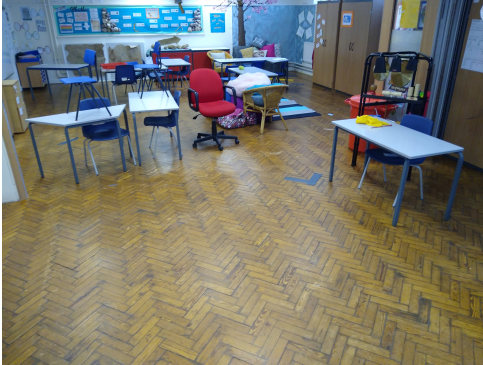
Item 1 Ref: 428662-15

The bitumen adhesive below
parquet flooring in -1/006
Classroom does not contain
asbestos.

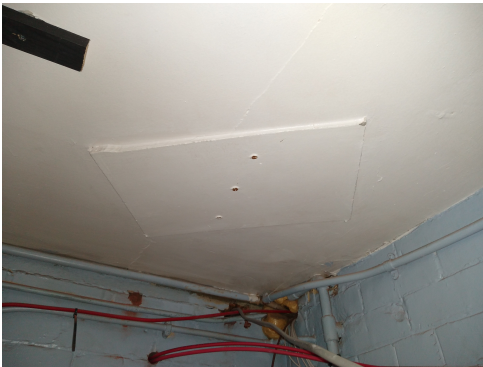
Item 2 Ref: 22-45856-15

The panel to ceiling in -1/006
Classroom – wraparound care
was tested by Pattinsons and
found to not contain asbestos.

*(Previously tested by Lucion ref:
428662-16)*

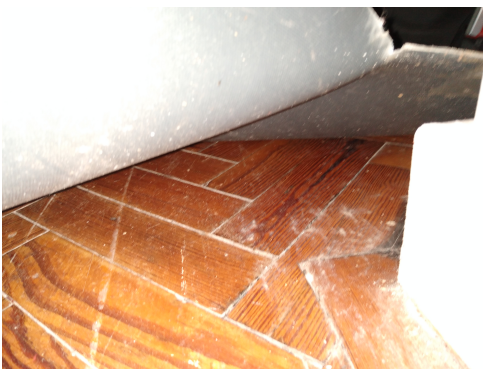
Item 3 Ref: As 428662-15

The bitumen adhesive below
parquet flooring in -1/008
Toilet does not contain
asbestos.

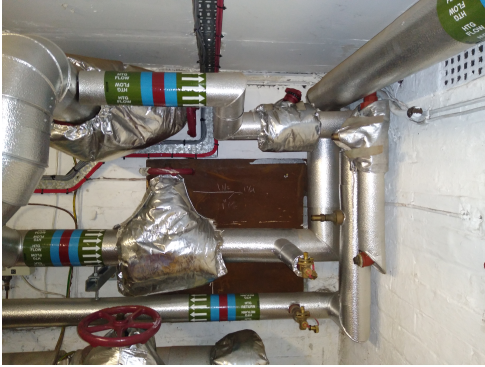
Item 4 Ref: Presumed

The undercroft in -1/012 Boiler Room is presumed to contain asbestos.

Any change in its appearance should be recorded and passed to Property Services

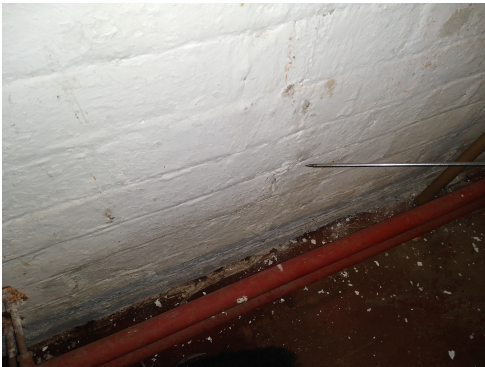
Item 5 Ref: 428662-9

The debris to walls (behind paint) in -1/012 Boiler Room does not contain asbestos.

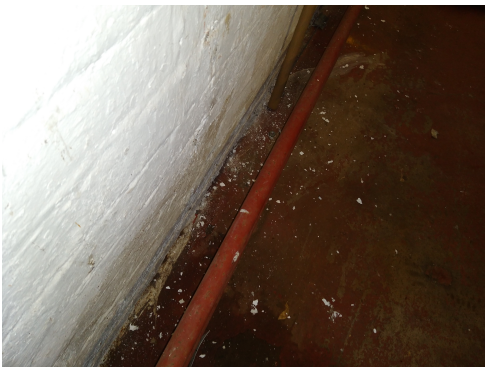
Item 6 Ref: 428662-13

The debris to floor in -1/012 Boiler Room does not contain asbestos.

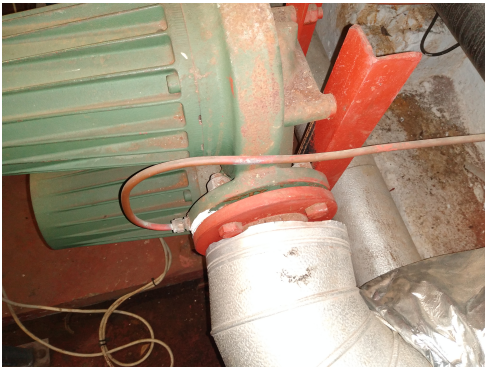
Item 7 Ref: 428662-14

The pipework flange gasket in -1/012 Boiler Room does not contain asbestos.

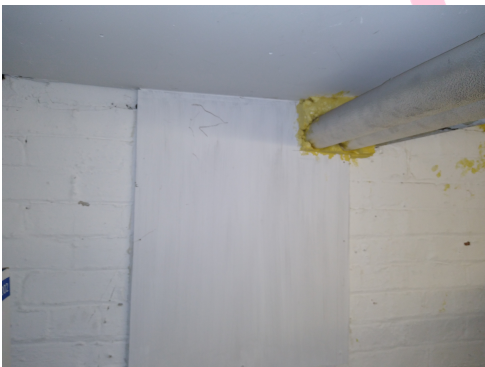
Item 8 Ref: Presumed

The undercroft in -1/013 Store is presumed to contain asbestos.

Any change in its appearance should be recorded and passed to Property Services

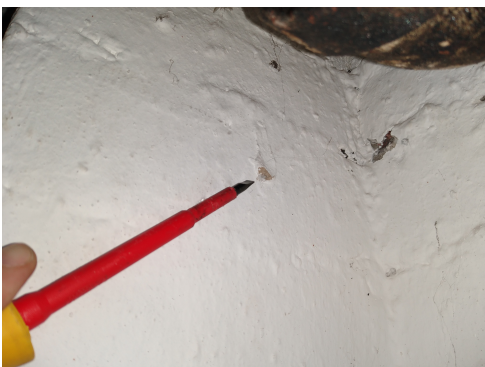
Item 9 Ref: 428662-7

The debris to walls (behind paint) in -1/013 Store does not contain asbestos.

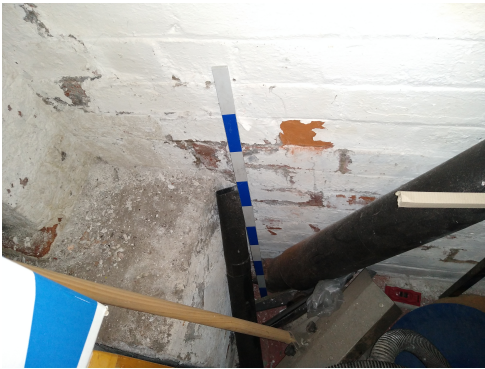
Item 10 Ref: 428662-8

The general debris to floor in -
1/013 Store does not contain
asbestos.

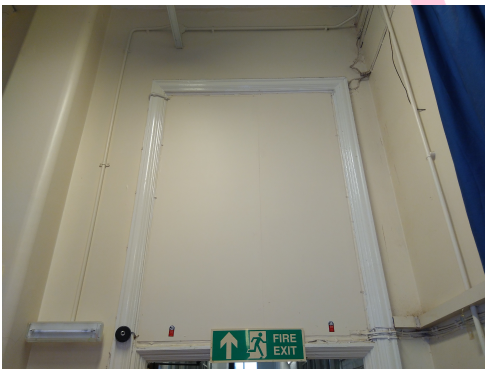
Item 11 Ref: As 428662-2

The panel above door in 0/006
Hall contains asbestos.

Removed December 2022

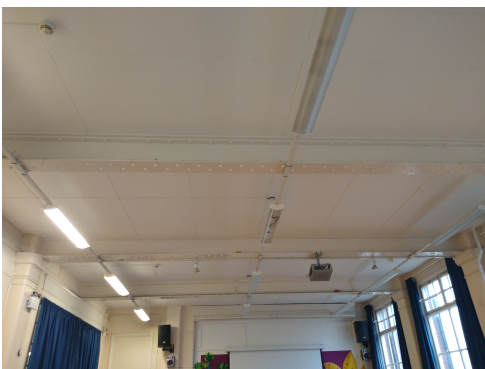
Item 12 Ref: 428662-3

The ceiling in 0/006 Hall does
not contain asbestos.

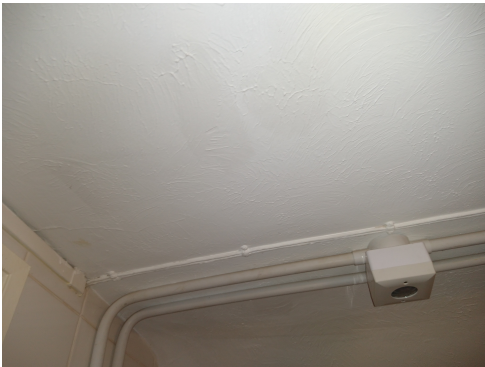
Item 13 Ref: 428662-1

The ceiling in 0/010 Toilet does not contain asbestos.

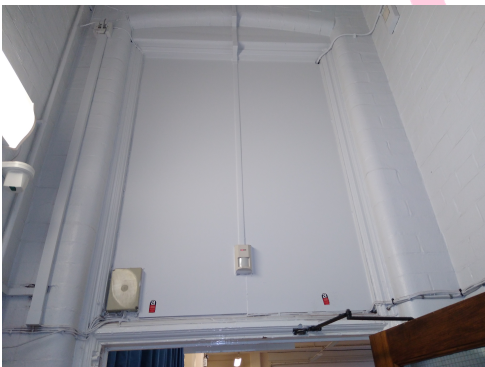
Item 14 Ref: 428662-2

The panel above door in 0/012 Corridor contains asbestos.

Removed December 2022

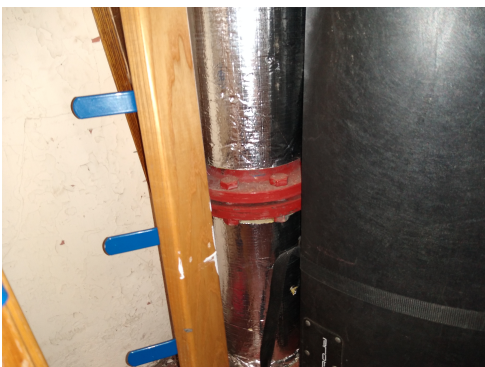
Item 15 Ref: 428662-4

The pipework flange gasket in 0/017 Hall store does not contain asbestos.

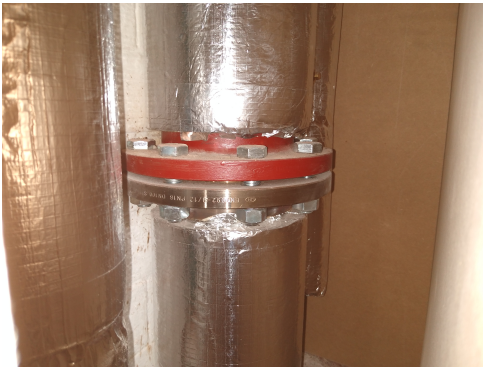
Item 16 Ref: As 428662-4

The pipework flange gasket within boxing in 0/018 Corridor and Stairs does not contain asbestos.

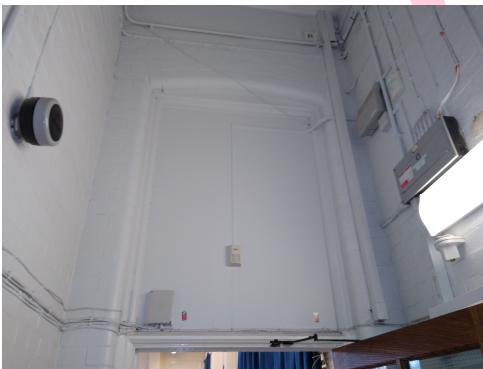
Item 17 Ref: As 428662-2

The panel above door in 0/023 Corridor contains asbestos.

Removed December 2022

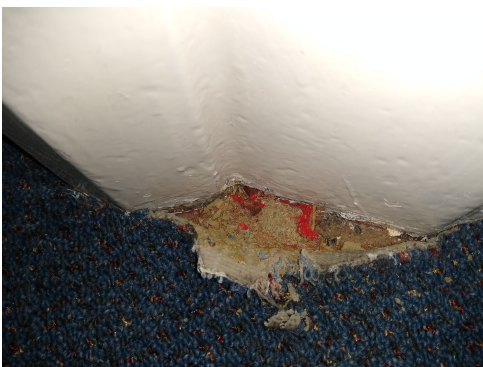
Item 18 Ref: 428662-5

The sub floor covering below carpet adjacent fireplace in 0.5/002 Deputy headteachers office does not contain asbestos.

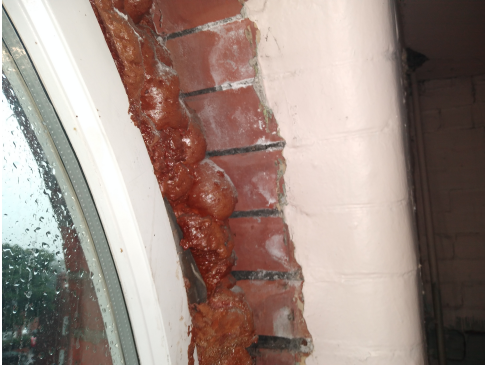
Item 19 Ref: 428662-10

The remnant sealant to window in 1/002 toilet and cloakroom void above does not contain asbestos.

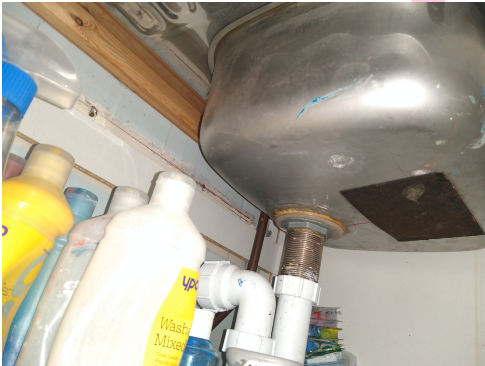
Item 20 Ref: As 428662-11

The sink pad in 1/003 cloakroom does not contain asbestos.

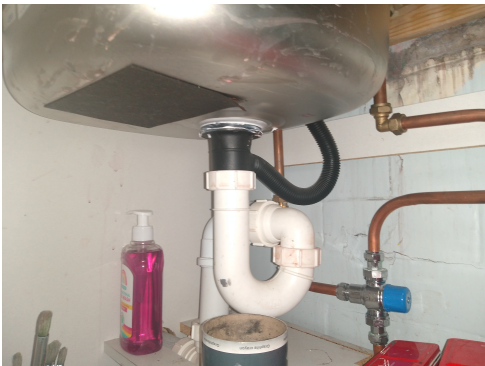
Item 21 Ref: As 428662-11

The sink pad in 1/005 cloakroom does not contain asbestos.

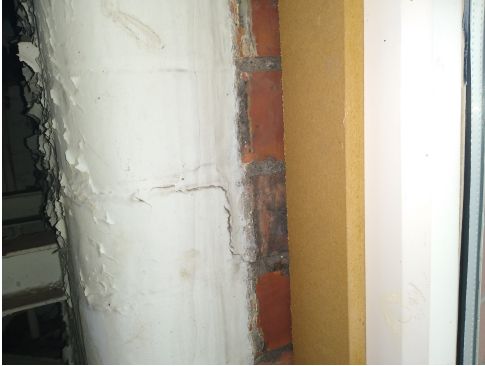
Item 22 Ref: As 428662-10

The remnant sealant to window in 1/006 toilet and cloakroom void above does not contain asbestos.

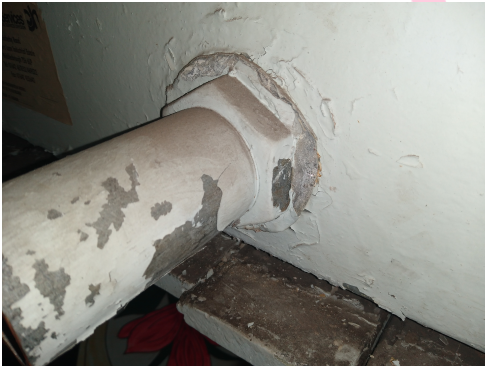
Item 23 Ref: 428662-12

The gasket to redundant water tanks in 1/006 toilet and cloakroom void above does not contain asbestos.

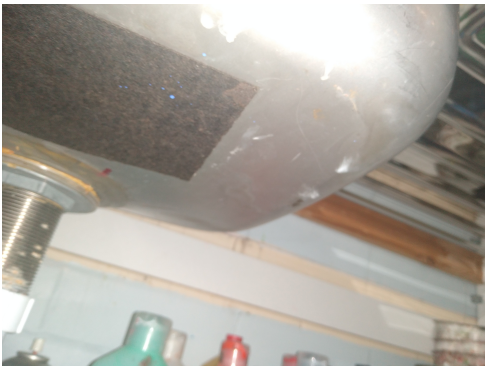
Item 24 Ref: As 428662-11

The sink pad in 1/010 classroom does not contain asbestos.

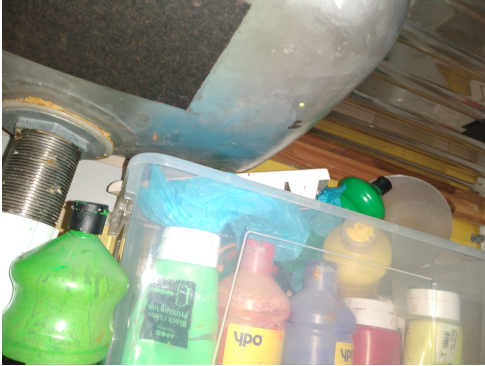
Item 25 Ref: As 428662-11

The sink pad in 1/015 classroom does not contain asbestos.

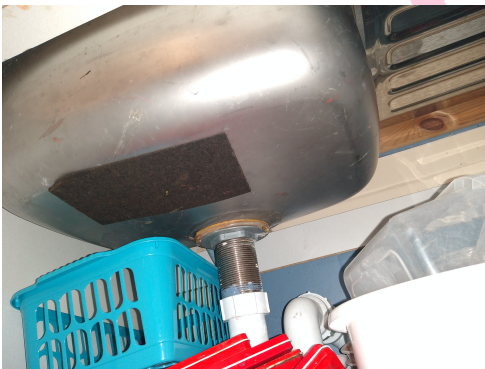
Item 26 Ref: As 428662-11

The sink pad in 1/017 classroom does not contain asbestos.

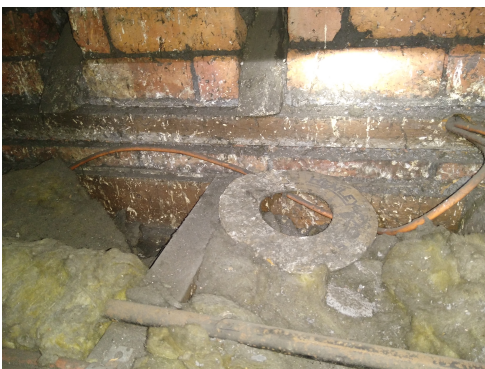
Item 27 Ref: 428662-6

The loose lying gasket adjacent to hatch in 2/014 loft void does not contain asbestos.

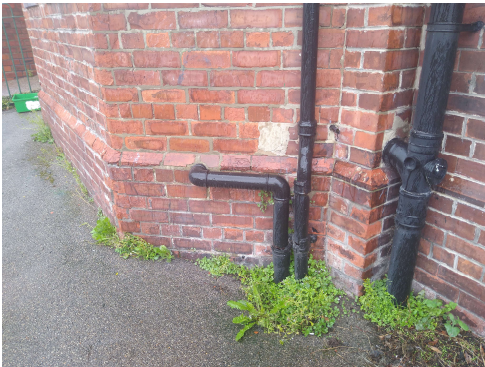
Item 28 Ref: 428662-17

The damp proof course
(External) does not contain
asbestos.

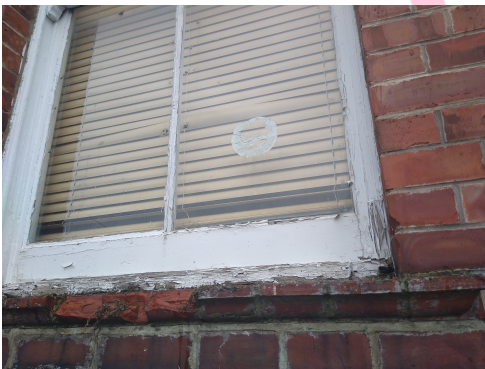
Item 29 Ref: 428662-18

The putty to window frames
(External) does not contain
asbestos.

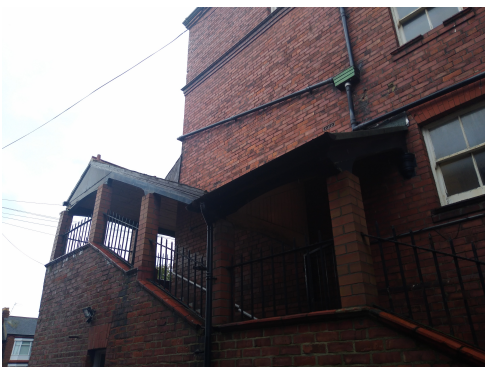
Item 30 Ref: 428662-19

The roof tile to low level roof
to external stairs (External)
does not contain asbestos.

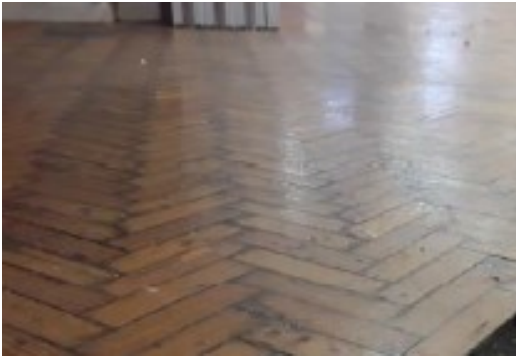
Item 31 Ref: 21-37468-1

The floor - rear of parkay flooring (bitumen) in Area 1 (Classroom) does not contain asbestos.

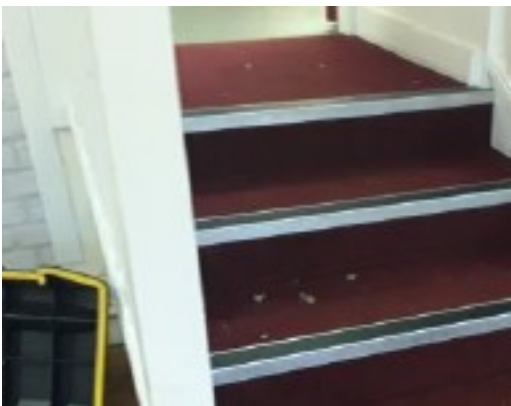
Item 32 Ref: 21-37468-2

The Floor – stair nosing (bitumen) in Area 1 (Classroom) does not contain asbestos.

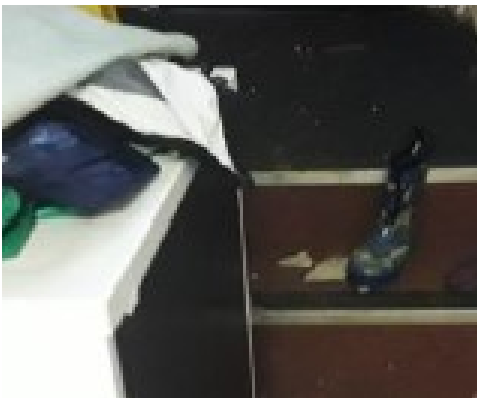
Item 33 Ref: 2-37468-2

The Floor – stair nosing (bitumen) in Area 3 (Fire exit hall way) does not contain asbestos.

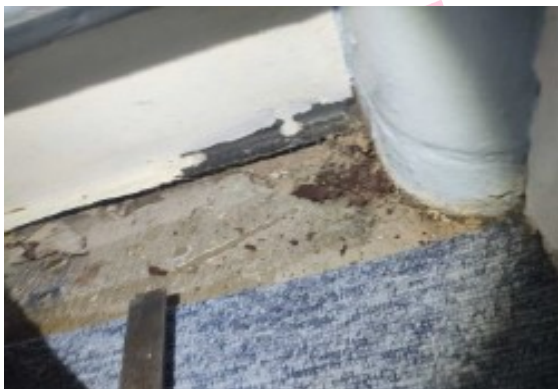
Item 35 Ref: 22-45856-8

The floor – asphalt in Area 0/0.004 Reception Store does not contain asbestos.

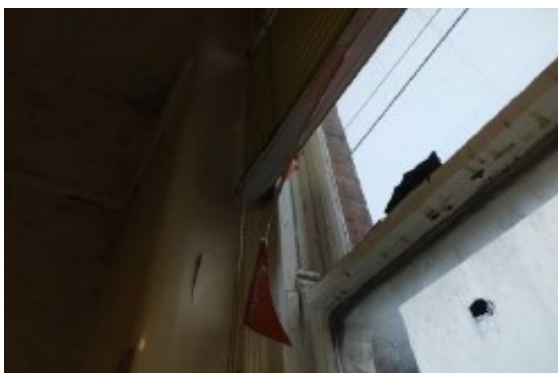
Item 36 Ref: 22-45856-10

The sash window cords in Area 0/0.007 Classroom 4CS does not contain asbestos.

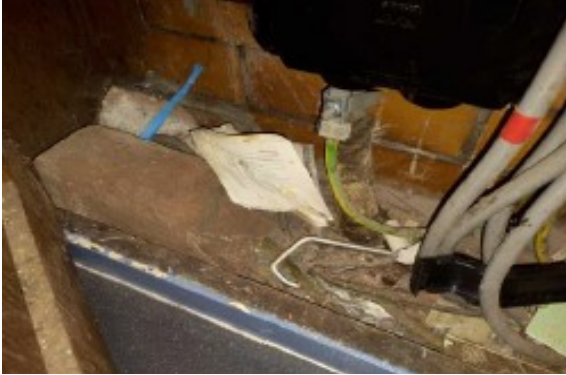
Item 37 Ref: 22-45856-12P

The cable wrap within mains cupboard in Area 0/0.012 Circulation is presumed to contain asbestos.

Any change in its appearance should be recorded and passed to Property Services

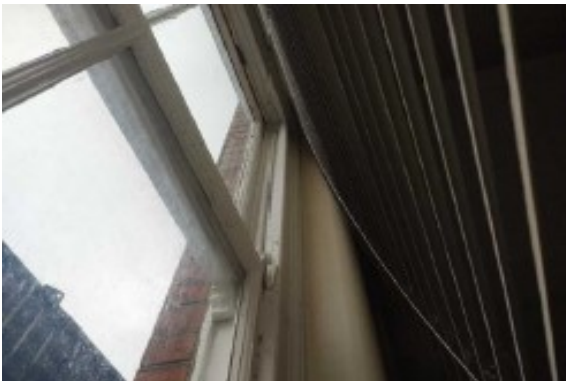
Item 38 Ref: 22-45856-10

The sash window cords in Area 0/0.015 Classroom 4RH does not contain asbestos.

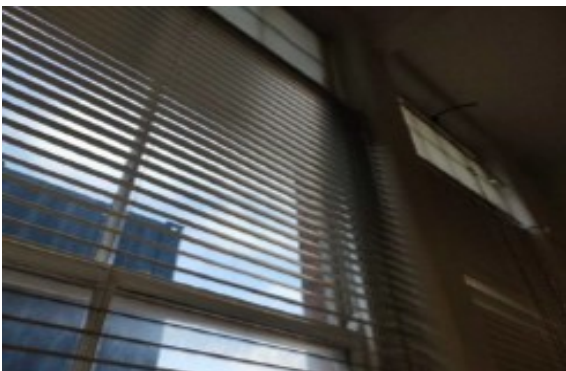
Item 39 Ref: 22-45856-10

The sash window cords in Area 0/0.016 Temporary catering room does not contain asbestos.

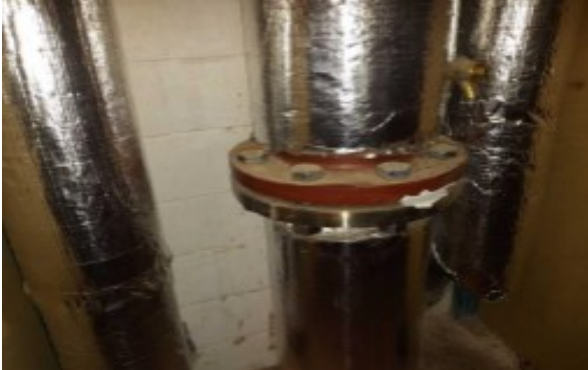
Item 40 Ref: 22-45856-13

The pipe flange gasket in Area 0/0.018 Fire Exit lobby does not contain asbestos.

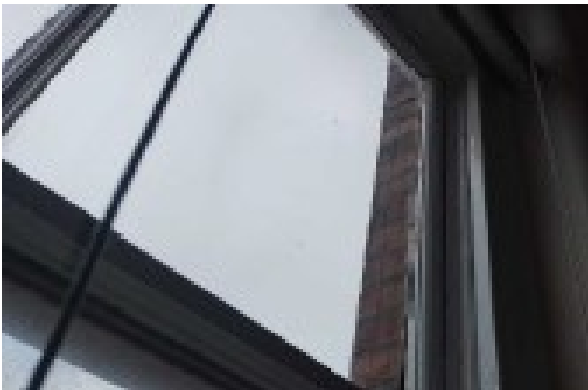
Item 41 Ref: 22-45856-10

The sash window cords in Area 0/0.019 Staff Room does not contain asbestos.

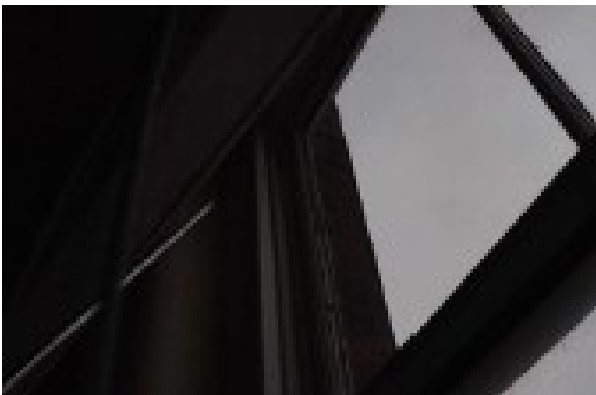
Item 42 Ref: 22-45856-10

The sash window cords in Area 0/0.02 Classroom 3KA does not contain asbestos.

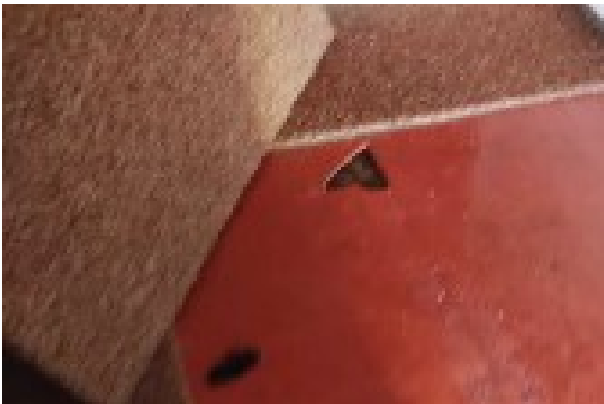
Item 45 Ref: 22-45856-14

The tiles & adhesive to the floor in Area 0/0.023 Circulation 2 does not contain asbestos.

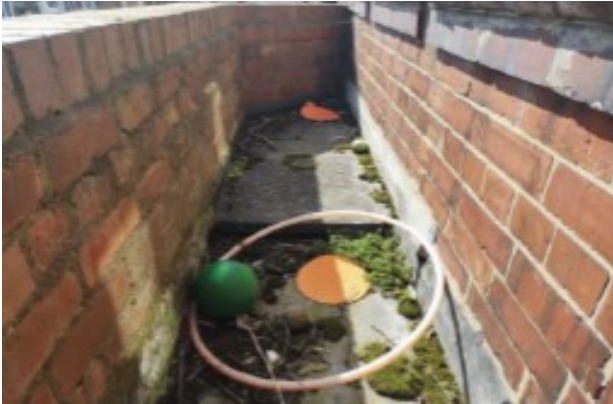
Item 46 Ref: 22-45856-23

The bitumen covering to flat roof by parapet wall to mezzanines (External) contains asbestos.

Removed January 2023

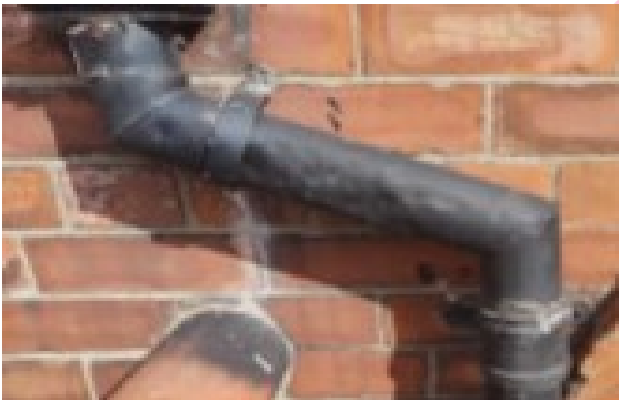
Item 47 Ref: 22-45856-29

The mastic infill to knuckles on metal down pipes (External) does not contain asbestos.

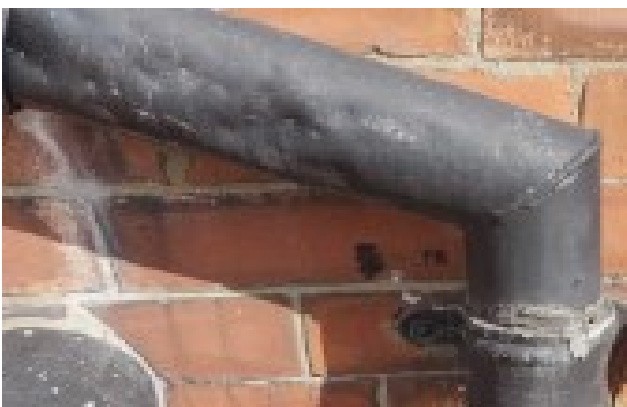
Item 48 Ref: 22-45856-29

The mastic infill to knuckles on metal down pipes (External) does not contain asbestos.

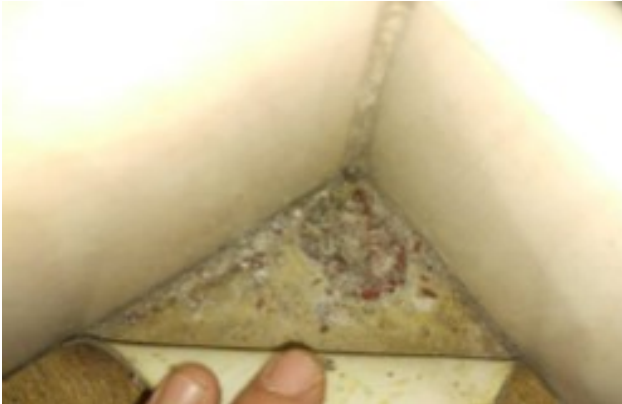
Item 49 Ref: 22-45856-1

The remnant adhesive beneath modern screed in Area 1/1.001 WC & lobby does not contain asbestos.

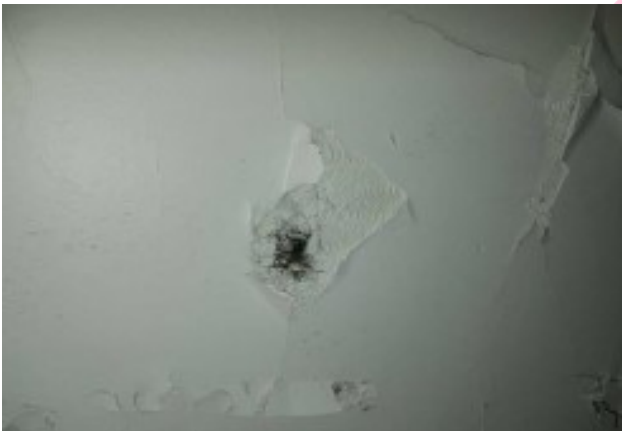
Item 50 Ref: 22-45856-2

The possible textured coating to lath and plaster ceiling in Area 1/1.002 WC does not contain asbestos.

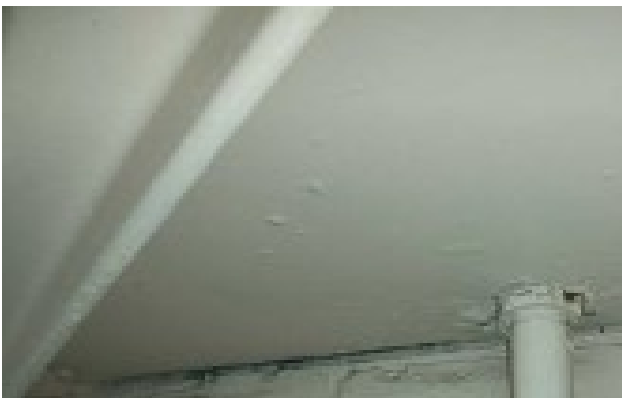
Item 51 Ref: 22-45856-3

The gaskets to redundant water tank in Area 1/1.002 WC contains asbestos.

Any change in its appearance should be recorded and passed to Property Services

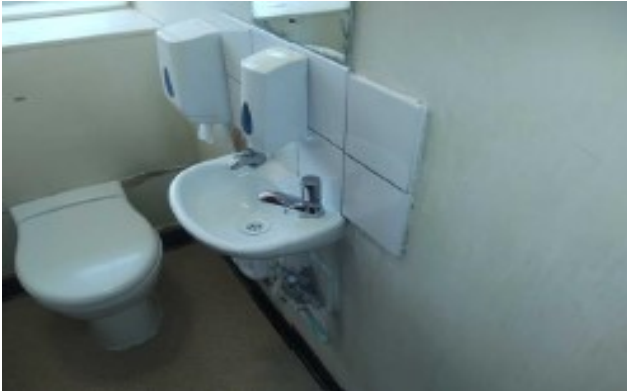
Item 52 Ref: 22-45856-7

The ceramic wall tiles adhesive in Area 1/1.002 WC does not contain asbestos.

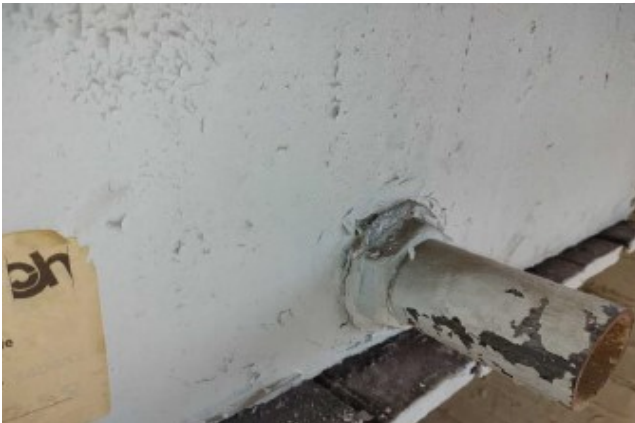
Item 53 Ref: 22-45856-5

The sealant to hex nuts on redundant water tanks in Area 1/1.006 WC does not contain asbestos.

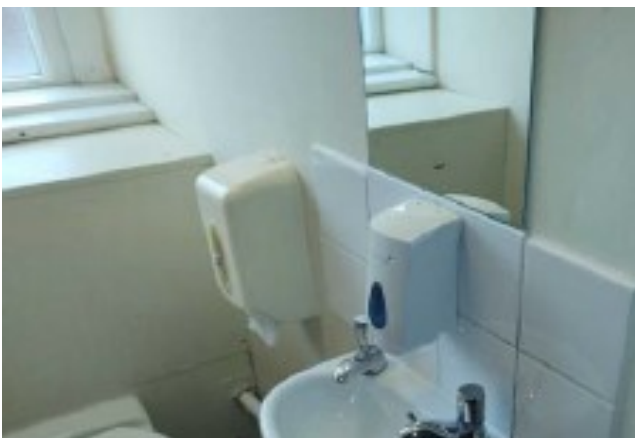
Item 54 Ref: 22-45856-7

The ceramic wall tiles adhesive in Area 1/1.006 WC does not contain asbestos.

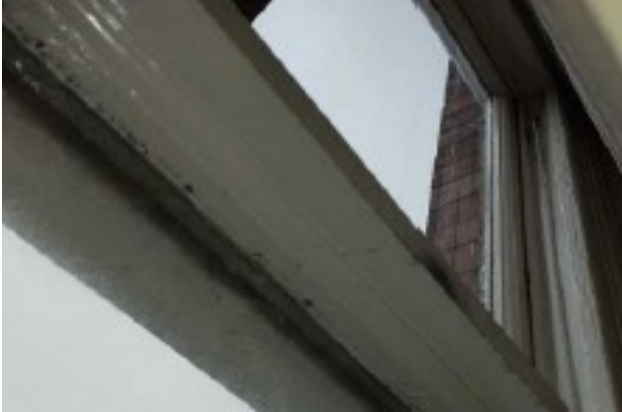
Item 55 Ref: 22-45856-10

The sash window cords in Area 1/1.01 Classroom 6GW does not contain asbestos.

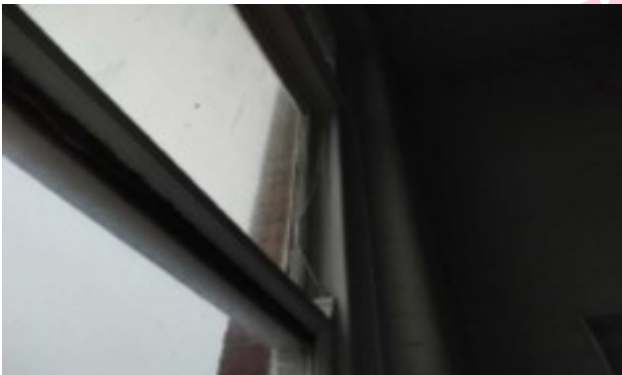
Item 56 Ref: 22-45856-10

The sash window cords in Area 1/1.012 Landing and Stairs does not contain asbestos.

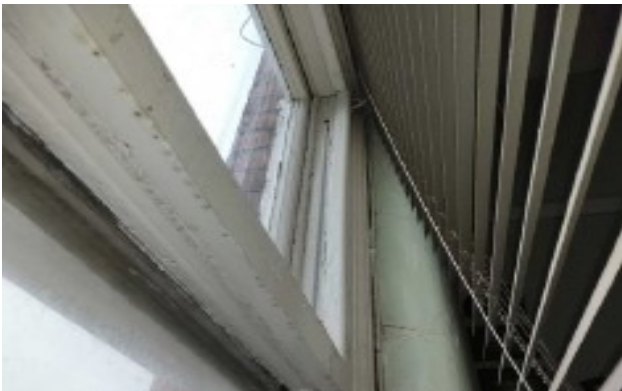
Item 57 Ref: 22-45856-7

The sash window cords in Area 1/1.014 Classroom – IT Suite does not contain asbestos.

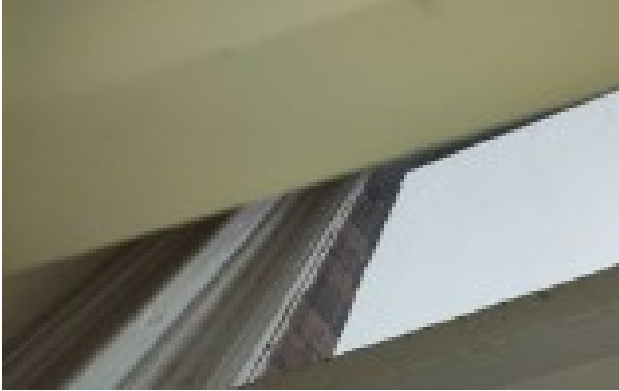
Item 58 Ref: 22-45856-10

The sash window cords in Area 1/1.015 Classroom 5CQ does not contain asbestos.

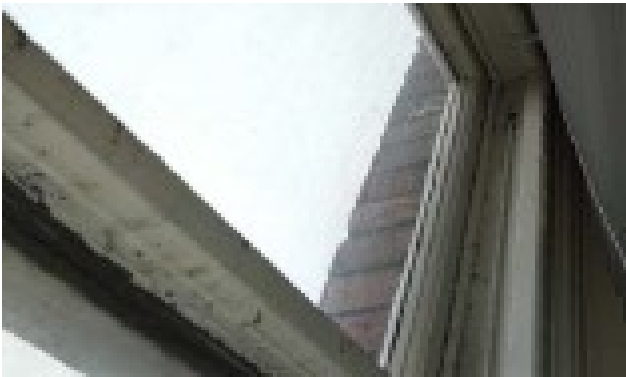
Item 59 Ref: 22-45856-10

The sash window cords in Area 1/1.017 Classroom 5TA does not contain asbestos.

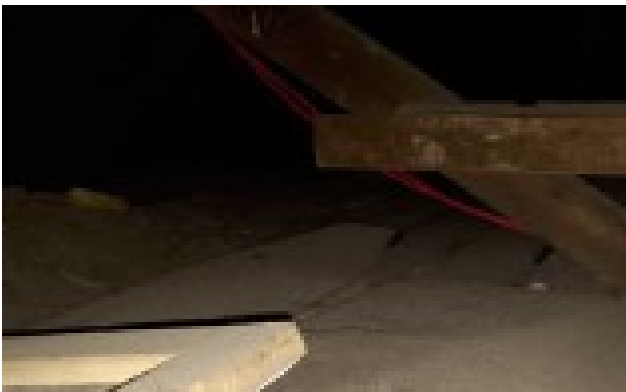
Item 60 Ref: 22-45856-30

The loose lying felt in Area 2/2.009 Loft 9 does not contain asbestos.

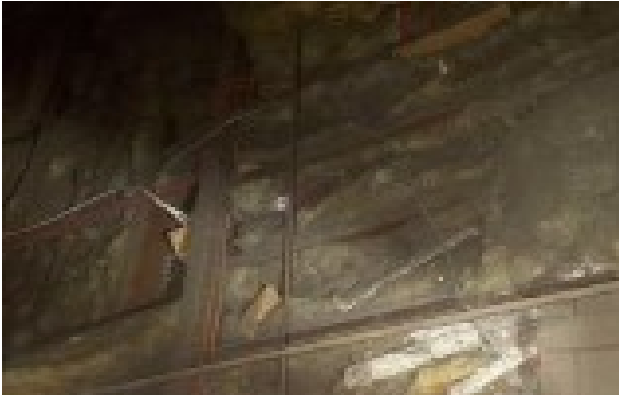
Item 61 Ref: 22-45856-6

The loose lying plaster and possible textured coating in Area 2/2.014 Loft 14 does not contain asbestos.

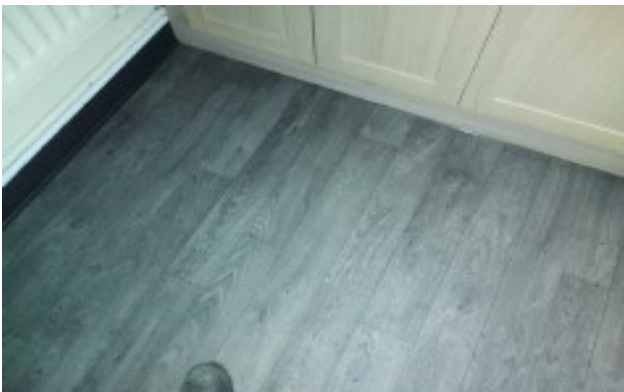
Item 62 Ref: 22-45856-16

The bitumen adhesive beneath modern vinyl flooring and screed in Area -1/-1.007 Kitchen does not contain asbestos.

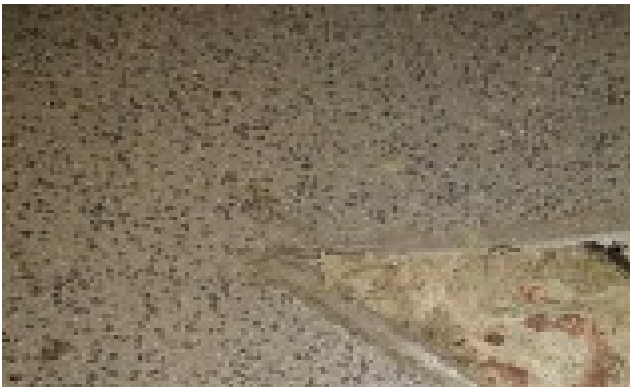
Item 63 Ref: 22-45856-17

The coating to concrete floor in Area -1/-1.009 Storage Areas does not contain asbestos.

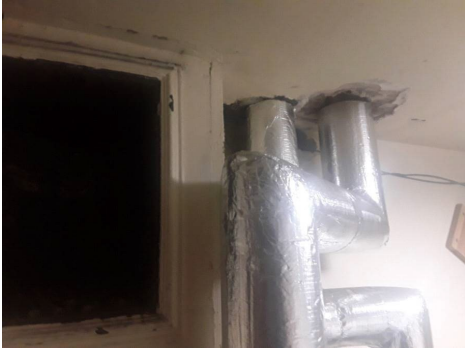
Item 64 Ref: NZ000384/003

The debris/residue to pipework penetrations adjacent chimney stack, Ground Floor, Cupboard, G.001 contains asbestos.

Removed August 2023

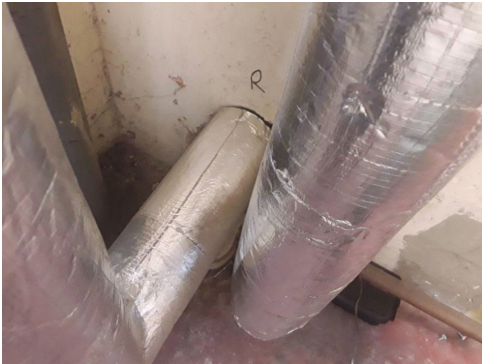
Item 65 Ref: NZ000385/004

The debris/residue to floor and unlagged pipes Ground Floor, Cupboard, G.001 contains asbestos.

Removed August 2023
