ASBESTOS SURVEY REPORT FOR NEW SILKSWORTH INFANTS SCHOOL, SUNDERLAND

NEW SILKSWORTH INFANTS SCHOOL, SUNDERLAND

UPRN: - G08-0467

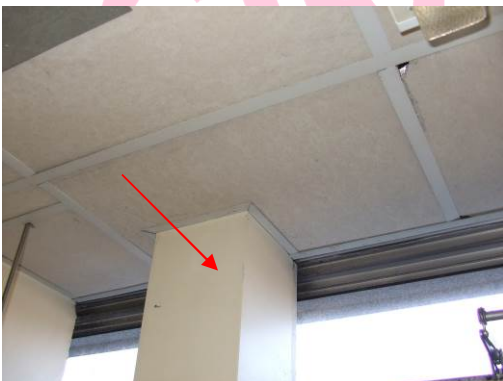
Item 3 – As Sample 01

The column cladding to the boiler room (Room 0/03) contains asbestos.

Any change in its appearance should be recorded and passed to Property Services.

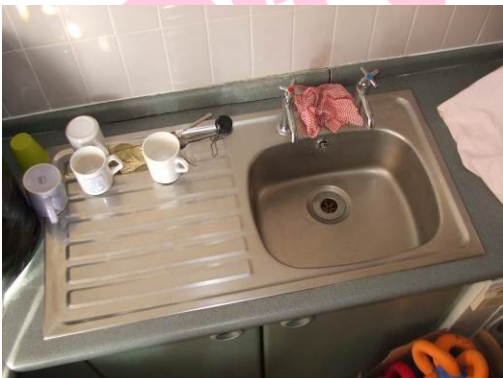
Item 6 - Ref: Sample 03

The sink pad to the kitchen area (Rm 0/05) does not contain asbestos.

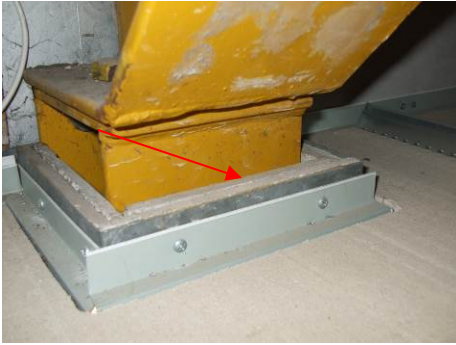
Item 7 – As Sample 01

The column cladding to the entrance lobby (Room 0/07) contains asbestos.

Any change in its appearance should be recorded and passed to Property Services.

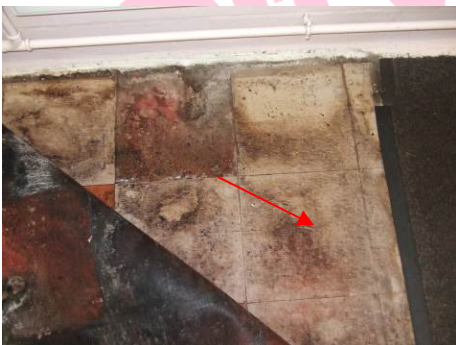
Item 9 - Ref: Sample 04

The floor covering to the WC/Office/Corridor (Rm 0/09) contained asbestos.

These were removed in April 2014.

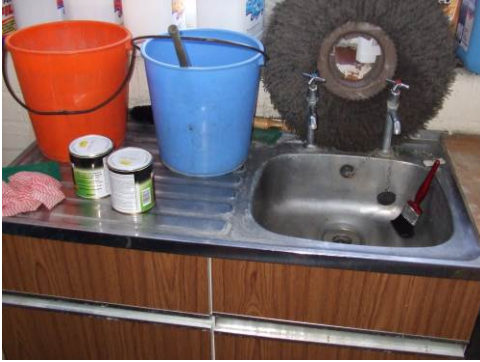
Item 10 - Ref: Sample 05

The sink pad to the WC/Office/Corridor (Rm 0/09) does not contain asbestos.

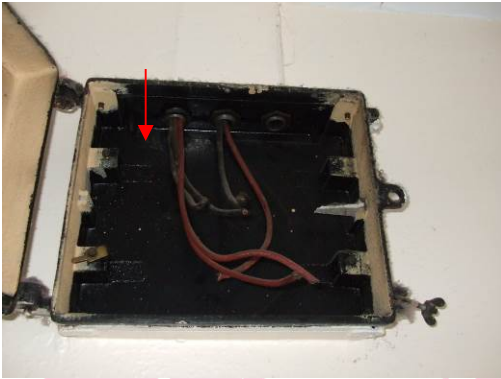
Item 11 - Ref: Sample 06

The panel inside the electrical box in the cloak room and WC (Rm 0/14) contains asbestos.

Any change in its appearance should be recorded and passed to Property Services.

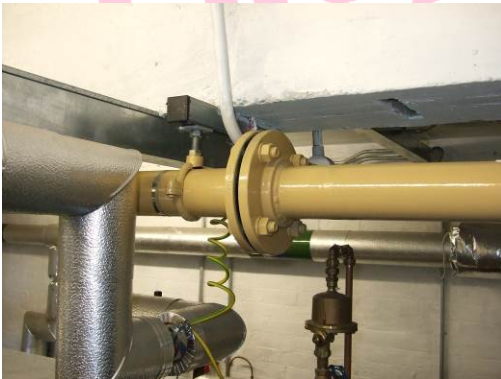
Item 12 - Ref: Sample 07

The gaskets to the pipework in the boiler room (Rm -1/01) do not contain asbestos.

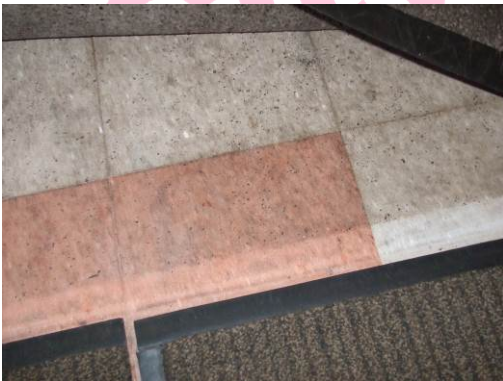
Item 15 - As Sample 04

The floor covering to the WC/Medical Room/Store (Rm 0/21) contained asbestos.

This was removed in April 2014.

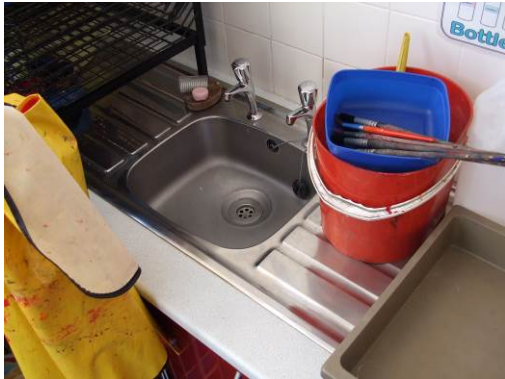
Item 16 – As Sample 03

The sink pad to class 3 (Rm 0/25) does not contain asbestos.

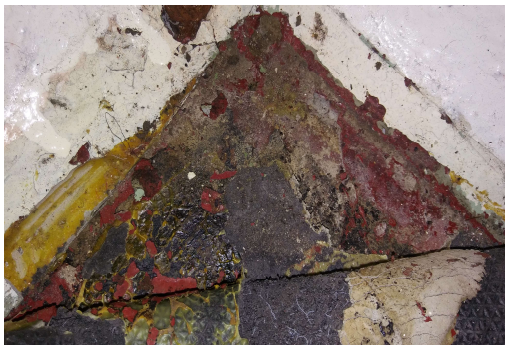
Item 17- 345159-8

The subfloor beneath chemical store and classroom in the corridor (Room 001) contains asbestos.

Any change in appearance should be reported to Property Services.

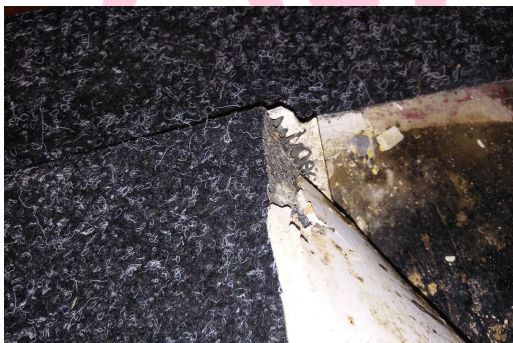
Item 18 – As 345159-7

The subfloor in the corridor (Room 010) does not contain asbestos.

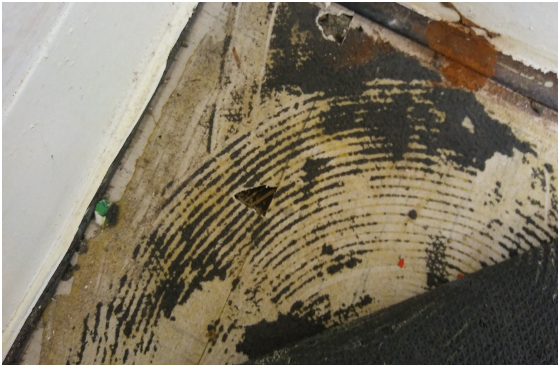
Item 20 - 345159-7

The subfloor in the corridor (Room 010) does not contain asbestos.

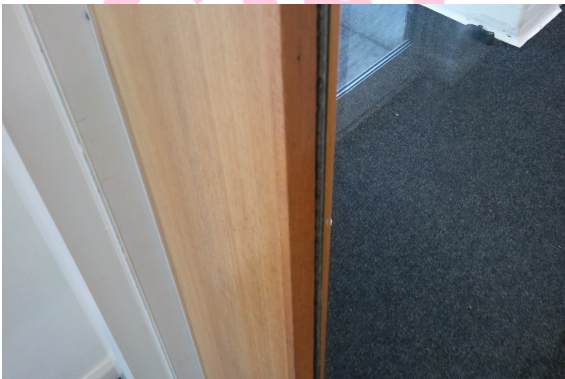
Item 21 – As 345159-1

The grey sealant to glazed panes within the door in the corridor (Room 023) does not contain asbestos.

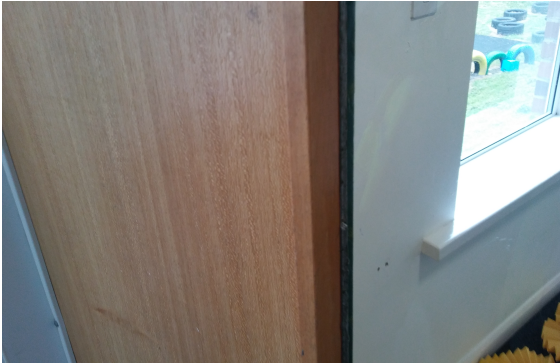
Item 22 – As 345159-1

The grey sealant to glazed panes within the door in the corridor (Room 026) does not contain asbestos.

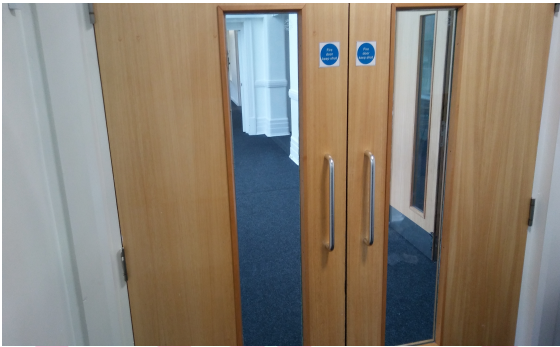
Item 23 – As 345159-1

The grey sealant to glazed panes within the door in the corridor (Room 029) does not contain asbestos.

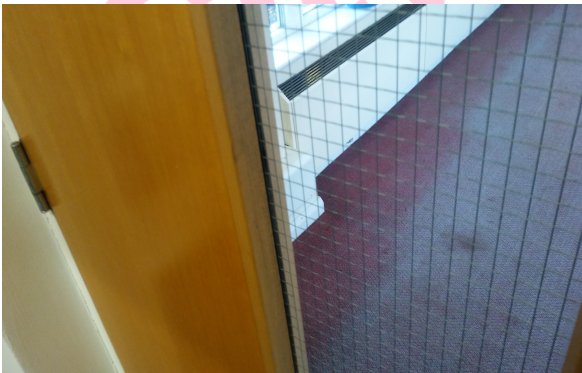
Item 24 – 345159-3

The black sealant to glazed panes within the door in the corridor (Room 029) does not contain asbestos.

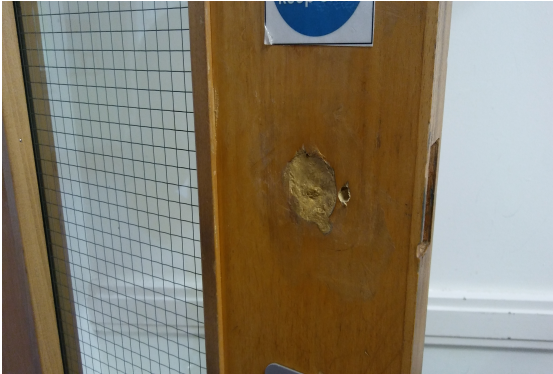
Item 25 – 345159-4

The packing to the door in the corridor (Room 029) does not contain asbestos.

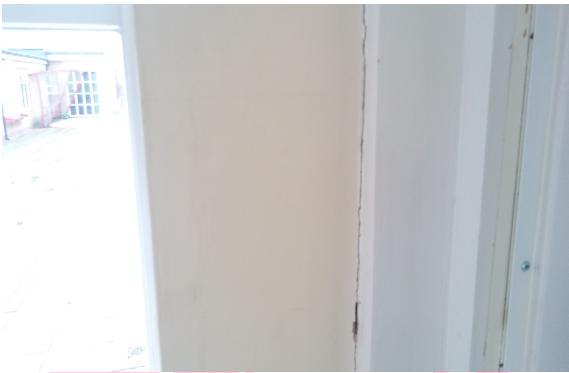
Item 26 – 345159-5

The sealant to the door frame in the corridor (Room 029) does not contain asbestos.

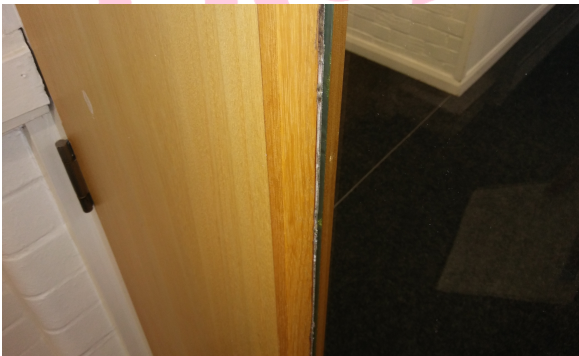
Item 27 – 345159-1

The grey sealant to glazed panes within the door in the corridor (Room 037) does not contain asbestos.

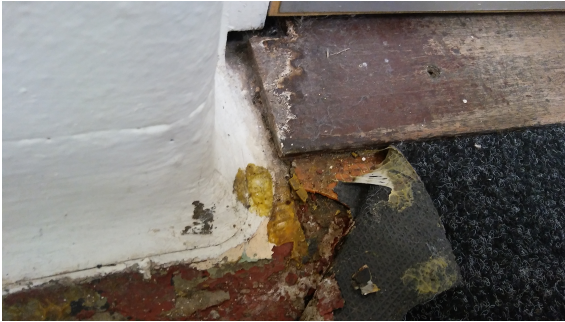
Item 28 – 345159-2

The remnant floor tile beneath wood sole plate to base of door in the corridor (Room 37) does contain asbestos.

Any change in appearance should be reported to Property Services.

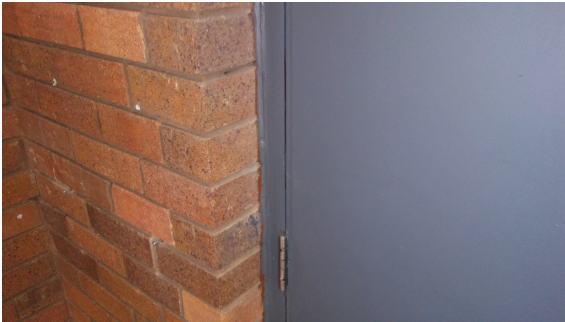
Item 29 – 345159-11

The sealant to the door frame in the link corridor (Room 049) does not contain asbestos.

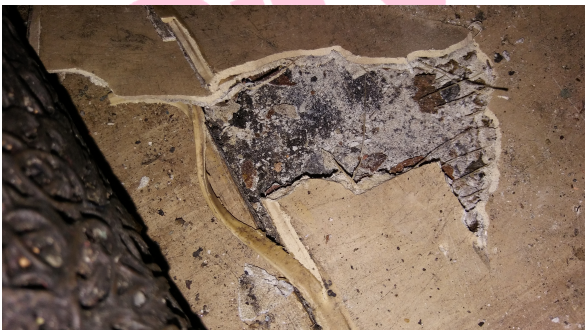
Item 30 – 345159-12

The black screed beneath modern linoleum in the link corridor (Room 047) does not contain asbestos.

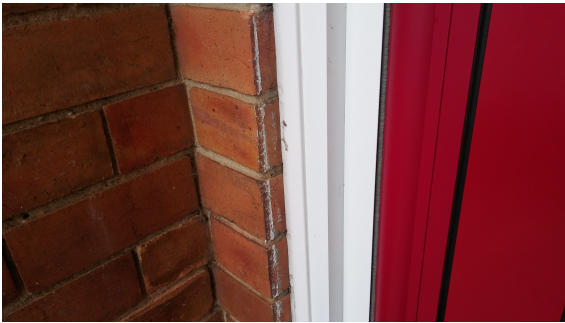
Item 31 – 345159-10

The remnant sealant to the walls externally does not contain asbestos.

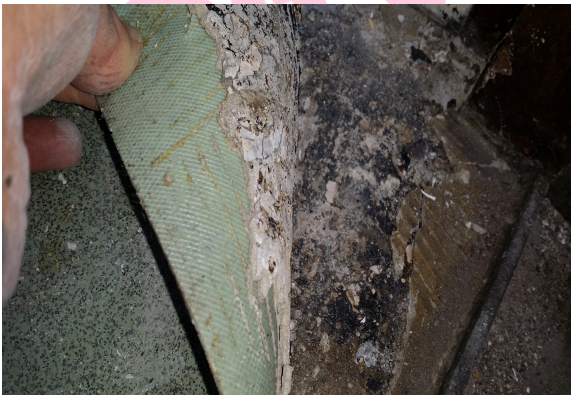
Item 33 – 118815-2

The screed to floor in the kitchen (Rm 0/05) does contain asbestos.

Any change in appearance should be reported to Property Services.

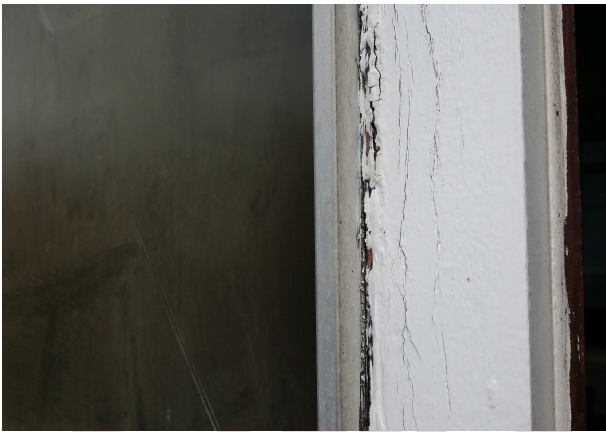
Item 35 – 118815-4

The sealant to framework (External) does not contain asbestos.

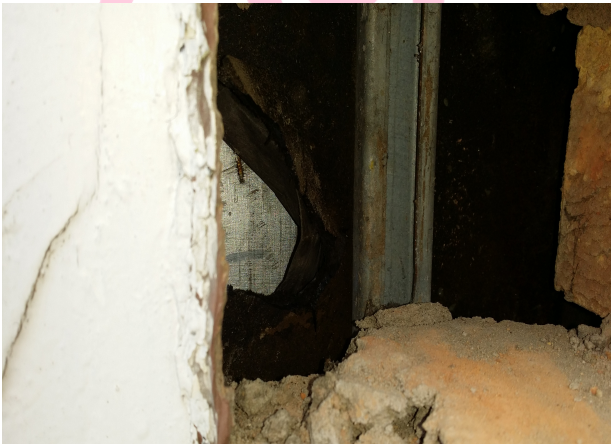
Item 36 – 118815-5

The damp proof course to wall cavity (External) does contain asbestos.

Any change in appearance should be reported to Property Services.

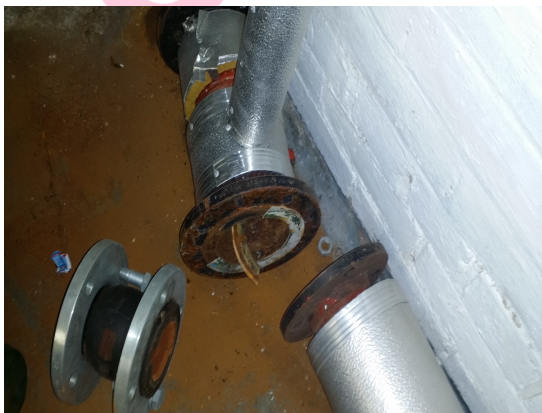
Item 39 – 106221-21

The loose lying gasket to redundant pipework (01/01 Boiler Room) does not contain asbestos.

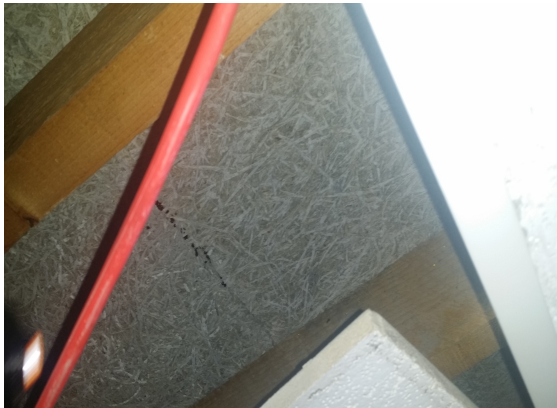
Item 40 – 106221-1

The underside of roof (0/01 Corridor – void above) does not contain asbestos.

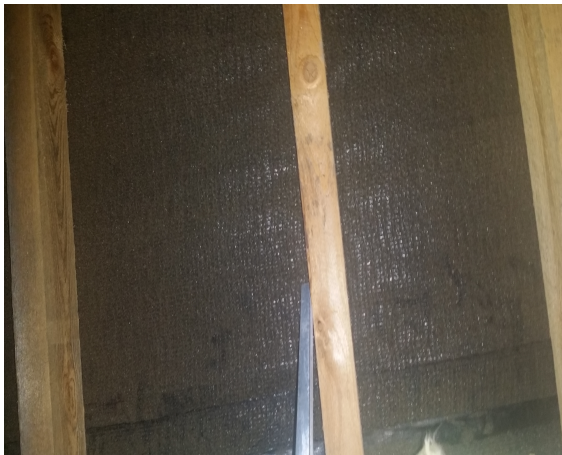
Item 41 – 106221-2

The underside of roof (0/03 Corridor – void above) does not contain asbestos.

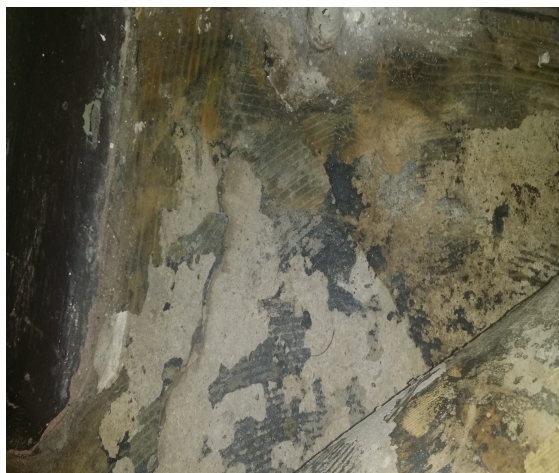
Item 42 – 106221-3

The adhesive backing to linoleum (0/04 Toilets) does contain asbestos.

This was removed 2018

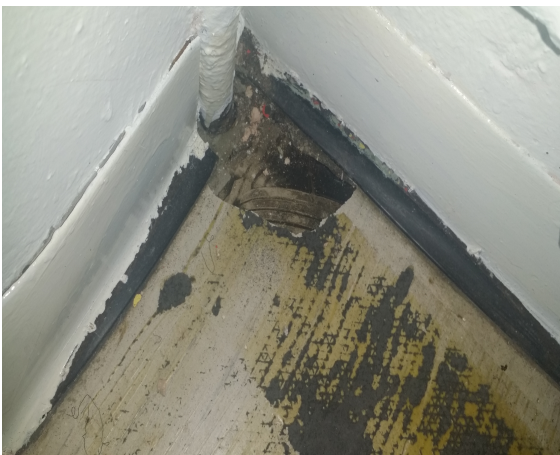
Item 45 – 106221-5

The adhesive backing to floor tiles (0/10 Corridor) does not contain asbestos.

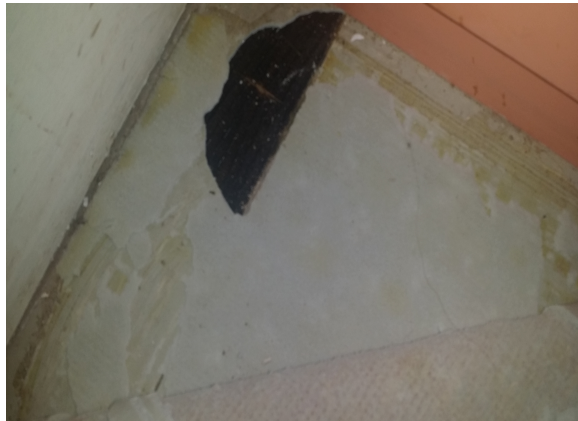
Item 46 – 106221-6

The subfloor (0/11 Female Toilets) does contain asbestos.

Any change in appearance should be reported to Property Services.

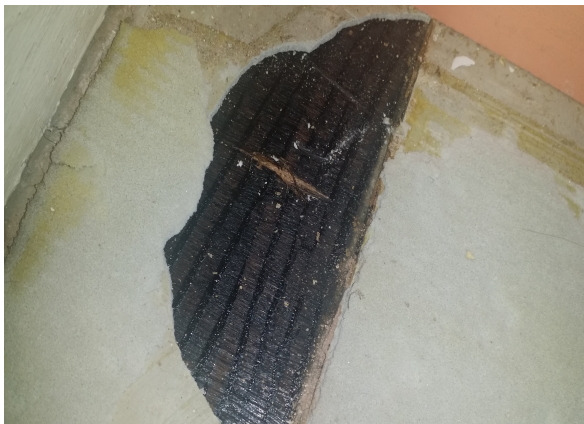
Item 47 – 106221-7

The adhesive backing to floor tiles (0/11 Female Toilets) does contain asbestos.

Any change in appearance should be reported to Property Services.

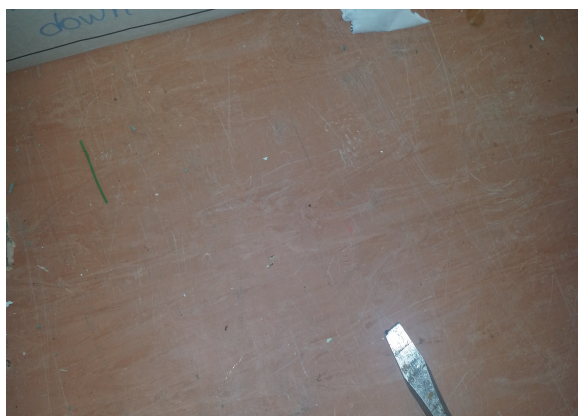
Item 48 – 106221-8

The floor covering (0/12 Store) does not contain asbestos.

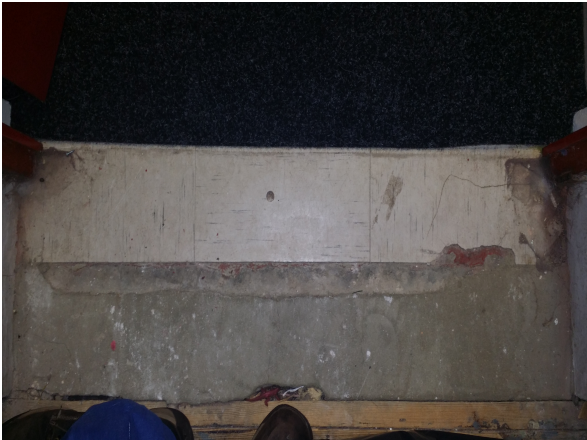
Item 50 – As 106221-6

The floor covering (0/13 Store) does contain asbestos.

Any change in appearance should be reported to Property Services.

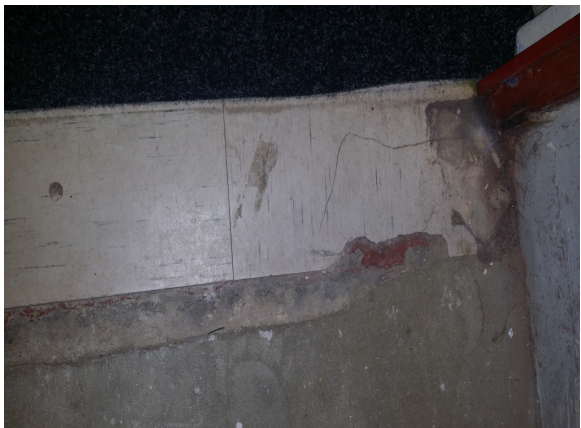
Item 51 – As 106221-9

The adhesive backing to linoleum (0/13 Store) does not contain asbestos.

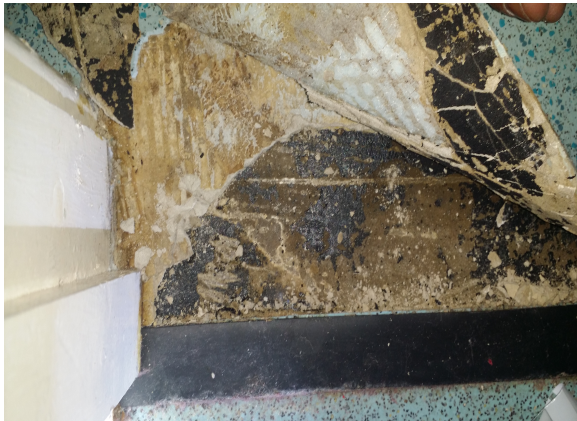
Item 52 – 106221-19

The subfloor (0/17 Disabled Toilet) does contain asbestos.

Any change in appearance should be reported to Property Services.

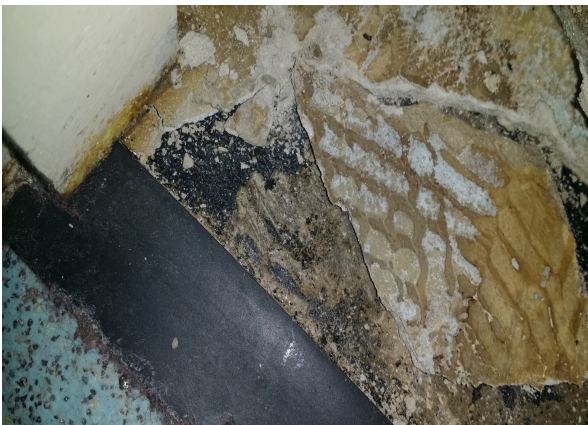
Item 53 – 106221-20

The adhesive backing to floor tiles (0/17 Disabled Toilet) does not contain asbestos.

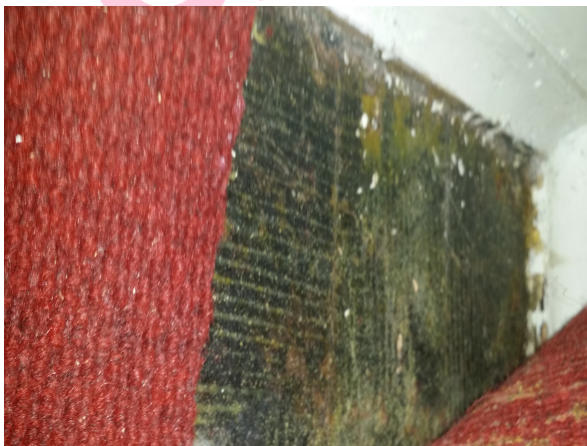
Item 54 – 106221-18

The adhesive backing to floor covering (0/21 Office) does not contain asbestos.

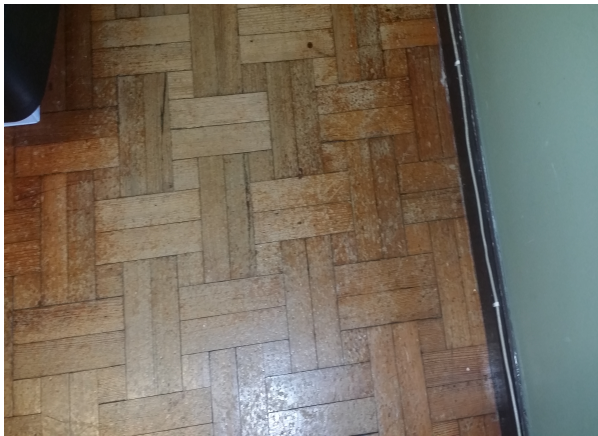
Item 56 – As 106221-17

The adhesive backing to parquet floor (0/27 Photocopy Room) does not contain asbestos.

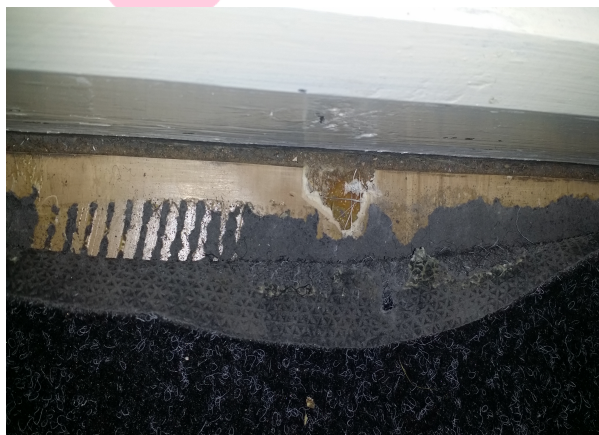
Item 57 – 106221-15

The subfloor (0/29 Corridor) does not contain asbestos.

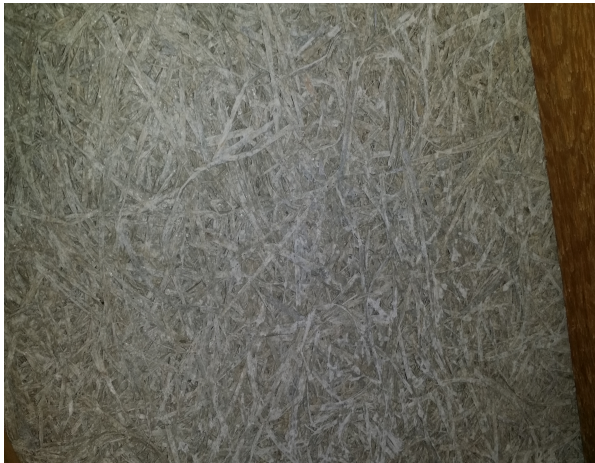
Item 58 – As 106221-1

The underside of roof (0/29 Corridor – void above) does not contain asbestos.

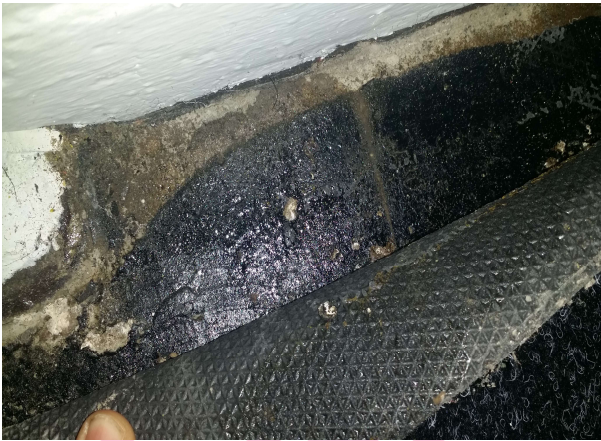
Item 59 – As 106221-16

The remnant adhesive backing to floor covering (0/32 Toilets) does contain asbestos.

Any change in appearance should be reported to Property Services.

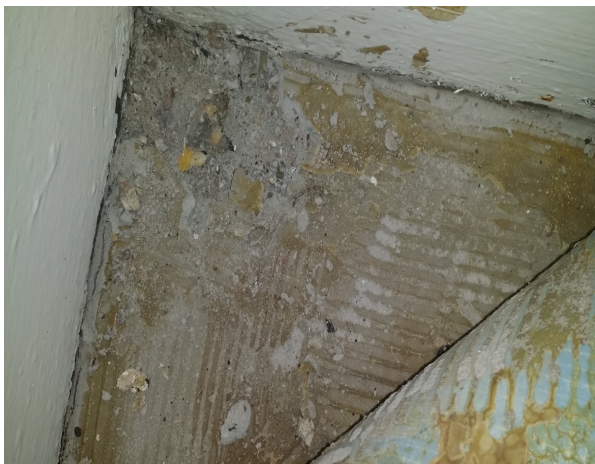
Item 60 – As 106221-16

The remnant adhesive backing to floor covering (0/35 Toilet lobby) does contain asbestos.

Any change in appearance should be reported to Property Services.

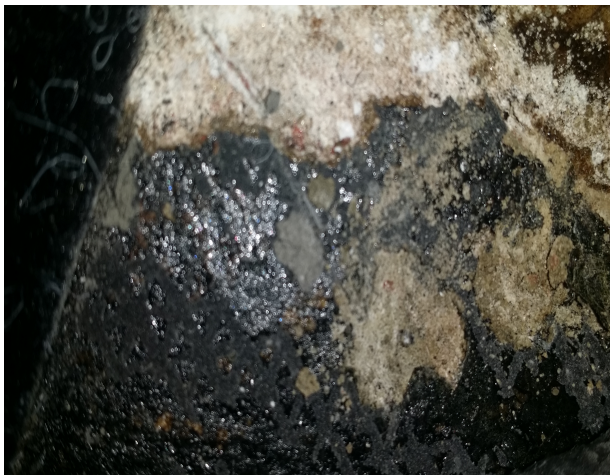
Item 62 – 106221-16

The remnant adhesive backing to floor covering (0/37 Corridor) does contain asbestos.

Any change in appearance should be reported to Property Services.

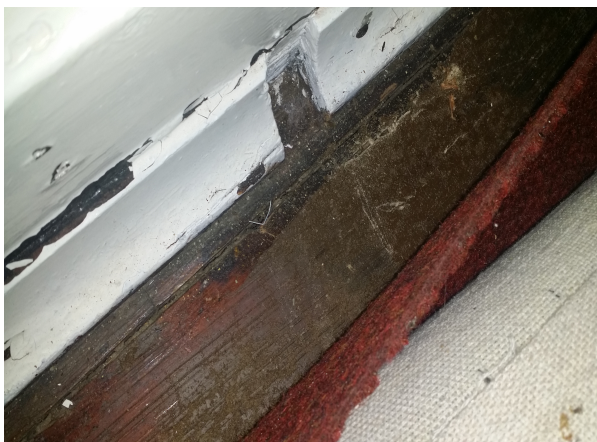
Item 63 – As 106221-14

The adhesive to back of parquet flooring (0/38 Creche) does not contain asbestos.

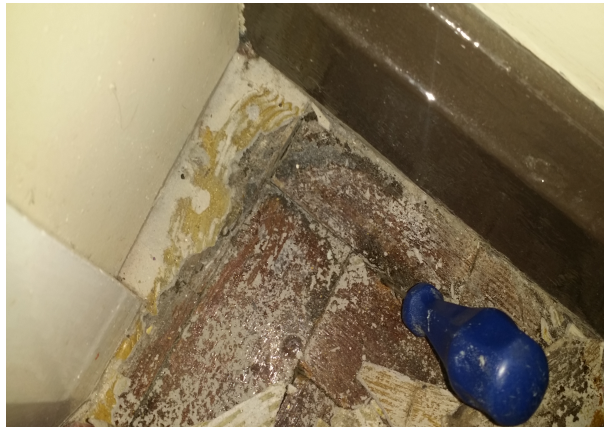
Item 64 – 106221-14

The adhesive to back of parquet flooring (0/39 Soft Play) does not contain asbestos.

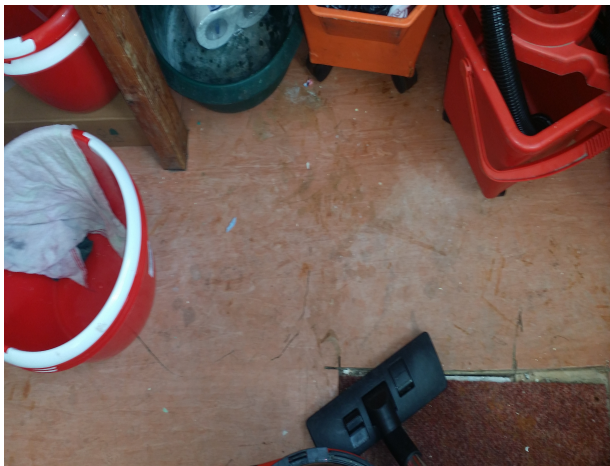
Item 65 – As 106221-8

The floor covering (0/40 Store) does not contain asbestos.

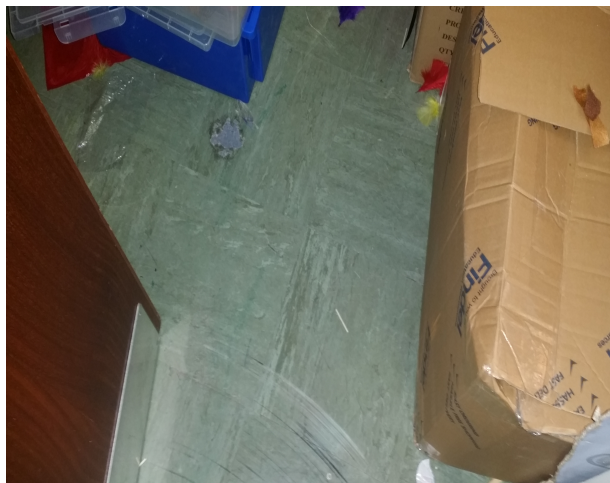
Item 66 – 106221-12

The floor covering (0/41 Store) does not contain asbestos.

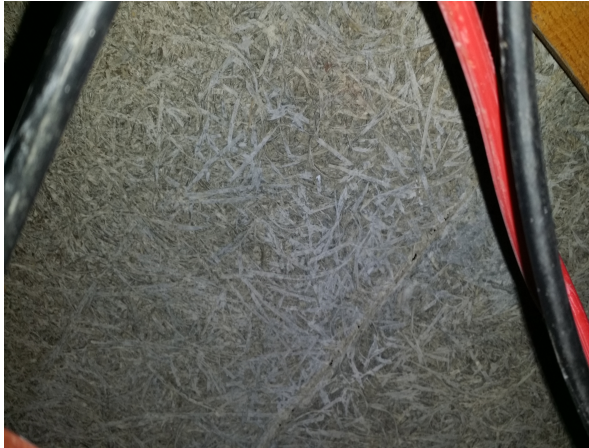
Item 67 – As 106221-1

The underside of roof (0/48 Corridor – void above) does not contain asbestos.
