ASBESTOS SURVEY REPORT FOR SOUTH HYLTON PRIMARY SCHOOL, SUNDERLAND

Asbestos Register for SOUTH HYLTON PRIMARY SCHOOL, SUNDERLAND

Date: 20 March 2025

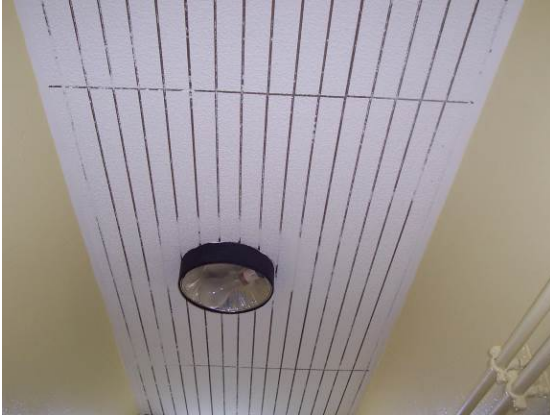
Item 1 Ref: Sample NO06/531

The ceiling boards in the staff gents/female toilet does not contain asbestos.

Similar ceilings are located in the Ladies WCs and head teachers office.

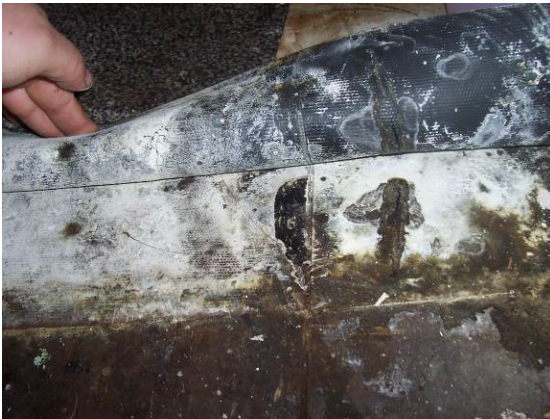
Item 2 - Ref: Sample NO06/532

The floor tiles in the electrical intake room do not contain asbestos.

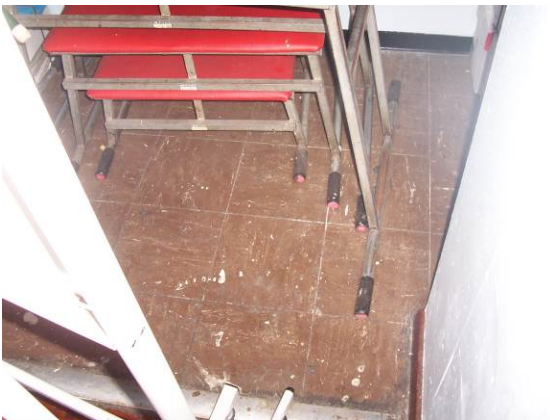
Item 3 - Ref: Sample NO06/533

The floor tiles in hall store 1 do not contain asbestos.

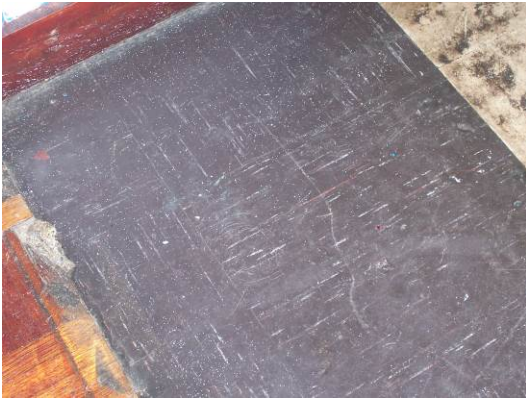
Item 4 - Ref: Sample NO06/534

The black floor tiles to hall store 2 entrance do not contain asbestos.

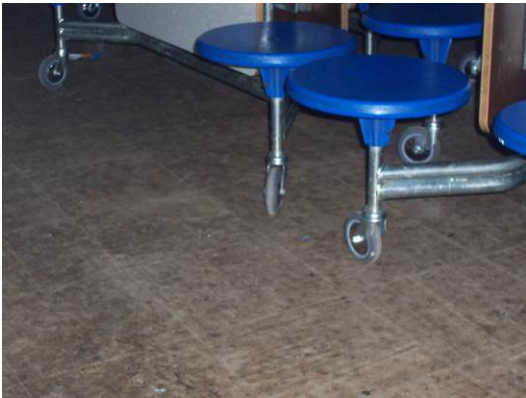
Item 5 - Ref: Sample NO06/535

The hall store 2 floor tiles do not contain asbestos.

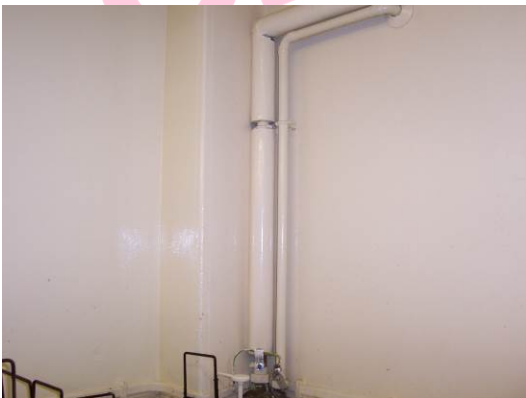
Item 6 - Ref: Sample NO06/536

The pipe insulation in kitchen main floor area does not contain asbestos.

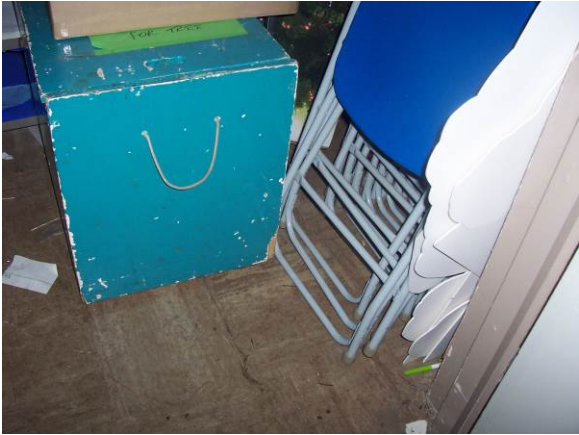
Item 7 - Ref: Sample NO06/537

The floor tiles in the community store do not contain asbestos.

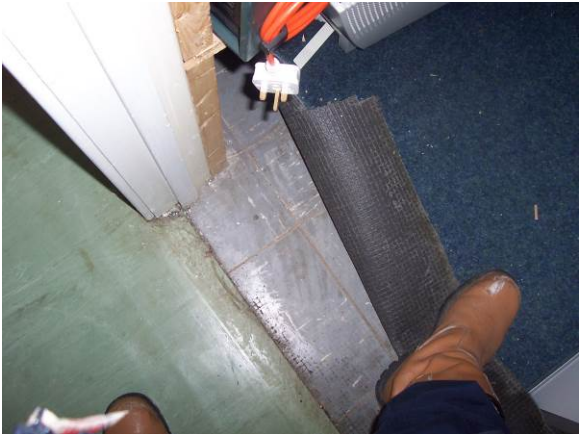
Item 8 - Ref: Sample NO06/538

The floor tiles in computer store do not contain asbestos.

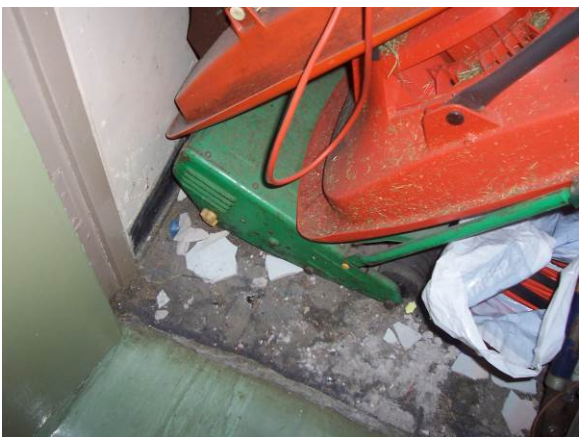
Item 9 – Ref: Sample NO06/539

The floor tiles in junior practical 2 (electrical intake) room do not contain asbestos.

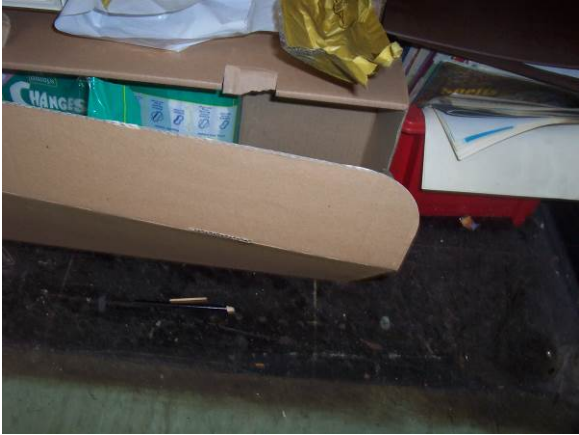
Item 10 - Ref: Sample NO06/540

The floor tiles in junior practical 2 paper store do not contain asbestos.

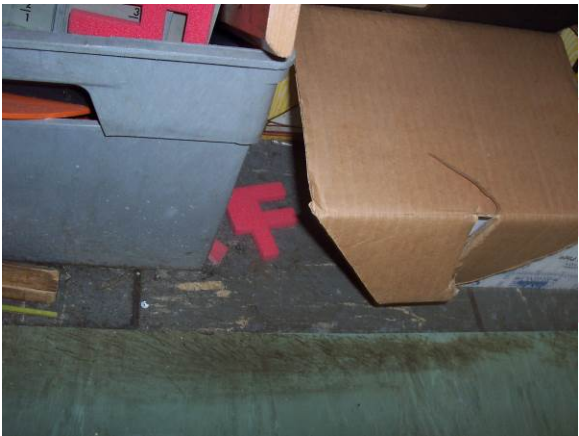
Item 11 – Ref: Sample NO06/541

The floor tiles in junior practical 2 book store do not contain asbestos.

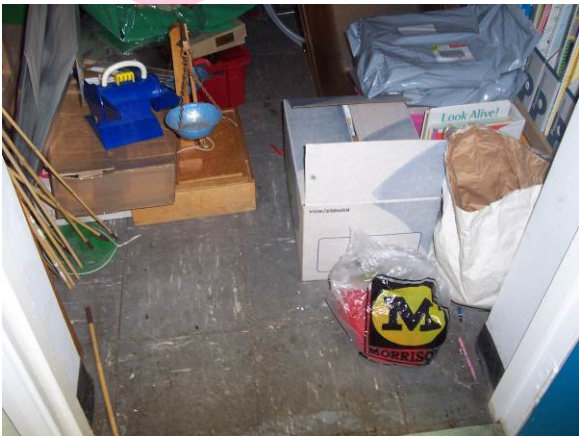
Item 12 – Ref: Sample NO06/542

The floor tiles in Junior Practical 2 Equipment store room do not contain asbestos.

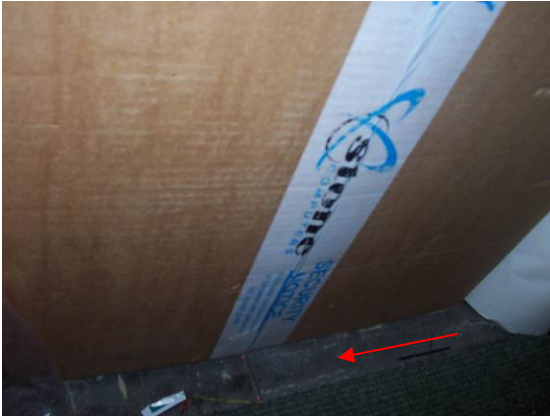
Item 13 – Ref: Sample NO06/543

The floor tiles in junior class 4 store do not contain asbestos.

Similar floor tiles are located in Jnr class 1, 2 and 5 store, reception class 1 store, reception waiting room store and Jnr practical and cloaks store.

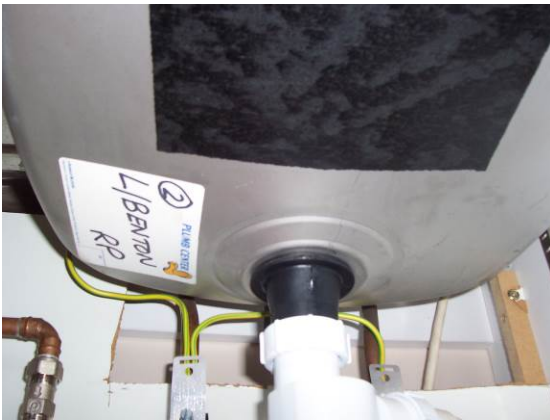
Item 14 – Ref: Sample NO06/544

The sink pad in Junior class 6 does not contain asbestos.

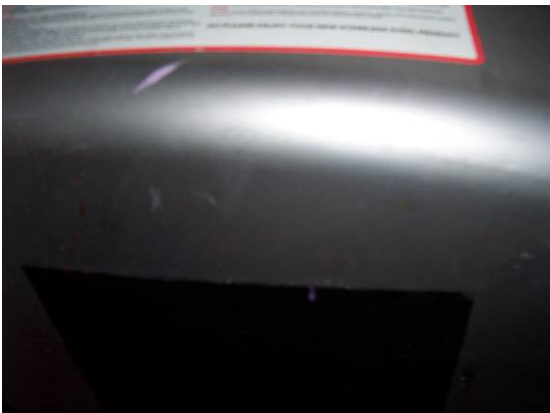
Item 15 – Ref: Sample NO06/545

The sink pad in Junior class 7 does not contain asbestos.

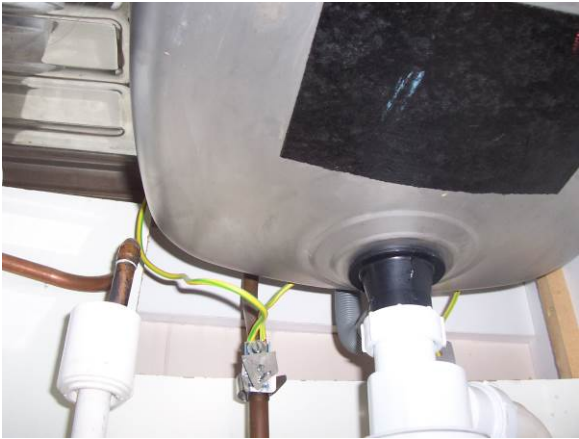
Item 16 – Ref: Sample NO06/546

The sink pad in Junior class 8 does not contain asbestos.

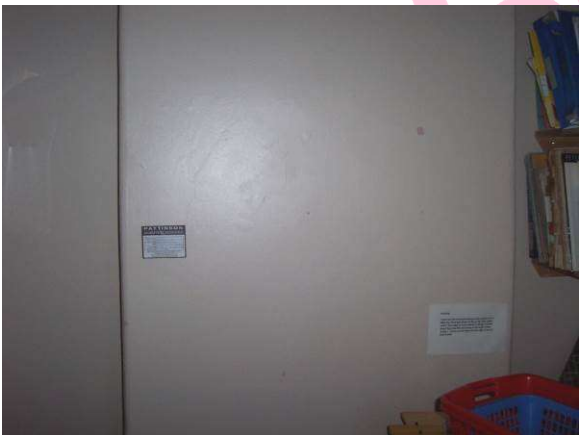
Item 17 – Ref: Sample NO06/547

The insulation to the heater in the infants class 3 store does not contain asbestos.

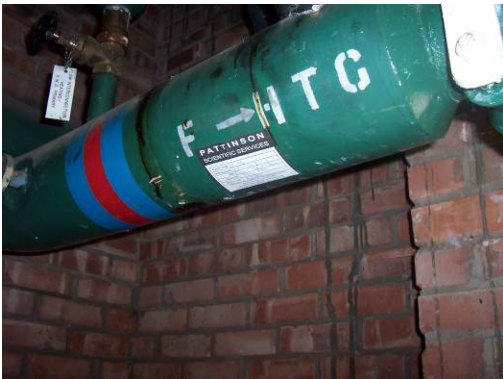
Item 18 – Ref: Sample NO06/548

The pipe insulation in the boiler room does not contain asbestos.

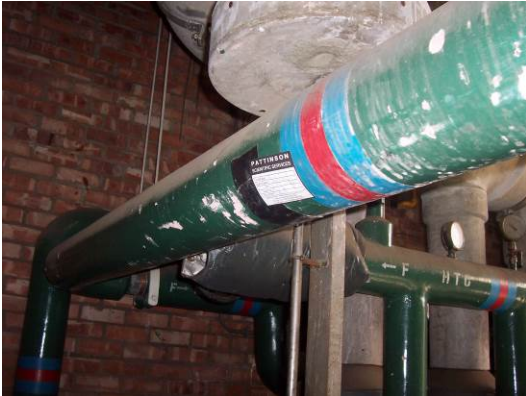
Item 19 – Ref: Sample NO06/549

The pipe insulation in the boiler room does not contain asbestos.

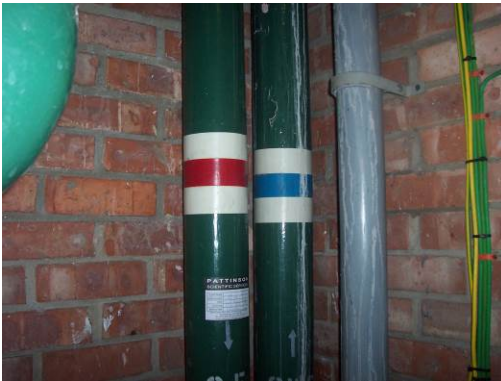
Item 20 – Ref: Sample NO06/550

The pipe insulation in the boiler room does not contain asbestos.

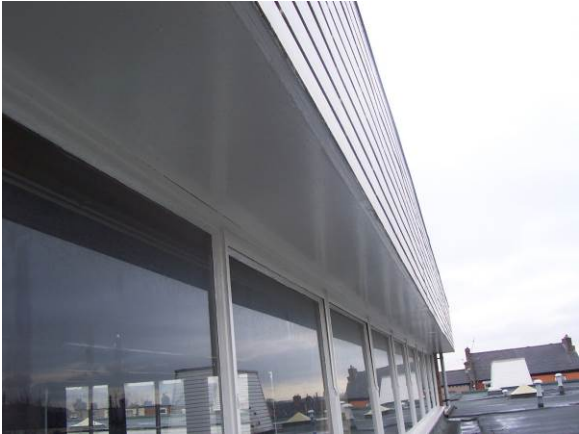
Item 22 – Ref: Sample NO06/555

The soffit boards to the hall do not contain asbestos.

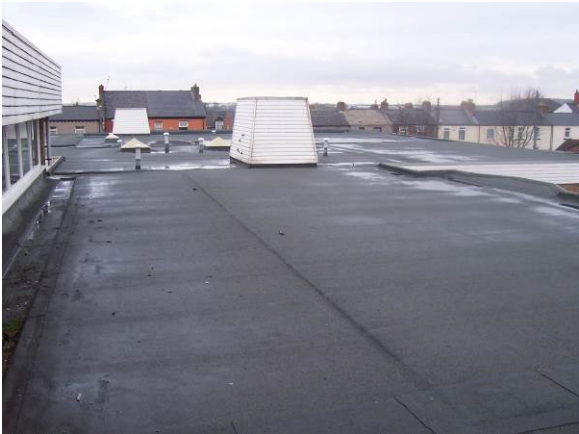
Item 23 – Ref: Sample NO06/556

The felt to the roof does not contain asbestos.

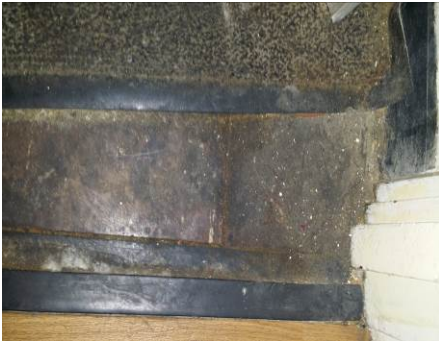
Item 24 – Ref: 107247-2

The floor covering to the electrical cupboard contains asbestos.

Any change in its appearance should be noted and passed to Property Services.

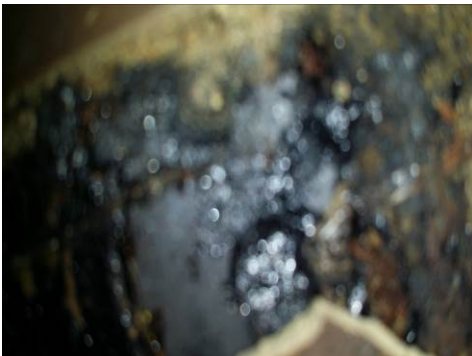
Item 25 – Ref: 107247-3

The adhesive to the flooring in the electrical cupboard contains asbestos.

Any change in its appearance should be noted and passed to Property Services.

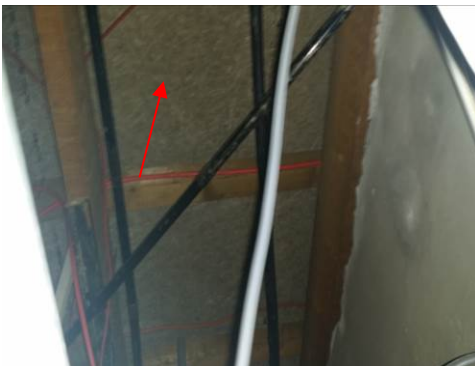
Item 26 – Ref: 107247-1

The underside of the roof in the void above the electrical cupboard does not contain asbestos.

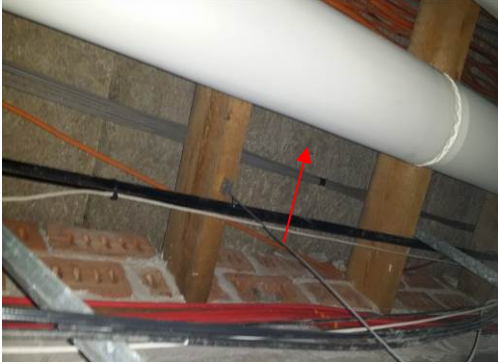
Item 27 – As 107247-1

The underside of the roof in the void above the stock room does not contain asbestos.

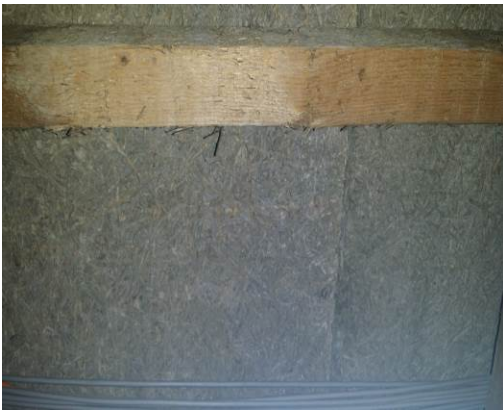
Item 28 – As 107247-1

The underside of the roof in the void above the corridor does not contain asbestos.

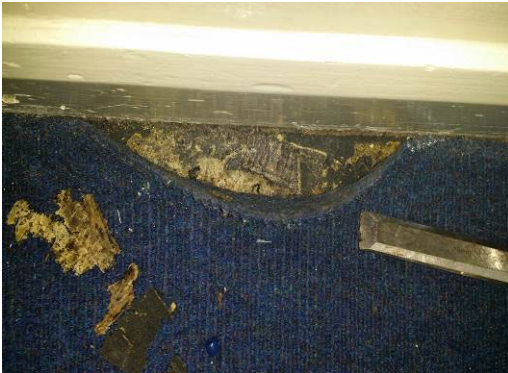
Item 34 – Ref: 107247-6

The screed to the floor in the nursery/practical area contains asbestos.

Removed - However no paperwork or waste certificates held. Item has to remain on register until this paperwork is received.

Any change in its appearance should be noted and passed to Property Services.

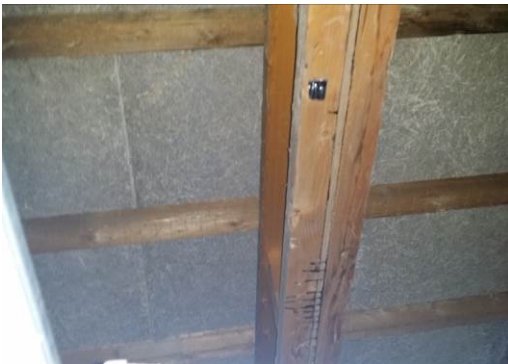
Item 35 – As 107247-4

The underside of the roof in the void above the nursery/practical area does not contain asbestos.

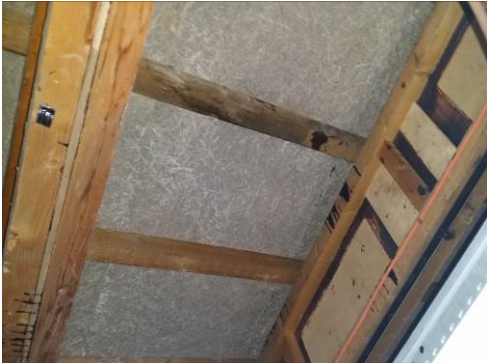
Item 36 – As 107247-4

The underside of the roof in the void above the store does not contain asbestos.

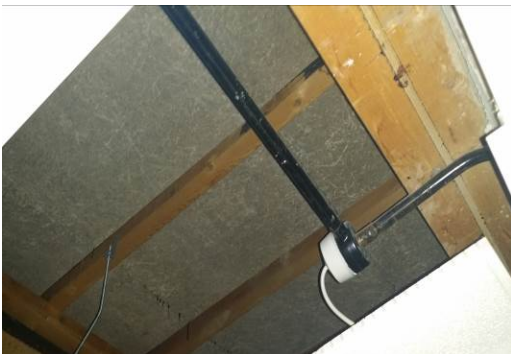
Item 38 – Ref: 107247-5

The underside of the roof in the void above the Resources cupboard does not contain asbestos.

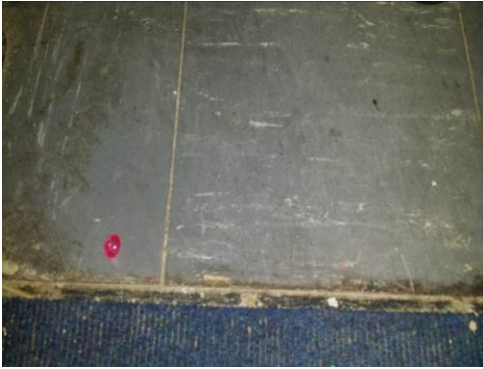
Item 39 – Ref:107247-5

The floor covering to the reception classroom area contains asbestos.

Removed - However no paperwork or waste certificates held. Item has to remain on register until this paperwork is received.

Any change in its appearance should be noted and passed to Property Services.

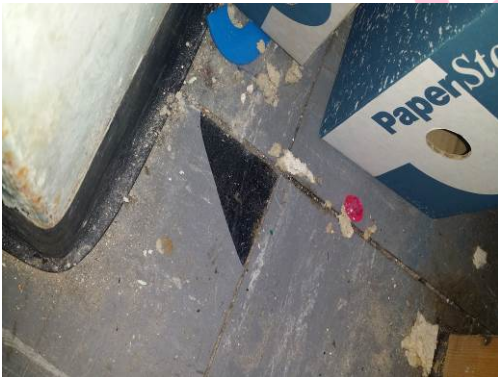
Item 40 – As 107247-6

The screed to floor in the reception classroom contains asbestos.

Removed - However no paperwork or waste certificates held. Item has to remain on register until this paperwork is received.

Any change in its appearance should be noted and passed to Property Services.

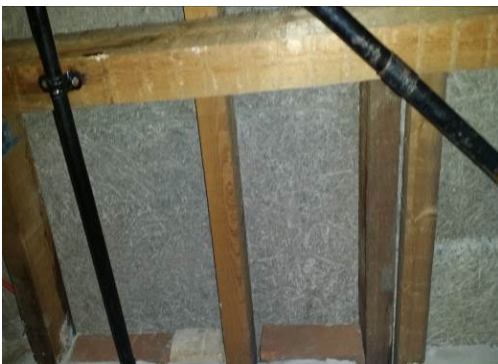
Item 41 – As 107247-5

The underside of the roof in the void above the reception classroom area does not contain asbestos.

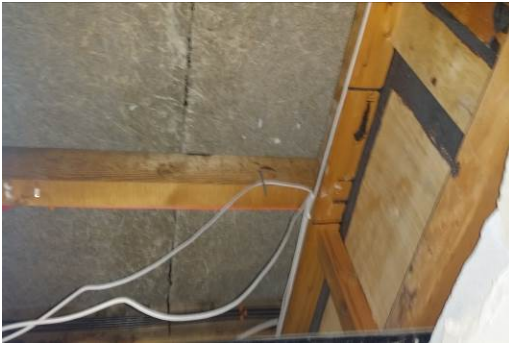
Item 43 – As 107247-8

The underside of the roof in the void above the store does not contain asbestos.

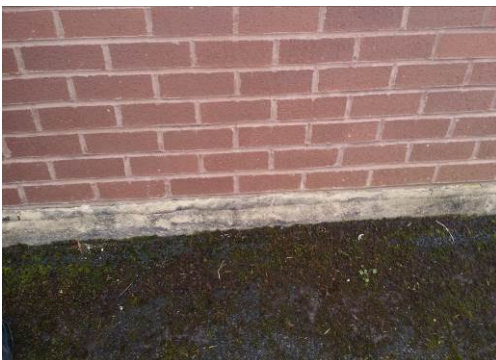
Item 47 – Ref: 107247-10

The damp proof course to the external does not contain asbestos.

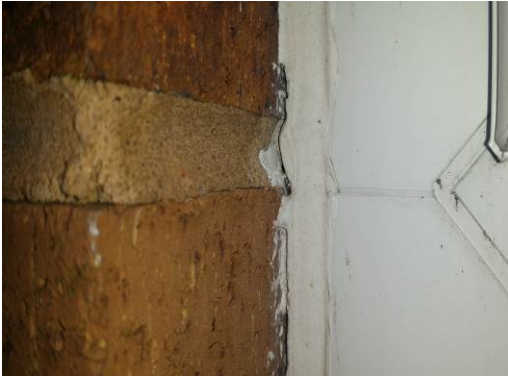
Item 48 – Ref:107247-11

The remnant mastic to the window and door frames to the external contains asbestos.

Any change in its appearance should be noted and passed to Property Services.

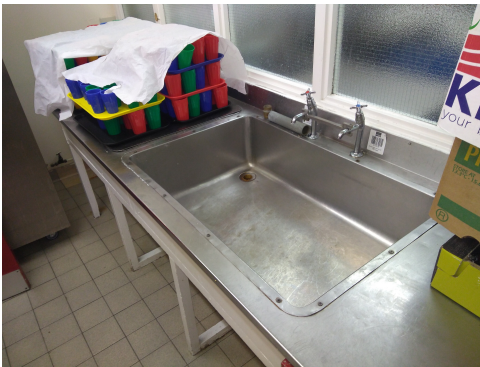
Item 49 – Ref 277974-1

The acoustic paint to underside of sinks in the kitchen does not contain asbestos.

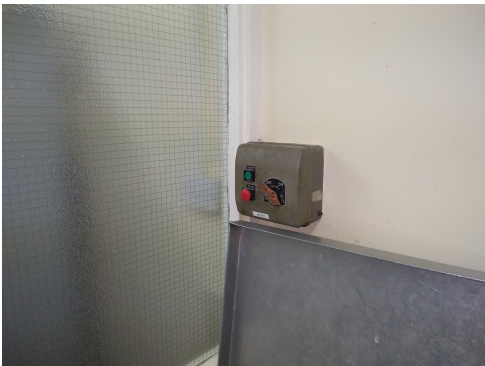
Item 50 – Ref Presumed

The electrics in the kitchen is presumed to contain asbestos.

Further investigation will be required before any work can commence.

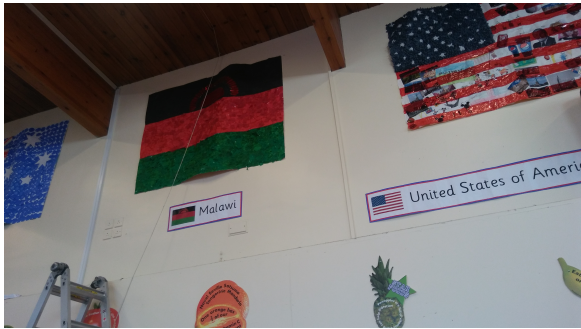
Item 51 – Ref: 288787-1

The coating to the wall in the hall does not contain asbestos.

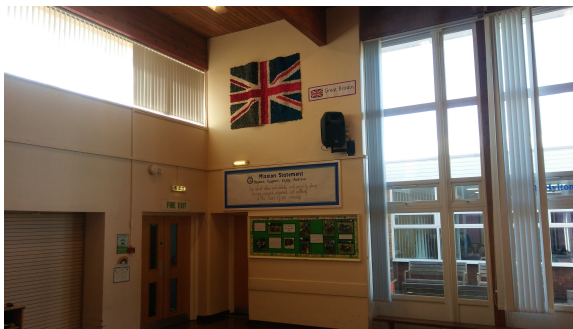
Item 52 – Ref 288787-2

The plaster to the wall in the hall does not contain asbestos.

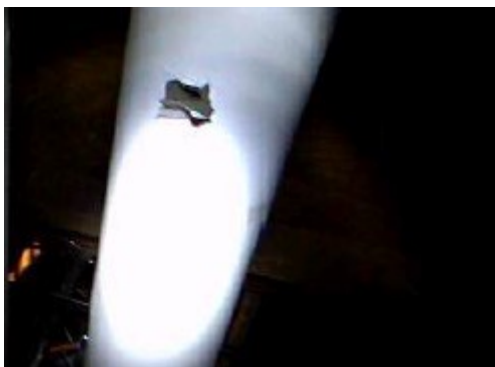
Item 53 – Ref BB000978

The Pipe lagging in Room 1 (Water Tank 1) does not contain asbestos.

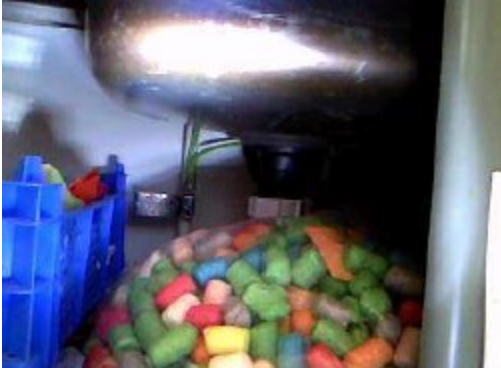
Item 54 – Ref BB000979

The Sink Pad in Room 4 (Nursery sink area) does not contain asbestos.

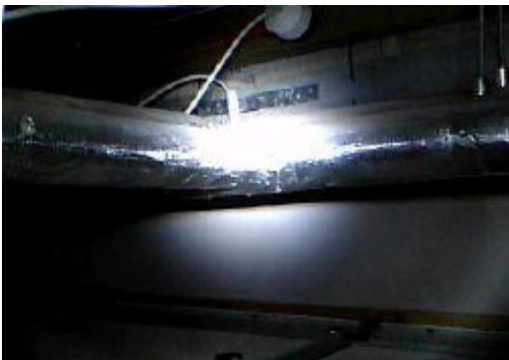
Item 55 – Ref As BB000978

The Pipe lagging in Room 6 (Water Tank 2) does not contain asbestos.

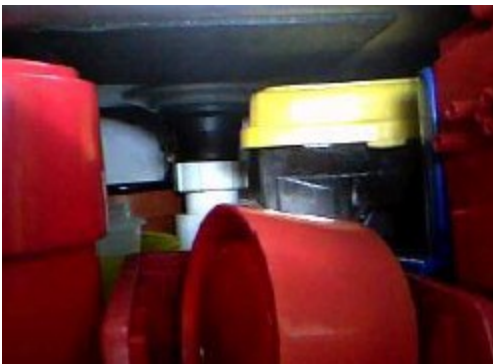
Item 56 – Ref BB000980

The Sink Pad in Room 7 (Reception sink area) does not contain asbestos.

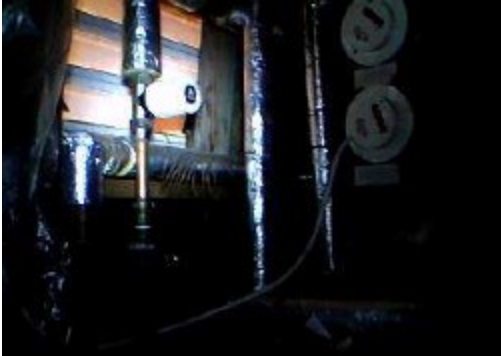
Item 57 – Ref As BB000978

The Pipe lagging in Room 10 (Water Tank 3) does not contain asbestos.

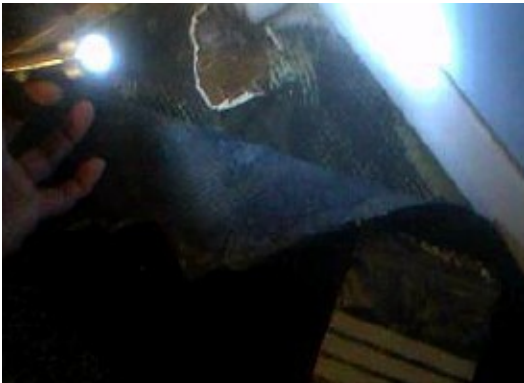
Item 76 – Ref CB007003

The Carpet to sampled lino (Room 1 Key stage 1 activity area) does not contain asbestos.

Further investigation will be required before any work can commence.

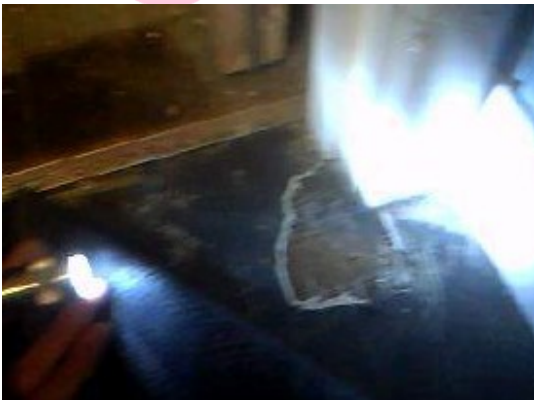
Item 77 – Ref CB007004

The Bitumen adhesive below lino (Room 1 Key stage 1 activity area) does not contain asbestos.

Further investigation will be required before any work can commence.

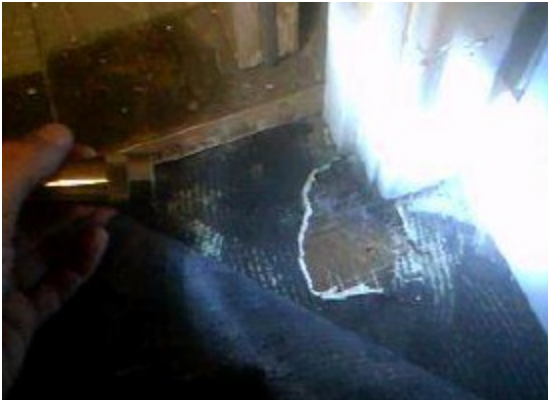
Item 78 – Ref CB007005

The Ashfelt floor (Room 1 Key stage 1 activity area) contains asbestos.

Further investigation will be required before any work can commence.

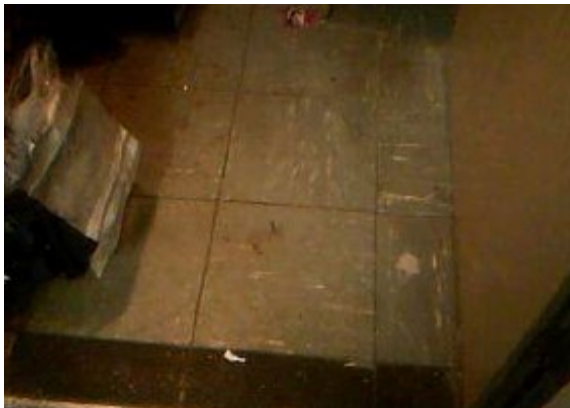
Item 79 – Ref CB007006

The Floor tiles (Room 2 Resource cupboard 1) contain asbestos – possibly overlaid

Further investigation will be required before any work can commence.

Any change in its appearance should be noted and passed to Property Services.

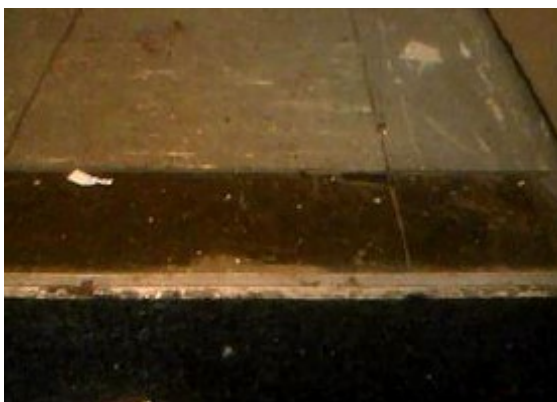
Item 80 – Ref CB007007

The Bitumen below floor tiles (Room 2 Resource cupboard 1) contain asbestos – possibly overlaid

Further investigation will be required before any work can commence.

Any change in its appearance should be noted and passed to Property Services.

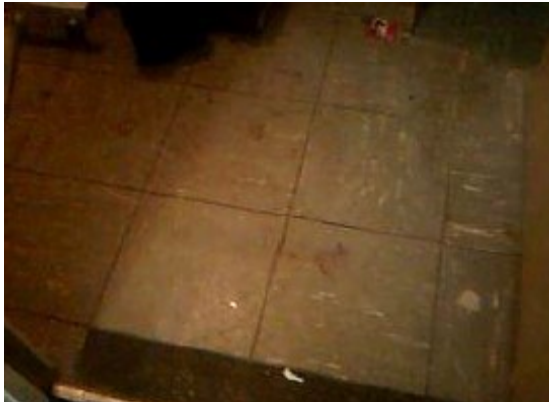
Item 81 – Ref As CB007005

The Ashfelt floor (Room 2 Resource cupboard 1) contains asbestos – possibly overlaid

Further investigation will be required before any work can commence.

Any change in its appearance should be noted and passed to Property Services.

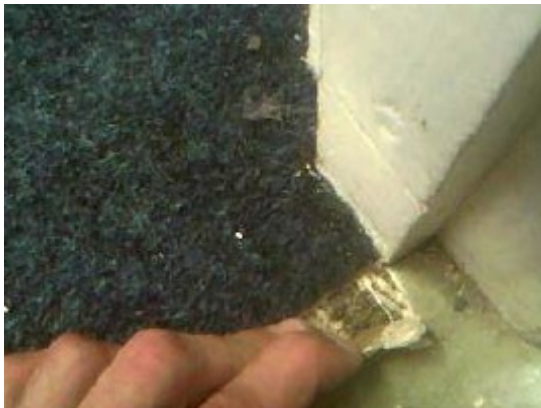
Item 82 – Ref As CB007004

The Bitumen adhesive below lino (Room 3 Resource cupboard 2) does not contain asbestos – possibly overlaid

Further investigation will be required before any work can commence.

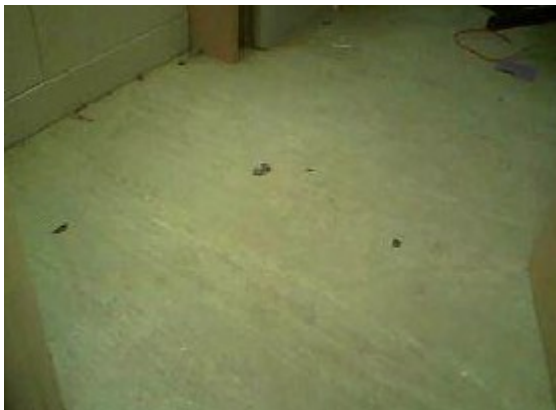
Item 83 – Ref As CB007005

The Ashfelt floor (Room 3 Resource cupboard 2) contains asbestos – possibly overlaid

Further investigation will be required before any work can commence.

Any change in its appearance should be noted and passed to Property Services.

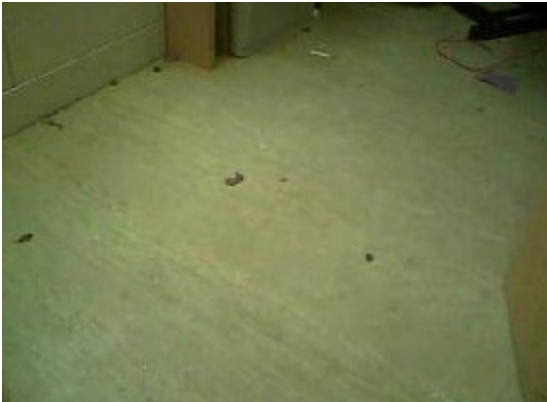
Item 84 – Ref As CB007003

The Lino (Room 3 Resource cupboard 2) does not contain asbestos – possibly overlaid

Further investigation will be required before any work can commence.

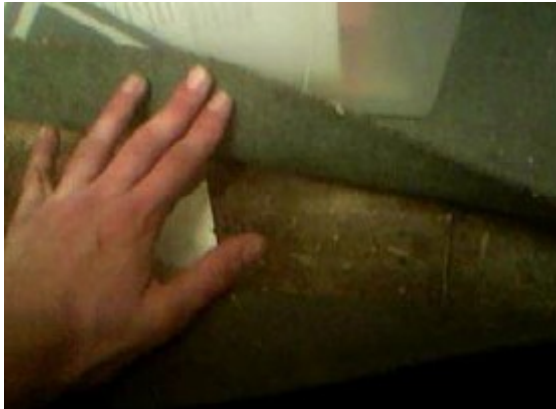
Item 85 – Ref As CB007006

The Floor tiles below carpet (Room 4 Resource cupboard 3) contains asbestos – possibly overlaid

Further investigation will be required before any work can commence.

Any change in its appearance should be noted and passed to Property Services.

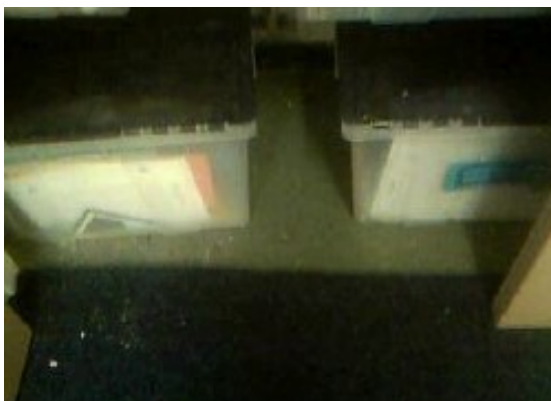
Item 86 – Ref As CB007007

The Bitumen below floor tiles (Room 4 Resource cupboard 3) contains asbestos – possibly overlaid

Further investigation will be required before any work can commence.

Any change in its appearance should be noted and passed to Property Services.

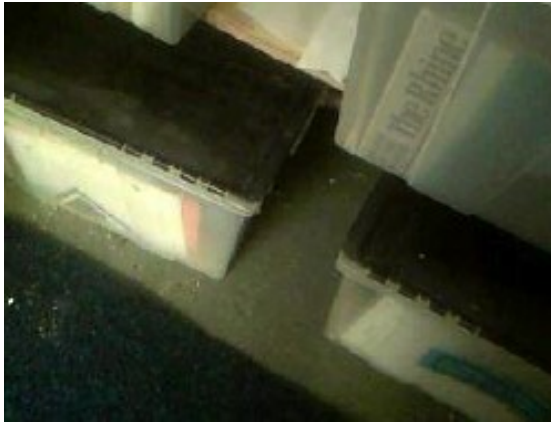
Item 87 – Ref As CB007005

The Ashfelt floor (Room 4 Resource cupboard 3) contains asbestos – possibly overlaid

Further investigation will be required before any work can commence.

Any change in its appearance should be noted and passed to Property Services.

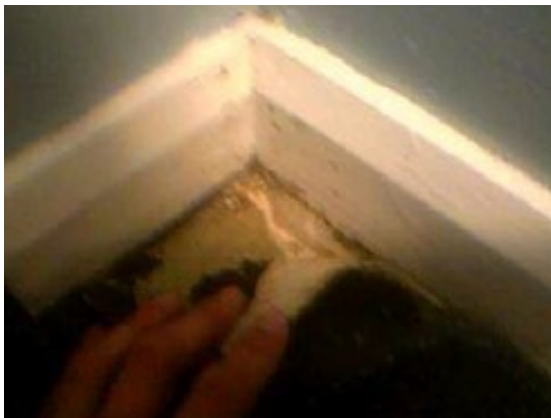
Item 88 – Ref As CB007003

The Newly fitted carpet to lino to concrete floor (Room 5 Keystage 2 corridor) does not contain asbestos.

Further investigation will be required before any work can commence.

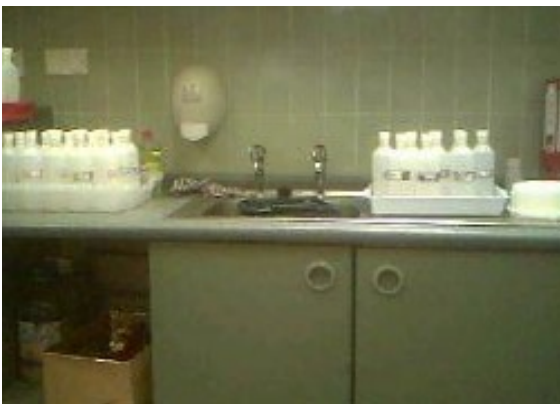
Item 89 – Ref CB007008

The Bitumen pads to underside of sink and drainer (Nursery Kitchen) does not contain asbestos.

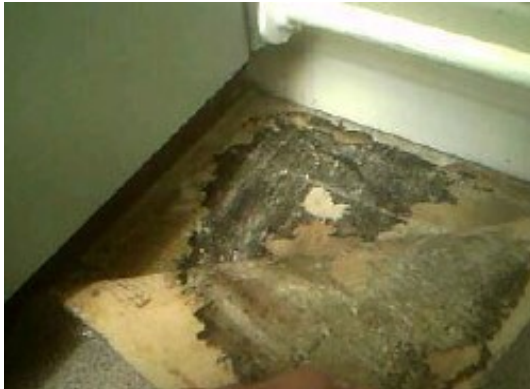
Item 90 – Ref CB007009

The Lino to bitumen (Nursery Kitchen) contains asbestos – possibly overlaid

Further investigation will be required before any work can commence.

Any change in its appearance should be noted and passed to Property Services.

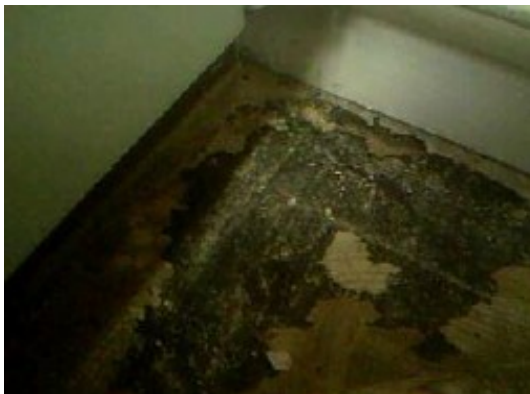
Item 91 – Ref CB007010

The Ashfelt floor (Room 6 Nursery Kitchen) contains asbestos – possibly overlaid

Further investigation will be required before any work can commence.

Any change in its appearance should be noted and passed to Property Services.

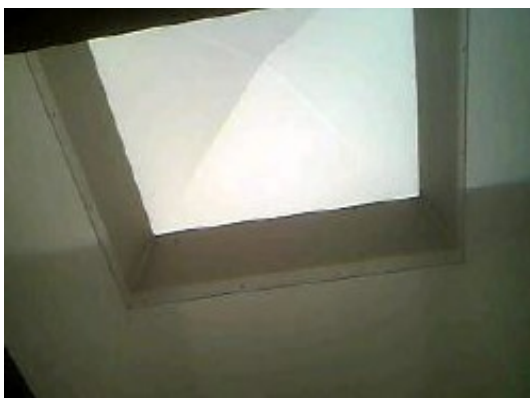
Item 92 – Ref Presumed

The Rope seal to skylight (Room 6 Nursery Kitchen) is presumed to contain asbestos.

Further investigation will be required before any work can commence.

Any change in its appearance should be noted and passed to Property Services.

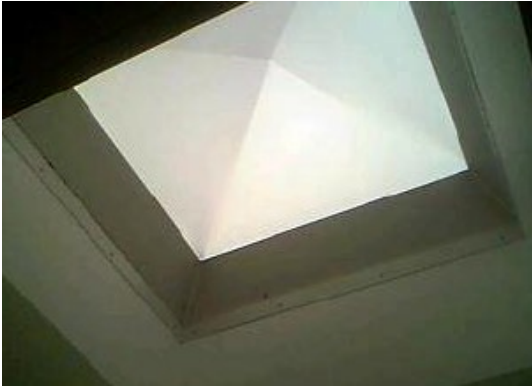
Item 93 – Ref Presumed

The rope seal to skylight although not visible limited access without causing possible damage (Room 3 Resource Cupboard 2) is presumed to contain asbestos.

Any change in its appearance should be noted and passed to Property Services.

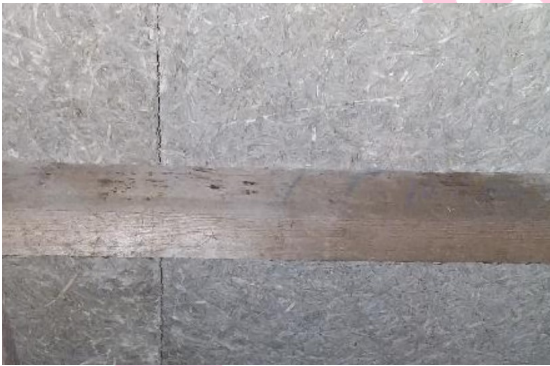
Item 94 – Ref VK001283

The strammit board to underside of roof throughout ground floor does not contain asbestos.

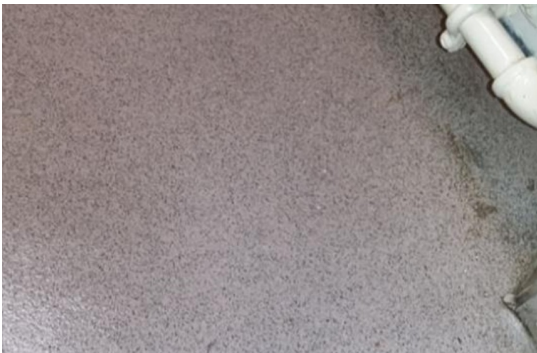
Item 95 – Ref JS000384

The Bitumen adhesive to floor beneath screed and modern vinyl floor covering (WC 02) does contain asbestos.

Any change in its appearance should be noted and passed to Property Services.

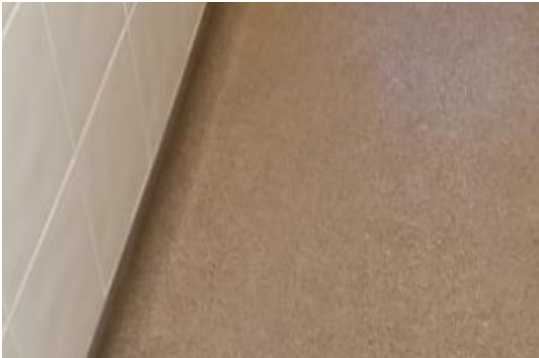
Item 96 – Ref As JS000384

The Bitumen adhesive to floor beneath screed and modern vinyl floor covering (WC 01) does contain asbestos.

Any change in its appearance should be noted and passed to Property Services.

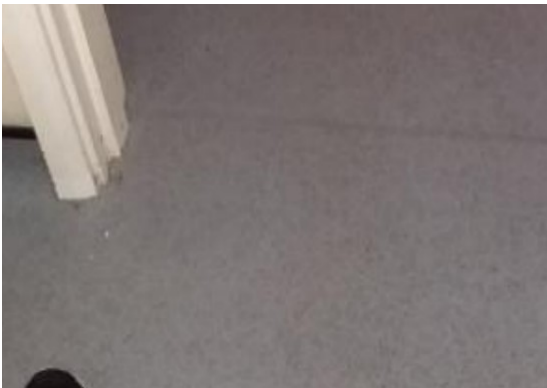
Item 97 – Ref As JS000384

The Bitumen adhesive to floor beneath screed and modern vinyl floor covering (WC 05) does contain asbestos.

Any change in its appearance should be noted and passed to Property Services.
