ASBESTOS SURVEY REPORT FOR COLUMBIA COMMUNITY ASSOCIATION,
OXCLOSE ROAD, WASHINGTON, NE38 8ND.

Asbestos Register for Columbia CA, Oxclose Road, Washington, NE38 8ND

Date: 06 January 2023

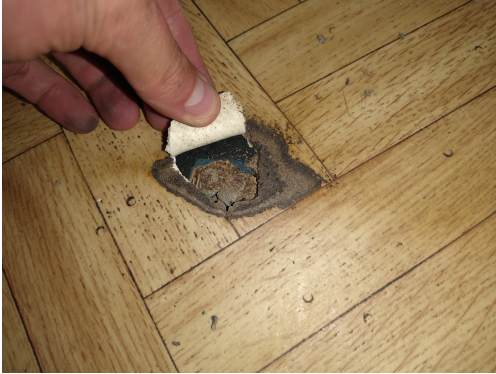
Item 1 Ref: 416024-1

The subfloor in the playroom (Rm 0/002) does not contain asbestos.

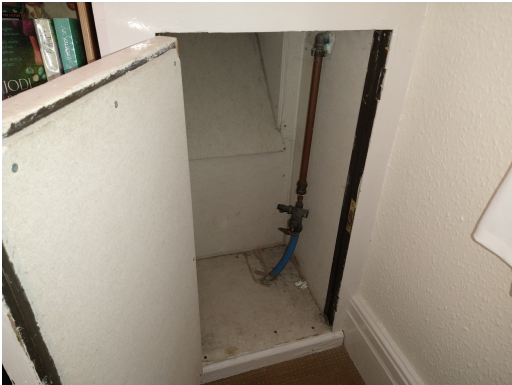
Item 2 Ref: 416024-2

The lining to cupboard in the office (Rm 0/003) does not contain asbestos.

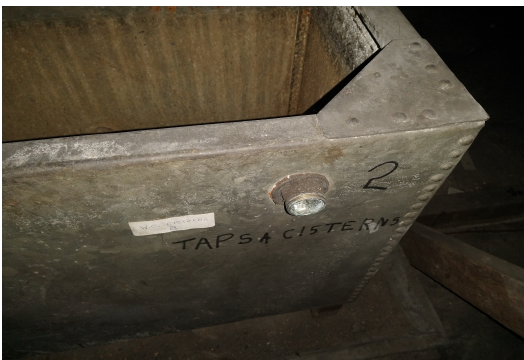
Item 3 Ref: 416024-3

The gasket to redundant water tank in the void above corridor (Rm 0/004) does not contain asbestos.

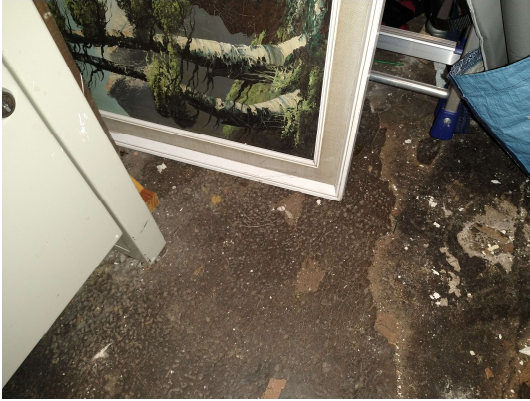
Item 4 Ref: 416024-4

The floor covering in the cleaning cupboard (Rm 0/006) does not contain asbestos.

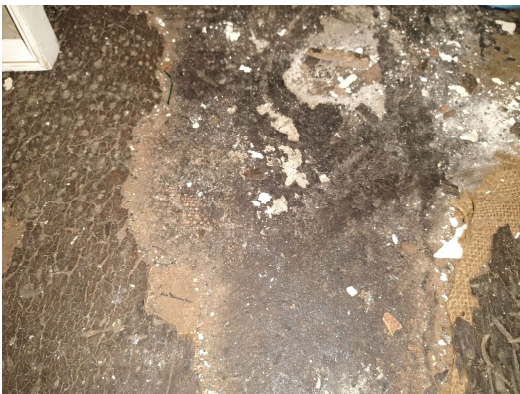
Item 5 Ref: 416024-5

The adhesive to floor in the cleaners cupboard (Rm 0/006) does not contain asbestos.

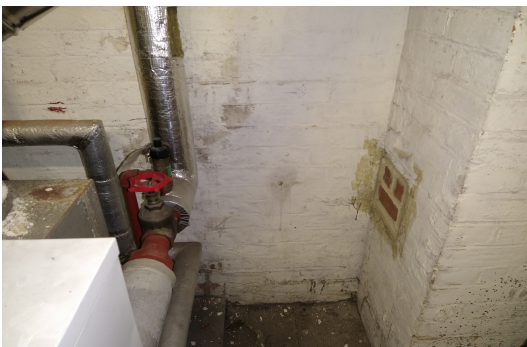
Item 6 Ref: 416024-6

- (Item 6) Ref: 416024-6 – Debris to wall (0/011 Boiler Room) – Low Risk
- (Item 7) Ref: Presumed – Electrics (0/011 Boiler Room) – Very Low Risk
- (Item 8) Ref: 416024-7 – Panels behind radiators (0/012 Hall) – Low Risk

The debris to the wall in the boiler room (Rm 0/011) does contain asbestos. This has been encapsulated previously however any change in appearance should be reported to Property Services.

Item 5	No asbestos	Is present		
Item 6	Debris to wall (0/011 Boiler Room)	Low Risk	6 monthly	26/06/2023
Item 7	Electrics (0/011 Boiler Room)	Very Low Risk	12 monthly	26/6/2023

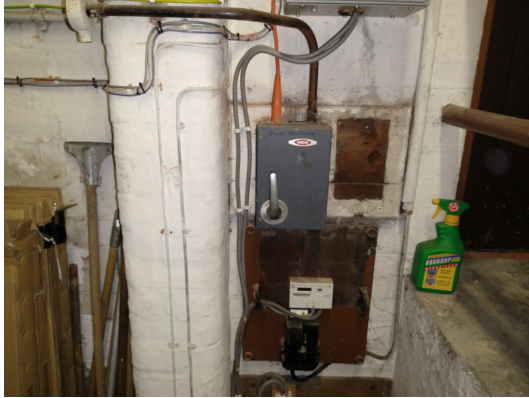
Item 7 Ref: Presumed

The electrics in the boiler room (Rm 0/011) are presumed to contain asbestos.

Further investigation is required if works are planned. Any change in appearance should be reported to Property Services.

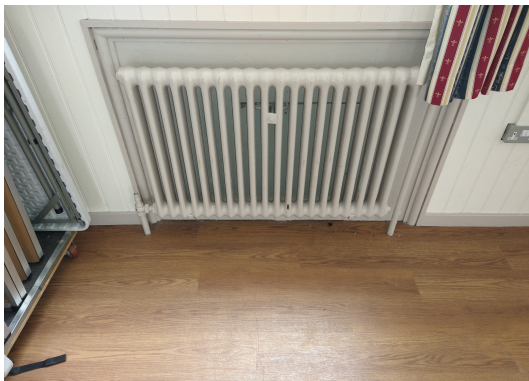
Item 8 Ref: 416024-7

The panels behind the radiators in the hall (Rm 0/012) contain asbestos.

Item 8	Panels behind radiators (0/012 Hall)	Low Risk	6 monthly	26/06/2023
Item 9	No asbestos	Is present		
Item 10	Telecommunication cowls (External)	Very Low Risk	12 monthly	26/6/2023

Any change in appearance should be reported to Property Services.

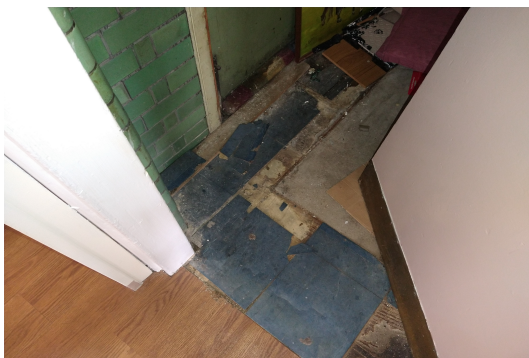
Item 9 Ref: 416024-8

The floor covering in the store (Rm 0/013) does not contain asbestos.

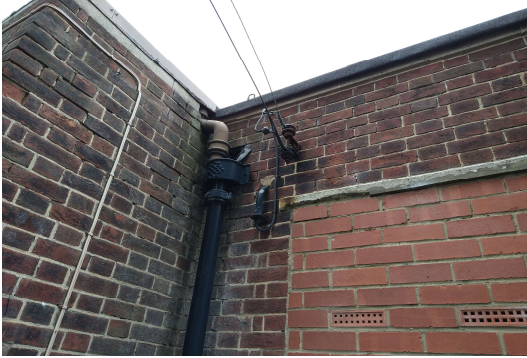
Item 10 Ref: Presumed

The telecommunication cowlings externally are presumed to contain asbestos.

Further investigation is required if works are planned. Any change in appearance should be reported to Property Services.

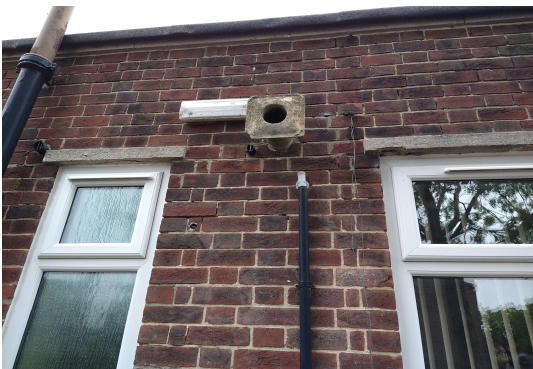
Item 11 Ref: 416024-9

The flue cowl externally contain asbestos.

Item 11	Flue cowl (External)	Very Low Risk	12 monthly	26/6/2023
Item 12	No asbestos	Is present		
Item 13	No asbestos	Is present		
Item 14	No asbestos	Is present

Any change in appearance should be reported to Property Services.

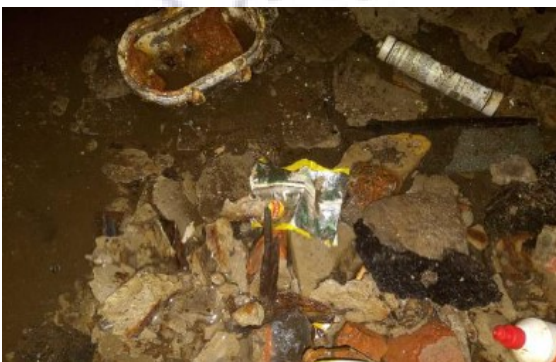
Item 12 Ref: 22-42203-1

The debris from roof lining to the floor in the main room of the air raid shelter does not contain asbestos.

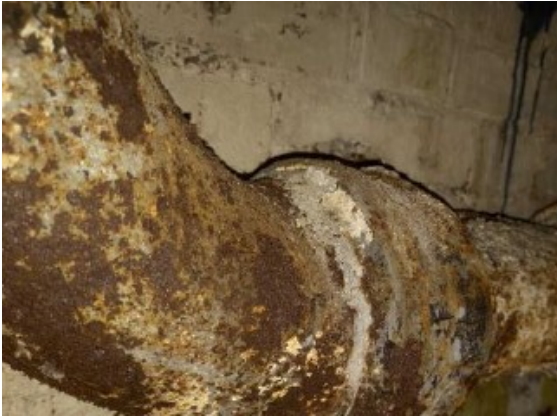
Item 13 Ref: 22-42203-2

The sealant within joints to the soil pipe in the main room of the air raid shelter does not contain asbestos.

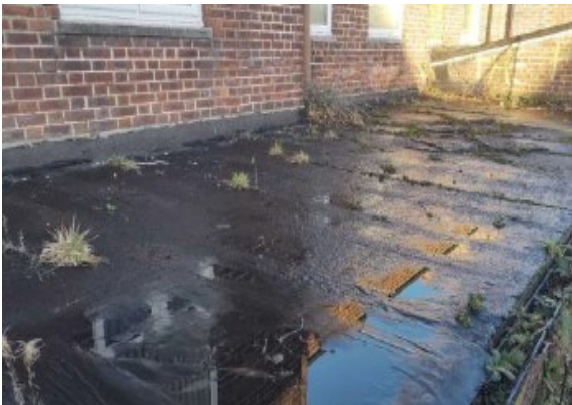
Item 14 Ref: 22-42203-1

The flat roof lining to the roof (External) of the air raid shelter does not contain asbestos.

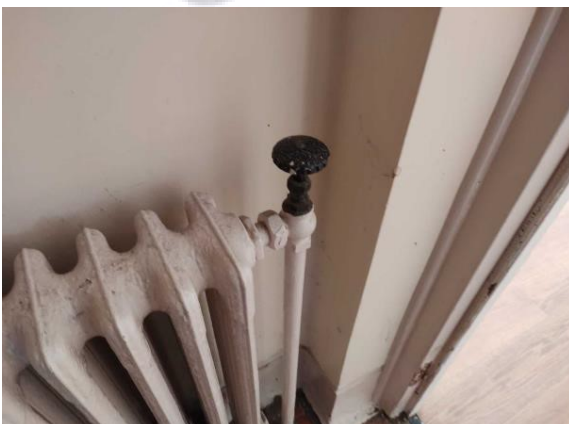
Item 15 Ref: 22-51008-3

The radiator knobs (Corridor/Area 2) do not contain asbestos.

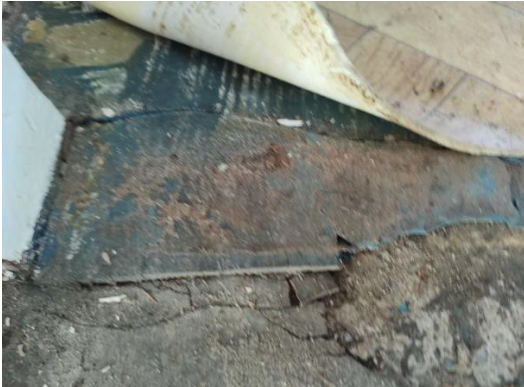
Item 16 Ref: 22-51008-1

The blue vinyl tiles below modern vinyl and carpet (Community Room/Area 3) do not contain asbestos.

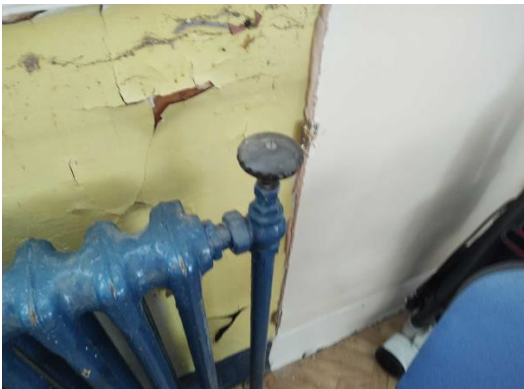
Item 17 Ref: 22-51008-3

The radiator knobs (Community Room/Area 3) do not contain asbestos.

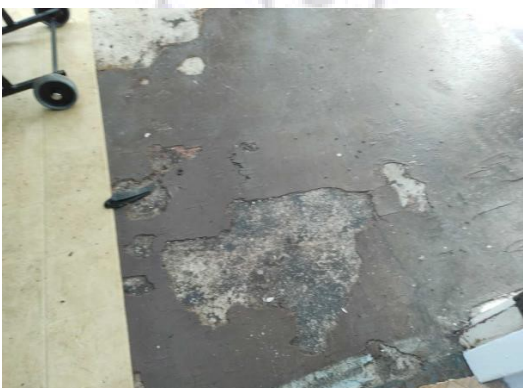
Item 18 Ref: 22-51008-2

The brown sheet vinyl (IT Room/Area 4) does not contain asbestos.

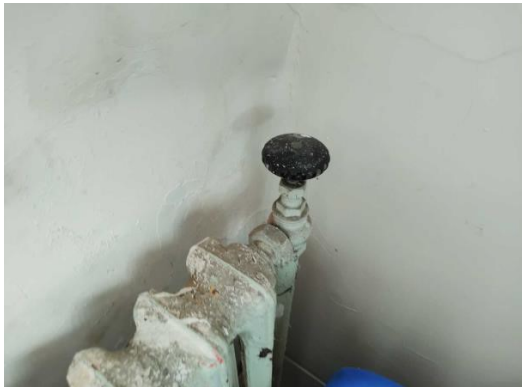
Item 19 Ref: 22-51008-3

The radiator knobs (IT Room/Area 4) do not contain asbestos.

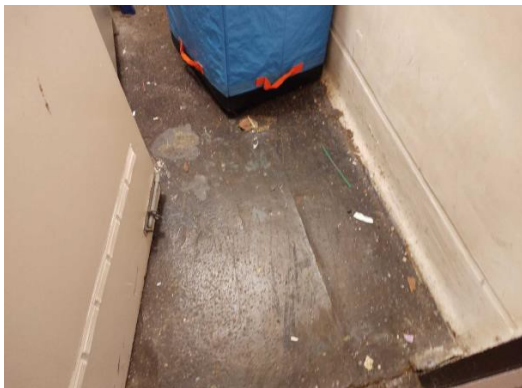
Item 20 Ref: 22-51008-2

The brown sheet vinyl (Emergency Lighting Room/Area 5) does not contain asbestos.

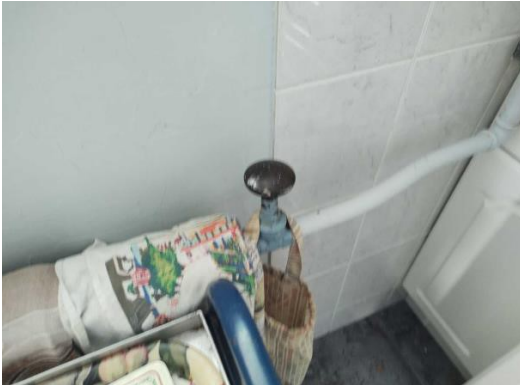
Item 22 Ref: 22-51008-3

The radiator knobs (Kitchen/Area 12) do not contain asbestos.

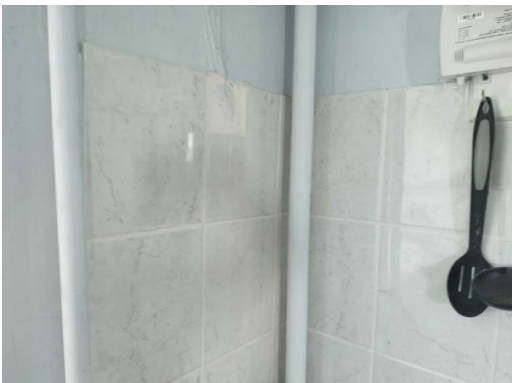
Item 23 Ref: 22-51008-5

The walls behind ceramic tiles (Kitchen/Area 12) do not contain asbestos.

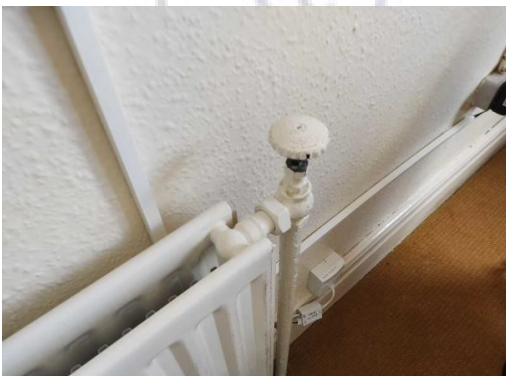
Item 24 Ref: 22-51008-3

The radiator knobs (Office/Area 15) do not contain asbestos.

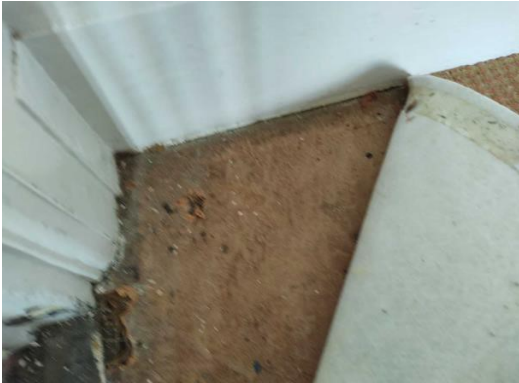
Item 25 Ref: 22-51008-6

The brown sheet vinyl below carpet (Office/Area 15) does not contain asbestos.

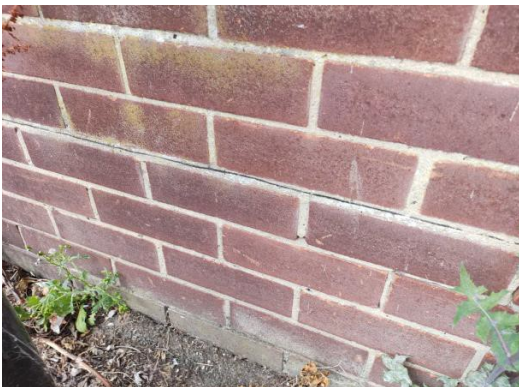
Item 26 Ref: 22-51008-7

The damp proof course (External/Area 16) does not contain asbestos.

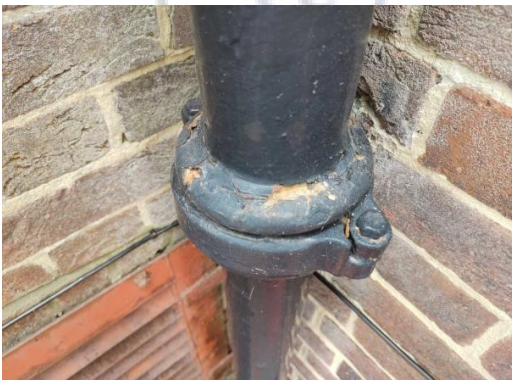
Item 27 Ref: 22-51008-8

The soil pipe joint capping (External/Area 16) does not contain asbestos.
