ASBESTOS SURVEY REPORT FOR DERWENT HILL OUTDOOR EDUCATION AND TRAINING CENTRE, PORTINSCALE, KESWICK, CUMBRIA, CA12 5RD.

Asbestos Register for Derwent Hill Outdoor Education and Training Centre

Date: 25 June 2025

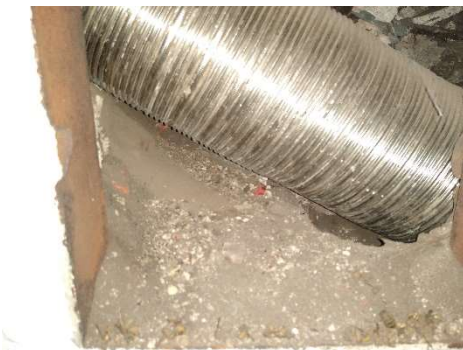
Item 3 Ref: 418920-15

The debris within chimney in Store Room/-1/001 does not contain asbestos.

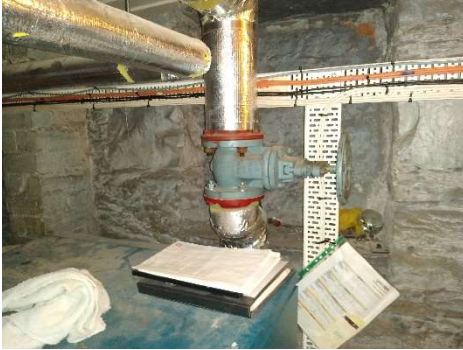
Item 7 Ref: 418920-18

The pipework flange gaskets in Boiler Room/-1/002 does not contain asbestos.

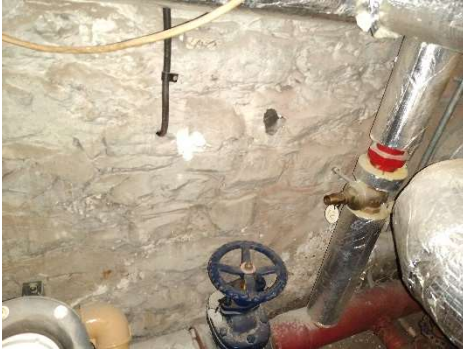
Item 10 Ref: 418920-21

The insulation debris to walls in Boiler Room/-1/002 does not contain asbestos.

Removed November 2020

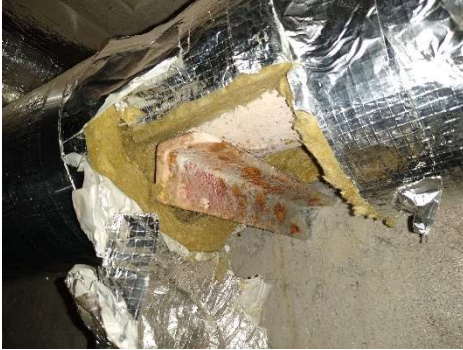
Item 13 Ref: 418920-23

The debris to pipework and bracket in Store/-1/003 contains asbestos.

Removed November 2020

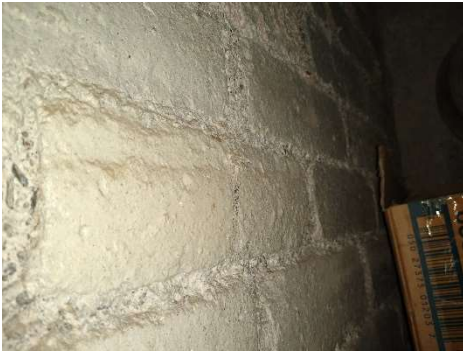
Item 14 Ref: 418920-24

The debris to walls in Store/-1/003 does not contain asbestos.

Removed November 2020

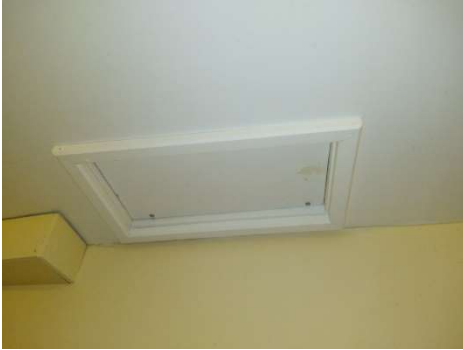
Item 16 Ref: 418920-30

The panel to loft hatch in Staff drying room/0/005 does not contain asbestos.

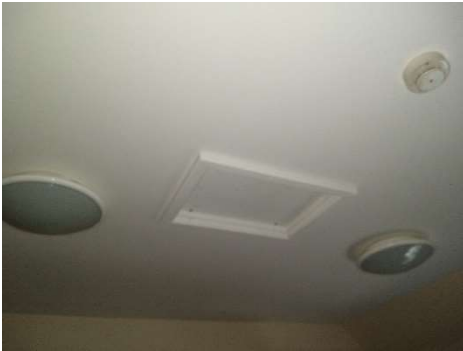
Item 17 Ref: As 418920-30

The panel to loft hatch in Staff office/0/006 does not contain asbestos.

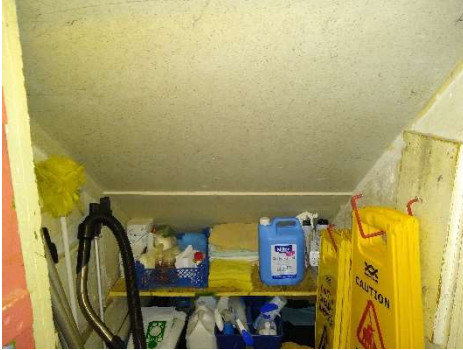
Item 19 Ref: As 418920-16

The ceiling panels in Cleaning Store/0/014 do not contain asbestos.

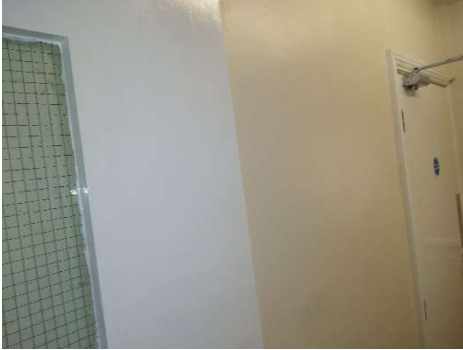
Item 22 Ref: As 418920-26

The partition wall to staff stairwell in Corridor/1/014 does not contain asbestos.

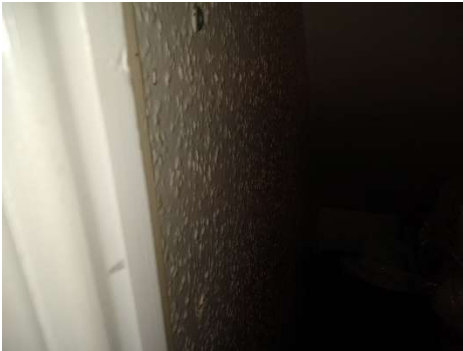
Item 23 Ref: As 418920-26

The partition wall in Corridor under stair cupboard /1/014 does not contain asbestos.

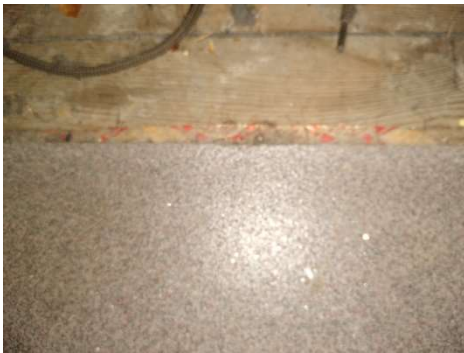
Item 26 Ref: 418920-27

The floor covering below plyboard in Corridor 2/001 contains asbestos.

Any change in its appearance should be recorded and passed to Property Services.

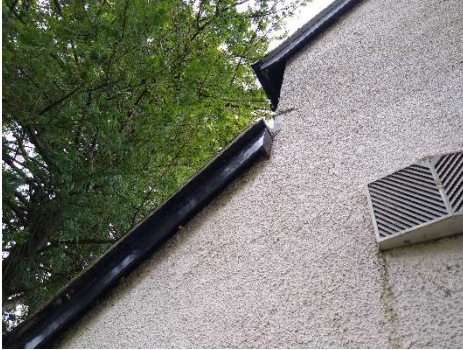
Item 28 Ref: 418920-32

The fillet to extension (External) does not contain asbestos.

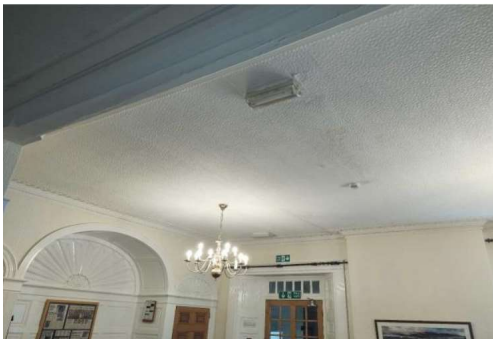
Item 64 Ref: 22-63253-1

The textured coated ceiling in the lounge (Area 1) contains asbestos.

Any change in its appearance should be recorded and passed to Property Services.

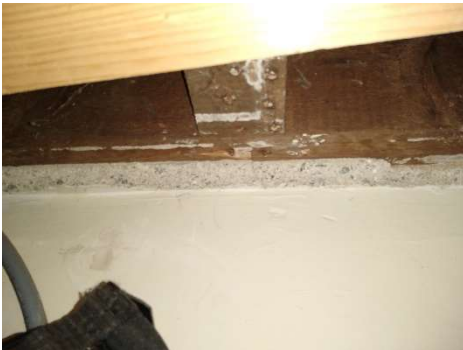
Item 33 Ref: 418920-10

The residue to beams above store cupboard in Boot Store/0/001 does not contain asbestos.

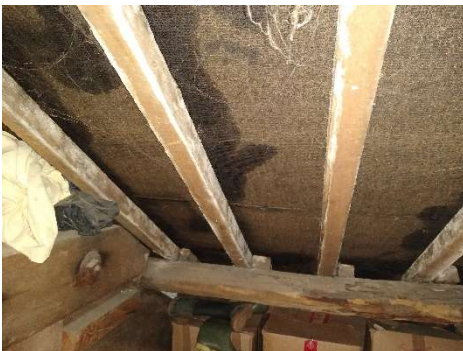
Item 37 Ref: 418920-8

The sarking in First floor/1/001 does not contain asbestos.

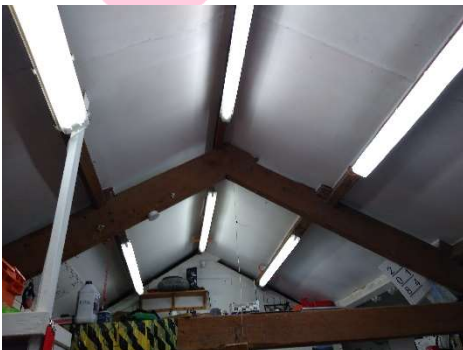
Item 38 Ref: 418920-9

The paper lining to ceiling panels in First floor/1/001 does not contain asbestos.

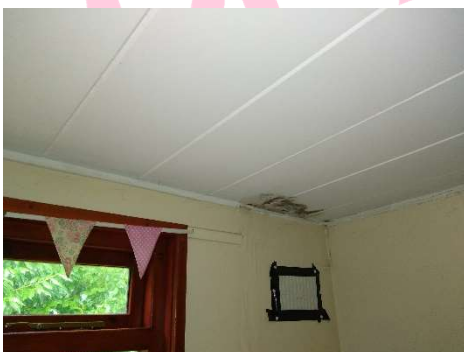
Item 41 Ref: As 418920-1

The ceiling in Kitchen/0/002 contains asbestos.

Any change in its appearance should be recorded and passed to Property Services.

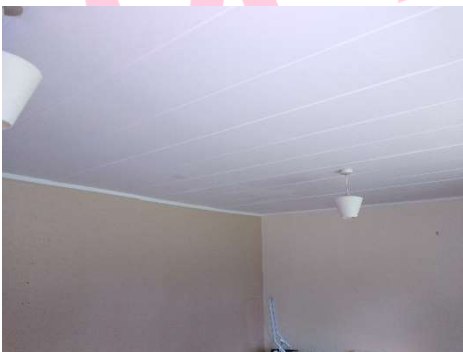
Item 44 Ref: As 418920-1

The ceiling in Living Room 0/003 contains asbestos.

Any change in its appearance should be recorded and passed to Property Services.

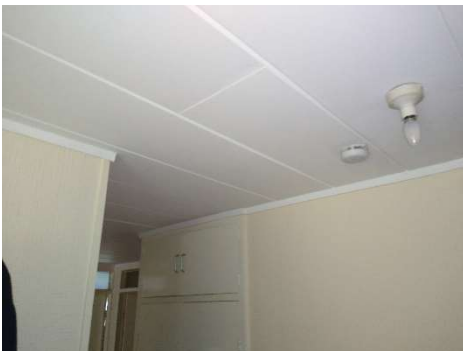
Item 46 Ref: As 418920-1

The ceiling in Hallway 0/004 contains asbestos.

Any change in its appearance should be recorded and passed to Property Services.

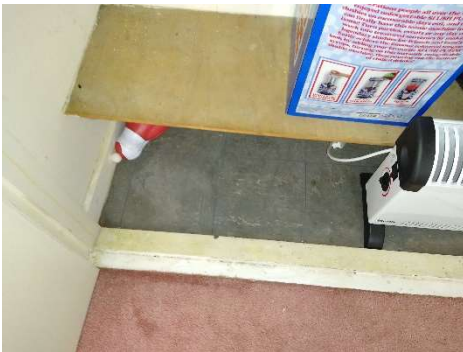
Item 49 Ref: As 418920-2

The sub floor covering in Bedroom 0/005 contains asbestos.

Any change in its appearance should be recorded and passed to Property Services.

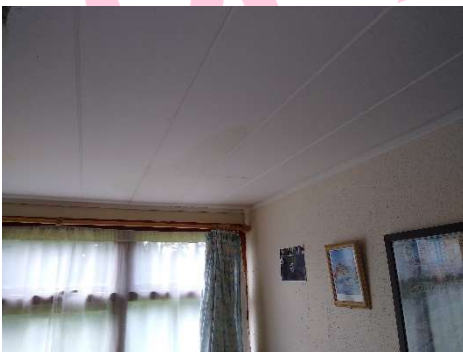
Item 50 Ref: As 418920-1

The ceiling in Bedroom 0/006 contains asbestos.

Any change in its appearance should be recorded and passed to Property Services.

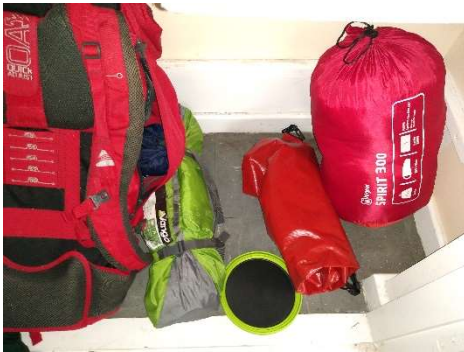
Item 51 Ref: As 418920-2

The sub floor covering in Bedroom 0/006 contains asbestos.

Any change in its appearance should be recorded and passed to Property Services.

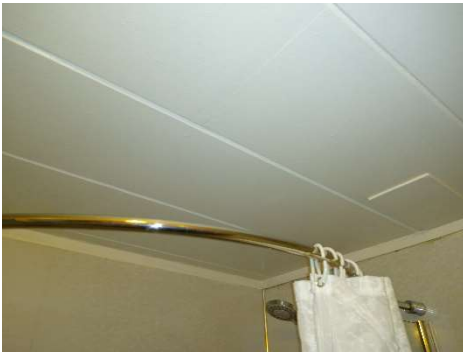
Item 55 Ref: As 418920-1

The ceiling in Shower Room 0/009 contains asbestos.

Any change in its appearance should be recorded and passed to Property Services.

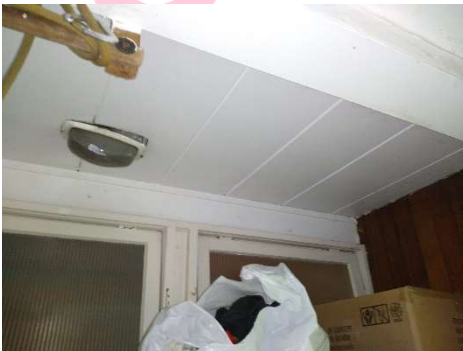
Item 56 Ref: As 418920-1

The ceiling in Rear porch 0/010 contains asbestos.

Any change in its appearance should be recorded and passed to Property Services.

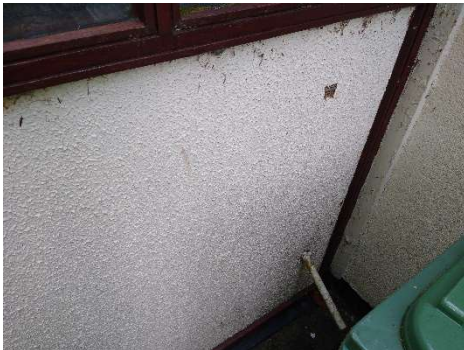
Item 57 Ref: 418920-4

The textured coating to panel below window (External) does not contain asbestos.

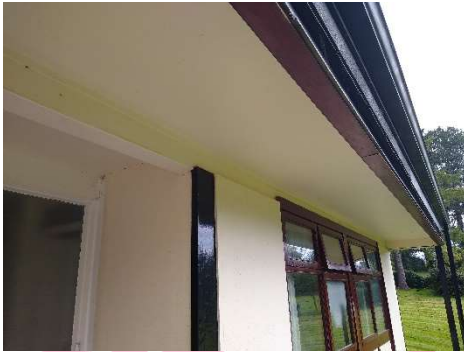
Item 58 Ref: 418920-5

The canopy and boxing to front porch and above lounge window (External) contains asbestos.

Any change in its appearance should be recorded and passed to Property Services.

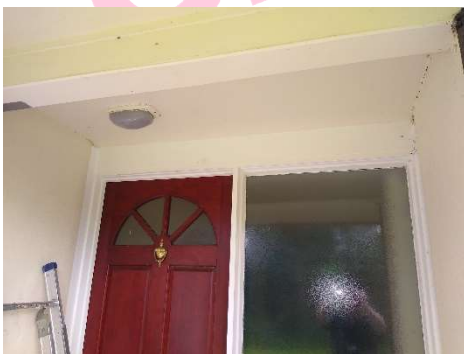
Item 59 Ref: As 418920-5

The panel above door (External) contains asbestos.

Any change in its appearance should be recorded and passed to Property Services.

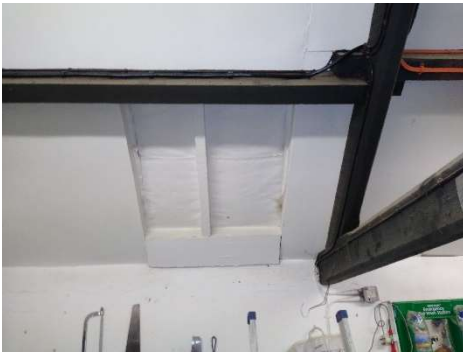
Item 60 Ref: 418920-6

The sarking over roof lights in Workshop 0/003 does not contain asbestos.
