ASBESTOS SURVEY REPORT FOR DERWENT HILL OUTDOOR EDUCATION AND TRAINING CENTRE, PORTINSCALE, KESWICK, CUMBRIA, CA12 5RD.

## **Asbestos Register for**

### **Derwent Hill Outdoor Education and Training Centre**

**Date: 29 October 2024**

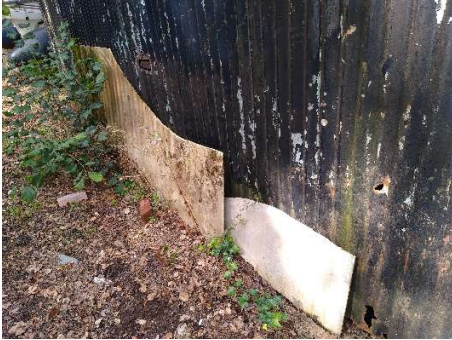
### **Item 1 Ref: 418920-7**

(Item 1) Ref: 418920-7 – Loose panel to rear of garages (External) – Removed

The loose panel to rear of garages (External) contains asbestos.

***Removed***

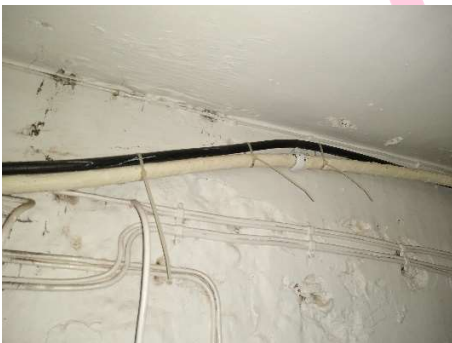
### **Item 2 Ref: 418920-14**

The wrap to main cable in Store Room/-1/001 does not contain asbestos.

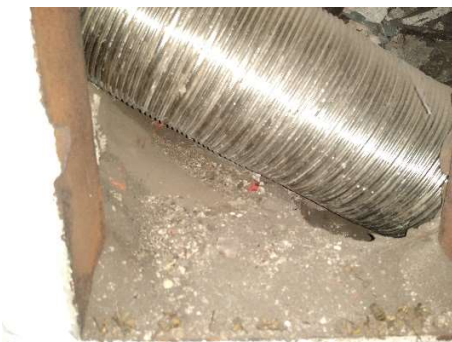
### **Item 3 Ref: 418920-15**

The debris within chimney in Store Room/-1/001 does not contain asbestos.

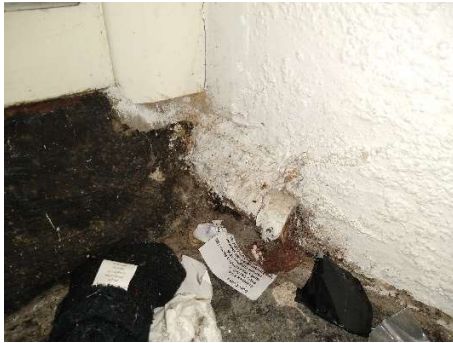
**Item 4 Ref: As 418920-14**

The wrap to cut off cable to fire exit in Store Room/-1/001 does not contain asbestos.

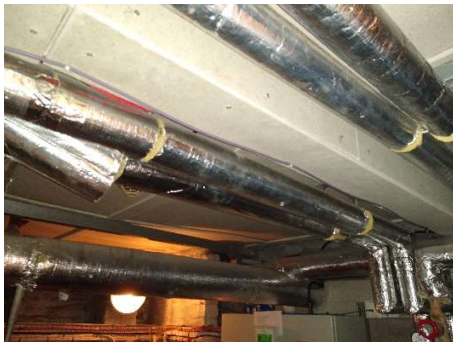
**Item 5 Ref: 418920-16**

The ceiling and beam cladding in Boiler Room/-1/002 does not contain asbestos.

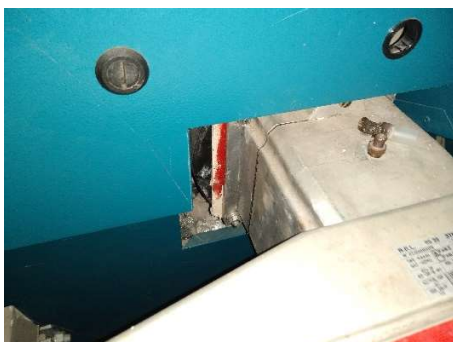
**Item 6 Ref: 418920-17**

The gasket to boiler front in Boiler Room/-1/002 does not contain asbestos.

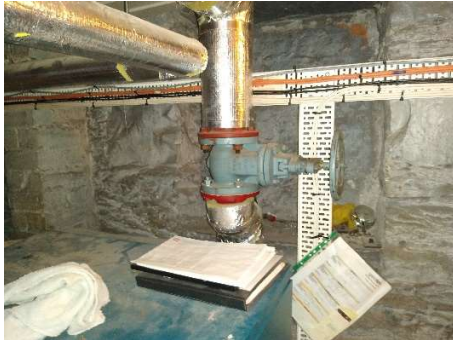
**Item 7 Ref: 418920-18**

The pipework flange gaskets in Boiler Room/-1/002 does not contain asbestos.

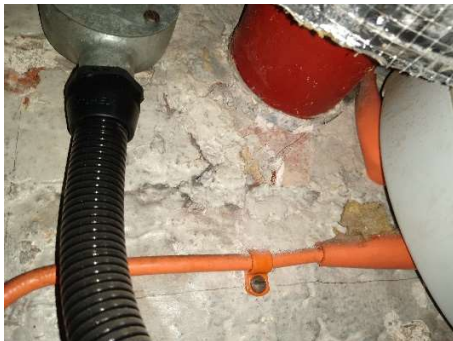
**Item 8 Ref: 418920-19**

The debris to wall pipe penetration in Boiler Room/-1/002 contains asbestos.

**Removed and Encapsulated November 2020**

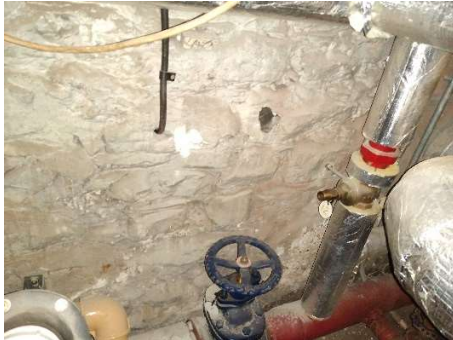
**Item 10 Ref: 418920-21**

The insulation debris to walls in Boiler Room/-1/002 does not contain asbestos.

***Removed November 2020***

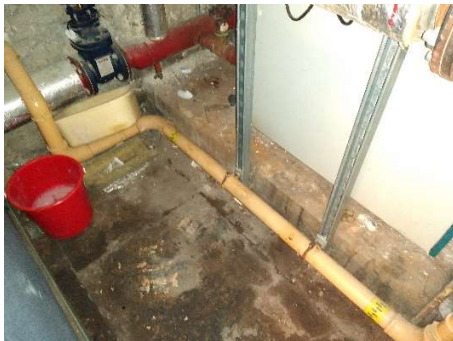
**Item 11 Ref: 418920-22**

The debris to floor in Boiler Room/-1/ does not contain asbestos.

***Removed November 2020***

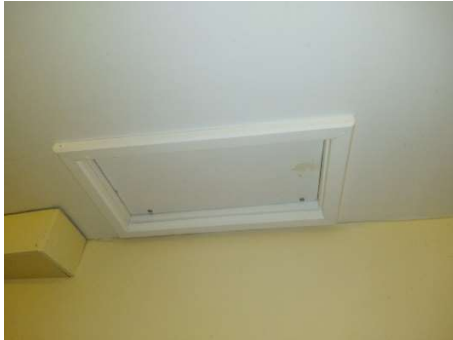
**Item 16 Ref: 418920-30**

The panel to loft hatch in Staff drying room/0/005 does not contain asbestos.

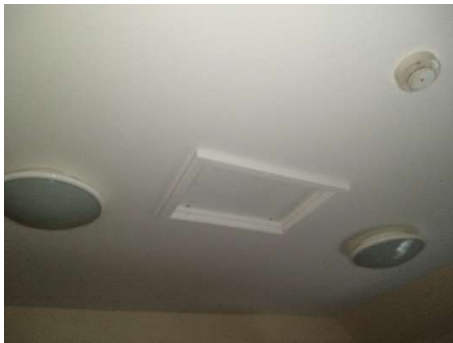
**Item 17 Ref: As 418920-30**

The panel to loft hatch in Staff office/0/006 does not contain asbestos.

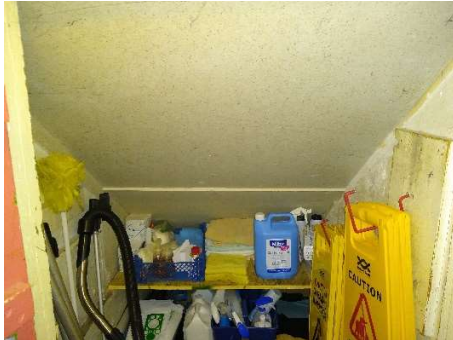
**Item 19 Ref: As 418920-16**

The ceiling panels in Cleaning Store/0/014 do not contain asbestos.

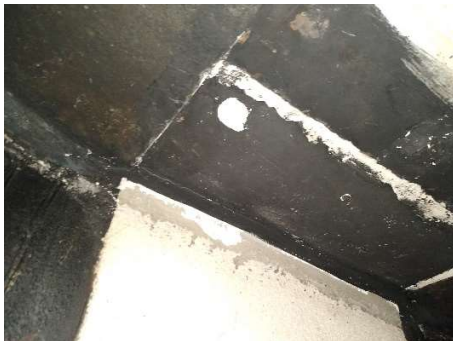
**Item 20 Ref: 418920-31**

(Item 20) Ref: 418920-31 – Blanking panel to chimney (Dining Room/0/023) – Low Risk

The blanking panel to chimney in Dining Room/0/023 contains asbestos.

Any change in its appearance should be recorded and passed to Property Services.

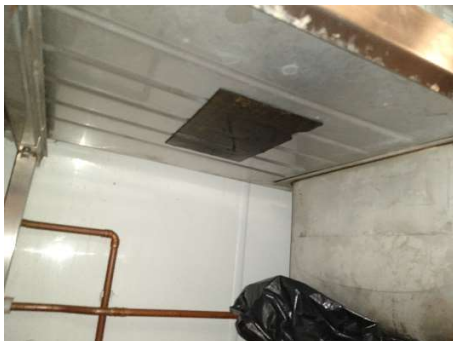
**Item 21 Ref: 418920-33**

The sink pad in Kitchen/0/032 does not contain asbestos.

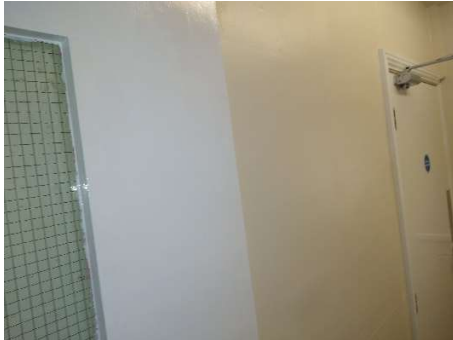
**Item 22 Ref: As 418920-26**

The partition wall to staff stairwell in Corridor/1/014 does not contain asbestos.

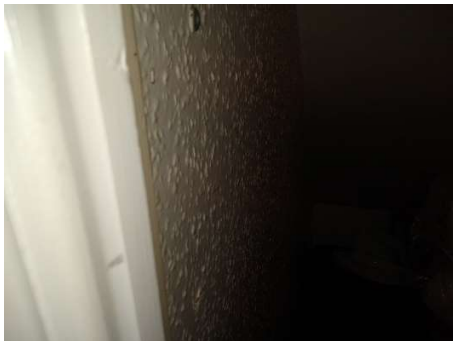
**Item 23 Ref: As 418920-26**

The partition wall in Corridor understair cupboard /1/014 does not contain asbestos.

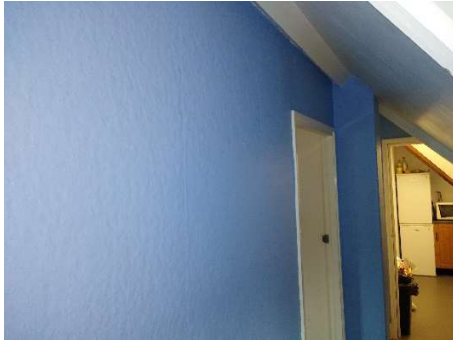
### Item 25 Ref: 418920-26

The partition wall to rooms 2/003 & 004 in Corridor 2/001 does not contain asbestos.

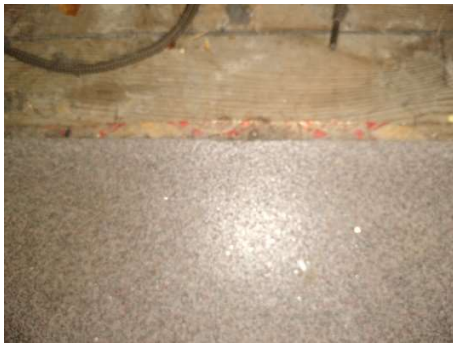
### Item 26 Ref: 418920-27

(Item 26) Ref: 418920-27 – Floor covering below plyboard (Corridor 2/001) – Low Risk

The floor covering below plyboard in Corridor 2/001 contains asbestos.

Any change in its appearance should be recorded and passed to Property Services.

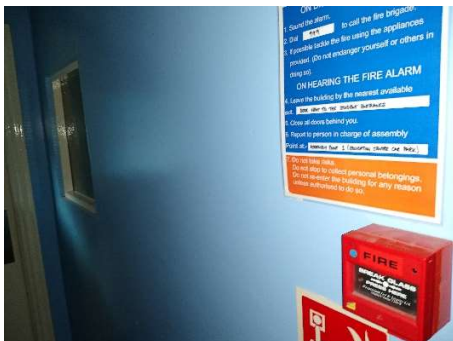
### Item 27 Ref: As 418920-26

The partition wall to stairwell in Landing and Stairwell/2/007 does not contain asbestos.

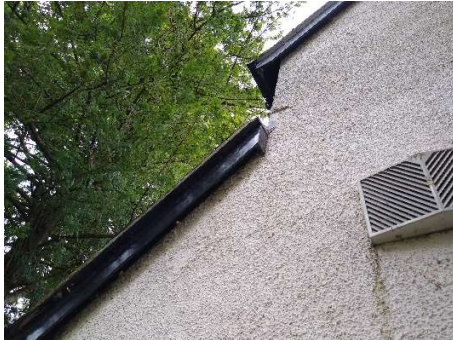
**Item 28 Ref: 418920-32**

The fillet to extension (External) does not contain asbestos.

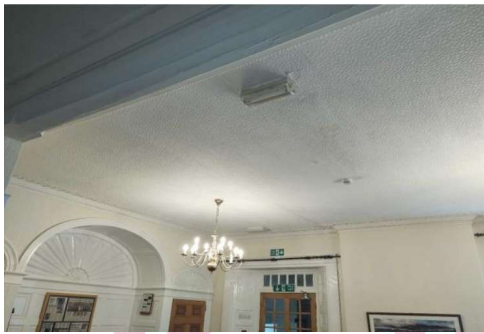
**Item 64 Ref: 22-63253-1**

The textured coated ceiling in the lounge (Area 1) contains asbestos.

Any change in its appearance should be recorded and passed to Property Services.

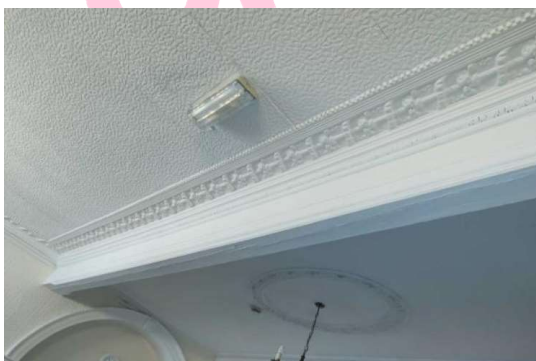
**Item 65 Ref: 22-63253-1**

The textured coated ceiling in the lounge (Area 1) contains asbestos.

Any change in its appearance should be recorded and passed to Property Services.

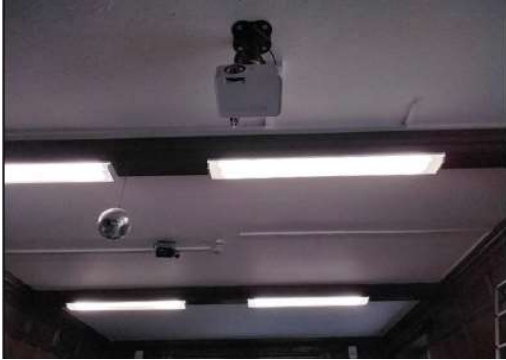
**Item 66 Ref: KX001961**

The ceiling papered with woodchip paper in the Common Room (G/001) does not contain asbestos.

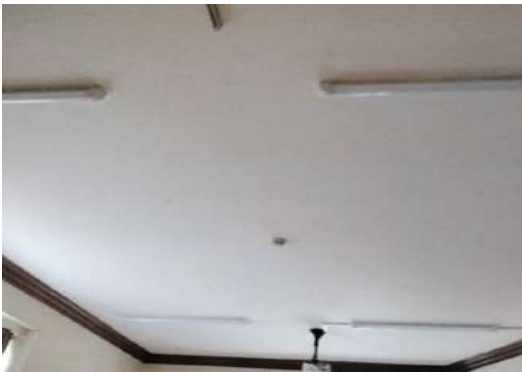
**Item 67 Ref: KX001962**

The ceiling papered with woodchip paper in the Living Room/Lounge (G/002) does not contain asbestos.

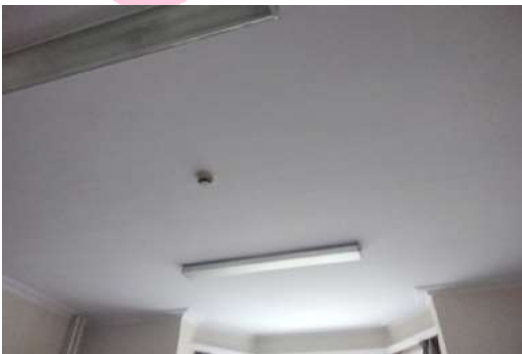
**Item 68 Ref: KX001963**

The ceiling in the Dales Dining Room (Room G/003) does not contain asbestos.

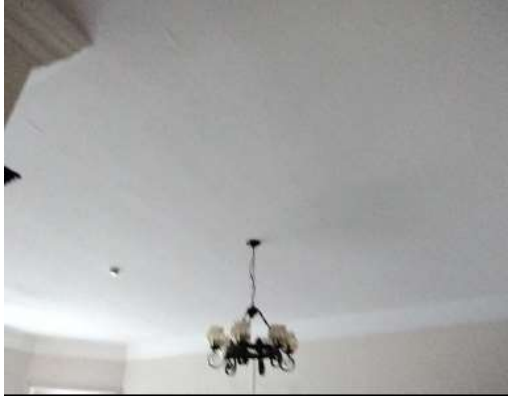
**Item 69 Ref: KX001961**

The papered ceiling in the Fells Dining Room (Room G/004) does not contain asbestos.

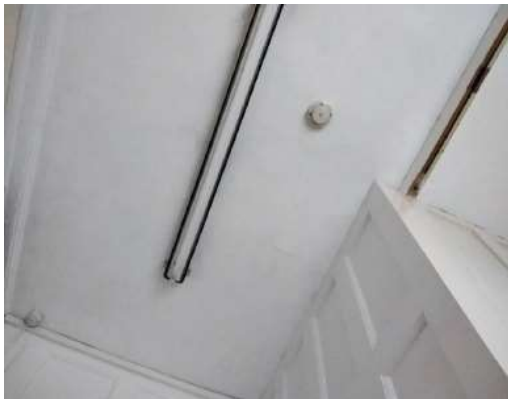
**Item 70 Ref: KX001965**

The ceiling in the Store Room Shop (G/005) does not contain asbestos.

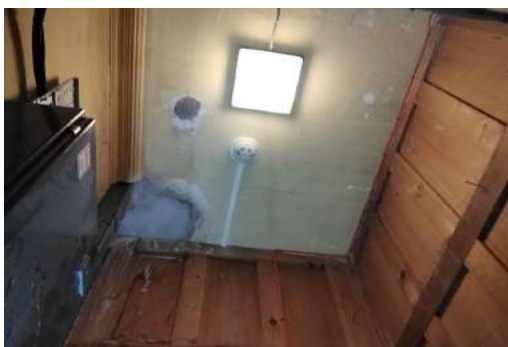
**Item 71 Ref: KX001966**

The ceiling in the Electrical cupboard in the shop (Room G/00) does not contain asbestos.

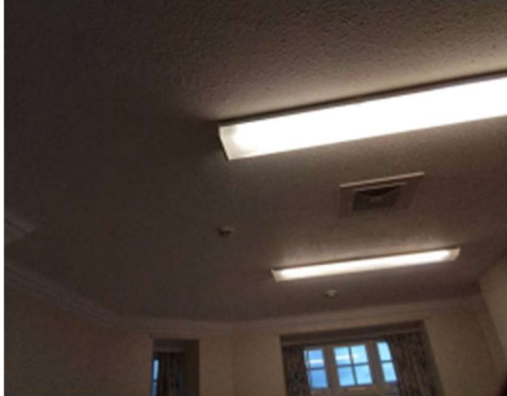
**Item 72 Ref: QK000867**

The ceiling wallpapered (Bedroom Borrowdale Dormitory Rm1/001) does not contain asbestos.

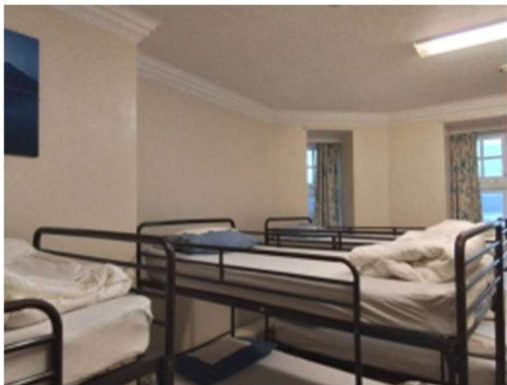
**Item 73 Ref: QK000868**

The wall (Borrowdale (Bedroom Dormitory Rm1/001) does not contain asbestos.

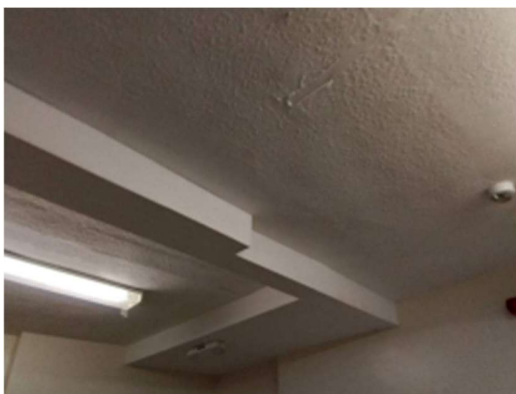
**Item 74 Ref: QK000869**

The ceiling wallpapered (Bedroom Scarfell Dormitory Rm 1/002) does not contain asbestos.

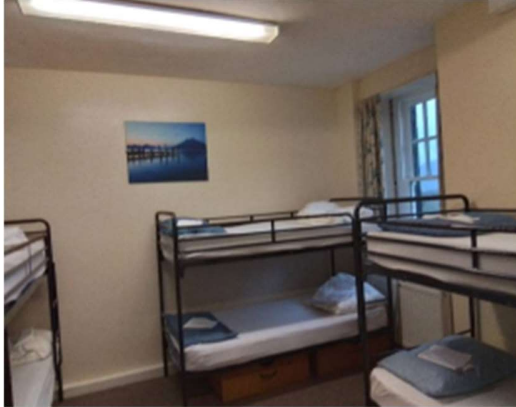
**Item 75 Ref: QK000870**

The wall (Bedroom Scarfell Dormitory Rm 1/002) does not contain asbestos.

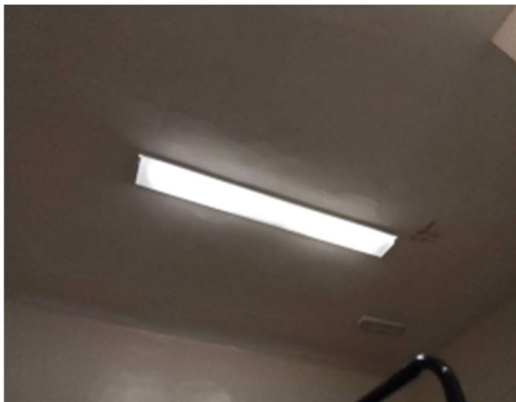
**Item 76 Ref: QK000871**

The ceiling (Bedroom Latrigg Dormitory Rm 1/003) does not contain asbestos.

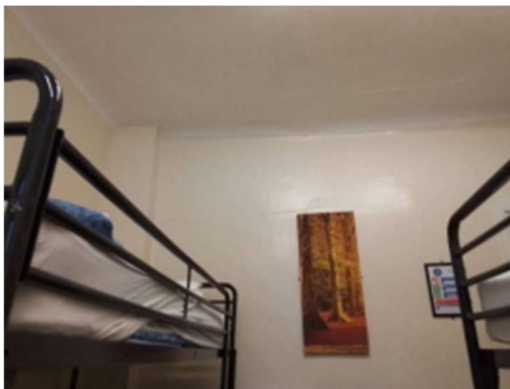
**Item 77 Ref: QK000872**

The wall (Bedroom Latrigg Dormitory Rm 1/003) does not contain asbestos.

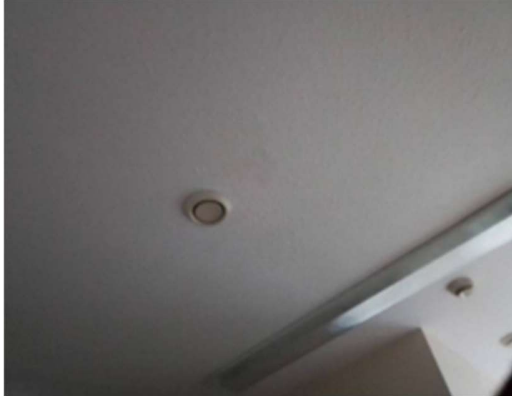
**Item 78 Ref: QK000873**

The ceiling (Bedroom Littleman Dormitory Rm 1/004) does not contain asbestos.

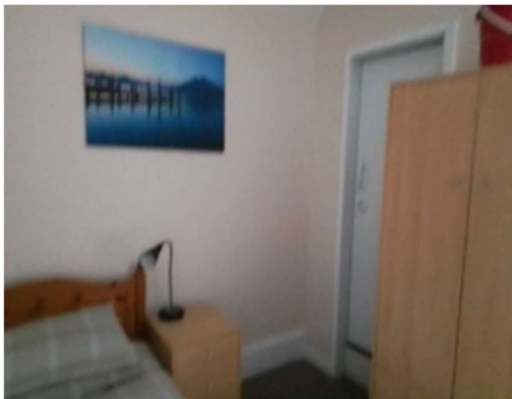
**Item 79 Ref: QK000874**

The wall (Bedroom Littleman Dormitory Rm 1/004) does not contain asbestos.

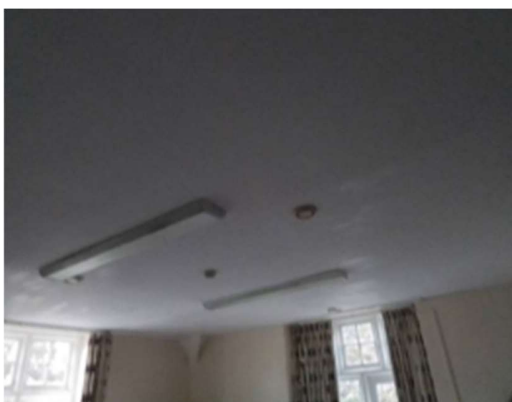
**Item 80 Ref: QK000875**

The ceiling (Bedroom Skiddaw Dormitory Rm 1/005) does not contain asbestos.

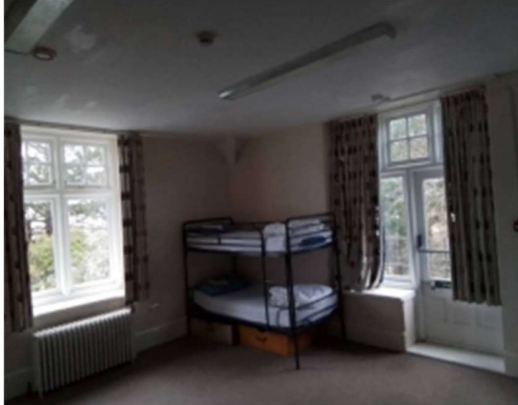
**Item 81 Ref: QK000876**

The wall (Bedroom Skiddaw Dormitory Rm 1/005) does not contain asbestos.

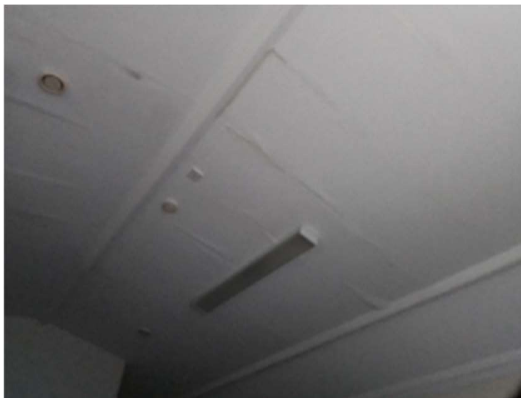
**Item 82 Ref: QK000877**

The ceiling (Bedroom Blencathra Dormitory Rm 1/006) does not contain asbestos.

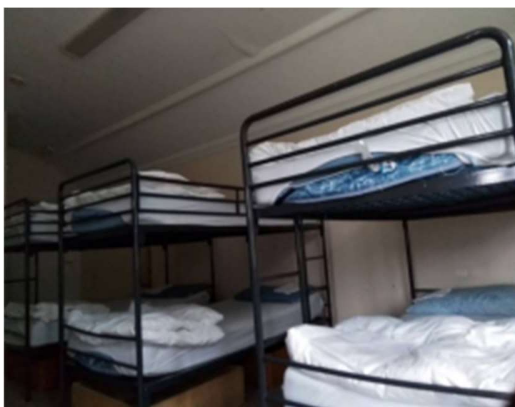
**Item 83 Ref: QK000878**

The wall (Bedroom Blencathra Dormitory Rm 1/006) does not contain asbestos.

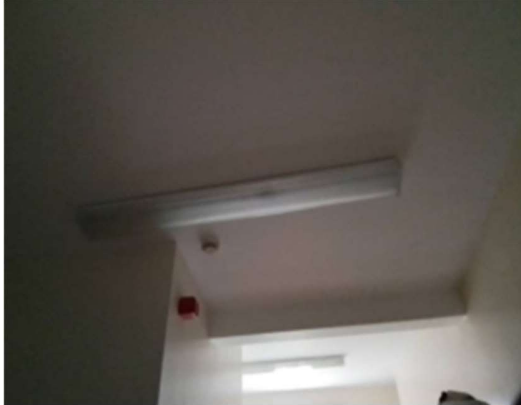
**Item 84 Ref: QK000879**

The ceiling (Bedroom Helvellyn Dormitory Rm 1/007) does not contain asbestos.

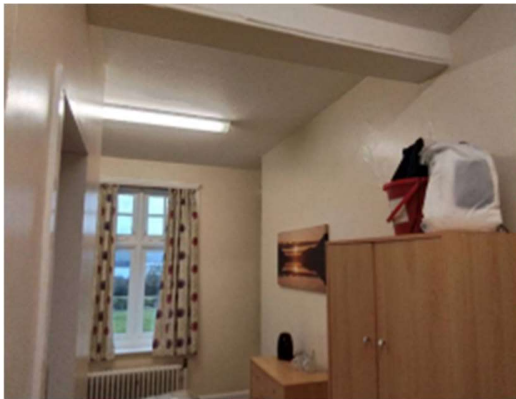
**Item 85 Ref: QK000880**

The wall (Bedroom Helvellyn Dormitory Rm 1/007) does not contain asbestos.

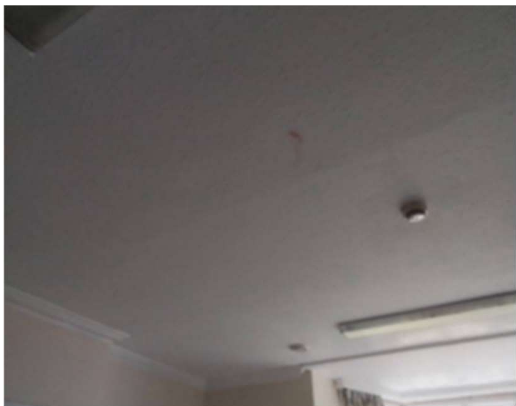
**Item 86 Ref: QK000881**

The ceiling (Bedroom Catbells Dormitory Rm 1/008) does not contain asbestos.

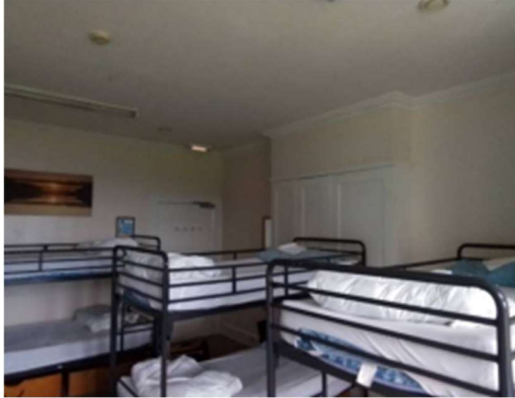
**Item 87 Ref: QK000882**

The wall (Bedroom Catbells  
Dormitory Rm 1/008) does  
not contain asbestos.

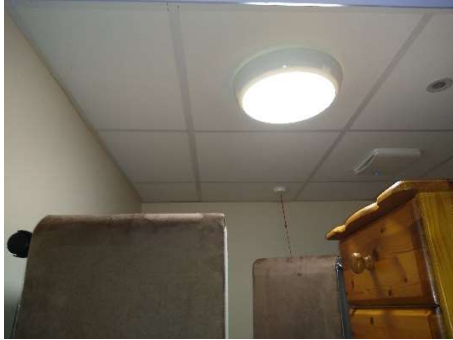
**Item 29 Ref: As 418920-12**

The suspended ceiling in Bedroom 15 ensuite bathroom/0/001 does not contain asbestos.

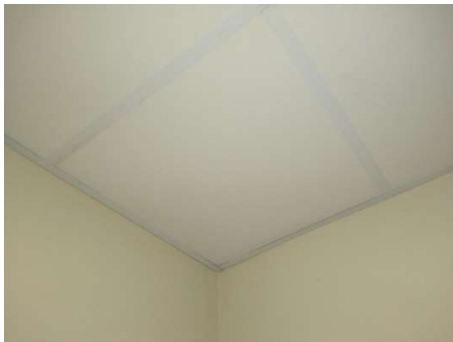
**Item 30 Ref: 418920-12**

The suspended ceiling in Bedroom 16 ensuite bathroom/0/002 does not contain asbestos.

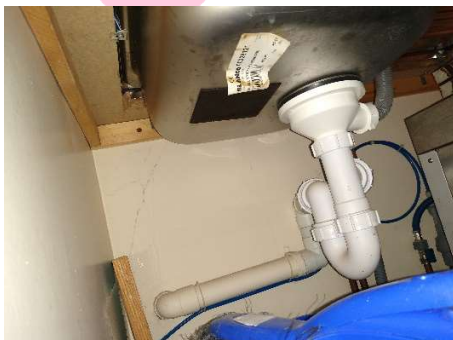
**Item 31 Ref: 418920-13**

The sink pad in Bar area/0/025 does not contain asbestos.

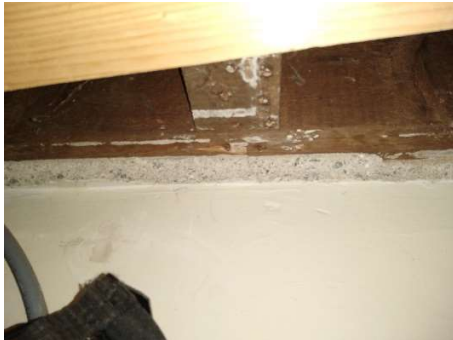
**Item 33 Ref: 418920-10**

The residue to beams above store cupboard in Boot Store/0/001 does not contain asbestos.

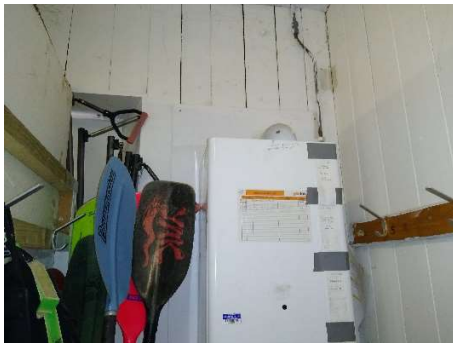
**Item 34 Ref: 418920-11**

The mounting board to boiler in Watersports store/0/002 does not contain asbestos.

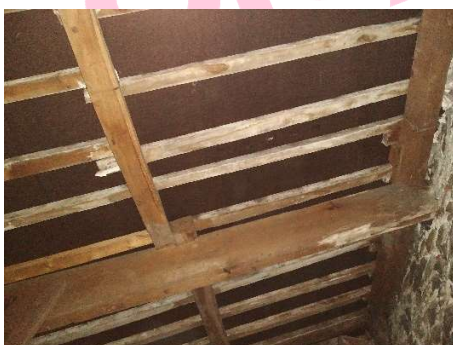
**Item 35 Ref: As 418920-8**

The sarking in Watersports store loft above/0/002 does not contain asbestos.

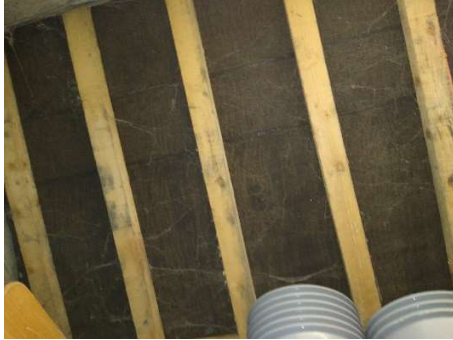
**Item 36 Ref: As 418920-8**

The sarking in Utility Room/0/004 does not contain asbestos.

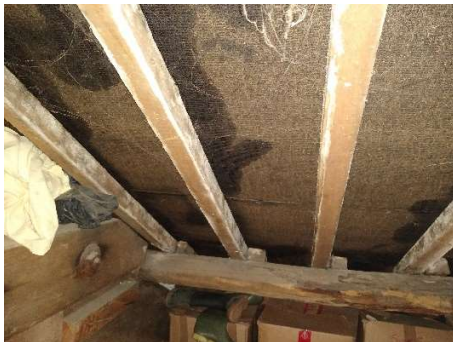
**Item 37 Ref: 418920-8**

The sarking in First floor/1/001 does not contain asbestos.

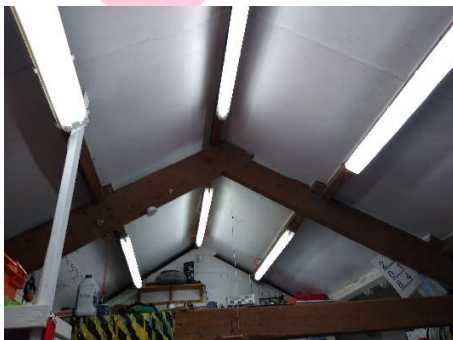
**Item 38 Ref: 418920-9**

The paper lining to ceiling panels in First floor/1/001 does not contain asbestos.

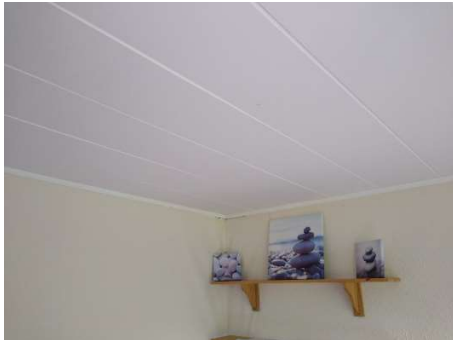
### **Item 39 Ref: As 418920-1**

The ceiling in Bedroom/0/001 contains asbestos.

Any change in its appearance should be recorded and passed to Property Services.

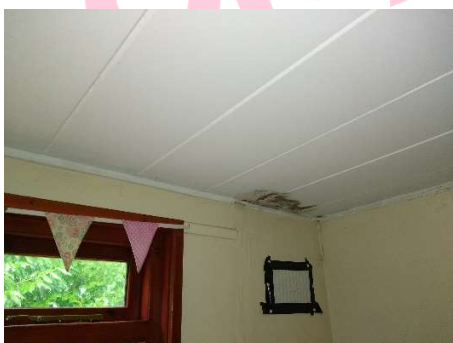
### **Item 41 Ref: As 418920-1**

The ceiling in Kitchen/0/002 contains asbestos.

Any change in its appearance should be recorded and passed to Property Services.

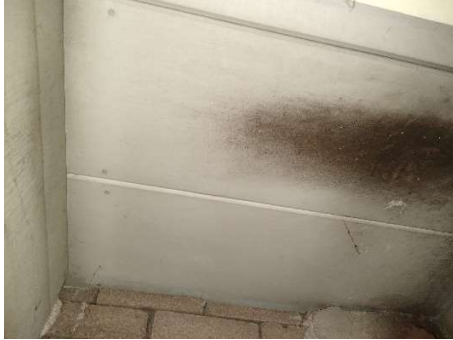
**Item 42 Ref: As 418920-1**

The ceiling in Kitchen cupboard/0/002 contains asbestos.

Any change in its appearance should be recorded and passed to Property Services.

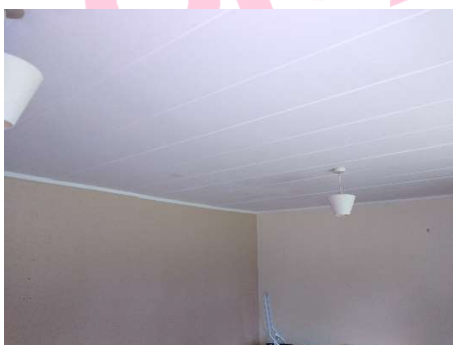
**Item 44 Ref: As 418920-1**

The ceiling in Living Room 0/003 contains asbestos.

Any change in its appearance should be recorded and passed to Property Services.

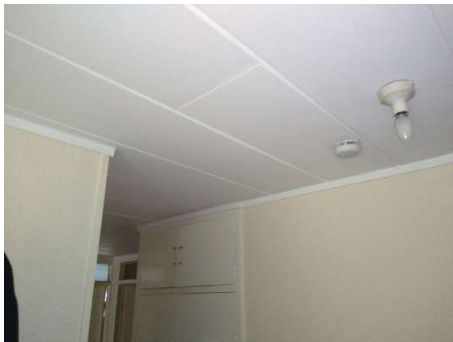
**Item 46 Ref: As 418920-1**

The ceiling in Hallway 0/004 contains asbestos.

Any change in its appearance should be recorded and passed to Property Services.

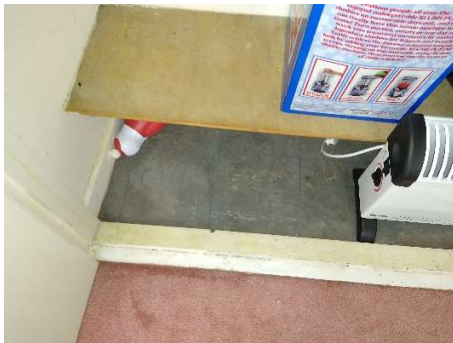
**Item 49 Ref: As 418920-2**

The sub floor covering in Bedroom 0/005 contains asbestos.

Any change in its appearance should be recorded and passed to Property Services.

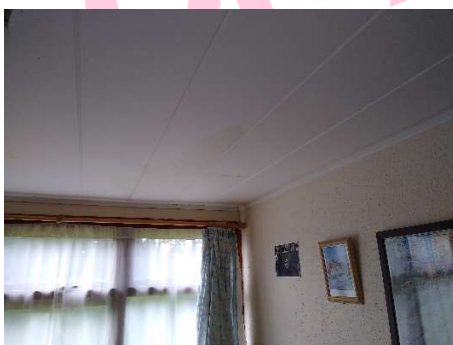
**Item 50 Ref: As 418920-1**

The ceiling in Bedroom 0/006 contains asbestos.

Any change in its appearance should be recorded and passed to Property Services.

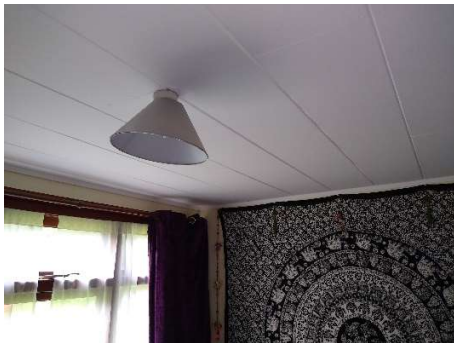
**Item 52 Ref: As 418920-1**

The ceiling in Bedroom 0/007 contains asbestos.

Any change in its appearance should be recorded and passed to Property Services.

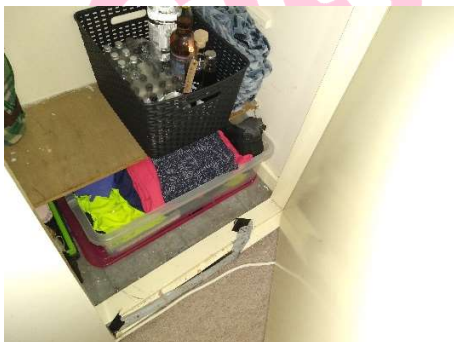
**Item 53 Ref: As 418920-2**

The sub floor covering in Bedroom 0/007 contains asbestos.

Any change in its appearance should be recorded and passed to Property Services.

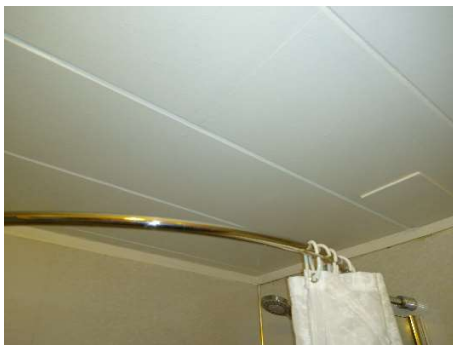
**Item 55 Ref: As 418920-1**

The ceiling in Shower Room 0/009 contains asbestos.

Any change in its appearance should be recorded and passed to Property Services.

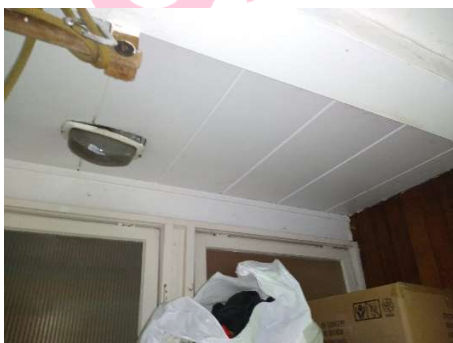
**Item 56 Ref: As 418920-1**

The ceiling in Rear porch 0/010 contains asbestos.

Any change in its appearance should be recorded and passed to Property Services.

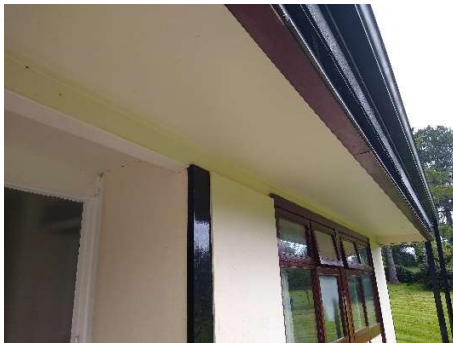
**Item 58 Ref: 418920-5**

The canopy and boxing to front porch and above lounge window (External) contains asbestos.

Any change in its appearance should be recorded and passed to Property Services.

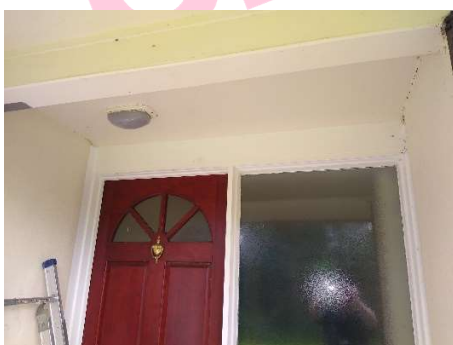
**Item 59 Ref: As 418920-5**

The panel above door (External) contains asbestos.

Any change in its appearance should be recorded and passed to Property Services.
