### **ASBESTOS SURVEY REPORT FOR PENSHAW PARK, HOUGHTON LE SPRING**

**Asbestos Register for**  
**PENSHAW PARK**

**Premises Manager / Samo: - Tenant      Date: 10<sup>th</sup> June 2021**

### **Bowls Pavilion**

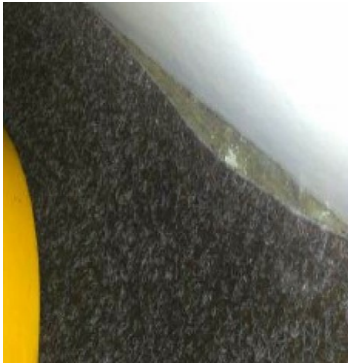
### **Item 1 Ref: EA003019**

The green vinyl flooring to the kitchen / sitting area (Room 1) does not contain asbestos.

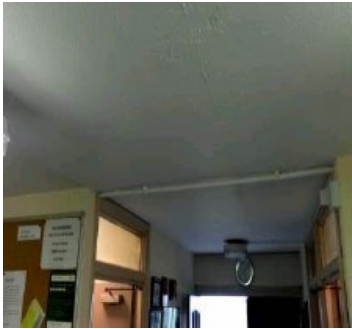
### **Item 2 - Ref: EA003020**

The textured coating to the ceiling in the kitchen / sitting area (Room 1) does not contain asbestos.

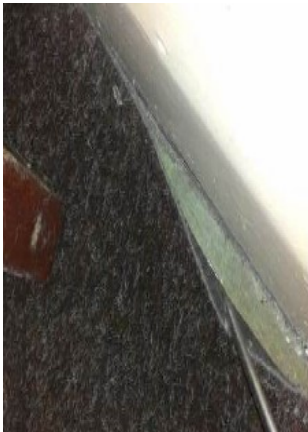
### **Item 3 - Ref: EA003019**

The green vinyl floor tiles to the Office (Room 2) do not contain asbestos.

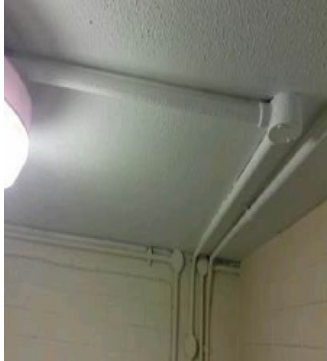
**Item 4 - Ref: EA003020**

The textured coating to the ceiling in the Office (Room 2) was accessed and no suspect materials were found.

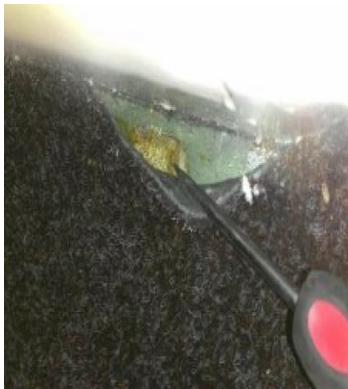
**Item 5 - Ref: EA003019**

The green floor tiles to the female changing room (Room 3) do not contain asbestos.

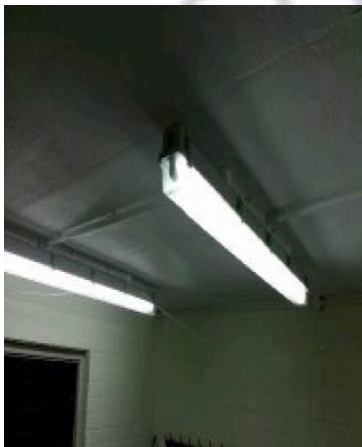
**Item 6 - Ref: EA003020**

The textured coating to the ceiling in the female changing room (Room 3) does not contain asbestos.

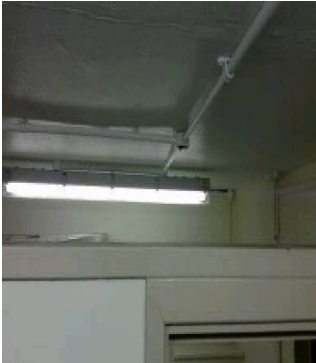
**Item 7 - Ref: EA003020**

The textured coating to the ceiling in the female wc (Room 4) does not contain asbestos.

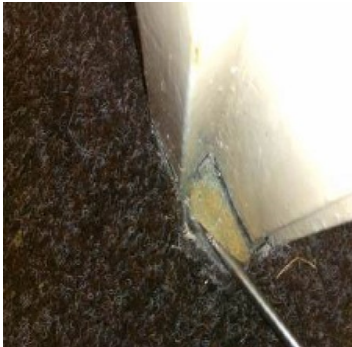
**Item 8 - Ref: EA003019**

The green vinyl floor tiles to the male changing room (Room 5) do not contain asbestos.

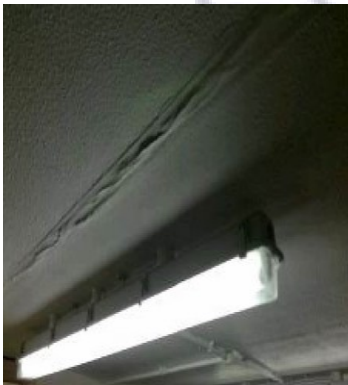
**Item 9 - Ref: EA003020**

The textured coating to the ceiling in the male changing room (Room 5) does not contain asbestos.

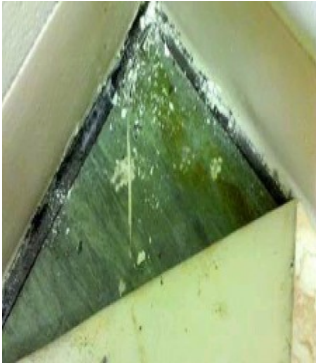
**Item 10 - Ref: EA003019**

The green vinyl floor tiles to the male wc (Room 6) does not contain asbestos.

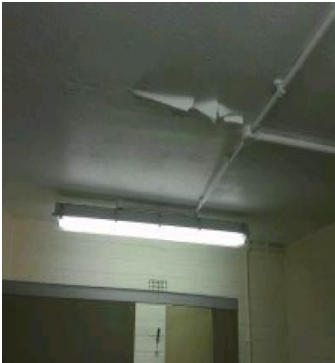
**Item 11 - Ref: EA003020**

The textured coating to the ceiling in the male wc (Room 6) does not contain asbestos.

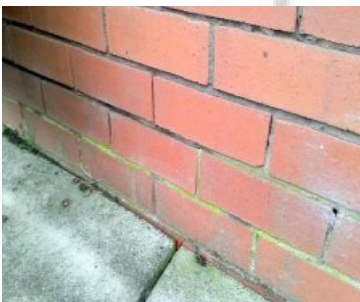
**Item 12 - Ref: EA003021**

The damp proof course to the external of the building, does not contain asbestos.

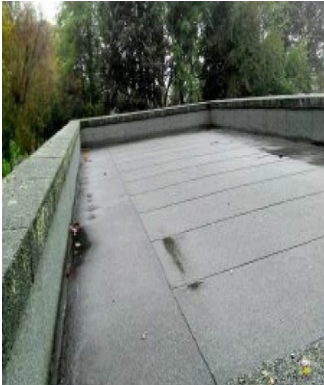
**Item 13 - Ref: EA003022**

The bitumen to the flat roof does not contain asbestos.
