ASBESTOS SURVEY REPORT FOR PLAINS FARM ACADEMY, CARETAKERS HOUSE, SUNDERLAND

Asbestos Register for PLAINS FARM ACADEMY CARETAKERS HOUSE

Date: 04 June 2025

Plan of Building and Samples Location – Caretakers House

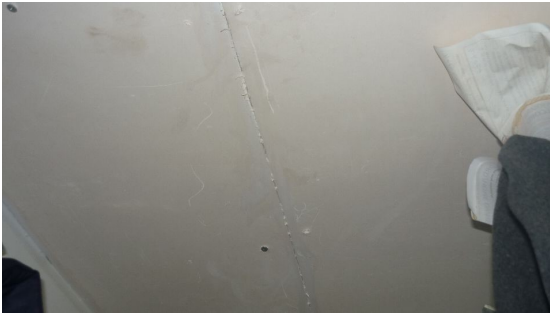
Item 1 Ref: ME1462/10

ME1462/10 – Ceiling (Rm 0/02) (Item 1) - No Risk

The ceiling board to the heating cupboard (Rm 0/02) does not contain asbestos.

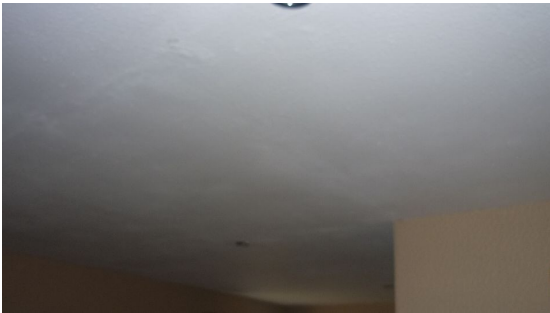
Item 2 - Ref: ME1463/10

ME1463/10 - Ceiling coating (Rm 0/03) (Item 2) – Very Low Risk

The coating to the ceiling in the living room (Rm 0/03) contains asbestos. Any change in its appearance should be recorded, and passed to Property Services.

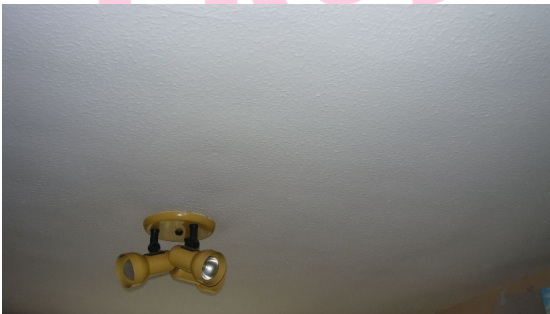
Item 3 – As ME1463/10

As ME1463/10 – Ceiling coating (Rm 0/04) (Item 3) – Very Low Risk

The coating to the ceiling in the kitchen (Rm 0/04) contains asbestos. Any change in its appearance should be recorded, and passed to Property Services.

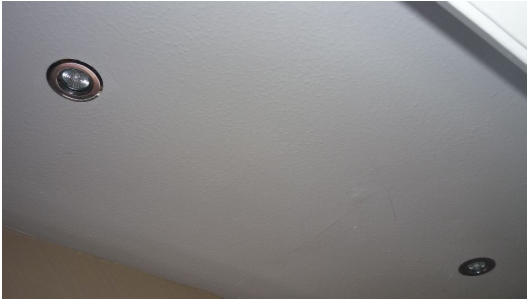
Item 4 –As ME1463/10

As ME1463/10 – Ceiling coating (Rm 0/05) (Item 4) – Very Low Risk

The coating to the ceiling in the toilet (Rm 0/05) contains asbestos. Any change in its appearance should be recorded, and passed to Property Services.

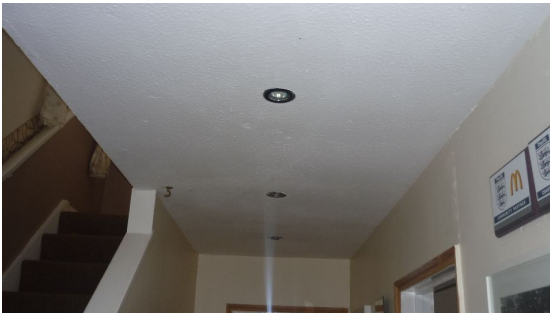
Item 5 – As ME1463/10

As ME1463/10 - Ceiling coating (Rm 1/01) (Item 5) – Very Low Risk

The coating to the ceiling to the stairs/hall/landing (Rm 1/01) contains asbestos. Any change in its appearance should be recorded, and passed to Property Services.

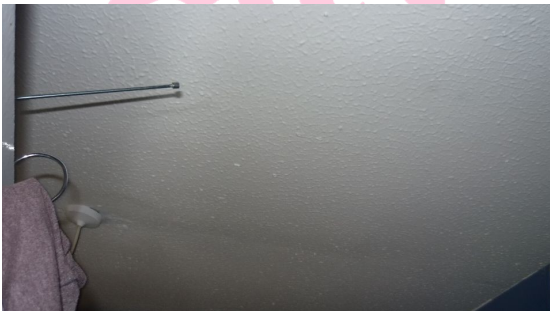
Item 6 – As ME1463/10

As ME1463/10 – Ceiling coating (Rm 1/02) (Item 6) – Very Low Risk

The coating to the ceiling in bedroom 1 (Rm 1/02) contains asbestos. Any change in its appearance should be recorded, and passed to Property Services.

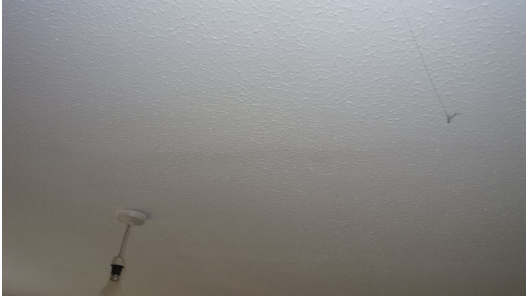
Item 7 – As ME1463/10

As ME1463/10 – Ceiling coating (Rm 1/03) (Item 7) – Very Low Risk

The coating to the ceiling in bedroom 2 (Rm 1/03) contains asbestos. Any change in its appearance should be recorded, and passed to Property Services.

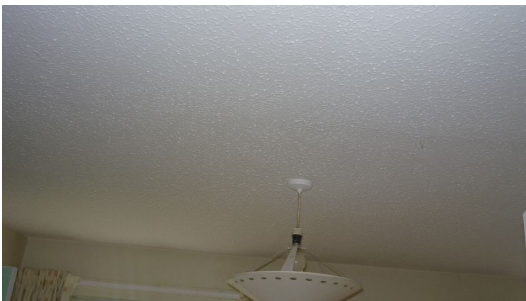
Item 8 – As ME1463/10

As ME1463/10 - Ceiling coating (Rm 1/07) (Item 8) - Very Low Risk

The coating to the ceiling in bedroom 3 (Rm 1/07) contains asbestos. Any change in its appearance should be recorded, and passed to Property Services.

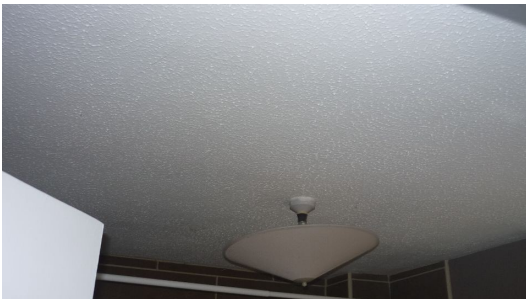
Item 9 - Ref: ME1464/10

ME1464/10 – Ceiling coating (Rm 1/08) (Item 9) – Very Low Risk

The coating to the ceiling in the bathroom (Rm 1/08) contains asbestos. Any change in its appearance should be recorded, and passed to Property Services.

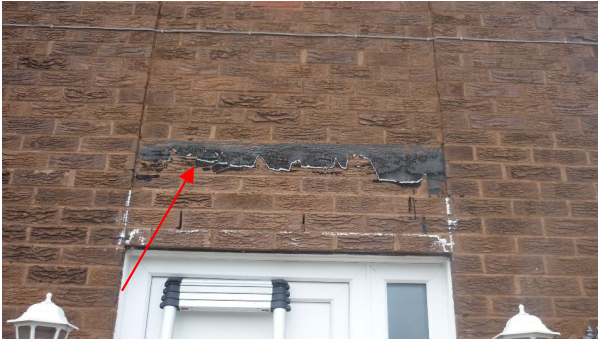
Item 10 - Ref: ME1465/10

ME1465/10 – Flashing to front (External) (Item 10) – Very Low Risk

The flashing above the front entrance (External) contains asbestos. Any change in its appearance should be recorded, and passed to Property Services.

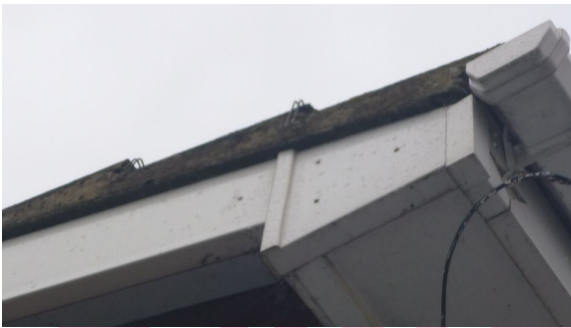
Item 11 - Ref: Presumed

Presumed – Undercloaking (External) (Item 11) – Very Low Risk

The undercloaking to the external of the house is presumed to contain asbestos. Any change in its appearance should be recorded, and passed to Property Services.
