ASBESTOS SURVEY REPORT FOR GROUNDSMAN HOUSE BILLY HARDY SPORTS COMPLEX, GRANGE ROAD, SUNDERLAND, SR5 3EQ.

## **Asbestos Register for**

### **Groundsman House, Billy Hardy Sports Complex**

**Date: 16 July 2024**

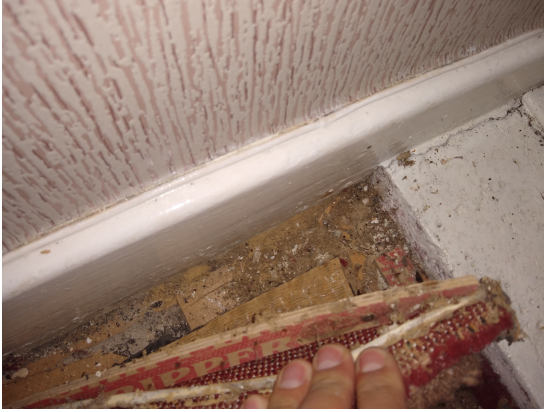
### **Item 1 Ref: 339069-1**

- (Item 1) Ref: 339069-1 Subfloor (Rm 001/Hall) – Very Low Risk
- (Item 2) Ref: As 339069-1 Subfloor (Rm 001/Hall Cupboard) – Very Low Risk
- (Item 3) Ref: As 339069-1 Subfloor (Rm 002/Lounge) – Very Low Risk

The subfloor in the hall (Room 001) contains asbestos.

Any change in appearance should be reported to Property Services.

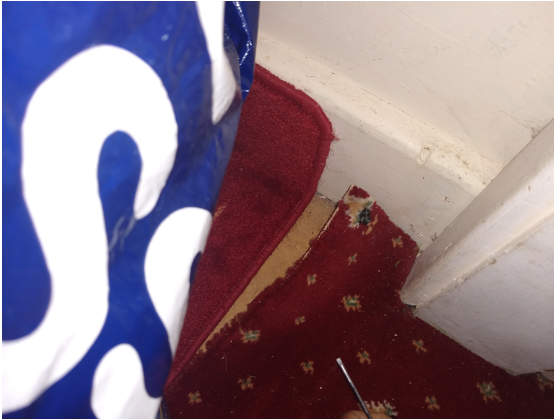
### **Item 2 Ref: As 339069-1**

The subfloor in the hall cupboard under the stairs (Room 001) contains asbestos.

Any change in appearance should be reported to Property Services.

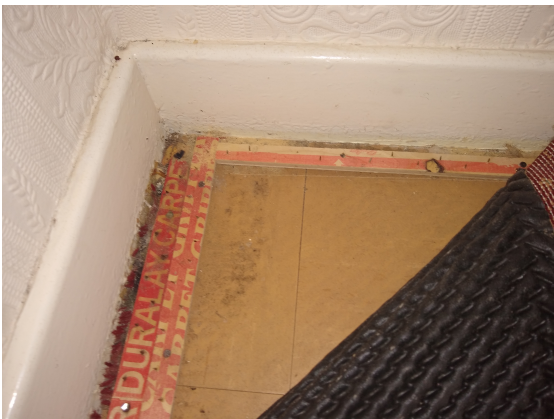
### **Item 3 Ref: As 339069-1**

The subfloor in the lounge (Room 002) contains asbestos.

Any change in appearance should be reported to Property Services.

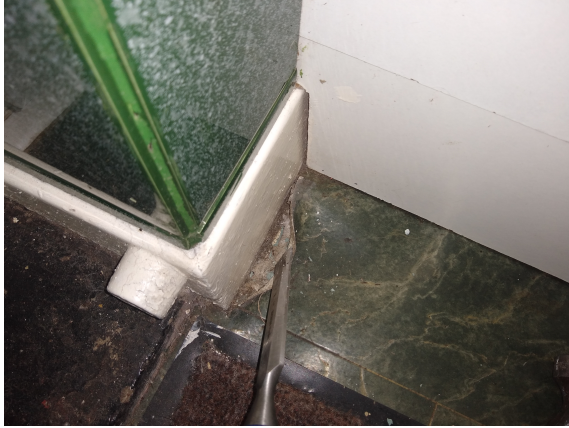
### **Item 4 Ref: 339069-2**

The subfloor in the kitchen (Room 003) contains asbestos.

Any change in appearance should be reported to Property Services.

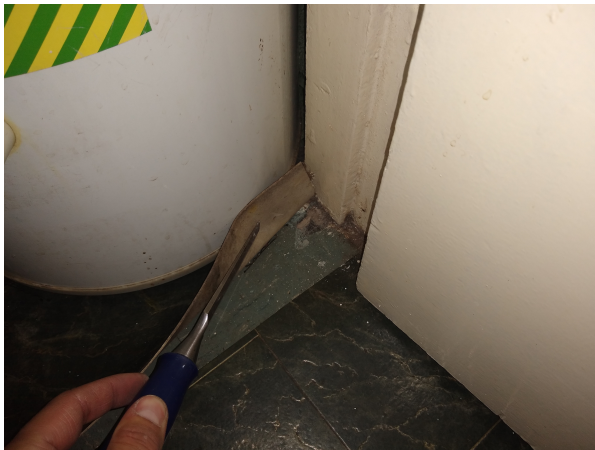
### **Item 5 Ref: As 339069-2**

The subfloor in the kitchen cupboard (Room 003) contains asbestos.

Any change in appearance should be reported to Property Services.

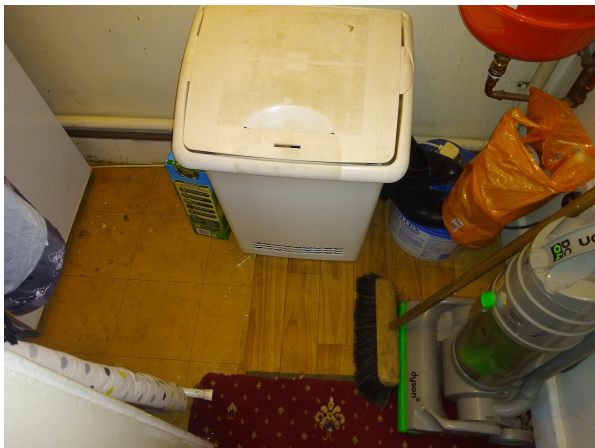
### **Item 6 Ref: As 339069-1**

The subfloor in the boiler cupboard (Room 004) contains asbestos.

Any change in appearance should be reported to Property Services.

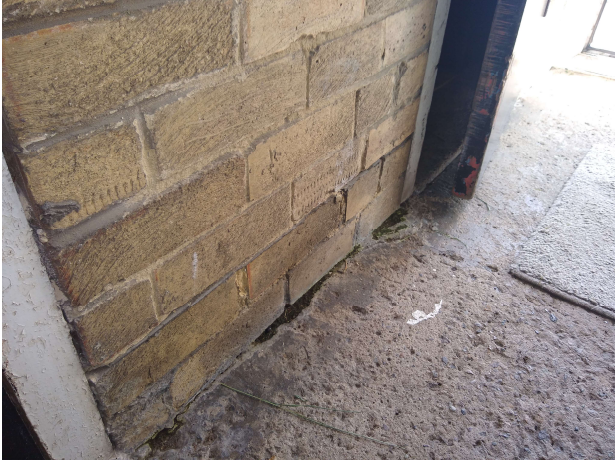
### **Item 7 Ref: 339069-3**

The damp proof course in the side passage (Room 005) does not contain asbestos.

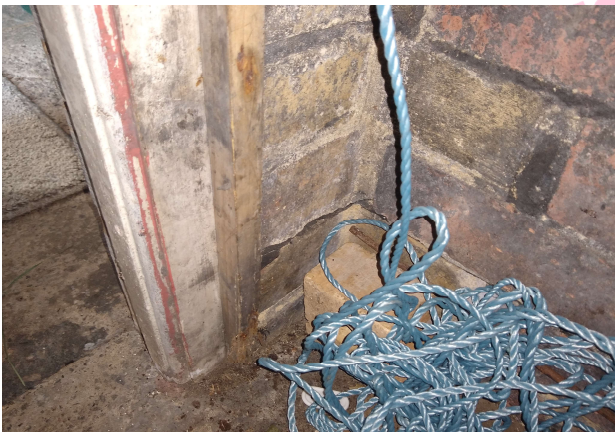
### **Item 8 Ref: As 339069-3**

The damp proof course in the store (Room 006) does not contain asbestos.

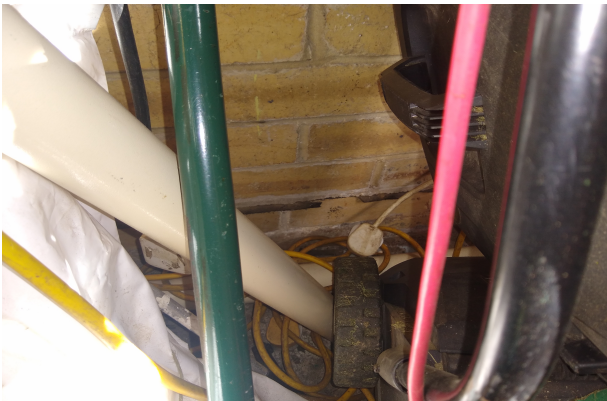
### **Item 9 Ref: As 339069-3**

The damp proof course in the store (Room 007) does not contain asbestos.

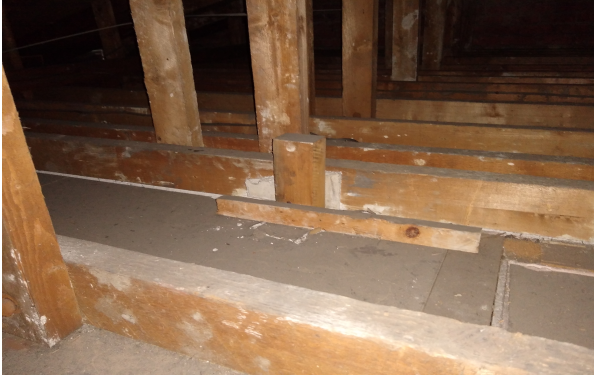
### **Item 10 Ref: 339069-4**

The packer to the stud wall in the roof void above the landing (Room 1/01) does contain asbestos.

Any change in appearance should be reported to Property Services.

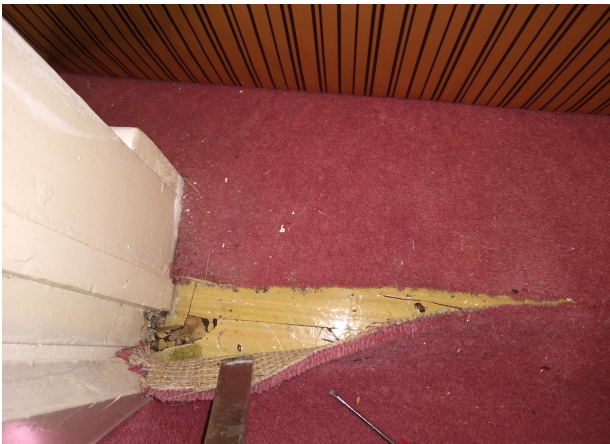
### **Item 11 Ref: 339069-5**

The subfloor in the bedroom (Room 003) does not contain asbestos.

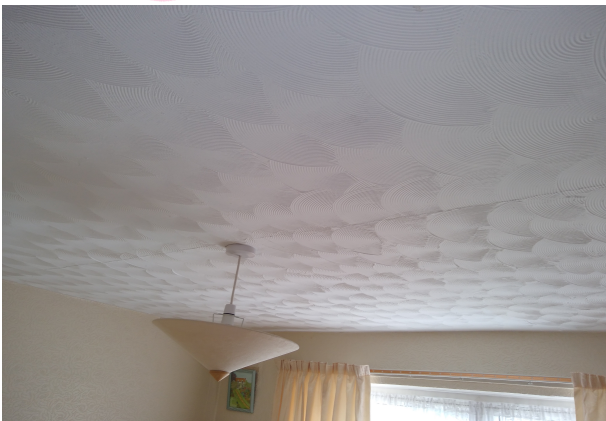
### **Item 12 Ref: 339069-6**

The textured coating to plasterboard ceiling in the bedroom (Room 004) does not contain asbestos.

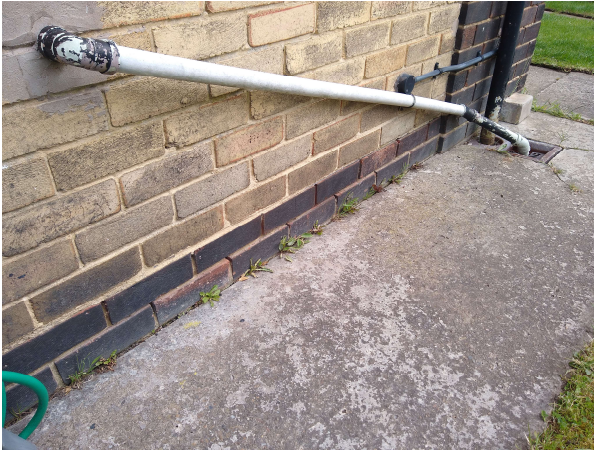
### **Item 13 Ref: 339069-7**

The damp proof course (External) does contain asbestos.

Any change in appearance should be reported to Property Services.

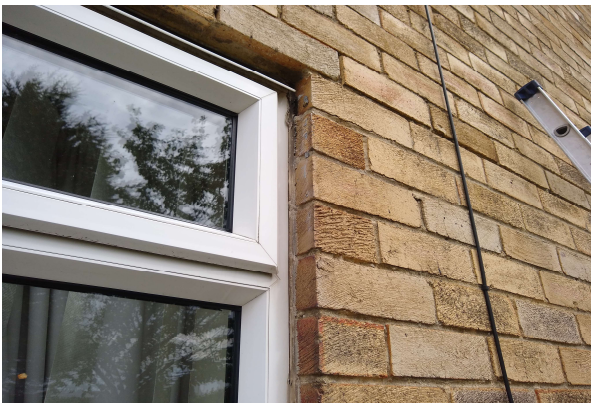
### **Item 14 Ref: 339069-8**

The remnant sealant to windows frames (External) does not contain asbestos.

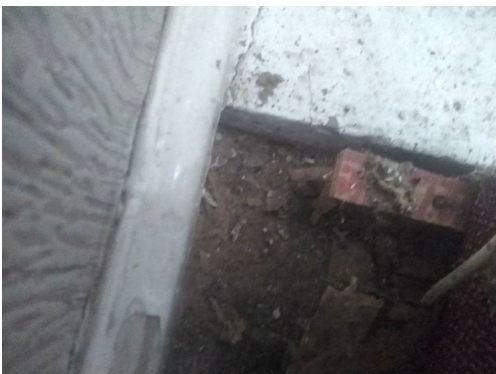
### **Item 15 Ref: VA004408**

The bitumen adhesive to floor (Entrance Hallway) does contain asbestos.

Any change in appearance should be reported to Property Services.

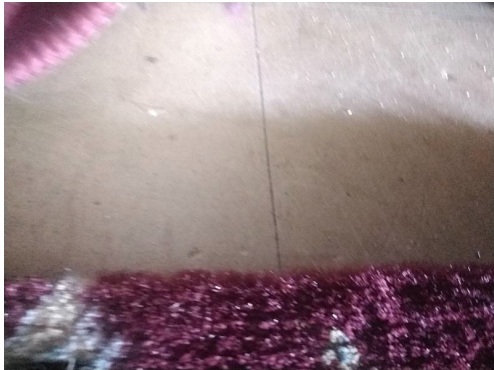
**Item 16 Ref: As VA004408**

The bitumen adhesive to floor (Understairs Cupboard) does contain asbestos.

Any change in appearance should be reported to Property Services.

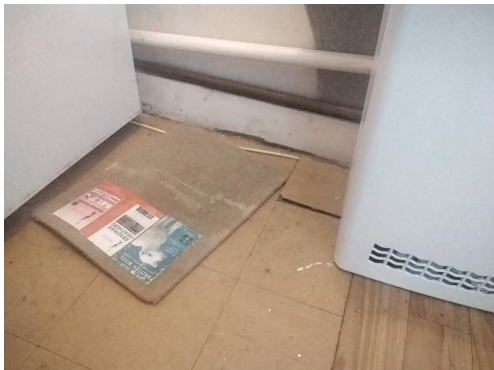
**Item 17 Ref: VA004410**

The bitumen adhesive to floor (Boiler Cupboard) does contain asbestos.

Any change in appearance should be reported to Property Services.

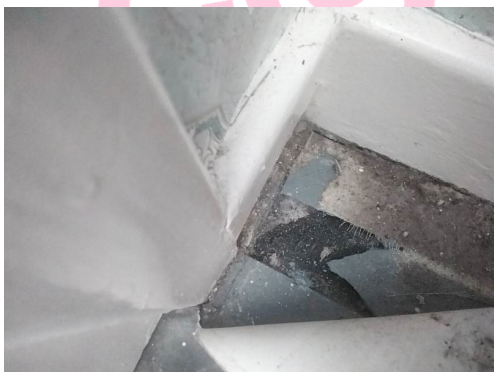
**Item 18 Ref: VA004412**

The bitumen adhesive to floor (Kitchen) does contain asbestos.

Any change in appearance should be reported to Property Services.

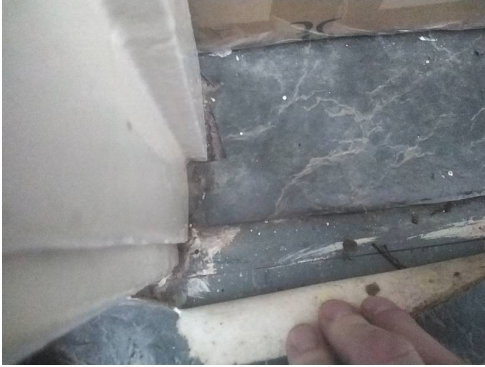
### **Item 19 Ref: As VA004412**

The bitumen adhesive to floor (Cupboard 1) does contain asbestos.

Any change in appearance should be reported to Property Services.

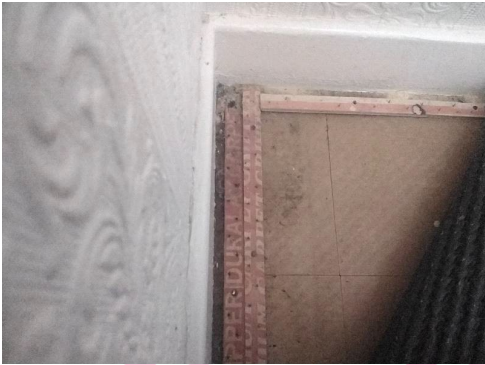
### **Item 20 Ref: VA004414**

The bitumen adhesive to floor (Living Room) does contain asbestos.

Any change in appearance should be reported to Property Services.

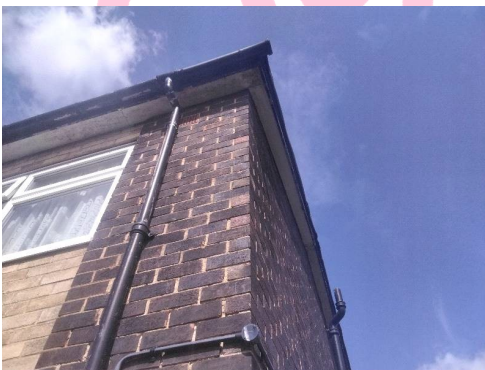
### **Item 21 Ref: Presumed**

The Cement Soffits (External) are presumed to contain asbestos.

Any change in appearance should be reported to Property Services.
