ASBESTOS SURVEY REPORT FOR BLOCK 4 EDWARD THOMPSON SITE, RICHMOND STREET, SUNDERLAND, SR5 1BQ

Asbestos Register for Block 4 Edward Thompson Site, Richmond Street, Sunderland, SR5 1BQ

Date: 19 July 2023

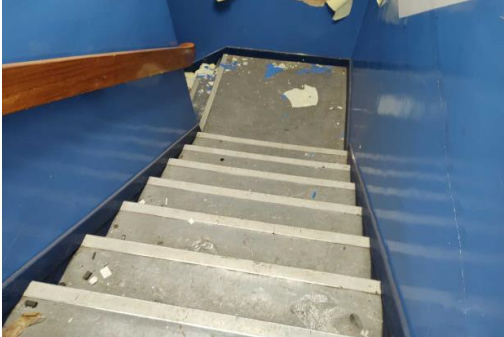
Item 1 Ref: 22-47234-12

The floor - vinyl to stairs (vinyl)
(Area: 1 Corridor and Stairs)
does not contain asbestos.

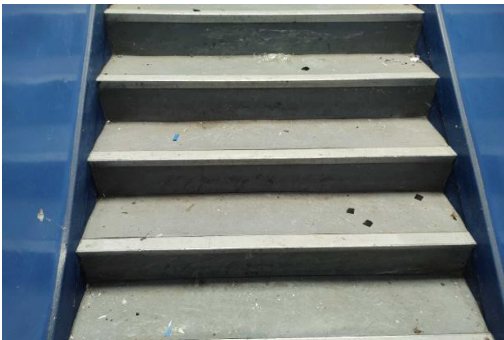
Item 2 Ref: 22-47234-13

The floor - stair nosing's
(composite) (area: 1 corridor
and stairs) contains asbestos.

Any change in its appearance
should be recorded and
passed to Property Services.

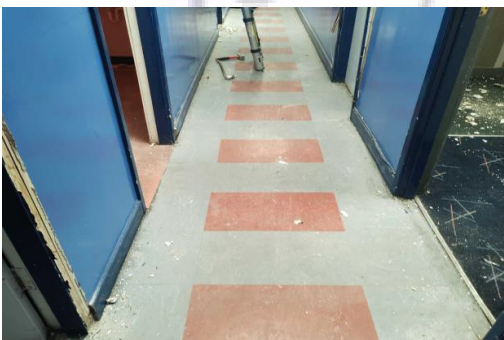
Item 3 Ref: 22-47234-2

The floor (tiles & adhesive)
(area: 1 corridor and stairs)
does not contain asbestos.

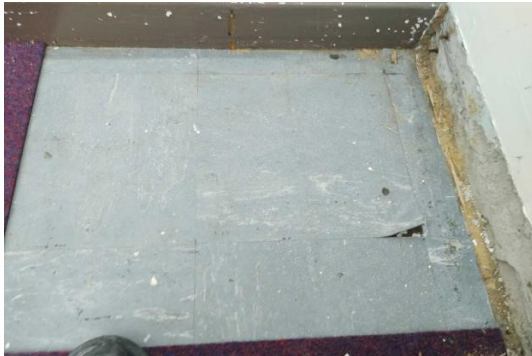
Item 4 Ref: 22-47234-14

The floor (tiles & adhesive)
(area: 2 office 1) does not
contain asbestos.

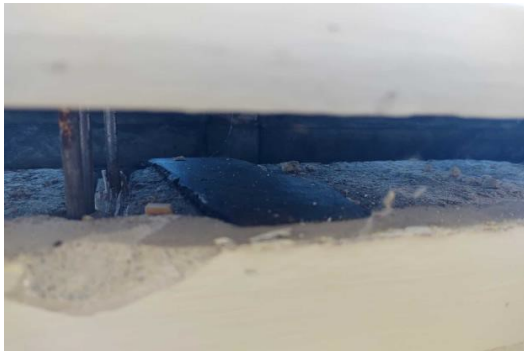
Item 5 Ref: 22-47234-4

The window – packers to sill
(bitumen) (area: 2 office 1)
does not contain asbestos.

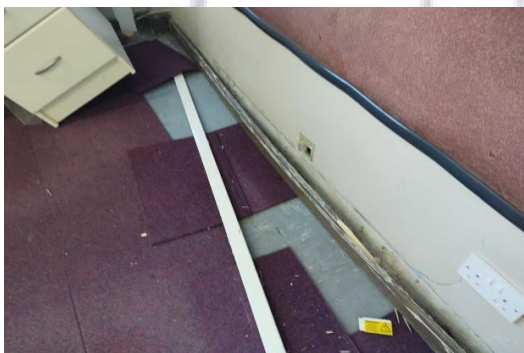
Item 6 Ref: 22-47234-14

The floor (tiles & adhesive)
(area: 3 office 2) does not
contain asbestos.

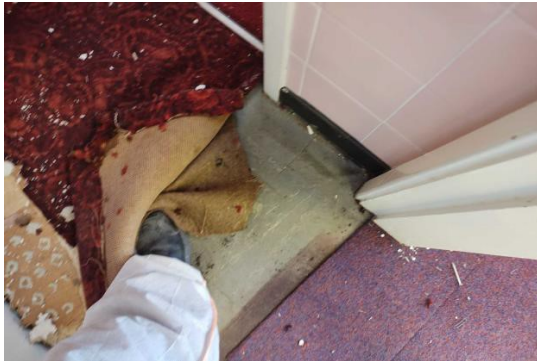
Item 7 Ref: 22-47234-14

The floor (tiles & adhesive) (area: 4 wc & lobby) does not contain asbestos.

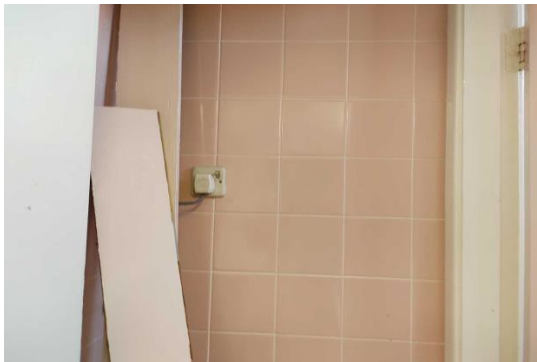
Item 8 Ref: 22-47234-15

The walls – ceramic (tiles & adhesive) (area: 4 wc & lobby) does not contain asbestos.

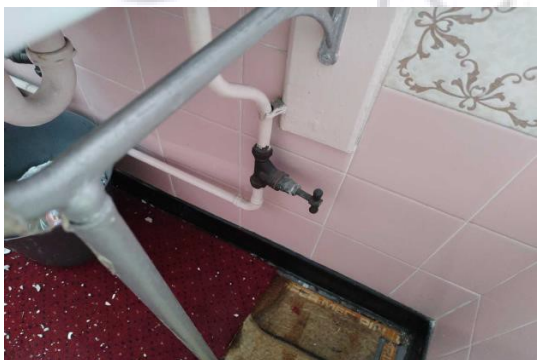
Item 9 Ref: 22-47234-16

The pipes (gaskets) (area: 4 wc & lobby) do not contain asbestos.

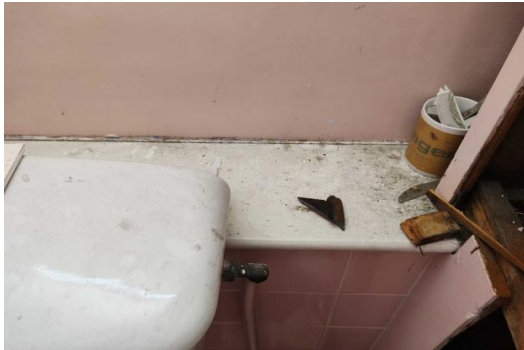
Item 10 Ref: 22-47234-4

The window – packers to sill (bitumen) (area: 4 wc & lobby) does not contain asbestos.

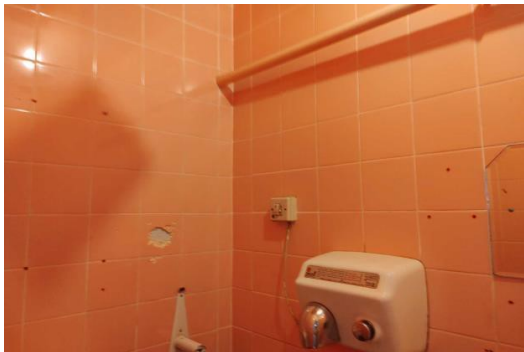
Item 11 Ref: 22-47234-15

The walls – ceramic tile adhesive (adhesive) (area: 5 wc & lobby 2) do not contain asbestos.

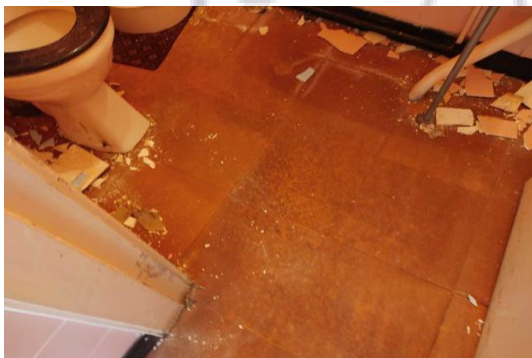
Item 12 Ref: 22-47234-17

The floor (tiles & adhesive) (area: 5 wc & lobby 2) does not contain asbestos.

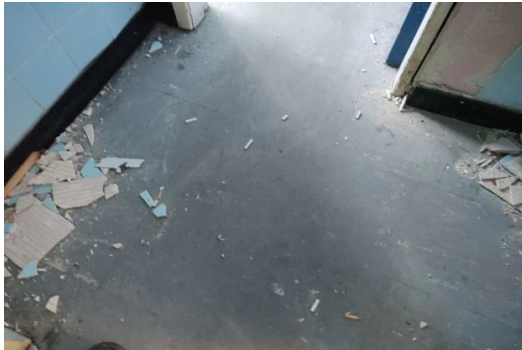
Item 13 Ref: 22-47234-14

The floor (tiles & adhesive) (area: 6 wc & lobby 3) does not contain asbestos.

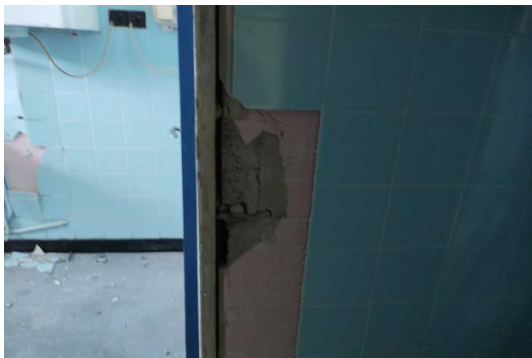
Item 14 Ref: 22-47234-15

The walls – ceramic tiles (adhesive) (area: 6 wc & lobby 3) do not contain asbestos.

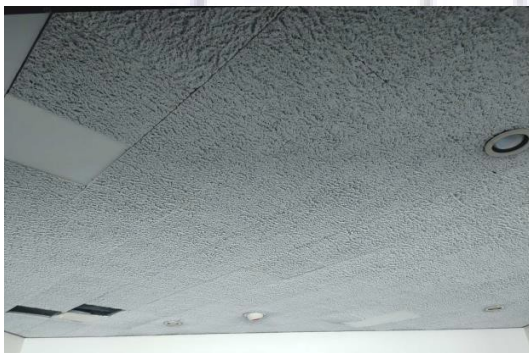
Item 15 Ref: 22-47234-1

The ceiling – ceiling tiles (insulating board) (area: 7 office 3) does not contain asbestos.

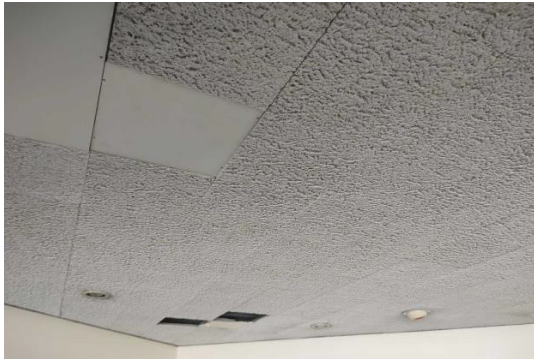
Item 16 Ref: 22-47234-1

The ceiling – ceiling tiles (insulating board) (area: 7 office 3) does not contain asbestos.

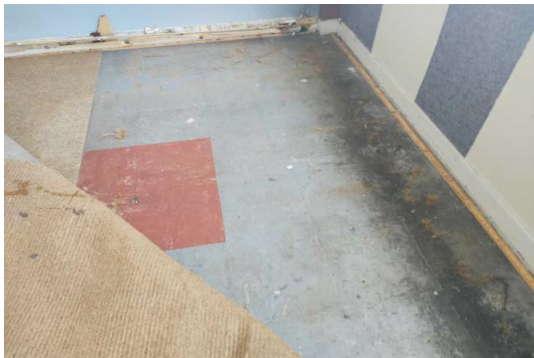
Item 17 Ref: 22-47234-2

The floor (tiles & adhesive) (area: 7 office 3) does not contain asbestos.

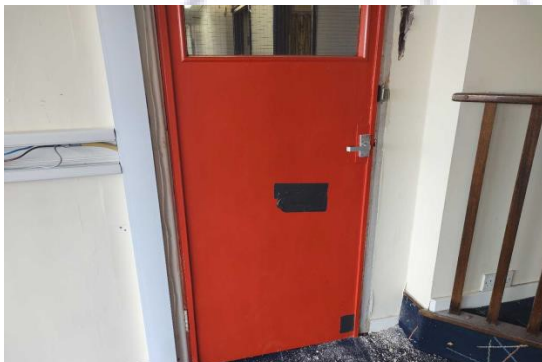
Item 18 Ref: 22-47234-3

The door – panel to corridor door (insulating board) (area: 7 office 3) contains asbestos.

Any change in its appearance should be recorded and passed to Property Services.

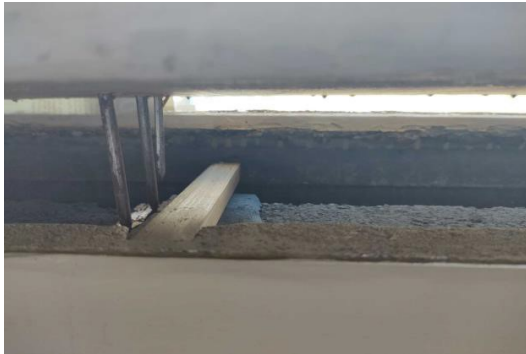
Item 19 Ref: 22-47234-4

The window – packers to sill (bitumen) (area: 7 office 3) does not contain asbestos.

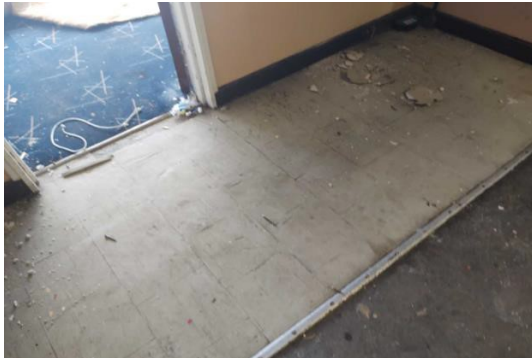
Item 20 Ref: 22-47234-5

The floor (tiles & adhesive) (area: 8 store) contains asbestos.

Any change in its appearance should be recorded and passed to Property Services.

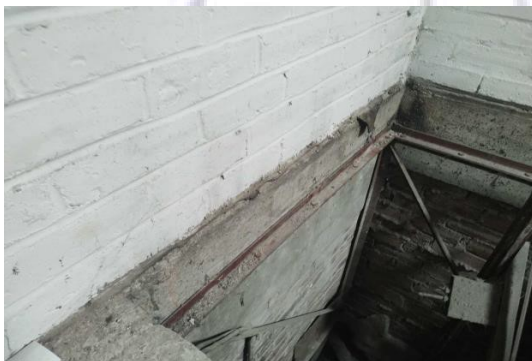
Item 21 Ref: 22-47234-6

The damp proof course to walls around goods lift (bitumen) (area: 8 store) does not contain asbestos.

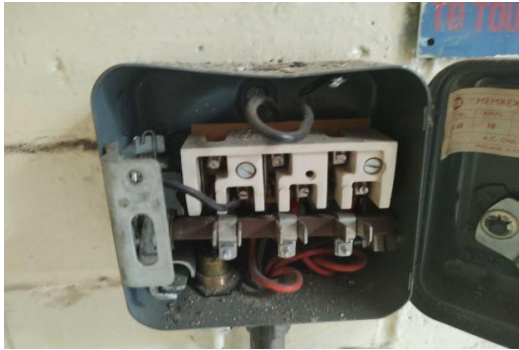
Item 22 Ref: Presumed

The electrical equipment – pad with mem switch (textile) (area: 10 Office 4) is presumed to contain asbestos.

Any change in its appearance should be recorded and passed to Property Services.

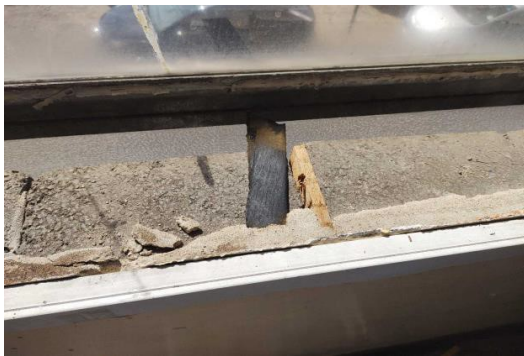
Item 23 Ref: 22-47234-4

The window – packers to sill (bitumen) (area: 12 workshop) does not contain asbestos.

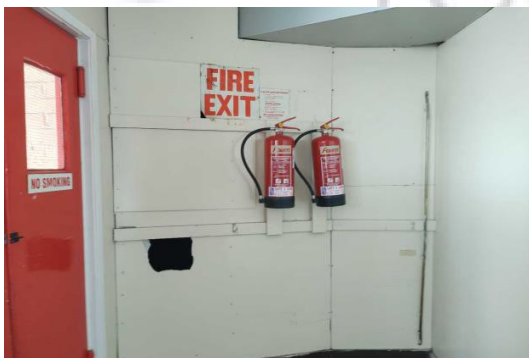
Item 24 Ref: 22-47234-8

The walls – wall panels to riser 12b (insulating board) (area: 12 workshop) contain asbestos.

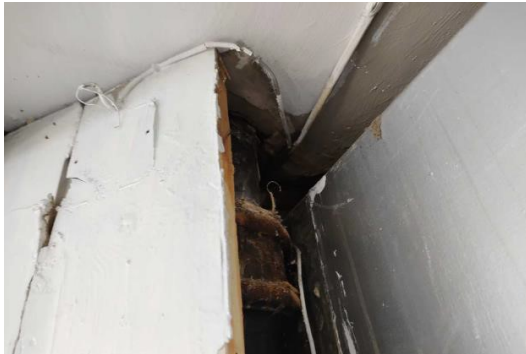
Item 25 Ref: 22-47234-10

The soil pipe – loose fill to top knuckle joint (insulation) (area: 13 office 8) contains asbestos.

(insulating board) (area:12 workshop)			
Item 25	soil pipe – loose fill to top knuckle joint (insulation) (area:13 office 8)	Medium Risk	3 monthly	13.12.2023
<i>Item 26</i>	<i>No asbestos</i>	<i>Is present</i>		
<i>Item 27</i>	<i>No asbestos</i>	<i>Is present</i>		
<i>Item 28</i>	<i>No asbestos</i>	<i>Is present</i>

Any change in its appearance should be recorded and passed to Property Services.

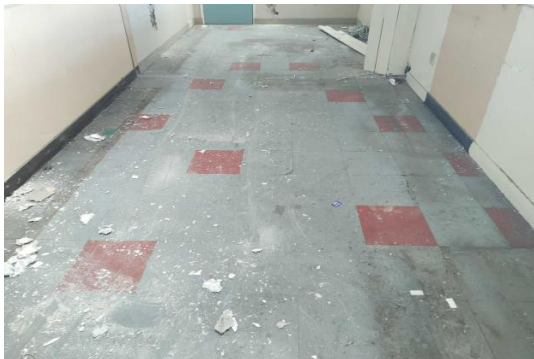
Item 26 Ref: 22-47234-2

The floor (tiles & adhesive) (area: 13 office 8) does not contain asbestos.

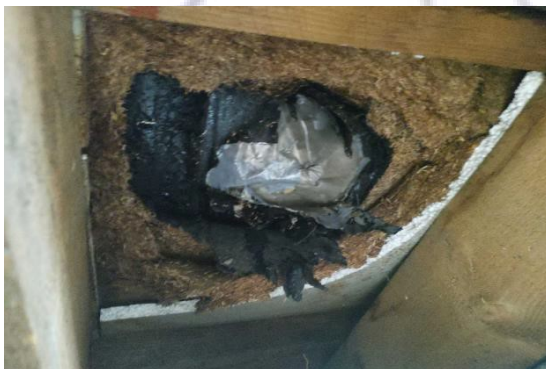
Item 27 Ref: 22-47234-9

The roof – roof felt (bitumen) (area: 13 office 8) does not contain asbestos.

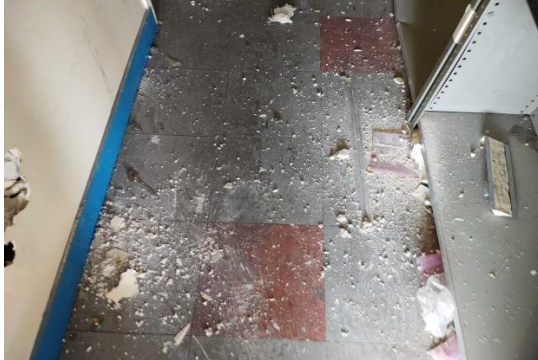
Item 28 Ref: 22-47234-2

The floor (tiles & adhesive)
(area: 14 store 2) does not
contain asbestos.

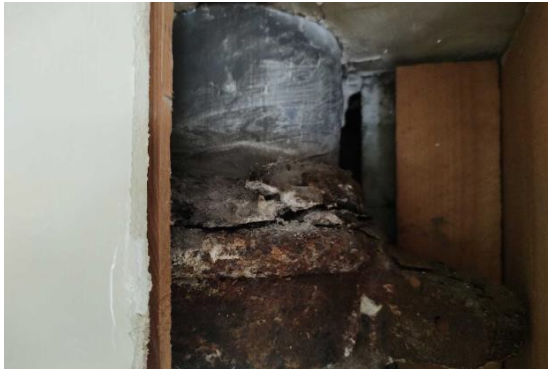
Item 29 Ref: 22-47234-10

The soil pipe – loose fill to top
knuckle joint to x2 soil pipes
(insulation) (area: 15 lab)
contains asbestos.

Item 29	soil pipe – loose fill to top knuckle joint to x2 soil pipes (insulation) (area:15 lab)	Medium Risk	3 monthly	13.12.2023
<i>Item 30</i>	<i>No asbestos</i>	<i>Is present</i>		
<i>Item 31</i>	<i>No asbestos</i>	<i>Is present</i>

Any change in its appearance
should be recorded and
passed to Property Services.

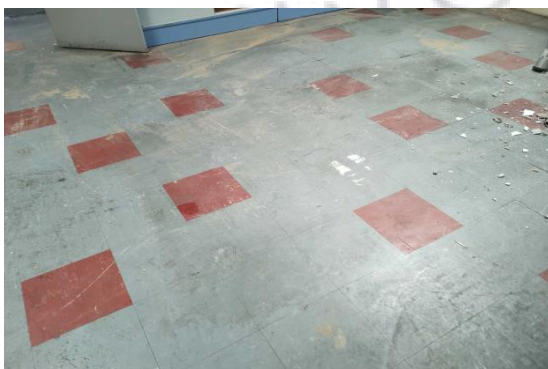
Item 30 Ref: 22-47234-2

The floor (tiles & adhesive)
(area: 15 lab) does not contain
asbestos.

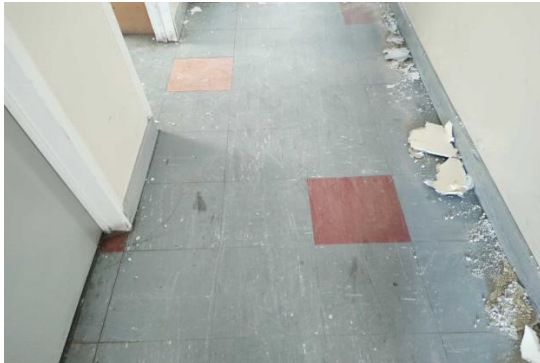
Item 31 Ref: 22-47234-11

The floor (tiles & adhesive)
(area: 16 corridor) does not
contain asbestos.

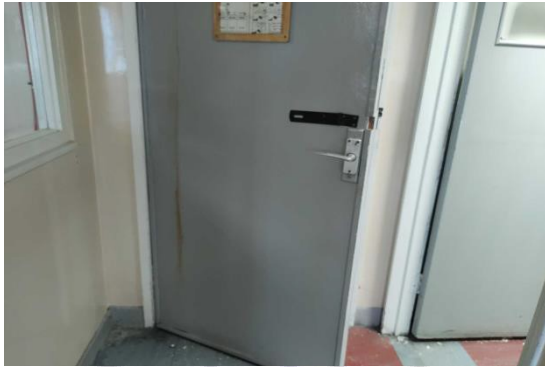
Item 32 Ref: 22-47234-3

The door – panel to corridor
door (insulating board) (area:
16 corridor) contains
asbestos.

Any change in its appearance
should be recorded and
passed to Property Services.

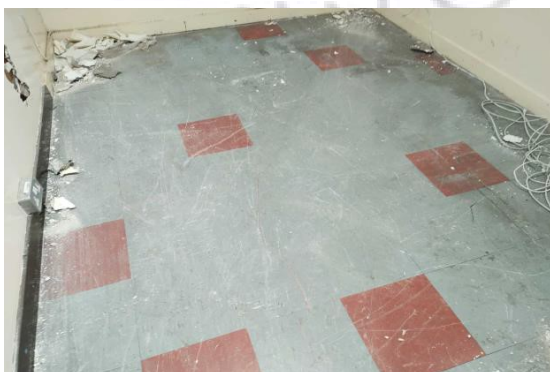
Item 33 Ref: 22-47234-11

The floor (tiles & adhesive)
(area: 17 office 5) does not
contain asbestos.

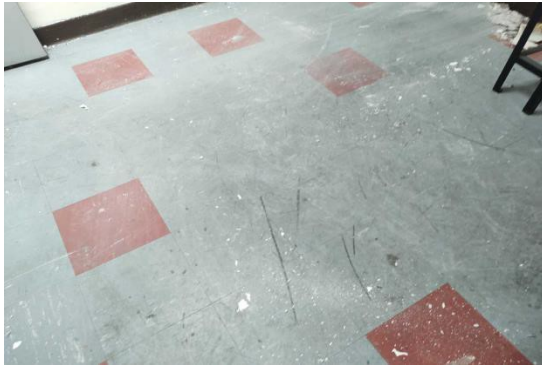
Item 34 Ref: 22-47234-11

The floor (tiles & adhesive) (area: 18 office 6) does not contain asbestos.

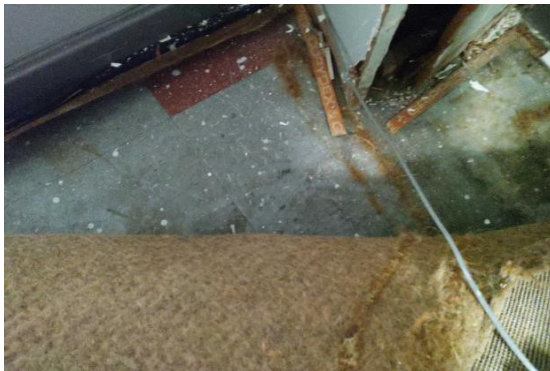
Item 35 Ref: 22-47234-11

The floor (tiles & adhesive) (area: 19 office 7) does not contain asbestos.

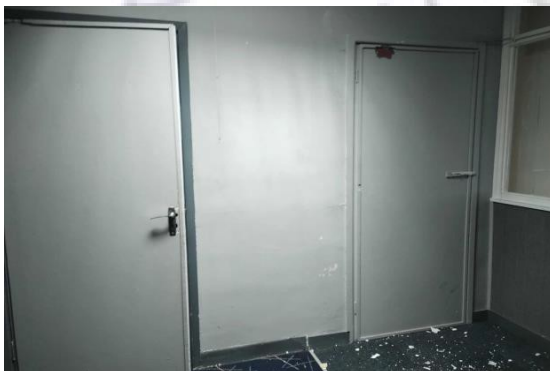
Item 36 Ref: 22-47234-3

The door – panel to x2 doors (insulating board) (area: 19 office 7) contains asbestos.

Any change in its appearance should be recorded and passed to Property Services.

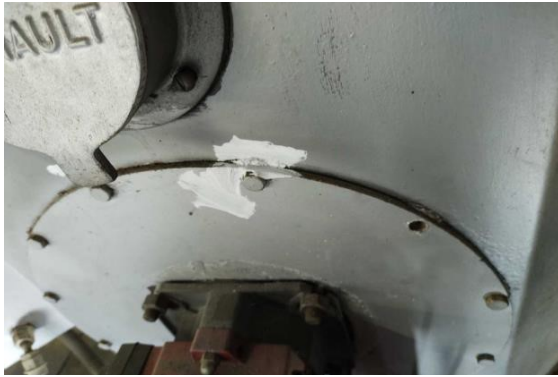
Item 37 Ref: 22-47234-18

The vessels (gaskets) (area: 20 main workshop) contain asbestos.

Any change in its appearance should be recorded and passed to Property Services.

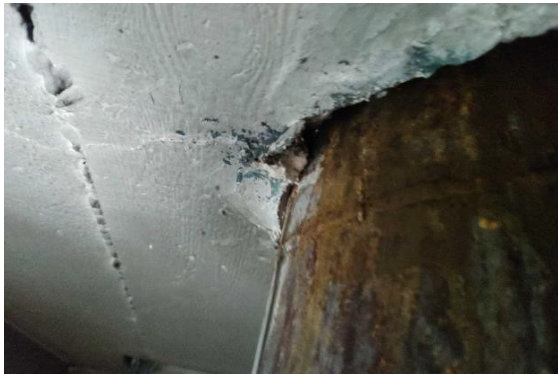
Item 38 Ref: 22-47234-18

The flue – loose fill to flue ceiling penetration (insulation) (area: 20 main workshop) contains asbestos.

Item 38	loose fill to flue ceiling penetration (insulation) (area:20 main workshop)	Low Risk	6 monthly	13.03.2024
Item 39	door (insulating	Low Risk	6 monthly	13.03.2024

Any change in its appearance should be recorded and passed to Property Services.

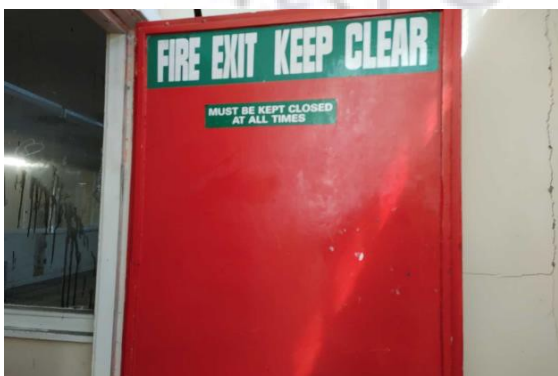
Item 39 Ref: 22-47234-20

The door (insulating board) (area: 20 main workshop) contains asbestos.

Any change in its appearance should be recorded and passed to Property Services.

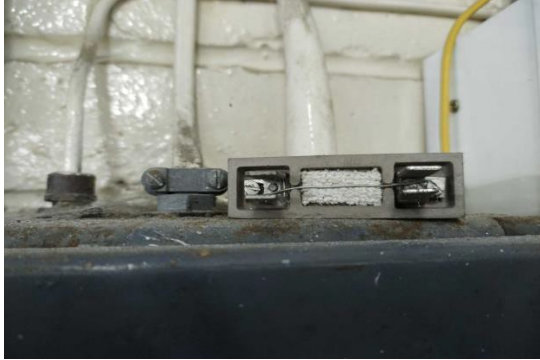
Item 40 Ref: 22-47234-21

The electrical equipment – flash guards to electrics (textile) (area: 20 main workshop) contains asbestos.

Any change in its appearance should be recorded and passed to Property Services.

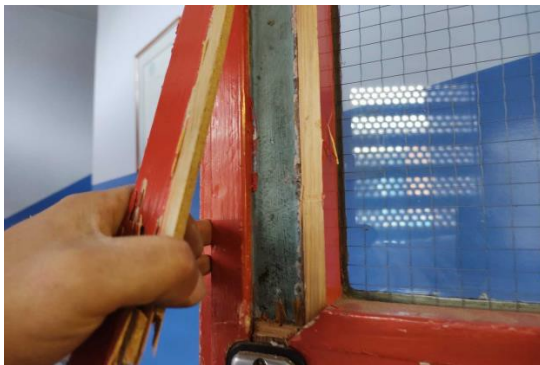
Item 41 Ref: 22-47234-22

The door – panels within x2 red doors (insulating board) (area: 20 main workshop) contains asbestos.

Any change in its appearance should be recorded and passed to Property Services.

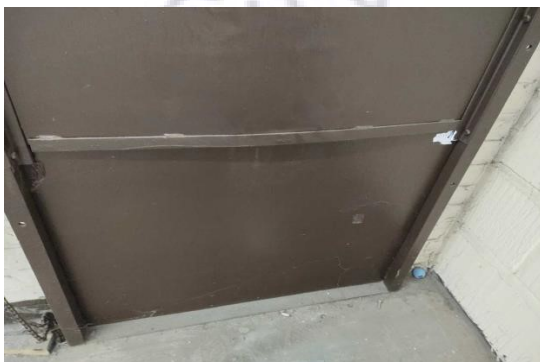
Item 42 Ref: 22-47234-24

The infill panels (insulating board) (area: 20 main workshop) contain asbestos.

Any change in its appearance should be recorded and passed to Property Services.

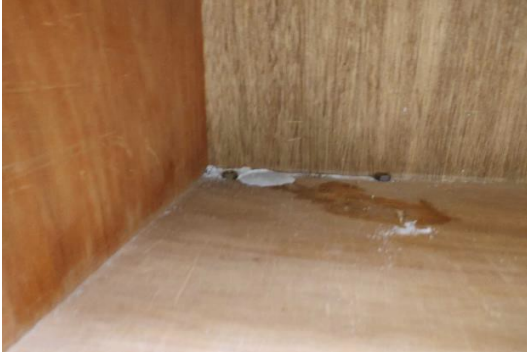
Item 43 Ref: 22-47234-23

The debris to cupboard (insulation) (area: 23 store 2) does not contain asbestos.

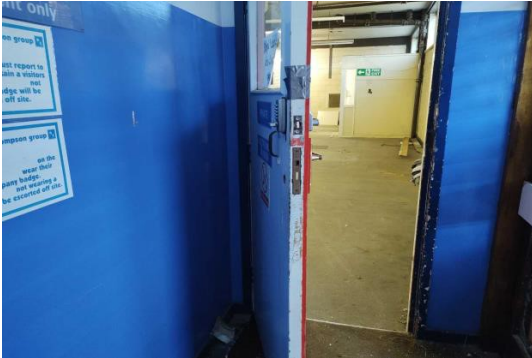
Item 44 Ref: 22-47234-22

The door – panels within door (insulating board) (area: 24 entrance lobby) contains asbestos.

Any change in its appearance should be recorded and passed to Property Services.

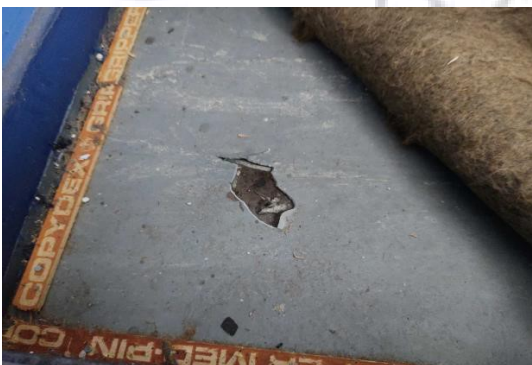
Item 45 Ref: 22-47234-25

The floor - vinyl (vinyl) (area: 24 entrance lobby) does not contain asbestos.

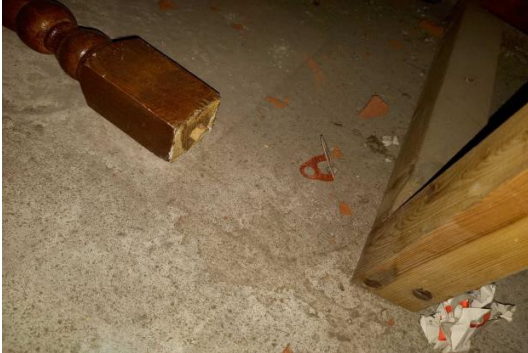
Item 46 Ref: 22-47234-26

The loose lying gasket (gasket) (area: 25 cupboard - understairs) contains asbestos.

Item 45	No asbestos	Is present		
Item 46	loose lying gasket (gasket) (area:25 cupboard - understairs)	Very Low Risk	12 monthly	13.09.2023 Removed on reinspection survey

Removed on reinspection survey.

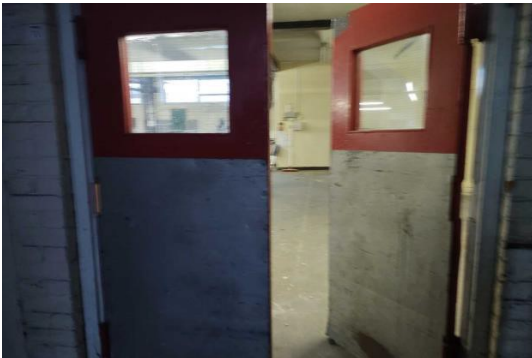
Item 47 Ref: 22-47234-22

The door (insulating board) (area: 26 garage) contains asbestos.

Any change in its appearance should be recorded and passed to Property Services.

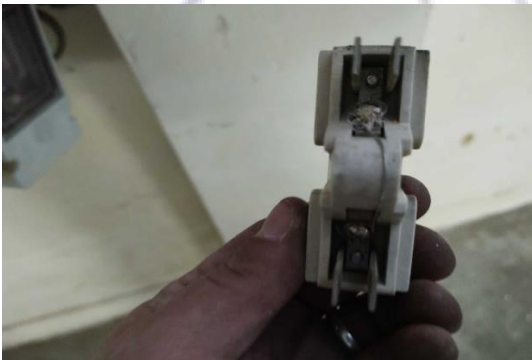
Item 48 Ref: 22-47234-21

The electrical equipment – residues to fuse holders (textile) (area: 27 workshop 2) contains asbestos.

Any change in its appearance should be recorded and passed to Property Services.

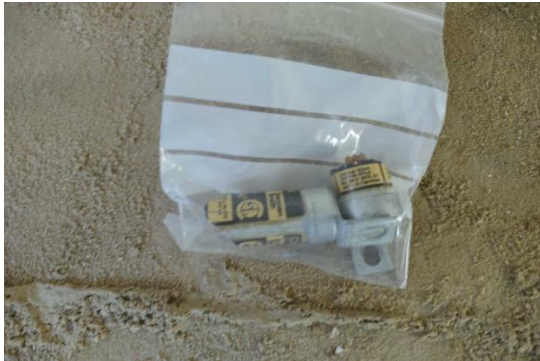
Item 49 Ref: 22-47234-27

The electrical equipment – fuse cartridges (textile) (area: 27 workshop 2) contains asbestos.

Any change in its appearance should be recorded and passed to Property Services.

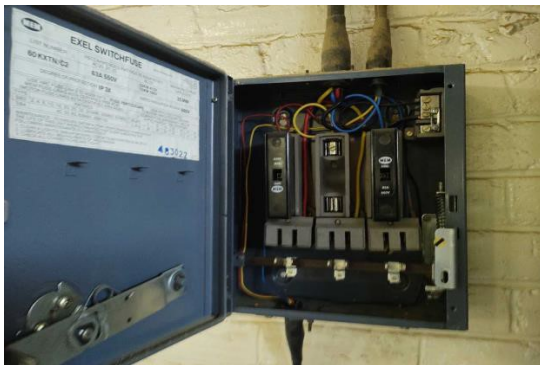
Item 50 Ref: 22-47234-27

The electrical equipment – fuse cartridges (textile) (area: 27 workshop 2) contains asbestos.

Removed on reinspection survey.

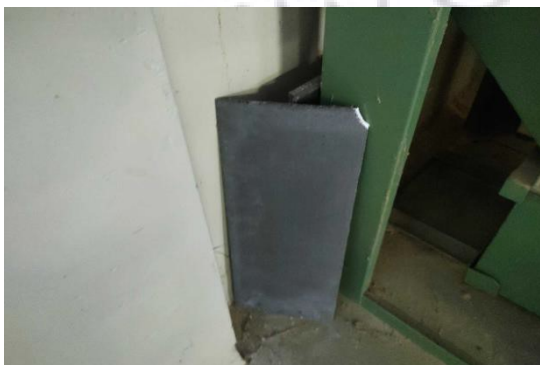
Item 51 Ref: 22-47234-28

The loose panels behind dust extraction (cement) (area: 27 workshop 2) contain asbestos.

Any change in its appearance should be recorded and passed to Property Services.

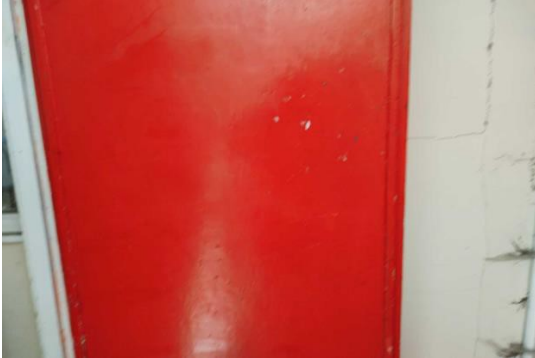
Item 52 Ref: 22-47234-20

The door (insulating board) (area: 28 fire exit) contains asbestos.

Any change in its appearance should be recorded and passed to Property Services.

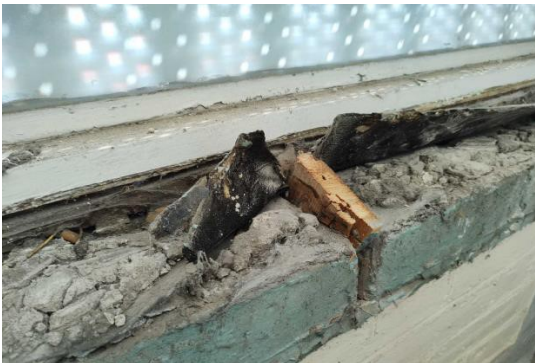
Item 53 Ref: 22-47234-29

The window – damp proof course below sill (bitumen) (area: 28 fire exit) does not contain asbestos.

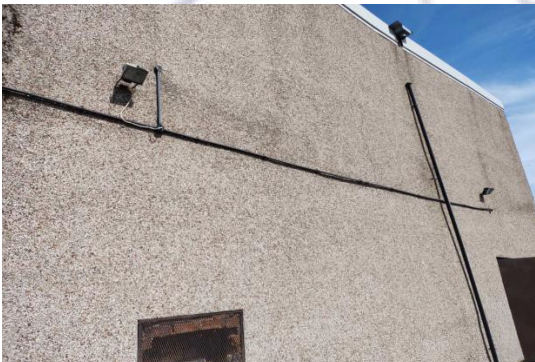
Item 54 Ref: 22-47234-30

The walls – render to walls (render) (area: 30 external) do not contain asbestos.

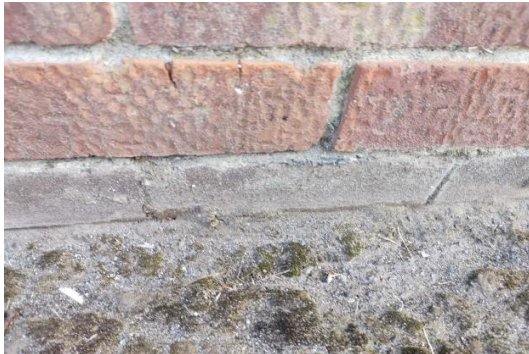
Item 55 Ref: 22-47234-31

The damp proof course to walls (bitumen) (area: 30 external) does not contain asbestos.

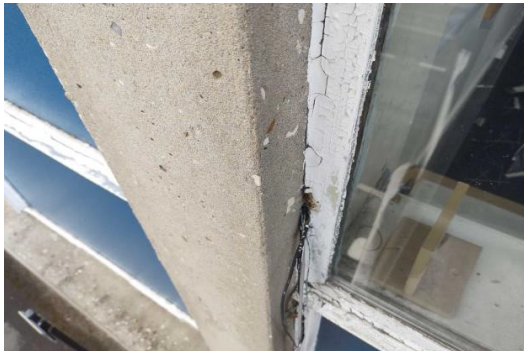
Item 56 Ref: 22-47234-32

The windows – window frame sealant between concrete and metal frames (mastic) (area: 30 external) contain asbestos.

Any change in its appearance should be recorded and passed to Property Services.

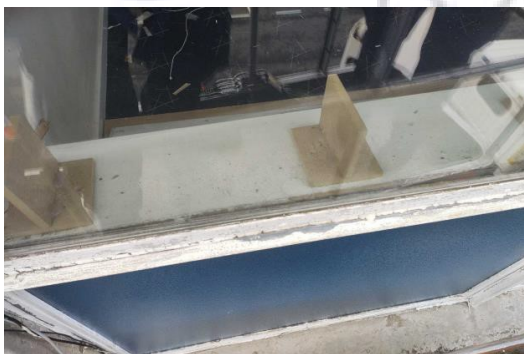
Item 57 Ref: 22-47234-33

The windows – glazing putty (putty) (area: 30 external) do not contain asbestos.

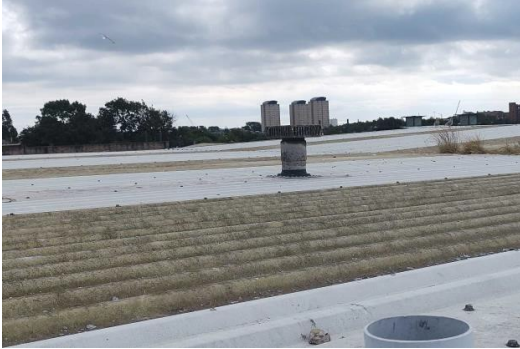
Item 58 Ref: Presumed

The flue (cement) (area: 30 external) is presumed to contain asbestos.

Any change in its appearance should be recorded and passed to Property Services.

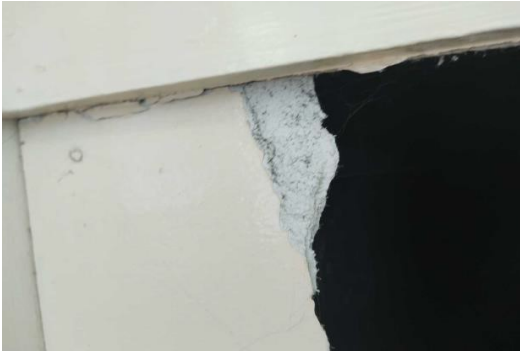
Item 59 Ref: 22-47234-8

The walls – wall panels to riser 12a (insulating board) (area: 12a riser) contain asbestos.

Any change in its appearance should be recorded and passed to Property Services.

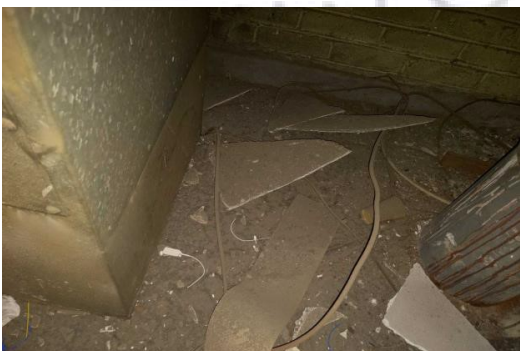
Item 60 Ref: 22-47234-8

The floor – broken insulating board panels within riser (insulating board) (area: 12a riser) contains asbestos.
