ASBESTOS SURVEY REPORT FOR WASHINGTON MILLENIUM CENTRE LIBRARY/THE OVAL, WASHINGTON, NE37 2QD.

## Asbestos Register for

**Washington Millennium Centre, Washington, NE37 2QD**

**Date: 07 February 2025**

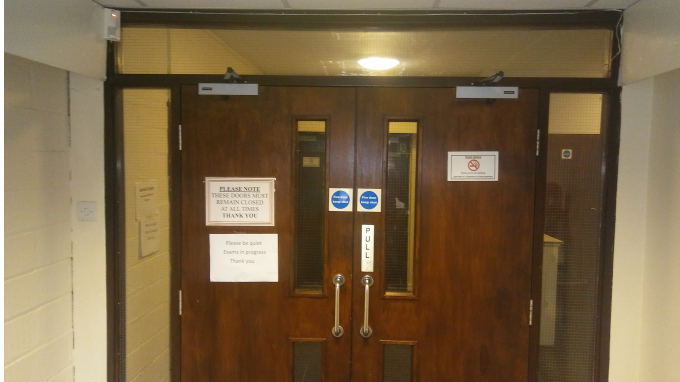
### **Item 1 Ref: 406601-1**

The sealant to internal door frame adjacent 003 in 001/Entrance lobby does not contain asbestos.

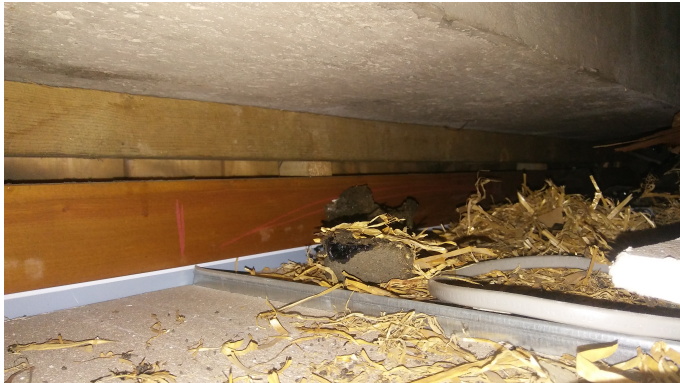
### **Item 2 Ref: 406601-2**

The debris above doors leading to 003 in 001/Entrance lobby void above contains asbestos.

Any change in its appearance should be recorded and passed to Property Services.

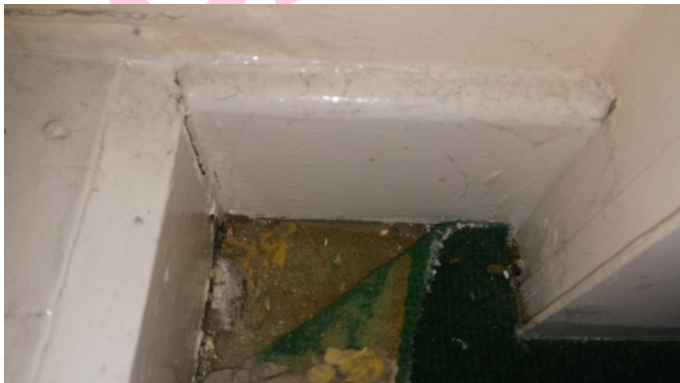
### **Item 3 Ref: 406601-11**

The sub floor covering in 002/Trust room contains asbestos.

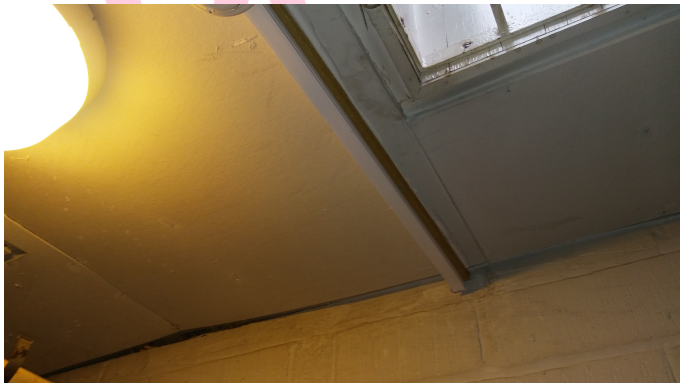
### **Item 6 Ref: As 406601-3**

The fixed suspended ceiling in 010/Store contains asbestos.

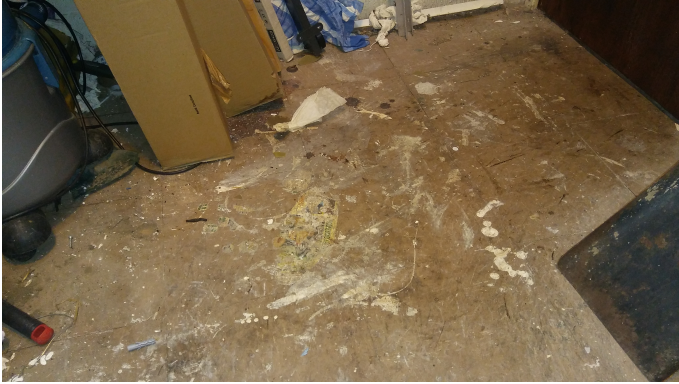
### **Item 7 Ref: 406601-12**

The floor covering in 010/Store contains asbestos.

Any change in its appearance should be recorded and passed to Property Services.

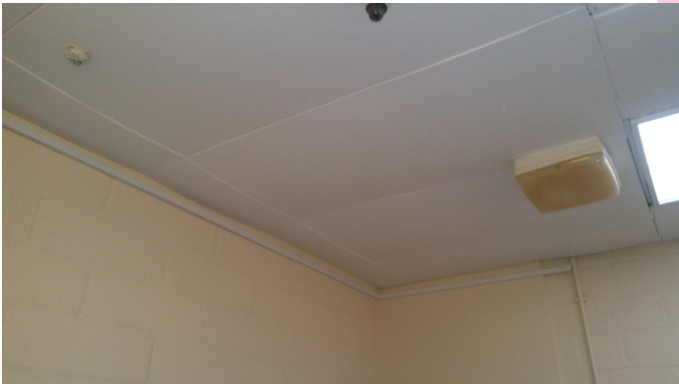
### **Item 8 Ref: As 406601-3**

The fixed suspended ceiling in 011/Female WC contains asbestos.

*Removed July 2021*

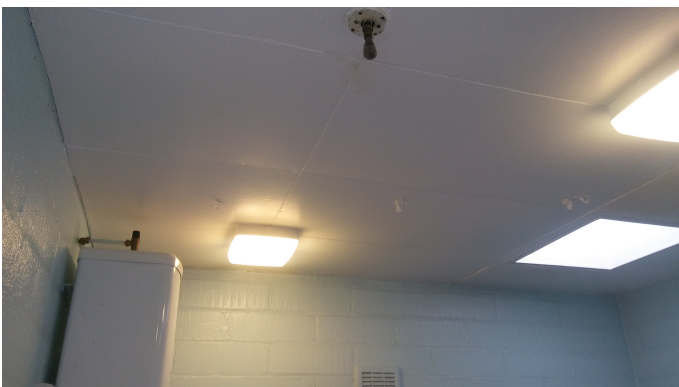
### **Item 9 Ref: As 406601-3**

The fixed suspended ceiling in 012/Male WC contains asbestos.

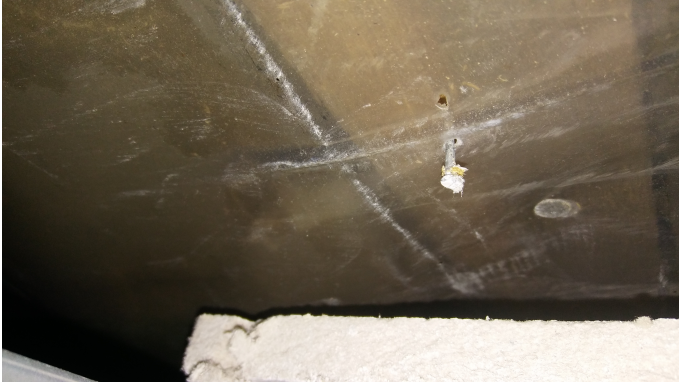
### **Item 13 Ref: 406601-7**

The debris to nails from previous fibreboard ceiling in 014/Activity room void above contains asbestos.

Any change in its appearance should be recorded and passed to Property Services.

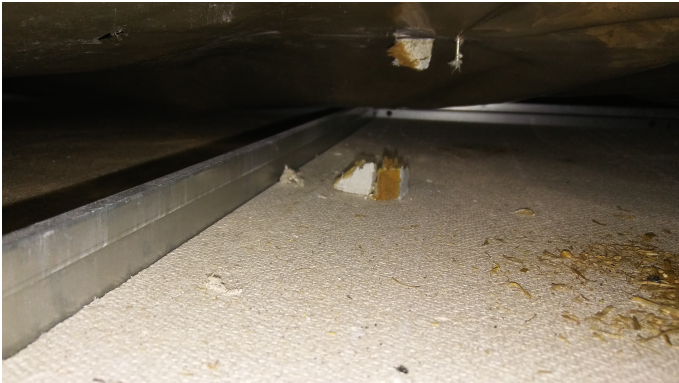
### **Item 14 Ref: 406601-8**

The debris to topside of suspended ceiling tiles below in 014/Activity room void above contains asbestos.

Any change in its appearance should be recorded and passed to Property Services.

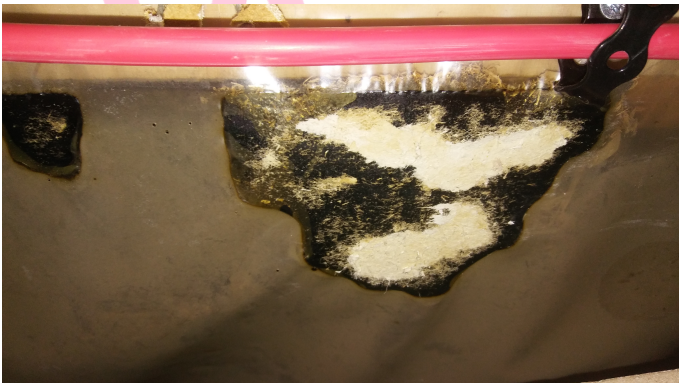
### **Item 15 Ref: 406601-10**

The debris to bitumen on polythene sheeting in 014/Activity room void above contains asbestos.

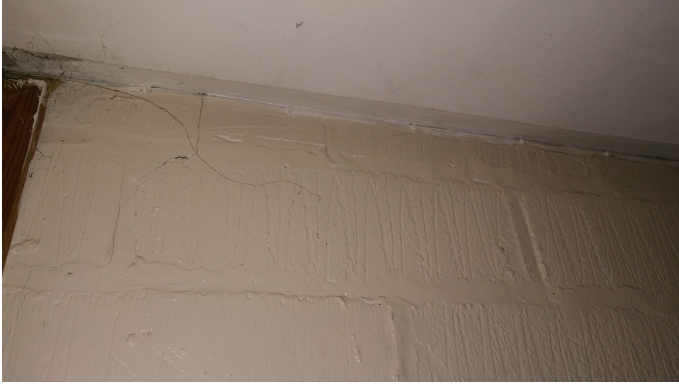
### **Item 16 Ref: 406601-13**

The ceiling in 014a/Cupboard contains asbestos.

Any change in its appearance should be recorded and passed to Property Services.

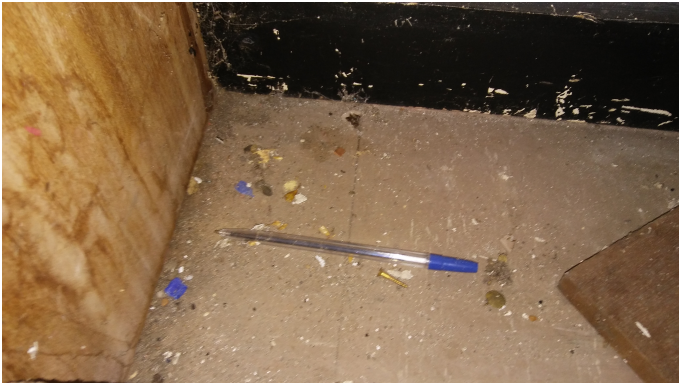
### **Item 17 Ref: 406601-16**

The floor covering in 014a/Cupboard contains asbestos.

Any change in its appearance should be recorded and passed to Property Services.

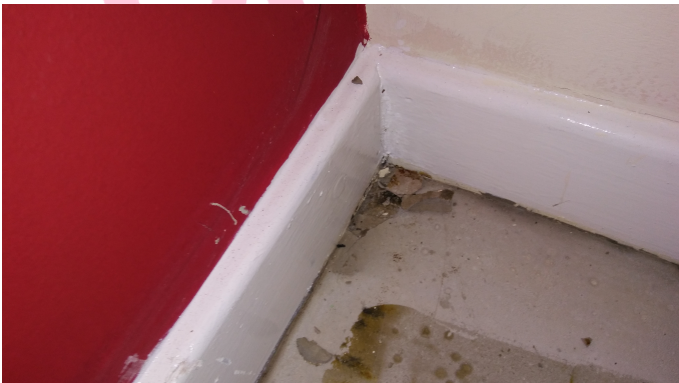
### **Item 18 Ref: As 406601-14**

The subfloor in 015/Classroom contains asbestos.

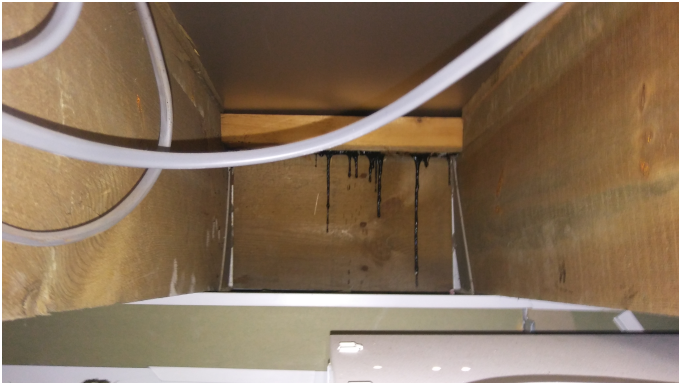
**Item 20 Ref: As 406601-5**

The remnant roof sealant to wood beams in 015a/ Classroom void above does not contain asbestos.

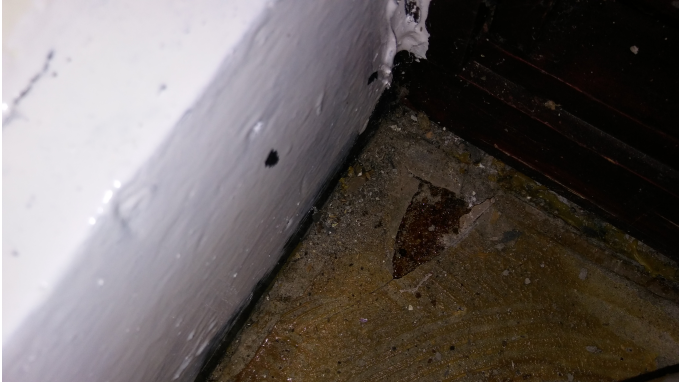
### **Item 22 Ref: 406601-17**

The floor beneath modern linoleum subfloor in 016/side entrance contains asbestos.

Any change in its appearance should be recorded and passed to Property Services.

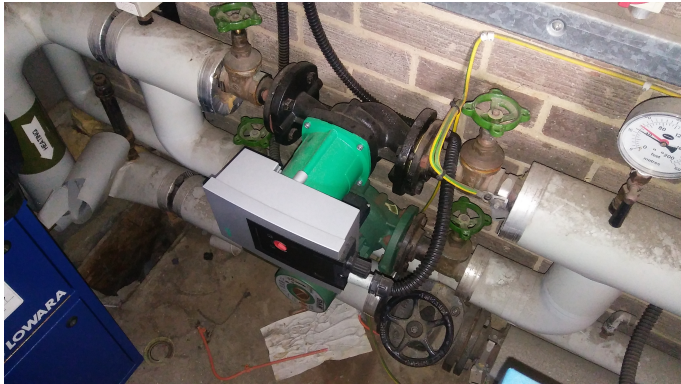
### **Item 28 Ref: 406601-15**

The pipework flange gasket in 020/Boiler Room does not contain asbestos.

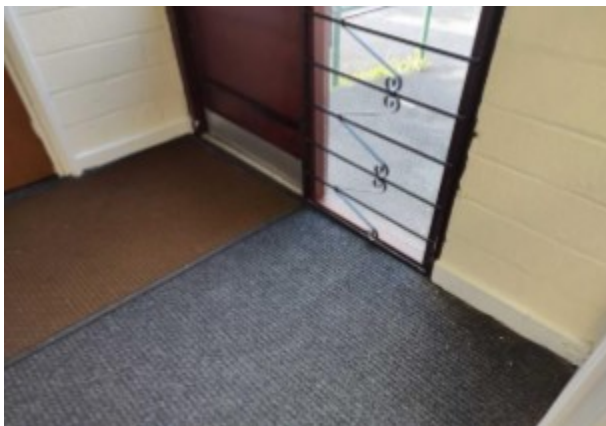
### **Item 29 Ref: 20-28493-1**

The tiles under the screed in the Entrance Hall does contain asbestos.

Any change in appearance should be reported to Property Services.

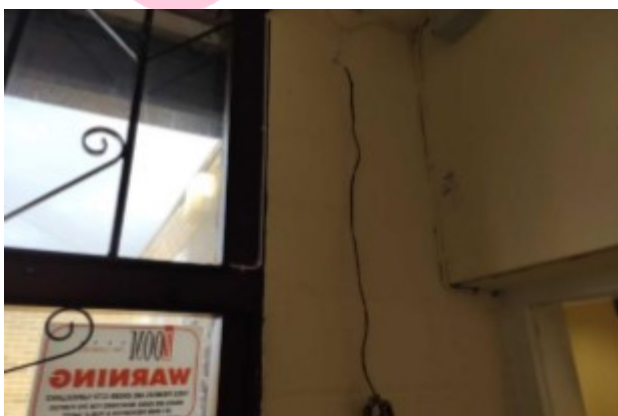
### **Item 30 Ref: 20-28493-2**

The putty sealant to the door frame in the Entrance Hall does not contain asbestos.

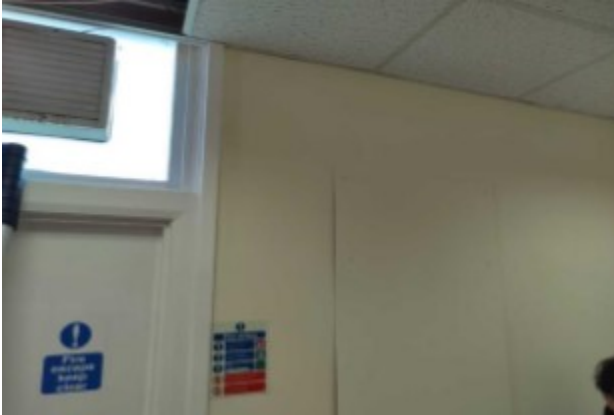
### **Item 31 Ref: 20-28493-3**

The backing paper to fibreboard behind plasterboard in the Annexe (fire exit) does not contain asbestos.

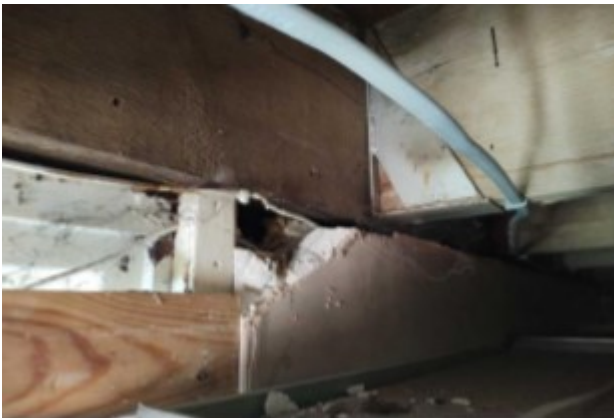
### **Item 32 Ref: As 20-28493-3**

The backing paper to fibreboard behind plasterboard in the Annexe (fire exit) does not contain asbestos.

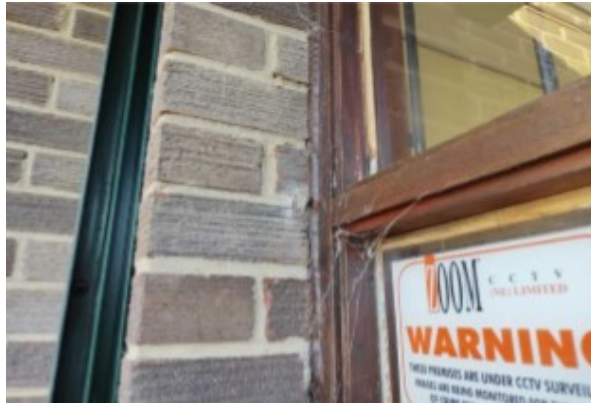
**Item 34 Ref: As 20-28493-4**

The residual putty sealant to the brickwork (Externally) does not contain asbestos.

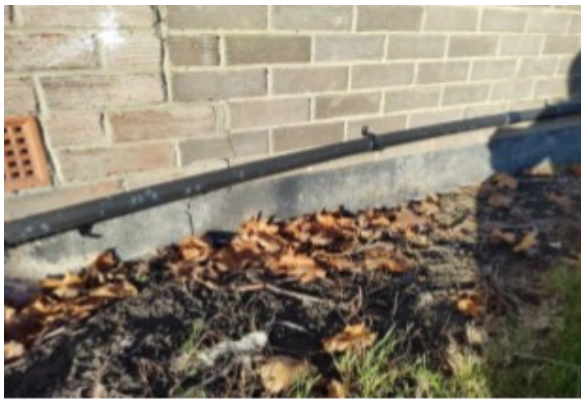
**Item 35 Ref: 20-28493-5**

The bitumen paint as low level walls (Externally) does not contain asbestos.

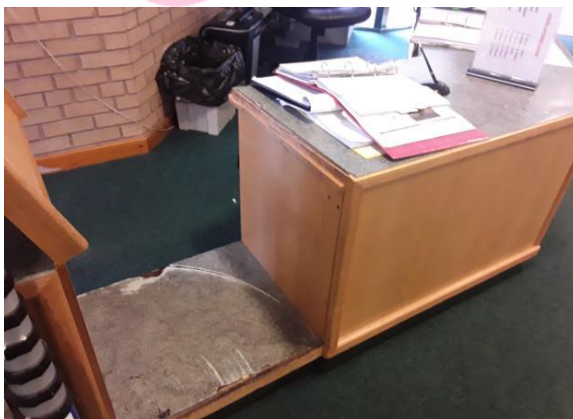
**Item 36 Ref: 21-35078-2**

The covering to main reception desk (Area 6/Reception area) does not contain asbestos.

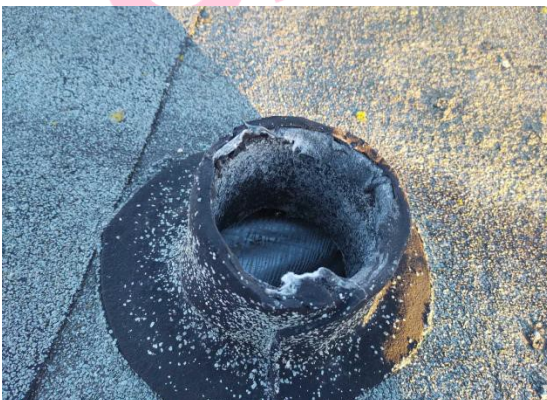
**Item 48 Ref: 22-41633-1**

The flue (Area: 1 Roof 1) contains asbestos.

Any change in appearance should be reported to Property Services.

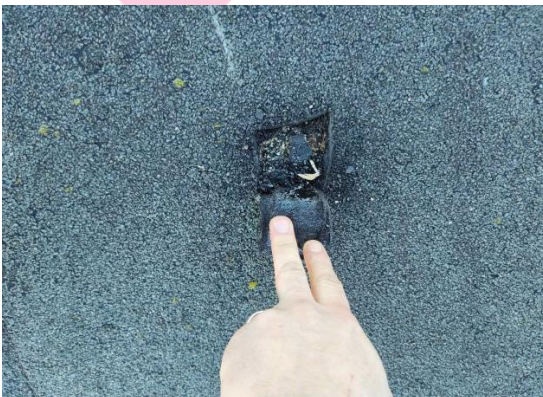
**Item 51 Ref: 22-41633-4**

The floor - felt roof (Bitumen)  
(Area: 1 Roof 1) does not  
contain asbestos.

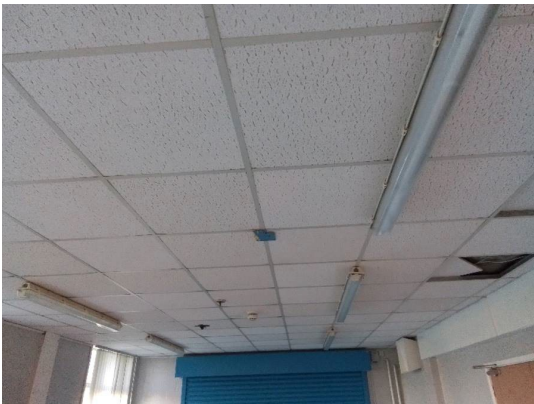
**Item 71 Ref: As PZ000781**

The debris adhesive to woodwool block (Room G/004) (Older Building – The Oval) does not contain asbestos.

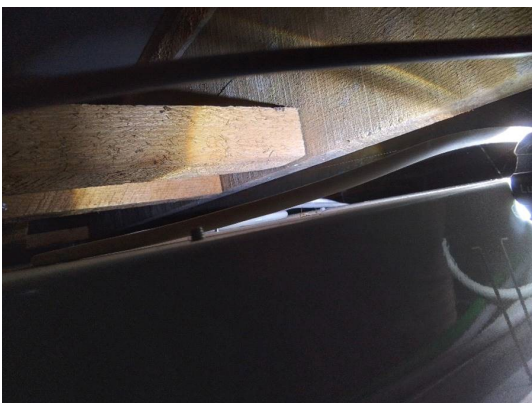
**Item 78 Ref: As PZ000785**

The debris within nail holes (Room Large G/012) (Older Building – The Oval) contains asbestos.

Any change in appearance should be reported to Property Services.

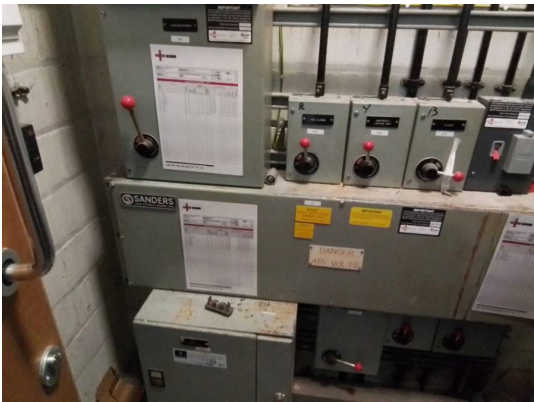
### **Item 83 Ref: PZ000786**

The electrical services (Cupboard Electrical G/015) (Older Building – The Oval) contains asbestos.

Any change in appearance should be reported to Property Services.

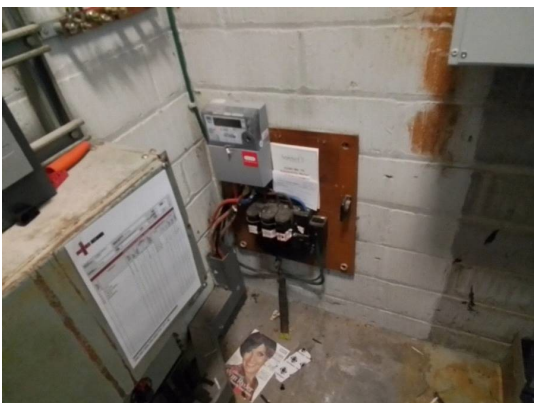
### **Item 84 Ref: Presumed**

The cable braiding/insulation (Cupboard Electrical G/015) (Older Building – The Oval) contains asbestos.

Any change in appearance should be reported to Property Services.

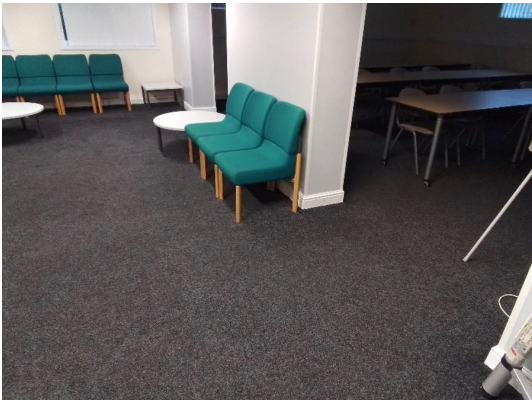
### Item 86 Ref: As PZ000782

The floor adhesive (Room Large G/017) (Older Building – The Oval) contains asbestos.

Any change in appearance should be reported to Property Services.

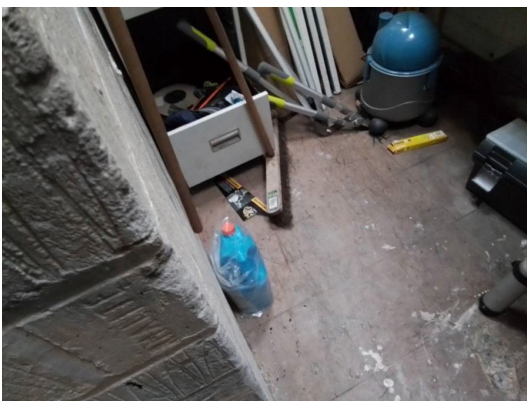
### Item 87 Ref: As PZ000784

The floor tile with adhesive (Beige) (Cupboard Electrical G/018) (Older Building – The Oval) does not contain asbestos.

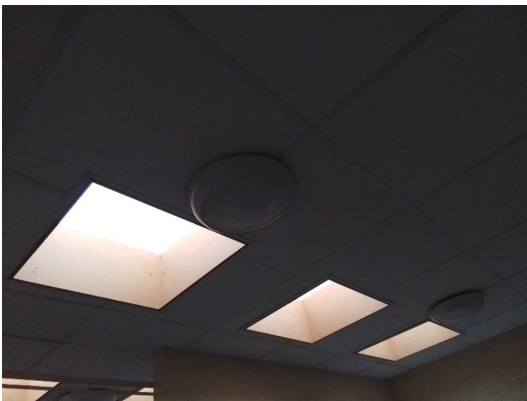
**Item 90 Ref: As PZ000788**

The debris (Female Toilets G/019) (Older Building – The Oval) contains asbestos.

Any change in appearance should be reported to Property Services.

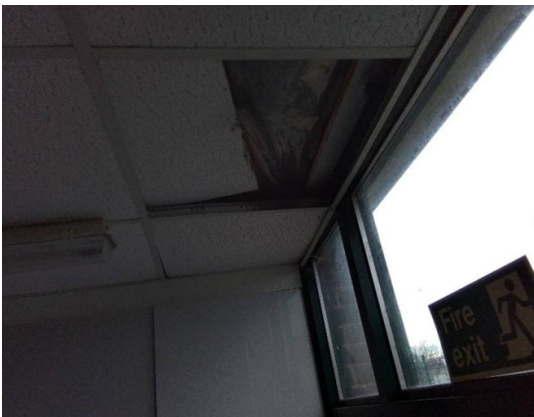
**Item 93 Ref: RN000224**

The Debris (Kitchen G/001) (Active Families Hub) does not contain asbestos.

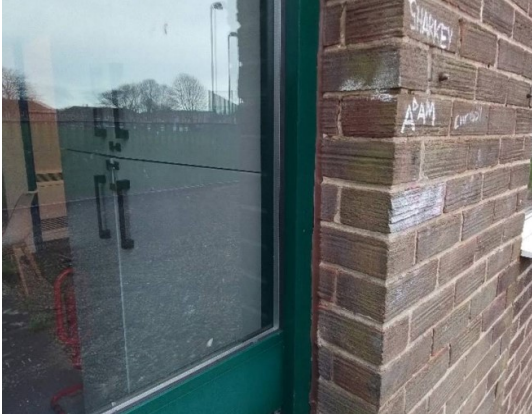
**Item 94 Ref: PZ000789**

The door seal/gasket (Kitchen G/001) (Active Families Hub) does not contain asbestos.

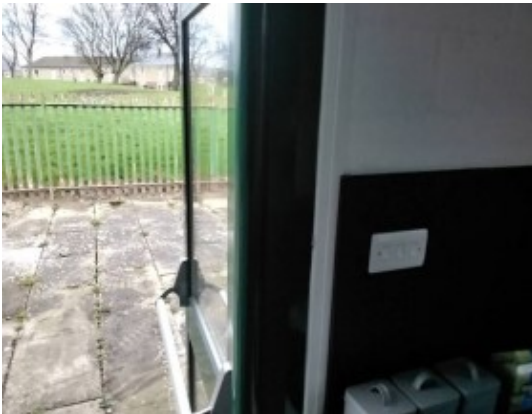
**Item 95 Ref: AW005449**

The door frame sealant (Activities Room G/001) (Active Families Hub) does not contain asbestos.

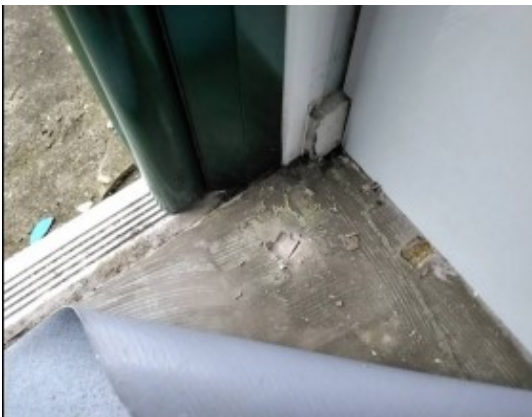
**Item 96 Ref: AW005451**

The floor tile with adhesive (Activities Room G/001) (Active Families Hub) does not contain asbestos.

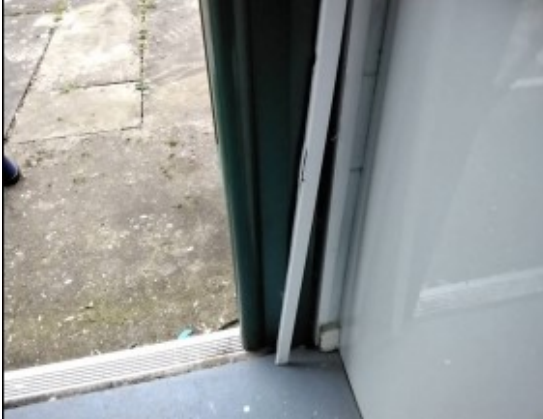
**Item 97 Ref: AW005455**

The wall – void/cavity damp proof course (Activities Room G/001) (Active Families Hub) does not contain asbestos.

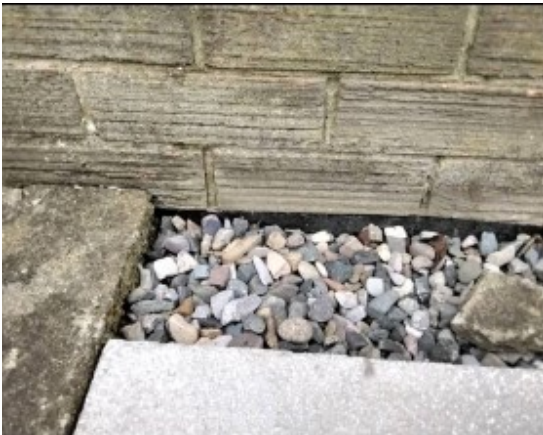
**Item 98 Ref: AW005452**

The damp proof course (External) (Active Families Hub) does not contain asbestos.

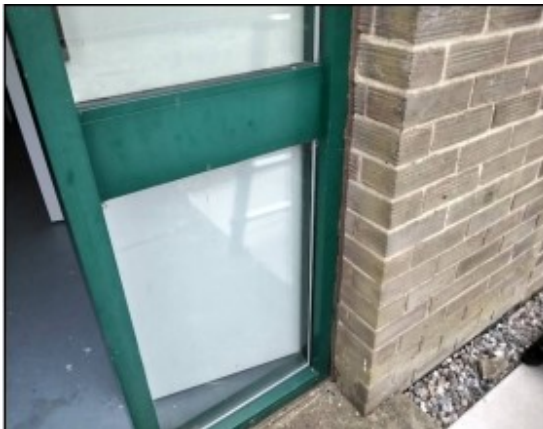
**Item 99 Ref: AW005453**

The door frame sealant (External) (Active Families Hub) does not contain asbestos.

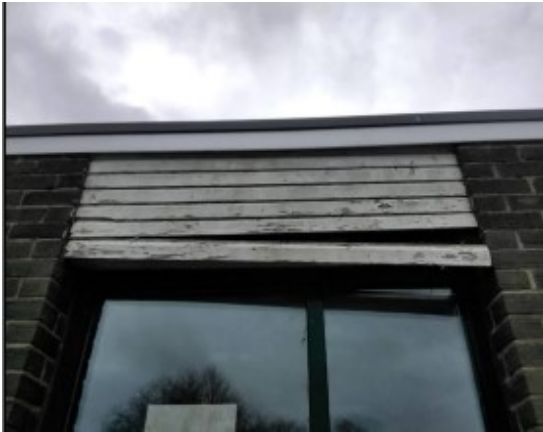
### **Item 100 Ref: AW005454**

The door vapour barrier within heading boxing (External) (Active Families Hub) does not contain asbestos.

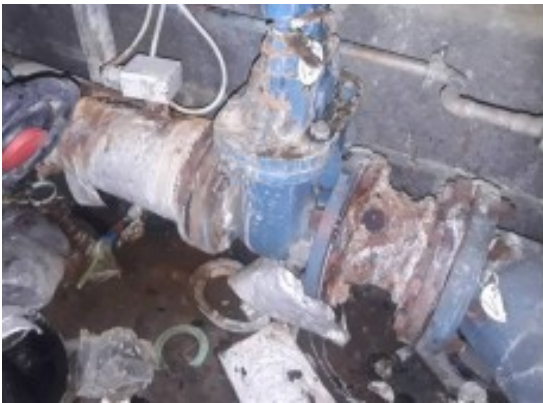
### **Item 101 Ref: NZ001264**

The pipework gasket to bottom pipework V28 left side (Boiler Room G/001 – The Oval) does contain asbestos.

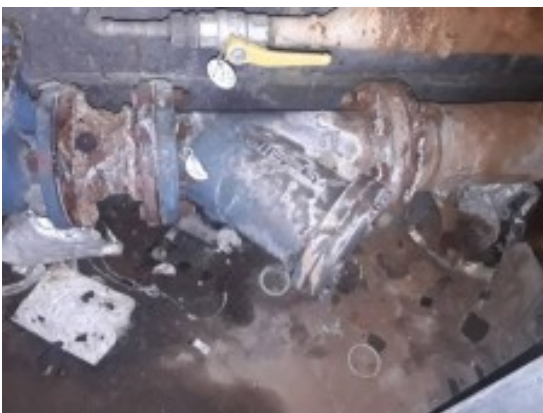
### **Item 102 Ref: NZ001265**

The pipework gasket to bottom pipework V28 right side (Boiler Room G/001 – The Oval) does contain asbestos.

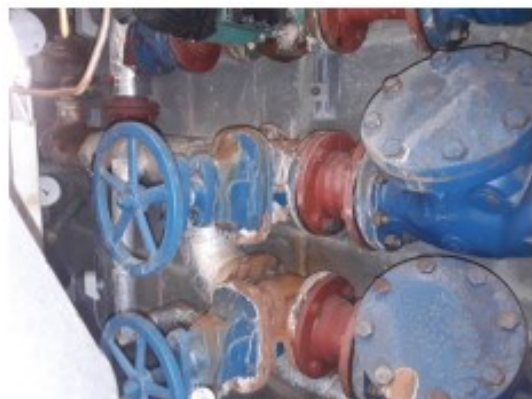
**Item 105 Ref: NZ001268**

The pipework gasket to pipework V8 left side (Boiler Room G/001 – The Oval) does contain asbestos.

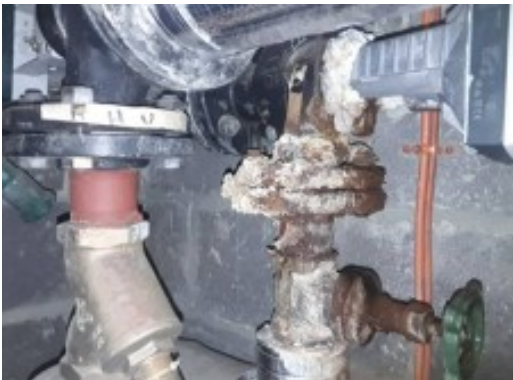
**Item 111 Ref: NZ001274**

- (Item 111) Ref: NZ001274 – Pipework Gasket to pipework right of V21 rusting black pipework (Boiler Room G/001 The Oval Building) – Removed May 2024
- (Item 112) Ref: NZ001275 – Debris/Residue to floor discarded gaskets within water and insulation (Boiler Room G/001 The Oval Building) – Low Risk

The pipework gasket to pipework right of V21 rusting lack pipework (Boiler Room G/001 – The Oval) does contain asbestos.

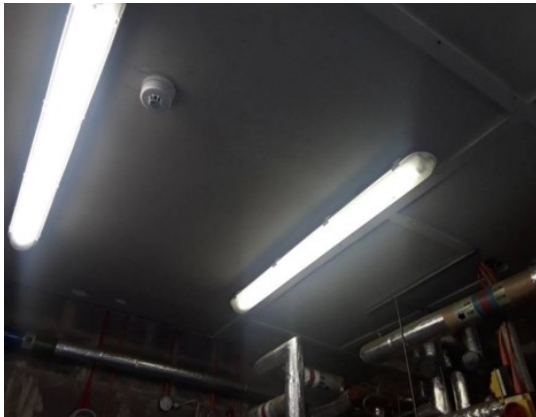
**Item 113 Ref: NZ001276**

- (Item 113) Ref: NZ001276 – Ceiling (Boiler Room G/001 The Oval Building) – No Risk

The ceiling (Boiler Room G/001 – The Oval) does not contain asbestos.
