ASBESTOS SURVEY REPORT FOR SOUTH HYLTON HOUSE, SOUTH HYLTON BANK, SR4 0JL.

Asbestos Register for

South Hylton House, South Hylton Bank, SR4 0JL

Date: 24 March 2025

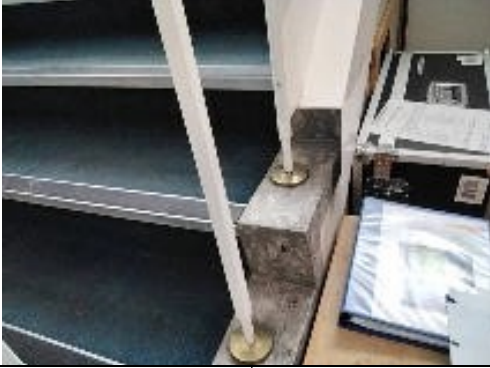
1.	KX000892	Floor screed to stairs	Block 1, Ground Floor, Reception/Entrance Hall (Room G/002)	Contains asbestos - Any change in its appearance should be recorded and passed to Property Services.

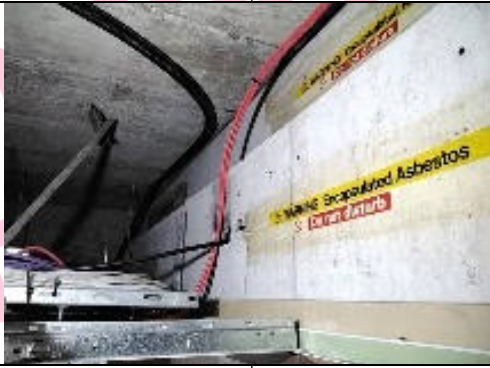
2.	KX000893	Ceiling Void Window Header Panel	Block 1, Ground Floor, Reception/Entrance Hall (Room G/002)	Contains asbestos - Any change in its appearance should be recorded and passed to Property Services.

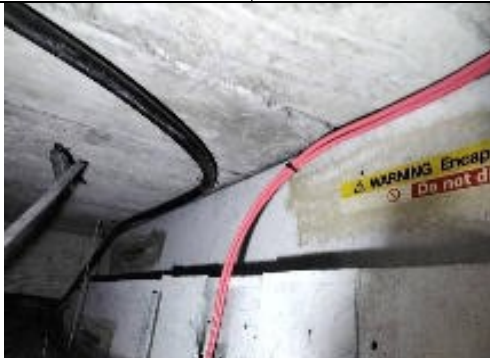
3.	KX000894	Ceiling Void Beam Cladding	Block 1, Ground Floor, Reception/Entrance Hall (Room G/002)	Contains asbestos - Any change in its appearance should be recorded and passed to Property Services.

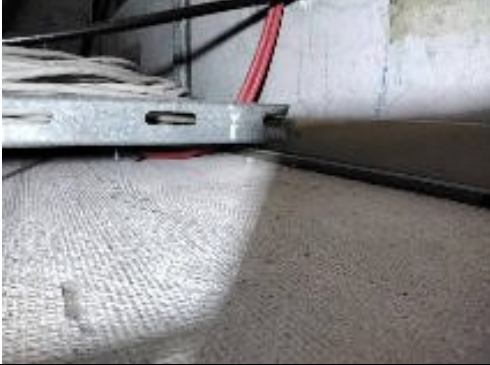
4.	As KX000893	Ceiling void debris on tiles adjacent window header panel	Block 1, Ground Floor, Reception/Entrance Hall (Room G/002)	Contains asbestos - Any change in its appearance should be recorded and passed to Property Services.

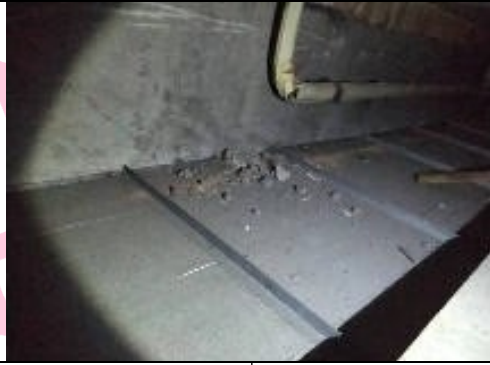
5.	KX000895	Ceiling void external canopy topside	Block 1, Ground Floor, Reception/Entrance Hall (Room G/002)	Contains asbestos - Any change in its appearance should be recorded and passed to Property Services.

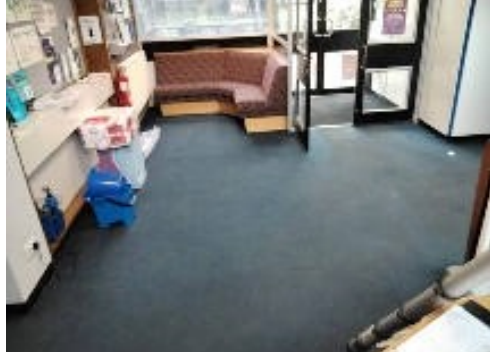
6.	KX000904	Floor under floor covering	Block 1, Ground Floor, Reception/Entrance Hall (Room G/002)	Contains asbestos - Any change in its appearance should be recorded and passed to Property Services.

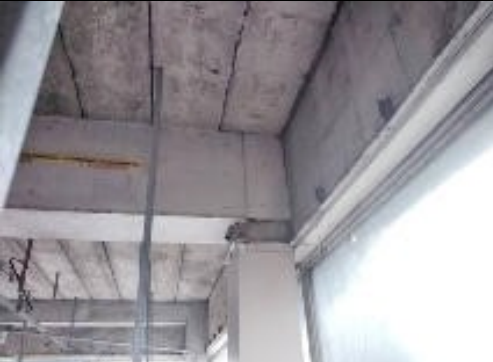
9	KX000897	Ceiling void column cladding, including section lying loose on ceiling tiles	Block 1, Ground Floor, Kitchen (Room G/005)	Medium Risk
10	KX000898	Window Putty / Seal	Block 1, Ground Floor, Kitchen (Room G/005)	No Risk
11	As KX000894	Ceiling void fire breaks to kitchen area	Block 1, Ground Floor, Kitchen (Room G/005)	Medium Risk
12	As KX000894	Ceiling Void Beam cladding	Block 1, Ground Floor, Store Room (Room G/006)	Low Risk
13	As KX000897	Ceiling void column cladding	Block 1, Ground Floor, Store Room (Room G/006)	Medium Risk
14	As KX000898	Window Putty / Seal	Block 1, Ground Floor, Store Room (Room G/006)	No Risk
15	KX000899	Ceiling void – Jointing paper to wall	Block 1, Ground Floor, Store Room (Room G/006)	No Risk
16	As KX000894	Ceiling Void Beam cladding	Block 1, Ground Floor, Store Room (Room G/007)	Low Risk
17	As KX000897	Ceiling void column cladding	Block 1, Ground Floor, Store Room (Room G/007)	Medium Risk

9.	KX000897	Ceiling void column cladding, including section lying loose on ceiling tiles	Block 1, Ground Floor, Kitchen (Room G/005)	Contains asbestos - Any change in its appearance should be recorded and passed to Property Services.

7	Floor tile	Block 1, Ground Floor, Cupboard (Room G/004)	Very Low Risk	15/06/2025			
8	Ceiling Void Beam cladding	Block 1, Ground Floor, Kitchen (Room G/005)	Low Risk	15/12/2025			Analytical company to inspect
9	Ceiling void column cladding, including section lying loose on ceiling tiles	Block 1, Ground Floor, Kitchen (Room G/005)	Medium Risk	15/12/2025			Analytical company to inspect
10	Window Putty / Seal	Block 1, Ground Floor, Kitchen (Room G/005)	No Risk	N/A			
11	Ceiling void fire breaks to kitchen area	Block 1, Ground Floor, Kitchen (Room G/005)	Medium Risk	15/12/2025			Analytical company to inspect

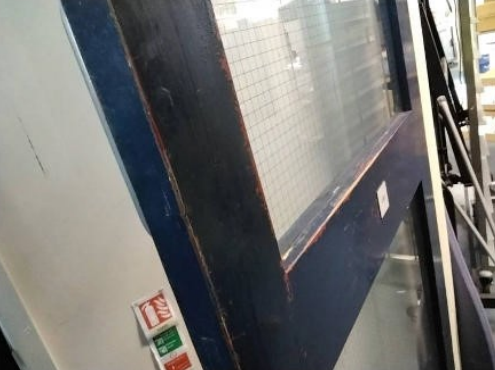
23.	KX000900	Door window beading	Block 1, Ground Floor, Corridor (Room G/008)	Does not contain asbestos.

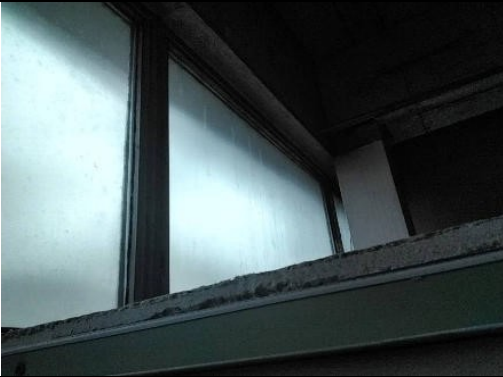
25.	As KX000898	Window Putty seal	Block 1, Ground Floor, Cupboard (Room G/009)	Does not contain asbestos.

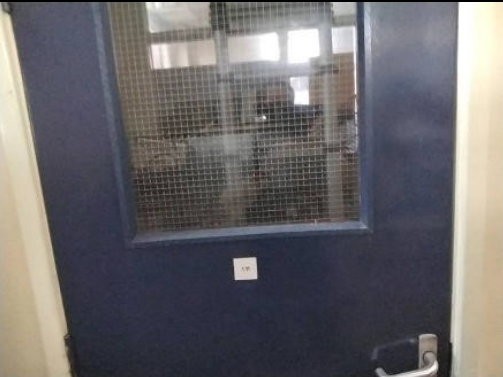
26.	As KX000900	Door window beading	Block 1, Ground Floor, Cupboard (Room G/009)	Does not contain asbestos.

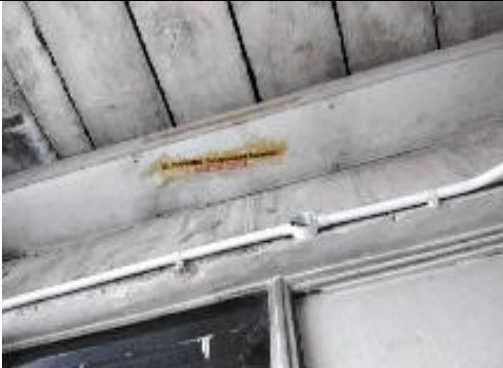
27.	As KX000894	Ceiling Void Beam cladding	Block 1, Ground Floor, Kitchen (Room G/010)	Contains asbestos - Any change in its appearance should be recorded and passed to Property Services.

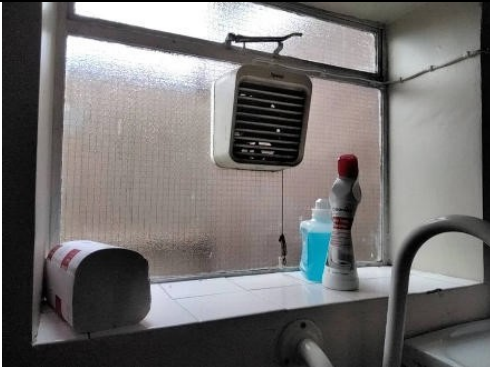
34.	As KX000903	Window Putty seal	Block 1, Ground Floor, Toilets (Room G/014)	Does not contain asbestos.

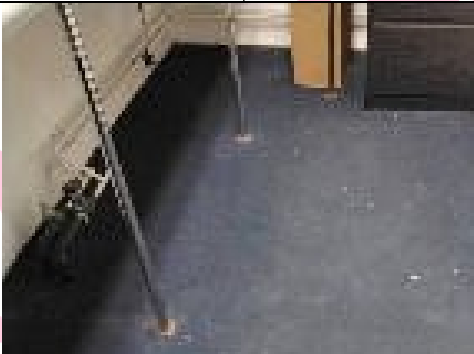
35.	KX000904	Floor under floor covering	Block 1, Ground Floor, Small Office (Room G/016)	Contains asbestos - Any change in its appearance should be recorded and passed to Property Services.

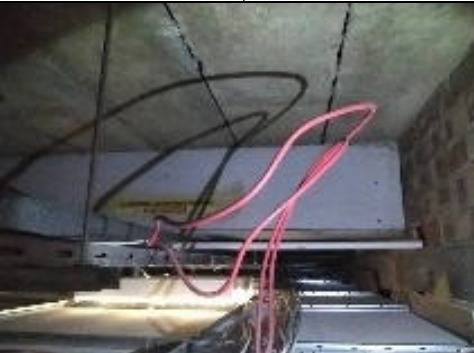
36.	As KX000894	Ceiling Void Beam cladding x 4	Block 1, Ground Floor, Corridor (Room G/017)	Contains asbestos - Any change in its appearance should be recorded and passed to Property Services.

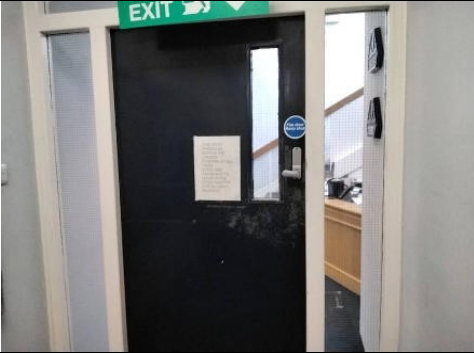
37.	KX000905	Door window beading	Block 1, Ground Floor, Corridor (Room G/017)	Does not contain asbestos.

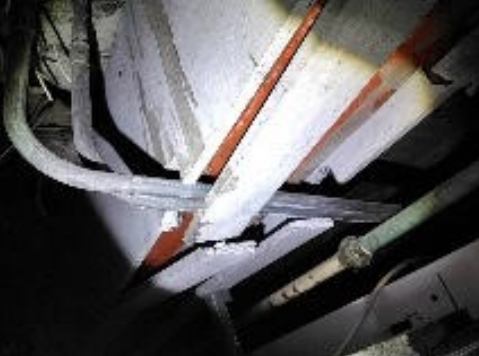
43.	As KX000894	Ceiling Void Beam cladding	Block 1, Ground Floor, Office (Room G/019)	Contains asbestos - Any change in its appearance should be recorded and passed to Property Services.

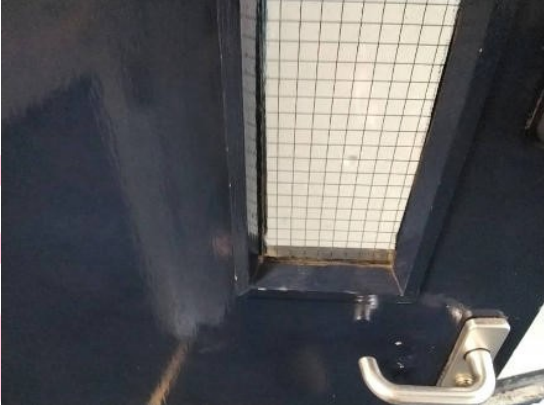
44.	KX000905	Door window beading	Block 1, Ground Floor, Office (Room G/019)	Does not contain asbestos.

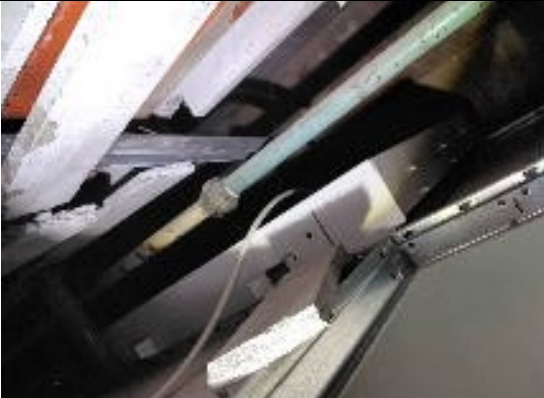
45.	As KX000894	Ceiling void debris to stench pipe penetration	Block 1, Ground Floor, Office (Room G/019)	Contains asbestos - Any change in its appearance should be recorded and passed to Property Services.

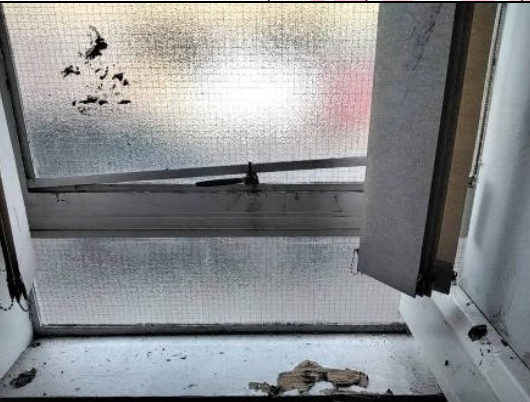
47.	As KX000898	Window Putty seal	Block 1, Ground Floor, Office (Room G/019)	Does not contain asbestos.

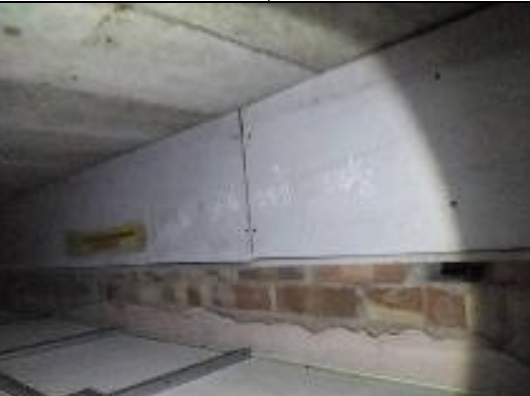
48.	As KX000894	Ceiling void beam cladding	Block 1, Ground Floor, Office (Room G/020)	Contains asbestos - Any change in its appearance should be recorded and passed to Property Services.

residue under floor covering	(Room G/019)					
47	Window Putty seal	Block 1, Ground Floor, Office (Room G/019)	No Risk	N/A			
48	Ceiling void beam cladding	Block 1, Ground Floor, Office (Room G/020)	Low Risk	15/12/2025			Analytical company to inspect
49	Door window beading	Block 1, Ground Floor, Office (Room G/020)	No Risk	N/A			
50	Ceiling void debris hanging off damaged beams	Block 1, Ground Floor, Office (Room G/020)	Medium	15/12/2025			Analytical company to inspect
51	Floor adhesive residue under floor covering	Block 1, Ground Floor, Office (Room G/020)	Very Low Risk	15/06/2025			
52	Ceiling void debris to stench pipe penetration	Block 1, Ground Floor, Office (Room G/020)	Low Risk	15/12/2025			Analytical company to inspect
53	Window Putty seal	Block 1, Ground Floor, Office (Room G/020)	No Risk	N/A			
54	Ceiling void beam cladding	Block 1, Ground Floor, Office (Room G/021)	Low Risk	15/12/2025			Analytical company to inspect

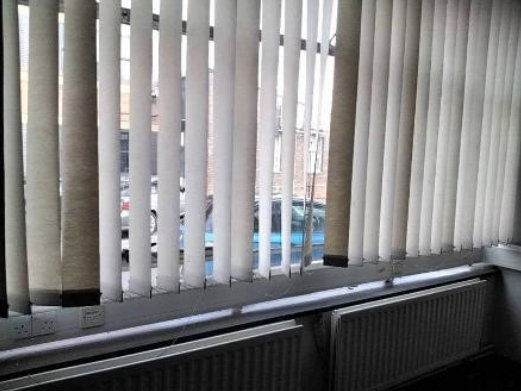
53.	As KX000898	Window Putty seal	Block 1, Ground Floor, Office (Room G/020)	Does not contain asbestos.

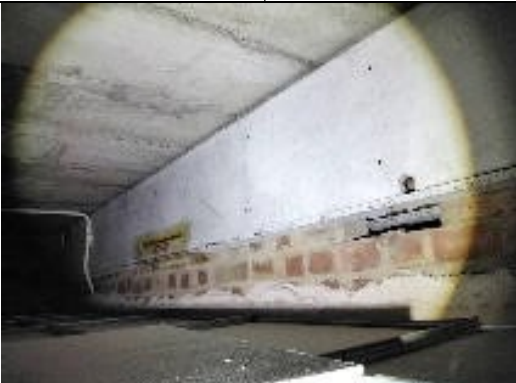
54.	As KX000894	Ceiling void beam cladding	Block 1, Ground Floor, Office (Room G/021)	Contains asbestos - Any change in its appearance should be recorded and passed to Property Services.

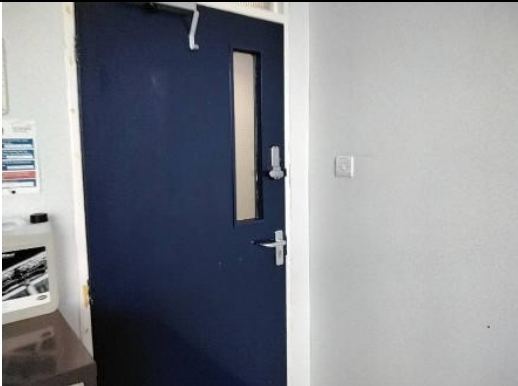
55.	As KX000905	Door window beading	Block 1, Ground Floor, Office (Room G/021)	Does not contain asbestos.

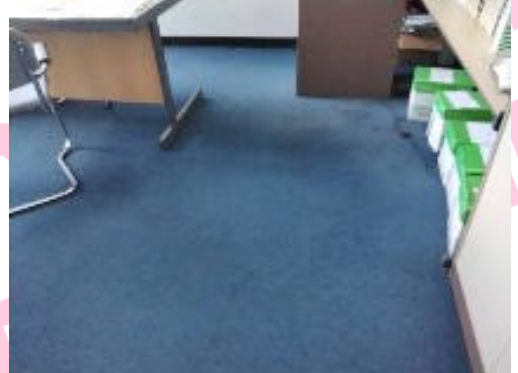
56.	As KX000907	Floor adhesive residue under floor covering	Block 1, Ground Floor, Office (Room G/021)	Contains asbestos - Any change in its appearance should be recorded and passed to Property Services.

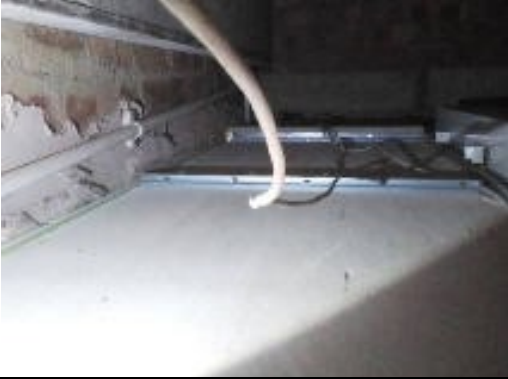
59	As KX000894	Ceiling void beam cladding	Block 1, Ground Floor, Office (Room G/022)	Medium Risk
60	As KX000905	Door window beading	Block 1, Ground Floor, Office (Room G/022)	No Risk
61	As KX000894	Ceiling void debris hanging off damaged beams	Block 1, Ground Floor, Office (Room G/022)	Medium Risk
62	As KX000907	Floor adhesive residue under floor	Block 1, Ground Floor, Office (Room G/022)	Very Low Risk

61.	As KX000894	Ceiling void debris hanging off damaged beams	Block 1, Ground Floor, Office (Room G/022)	Contains asbestos - Any change in its appearance should be recorded and passed to Property Services.

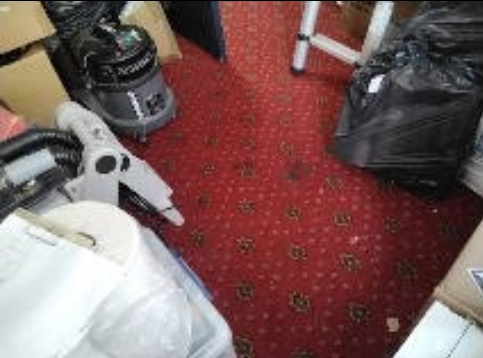
62.	As KX000907	Floor adhesive residue under floor covering	Block 1, Ground Floor, Office (Room G/022)	Contains asbestos - Any change in its appearance should be recorded and passed to Property Services.

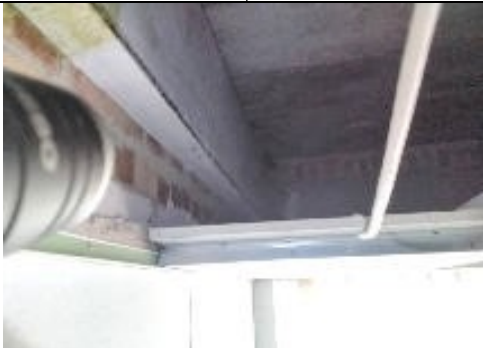
63.	As KX000906	Ceiling void debris to stench pipe penetration	Block 1, Ground Floor, Office (Room G/022)	Contains asbestos - Any change in its appearance should be recorded and passed to Property Services.

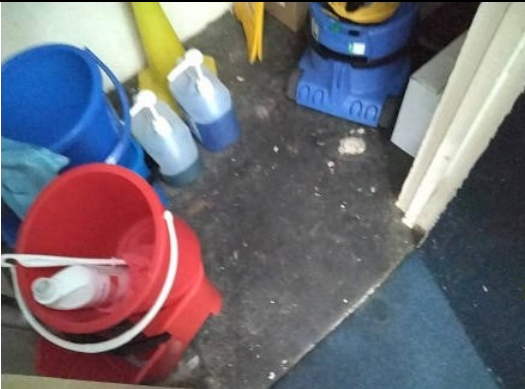
81.	KX000909	Floor tile	Block 1, Ground Floor, Cupboard understairs (Room G/027)	Does not contain asbestos.

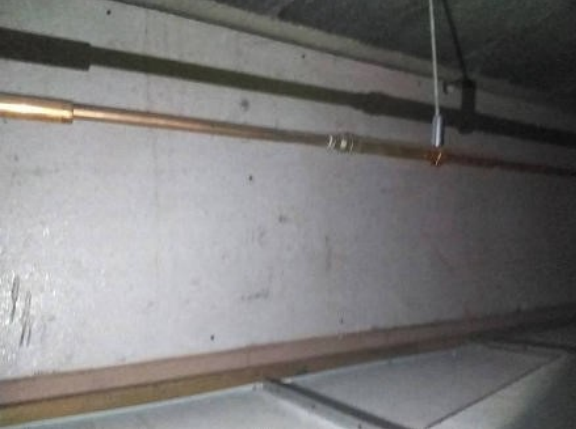
86.	KX000913	Ceiling void fire breaks	Block 1, Ground Floor, Corridor (Room G/028)	Does not contain asbestos.

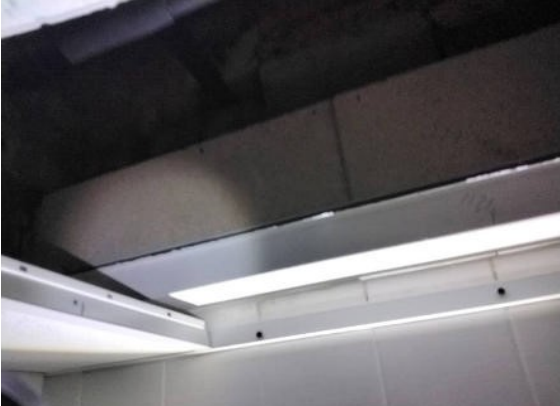
87.	As KX000912	Ceiling void beam cladding	Block 1, Ground Floor, Hallway/Passageway (Room G/029)	Does not contain asbestos.

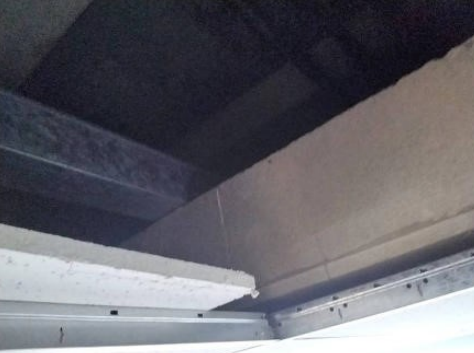
90.	As KX000912	Ceiling void beam cladding	Block 1, Ground Floor, Corridor (Room G/031)	Does not contain asbestos.

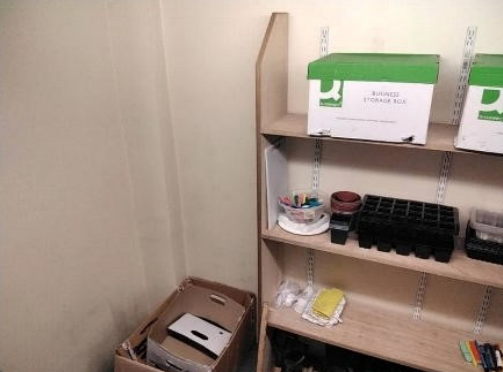
129.	KX000904	Boxing vertical adhesive residue under floor covering	Block 1, Ground Floor, Storage Area (Room G/042)	Does not contain asbestos.

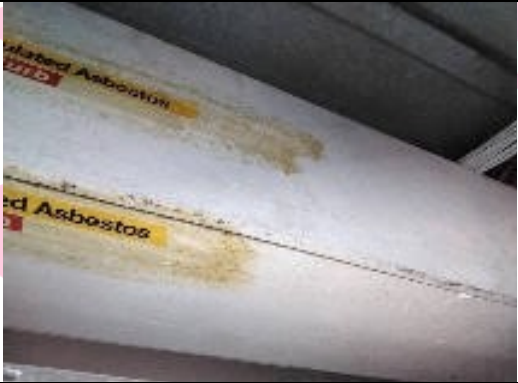
131.	KX000928	Ceiling void beam cladding	Block 1, First Floor, Landing within Stairwell (Room 1/001)	Contains asbestos - Any change in its appearance should be recorded and passed to Property Services.

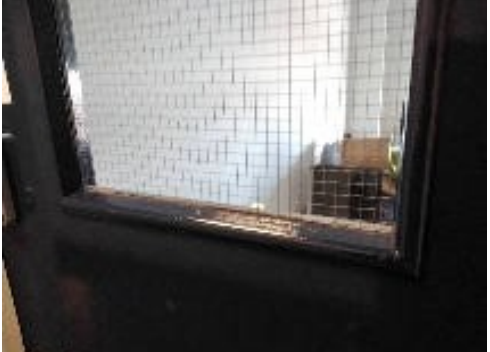
153.	As KX000929	Door window beading including to header	Block 1, First Floor, Office ceiling void from adjacent room (Room 1/008)	Contains asbestos - Any change in its appearance should be recorded and passed to Property Services.

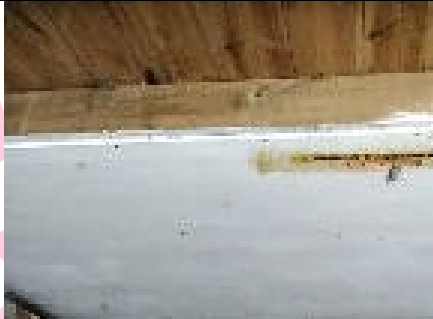
302	As KX000976	Ceiling panels missing however encapsulated	Garages, Ground Floor, Garage (Room G/003)	Low Risk
303	As	Ceiling	Garages, Ground	Low Risk

302.	As KX000976	Ceiling panels missing however encapsulated	Garages, Ground Floor, Garage (Room G/003)	Contains asbestos - Any change in its appearance should be recorded and passed to Property Services.

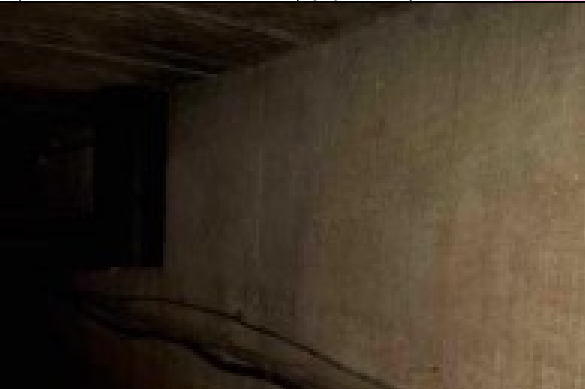
326	24-71128-1	Walls Cement	Area 001 (Internal pipe run)	Does not contain asbestos

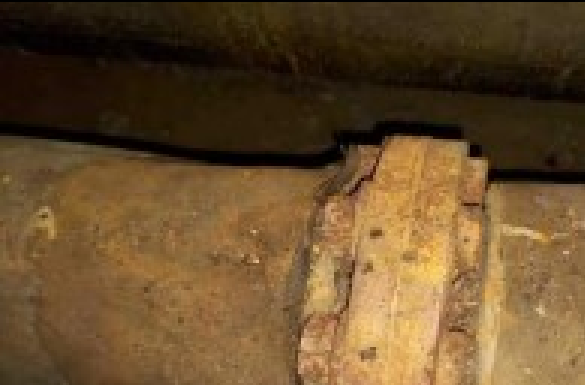
327	24-71128-2	Pipes - Gasket	Area 001 (Internal pipe run)	Contains asbestos - Any change in its appearance should be recorded and passed to Property Services.

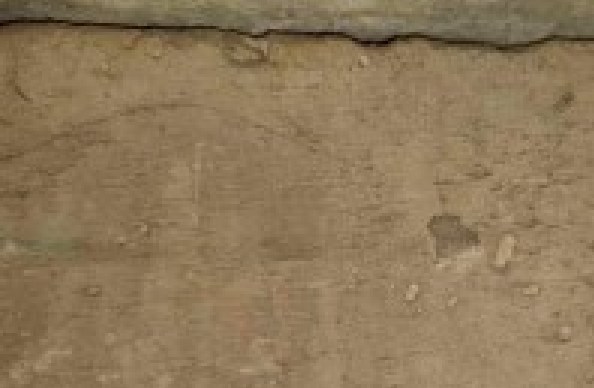
329	24-71128-4	Walls - Piece of insulation found on wall inside pipe run - Insulation	Area 001 (Internal pipe run)	Does not contain asbestos
