ASBESTOS SURVEY REPORT FOR SOUTH HYLTON HOUSE, SOUTH HYLTON BANK, SR4 0JL.

South Hylton House, South Hylton Bank, SR4 0JL

Date: 23 January 2025

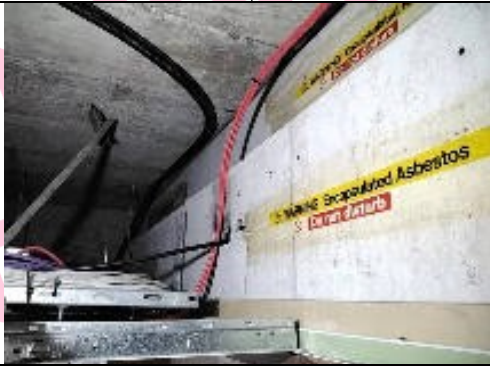
| 2. | KX000893 | Ceiling Void Window Header Panel | Block 1, Ground Floor, Reception/Entrance Hall (Room G/002) | Contains asbestos - Any change in its appearance should be recorded and passed to Property Services. |

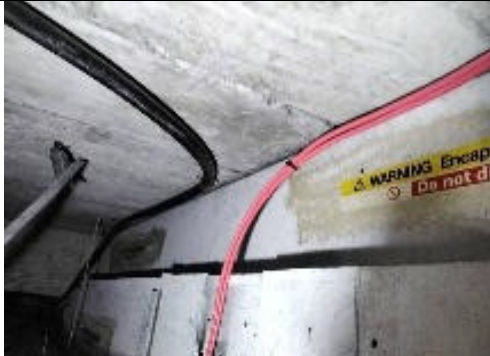
| 3. | KX000894 | Ceiling Void Beam Cladding | Block 1, Ground Floor, Reception/Entrance Hall (Room G/002) | Contains asbestos - Any change in its appearance should be recorded and passed to Property Services. |

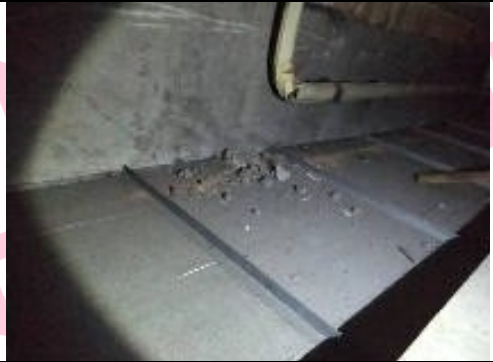
| 5. | KX000895 | Ceiling void external canopy topside | Block 1, Ground Floor, Reception/Entrance Hall (Room G/002) | Contains asbestos - Any change in its appearance should be recorded and passed to Property Services. |

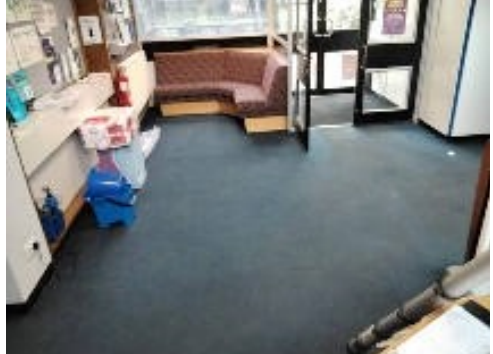
| 6. | KX000904 | Floor under floor covering | Block 1, Ground Floor, Reception/Entrance Hall (Room G/002) | Contains asbestos - Any change in its appearance should be recorded and passed to Property Services. |

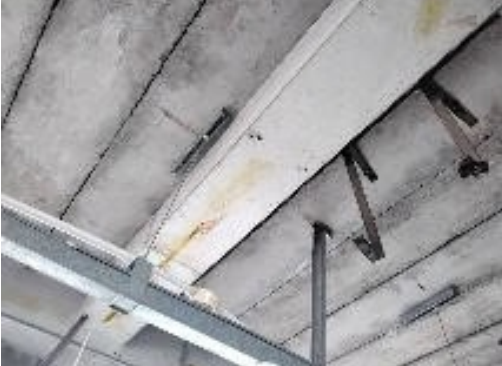
| 17. | As KX000897 | Ceiling void column cladding | Block 1, Ground Floor, Store Room (Room G/007) | Contains asbestos - Any change in its appearance should be recorded and passed to Property Services. |

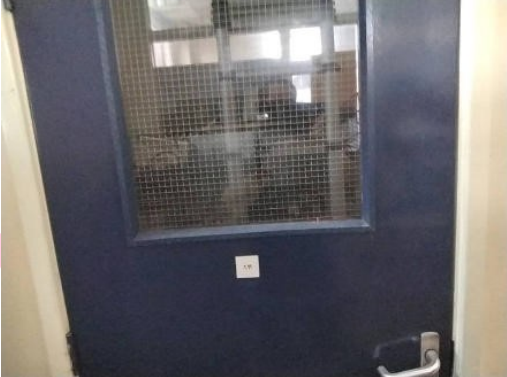
| 26. | As KX000900 | Door window beading | Block 1, Ground Floor, Cupboard (Room G/009) | Does not contain asbestos. |

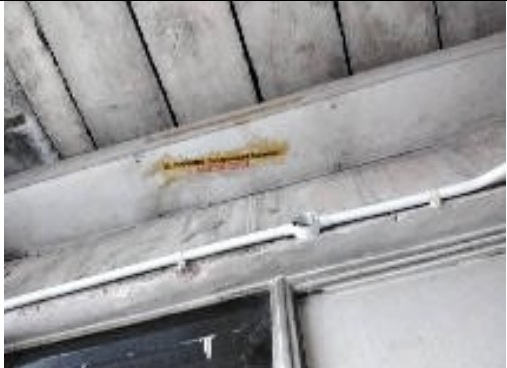
| 27. | As KX000894 | Ceiling Void Beam cladding | Block 1, Ground Floor, Kitchen (Room G/010) | Contains asbestos - Any change in its appearance should be recorded and passed to Property Services. |

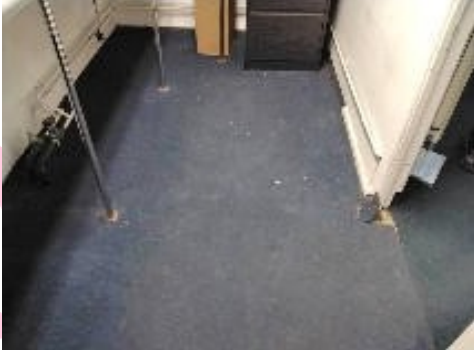
| 35. | KX000904 | Floor under floor covering | Block 1, Ground Floor, Small Office (Room G/016) | Contains asbestos - Any change in its appearance should be recorded and passed to Property Services. |

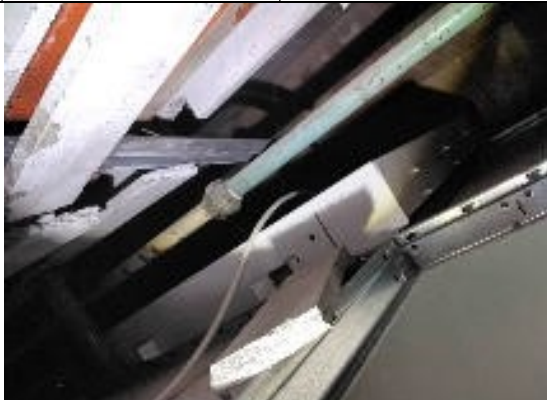
| 45. | As KX000894 | Ceiling void debris to stench pipe penetration | Block 1, Ground Floor, Office (Room G/019) | Contains asbestos - Any change in its appearance should be recorded and passed to Property Services. |

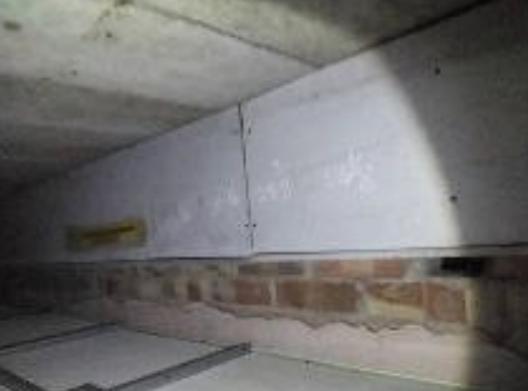
| 48. | As KX000894 | Ceiling void beam cladding | Block 1, Ground Floor, Office (Room G/020) | Contains asbestos - Any change in its appearance should be recorded and passed to Property Services. |

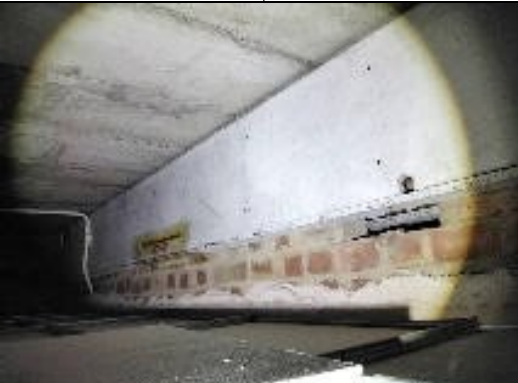
| 54. | As KX000894 | Ceiling void beam cladding | Block 1, Ground Floor, Office (Room G/021) | Contains asbestos - Any change in its appearance should be recorded and passed to Property Services. |

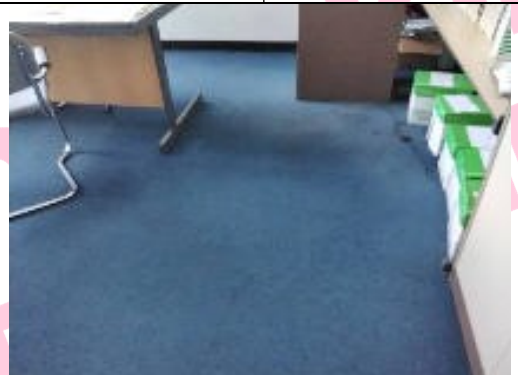
| 56. | As KX000907 | Floor adhesive residue under floor covering | Block 1, Ground Floor, Office (Room G/021) | Contains asbestos - Any change in its appearance should be recorded and passed to Property Services. |

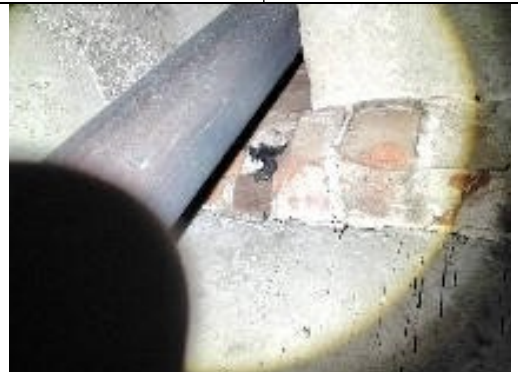
| 57. | As KX000906 | Ceiling void debris to stench pipe penetration | Block 1, Ground Floor, Office (Room G/021) | Contains asbestos - Any change in its appearance should be recorded and passed to Property Services. |

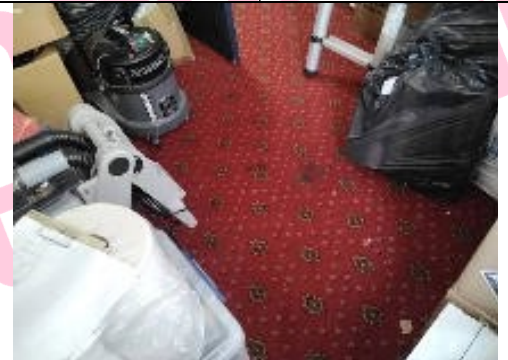
| 62. | As KX000907 | Floor adhesive residue under floor covering | Block 1, Ground Floor, Office (Room G/022) | Contains asbestos - Any change in its appearance should be recorded and passed to Property Services. |

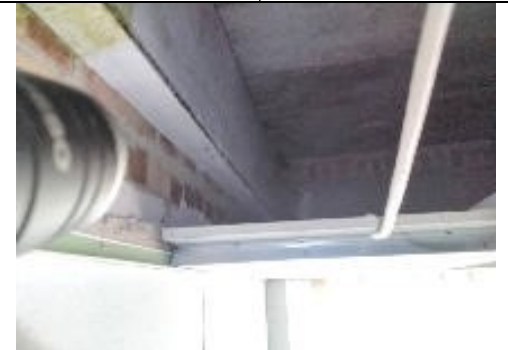
| 63. | As KX000906 | Ceiling void debris to stench pipe penetration | Block 1, Ground Floor, Office (Room G/022) | Contains asbestos - Any change in its appearance should be recorded and passed to Property Services. |

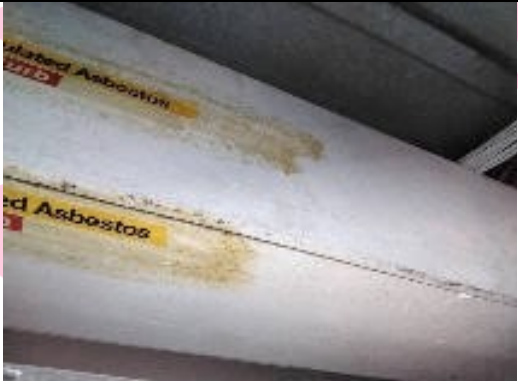
| 131. | KX000928 | Ceiling void beam cladding | Block 1, First Floor, Landing within Stairwell (Room 1/001) | Contains asbestos - Any change in its appearance should be recorded and passed to Property Services. |

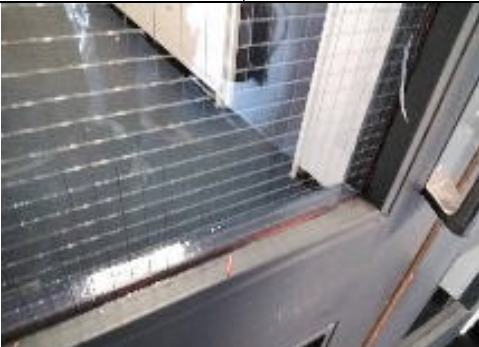
| 132. | KX000929 | Door window beading including to header | Block 1, First Floor, Landing within Stairwell (Room 1/001) | Contains asbestos - Any change in its appearance should be recorded and passed to Property Services. |

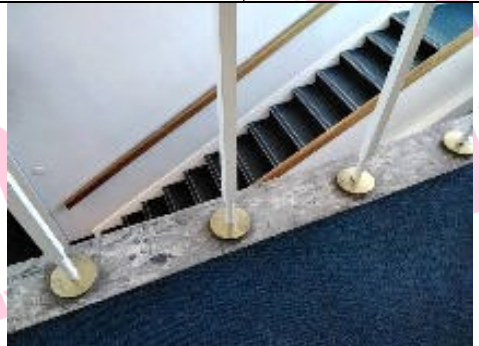
| 134. | As KX000892 | Floor screed to stairs | Block 1, First Floor, Landing within Stairwell (Room 1/001) | Contains asbestos - Any change in its appearance should be recorded and passed to Property Services. |

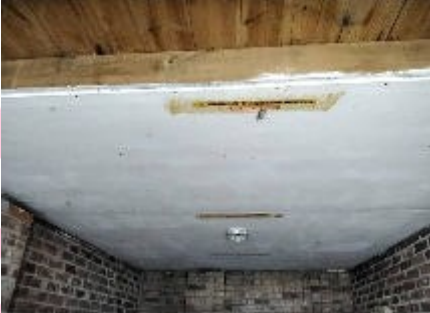
| 302. | As KX000976 | Ceiling panels missing however encapsulated | Garages, Ground Floor, Garage (Room G/003) | Contains asbestos - Any change in its appearance should be recorded and passed to Property Services. |

| 302 | Ceiling panels missing however encapsulated | Garages, Ground Floor, Garage (Room G/003) | Low Risk | 15/06/2025 | | |
