ASBESTOS SURVEY REPORT FOR MARKET PLACE DEPOT, HOUGHTON LE SPRING,

Asbestos Register for Market Place Depot, Houghton le Spring

Premises Manager / Samo: - Tenant Date: 10 June 2025

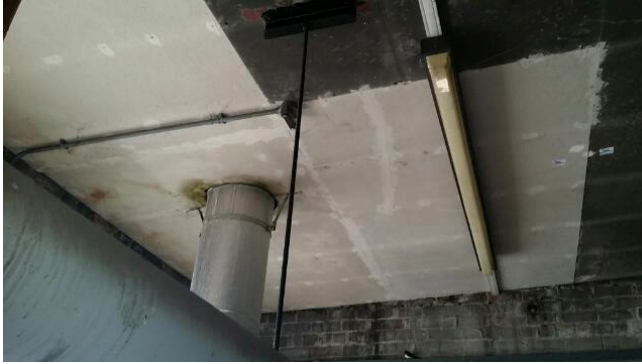
Item 22 Ref: 17

The repair board to ceiling in the Boiler Room (Rm 0/40) do not contain asbestos.

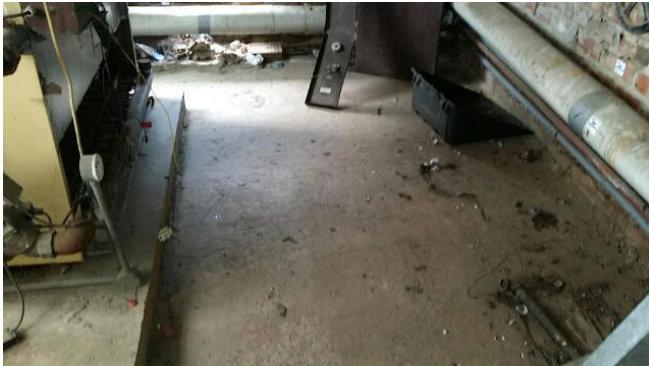
Item 23 Ref: 18

The debris to floor in the Boiler Room (Rm 0/40) contained asbestos.

An Environmental clean was carried out in the Boiler Room in October 2016. This has now been removed.

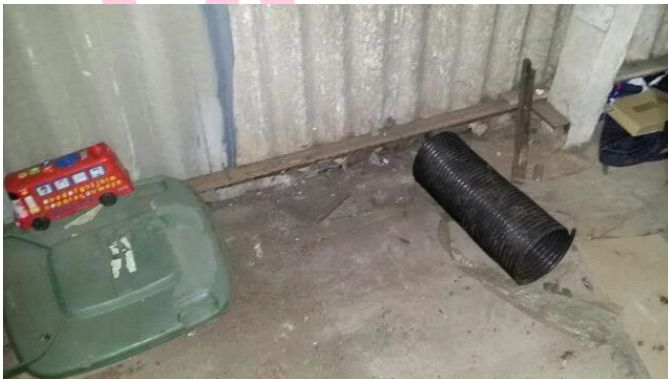
Item 33 Ref: 20

The debris from damaged wall cladding in the Shed (Rm 0/43) contain asbestos.

Item 33	Debris from damaged wall cladding in Shed Room (0/43)	Low Risk	6 monthly	18/08/2025
Item 34	Sheet cladding to wall in Shed Room (0/43)	Low Risk	6 monthly	Removed 2023

Any change in the appearance should be recorded and passed to Property Services.

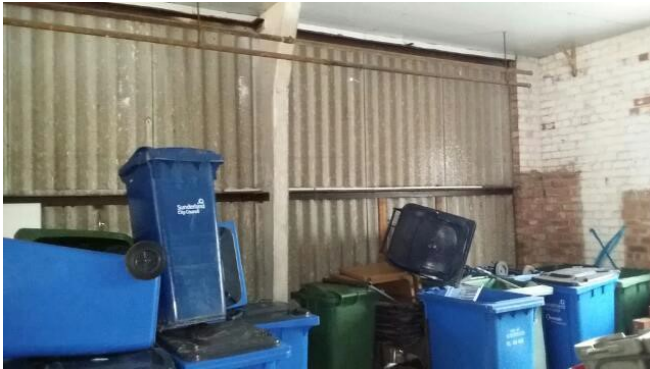
Item 34 Ref: As 20

The sheet cladding to wall in the Shed (Rm 0/43) contains asbestos.

Marked as removed – awaiting paperwork.

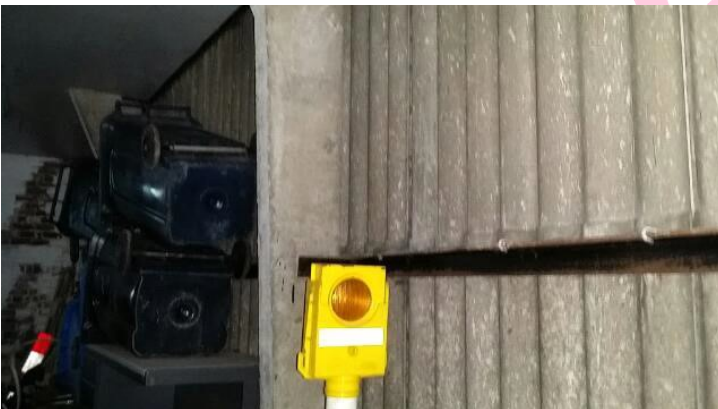
Item 38 Ref: As 20

The wall cladding in the Salt Shed (Rm 0/44) contains asbestos.

Any change in its appearance should be recorded and passed to Property Services.

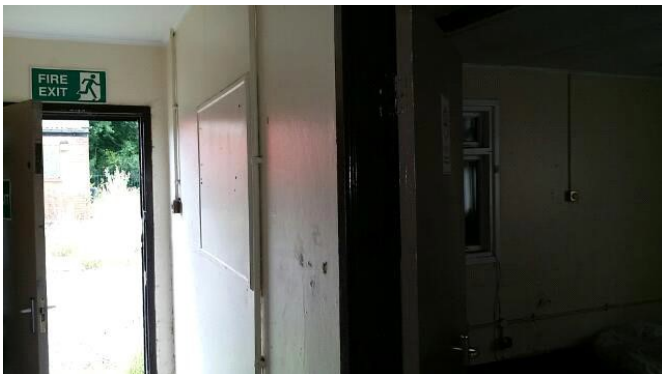
Item 42 Ref: 24

The wall in the Hallway (Rm 0/49) contains asbestos.

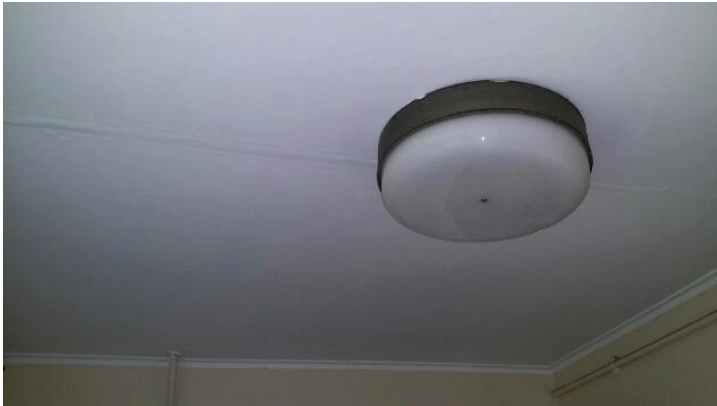
Item 46 Ref: As 25

The ceiling in the Toilets (Rm 0/51) contains asbestos.

Any change in its appearance should be recorded and passed to Property Services.

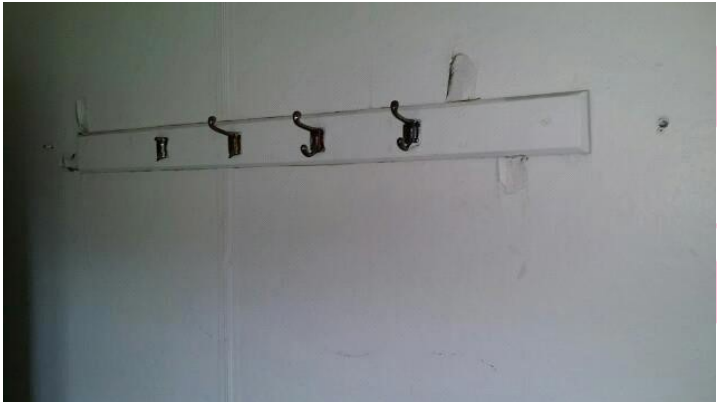
Item 47 Ref: As 24

The wall in the Toilets (Rm 0/51) contains asbestos.

Any change in its appearance should be recorded and passed to Property Services.

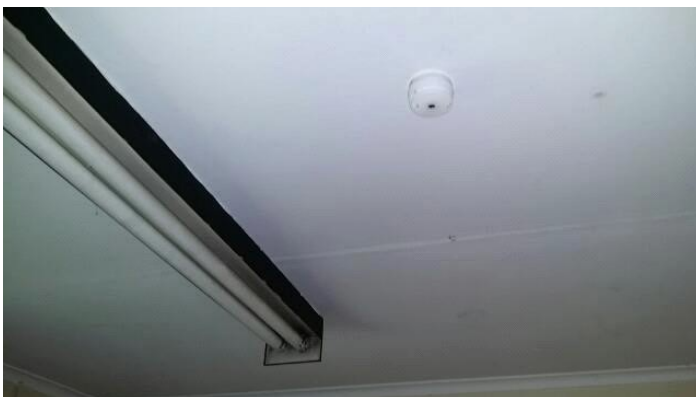
Item 48 Ref: As 25

The ceiling in the Office (Rm 0/52) contains asbestos.

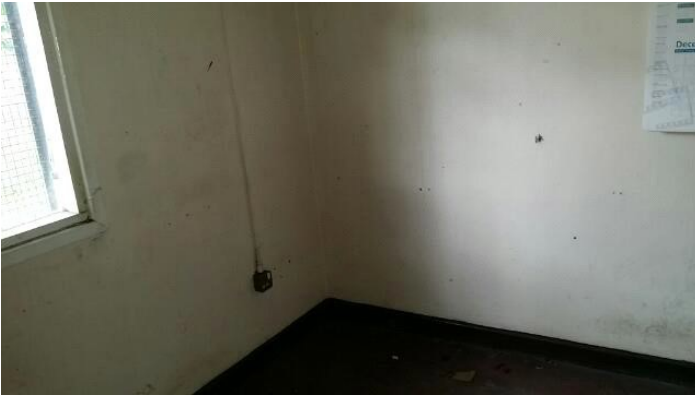
Item 49 Ref: As 24

The wall in the Office (Rm 0/52) contains asbestos.

Any change in its appearance should be recorded and passed to Property Services.

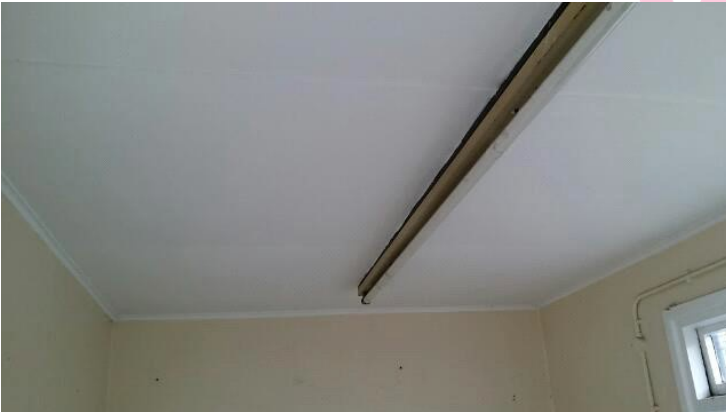
Item 50 Ref: As 25

The ceiling in the Office (Rm 0/53) contains asbestos.

Any change in its appearance should be recorded and passed to Property Services.

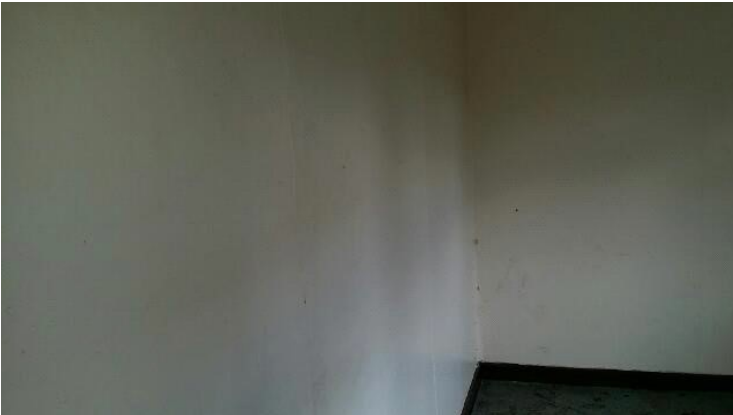
Item 51 Ref: As 24

The wall in the Office (Rm 0/53) contains asbestos.

Any change in its appearance should be recorded and passed to Property Services.

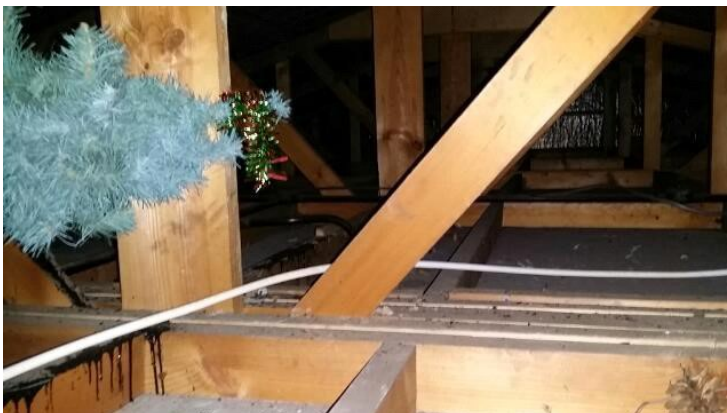
Item 54 Ref: As 25

The ceiling in the Loft Space (Rm L0/5) contains asbestos.

Any change in its appearance should be recorded and passed to Property Services.

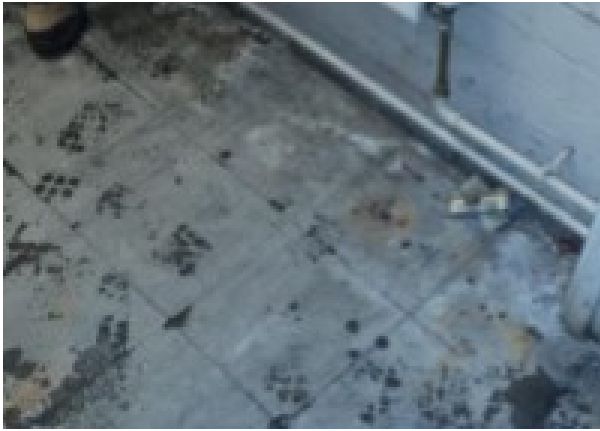
Item 64 Ref: 21-30435-2

The floor tiles and adhesive in the corridor adjacent to Debra's office does not contain asbestos.

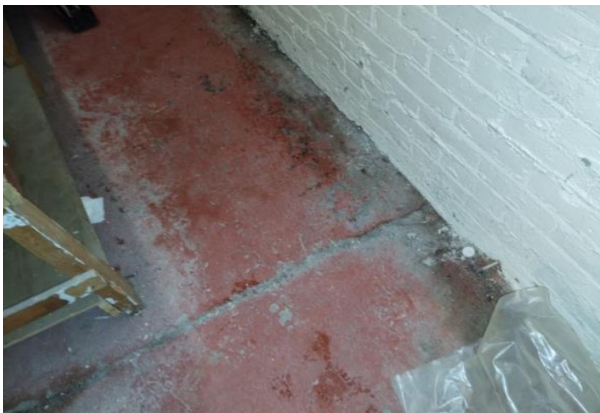
Item 65 Ref: 21-30764-1

The putty to joints in floor in Area 1/Store Room does not contain asbestos.

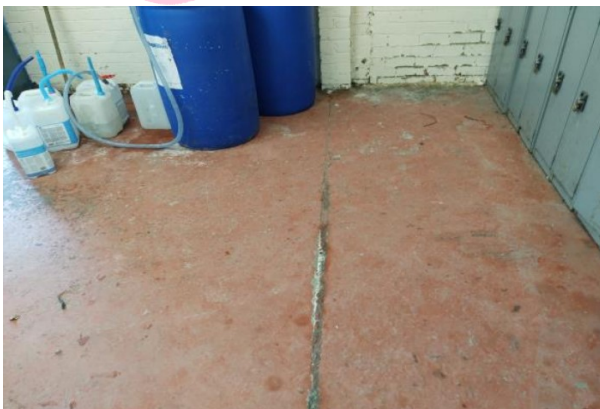
Item 66 Ref: 21-30764-1

The putty on floor in Area 2/Locker Room does not contain asbestos.

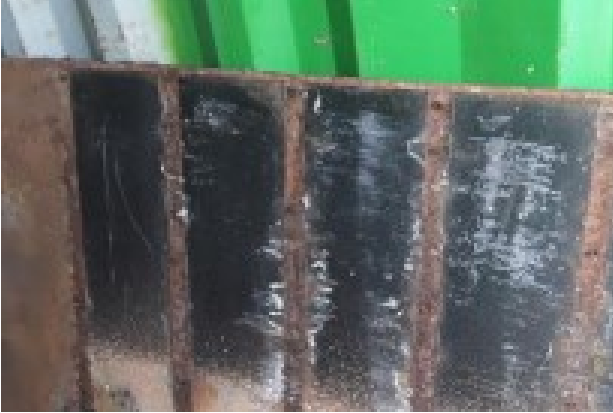
Item 76 Ref: 21-32018-1

The bitumen to the underside of the wood flooring in Container 3 does contain asbestos.

Removed 2023

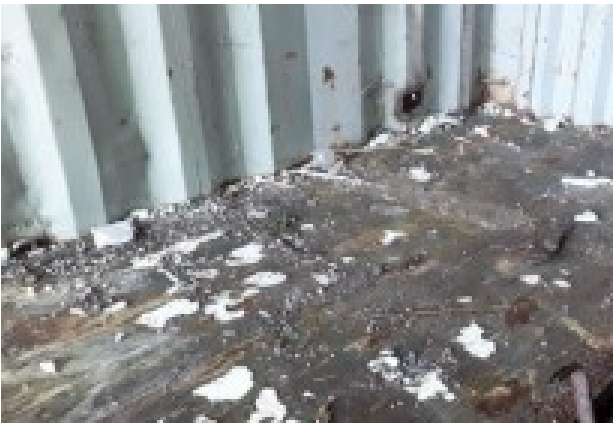
Item 78 Ref: 21-32018-1

The bitumen to the underside of the wood flooring in Container 6 does contain asbestos.

Removed 2023

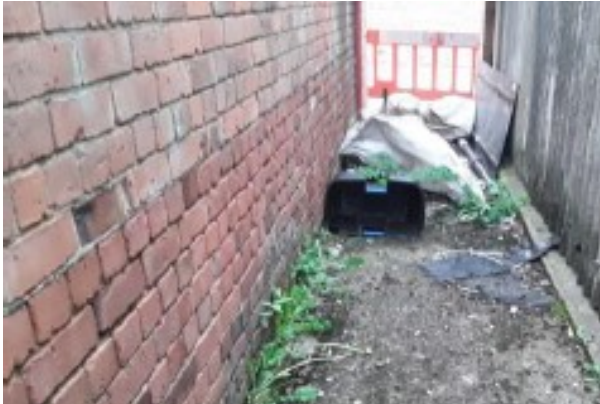
Item 94 Ref: 22-46862-18

The roof felt debris between warehouses (External) contains asbestos.

Removed 2023

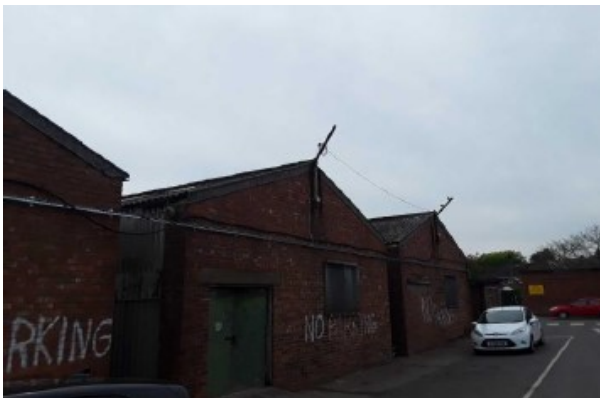
Item 96 Ref: 22-46862-20

The cement roof edging (External) contains asbestos.

Removed 2023

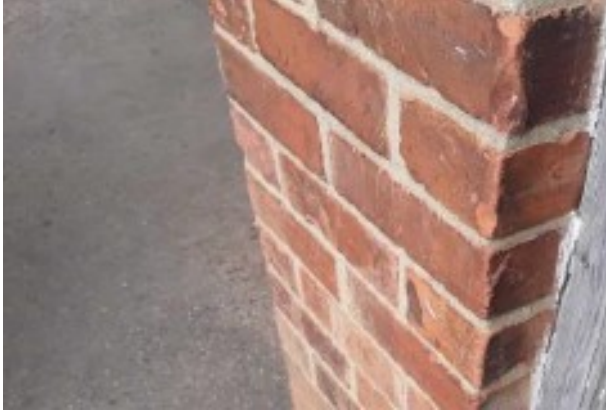
Item 97 Ref: 22-46862-21

The frame sealant to brickwork (External) does not contain asbestos.

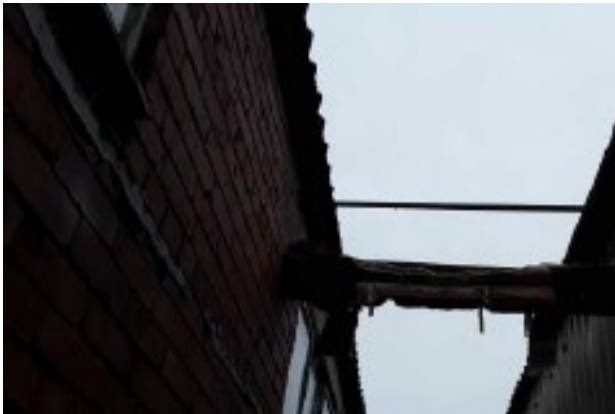
Item 98 Ref: 22-46862-26

The wrap to external pipes (External) contains asbestos.

Removed 2023
