ASBESTOS SURVEY REPORT FOR RYHOPE CEMETERY, SUNDERLAND

**Asbestos Register for
Ryhope Cemetery**

UPRN: - J549268

Premises Manager / Samo: - Tenant Date: 17 January 2023

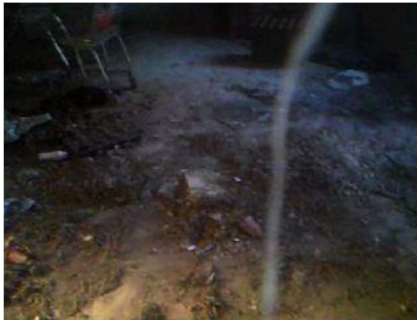
Item 1: Ref CB008495

CB008495 – Debris (Room 2) (Item 1) - No Risk

The debris to the floor in the entrance Lobby (Room 2) does not contain asbestos.

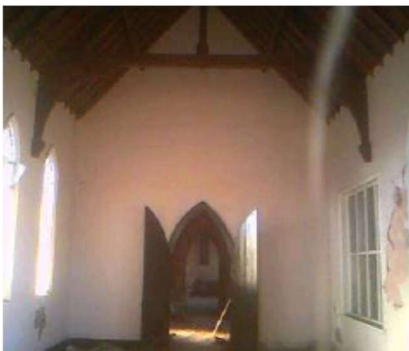
Room 3 (Chapel on the left) was accessed and no suspect materials were found.

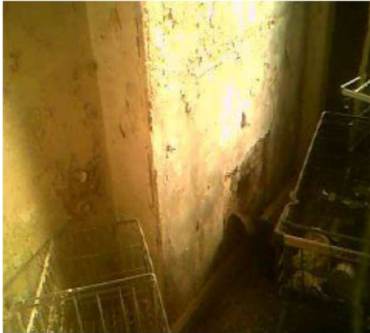
Room 4 – Chimney breast - No access therefore further investigation required

The chimney breast to the Store (Room 4) could not be accessed. Further investigation may be required prior to any works being carried out.

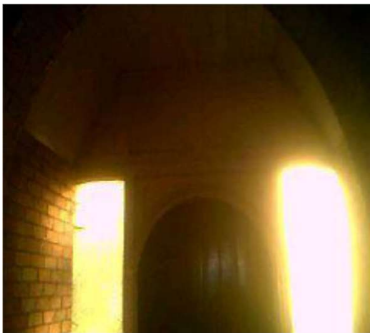
The rear porch (Room 5) was accessed and no suspect materials were found.

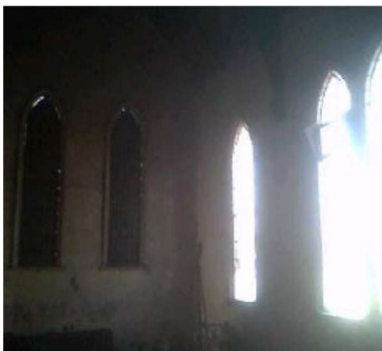
Room 6 (Chapel on the right) was accessed and no suspect materials were found.

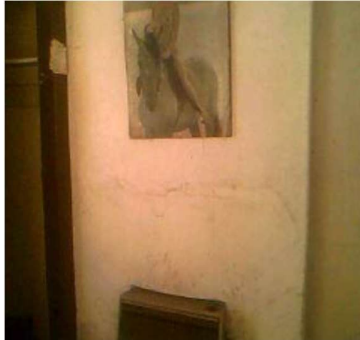
Room 7 – Chimney breast - No access therefore further investigation required

The chimney breast to the Utility Room (Room 7) could not be accessed. Further investigation may be required prior to any works being carried out.

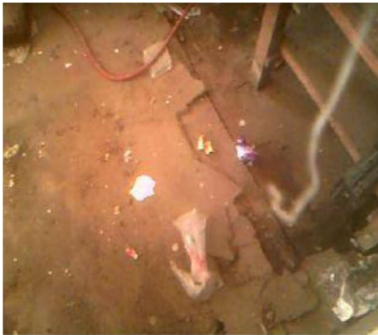
Item 2: Ref CB008496

CB008496 – Lino (Room 7) (Item 2) – No Risk

The lino to the utility room (Room 7) does not contain asbestos.

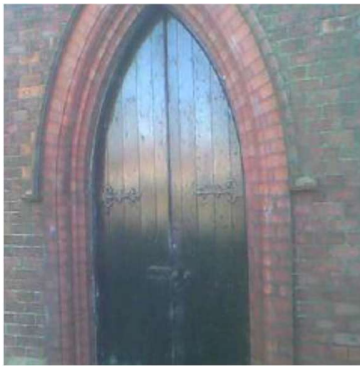
Room 8 – No access therefore further investigation required

Room 8 (Room to the left of the entrance) could not be accessed. Further investigation may be required prior to any works being carried out.

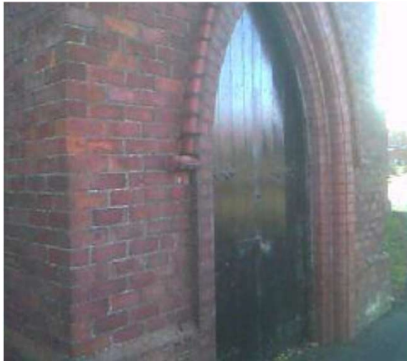
Room 9 – No access therefore further investigation required

Room 9 (Room to right of entrance) could not be accessed. Further investigation may be required prior to any works being carried out.

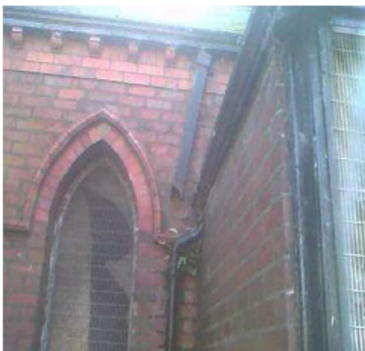
The external to the chapel of rest was accessed and no suspect materials were found.

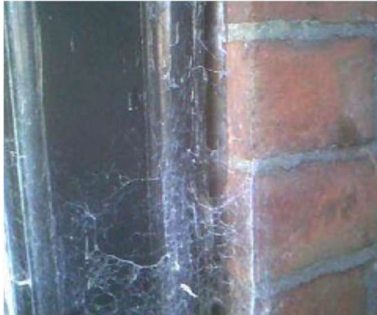
Item 3: Ref CB008497

CB008497 – Window putty (External) (Item 3) - No Risk

The external window putty to the chapel of rest does not contain asbestos. .
