*Control of Asbestos
Regulations 2012*

Asbestos Register for

Easington Lane Access Point

Date: 18 September 2024

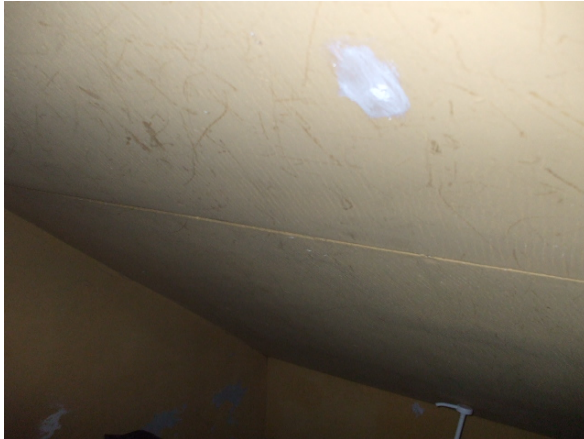
Item 1 Ref: 20915126-003

20915126-003 – Panel under stairs (Rm 0/005) (Item 1) Very Low Risk

The panel to under stairs in 0/005 reception hall cleaners cupboard contains asbestos. Any change in appearance should be recorded and passed to property services.

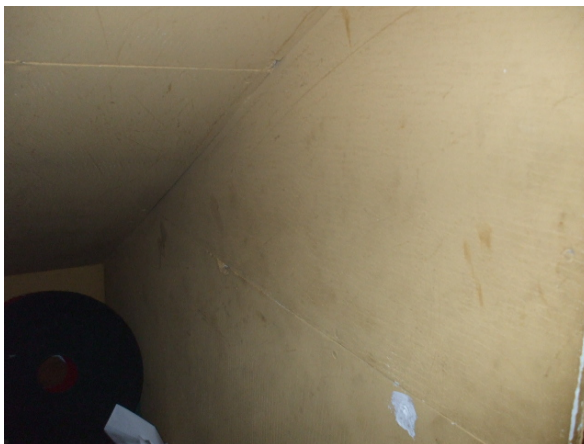
Item 2 Ref: 20915126-004

20915126-004 – Panel to Walls (Rm 0/005) (Item 2) Very Low Risk

The panels to the walls under stairs in 0/005 reception hall cleaners cupboard contains asbestos. Any change in appearance should be recorded and passed to property services.

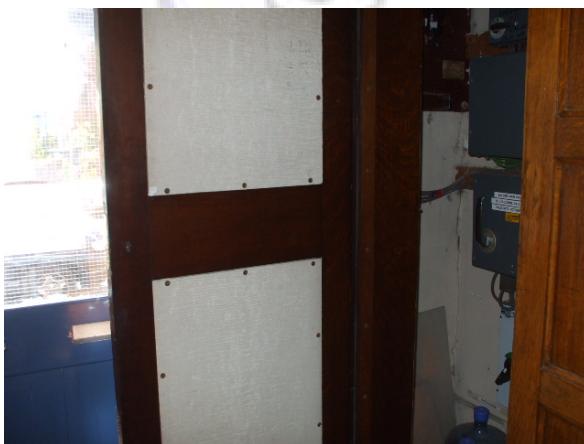
Item 3 Ref: 20915126-001

20915126-001 – Panel above Doors (Rm 0/005) (Item 3) Very Low Risk

The panels above the doors to 0/005 reception hall electric cupboard contain asbestos. Any change in appearance should be recorded and passed to property services.

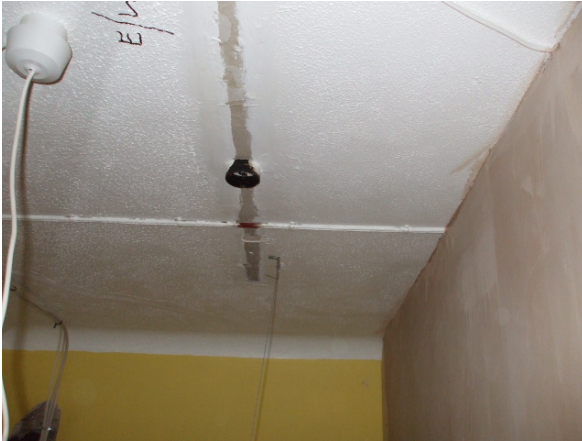
Item 4&5 Ref: 20915126-002

20915126-002 – Textured Coating to Ceiling (Rm 0/008) (Item 4) No Risk

As 20915126-002 – Textured Coating to Ceiling (Rm 0/010) (Item 5) No Risk

The textured coating to the ceiling above the suspended ceiling in 0/008 does not contain asbestos. Similar coating can be found in 0/010 female W.C.

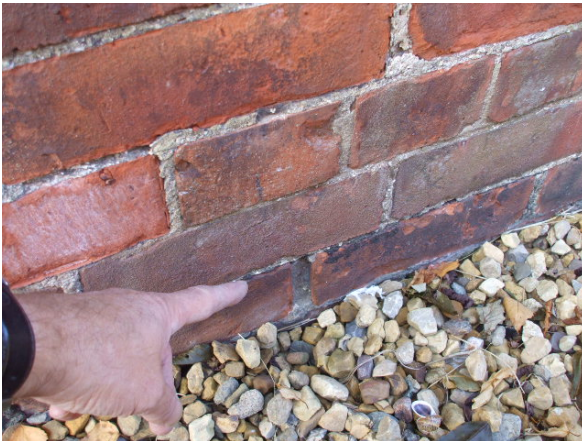
Item 6 Ref: 20915126-007

20915126-007 – Damp proof Course (Externals) (Item 6) No Risk

The Damp Proof Course to externals does not contain asbestos.

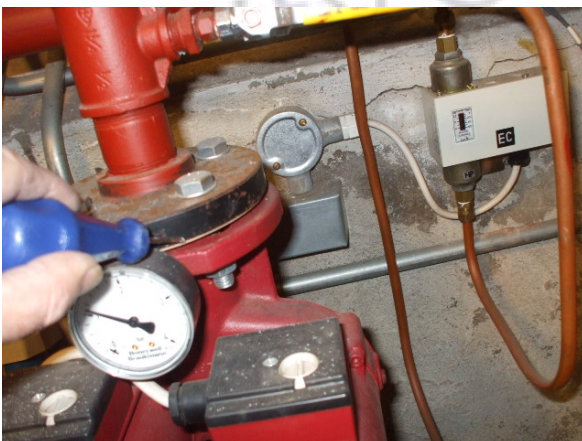
Item 7 Ref: 20915126-005

20915126-005 – Flange Gaskets (Externals Boiler Room) (Item 7) No Risk

The Flange Gaskets to the externals Boiler Room does not contain asbestos.

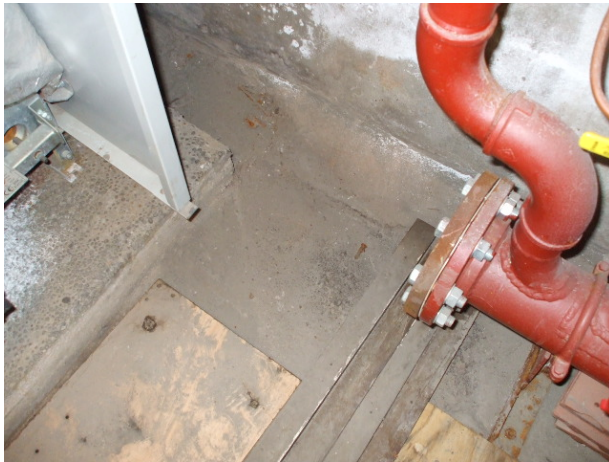
Item 8 Ref: 20915126-006

20915126-005 – Debris (Externals Boiler Room) (Item 8) No Risk

The debris to the floor in 9/999 external Boiler Room does not contain asbestos.

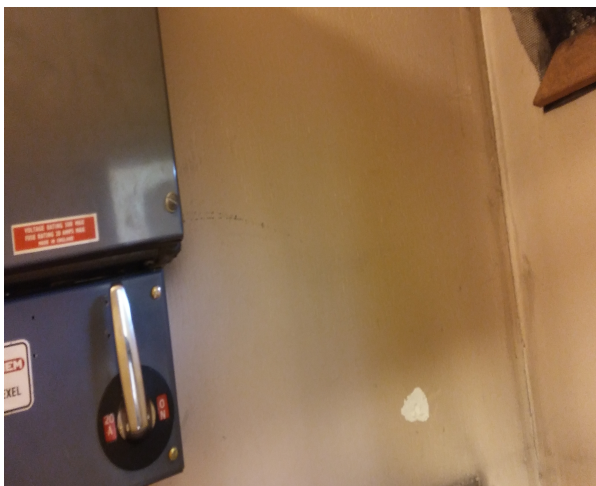
Item 9 Ref: 223226-1

223226-1 – Wall Boards and door header (Rm10 Cupboard) (Item 9) Low Risk

The panels to the walls and door header in the cupboard (Rm10) do contain asbestos.

Any change in appearance should be recorded and passed to property services.

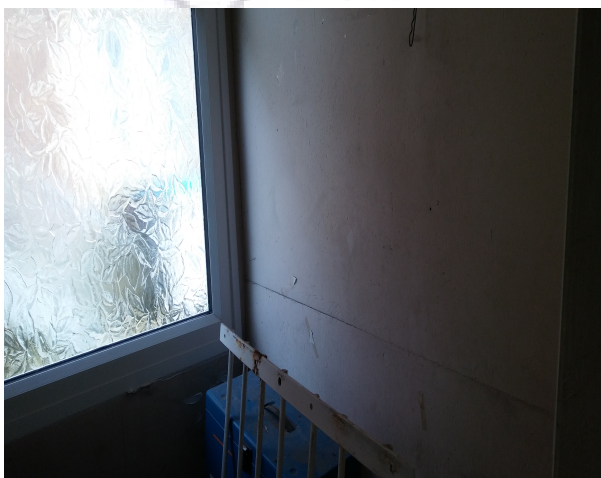
Item 10 Ref: As 223226-1

As 223226-1 - Wall Boards and door header (Rm12 Cupboard) (Item 10) Low Risk

The panels to the walls and door header in the cupboard (Rm12) do contain asbestos.

Any change in appearance should be recorded and passed to property services.

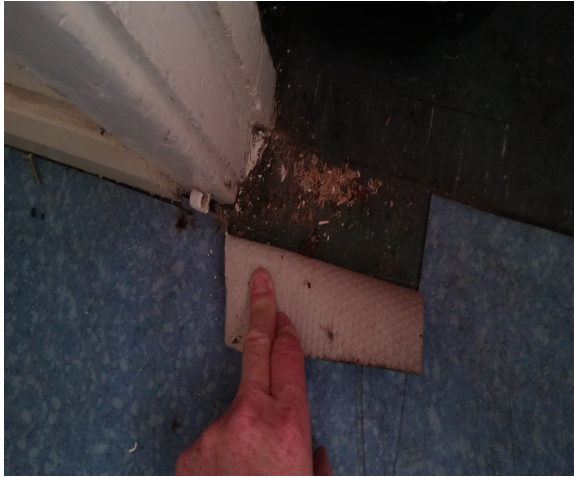
Item 11 Ref: 223226-2

223226-2 – Floor tile & bitumen adhesive (Kitchen) (Item 11) - Removed 2017

The floor tiles & bitumen adhesive in the kitchen (Rm14) do contain asbestos.

Removed November 2017.

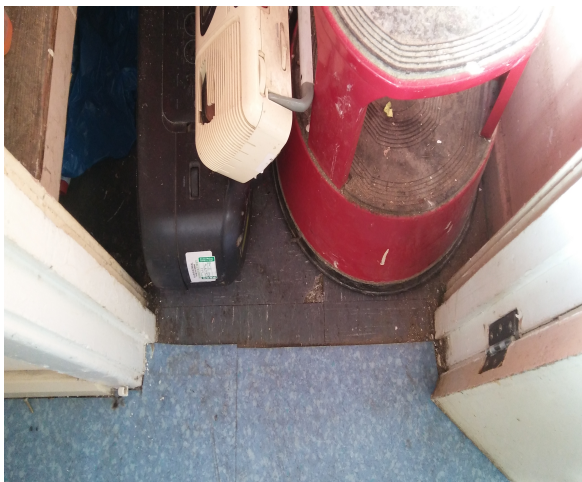
Item 12 Ref: As 223226-2

As 223226-2 – Floor tile & bitumen adhesive (Tank cupboard) (Item 12) - Removed 2017

The floor tiles & bitumen adhesive in the tank cupboard (Rm15) do contain asbestos.

Removed November 2017.

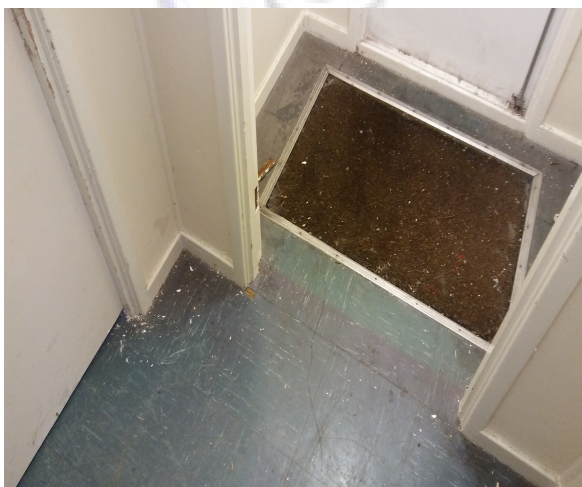
Item 13 Ref: 223226-3

223226-3 – Floor tile & bitumen adhesive (Rear Fire Exit Lobby) (Item 13) Very low Risk

The floor tiles & bitumen adhesive in the rear fire exit lobby (Rm18) do contain asbestos.

Any change in appearance should be recorded and passed to property services.

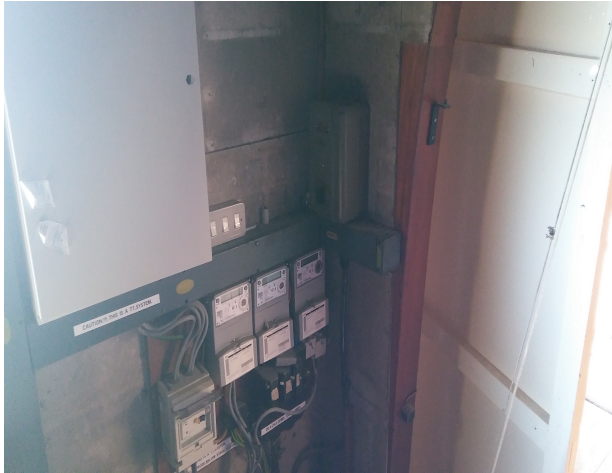
Item 14 Ref: 223226-4

223226-4 – Panels around electrics (Stage Area) (Item 14) Very Low Risk

The panels around the electrics in the stage area (Rm19) do contain asbestos.

Any change in appearance should be recorded and passed to property services.

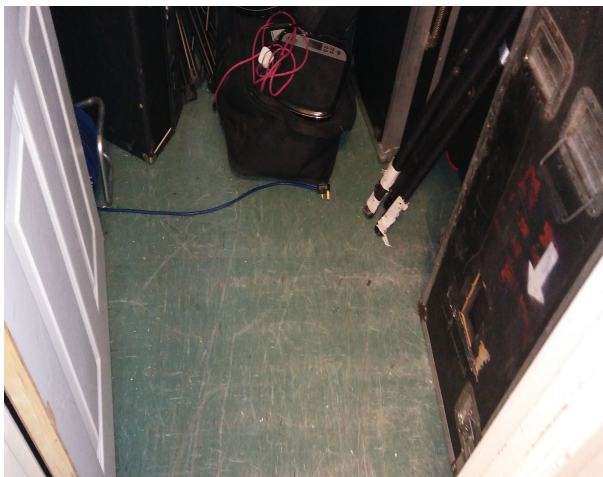
Item 15 Ref: As 223226-3

As 223226-3 - Floor tile & bitumen adhesive (Rm21 Rear Store) (Item 15) Very Low Risk

The floor tiles & bitumen adhesive in the rear store (Rm21) do contain asbestos.

Any change in appearance should be recorded and passed to property services.

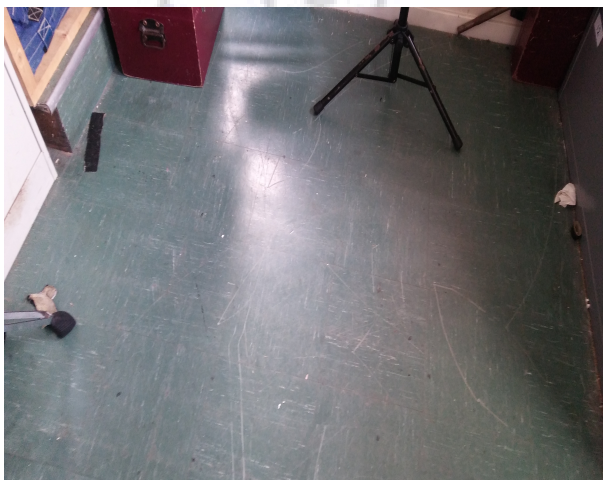
Item 16 Ref: As 223226-3

As 223226-3 - Floor tile & bitumen adhesive (Rm 22 Rear Store) (Item 16) Very Low Risk

The floor tiles & bitumen adhesive in the rear store (Rm22) do contain asbestos.

Any change in appearance should be recorded and passed to property services.

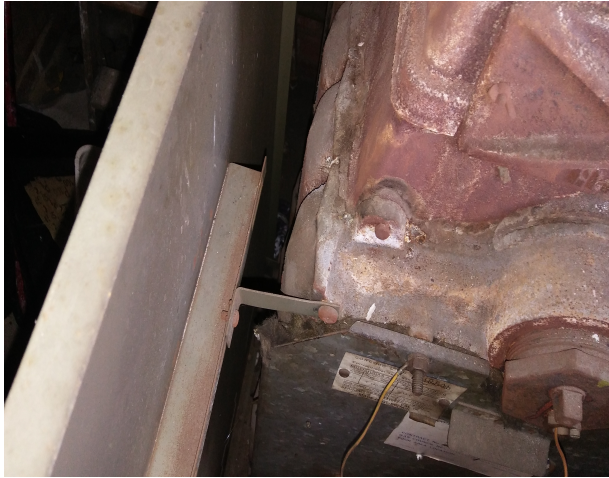
Item 17 Ref: 223226-5

223226-5 – Ropes (Boiler room) (Item 17) Removed November 2019

The ropes to the boiler sections in the boiler room (Rm23) do contain asbestos.

Removed November 2019.

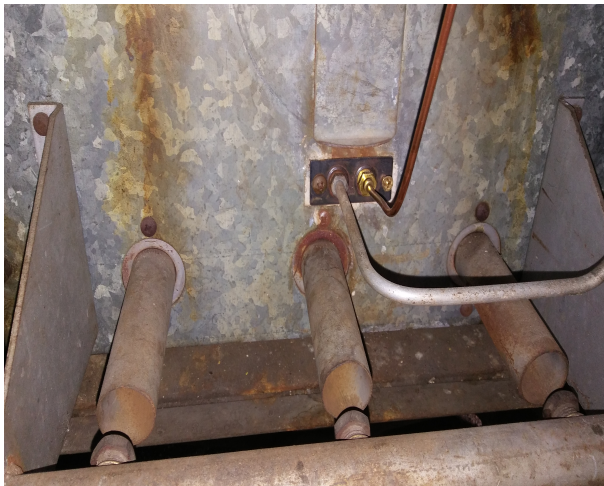
Item 18 Ref: 223226-6

226226-6 – Gasket to boilers (Boiler room) (Item 18) Removed November 2019

The gaskets to pipe inlets in the boiler room (Rm23) do contain asbestos.

Removed November 2019.

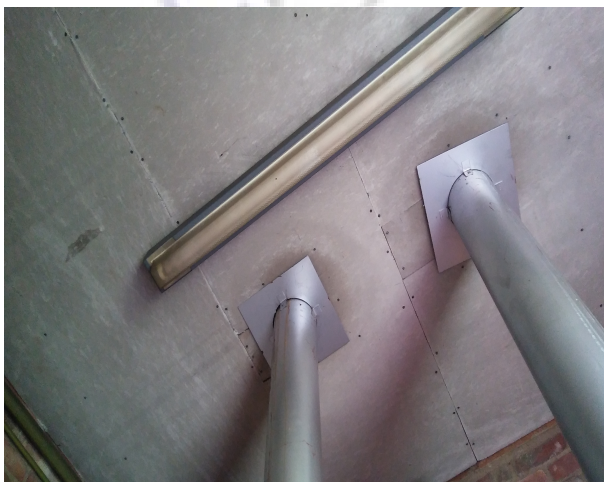
Item 19 Ref: 223226-7

223226-7 – Ceiling Panels (Boiler room) (Item 19) Very Low Risk

The ceiling panels in the boiler room (Rm23) do contain asbestos.

Any change in appearance should be recorded and passed to property services.

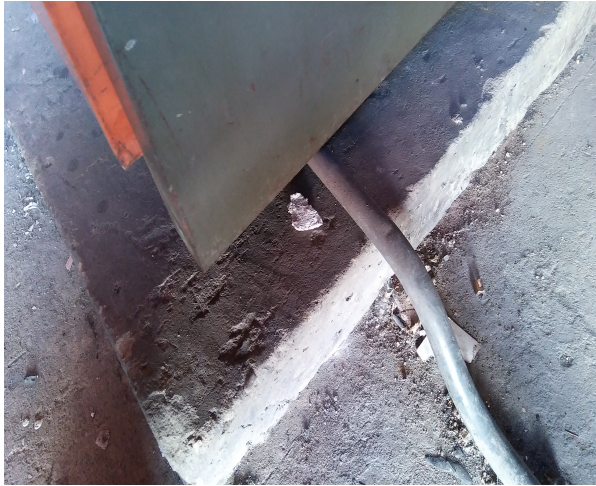
Item 20 Ref: 223226-8

223226-8 – Debris (Boiler room) (Item 20) No Risk

The debris in the boiler room (Rm23) does not contain asbestos.

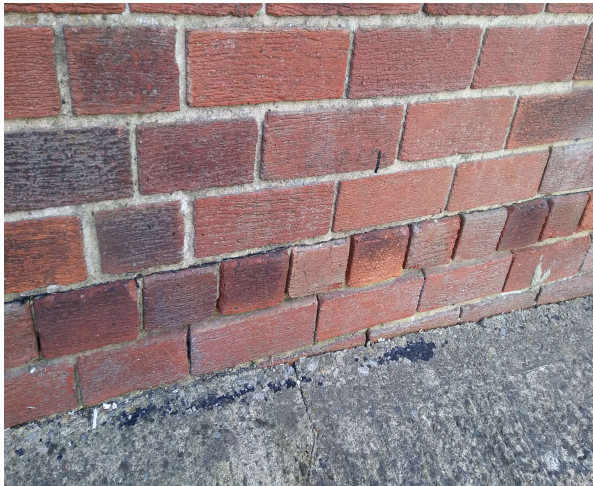
Item 21 Ref: 223226-9

223226-9 – Damp Proof Course (Externals) (Item 21) No Risk

The damp proof course to the externals does not contain asbestos.

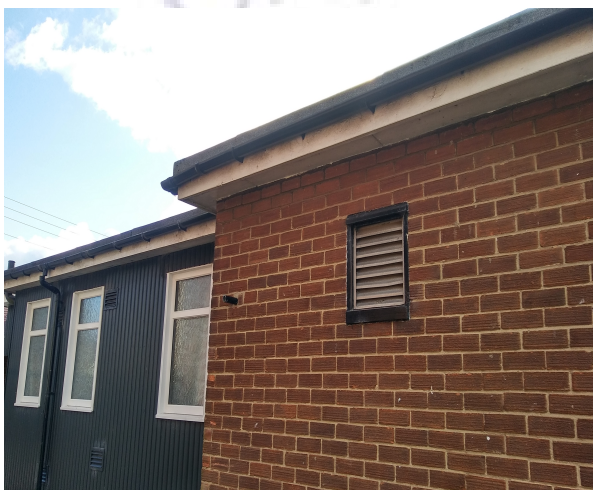
Item 22 Ref: 223226-10

223226-10 – Soffit (Externals) (Item 22) Very Low Risk

The soffit to the externals does contain asbestos.

Any change in appearance should be recorded and passed to property services.

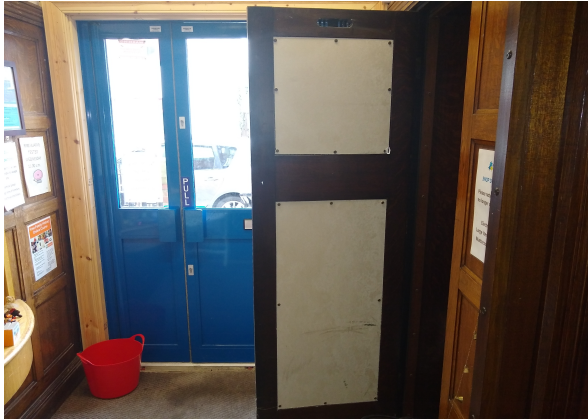
Item 23 Ref: 349822-2

349822-2 – Panel to rear of electrical cupboard doors (Room 0/005) (Item 23) No Risk

The panel to the rear of the electrical cupboard doors in the reception (Room 0/005) does not contain asbestos.

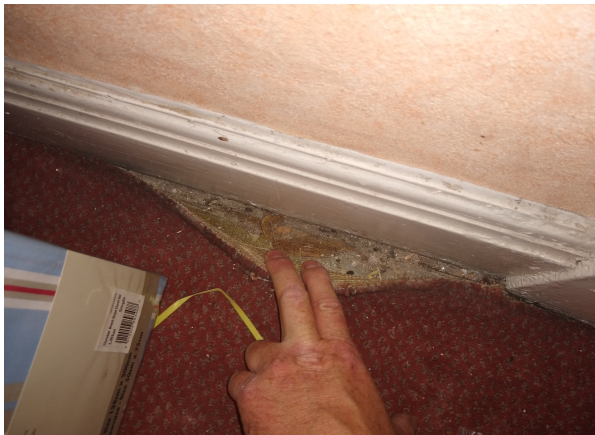
Item 24 Ref: 349822-1

349822-1 – Floor covering (Room 0/007) (Item 24) No Risk

The floor covering in the office (Room 0/07) does not contain asbestos.
