ASBESTOS SURVEY REPORT FOR FORMER RINGTONS UNIT, BROOKE STREET, SUNDERLAND

Asbestos Register for

BROOKE STREET, SUNDERLAND

Date:- 27 March 2024

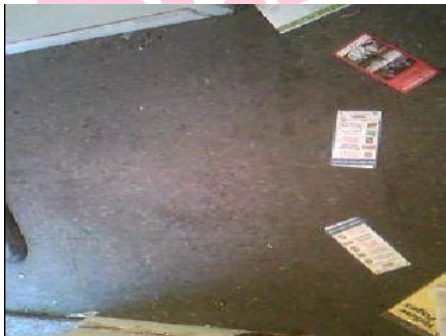
Item 1 - Ref: AD001799

The floor, composite vinyl tile/lino to room 1 (entrance) does not contain asbestos.

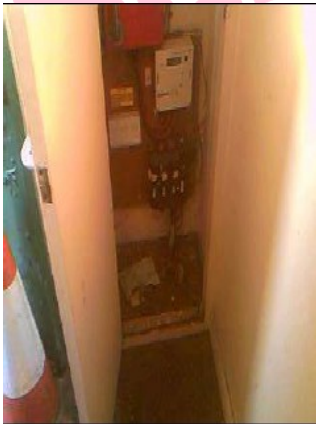
The ceiling, plaster board to Room 2 (Electrical cupboard) does not contain asbestos.

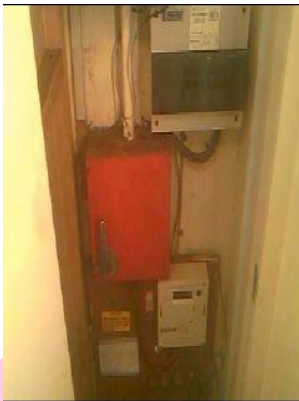
Unable to gain access to electrical services in room 2 (electrical cupboard), further investigation required.

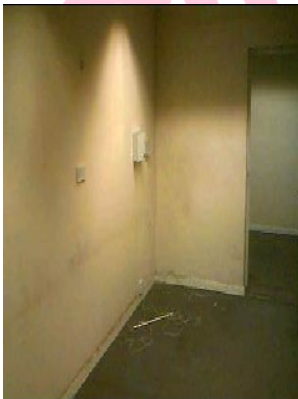
The ceiling, plaster board to Room 3 (Office 1) does not contain asbestos.

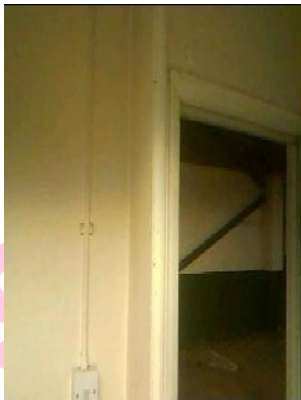
Item 3 - Ref: As AD001800

The wall panels to the door insulation board to Room 4 (Office 2) does contain asbestos.

Any changes should be reported to Property Services.

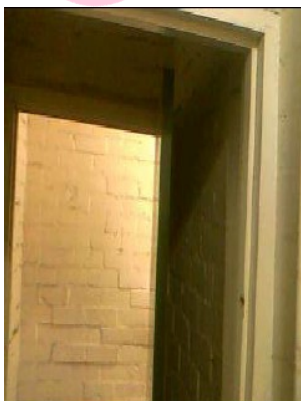
The ceiling, wood to Room 5 (Passage) does not contain asbestos.

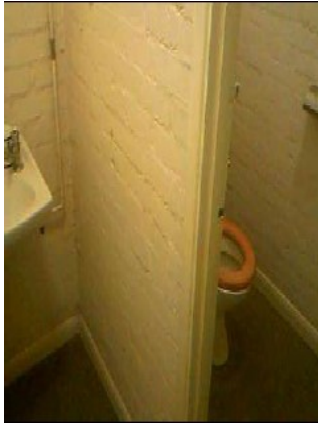
The ceiling, wood in Room 6 (Ladies toilet) does not contain asbestos.

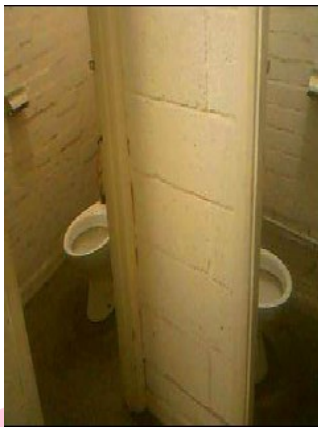
The ceiling, wood to Room 7 (gents toilet) does not contain asbestos.

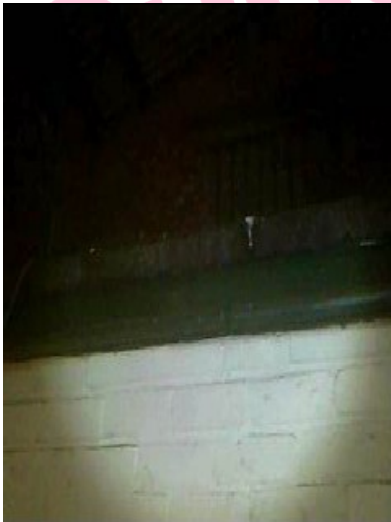
Item 4 - Ref: AD001801

The roof felt to offices, Room 8 (Main warehouse) does contain asbestos.

Any changes should be reported to Property Services.

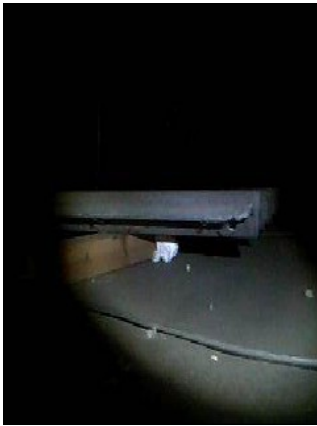
Item 5 - Ref: AD001802

The panel to the flat room cement panel in Room 8 (Main warehouse) does contain asbestos.

Any changes should be reported to Property Services.

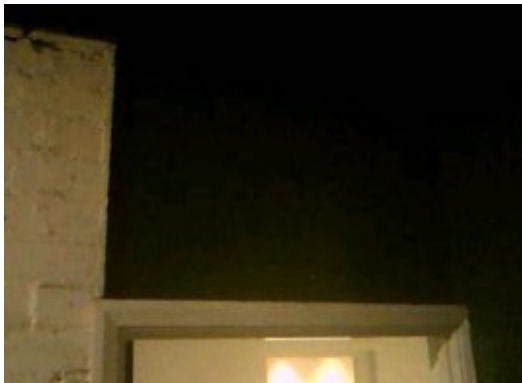
Item 6 - Ref: As AD001800

The header panel to door insulation board (main warehouse) does contain asbestos.

Any changes should be reported to Property Services.

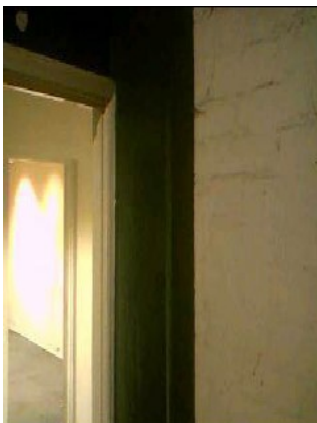
Item 7 - Ref As AD001800

The wall panels to door insulation board, Room 8 (main warehouse) does contain asbestos.

Any changes should be reported to Property Services.

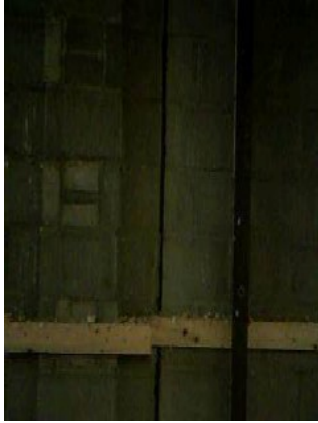
Item 8 – Ref: AD001803

The seal to wall joints in Room 8 (main entrance) does not contain asbestos.

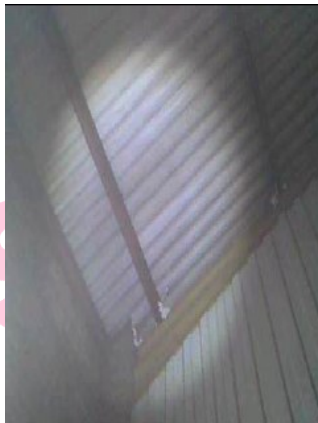
Item 9 - Ref: AD001804

The debris to the steel beams to Room 8 (main warehouse) does not contain asbestos.

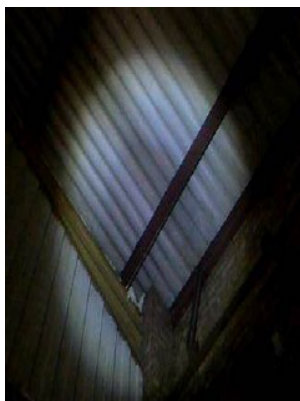
Item 10 – Ref: AD001805

The debris to the steel beams Room 8 (main warehouse) does not contain asbestos.

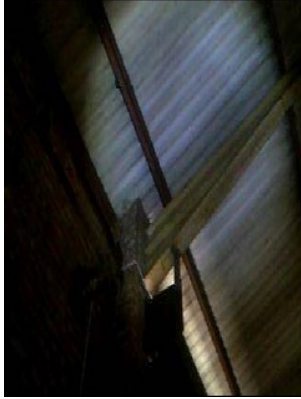
Item 11 – Ref AD001806

The debris to the steel beams
Room 8 (main entrance) does
not contain asbestos.

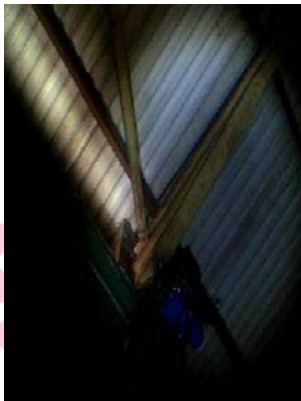
Item 12 - Ref: As AD001807

The debris to the steel beams
Room 8 (main entrance) does
not contain asbestos.

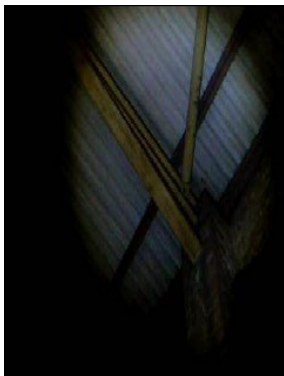
Item 13 – Ref: AD001808

The debris to the steel beams
Room 8 (main entrance) does
not contain asbestos.

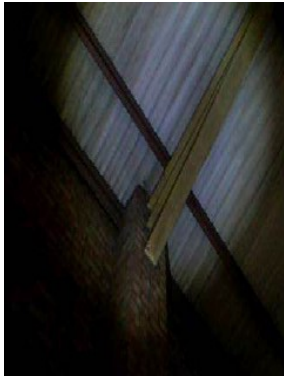
Item 14 – Ref: AD001809

The debris to the steel beams Room 8 (main entrance) does not contain asbestos.

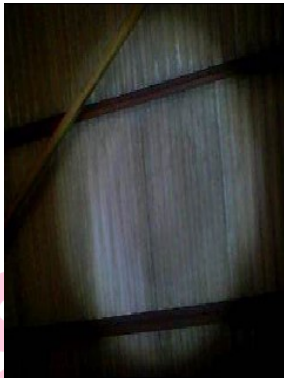
Item 15 – Ref: AD001810

The ceiling, cement corrugated sheet to Room 8 (main warehouse) does contain asbestos.

<i>Item 15</i>	<i>Ceiling (Room 8)</i>	<i>Low Risk</i>	<i>6 monthly (inspect from ground level)</i>	<i>03/07/2024</i>
<i>Item 16</i>	No asbestos	Is present		
<i>Item 17</i>	No asbestos	Is present		
<i>Item 18</i>	<i>Skylight (Room 8)</i>	<i>Low Risk</i>	<i>6 monthly (inspect from ground level)</i>	<i>03/07/2024</i>
<i>Item 19</i>	<i>Roof (External)</i>	<i>Low Risk</i>	<i>6 monthly (inspect from ground level)</i>	<i>03/07/2024</i>
<i>Item 20</i>	<i>Damp proof course (External)</i>	<i>Very Low Risk</i>	<i>12 monthly</i>	<i>03/01/2025</i>
<i>Item 21</i>	<i>Fascia (External)</i>	<i>Very Low Risk</i>	<i>12 monthly (inspect from ground level)</i>	<i>03/01/2025</i>
<i>Item 22</i>	<i>Boxing to roller shutter</i>	<i>Low Risk</i>	<i>6 monthly</i>	<i>03/07/2024</i>

Any changes should be reported to Property Services.

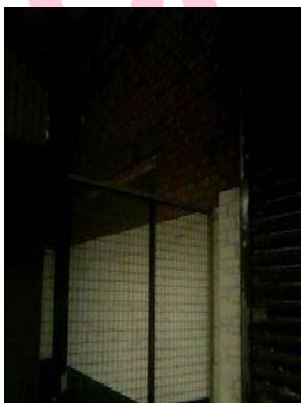
The walls, bricks to Room 8 (main warehouse) does not contain asbestos.

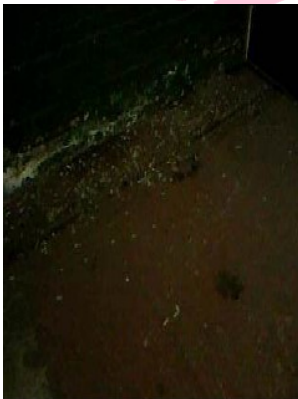
Item 17 – Ref AD001812

The floors, (random debris) to Room 8 (main warehouse) do not contain asbestos.

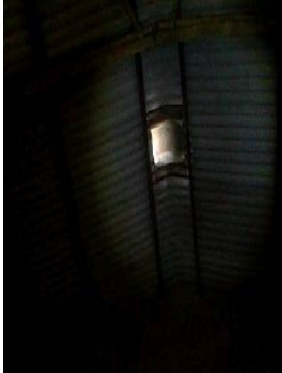
Item 18 – Ref Presumed

The skylights to Room 8 (main warehouse) are presumed to contain asbestos.

Any changes should be reported to Property Services.

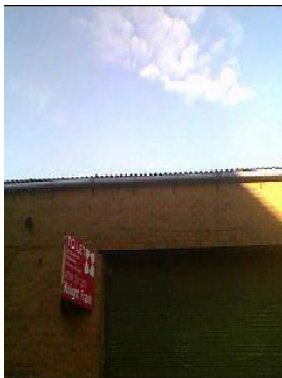
Item 19 – Ref AD001813

AD001813 – Roof (External) (Item 19) – Low Risk
AD001814 – Damp proof course (External) (Item 20) – Very Low Risk
AD001815 – Fascia (External) (Item 21) – Very Low Risk
AD001816 – Boxing to roller shutter (External) (Item 22) – Low Risk

The roof to Room 1 (external) does contain asbestos.

Any changes should be reported to Property Services.

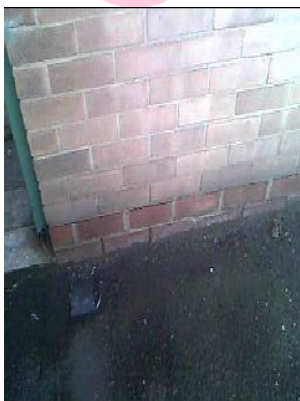
Item 20 – Ref AD001814

The damp proof course to Room 1 (external) does contain asbestos.

Any changes should be reported to Property Services.

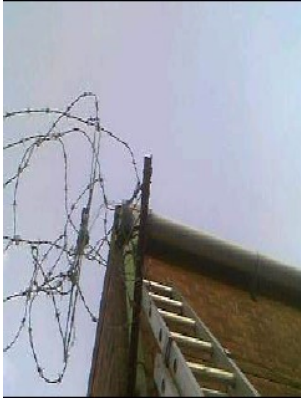
Item 21 – Ref AS001815

The fascia to Room 1 (external) does contain asbestos. Any changes should be reported to Property Services.

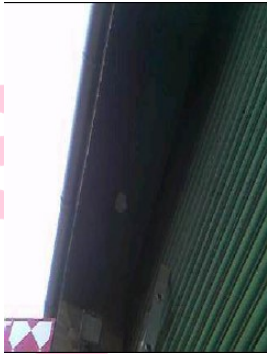
Item 22 – Ref AD001816

The fascia to Room 1 (external) does contain asbestos. Any changes should be reported to Property Services.
