ASBESTOS SURVEY REPORT FOR CRICKET PAVILLION/TEA ROOM, BILLY HARDY SPORTS COMPLEX, GRANGE ROAD, SUNDERLAND, SR5 3EQ.

Asbestos Register for

Cricket Pavillion/Tea Room, Billy Hardy Sports Complex

Date: 27 September 2024

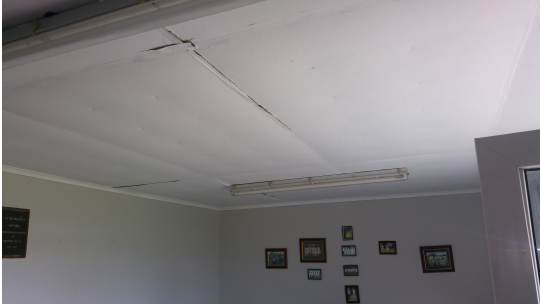
Item 1 Ref: 339062-1

The fixed ceiling in the seating area (Rm 0/01) does not contain asbestos.

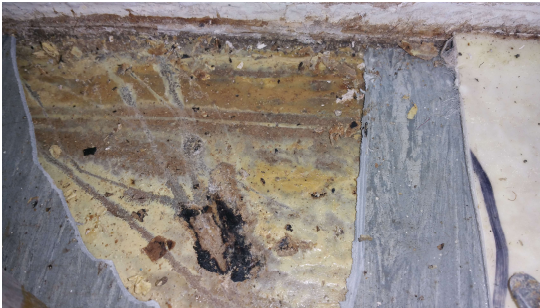
Item 2 Ref: 339062-2

The remnant adhesive to concrete floor (below screed) in the seating area (Room 0/01) contains asbestos.

Any change in appearance should be reported to Property Services.

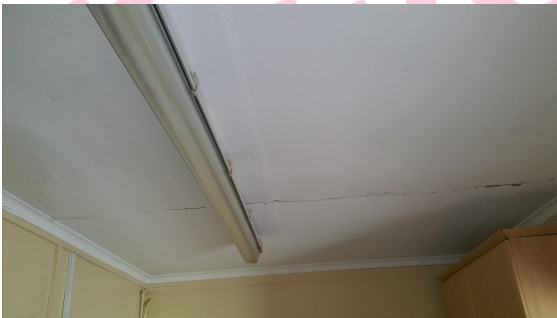
Item 3 Ref: As 339062-1

The fixed ceiling in the kitchen (Rm 0/02) does not contain asbestos.

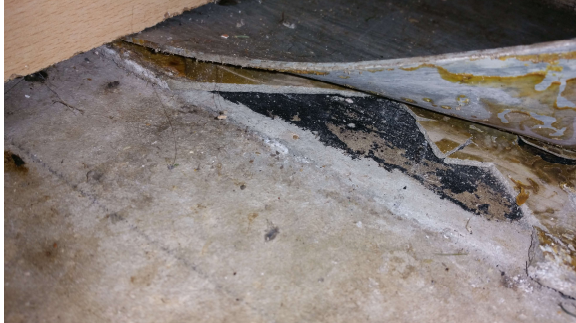
Item 4 Ref: As 339062-2

The remnant adhesive to concrete floor (below screed) in the kitchen (Room 0/02) contains asbestos.

Any change in appearance should be reported to Property Services.

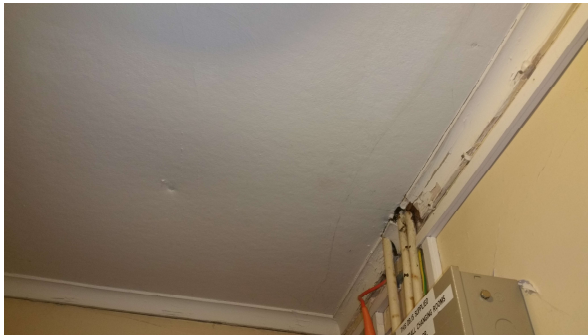
Item 5 Ref: As 339062-1

The fixed ceiling in the kitchen store (Rm 0/03) does not contain asbestos.

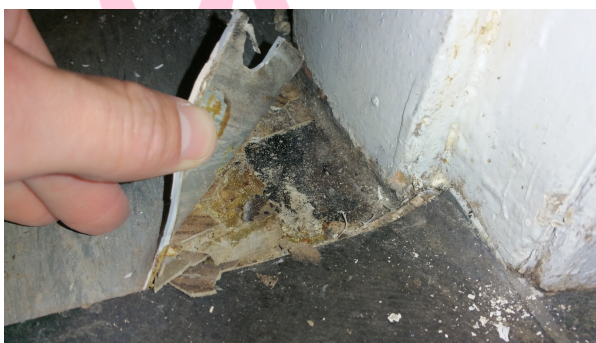
Item 6 Ref: As 339062-2

The remnant adhesive to concrete floor (below screed) in the kitchen store (Room 0/03) contains asbestos.

Any change in appearance should be reported to Property Services.

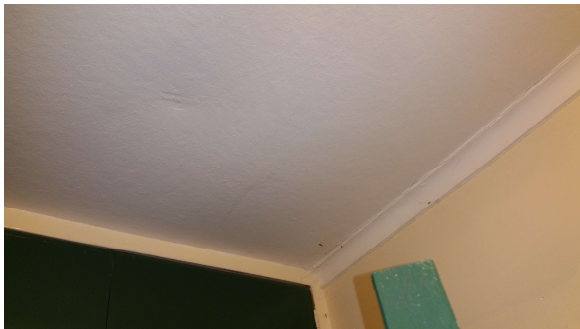
Item 7 Ref: As 339062-1

The fixed ceiling in the WC lobby (Rm 0/04) does not contain asbestos.

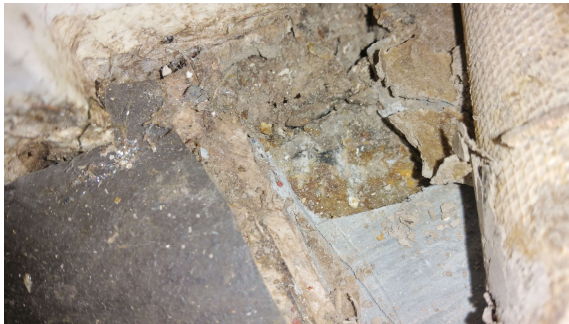
Item 8 Ref: As 339062-2

The remnant adhesive to concrete floor (below screed) in the WC lobby (Room 0/04) contains asbestos.

Any change in appearance should be reported to Property Services.

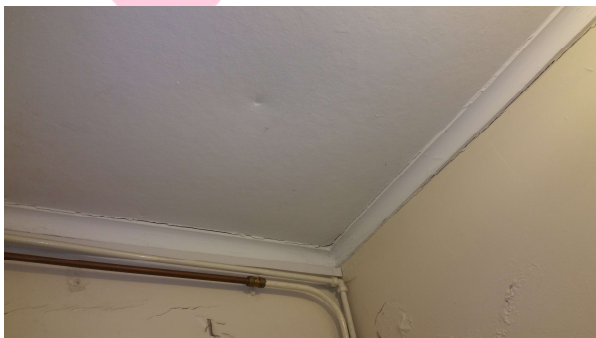
Item 9 Ref: As 339062-1

The fixed ceiling in the WC (Rm 0/05) does not contain asbestos.

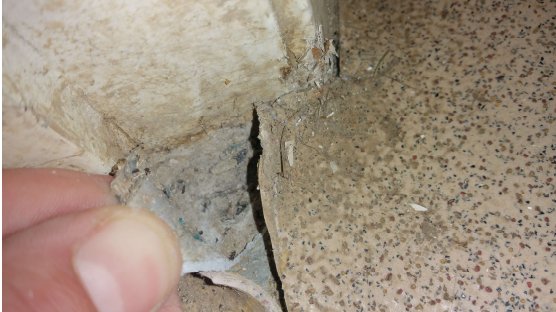
Item 10 Ref: As 339062-2

The remnant adhesive to concrete floor (below screed) in the WC (Room 0/05) contains asbestos.

Any change in appearance should be reported to Property Services.

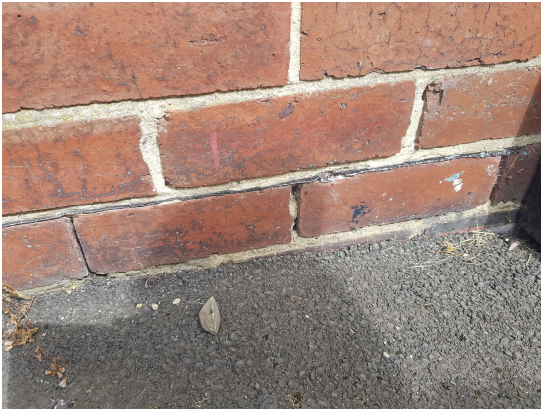
Item 11 Ref: 339062-3

The damp proof course (External) contains asbestos.

Any change in appearance should be reported to Property Services.
