ASBESTOS SURVEY REPORT FOR SILKSWORTH RECREATION PARK,
BLIND LANE, SUNDERLAND, SR3 1AU.

**Silksworth Recreation Park, Blind Lane,
Sunderland, SR3 1AU.**

Date: 06 March 2025

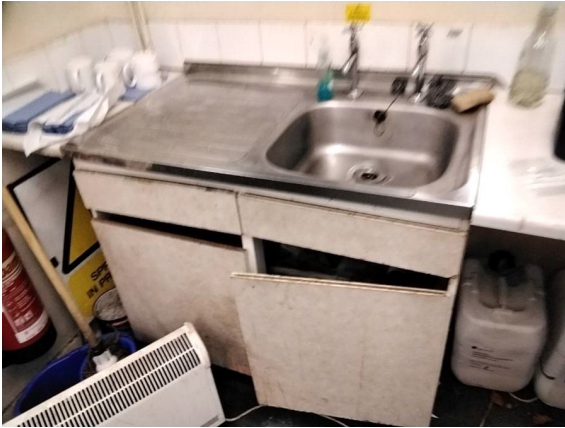
Item 1 Ref: KX000468

The Under Sink Mat - Bitumen in Boiler House/Changing Rooms G/001 Staff Room does not contain asbestos.

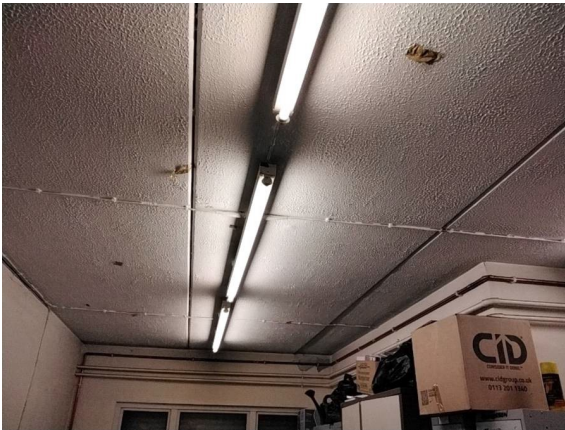
Item 2 Ref: KX000469

The Ceiling – Coating – decorative finish in Boiler House/Changing Rooms G/001 Staff Room does not contain asbestos.

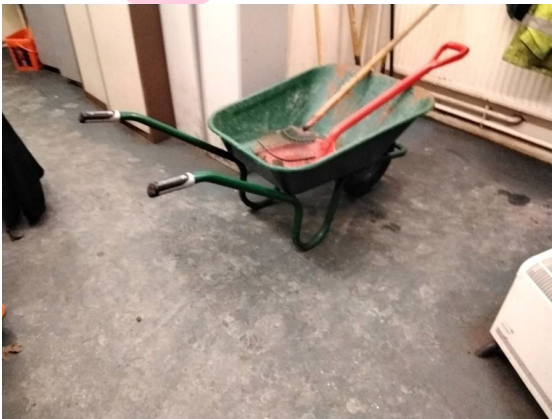
Item 3 Ref: KX000470

The Floor – Covering - Vinyl Tile, Vinyl/Lino in Boiler House/Changing Rooms G/001 Staff Room does not contain asbestos.

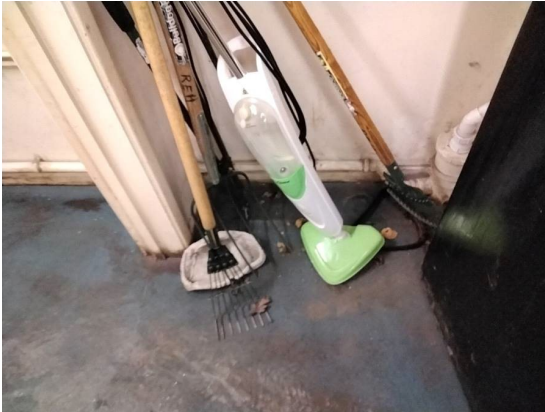
Item 4 Ref: As KX000470

The Floor – Covering - Vinyl Tile, Vinyl/Lino in Boiler House/Changing Rooms
G/002 Passageway does not contain asbestos.

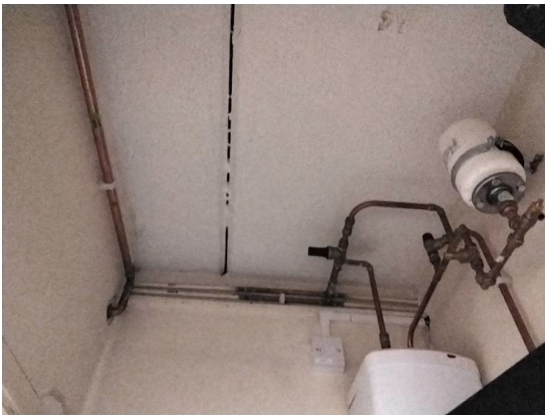
Item 5 Ref: As KX000469

The Ceiling – Coating – decorative finish in Boiler House/Changing Rooms
G/002 Passageway does not contain asbestos.

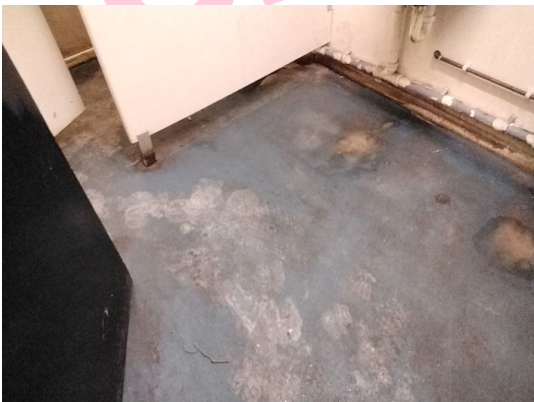
Item 6 Ref: As KX000470

The Floor – Covering - Vinyl Tile, Vinyl/Lino in Boiler House/Changing Rooms
G/003 Toilets does not contain asbestos.

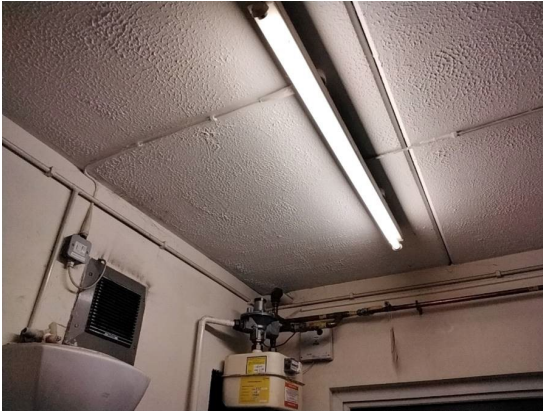
Item 7 Ref: As KX000469

The Ceiling – Coating – decorative finish in Boiler House/Changing Rooms G/003 Toilets does not contain asbestos.

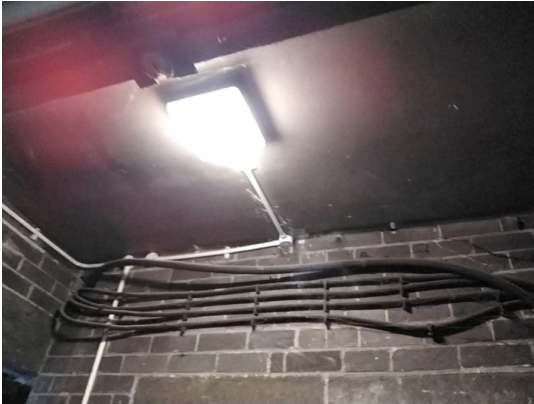
Item 8 Ref: KX000471

8.	KX000471	Ceiling - Insulating Board	Boiler House/Changing Rooms G/004 Boiler Room	Low
9.	KX000472	Debris/Residue - to floor	Boiler House/Changing Rooms G/004 Boiler Room	No Risk

The Ceiling - Insulating Board in Boiler House/Changing Rooms G/004 Boiler Room contains asbestos.

Any change in its appearance should be recorded and passed to Property Services.

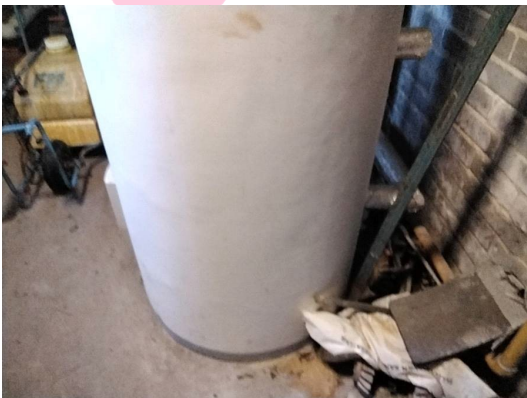
Item 9 Ref: KX000472

The Debris/Residue - to floor in Boiler House/Changing Rooms G/004 Boiler Room does not contain asbestos.

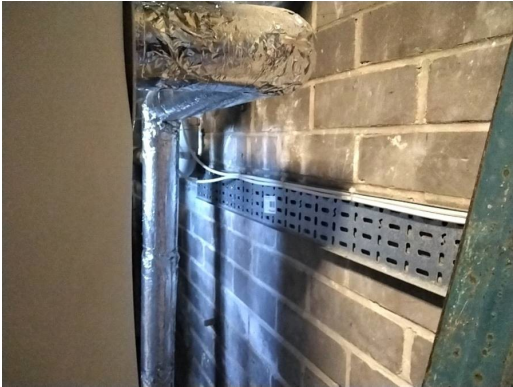
Item 10 Ref: KX000473

The Debris/Residue - to walls behind calorifiers - Thermal Insulation Lagging in Boiler House/Changing Rooms G/004 Boiler Room does not contain asbestos.

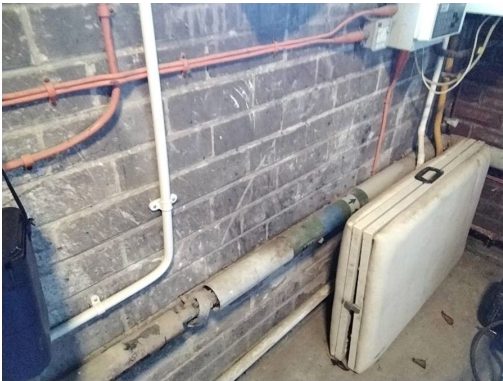
Item 11 Ref: KX000474

The Debris/Residue - to walls under window - Thermal Insulation Lagging in Boiler House/Changing Rooms G/004 Boiler Room does not contain asbestos.

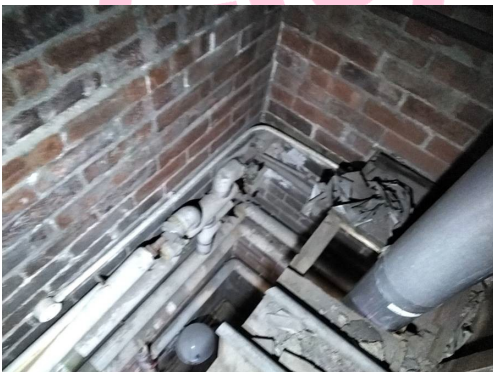
Item 12 Ref: KX000476

The Debris/Residue - to pipe penetrations - Thermal Insulation Lagging in Boiler House/Changing Rooms G/004 Boiler Room does not contain asbestos.

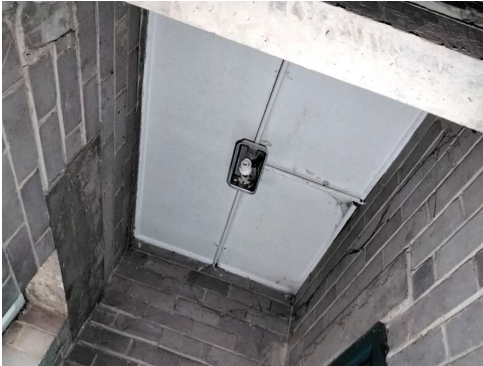
Item 13 Ref: As KX000471

The Ceiling - Insulating Board in Boiler House/Changing Rooms G/005 Cupboard-Store contains asbestos.

Any change in its appearance should be recorded and passed to Property Services.

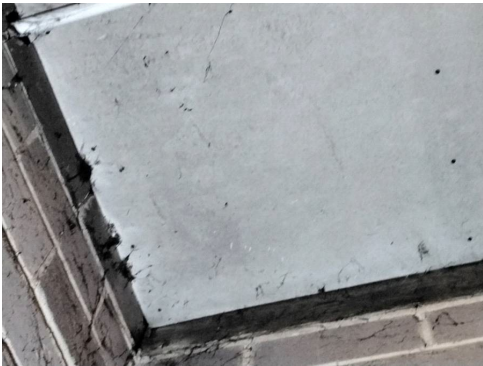
Item 14 Ref: As KX000471

The Ceiling - Insulating Board in Boiler House/Changing Rooms G/006 Passageway contains asbestos.

Any change in its appearance should be recorded and passed to Property Services.

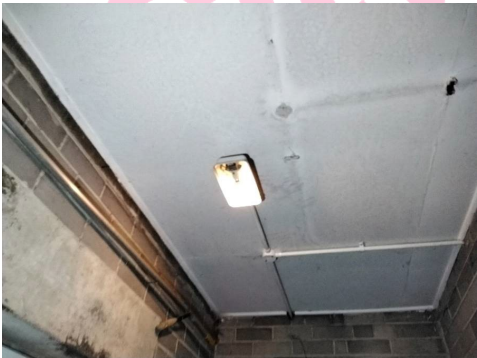
Item 15 Ref: KX000476

The Ceiling - Insulating Board in Boiler House/Changing Rooms G/007 Cupboard-Store contains asbestos.

Any change in its appearance should be recorded and passed to Property Services.

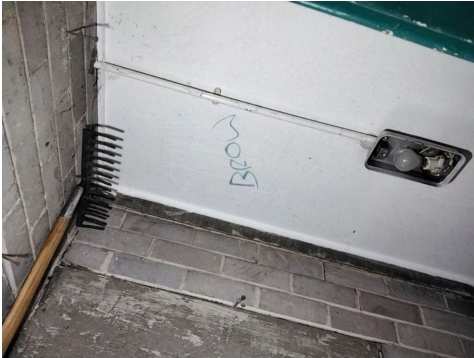
Item 16 Ref: As KX000471

The Ceiling - Insulating Board in Boiler House/Changing Rooms G/008 Cupboard-Store contains asbestos.

Any change in its appearance should be recorded and passed to Property Services.

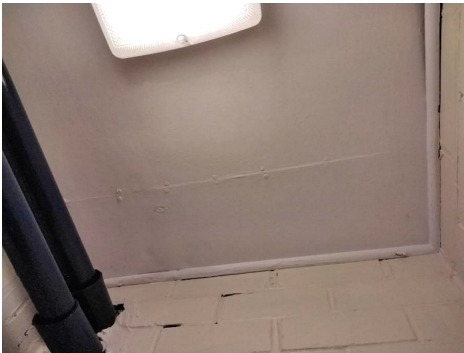
Item 17 Ref: KX000477

The Ceiling - Insulating Board in Boiler House/Changing Rooms G/011 Toilets contains asbestos.

Any change in its appearance should be recorded and passed to Property Services.

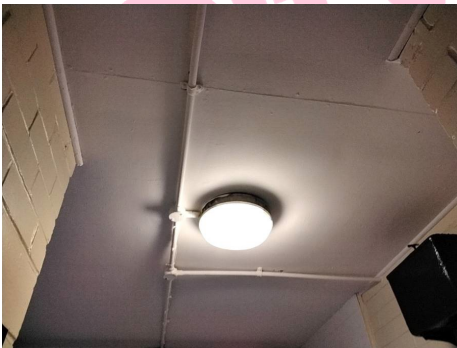
Item 18 Ref: As KX000477

The Ceiling - Insulating Board in Boiler House/Changing Rooms G/012 Shower Room contains asbestos.

Any change in its appearance should be recorded and passed to Property Services.

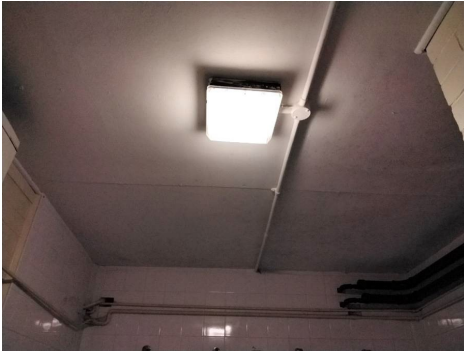
Item 19 Ref: As KX000477

The Ceiling - Insulating Board in Boiler House/Changing Rooms G/016 Shower Room contains asbestos.

Any change in its appearance should be recorded and passed to Property Services.

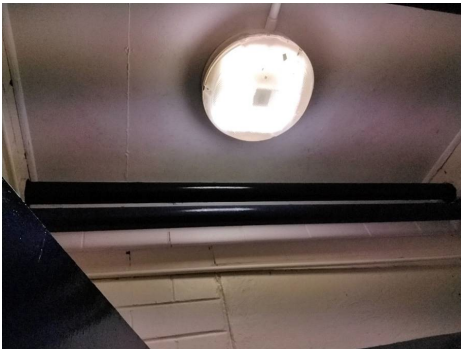
Item 20 Ref: As KX000477

The Ceiling - Insulating Board in Boiler House/Changing Rooms G/017 Toilets contains asbestos.

Any change in its appearance should be recorded and passed to Property Services.

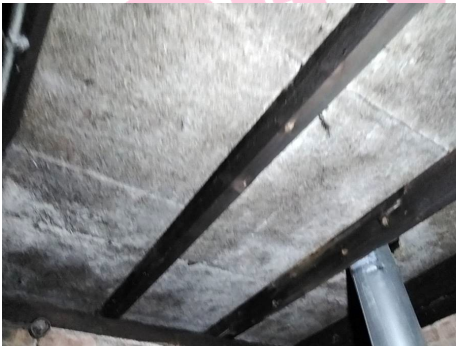
Item 21 Ref: KX000475

The Ceiling in Boiler House/Changing Rooms 1st Floor 1/001 Tank Room does not contain asbestos.

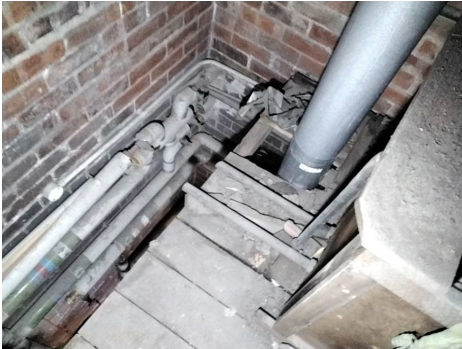
Item 22 Ref: As KX000475

The Ceiling in 1st Floor 1/001 Tank Room does not contain asbestos.

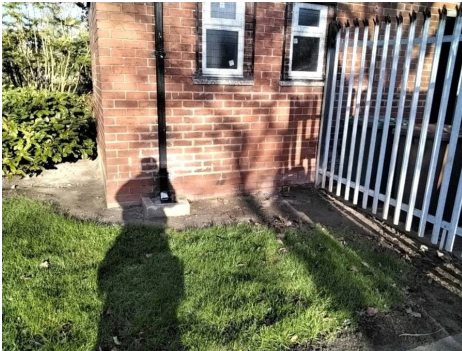
Item 23 Ref: KX000478

The Damp Proof Course – bitumen External Boiler House/Changing Rooms contains asbestos.

Any change in its appearance should be recorded and passed to Property Services.

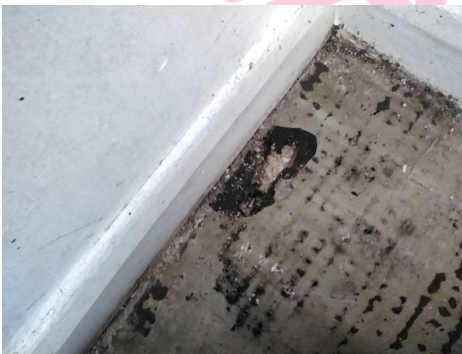
Item 24 Ref: KX000479

The Floor - adhesive residue – bitumen in Tea Rooms G/001 Entrance Hall contains asbestos.

Any change in its appearance should be recorded and passed to Property Services.

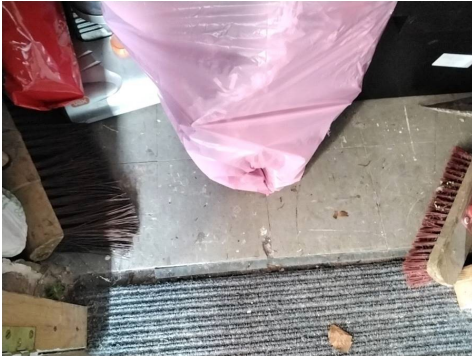
Item 25 Ref: KX000480

The Floor - Tile – green - Composite Vinyl Tile, Vinyl/Lino with adhesive in Tea Rooms G/002 Storeroom (Limited inspection within due to storage) contains asbestos.

Any change in its appearance should be recorded and passed to Property Services.

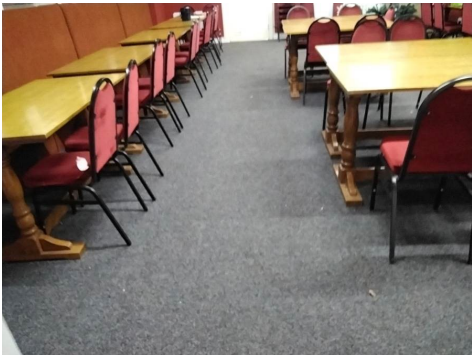
Item 26 Ref: As KX000479

The Floor - adhesive residue – bitumen in Tea Rooms G/003 Dining Hall contains asbestos.

Any change in its appearance should be recorded and passed to Property Services.

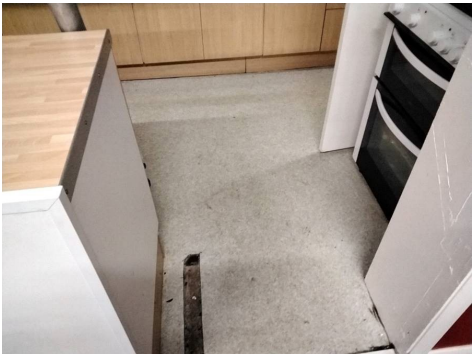
Item 27 Ref: As KX000479

The Floor - adhesive residue – bitumen in Tea Rooms G/004 Kitchen contains asbestos.

Any change in its appearance should be recorded and passed to Property Services.

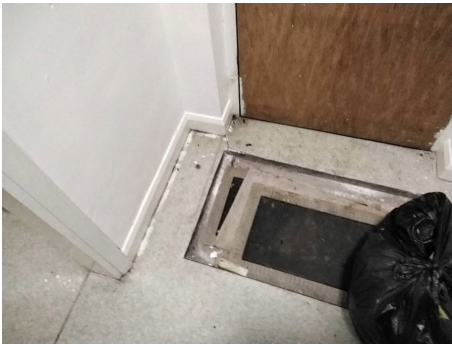
Item 29 Ref: As KX000479

The Floor - adhesive residue –
bitumen in Tea Rooms G/006
Passageway contains asbestos.

Any change in its appearance
should be recorded and passed to
Property Services.

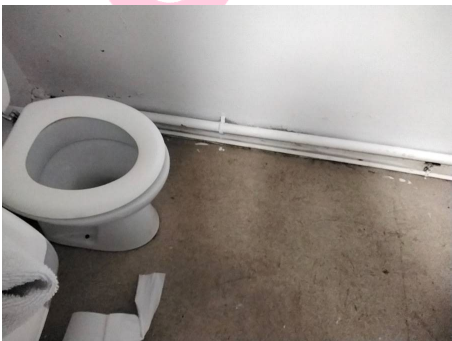
Item 30 Ref: As KX000479

The Floor - adhesive residue –
bitumen in Tea Rooms G/007
Toilets contains asbestos.

Any change in its appearance
should be recorded and passed to
Property Services.

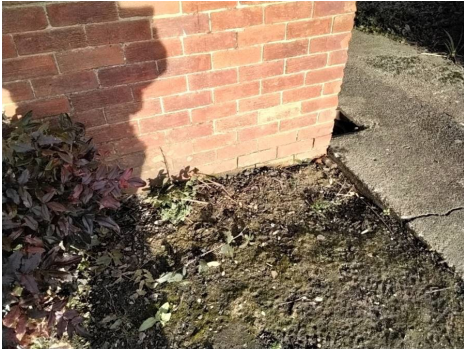
Item 31 Ref: KX000481

The Damp Proof Course External
Tea Rooms does not contain
asbestos.
