ASBESTOS SURVEY REPORT FOR BLOCK 1A – 1C EDWARD THOMPSON SITE, RICHMOND STREET, SUNDERLAND, SR5 1BQ

Asbestos Register for Block 1A – 1C Edward Thompson Site, Richmond Street, Sunderland, SR5 1BQ

Date: 26 November 2024

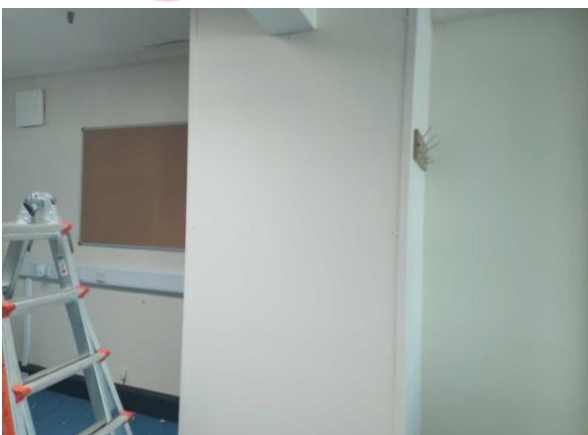
Item 57 Ref: 22-47230-13

The vertical boxing behind wood cladding (insulating board) (Area: Second Floor, Room 20 Office 5) contains asbestos.

Any change in its appearance should be recorded and passed to Property Services.

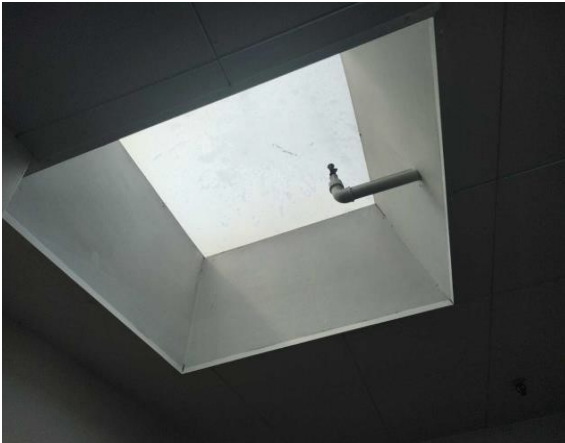
Item 113 Ref: 22-47230-32

The infill panels – upstands to skylights (insulating board) (Area: Second Floor, Room 46 Fire Exit Stairwell 1) contains asbestos.

Any change in its appearance should be recorded and passed to Property Services.

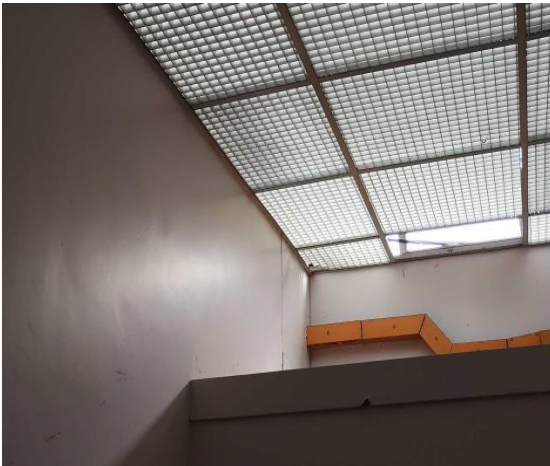
Item 181 Ref: 22-47230-60

The infill panels – panel to pipe penetration (insulating board) (Area: Second Floor, Room 65 Corridor 8) contains asbestos.

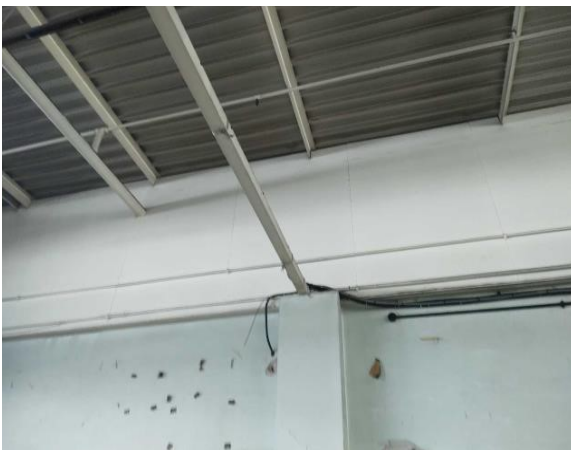
Item 219 Ref: 22-47230-71

The walls – high level panels to walls (insulating board) (Area: Second Floor, Room 75 Main Workshop) contains asbestos.

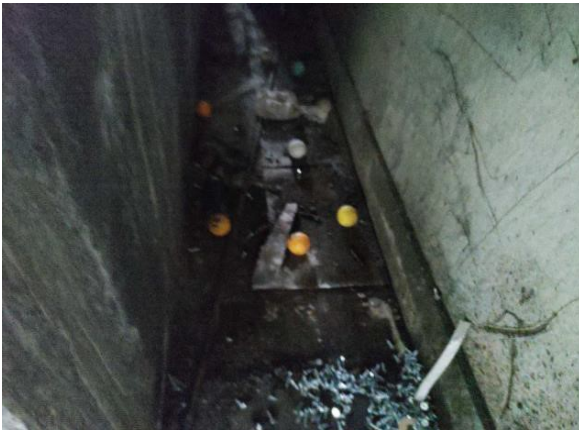
Item 221 Ref: 22-47230-72

221.	22-47230-72	Loose lying panel behind convector heater	Second Floor, Room 75 Main Workshop	High Risk
222.	22-47230-72	Debris to floor adjacent Electric Office	Second Floor, Room 75 Main Workshop	High Risk

The loose lying panel behind convector heater (insulating board) (Area: Second Floor, Room 75 Main Workshop) contains asbestos.

220.	Debris to floor adjacent convector heater	Second Floor, Room 75 Main Workshop	High Risk		To be removed		
221.	Loose lying panel behind convector heater	Second Floor, Room 75 Main Workshop	High Risk		To be removed

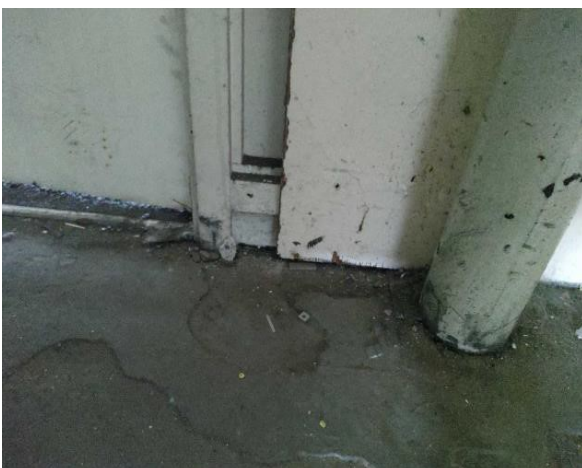
Item 222 Ref: 22-47230-72

The debris to floor adjacent Electric Office (insulating board) (Area: Second Floor, Room 75 Main Workshop) contains asbestos.

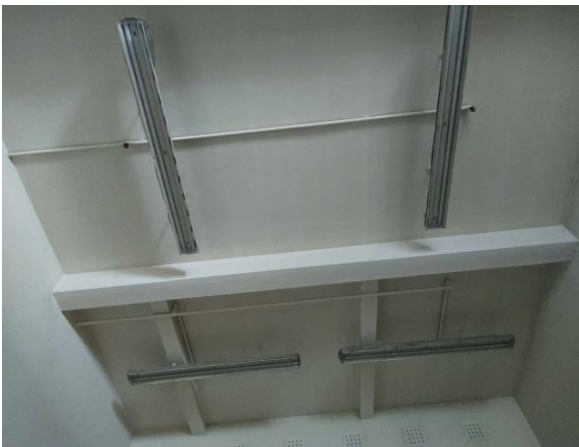
Item 231 Ref: 22-47230-75

The boxing to high level
beams (insulating board)
(Area: First Floor, Room 81
Squash Court) contains
asbestos.

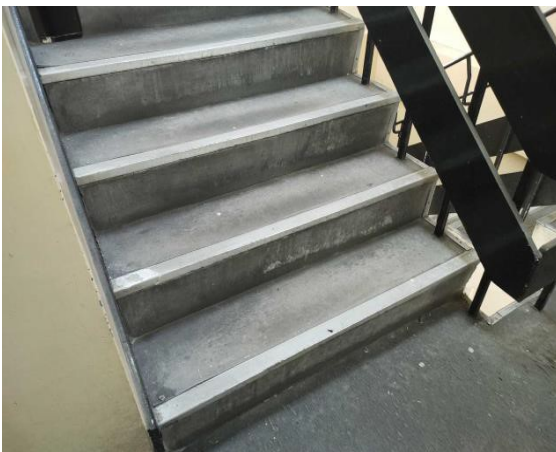
Item 237 Ref: 22-47230-84

The floor – stair nosings (composite) (Area: First Floor, Room 85 Fire Exit Stairwell 1) contains asbestos.

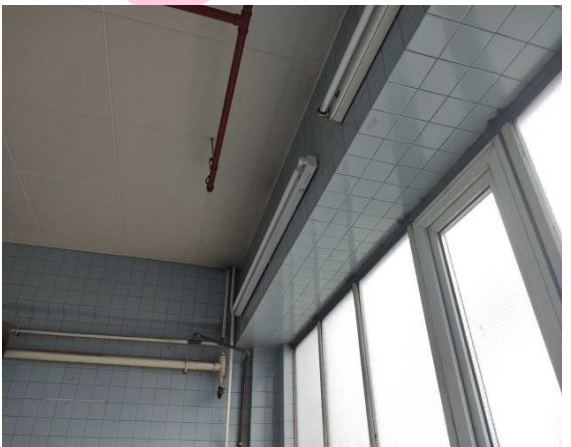
Item 243 Ref: 22-47230-86

The high level horizontal boxing (insulating board) (Area: First Floor, Room 86 Female WC and Lobby) contains asbestos.

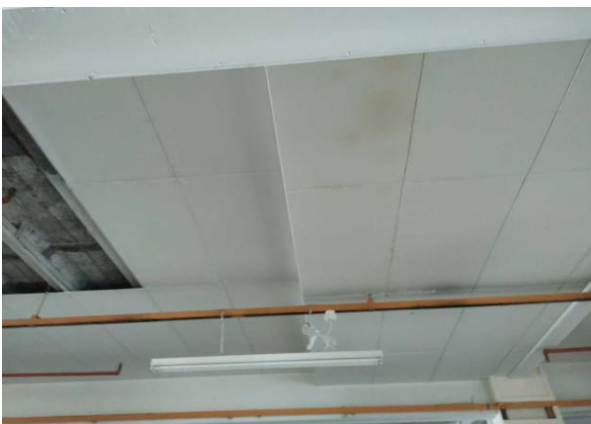
Item 258 Ref: 22-47230-87

The ceiling tiles (insulating board) (Area: First Floor, Room 95 Main Printer Workshop) contains asbestos.

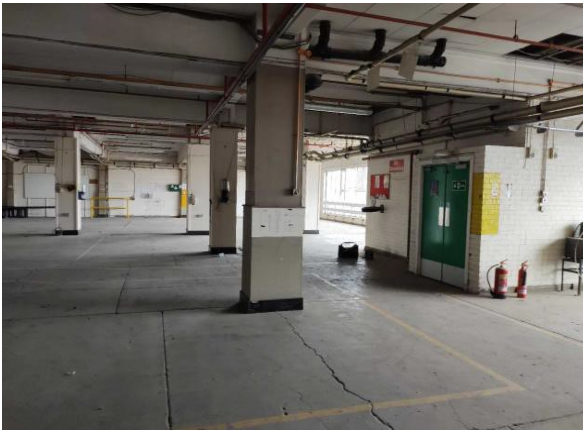
Item 260 Ref: 22-47230-88

The vertical boxing (insulating board) (Area: First Floor, Room 95 Main Printer Workshop) contains asbestos.

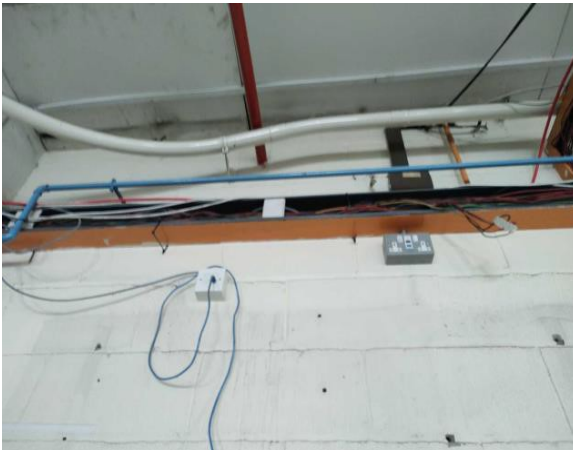
Item 262 Ref: 22-47230-89

262.	22-47230-89	Loose boards within trunking	First Floor, Room 95 Main Printer Workshop	Medium Risk
263.	22-47230-90	Vessels – gasket to boiler	First Floor, Room 95 Main Printer Workshop	Medium Risk

The loose boards within trunking (used as screw boards for fascia) (insulating board) (Area: First Floor, Room 95 Main Printer Workshop) contains asbestos.

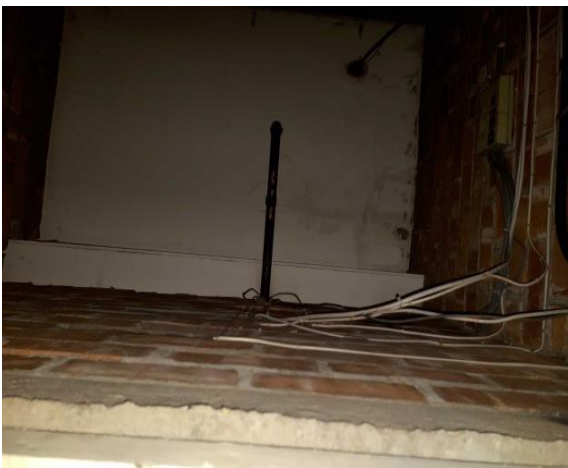
Item 267 Ref: 22-47230-93

The high level horizontal boxing (insulating board) (Area: Ground Floor, Room 98 Lift Motor Room) contains asbestos.

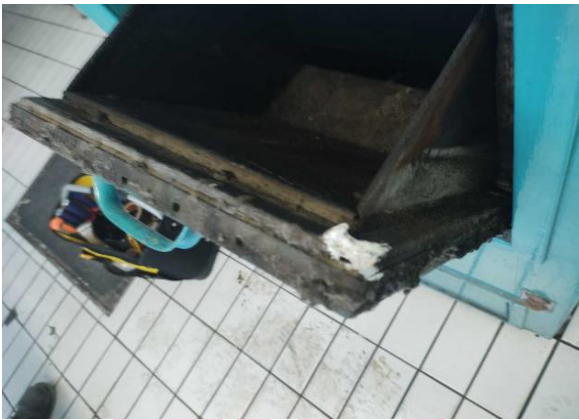
Item 275 Ref: 22-47230-96

274.	22-47230-95	Flue	Ground Floor, Room 105 Female WC & Lobby	Low Risk
275.	22-47230-96	Surround to hatch and burner	Ground Floor, Room 105 Female WC & Lobby	Medium Risk

The surround to hatch and burner (millboard) (Area: Ground Floor, Room 105 Female WC and Lobby) contains asbestos.

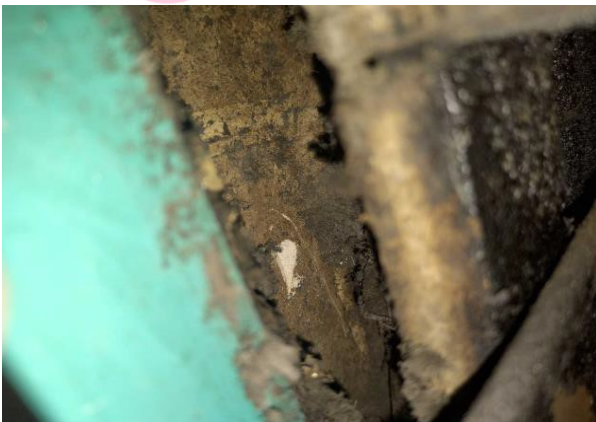
Item 276 Ref: 22-47230-97

The lining to incinerator unit (insulating board) (Area: Ground Floor, Room 105 Female WC and Lobby) contains asbestos.

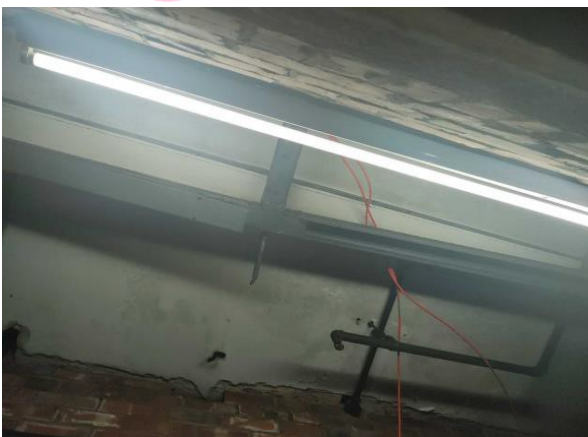
Item 285 Ref: 22-47230-101

The high level horizontal boxing (insulating board) (Area: Ground Floor, Room 114 Lift Motor Room 2) contains asbestos.

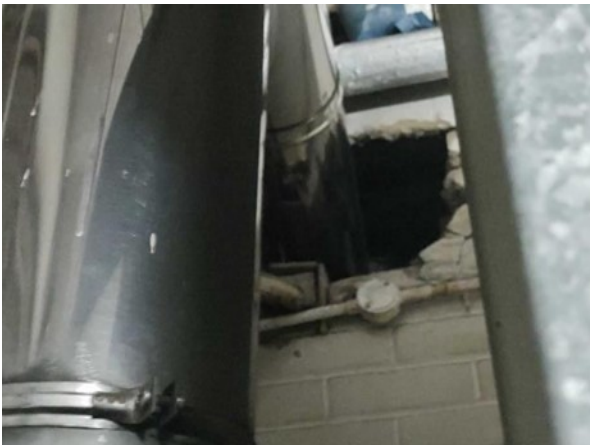
Item 304 Ref: Presumed

The packers below metal flue in pipe penetration behind convector heater (Area: Ground Floor, Room 129: Vehicle Maintenance Area) contains asbestos.

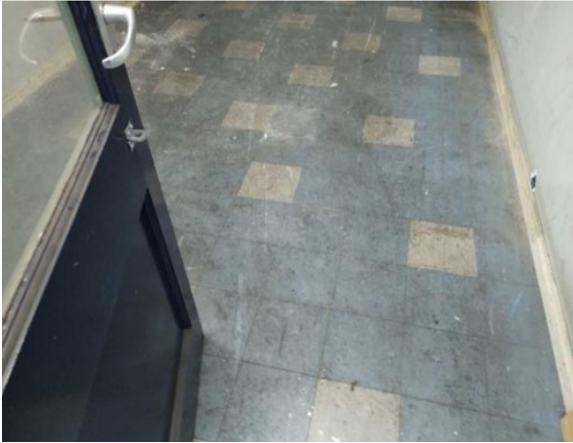
Item 322 Ref: 22-47230-119

The floor (Area: Ground Floor, Room 144: Store Room) contains asbestos.

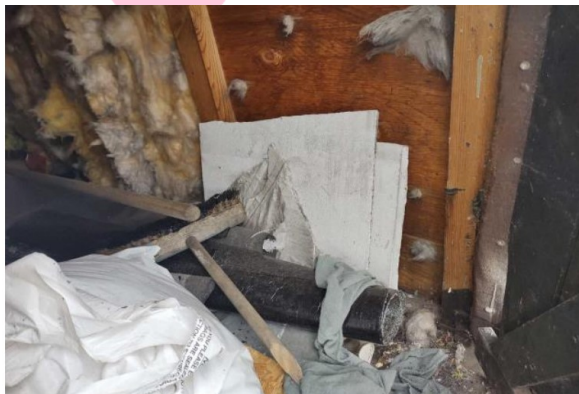
Item 330 Ref: 22-47230-77

329.	22-47230-79	Felt to roof	Floor Roof, Room 149 Roof	No Risk
330.	22-47230-77	Loose lying panels	Floor Roof, Room 150 Header tank room	Medium Risk
331.	22-47230-78	Flue	Floor Roof, Room 150 Header tank room	Low Risk

The loose lying panels (Insulating board) (Area: Floor roof, Room 150: Header tank room) contains asbestos.

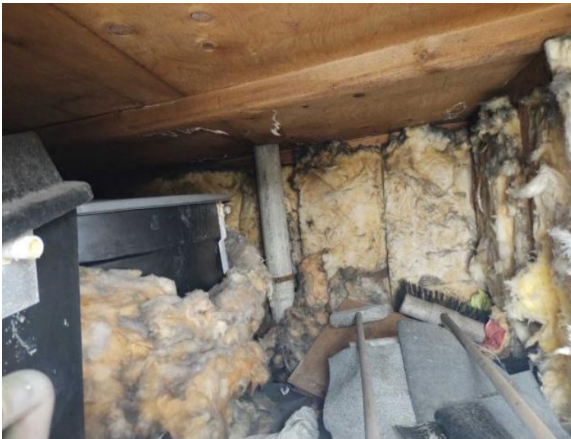
Item 331 Ref: 22-47230-78

The flue (Area: Floor roof, Room 150: Header tank room) contains asbestos.

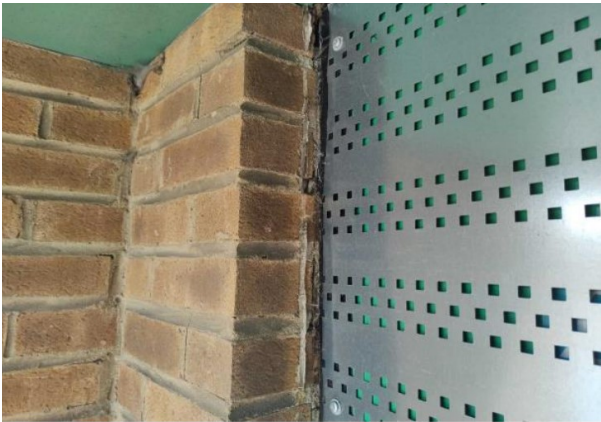
Item 340 Ref: 22-47230-130

The mastic to timber door frames (Area: Floor 0, Room 152: External) contains asbestos.

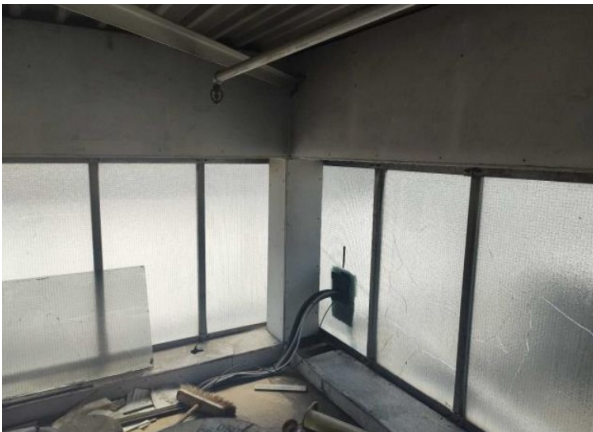
Item 347 Ref: 22-47230-13

The cladding to RSJ's above and below windows (insulating Board) (Area: Mezzanine Floor, Room 27a: above room 27) contains asbestos.

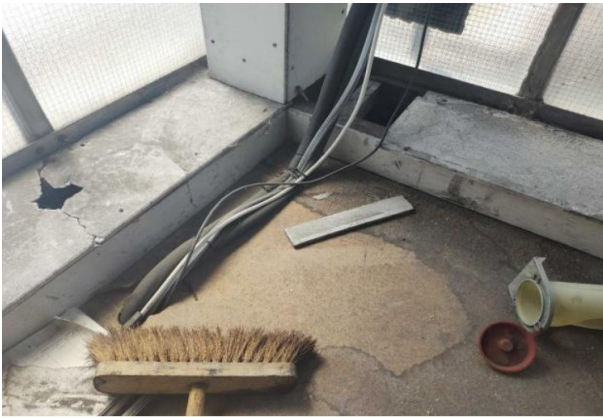
Item 349 Ref: 22-47230-15

The debris to the floor (insulating Board) (Area: Mezzanine Floor, Room 27a: above room 27) contains asbestos.

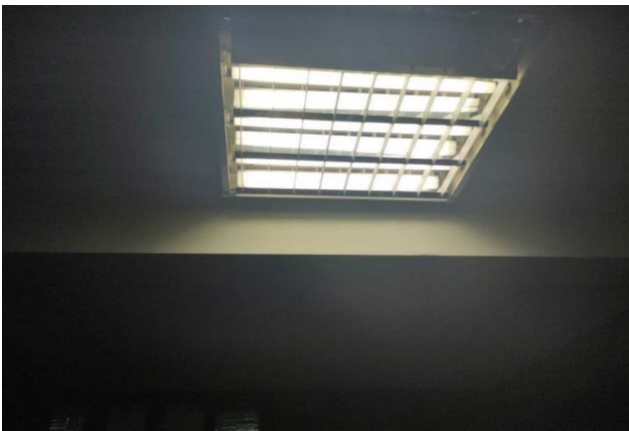
Item 350 Ref: 22-47230-23

The high level horizontal boxing (Insulating board) (Area: Second Floor, Room 37a: Office Lobby) contains asbestos.

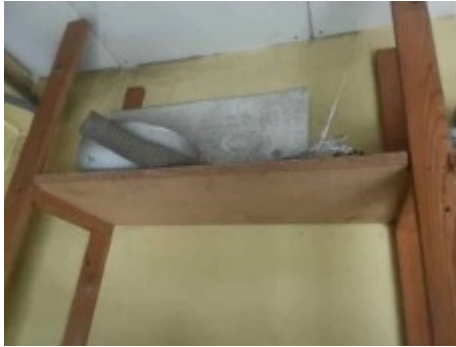
Item 355 Ref: As TL000363

355.	As TL000363	Ceiling Tile solid lying loose to shelving	First Floor Cupboard Store Room 1/078	Low Risk
356.	As TL000363	Ceiling Tile	First Floor Cupboard Store Room 1/078	Low Risk

The ceiling tile solid lying loose to shelving in First Floor Cupboard Store Room 1/078 contains asbestos.

Any change in its appearance should be recorded and passed to Property Services.

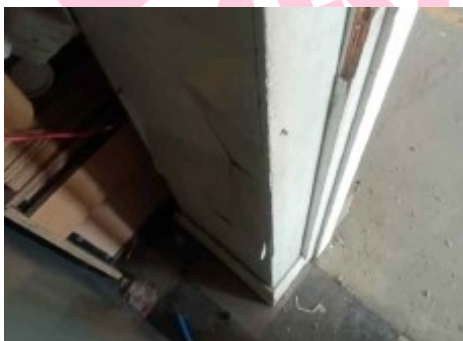
Item 357 Ref: As TL000363

357.	As TL000363	Boxing vertical damaged, enclose or removal required	First Floor Cupboard Store Room 1/078	Low Risk
358.	As TL000363	Ceiling Tile – Solid	First Floor Cupboard Store Room	Low Risk

The boxing vertical damaged (enclose or removal required) in First Floor Cupboard Store Room 1/078 contains asbestos.
