ASBESTOS SURVEY REPORT FOR 18 REVELSTOKE ROAD, SUNDERLAND

Asbestos Register for

18 REVELSTOKE ROAD, SUNDERLAND

Date: 02 July 2025

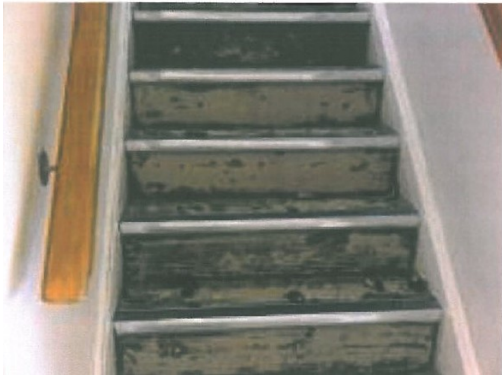
Item 4 Ref: IC10/1648

The stair nosing to the hall and stairs (Room 7) does not contain asbestos.

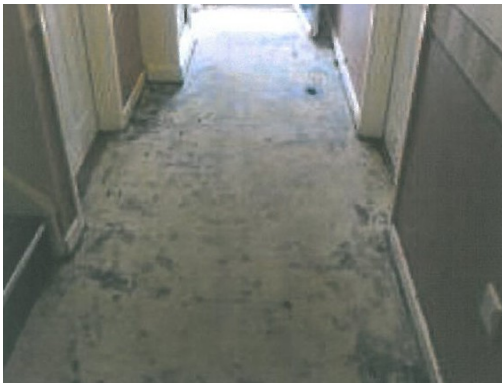
Item 5 - Ref: IC10/1647

IC10/1647 – Floor tiles (Room 7 Front Hall & Stairs) (Item 5) – Very Low Risk

The floor tiles to the hall and stairs (Room 7) contain asbestos. Any changes in its appearance should be noted and passed to Property Services.

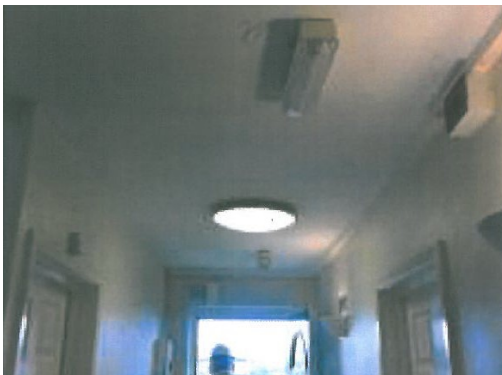
Item 6 - As IC10/1643

The textured coating to the ceiling in the hall and stairs (Room 7) contains asbestos. Any changes in its appearance should be noted and passed to Property Services.

This has been removed and resampled. See Item 24 for evidence.

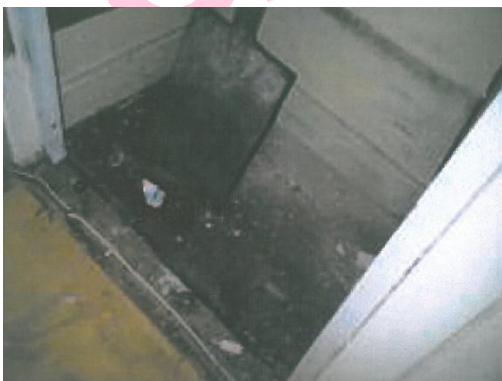
Item 9 - As IC10/1650

The flooring to Landing Cupboard B (Room 15) does not contain asbestos.

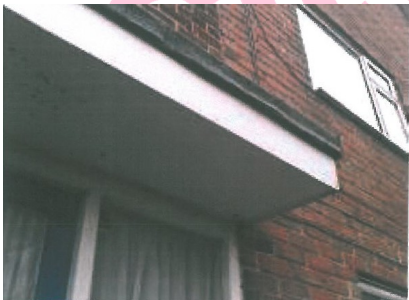
Item 15 Ref: IC10/1653

The canopy to the rear door does not contain asbestos.

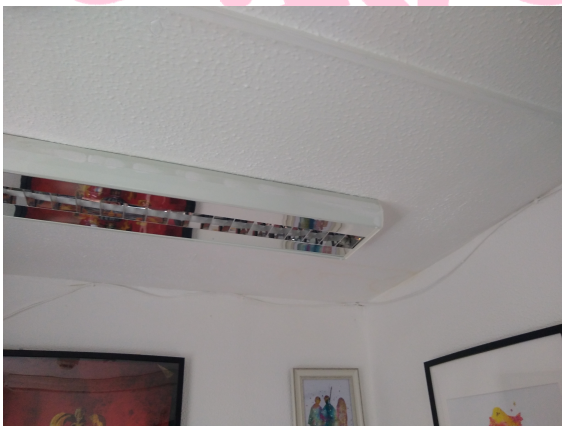
Item 21 Ref: As 340701-2

The Textured coating to ceiling in Room 006/office contains asbestos.

Any change in appearance should be reported to Property Services.

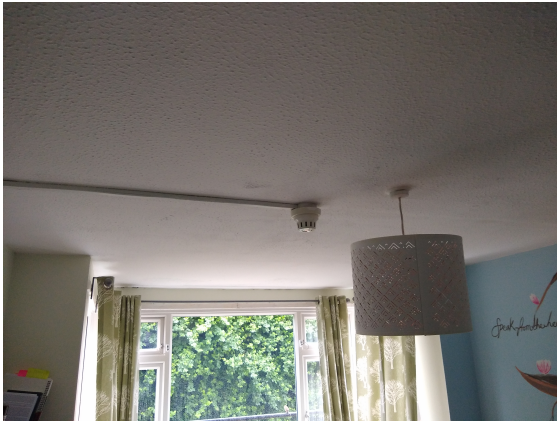
Item 22 Ref: 340701-2

The Textured coating to ceiling in Room 007/office contains asbestos.

Any change in appearance should be reported to Property Services.

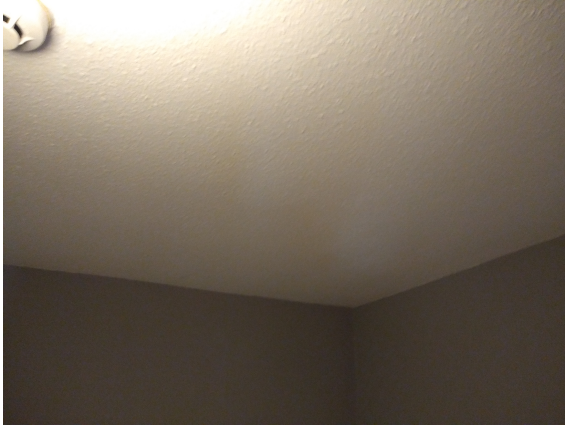
Item 28 Ref: 340701-6

The Textured coating to ceiling in Room 009/bedroom 6 does not contain asbestos.

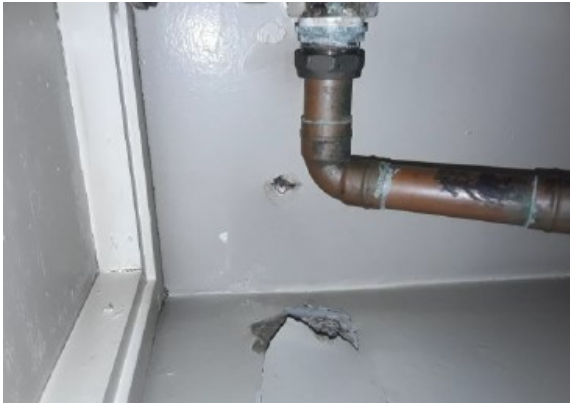
Item 29 Ref: 21-36178-1

The ceiling in the boiler/heating cupboard does not contain asbestos.

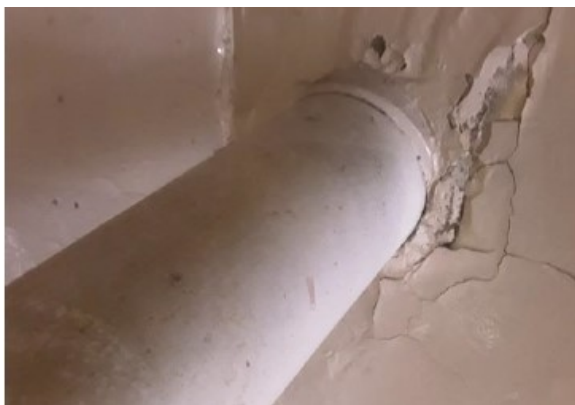
Item 30 Ref: 21-36178-2

The walls in the boiler/heating cupboard does not contain asbestos.

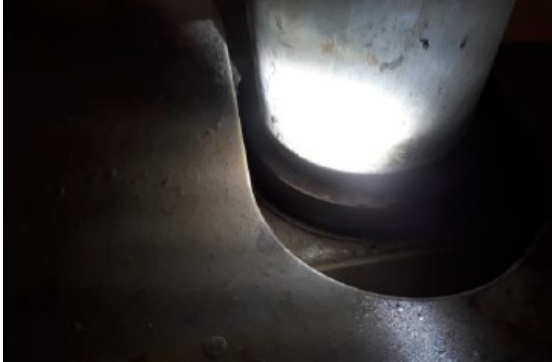
Item 31 Ref: 21-36178-3

The seal to the boiler from the flue in the boiler/heating cupboard does not contain asbestos.

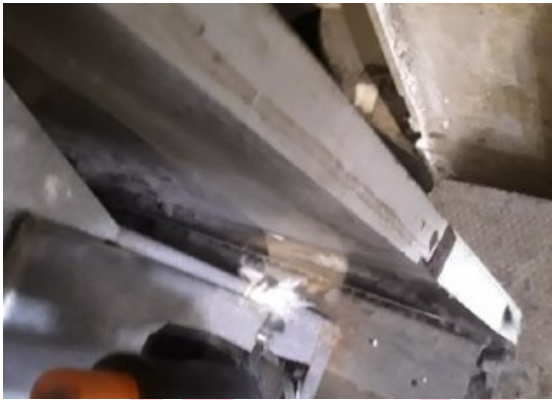
Item 32 Ref: 21-36178-4

The seal to boiler in the boiler/heating cupboard does not contain asbestos.

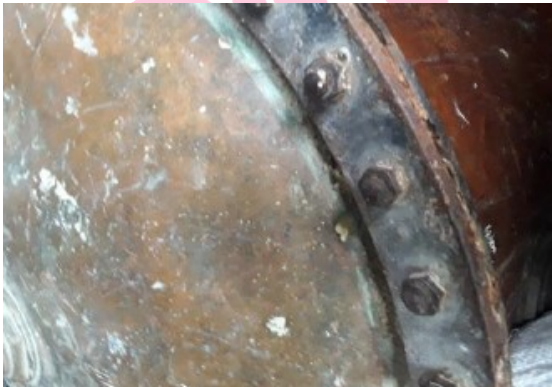
Item 33 Ref: 21-36330-1

The gasket to redundant water tank (External) does not contain asbestos.

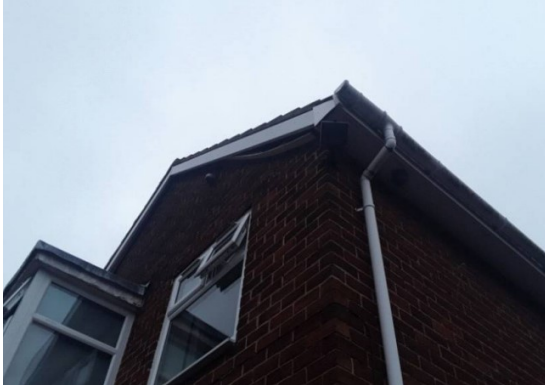
Item 34 Ref: NZ001241

The roof lining (External) does not contain asbestos.

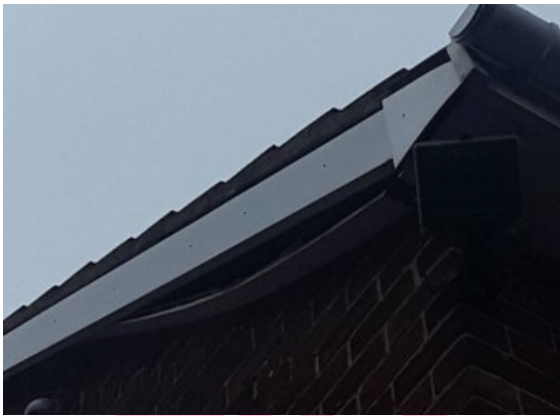
Item 35 Ref: NZ001242

NZ001242 – Undercloak to left hand rear extension (External) (Item 35) – Very Low Risk

The undercloak to left hand rear extension (External) does contain asbestos.

Any changes in appearance should be reported to Property Services.

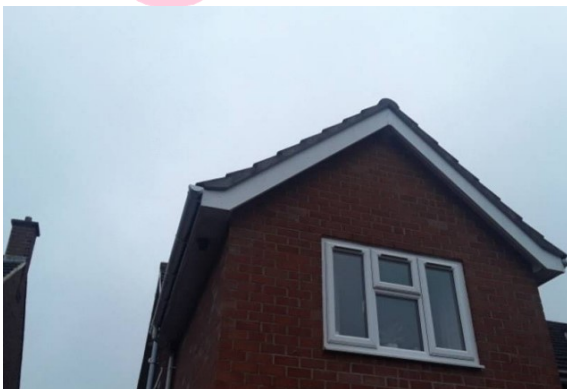
Item 36 Ref: NZ001244

The soffits to right hand rear extension (External) does not contain asbestos.
