ASBESTOS SURVEY REPORT FOR MARGARET THOMPSON PARK,  
NEWCASTLE ROAD, SUNDERLAND, SR5 1LG.

**Margaret Thompson Park, Newcastle Road,  
Sunderland, SR5 1LG**

**Date: 26 March 2024**

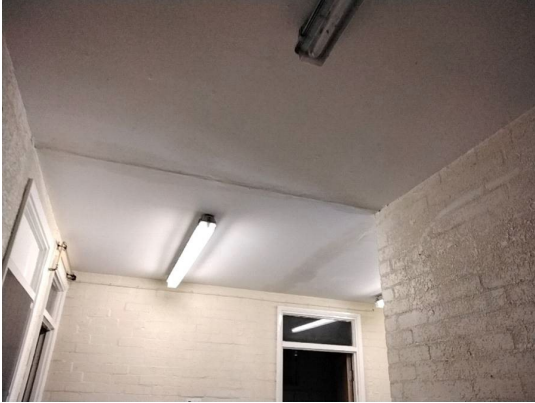
### **Item 1 Ref: KX000439/001**

The ceiling – coating in the corridor (Football Pavilion – G/001) does not contain asbestos.

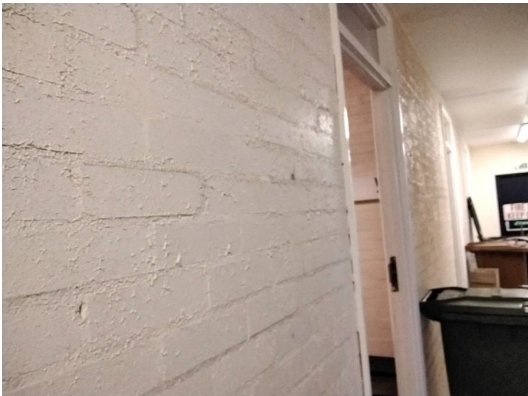
### **Item 2 Ref: KX000440/002**

The wall – coating in the corridor (Football Pavilion – G/001) does not contain asbestos.

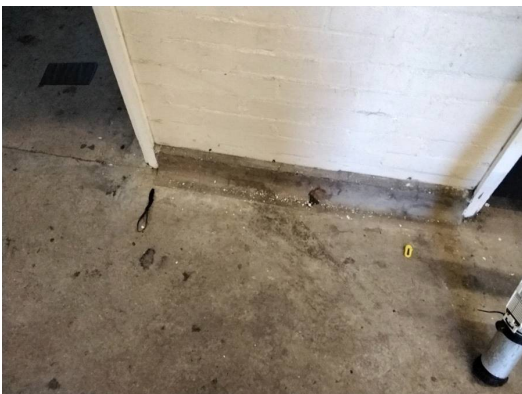
### **Item 3 Ref: KX000441/003**

The debris/residue – paint coating from deteriorating walls to floor in the corridor (Football Pavilion – G/001) does not contain asbestos.

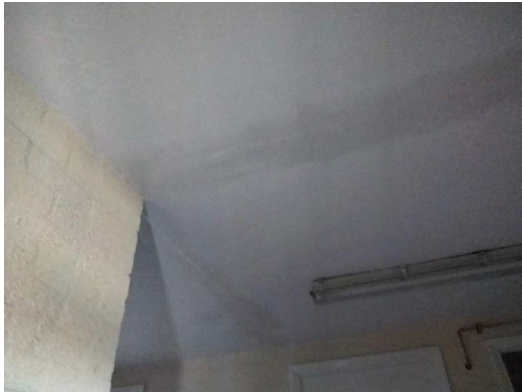
**Item 4 Ref: KX000703/040**

The ceiling – coating – to seams between slabs in the corridor (Football Pavilion – G/001) does not contain asbestos.

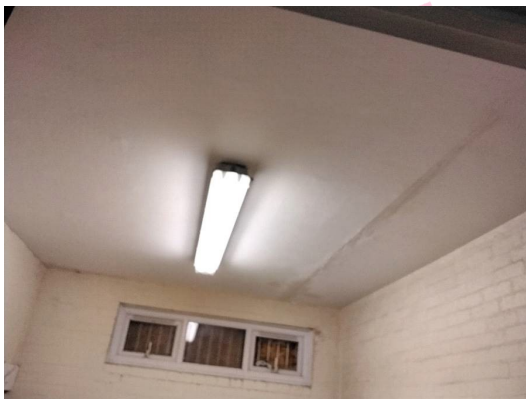
**Item 5 Ref: As KX000439**

The ceiling – coating in the changing room (Football Pavilion – G/002) does not contain asbestos.

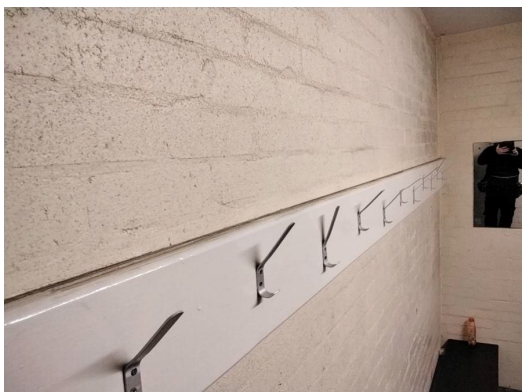
**Item 6 Ref: As KX000440**

The wall – coating in the changing room (Football Pavilion – G/002) does not contain asbestos.

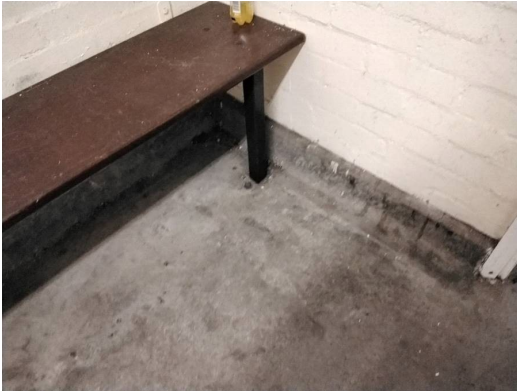
**Item 7 Ref: As KX000441**

The debris/residue – paint coating from deteriorating walls to floor in the changing room (Football Pavilion – G/002) does not contain asbestos.

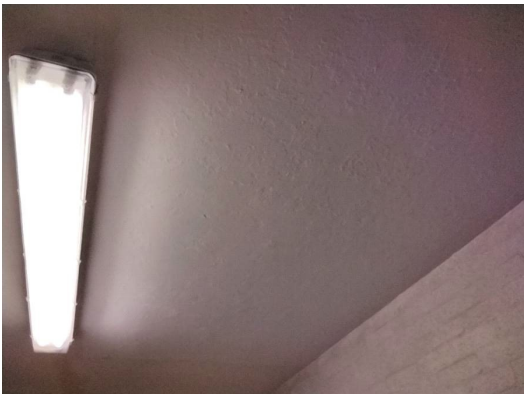
**Item 8 Ref: As KX000439**

The ceiling – coating in the changing room (Football Pavilion – G/003) does not contain asbestos.

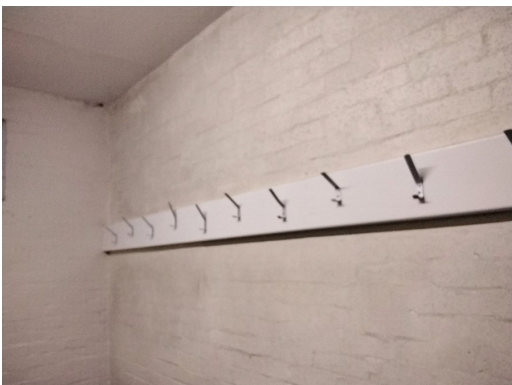
**Item 9 Ref: As KX000440**

The wall – coating in the changing room (Football Pavilion – G/003) does not contain asbestos.

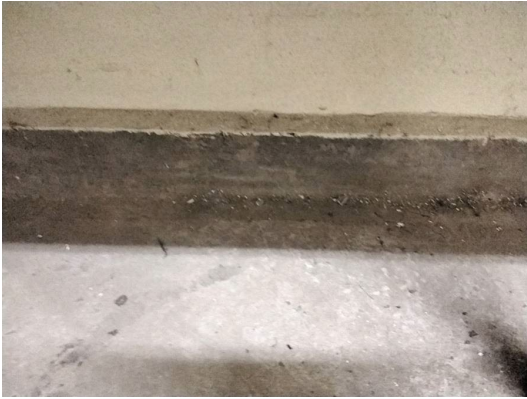
**Item 10 Ref: As KX000441**

The debris/residue – paint coating from deteriorating walls to floor in the changing room (Football Pavilion – G/003) does not contain asbestos.

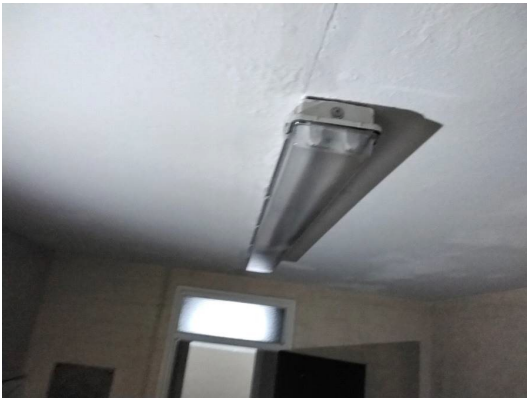
**Item 11 Ref: KX000704/041**

The ceiling – coating – to seams between slabs in the changing room (Football Pavilion – G/003) does not contain asbestos.

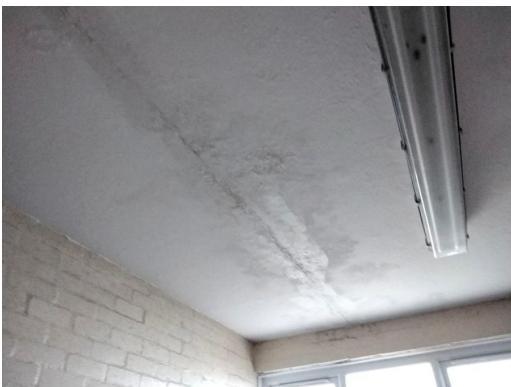
**Item 12 Ref: As KX000439**

The ceiling – coating in the changing room (Football Pavilion – G/004) does not contain asbestos.

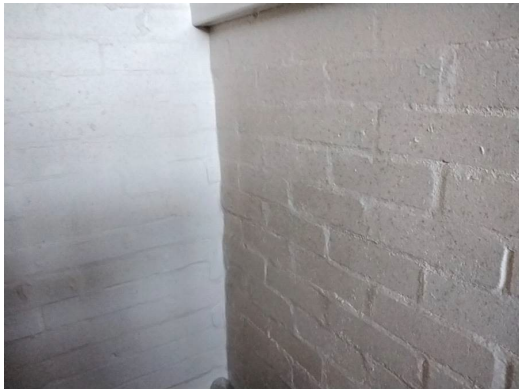
**Item 13 Ref: As KX000440**

The wall – coating in the changing room (Football Pavilion – G/004) does not contain asbestos.

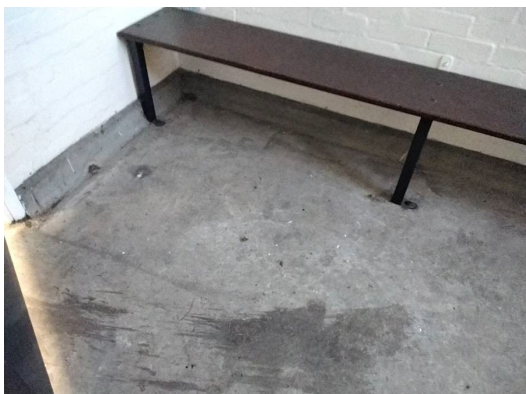
**Item 14 Ref: As KX000441**

The debris/residue – paint coating from deteriorating walls to floor in the changing room (Football Pavilion – G/004) does not contain asbestos.

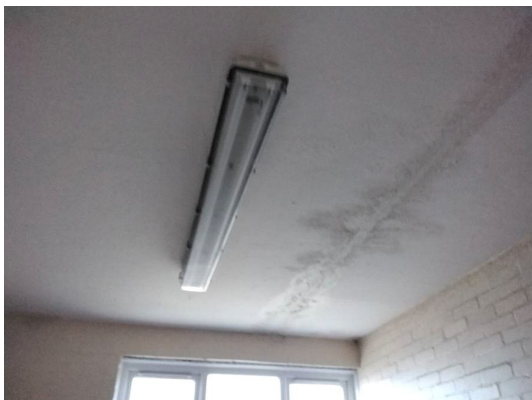
**Item 15 Ref: KX000442/013**

The ceiling – coating in the changing room (Football Pavilion – G/005) does not contain asbestos.

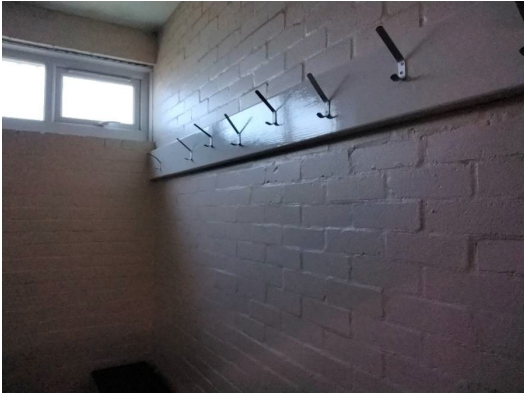
**Item 16 Ref: KX000443/014**

The wall – coating in the changing room (Football Pavilion – G/005) does not contain asbestos.

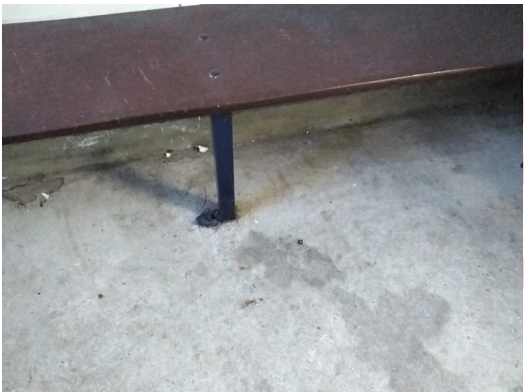
**Item 17 Ref: KX000444/015**

The debris/residue – paint coating from deteriorating walls to floor in the changing room (Football Pavilion – G/005) does not contain asbestos.

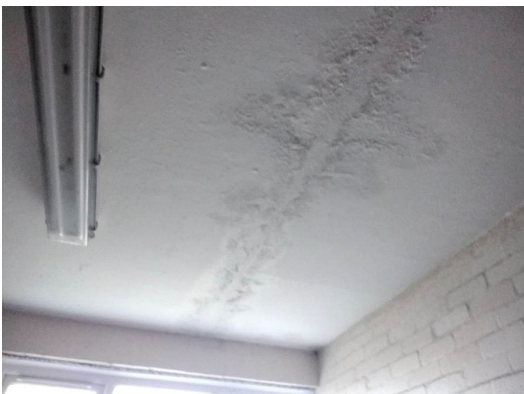
**Item 18 Ref: KX000705/042**

The ceiling – coating – to seams between slabs in the changing room (Football Pavilion – G/005) does not contain asbestos.

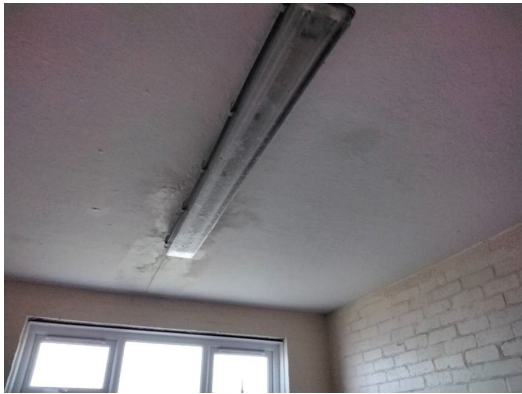
**Item 19 Ref: As KX000442**

The ceiling – coating in the changing room (Football Pavilion – G/006) does not contain asbestos.

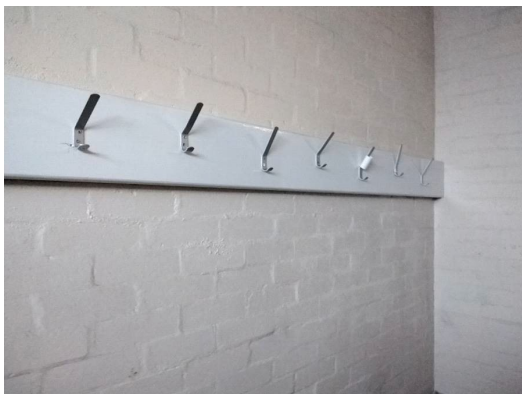
**Item 20 Ref: As KX000443**

The wall – coating in the changing room (Football Pavilion – G/006) does not contain asbestos.

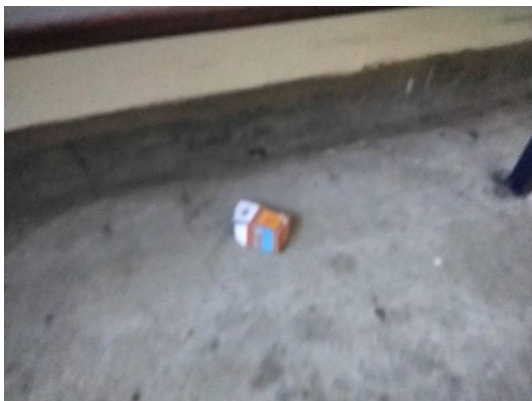
**Item 21 Ref: As KX000444**

The debris/residue – paint coating from deteriorating walls to floor in the changing room (Football Pavilion – G/006) does not contain asbestos.

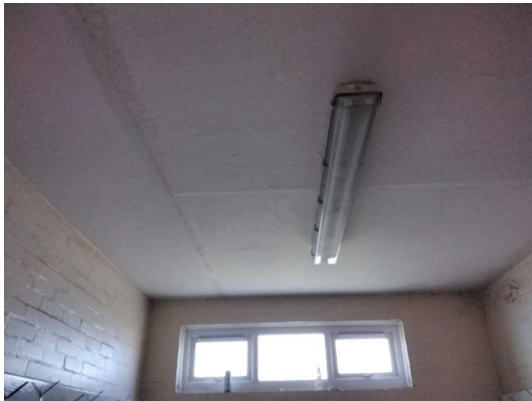
**Item 22 Ref: As KX000442**

The ceiling – coating in the changing room (Football Pavilion – G/007) does not contain asbestos.

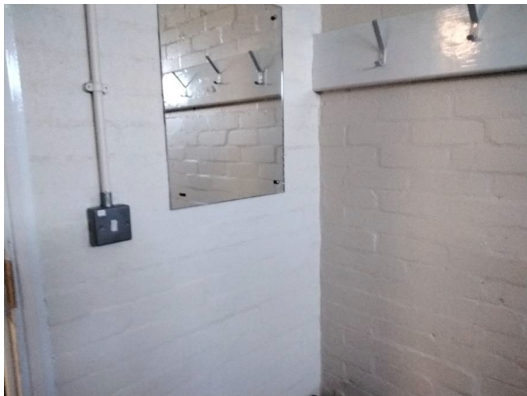
**Item 23 Ref: As KX000443**

The wall – coating in the changing room (Football Pavilion – G/007) does not contain asbestos.

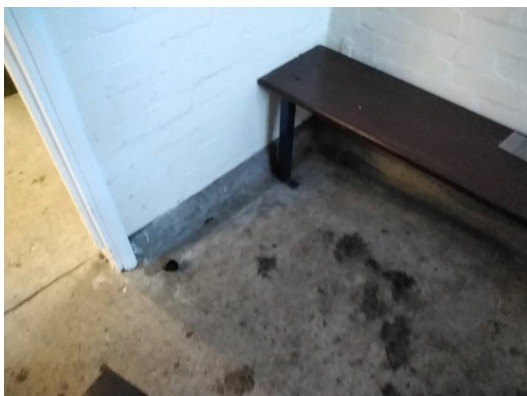
**Item 24 Ref: As KX000444**

The debris/residue – paint coating from deteriorating walls to floor in the changing room (Football Pavilion – G/007) does not contain asbestos.

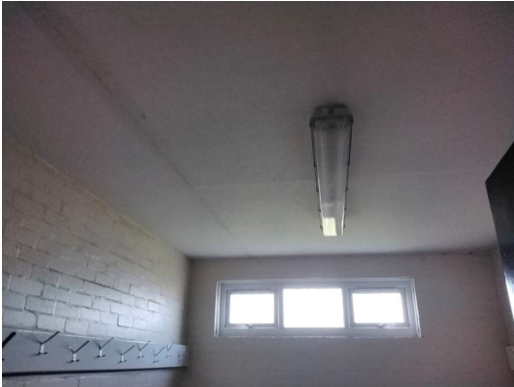
**Item 25 Ref: KX000706/044**

The ceiling – coating – to seams between slabs in the changing room (Football Pavilion – G/007) does not contain asbestos.

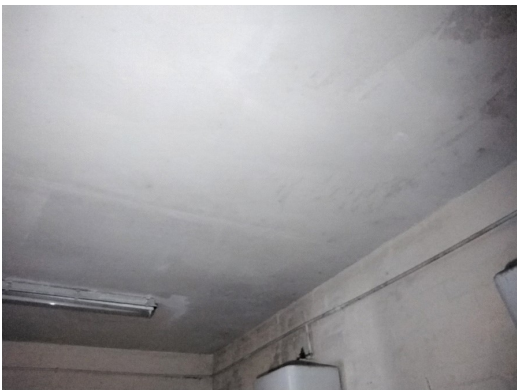
**Item 26 Ref: KX000445/022**

The ceiling – coating in the toilets including passage (Football Pavilion – G/008) does not contain asbestos.

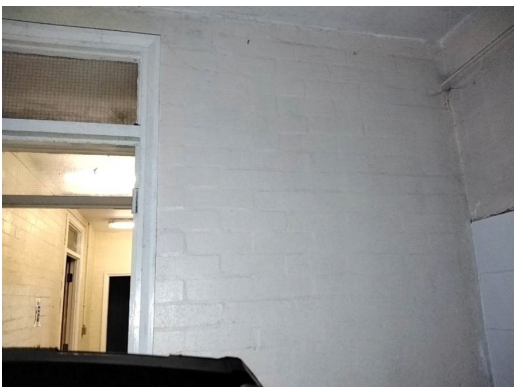
**Item 27 Ref: KX000447/023**

The wall – coating in the toilets including passage (Football Pavilion – G/008) does not contain asbestos.

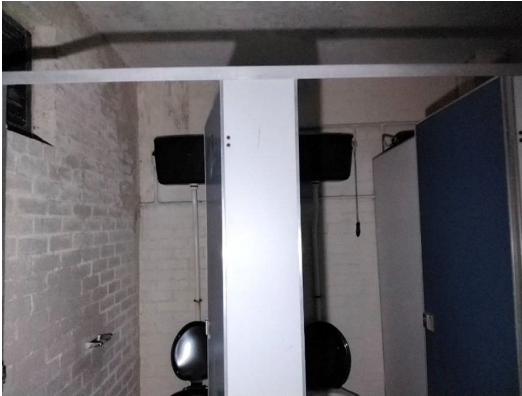
**Item 28 Ref: KX000446/025**

The toilet cisterns in the toilets including passage (Football Pavilion – G/008) does not contain asbestos.

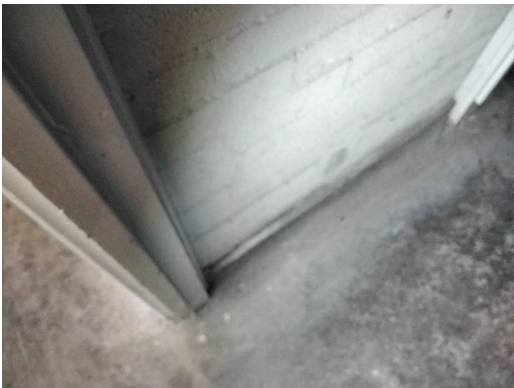
**Item 29 Ref: KX000448/026**

The debris/residue – from deteriorating walls in the toilets including passage (Football Pavilion – G/008) does not contain asbestos.

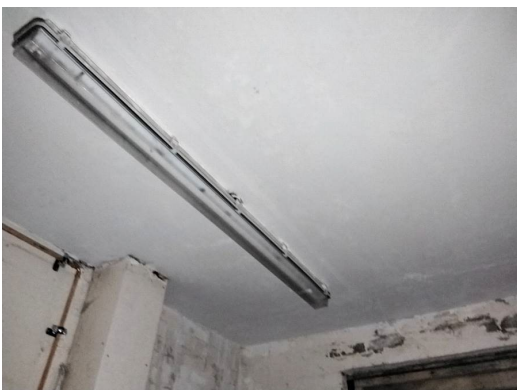
**Item 30 Ref: As KX000445**

The ceiling – coating in the toilets (Football Pavilion – G/009) does not contain asbestos.

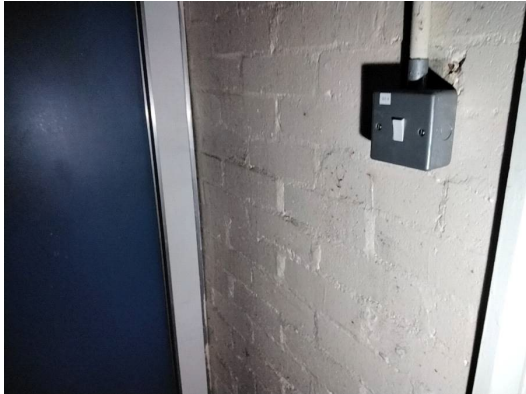
**Item 31 Ref: As KX000447**

The wall – coating in the toilets (Football Pavilion – G/009) does not contain asbestos.

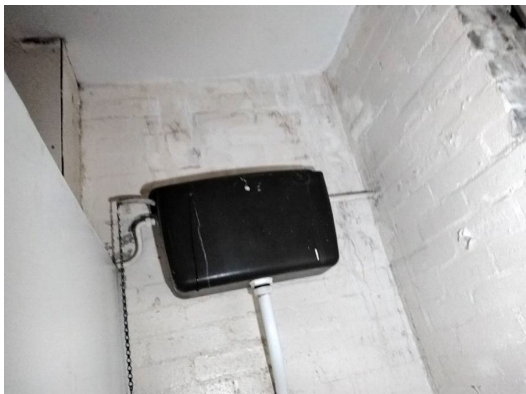
**Item 32 Ref: KX000449/029**

The toilet cisterns in the toilets (Football Pavilion – G/009) does not contain asbestos.

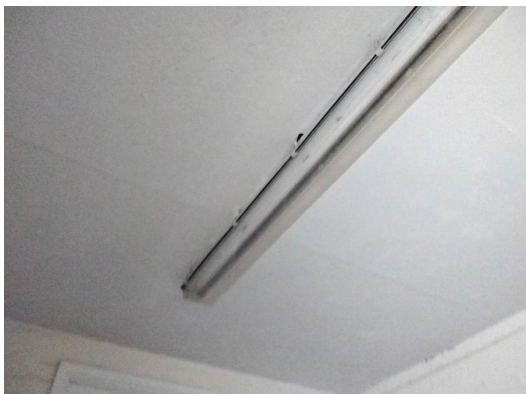
**Item 33 Ref: As KX000445**

The ceiling – coating in the changing room (Football Pavilion – G/010) does not contain asbestos.

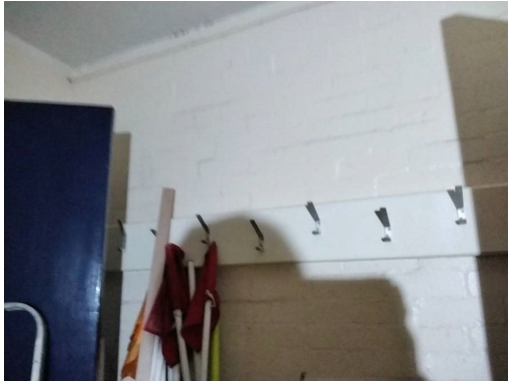
**Item 34 Ref: As KX000447**

The wall – coating in the changing room (Football Pavilion – G/010) does not contain asbestos.

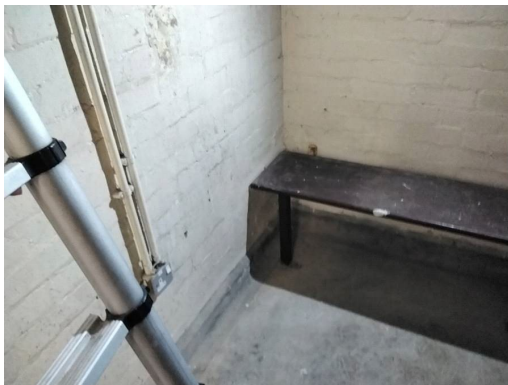
**Item 35 Ref: As KX000448**

The debris/residue – paint coating from deteriorating walls to floor in the changing room (Football Pavilion – G/010) does not contain asbestos.

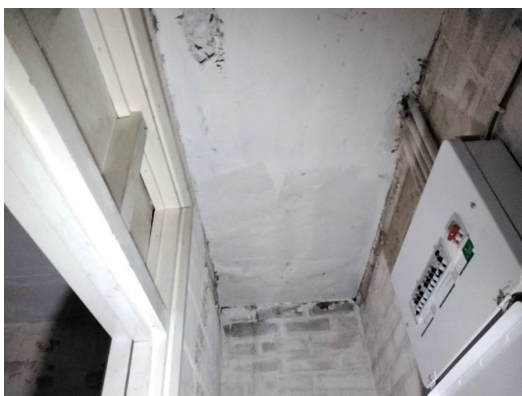
**Item 36 Ref: KX000450/033**

The ceiling – coating in the electrical cupboard (Football Pavilion – G/011) does not contain asbestos.

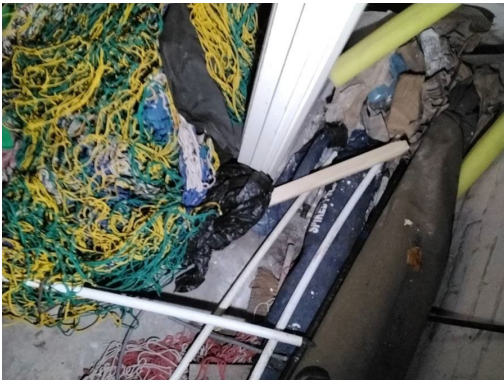
**Item 38 Ref: KX000451/035**

The debris – to floor from ceiling in the electrical cupboard (Football Pavilion – G/011) does not contain asbestos.

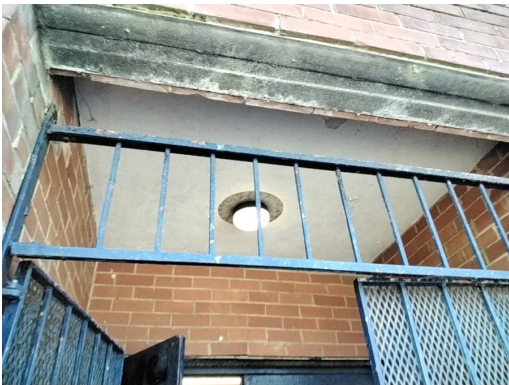
**Item 39 Ref: As KX000439**

The ceiling – coating (External) (Football Pavilion – E/001) does not contain asbestos.

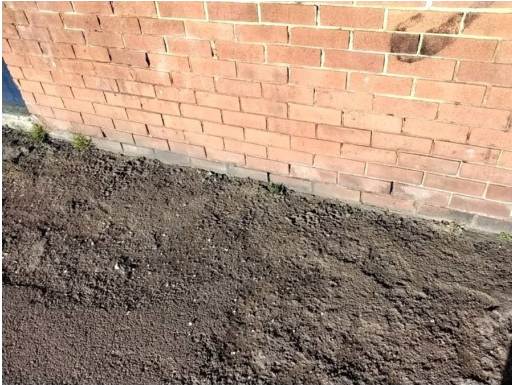
### **Item 40 Ref: KX000452/038**

The damp proof course (External) (Football Pavilion – E/001) does not contain asbestos.

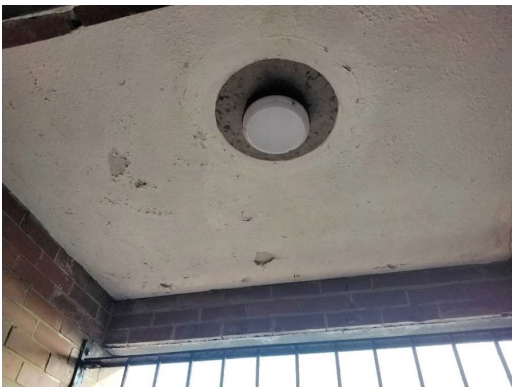
### **Item 41 Ref: KX000702/039**

The ceiling – coating to canopy (External) (Football Pavilion – E/001) does not contain asbestos.

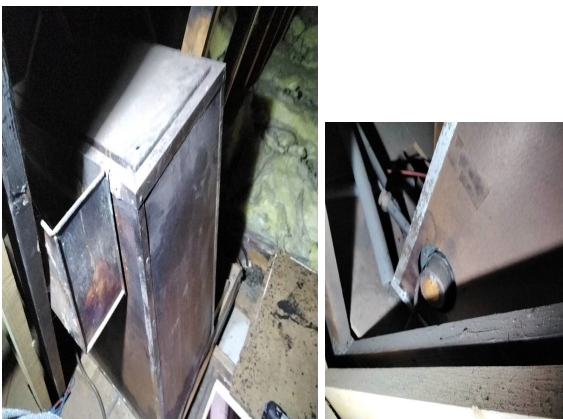
### **Item 42 Ref: Presumed**

41.	KX000702	Ceiling – Coating to Canopy	Football Pavillion, External, E/001	No Risk
42.	Presumed	Tank – to heating coils	Guard House, Loft Space, R/001	Very Low Risk

The Tank – heating coils in Loft Space (Guard House – R/001) is presumed to contain asbestos.

Any change in its appearance should be recorded and passed to Property Services.

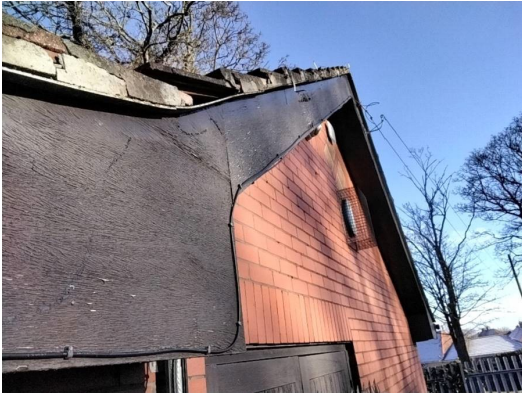
**Item 43 Ref: KX000453/043**

The undercloak (External) (Guard House – E/001) does not contain asbestos.

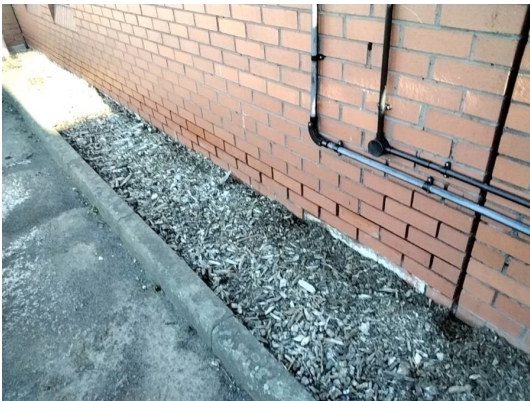
**Item 44 Ref: KX000454/044**

The damp proof course (External) (Guard House – E/001) does not contain asbestos.

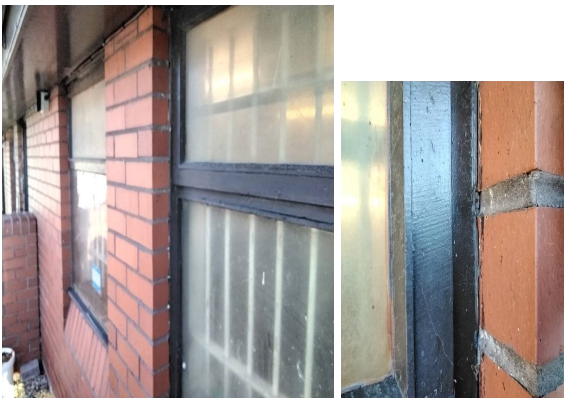
**Item 45 Ref: KX000455/045**

43.	KX000453	Undercloak	Guard House, External E/001	No Risk
44.	KX000454	Damp Proof Course	Guard House, External E/001	No Risk
45.	KX000455	Window Putty/seal frames to wall	Guard House, External E/001	Very Low Risk

The window putty/seal – frames to wall (External) (Guard House – E/001) contains asbestos.

Any change in its appearance should be recorded and passed to Property Services.

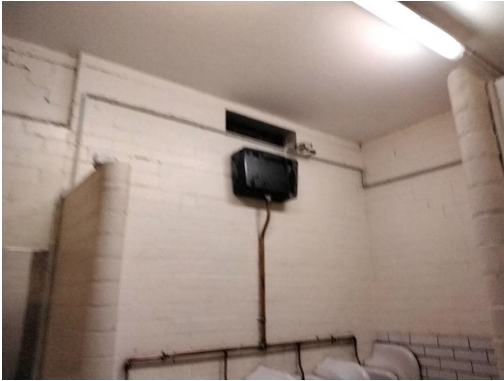
### **Item 46 Ref: KX000482/002**

The toilet cistern – shires in the Male Toilets (Bowls Pavilion – G/005) does not contain asbestos.

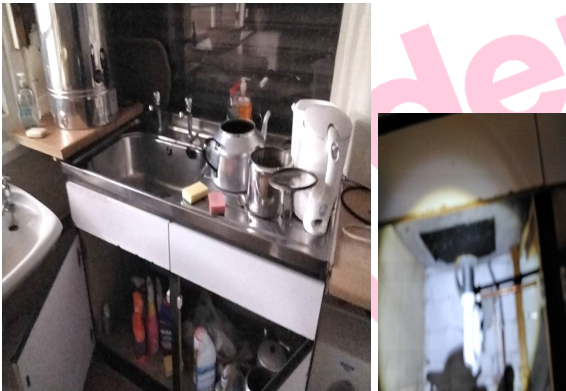
### **Item 47 Ref: KX000483/003**

46.	KX000482	Toilets – Cisterns	Bowls Pavillion, Ground Floor, Male Toilets G/005	No Risk
47.	KX000483	Under sink mat	Bowls Pavillion, Dining Hall Area, G/006	Very Low Risk

The under sink mat in the dining hall area (Bowls Pavilion – G/006) contains asbestos.

Any change in its appearance should be recorded and passed to Property Services.

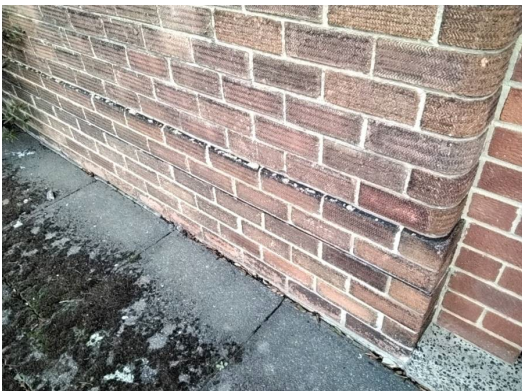
### **Item 48 Ref: KX000484/004**

The damp proof course (External) (Bowls Pavillion – E/001) does not contain asbestos.
