ASBESTOS SURVEY REPORT FOR 4th FLOOR 240 HIGH STREET WEST, SUNDERLAND, SR1 3BN.

4th Floor 240 High Street West, SR1 3BN

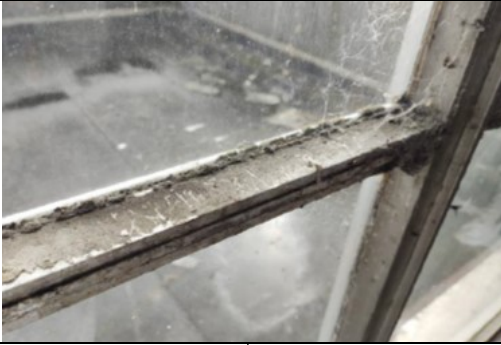
1	21-33327-1	Window putty	Area 1/Landing and Stairs	Does not contain asbestos

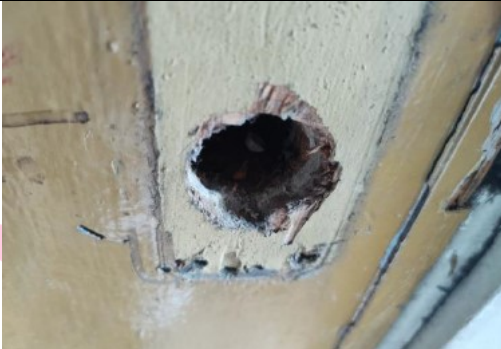
2	21-33327-2	Panel within lift motor room door	Area 1/Landing and Stairs	Contains Asbestos Any change in appearance should be recorded and passed to Property Services

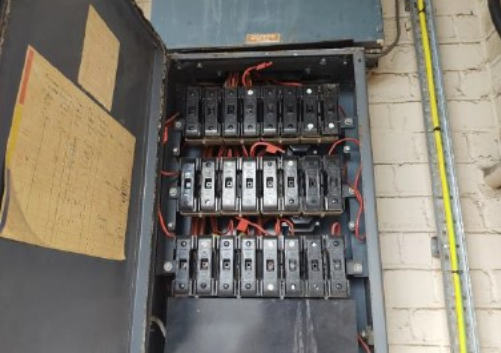
3	Presumed	Electrical Equipment	Area 1/Landing and Stairs	Contains Asbestos Any change in appearance should be recorded and passed to Property Services

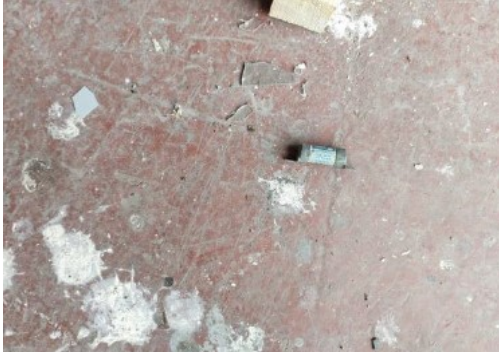
7	21-33327-8	Redundant cartridge fuses	Area 1/Landing and Stairs	Contains Asbestos Any change in appearance should be recorded and passed to Property Services

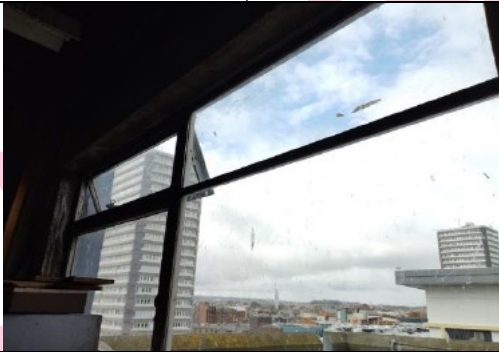
8	21-33327-1	Window putty	Area 2/Generator Room	Does not contain asbestos

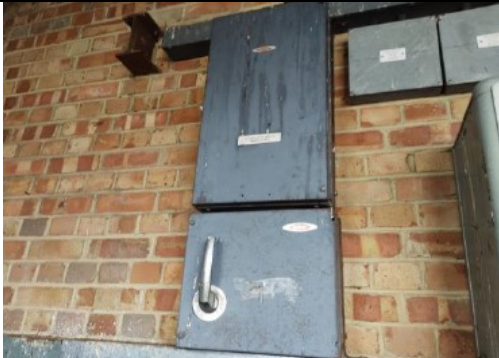
9	Presumed	Electrical Equipment	Area 2/Generator Room	Contains Asbestos Any change in appearance should be recorded and passed to Property Services

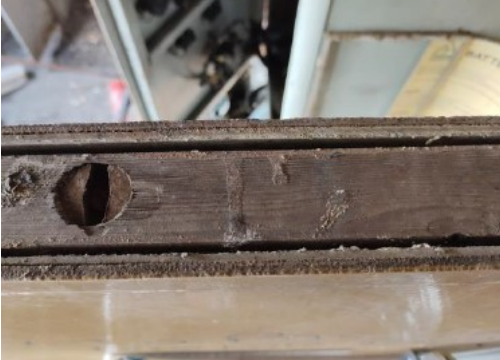
13	21-33327-7	Lining within door	Area 2/Generator Room	Low Risk
14	21-33327-9	Loose lying gasket	Area 2/Generator Room	Low Risk
15	21-33327-13	Pipe insulation	Area 4/Boiler Room	Low Risk
16	21-33327-13	Pipe insulation	Area 4/Boiler Room	Low Risk
17	21-33327-14	Gasket seal to ducting joint	Area 4/Boiler Room	No Risk
18	Presumed	Electrical Equipment	Area 4/Boiler Room	Very Low Risk
19	Presumed	Electrical Equipment	Area 4/Boiler Room	Very Low Risk
20	Presumed	Electrical Equipment	Area 4/Boiler Room	Very Low Risk
21	21-33327-16	Mastic sealant to ducting	Area 4/Boiler Room	No Risk
22	21-33327-17	Debris to central ducting	Area 4/Boiler Room	No Risk
23	21-33327-18	Lining to door to lobby	Area 4/ Boiler Room	Low Risk
24	21-33327-19	Residue to walls adjacent entrance door	Area 4/ Boiler Room	Low Risk
25	21-33327-19	Residue to walls adjacent lobby door	Area 4/ Boiler Room	Low Risk
26	21-33327-20	Debris to top of electric consumer box	Area 4/Boiler Room	No Risk

13	21-33327-7	Lining within door	Area 2/Generator Room	Contains Asbestos Any change in appearance should be recorded and passed to Property Services

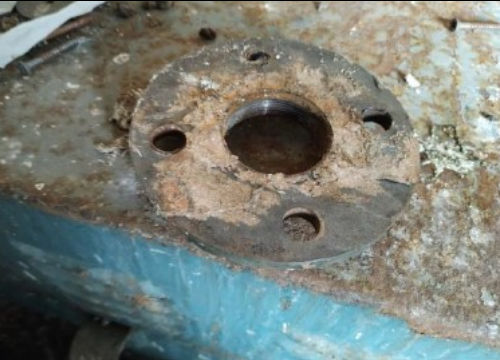
14	21-33327-9	Loose lying gasket	Area 2/Generator Room	Contains Asbestos Any change in appearance should be recorded and passed to Property Services

tender is drawn and work is completed
14	Loose lying gasket	Area 2/Generator Room	Low Risk/6 months	N/A			Do not inspect until tender is drawn and work is completed
15	Pipe insulation	Area 4/Boiler Room	Low Risk/6 months	N/A			Do not inspect until tender is drawn and work is completed
16	Pipe insulation	Area 4/Boiler Room	Low Risk/6 months	N/A			Do not inspect until tender is drawn and work is completed
17	Gasket seal to ducting joint	Area 4/Boiler Room	N/A	N/A	N/A	N/A	
18	Electrical Equipment	Area 4/Boiler Room	Very Low Risk/12 months	N/A			Do not inspect until tender is drawn and work is completed
19	Electrical Equipment	Area 4/Boiler Room	Very Low Risk/12 months	N/A			Do not inspect until tender is drawn and work is completed
20	Electrical Equipment	Area 4/Boiler Room	Very Low Risk/12 months	N/A			Do not inspect until tender is drawn and work is completed
21	Mastic sealant to ducting	Area 4/Boiler Room	N/A	N/A	N/A	N/A

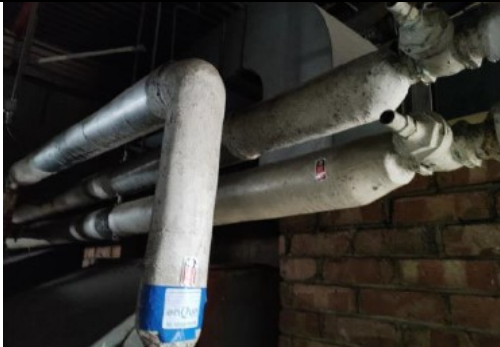
15	21-33327-13	Pipe insulation	Area 4/Boiler Room	Contains Asbestos Any change in appearance should be recorded and passed to Property Services

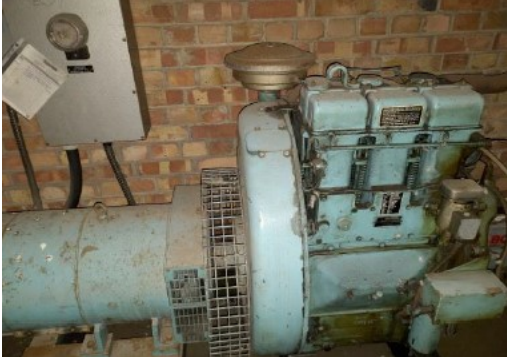
19	Presumed	Electrical Equipment	Area 4/Boiler Room	Contains Asbestos Any change in appearance should be recorded and passed to Property Services

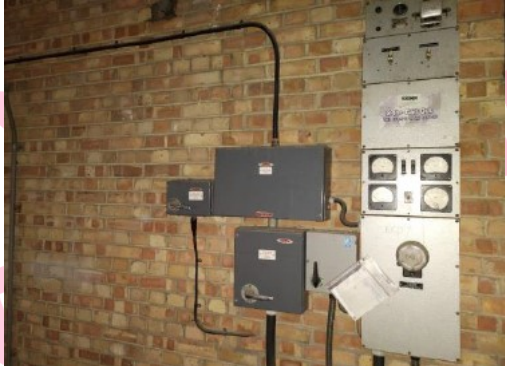
20	Presumed	Electrical Equipment	Area 4/Boiler Room	Contains Asbestos Any change in appearance should be recorded and passed to Property Services

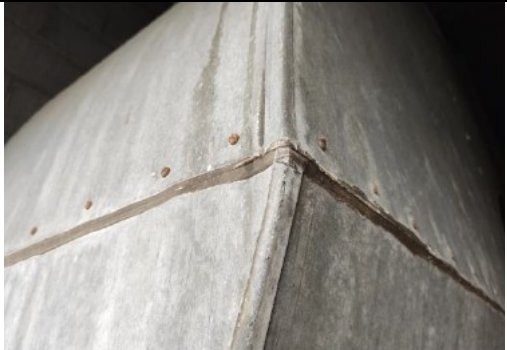
21	21-33327-16	Mastic sealant to ducting	Area 4/Boiler Room	Does not contain asbestos

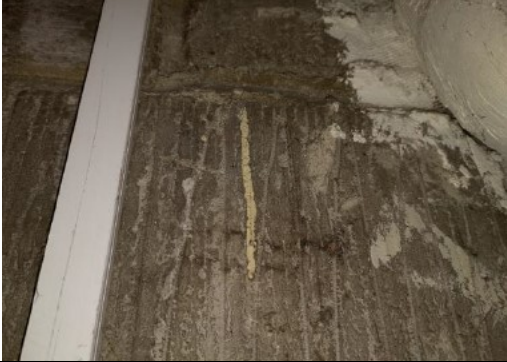
25	21-33327-19	Residue to walls adjacent lobby door	Area 4/ Boiler Room	Contains Asbestos Any change in appearance should be recorded and passed to Property Services

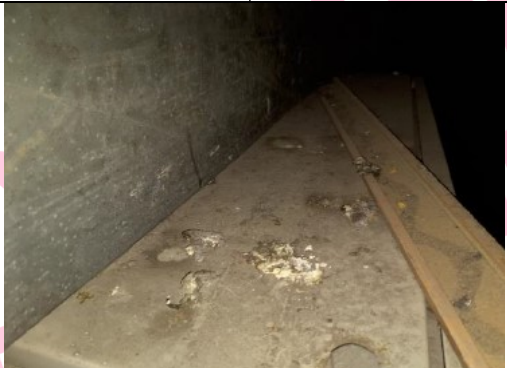
26	21-33327-20	Debris to top of electric consumer box	Area 4/Boiler Room	Does not contain asbestos

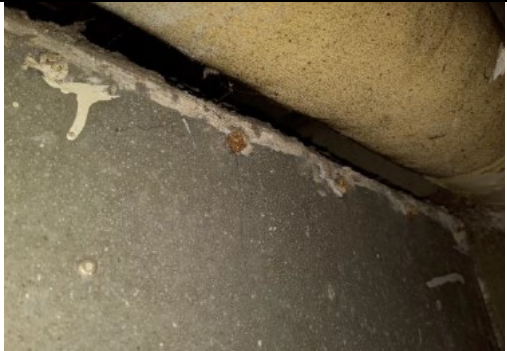
27	21-33327-21	21-33327-21 - Spatter to rear ventilation unit	Area 4/Boiler Room	Contains Asbestos Any change in appearance should be recorded and passed to Property Services

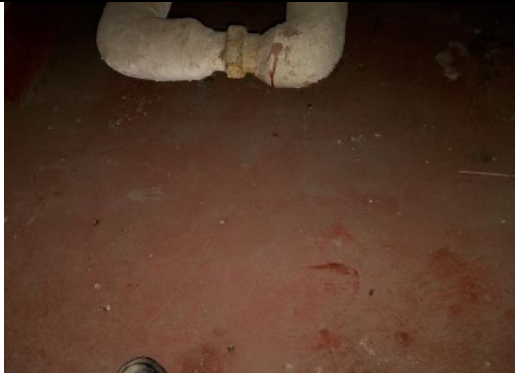
28	21-33327-34	Debris to floor	Area 4/Boiler Room	Contains Asbestos Any change in appearance should be recorded and passed to Property Services

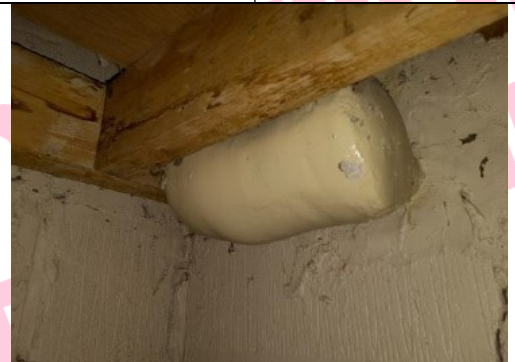
29	21-33327-13	Pipe insulation	Area 5/Store	Contains Asbestos Any change in appearance should be recorded and passed to Property Services

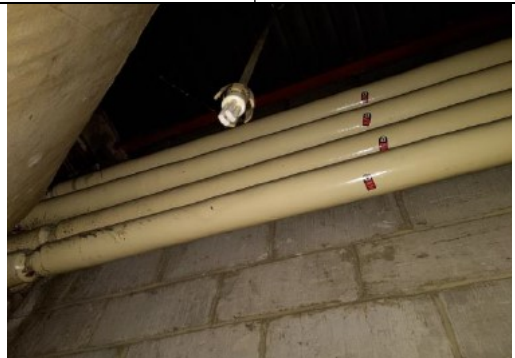
30	21-33327-13	Pipe insulation	Area 6/Lobby	Contains Asbestos Any change in appearance should be recorded and passed to Property Services

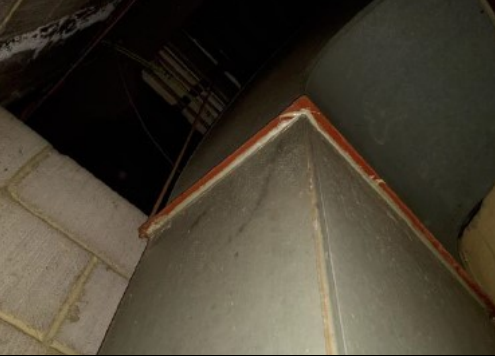
31	21-33327-16	Mastic sealant to ducting	Area 6/Lobby	Does not contain asbestos

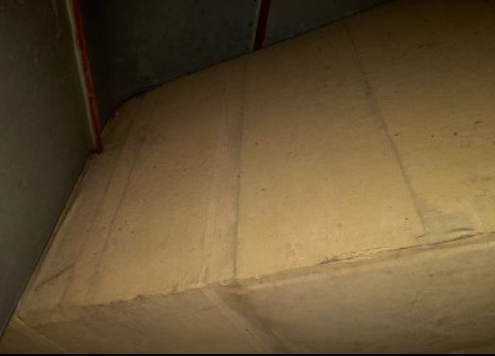
32	21-33327-16	Mastic sealant to ducting	Area 6/Lobby	Does not contain asbestos

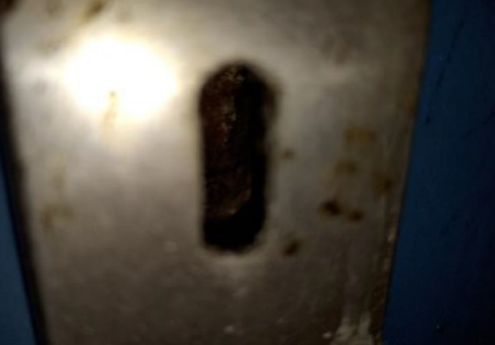
33	21-33327-18	Lining to x2 doors	Area 6/Lobby	Contains Asbestos Any change in appearance should be recorded and passed to Property Services

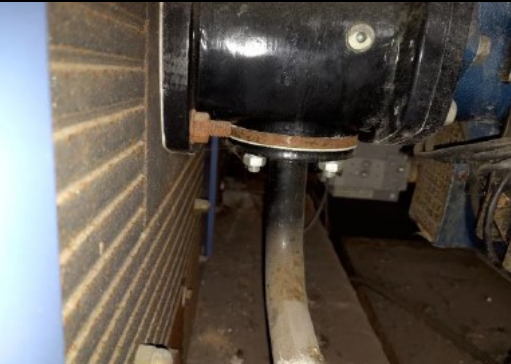
43	21-33327-28	Gas inlet gasket to boiler	Area 7/Boiler Room	Does not contain asbestos

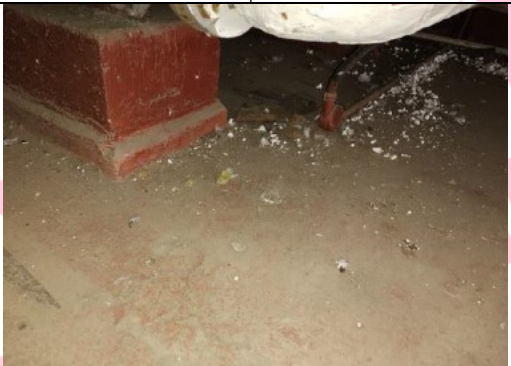
44	21-33327-29	Debris to floor	Area 7/Boiler Room	Contains Asbestos Any change in appearance should be recorded and passed to Property Services

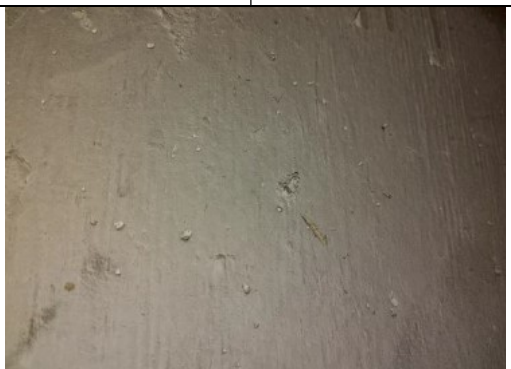
45	21-33327-30	Residue to walls	Area 7/Boiler Room	Contains Asbestos Any change in appearance should be recorded and passed to Property Services

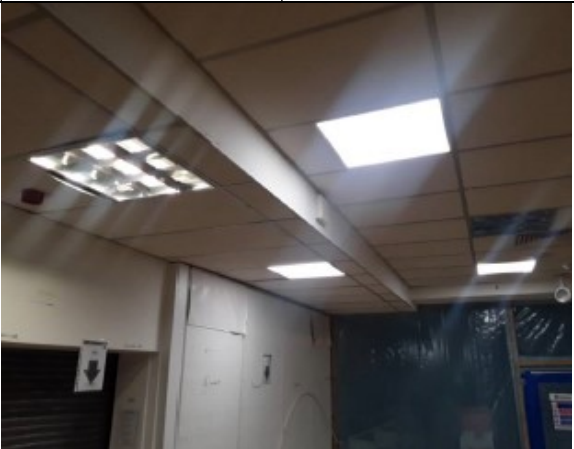
64	NZ002304	Bulkhead to lower compressed Cellulose tiles	1st Floor 1/001 Shop Floor	Does not contain asbestos

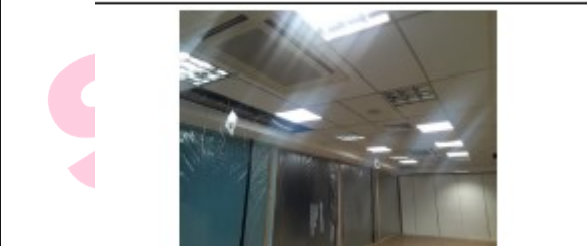
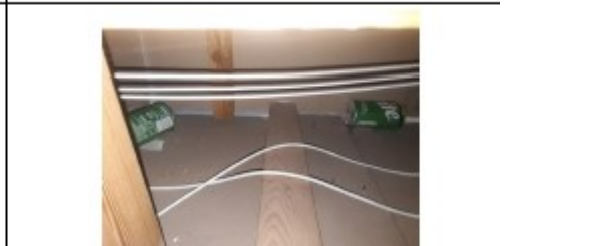
65	NZ002305	Debris/Residue to top of compressed Cellulose tiles and within bulkhead	1st Floor 1/001 Shop Floor	Contains Asbestos Any change in appearance should be recorded and passed to Property Services
Photo 1: Wide Angle			Photo 2: Close-up

65	Debris/Residue to top of compressed Cellulose tiles and within bulkhead	1st Floor 1/001 Shop Floor	Low Risk/6 months	N/A			Do not inspect until tender is drawn and work is completed
66	Ceiling Tile - Solid Including lowered bulkhead to each side	1st Floor 1/001 Shop Floor	Medium Risk/3 months	N/A			Do not inspect until tender is drawn and work is completed
67	Debris/Residue to floor from damaged ceiling also attached to flaking paint	1st Floor 1/001 Shop Floor	Low Risk/6 months	N/A			Do not inspect until tender is drawn and work is completed
68	Ceiling Void - Ceiling Above	1st Floor 1/004 Changing Room Baby	Very Low Risk/12 months	26/11/2025

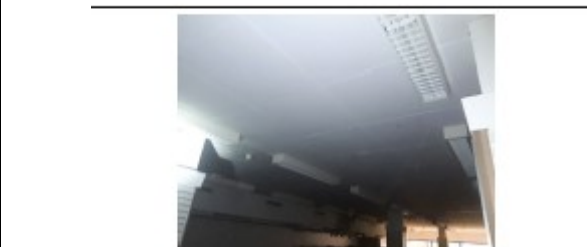
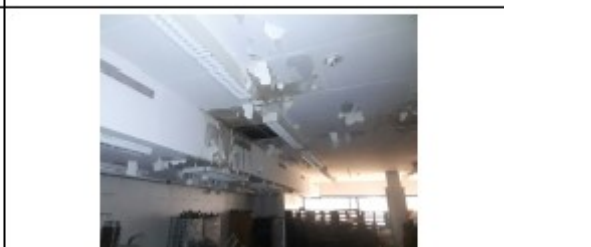
66	NZ002306	Ceiling Tile - Solid Including lowered bulkhead to each side	1st Floor 1/001 Shop Floor	Contains Asbestos Any change in appearance should be recorded and passed to Property Services
Photo 1: Wide Angle			Photo 2: Close-up

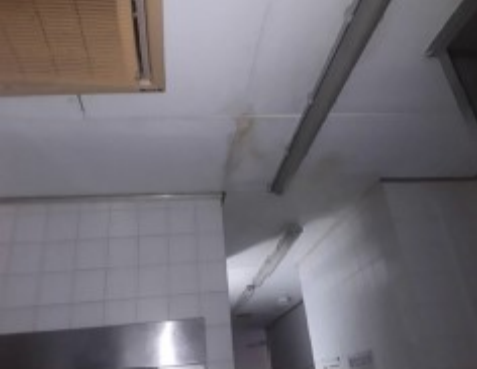
69	NZ002309	Ceiling Tile - Solid	1st Floor 1/005 Kitchen Cafe	Does not contain asbestos

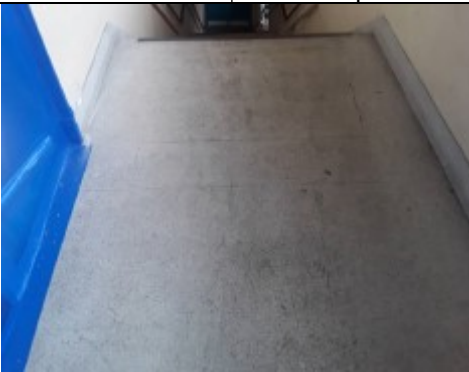
79	NZ002314	Floor - Tile Including Skirting	1st Floor 1/009 Stairs/Hall/Landing Fire escape	Does not contain asbestos

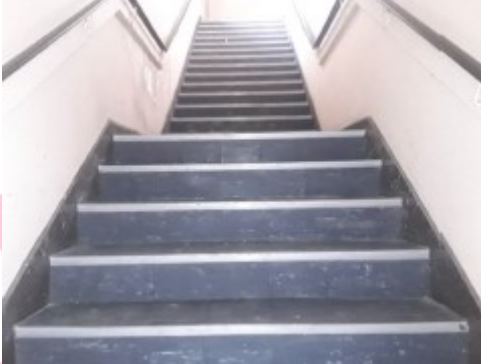
83	NZ002317	Floor - Tile (with adhesive) to upper section of staircase	1st Floor 1/009 Stairs/Hall/Landing Fire escape	Does not contain asbestos

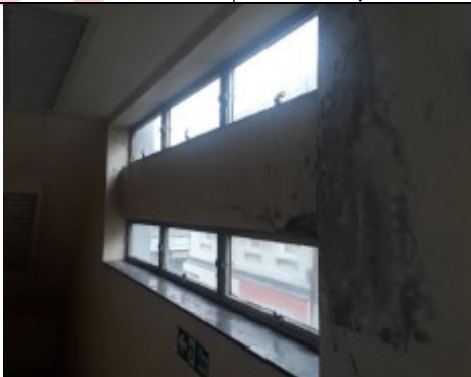
84	NZ002318	Window Putty/seal to glass	1st Floor 1/009 Stairs/Hall/Landing Fire escape	Does not contain asbestos

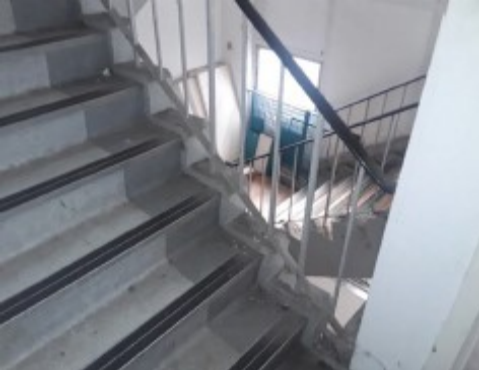
90	NZ002322	Floor - Nosing to stairs 2 per tread	1st Floor 1/015 Stairs/Hall/Landing	Does not contain asbestos

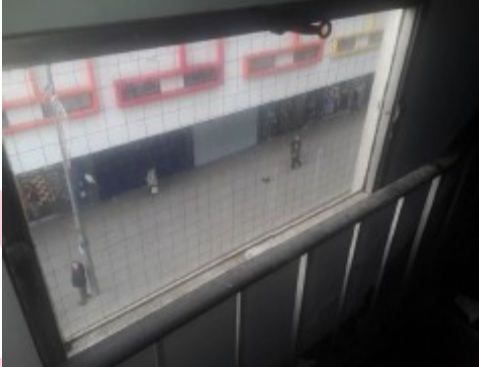
92	As NZ002318	Window Putty/seal to glass	1st Floor 1/015 Stairs/Hall/Landing	Does not contain asbestos

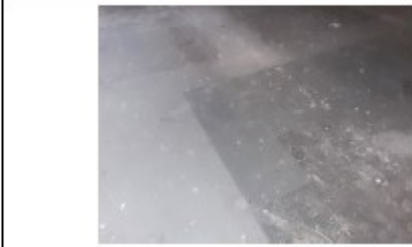
93	NZ002323	Floor - Tile (with adhesive) L/H side of shop floor	2nd Floor 2/001 Storeroom	Contains Asbestos Any change in appearance should be recorded and passed to Property Services
Photo 1: Wide Angle		Photo 2: Close-up

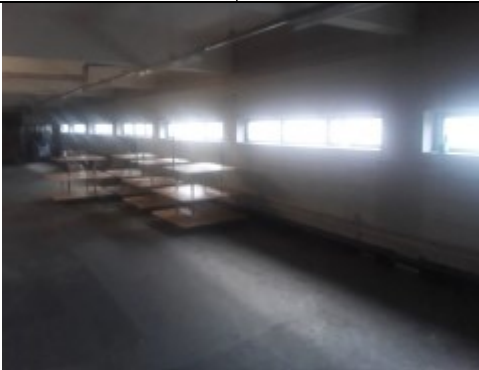
94	NZ002324	Window Putty/seal to glass	2nd Floor 2/001 Storeroom	Does not contain asbestos

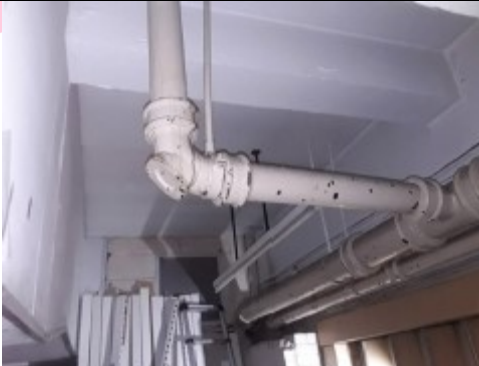
99	NZ002328	Soil Pipe - Horizontal Collar packing to joints	2nd Floor 2/001 Storeroom	Does not contain asbestos

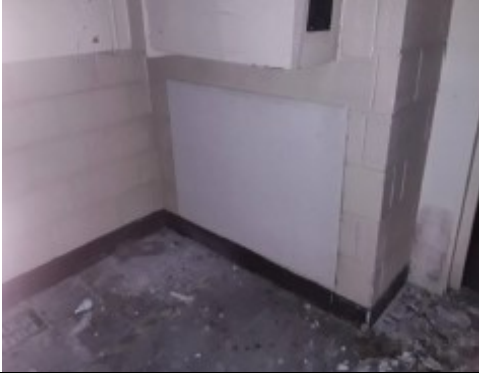
103	NZ002331	Wall - Panel to riser end of shop floor adjacent fire exit corridor	2nd Floor 2/001 Storeroom	Does not contain asbestos

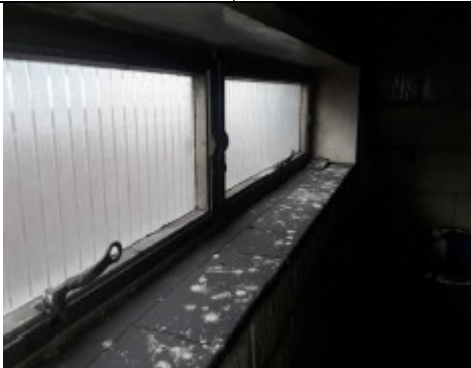
112	As NZ002324	Window Putty/seal to glass	2nd Floor 2/004 Tank Room	Does not contain asbestos

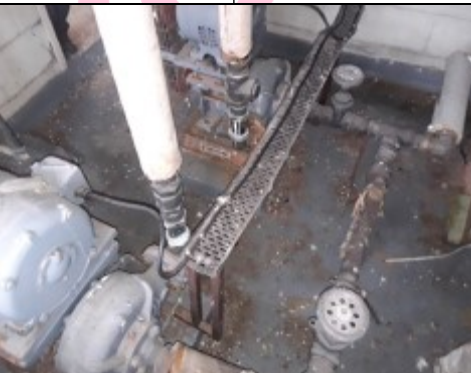
114	NZ002338	Pipework Gasket(s)	2nd Floor 2/004 Tank Room	Does not contain asbestos

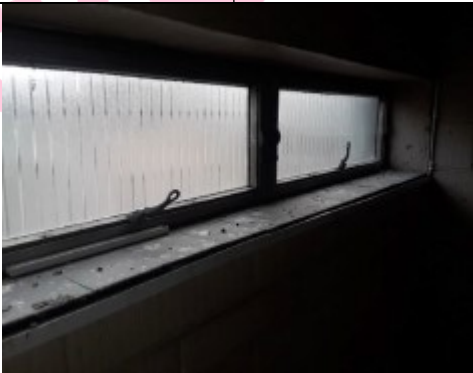
117	NZ002342	Window Putty/seal to glass	2nd Floor 2/006 Corridor	Does not contain asbestos

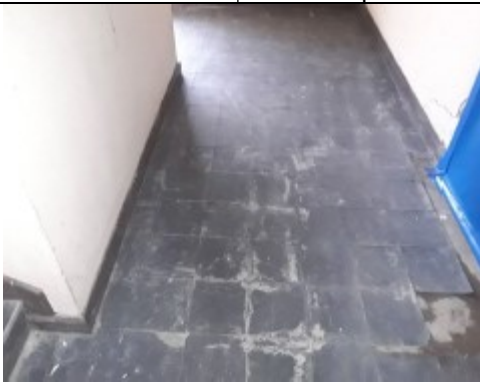
124	As NZ002317	Floor - Tile (with adhesive) Including staircase	2nd Floor 2/009 Stairs/Hall/Landing Fire escape	Does not contain asbestos

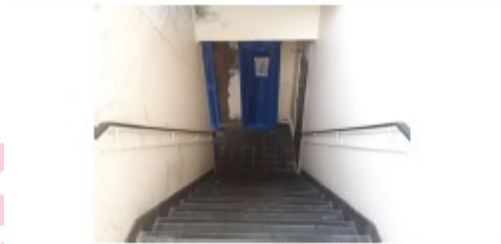
125	As NZ002334	Door - Fire door, Inner Lining to fire escape stairwell	2nd Floor 2/009 Stairs/Hall/Landing Fire escape	Contains Asbestos Any change in appearance should be recorded and passed to Property Services
Photo 1: Wide Angle

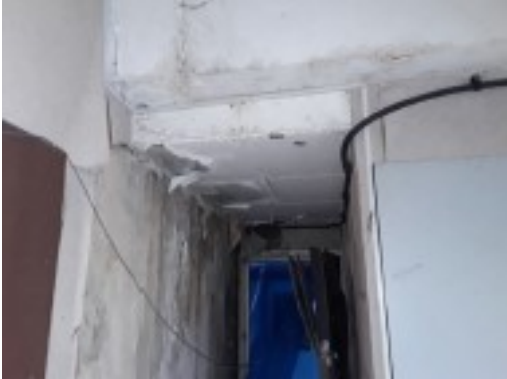
130	NZ002347	Ceiling Tile - Solid To escape corridor	2nd Floor 2/010 Office	Contains Asbestos Any change in appearance should be recorded and passed to Property Services
