### ASBESTOS SURVEY REPORT FOR WASHINGTON COMMUNITY RESOURCE CENTRE, AYTON ROAD, WASHINGTON, NE38 0DA.

### **Asbestos Register for**

### **Washington Resource Centre, Washington, NE38 0DA**

**UPRN: - 401888**

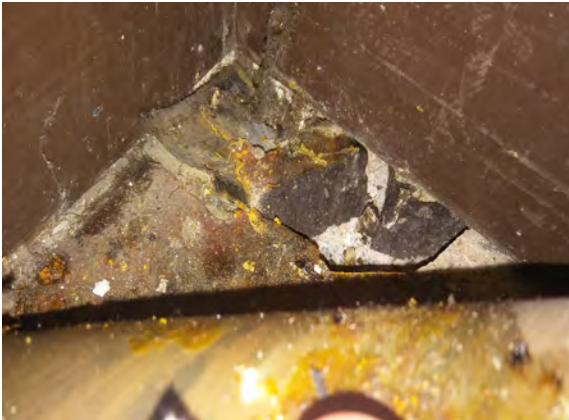
**Item 5 Ref: As 401888-13**

The floor screed in the Store (Rm 0/04) does not contain asbestos.

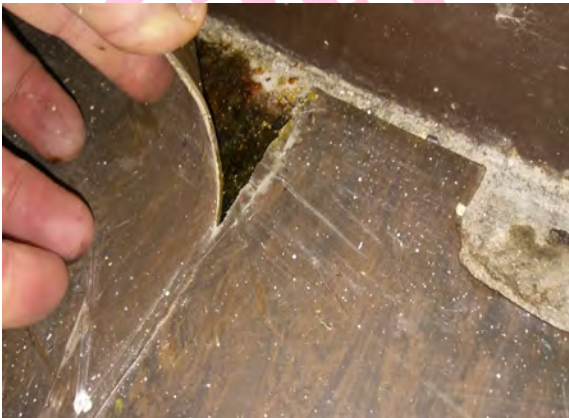
**Item 6 Ref: As 401888-13**

The floor screed in the Store (Rm 0/05) does not contain asbestos.

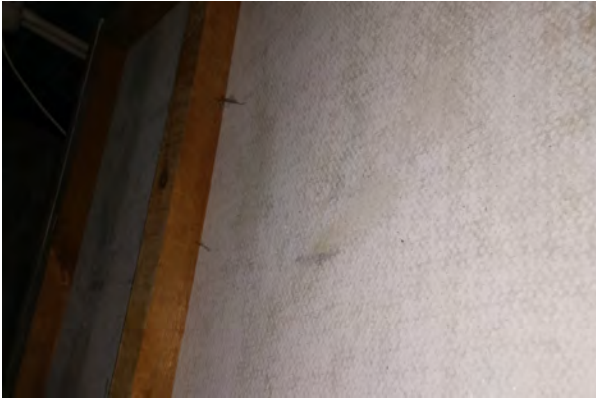
### **Item 7 Ref: As 401888-12**

The panels to skylights in the Textiles Room – ceiling void (Rm 0/06) do not contain asbestos.

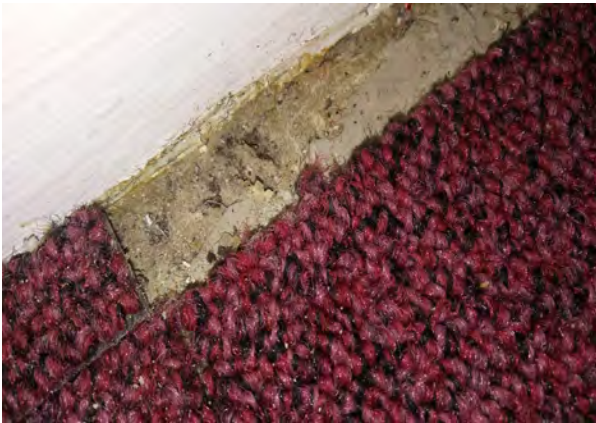
### **Item 8 Ref: As 401888-13**

The floor screed in the Corridor (Rm 0/15a) does not contain asbestos.

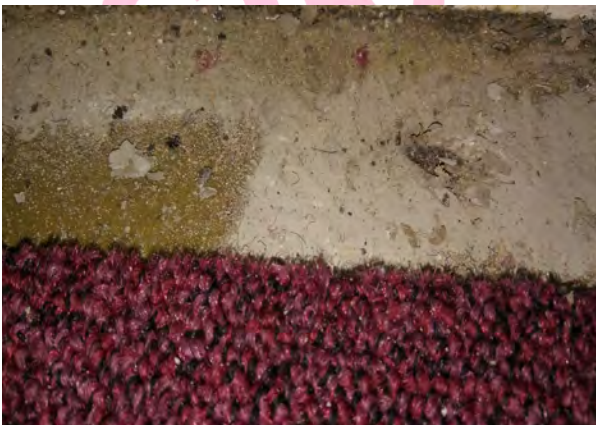
### **Item 9 Ref: As 401888-13**

The floor screed in the Seating Area (Rm 0/16) does not contain asbestos.

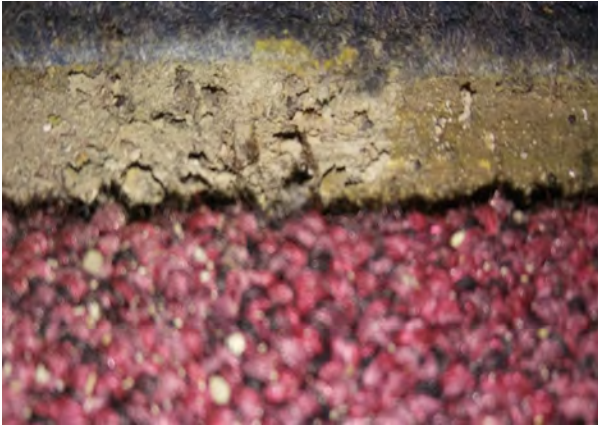
### **Item 10 Ref: As 401888-13**

The floor screed in the Electric Cupboard (Rm 0/17) does not contain asbestos.

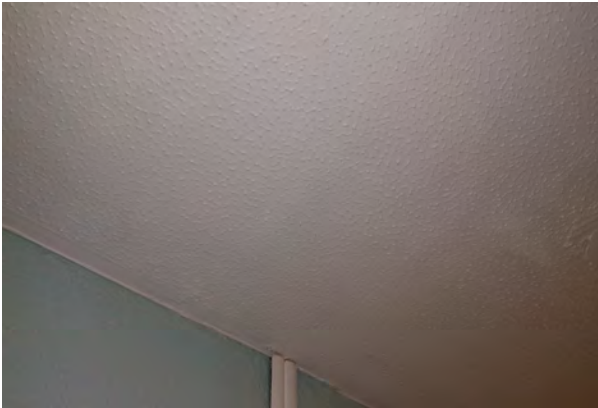
### **Item 11 Ref: As 401888-14**

The textured coated ceiling in the Toilet (Rm 0/18) contains asbestos.

Any change in its appearance should be recorded and passed to Property Services.

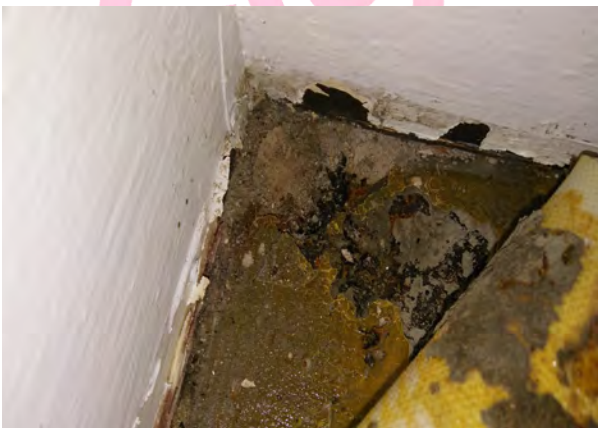
### **Item 12 Ref: As 401888-15**

The floor screed in the Toilet (Rm 0/18) does not contain asbestos.

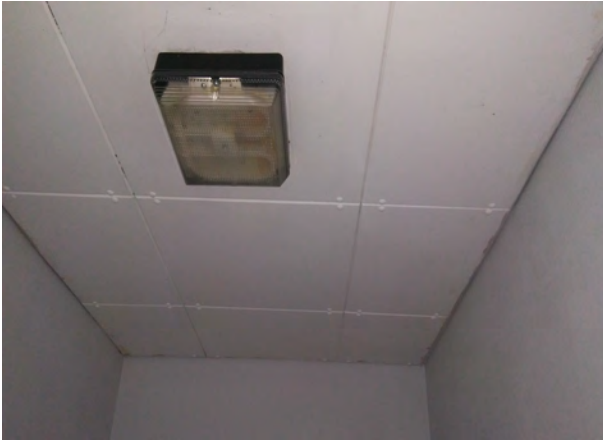
### **Item 13 Ref: As 401888-12**

The ceiling tiles in the Office Lobby (Rm 0/20) does not contain asbestos.

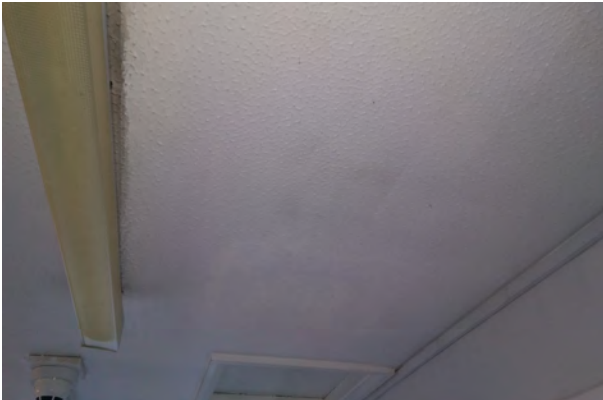
### **Item 14 Ref: As 401888-14**

The textured coated ceiling in the Corridor (Rm 0/20a) contains asbestos.

Any change in its appearance should be recorded and passed to Property Services.

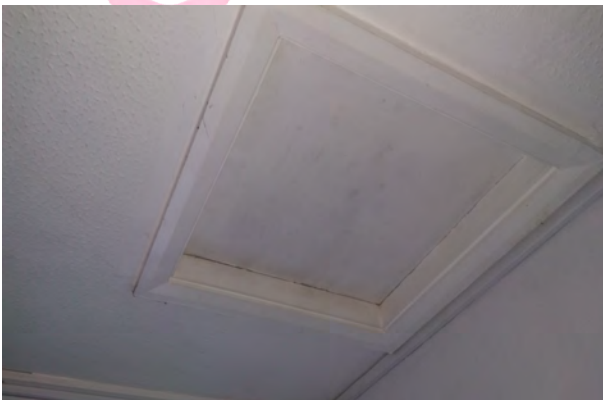
### **Item 15 Ref: As 401888-12**

The panel to ceiling void hatch in the Corridor (Rm 0/20a) does not contain asbestos.

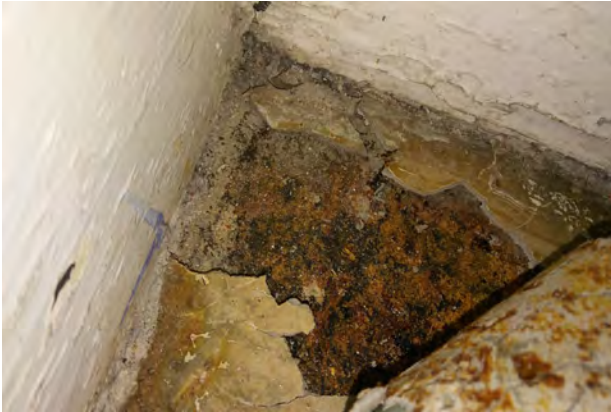
**Item 16 Ref: As 401888-15**

The floor screed in the Toilet (Rm 0/21) does not contain asbestos.

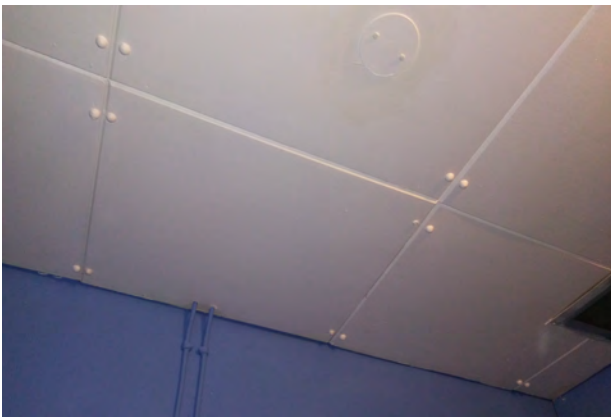
**Item 17 Ref: As 401888-12**

The ceiling tiles in the Toilet (Rm 0/21) does not contain asbestos.

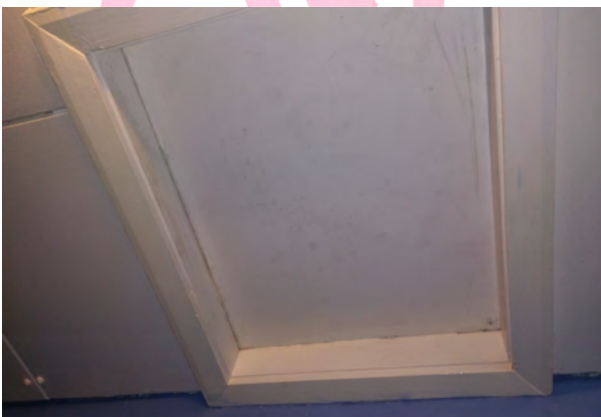
**Item 18 Ref: As 401888-12**

The panel to ceiling void hatch in the Toilet (Rm 0/21) does not contain asbestos.

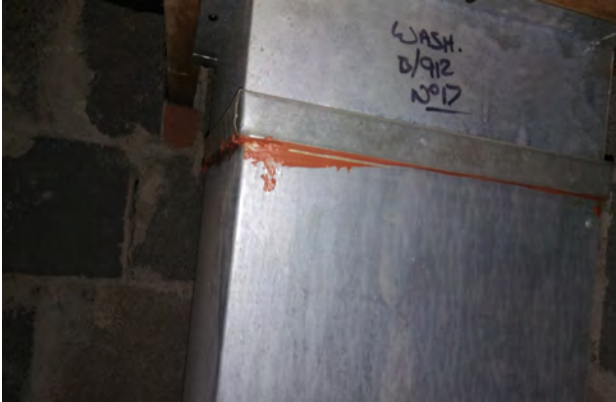
### **Item 19 Ref: 401888-16**

The mastic to ducting in the Toilet – ceiling void (Rm 0/21) does not contain asbestos.

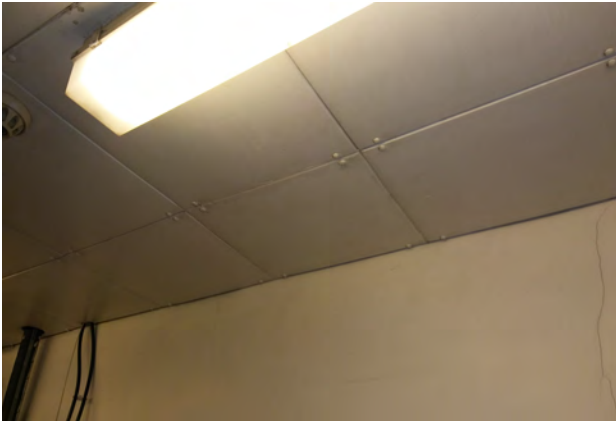
### **Item 20 Ref: As 401888-12**

The ceiling tiles in the Cellar (Rm 0/22) does not contain asbestos.

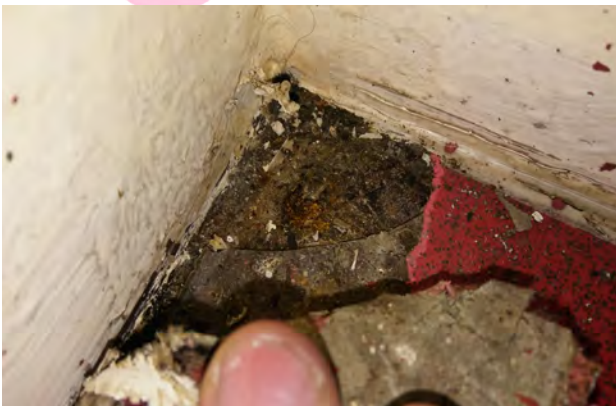
### **Item 21 Ref: As 401888-15**

The floor screed in the Bar (Rm 0/23) does not contain asbestos.

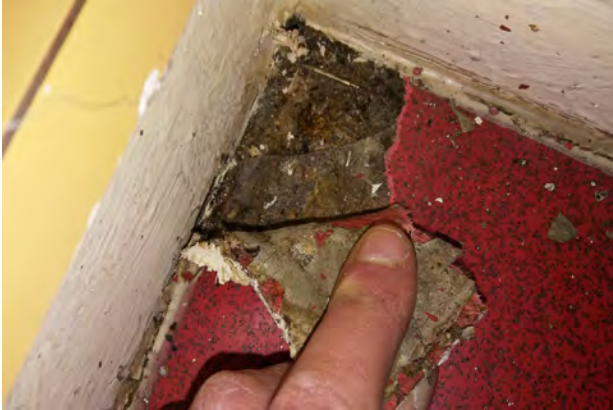
### **Item 22 Ref: 401888-17**

The floor tile with bitumen adhesive in the Bar (Rm 0/23) does contain asbestos.

Any change in its appearance should be recorded and passed to Property Services.

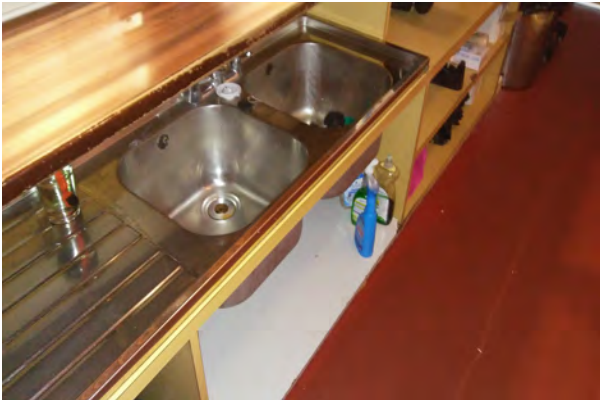
### **Item 23 Ref: 401888-18**

The sink pad in the Bar (Rm 0/23) does contain asbestos.

Any change in its appearance should be recorded and passed to Property Services.

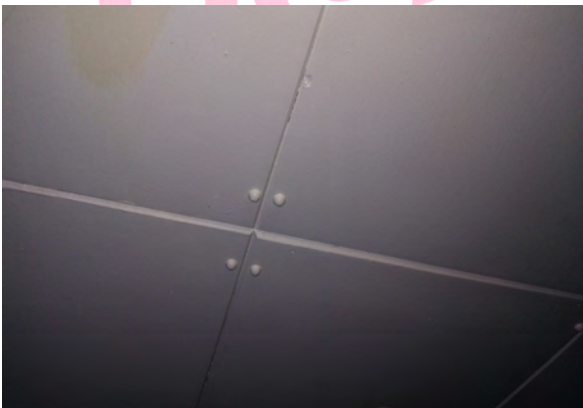
### **Item 24 Ref: As 401888-12**

The ceiling tiles in the Office (Rm 0/24) does not contain asbestos.

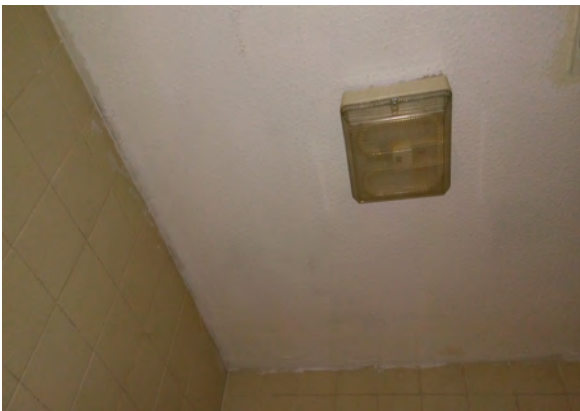
### **Item 29 Ref: As 401888-14**

The textured coated ceiling in the Freezer Cupboard (Rm 0/28) contains asbestos.

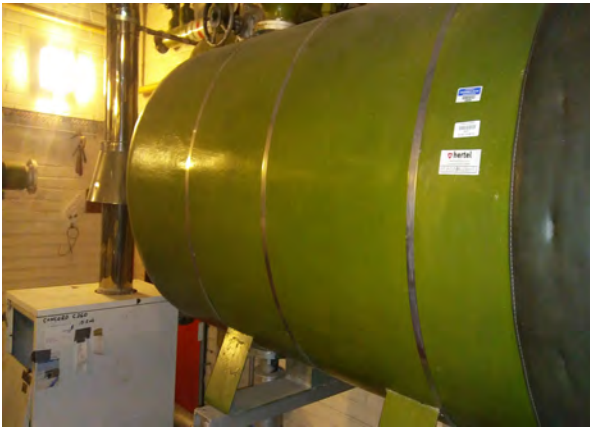
### **Item 32 Ref: 401888-23**

The lagging to raised cylinder in the Boiler Room (Rm 0/30) does not contain asbestos.

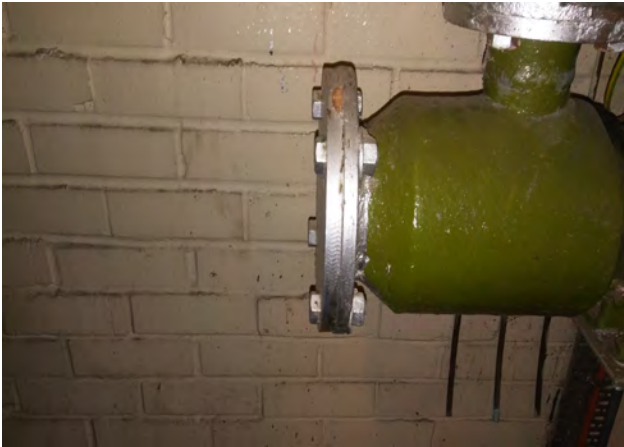
### **Item 34 Ref: 401888-25**

The debris to pipework flanges in the Boiler Room (Rm 0/30) does not contain asbestos.

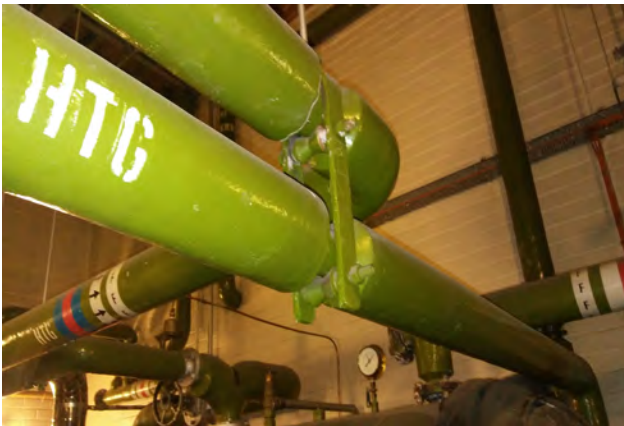
### **Item 35 Ref: As 401888-25**

The debris to pipework brackets in the Boiler Room (Rm 0/30) does not contain asbestos.

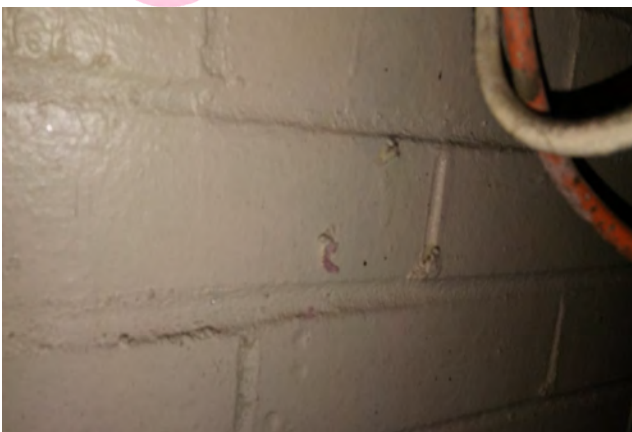
### **Item 36 Ref: 401888-26**

The debris to walls in the Boiler Room (Rm 0/30) does not contain asbestos.

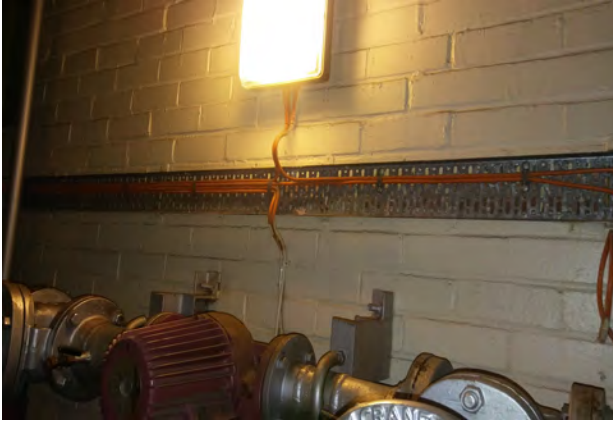
### **Item 37 Ref: As 401888-26**

The debris to wall mounted cable trays in the Boiler Room (Rm 0/30) does not contain asbestos.

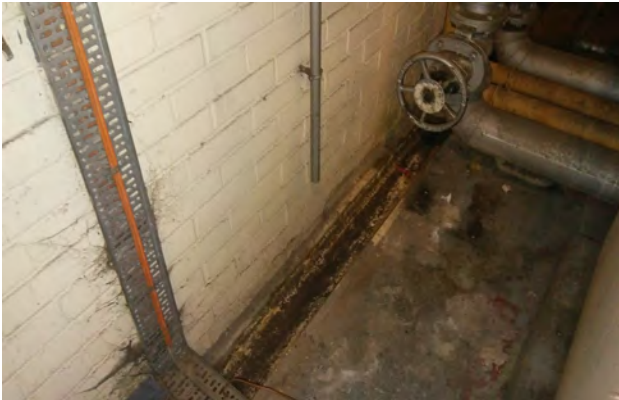
### **Item 38 Ref: 401888-27**

The debris to floor in the Boiler Room (Rm 0/30) does not contain asbestos.

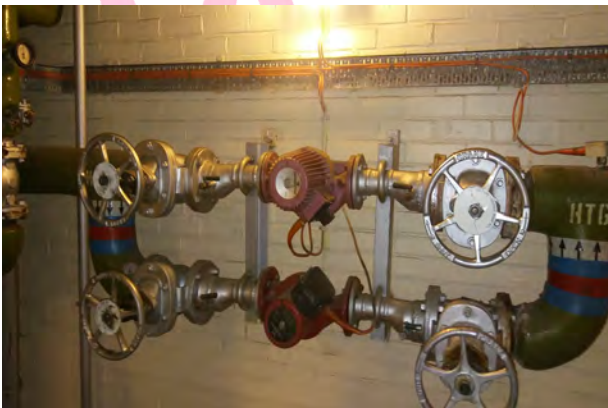
### **Item 39 Ref: 401888-28**

- (Item 39) Ref: 401888-28 – Gaskets to pipework flange (0/030/Boiler Room) – Removed November 2021
- (Item 40) Ref: As 401888-27 – Debris to high level cables (0/030/Boiler Room) – No Risk

The gaskets to pipework flange in the Boiler Room (Rm 0/30) contains asbestos.

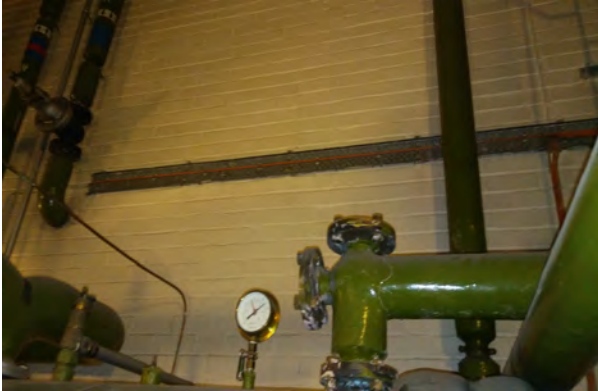
**Item 40 Ref: As 401888-27**

The debris to high level cables in the Boiler Room (Rm 0/30) does not contain asbestos.

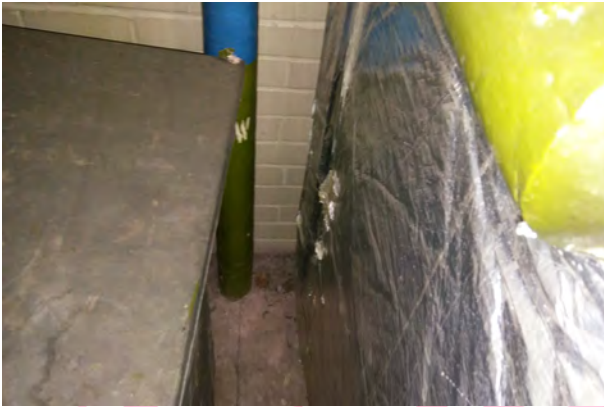
**Item 41 Ref: As 401888-27**

The debris to mezzanine floor in the Boiler Room (Rm 0/30) does not contain asbestos.

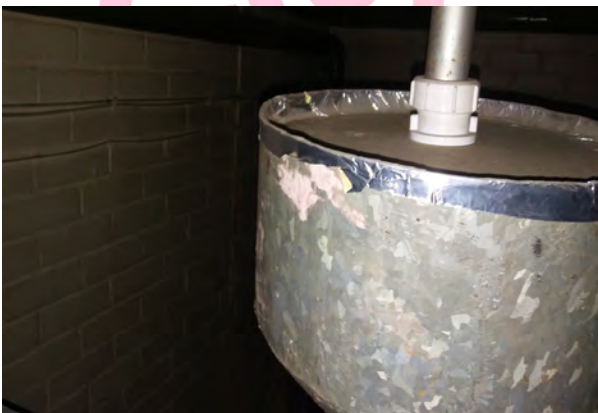
**Item 42 Ref: As 401888-27**

The debris to tank funnels in the Boiler Room (Rm 0/30) does not contain asbestos.

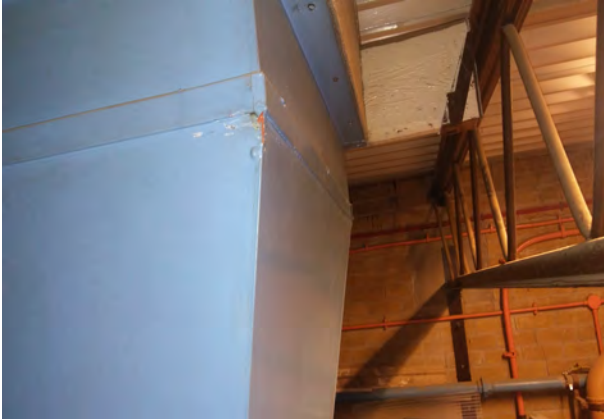
### **Item 43 Ref: As 401888-16**

The mastic to ducting in the Workshop Store (Rm 0/31) does not contain asbestos.

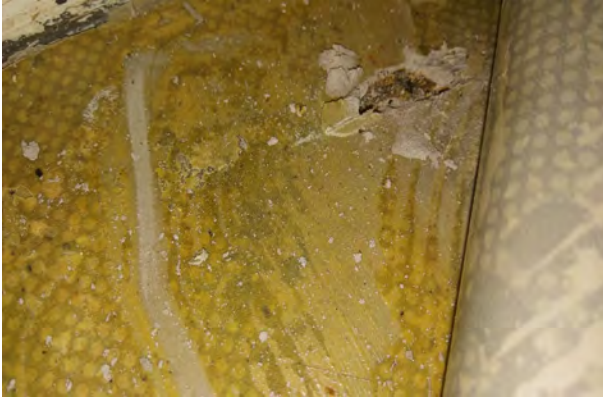
**Item 46 Ref: As 401888-15**

The floor screed in the Ayton Suite 5 Store (Rm 0/34) does not contain asbestos.

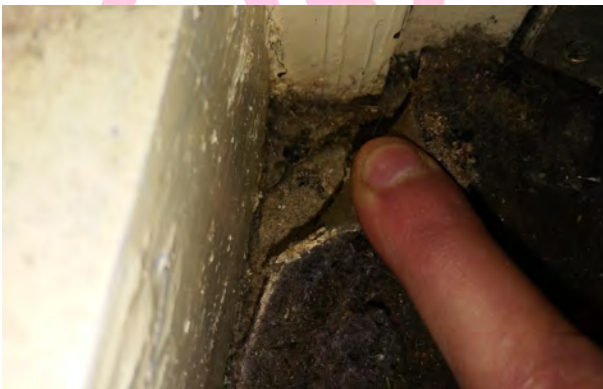
**Item 48 Ref: As 401888-15**

The floor screed in the Ayton Suite 4 Store (Rm 0/36) does not contain asbestos.

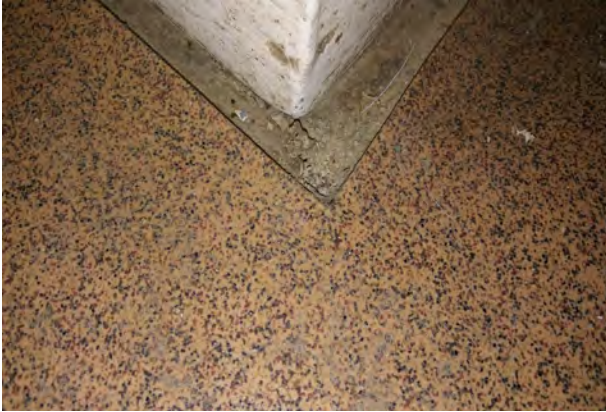
### **Item 49 Ref: As 401888-15**

The floor screed in the Male WC (Rm 0/37) does not contain asbestos.

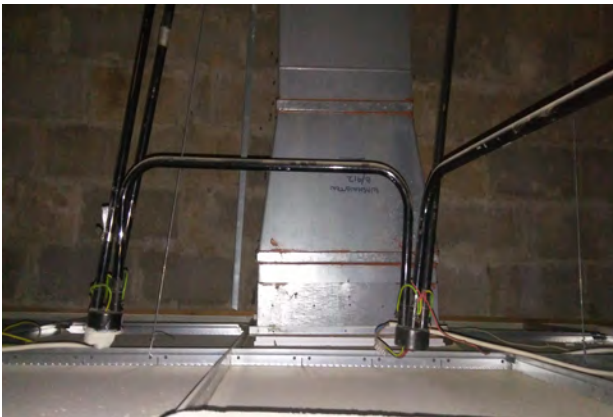
### **Item 50 Ref: As 401888-16**

The mastic to ducting in the Male WC – ceiling void (Rm 0/37) does not contain asbestos.

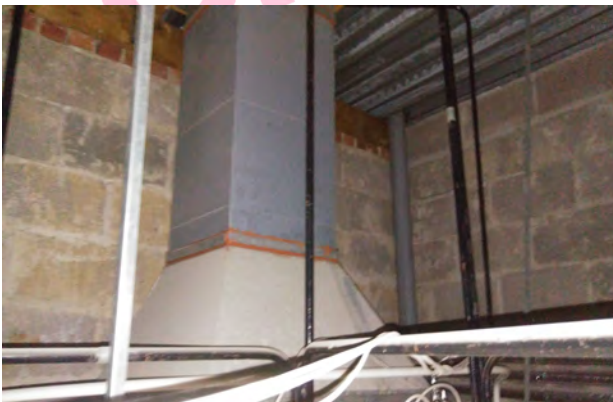
### **Item 51 Ref: As 401888-16**

The mastic to ducting in the Female WC – ceiling void (Rm 0/38) does not contain asbestos.

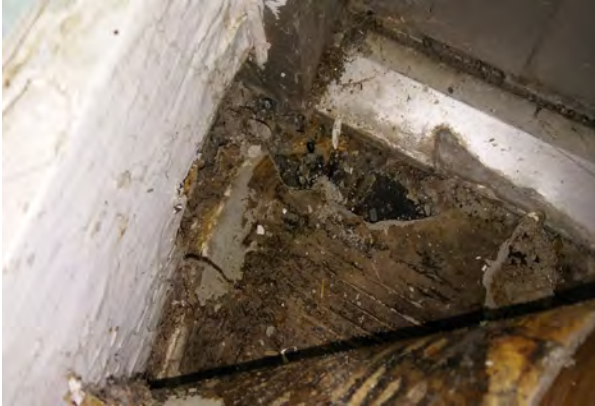
### **Item 52 Ref: As 401888-15**

The floor screed in the Corridor (Rm 0/39) does not contain asbestos.

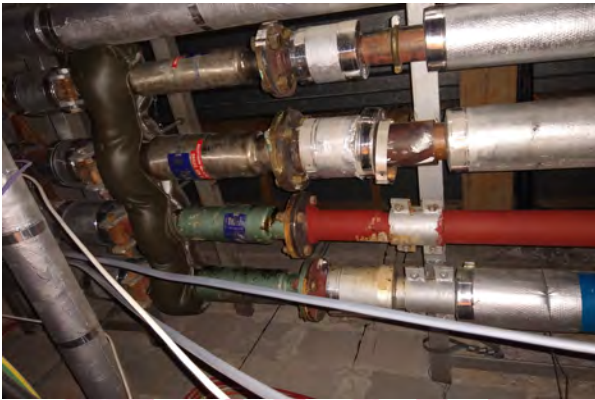
### **Item 53 Ref: Presumed**

The pipework flange gaskets at expansion bellows in the Corridor – ceiling void (Rm 0/40) contains asbestos.

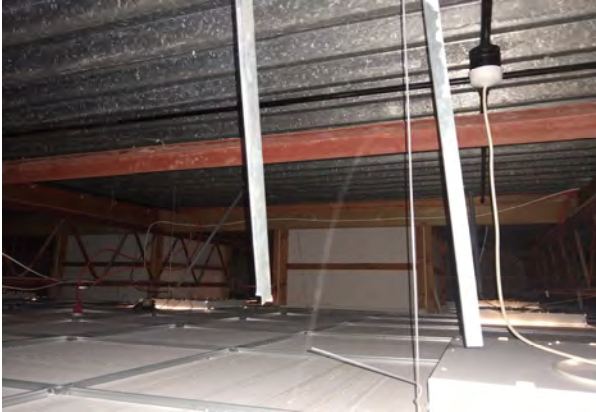
### **Item 55 Ref: As 401888-5**

The panels to skylights in the Ayton Suite 1 – ceiling void (Rm 0/48) do not contain asbestos.

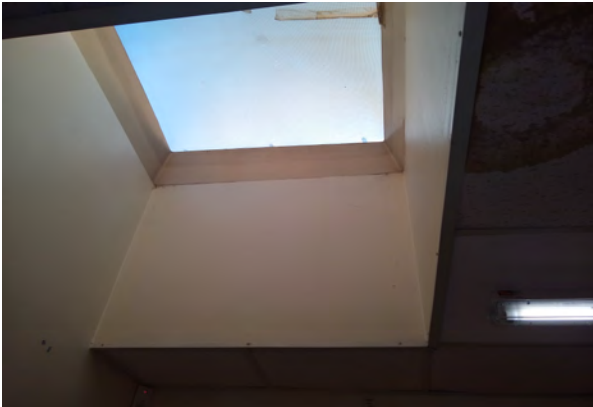
### **Item 56 Ref: As 401888-2**

The panels to skylights in the Ayton Suite 2 (Rm 0/51) do not contain asbestos.

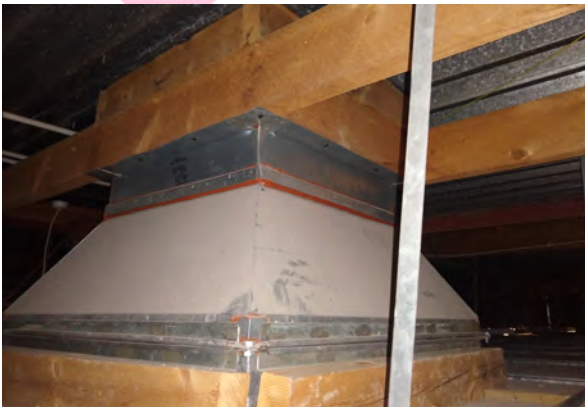
### **Item 57 Ref: 401888-1**

The mastic to ducting in the Ayton Suite 2 – ceiling void (Rm 0/51) does not contain asbestos.

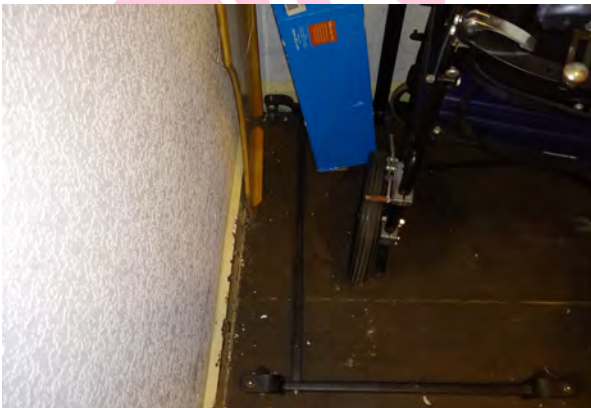
### **Item 60 Ref: As 401888-4**

The floor screed in the Cupboard (Rm 0/56) does not contain asbestos.

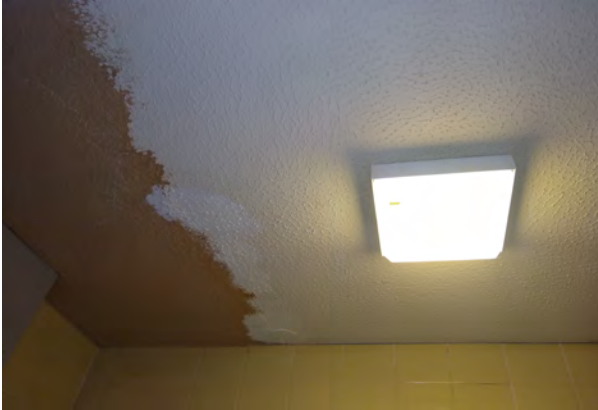
### **Item 61 Ref: As 401888-3**

The textured coating ceiling in the Cleaners Cupboard (Rm 0/57) contains asbestos.

Any change in its appearance should be recorded and passed to Property Services.

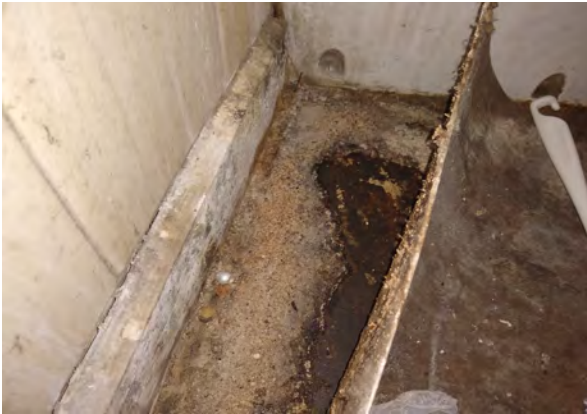
### **Item 62 Ref: As 401888-4**

The floor screed in the Cleaners Cupboard (Rm 0/57) does not contain asbestos.

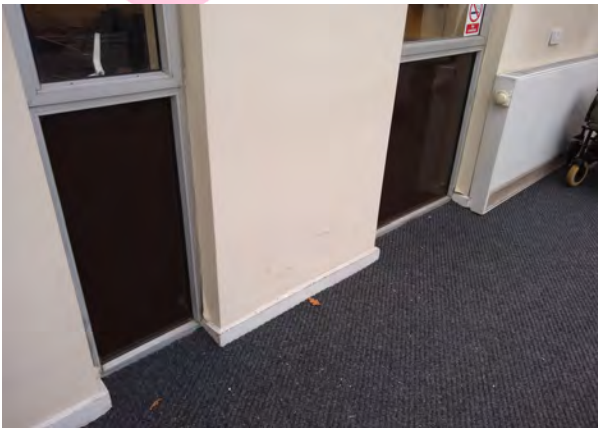
### **Item 63 Ref: As 401888-37**

The infill panels to windows in the Entrance Lobby (Rm 0/59) do not contain asbestos.

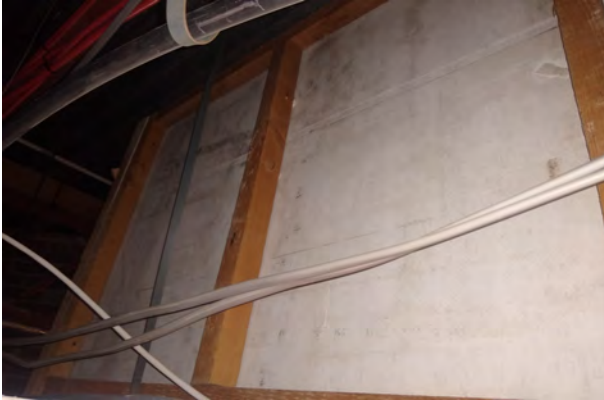
### **Item 64 Ref: As 401888-2**

The skylight surrounds in the Corridor – ceiling void (Rm 0/62) do not contain asbestos.

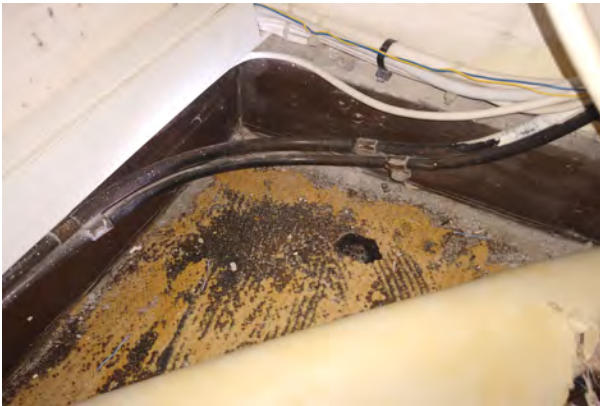
### **Item 65 Ref: 401888-4**

The floor screed in the Server Cupboard (Rm 0/65) does not contain asbestos.

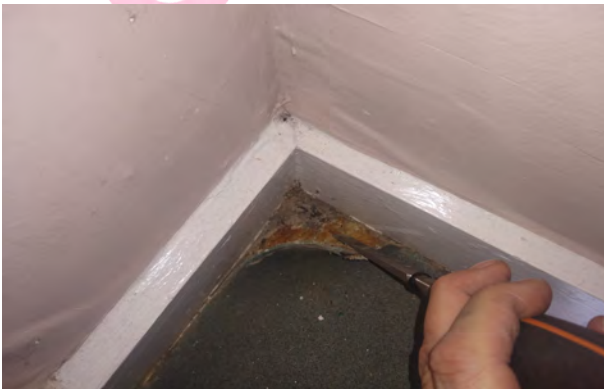
### **Item 66 Ref: As 401888-4**

The floor screed in the Corridor (Rm 0/68) does not contain asbestos.

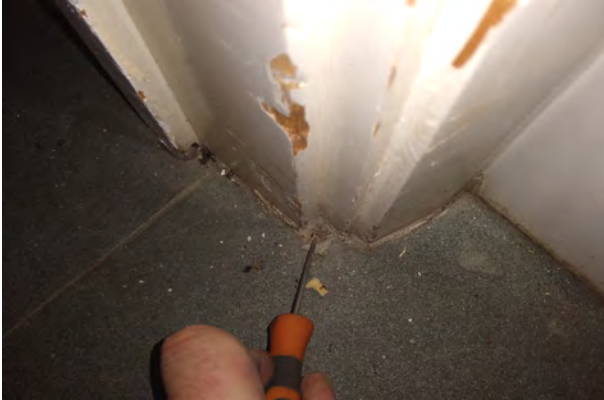
### **Item 67 Ref: As 401888-4**

The floor screed in the Bathroom (Rm 0/68a) does not contain asbestos.

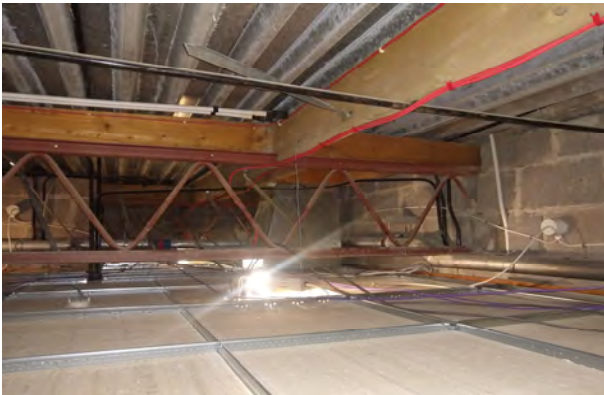
### **Item 68 Ref: As 401888-1**

The mastic to ducting in the Craft Room – ceiling void (Rm 0/74) does not contain asbestos.

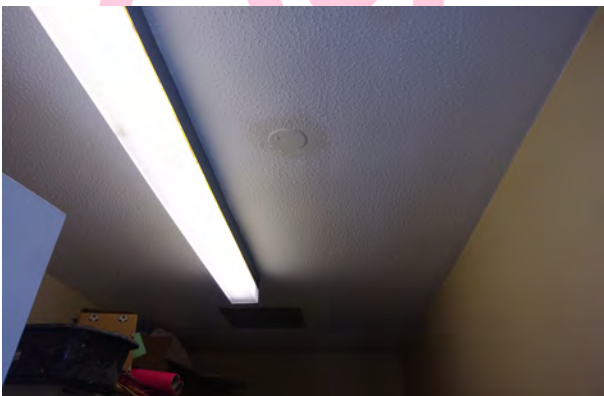
### **Item 69 Ref: As 401888-3**

The textured coating ceiling in the Craft Room Store (Rm 0/75) contains asbestos.

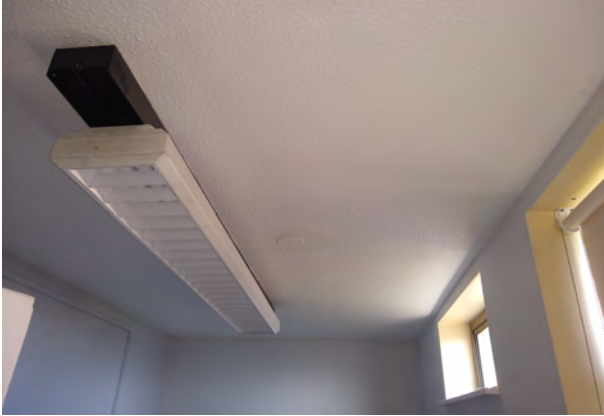
### **Item 70 Ref: As 401888-3**

The textured coating ceiling in the Craft Room Office (Rm 0/76) contains asbestos.

Any change in its appearance should be recorded and passed to Property Services.

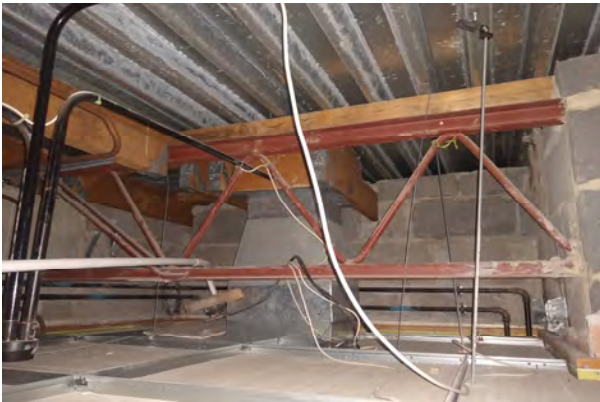
### **Item 71 Ref: As 401888-1**

The mastic to ducting in the Male Toilet – ceiling void (Rm 0/77) does not contain asbestos.

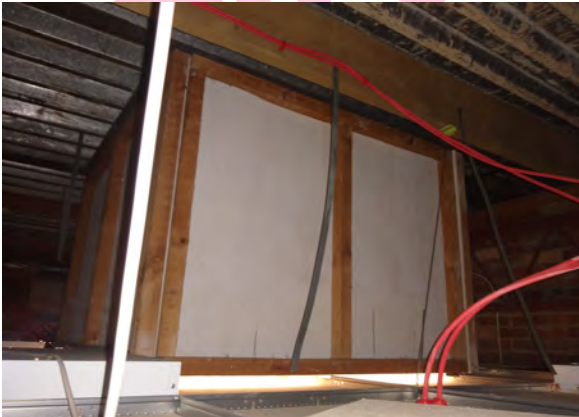
### **Item 75 Ref: 401888-5**

The skylight surround in the Entrance Lobby – ceiling void (Rm 0/83) does not contain asbestos.

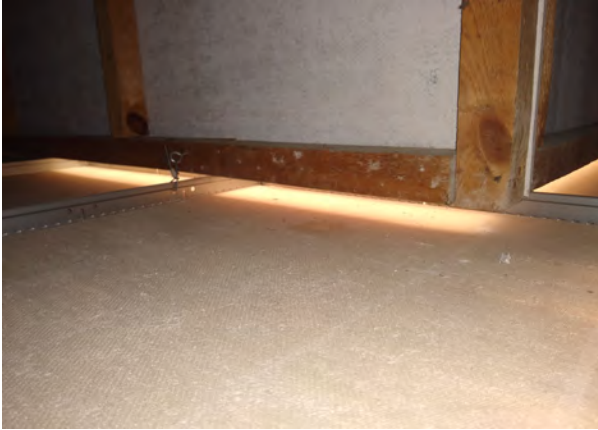
**Item 76 Ref: 401888-6**

The debris to the top of the suspended ceiling below skylights in the Entrance Lobby – ceiling void (Rm 0/83) does not contain asbestos.

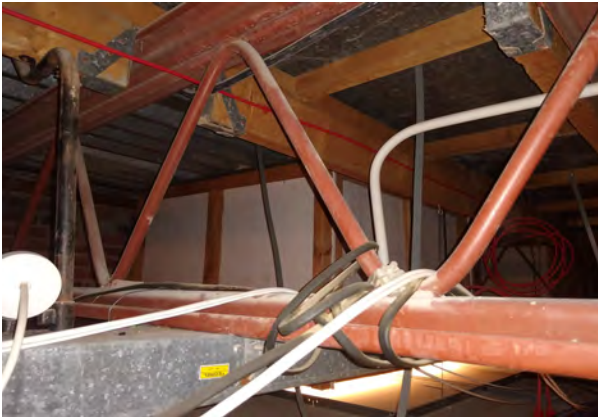
**Item 77 Ref: As 401888-5**

The skylight surround in the Corridor – ceiling void (Rm 0/83a) does not contain asbestos.

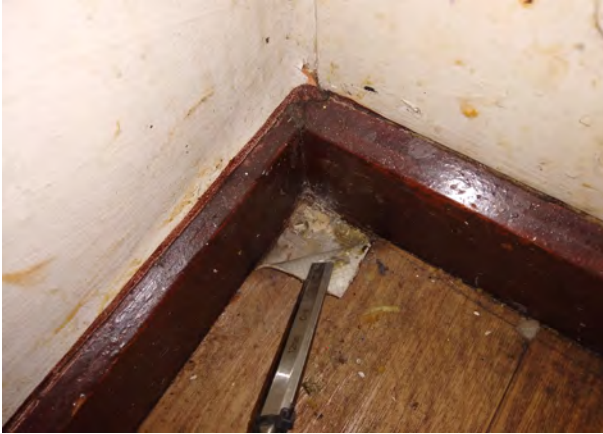
**Item 79 Ref: 401888-29**

The floor screed in the Dining Hall (Rm 0/85) does not contain asbestos.

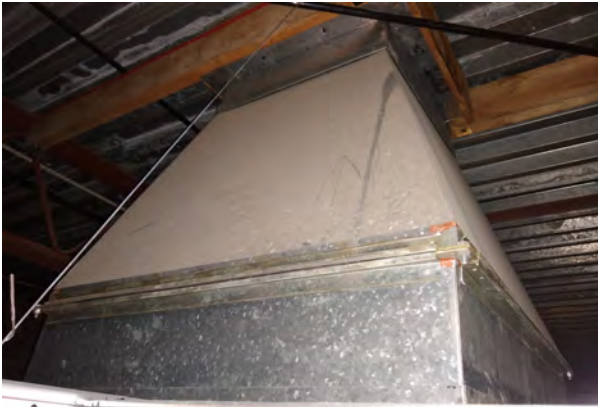
**Item 80 Ref: 401888-8**

The mastic to ducting in the Dining Hall – high level ceiling void (Rm 0/85) does not contain asbestos.

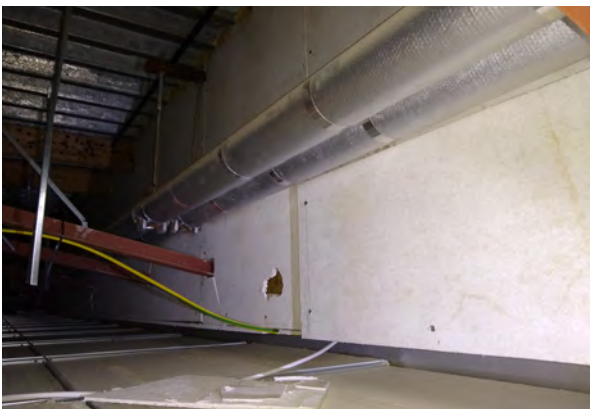
**Item 81 Ref: 401888-9**

The firebreak in the Dining Hall – high level ceiling void (Rm 0/85) does not contain asbestos.

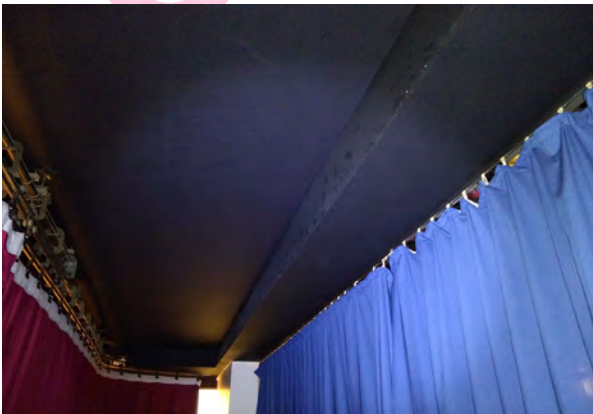
### **Item 84 Ref: As 401888-30**

The boxing to main stage ceiling in the Stage Area (Rm 0/86) does not contain asbestos.

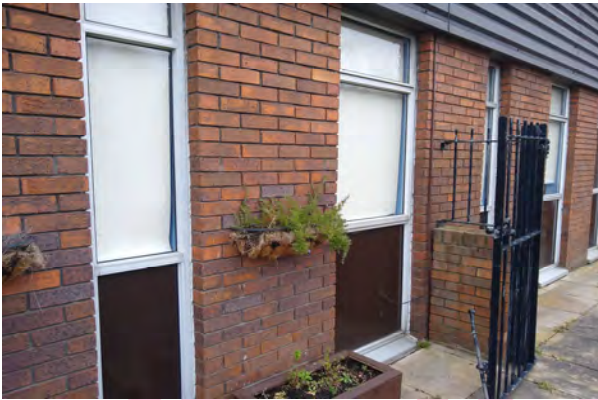
### **Item 86 Ref: 401888-36**

The sealant to windows and doors (External) does contain asbestos.

Any change in its appearance should be recorded and passed to Property Services.

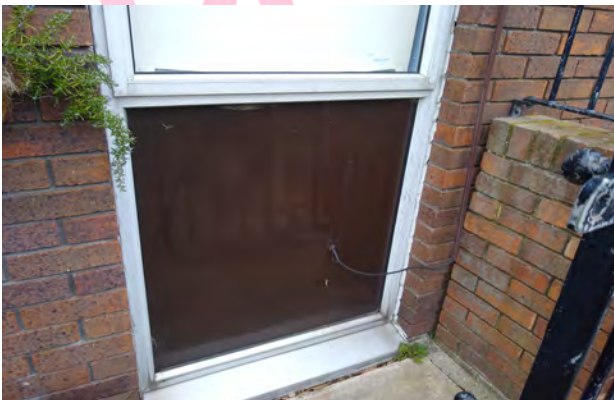
### **Item 87 Ref: 401888-37**

The window infill panels (External) does not contain asbestos.

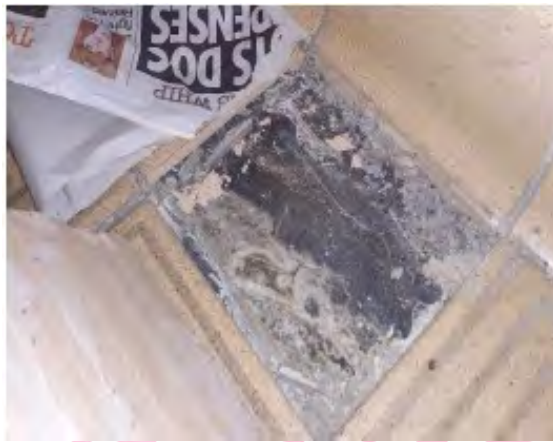
### **Item 106 Ref: RT000802**

The adhesive below tiles in the textiles room (Room G/01) does not contain asbestos.

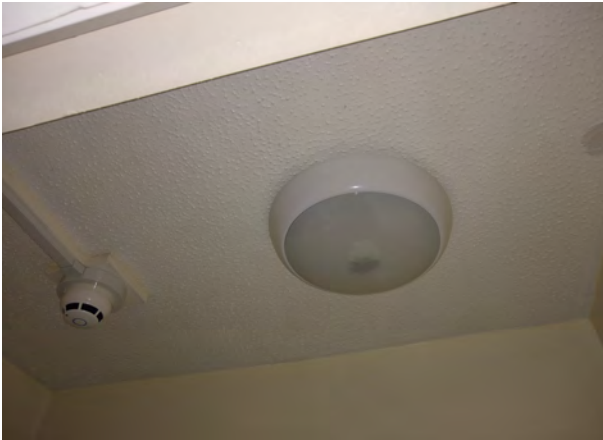
**Item 88 Ref: 401888-34**

The textured coating ceiling in the Porch – Caretakers House (Rm 0/01) contains asbestos.

Any change in its appearance should be recorded and passed to Property Services.

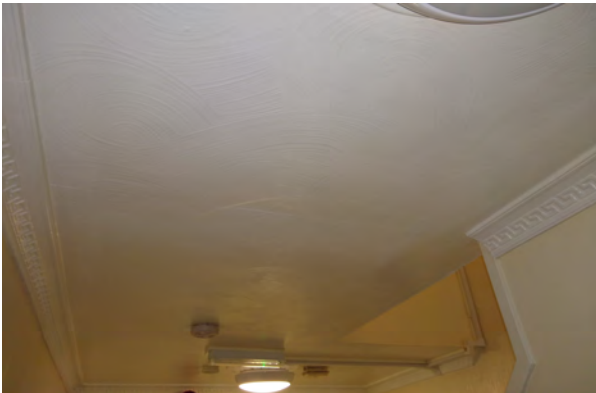
**Item 89 Ref: As 401888-33**

The textured coating ceiling in the Hallway – Caretakers House (Rm 0/02) contains asbestos.

Any change in its appearance should be recorded and passed to Property Services.

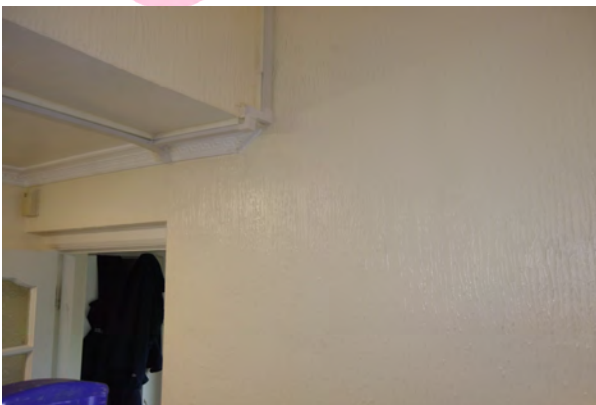
**Item 90 Ref: As 401888-32**

The textured coating walls in the Hallway – Caretakers House (Rm 0/02) contains asbestos.

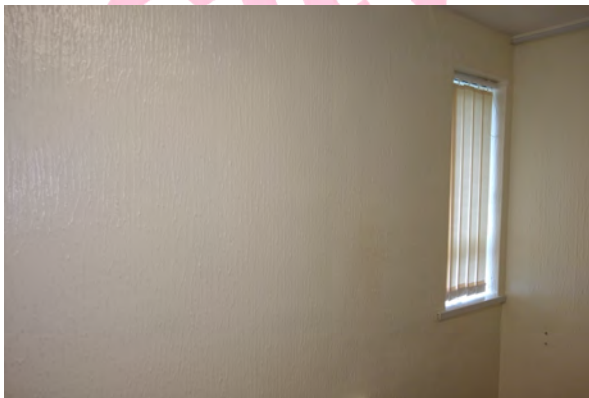
**Item 93 Ref: 401888-32**

The textured coating walls in the Stairwell & Landing – Caretakers House (Rm 1/01) contains asbestos.
