ASBESTOS SURVEY REPORT FOR PENSHAW COMMUNITY ASSOCIATION,
WENSLEYDALE AVENUE, HOUGHTON LE SPRING, DH4 7PD.

**Asbestos Register for
Penshaw CA, Wensleydale Avenue, Houghton le Spring,
DH4 7PD**

Date: 11 October 2023

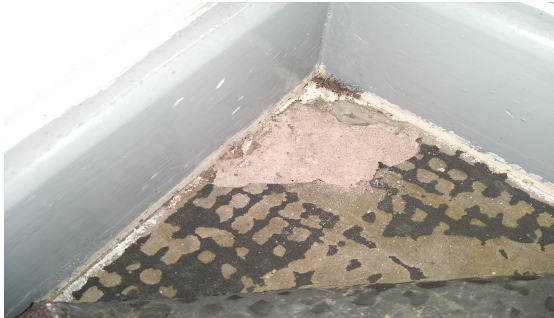
Item 1 Ref: 422055-1

The bitumen adhesive to floor in Rm 0/001 Entrance Lobby contains asbestos.

Any change in its appearance should be recorded and passed to Property Services.

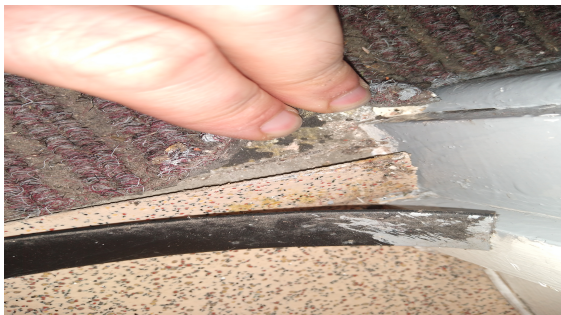
Item 2 Ref: As 422055-1

The bitumen adhesive to floor in Rm 0/002 Disabled Toilet contains asbestos.

Any change in its appearance should be recorded and passed to Property Services.

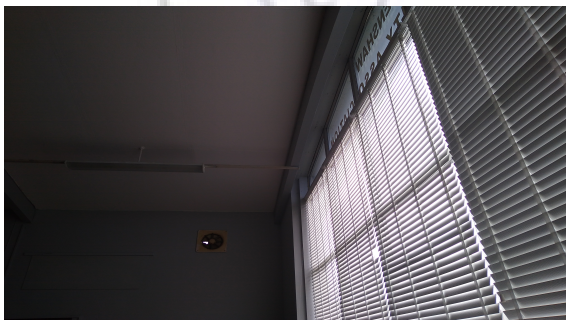
Item 3 Ref: Presumed

The ceiling in Rm 0/004 Hall is presumed to contain asbestos.

Any change in its appearance should be recorded and passed to Property Services.

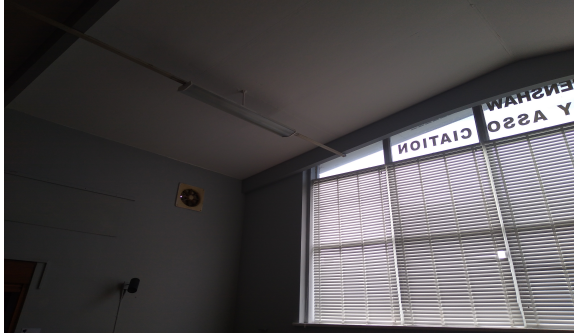
Item 4 Ref: Presumed

The ceiling in Rm 0/004 Hall is presumed to contain asbestos.

Any change in its appearance should be recorded and passed to Property Services.

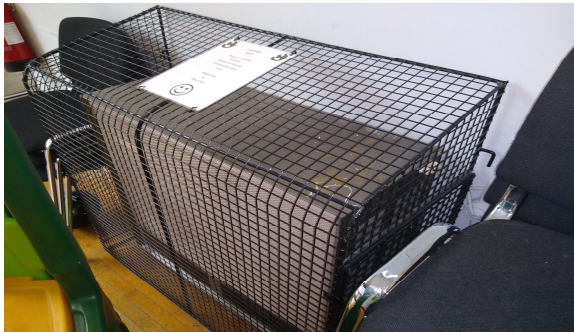
Item 5 Ref: Presumed

The walls in Rm 0/004 Hall is presumed to contain asbestos.

Any change in its appearance should be recorded and passed to Property Services.

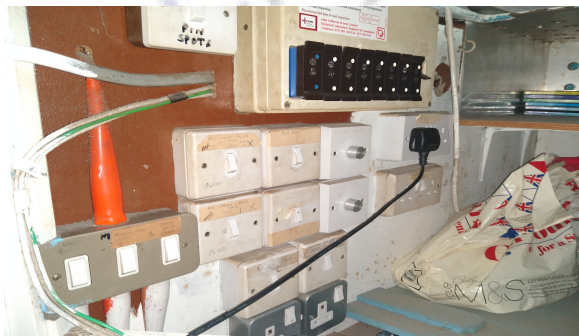
Item 6 Ref: Presumed

The electrics in Rm 0/004 Hall is presumed to contain asbestos.

Any change in its appearance should be recorded and passed to Property Services.

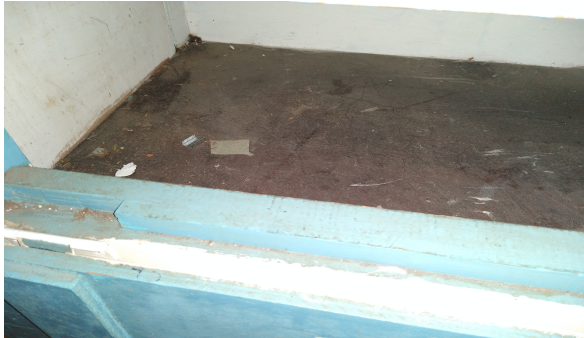
Item 7 Ref: 422055-2

The shelf in the electric cupboard in Rm 0/004 Hall does not contain asbestos.

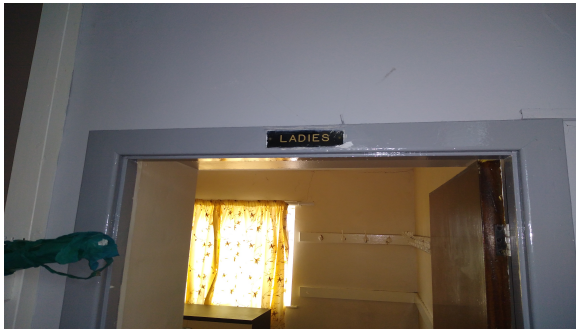
Item 8 Ref: 422055-3

The sign in Rm 0/004 Hall does not contain asbestos.

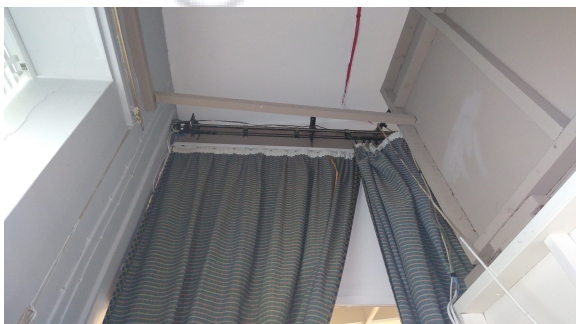
Item 9 Ref: 422055-4

The panel to wall in Rm 0/004 Hall does not contain asbestos.

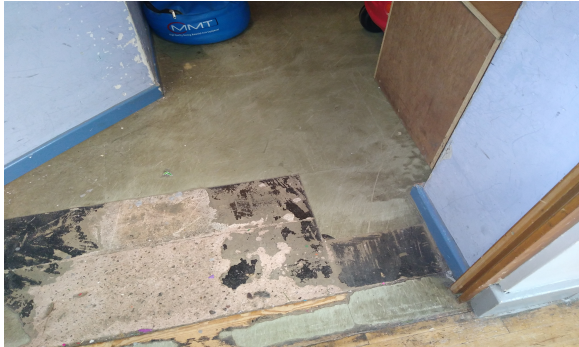
Item 10 Ref: 422055-5

The green vinyl tile floor in Rm 0/006 Store 1 contains asbestos.

Any change in its appearance should be recorded and passed to Property Services.

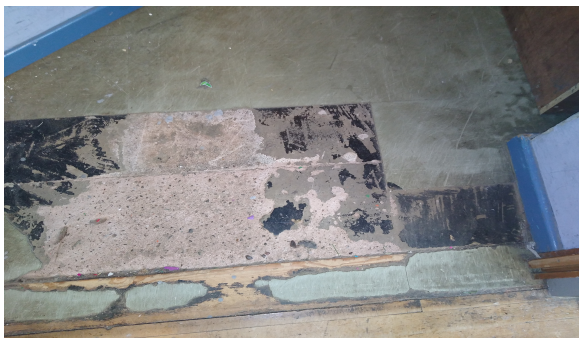
Item 11 Ref: 422055-6

The bitumen adhesive to floor in Rm 0/006 Store 1 contains asbestos.

Any change in its appearance should be recorded and passed to Property Services.

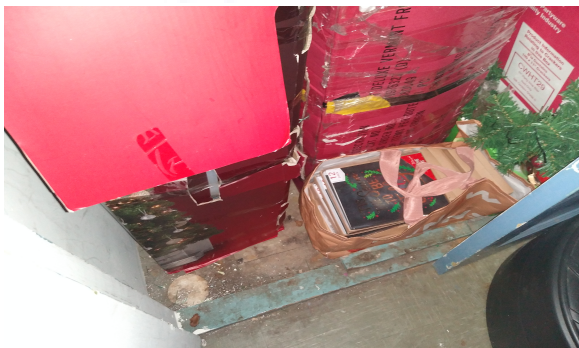
Item 12 Ref: As 422055-5

The green vinyl tile floor in Rm 0/007 Cupboard 1 contains asbestos.

Any change in its appearance should be recorded and passed to Property Services.

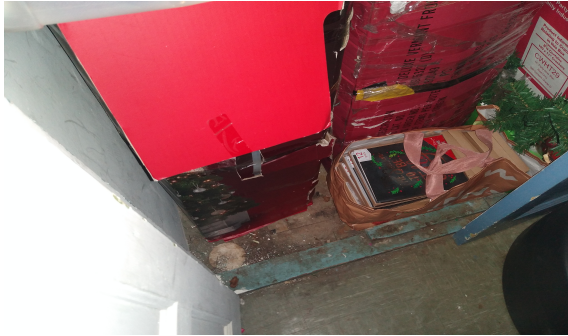
Item 13 Ref: As 422055-6

The bitumen adhesive in Rm 0/007 Cupboard 1 contains asbestos.

Any change in its appearance should be recorded and passed to Property Services.

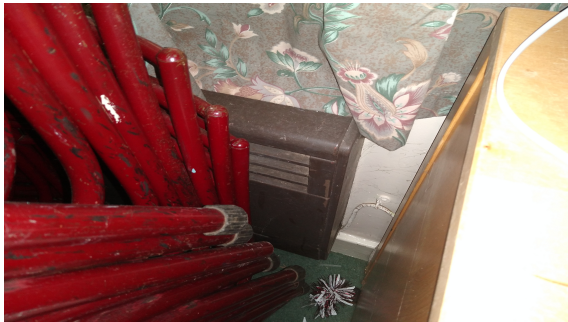
Item 14 Ref: Presumed

The electric heater in Rm 0/008 Male Changing is presumed to contain asbestos.

Any change in its appearance should be recorded and passed to Property Services.

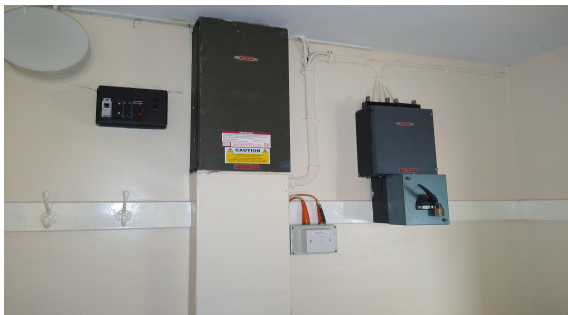
Item 15 Ref: Presumed

The electrics in Rm 0/010 Female Changing is presumed to contain asbestos.

Any change in its appearance should be recorded and passed to Property Services.

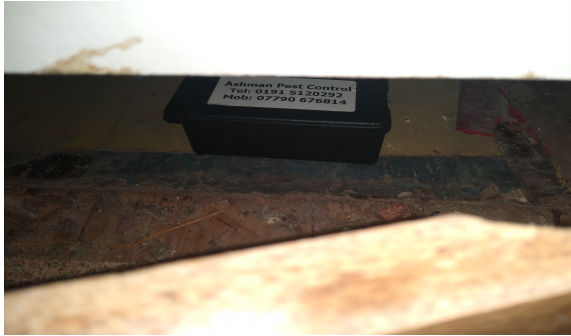
Item 16 Ref: 422055-7

The vinyl floor tile in Rm 0/012 Kitchen does not contain asbestos.

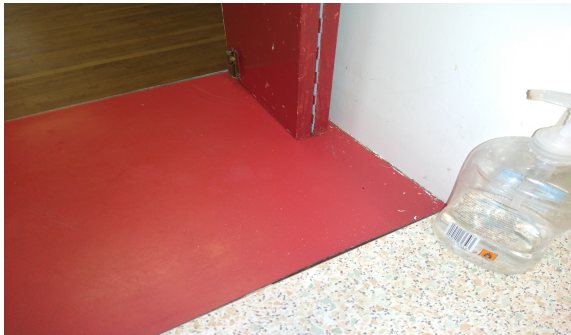
Item 17 Ref: 422055-8

The vinyl to the serving hatch in Rm 0/012 Kitchen does not contain asbestos.

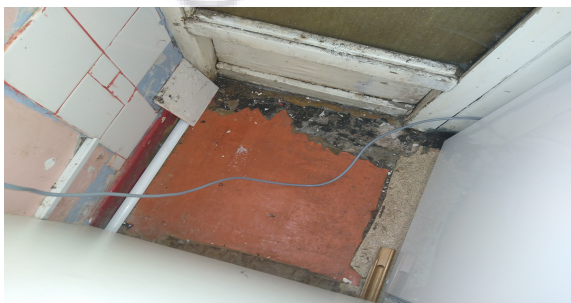
Item 18 Ref: 422055-9

The floor covering in Rm 0/012 Kitchen contains asbestos.

Any change in its appearance should be recorded and passed to Property Services.

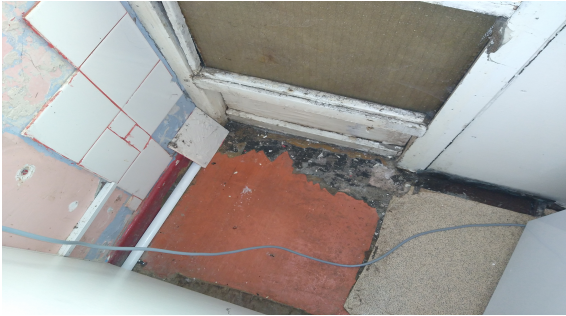
Item 19 Ref: 422055-10

The bitumen adhesive in Rm 0/012 Kitchen contains asbestos.

Any change in its appearance should be recorded and passed to Property Services.

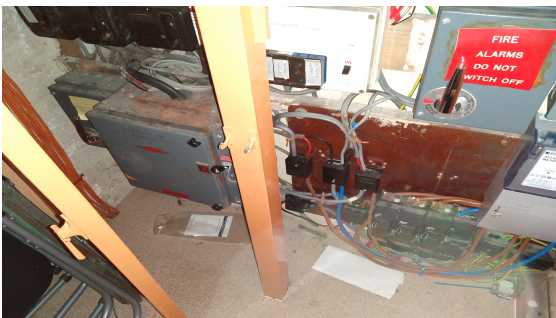
Item 20 Ref: Presumed

The electrics in Rm 0/013 Store 2 is presumed to contain asbestos.

Any change in its appearance should be recorded and passed to Property Services.

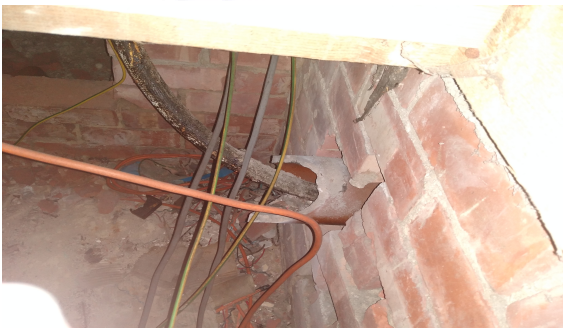
Item 21 Ref: 422055-11

The pipe lagging floor covering in Rm 0/013 Store 2 floor void does not contain asbestos.

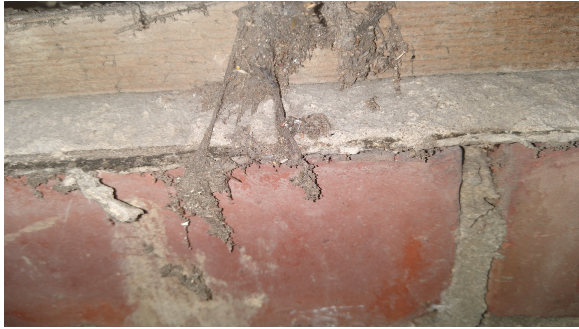
Item 22 Ref: 422055-12

The damp proof course in Rm 0/013 Store 2 floor void does not contain asbestos.

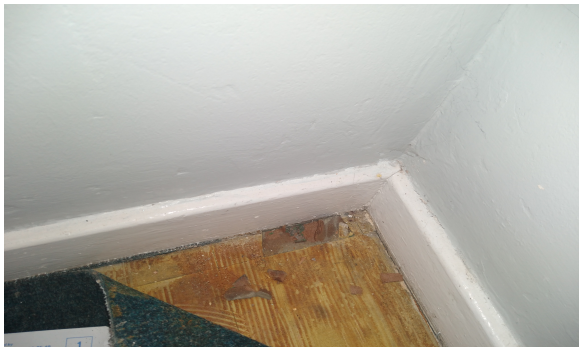
Item 23 Ref: 422055-13

The yellow vinyl tile floor in Rm 0/014 Meeting Room does not contain asbestos.

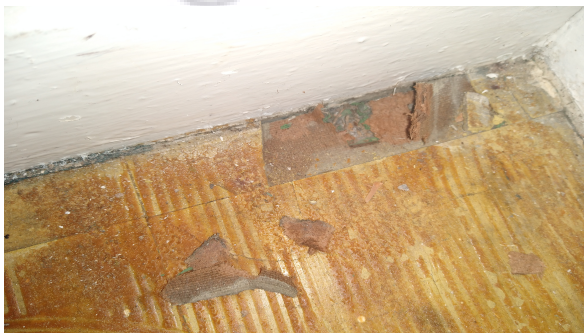
Item 24 Ref: 422055-14

The green vinyl tile floor in Rm 0/014 Meeting Room does not contain asbestos.

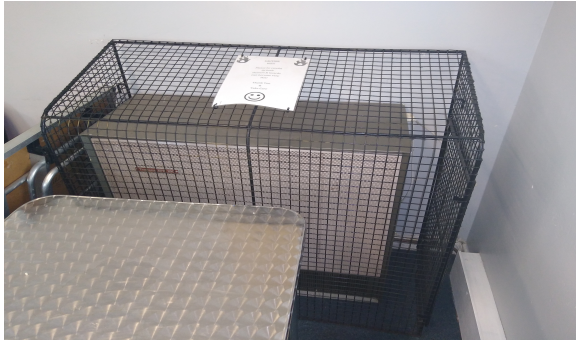
Item 25 Ref: Presumed

The electric heater in Rm 0/014 Meeting Room is presumed to contain asbestos.

Removed – no WCNs received.

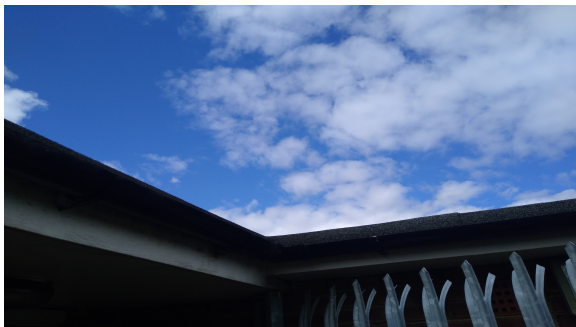
Item 26 Ref: 422055-15

The flat roof (External) does not contain asbestos.

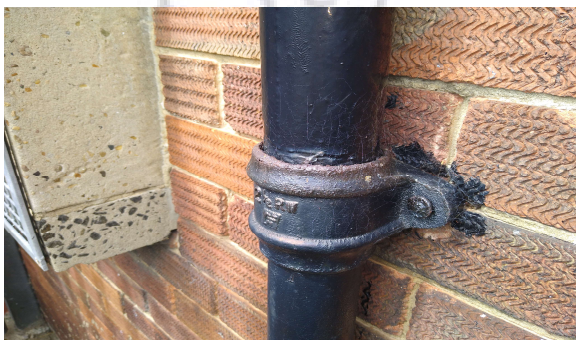
Item 27 Ref: 422055-16

The mastic in bracket (External) does not contain asbestos.

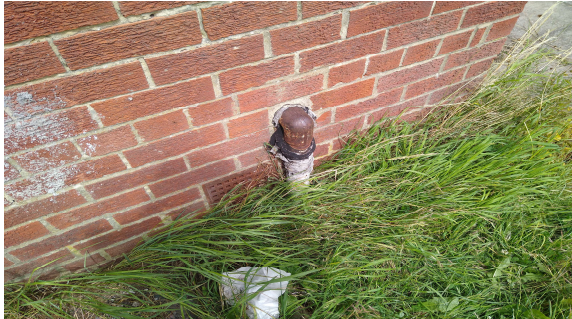
Item 28 Ref: 422055-17

The pipe lagging (External) does not contain asbestos.

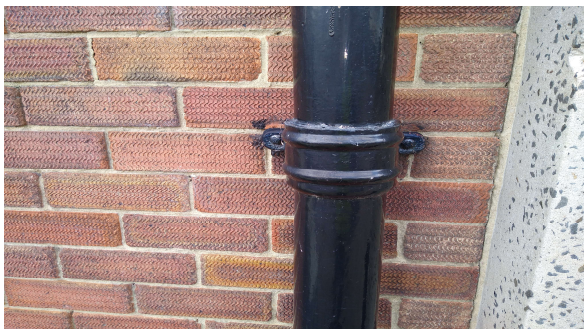
Item 29 Ref: Presumed

The soil pipe (External) is presumed to contain asbestos.

Any change in its appearance should be recorded and passed to Property Services.

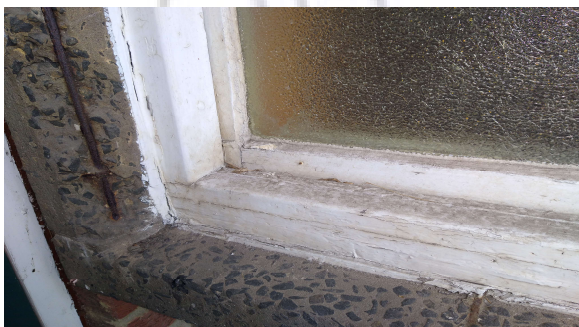
Item 30 Ref: 422055-18

The mastic to window frame (External) does not contain asbestos.

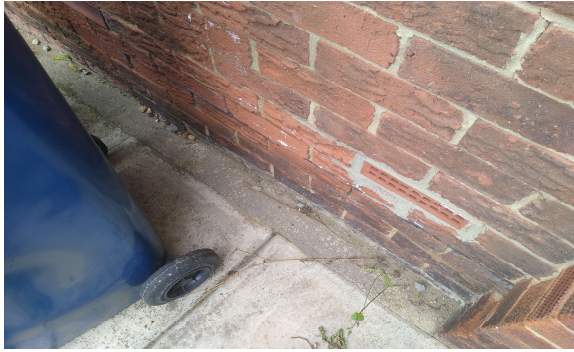
Item 31 Ref: As 422055-12

The damp proof course (External) does not contain asbestos.

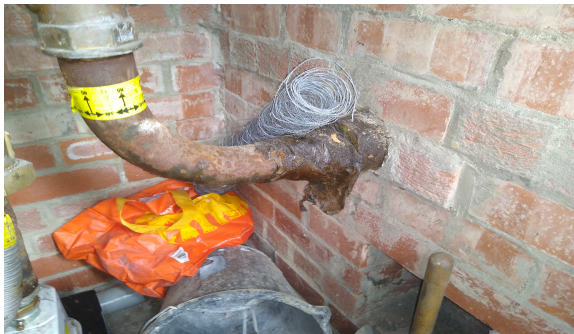
Item 32 Ref: As 422055-17

The pipe lagging in the gas store (External) does not contain asbestos.
