ASBESTOS SURVEY REPORT FOR HENDON HEALTH CENTRE, MEABURN TERRACE, SUNDERLAND, SR1 2RN

Asbestos Register for

Hendon Health Centre, Meaburn Terrace, Sunderland

Date: 26 June 2025

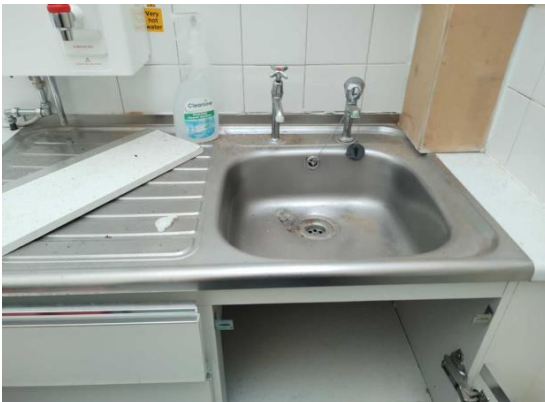
Item 2 Ref: 21-40548-2

The sink pad (Area 20/Kitchen and Cupboard) does not contain asbestos.

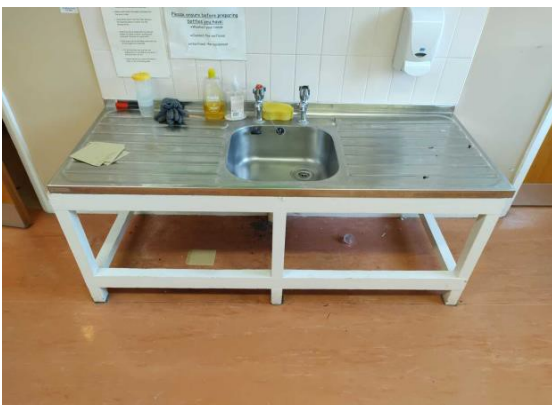
Item 3 Ref: 21-40548-3

The sink pad (Area 22/Playroom) does not contain asbestos.

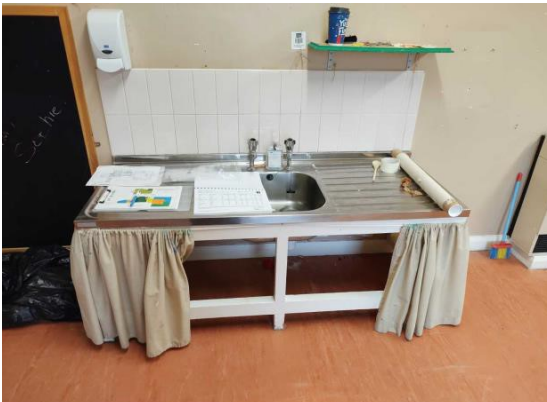
Item 5 Ref: 21-40548-4

The sink pad (Area 25/Playroom 2) does not contain asbestos.

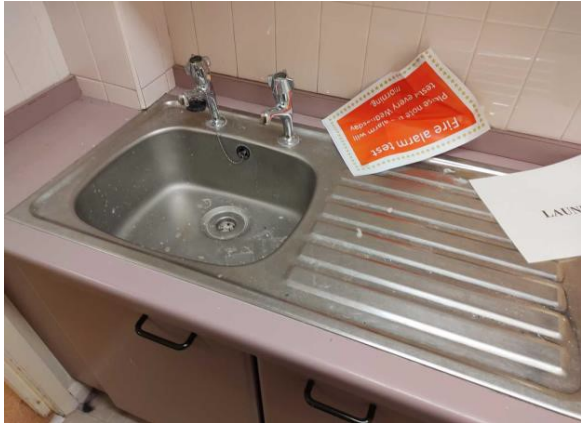
Item 7 Ref: 21-40548-5

The sink pad (Area 29/Laundry) does not contain asbestos.

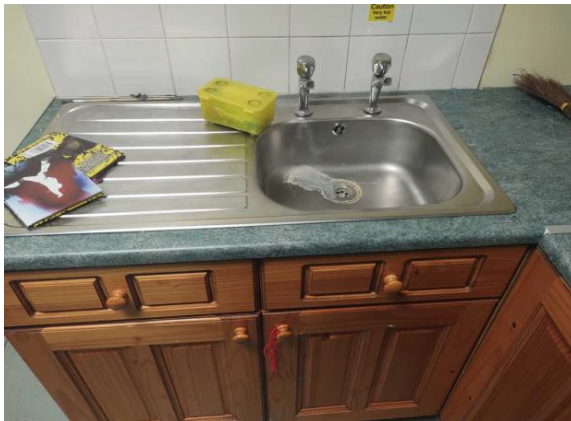
Item 8 Ref: 21-40548-6

The sink pad (Area 35/Family Room) does not contain asbestos.

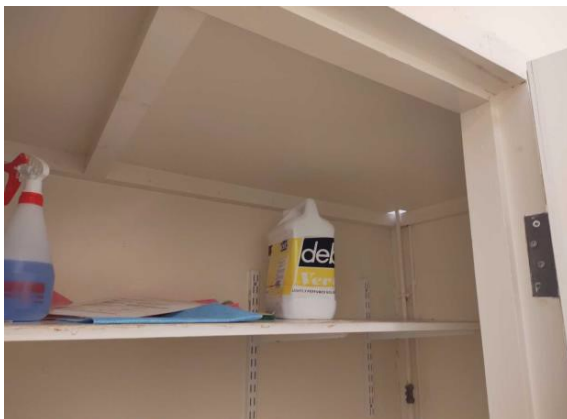
Item 9 Ref: 21-40548-7

The cupboard ceiling (Area 42/Male WC and Cupboard) does not contain asbestos.

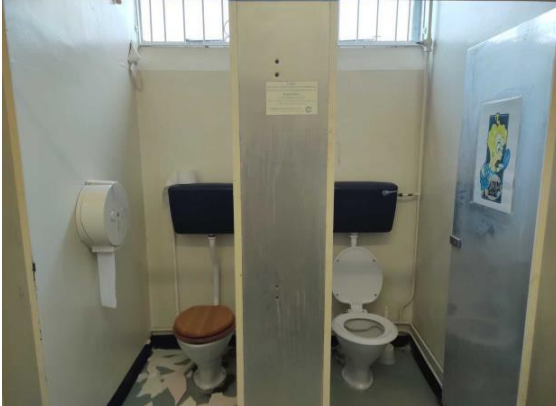
Item 10 Ref: 21-40548-8

The toilet (Area 43/Female WC) does not contain asbestos.

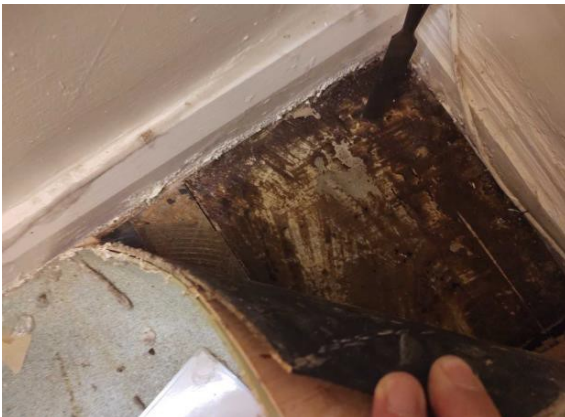
Item 11 Ref: 21-40548-9

The floor tiles and adhesive (Area 44/Store Cupboard) does not contain asbestos.

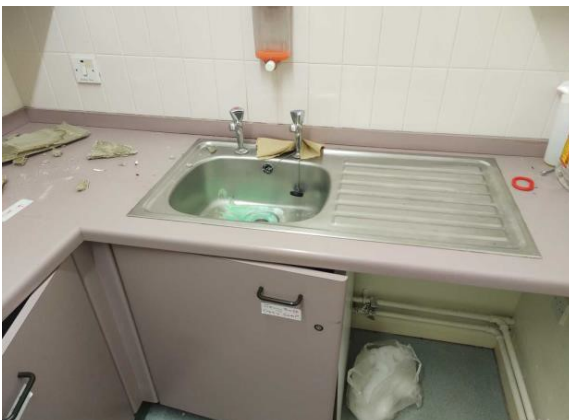
Item 12 Ref: 21-40548-10

The sink pad (Area 48/Kitchen young mums) does not contain asbestos.

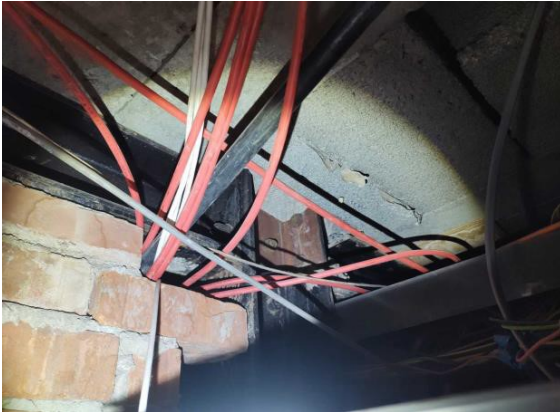
Item 16 Ref: Presumed

The ceiling (Area 64/Main entrance) is presumed to contain asbestos.

Item 16	Ceiling (Area 64/Main entrance)	Very Low Risk	12 monthly	13/12/2025
<i>Item 17</i>	<i>No asbestos</i>	<i>Is present</i>		
<i>Item 18</i>	<i>No asbestos</i>	<i>Is present</i>

Any change in its appearance should be recorded and passed to Property Services.

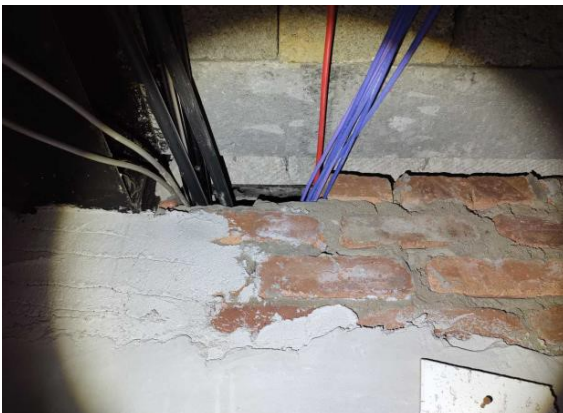
Item 21 Ref: Presumed

The shuttering within ceiling void (Area 75/Corridor 3) is presumed to contain asbestos.

Any change in its appearance should be recorded and passed to Property Services.

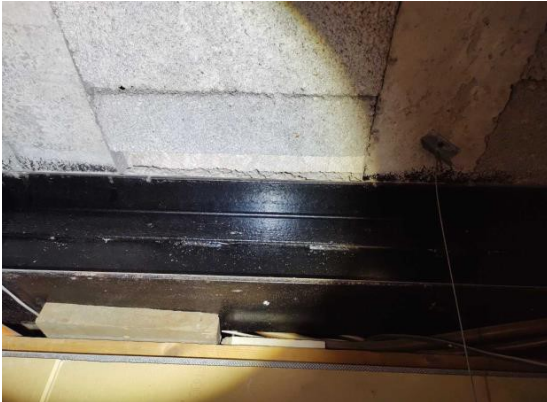
Item 25 Ref: Presumed

The cement shuttering within ceiling void (Area 85/Kitchen 2) is presumed to contain asbestos.

Any change in its appearance should be recorded and passed to Property Services.

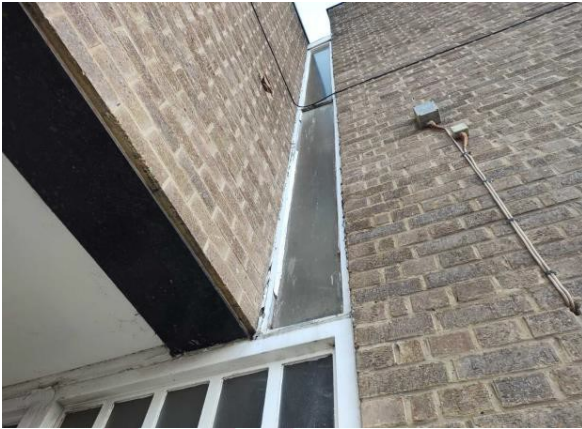
Item 29 Ref: 21-40548-18

The sealant to metal window frames (Area 95/External) contains asbestos.

Any change in its appearance should be recorded and passed to Property Services.

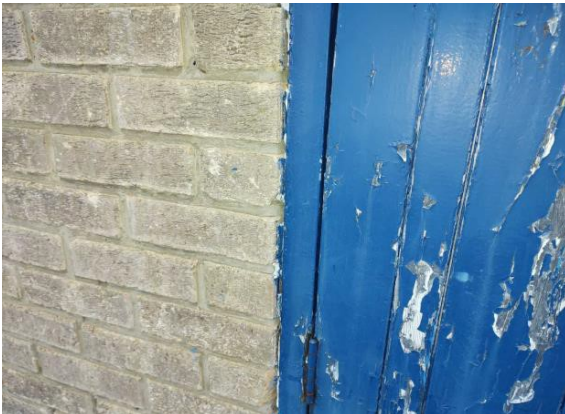
Item 32 Ref: 21-40548-21

The sealant to timber external door frame (Area 95/External) contains asbestos.

Any change in its appearance should be recorded and passed to Property Services.
