ASBESTOS SURVEY REPORT FOR JACKY WHITES MARKET, MARKET HALL, SOUTH STREET, SUNDERLAND, SR1 3DG.

Asbestos Register for

Jacky Whites Market, Market Hall, Sunderland, SR1 3DG

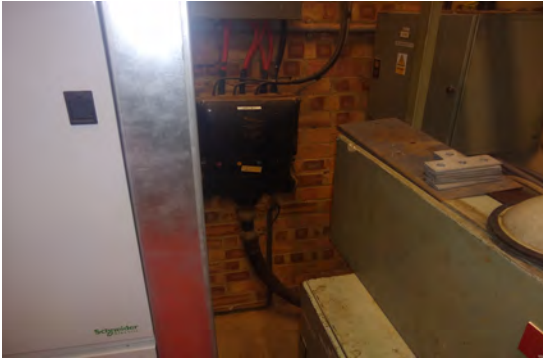
Item 1 Ref: Presumed

- (Item 1) Ref: Presumed – Cable wrap to income supply (0/002 electrics distribution store) – Low Risk
- (Item 2) Ref: Presumed – Electrics MEM (0/002 electrics distribution store) – Very Low Risk

The cable wrap to income supply in the Electrics Distribution Store (Rm 0/02) is presumed to contain asbestos.

Any change in its appearance should be reported to Property Services.

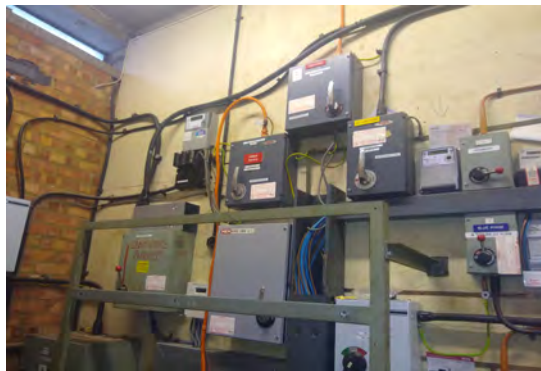
Item 2 Ref: Presumed

The electrics M.E.M in the Electrics Distribution Store (Rm 0/02) is presumed to contain asbestos.

Some items changed but no WCN received yet

Any change in its appearance should be reported to Property Services.

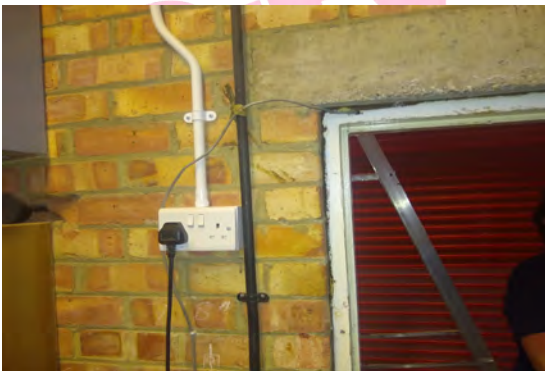
Item 3 Ref: 412163-12

- (Item 3) Ref: 412163-12 – Sealant to door frame (0/002 electrics distribution store) – Very Low Risk
- (Item 4) Ref: 412163-11 – Sealant to light (0/003 Loading bay) – Very Low Risk

The sealant to door frame in the Electrics Distribution Store (Rm 0/02) contains asbestos.

Any change in its appearance should be reported to Property Services.

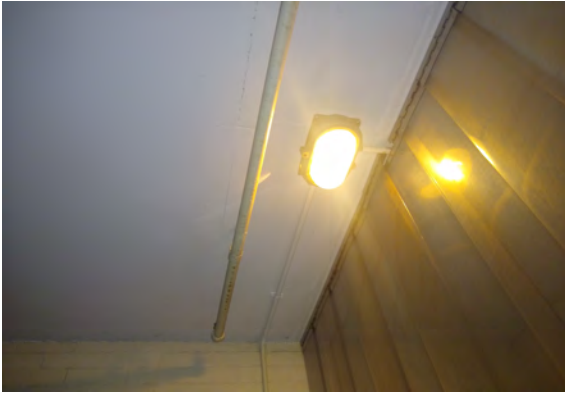
Item 4 Ref: 412163-11

The sealant to light in the Loading Bay (Rm 0/03) contains asbestos.

Any change in its appearance should be reported to Property Services.

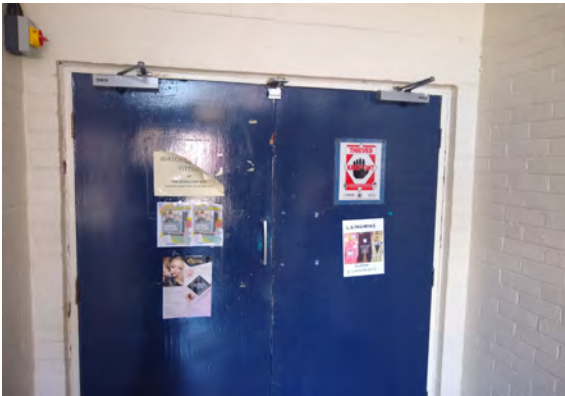
Item 5 Ref: 412163-15

- (Item 5) Ref: 412163-15 – Sealant to door frame (0/005 Lobby) – Very Low Risk
- (Item 6) Ref: As 412163-11 – Sealant to light (0/007 Loading Bay) - Very Low Risk

The sealant to door frame in the Lobby (Rm 0/05) contains asbestos.

Any change in its appearance should be reported to Property Services.

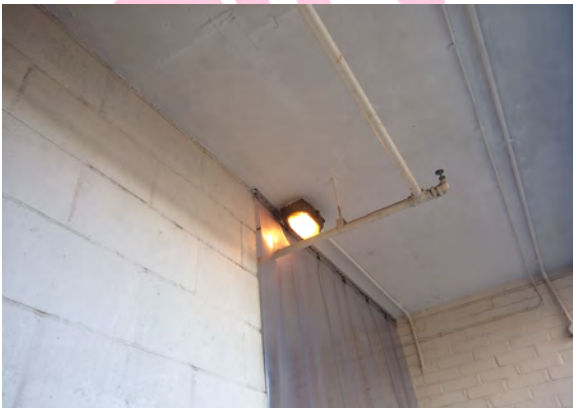
Item 6 Ref: As 412163-11

The sealant to light in the Loading Bay (Rm 0/07) contains asbestos.

Any change in its appearance should be reported to Property Services.

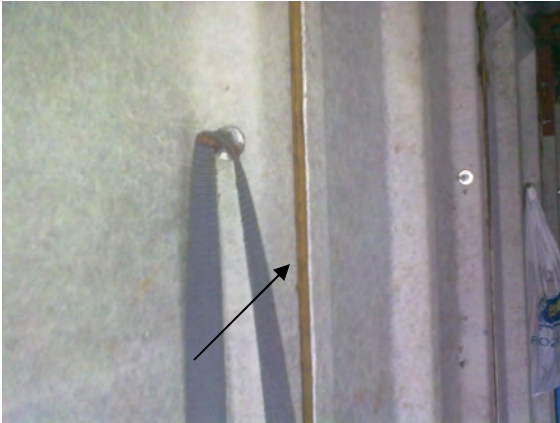
Item 7 Ref: 412163-16

The soffit and fascia above fire exit in the Lobby (Rm 0/08) does not contain asbestos.

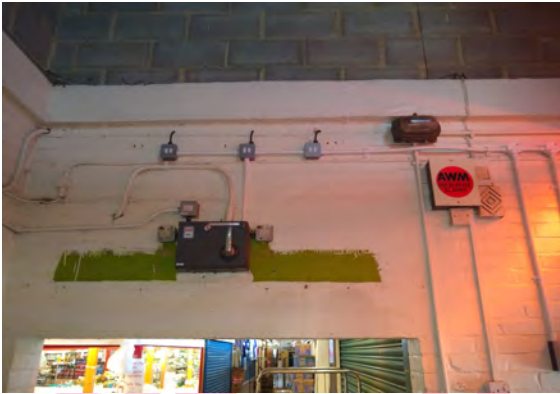
Item 8 Ref: Presumed

- (Item 7) Ref: 412162-16 – Soffit and fascia above fire exit (0/008 Lobby) – No Risk
- (Item 8) Ref: Presumed – Electrics MEM (0/008 Lobby) – Very Low Risk

The electrics M.E.M in the Lobby (Rm 0/08) are presumed to contain asbestos.

Item removed but no WCN received yet

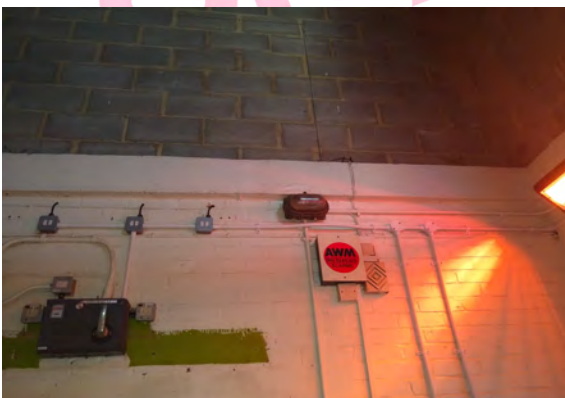
Item 9 Ref: As 412163-11

- (Item 9) Ref: As 412163-11 – Sealant to light fitting (0/008 Lobby) – Very Low Risk
- (Item 10) Ref: 412163-17 – Firebreak to shopping centre (0/009 main entrance lobby void above) – No Risk

The sealant to light fittings in the Lobby (Rm 0/08) contains asbestos.

Any change in its appearance should be reported to Property Services.

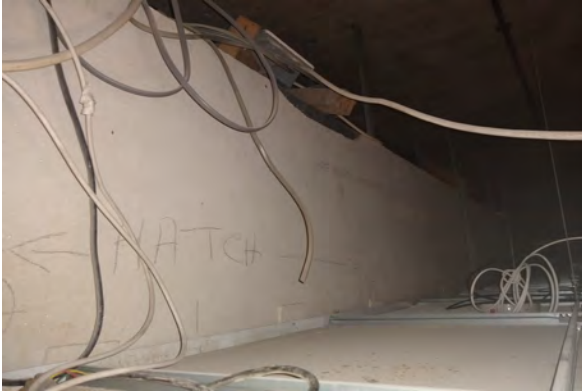
Item 10 Ref: 412163-17

The firebreak to shopping centre in the Main Entrance Lobby – void above suspended ceiling (Rm 0/09) does not contain asbestos.

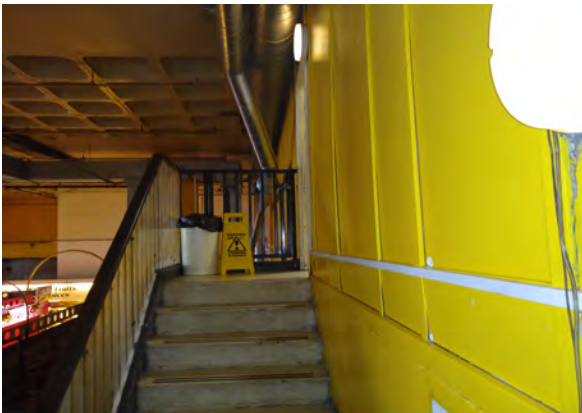
Item 11 Ref: As 412163-9

The partition wall to corridor in the Stairwell (Rm 0/12) does not contain asbestos.

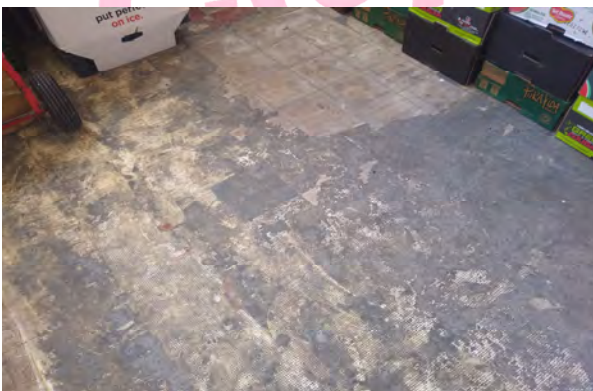
Item 12 Ref: 412163-14

The floor covering to vacant store unit 28 in the Market Hall (Rm 0/13) does not contain asbestos.

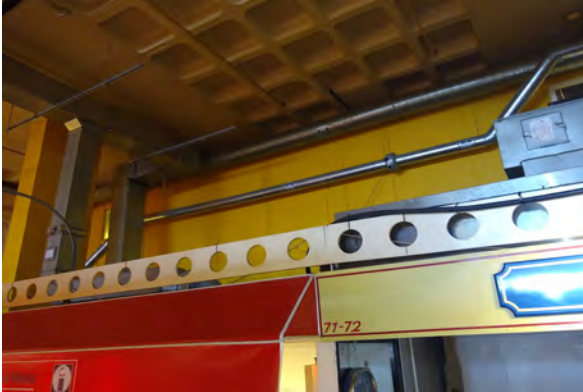
Item 13 Ref: As 412163-9

The partition walls back side of first floor corridor in the Market Hall (Rm 0/13) does not contain asbestos.

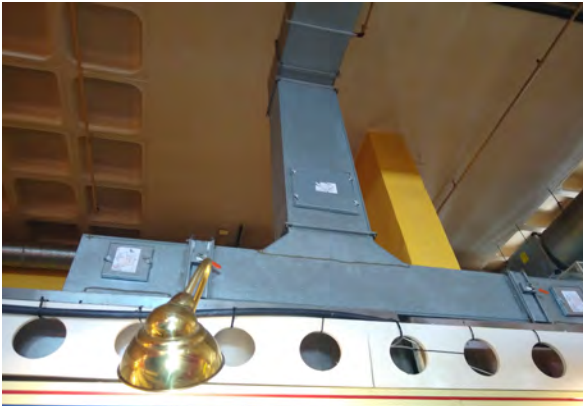
Item 14 Ref: 412163-18

The seal to ductwork in the Market Hall (Rm 0/13) does not contain asbestos.

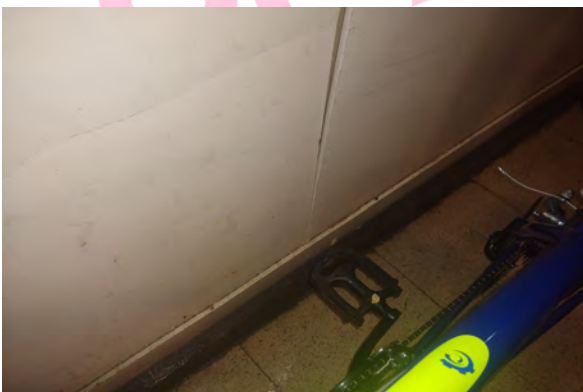
Item 15 Ref: As 412163-9

The skirting to partition wall in the Corridor (Rm 1/02) does not contain asbestos.

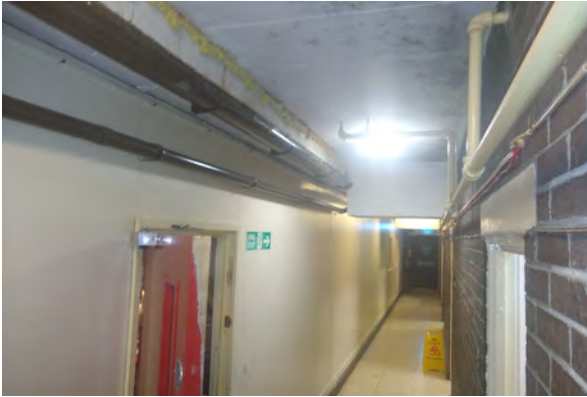
Item 16 Ref: 412163-9

The partition wall in the Corridor (Rm 1/02) does not contain asbestos.

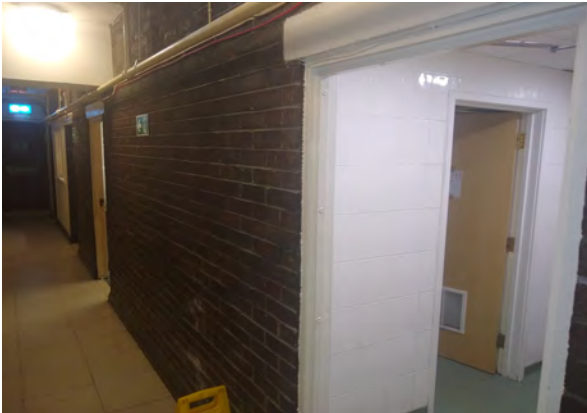
Item 17 Ref: 412163-10

- (Item 17) Ref: 412163-10 – Sealant to door frames (1/002 Corridor) – Very Low Risk
- (Item 18) Ref: 412163-6 – Yellow and black floor covering below sink (1/003 Tea room) – Very Low Risk

The sealant to door frames in the Corridor (Rm 1/02) contains asbestos.

Any change in its appearance should be reported to Property Services.

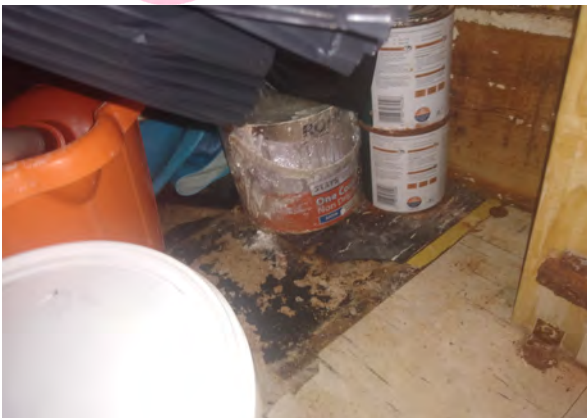
Item 18 Ref: 412163-6

The yellow and black floor covering below sink in the Tea Room (Rm 1/03) contains asbestos.

Any change in its appearance should be reported to Property Services.

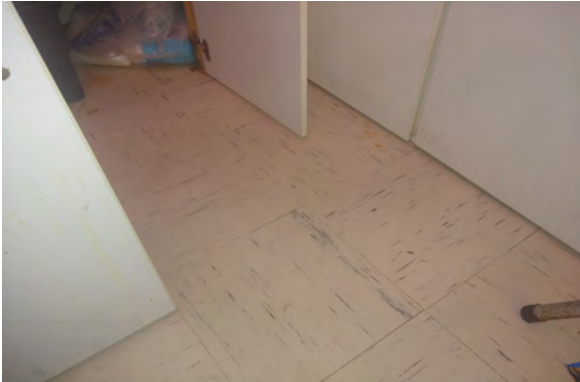
Item 19 Ref: 412163-7

- (Item 19) Ref: 412163-7 – White floor covering (1/003 Tea room) -Very Low Risk
- (Item 20) Ref: 412163-8 – Acoustic dampening finish to sink base (1/003 Tea room) – No Risk

The white floor covering in the Tea Room (Rm 1/03) contains asbestos.

Any change in its appearance should be reported to Property Services.

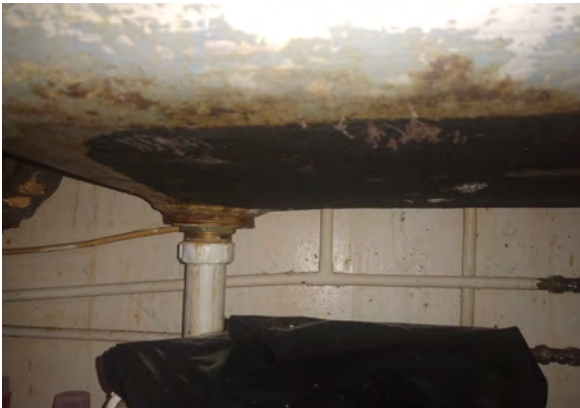
Item 20 Ref: 412163-8

The acoustic dampening finish to sink in the Tea Room (Rm 1/03) does not contain asbestos.

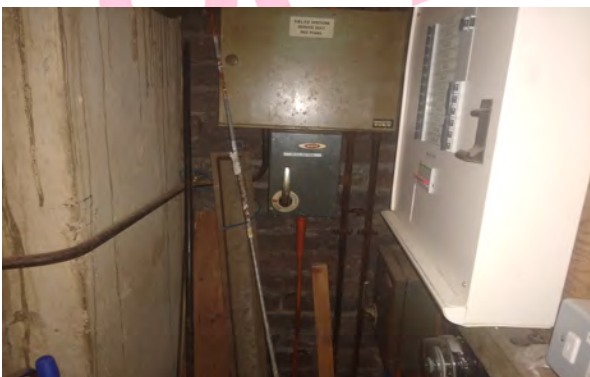
Item 21 Ref: Presumed

- (Item 21) Ref: Presumed – Electrics MEM (1/007 Toilet cistern service void) – Very Low Risk
- (Item 22) Ref: 412163-4 – Remnant tile adhesive below lino (1/010 Prep room) – Very Low Risk

The electrics M.E.M in the Toilet Cistern Service Void (Rm 1/07) are presumed to contain asbestos.

Any change in its appearance should be reported to Property Services.

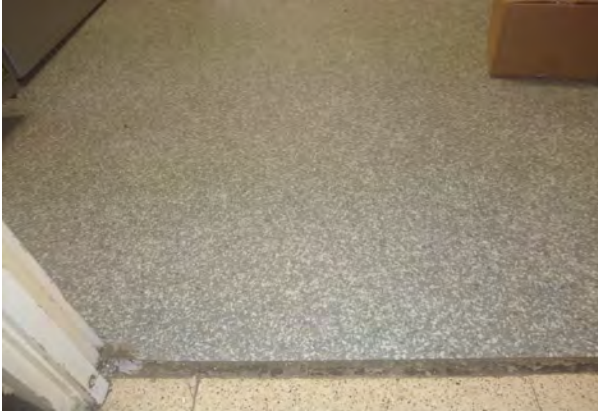
Item 22 Ref: 412163-4

The remnant tile adhesive below lino in the Prep Room (Rm 1/10) contains asbestos.

Any change in its appearance should be reported to Property Services.

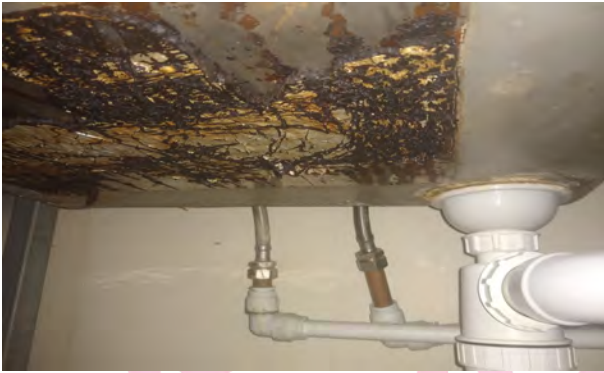
Item 23 Ref: 412163-5

- (Item 23) Ref: 412163-5 – Sink pad (1/010 Prep room) – Removed
- (Item 24) Ref: 412163-3 – Black and white floor covering removed May 2021 Bitumen remains (1/011 Store) Very Low Risk

The sink pad in the Prep Room (Rm 1/10) contains asbestos.

Any change in its appearance should be reported to Property Services.

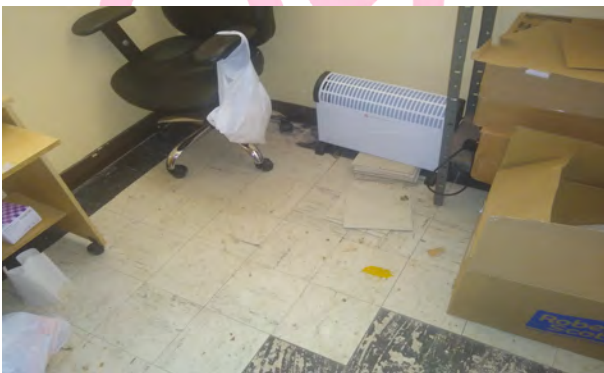
Item 24 Ref: 412163-3

The black and white floor covering in the Store (Rm 1/11) contains asbestos. Removed May 2021. However Bitumen remains and any change in its appearance should be reported to Property Services.

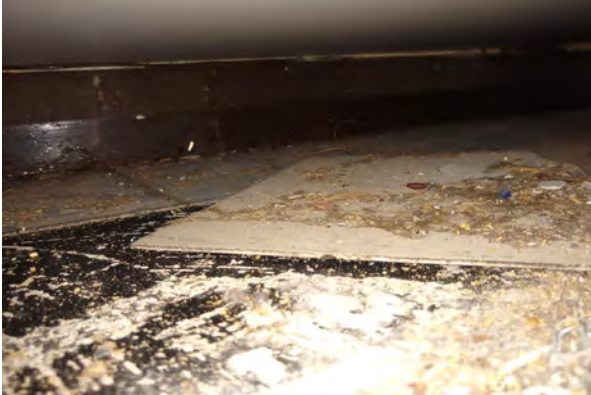
Item 25 Ref: 412163-1

- (Item 25) Ref: 412163-1 – Remnant floor covering below cupboards (1/014 Office) – Very Low Risk
- (Item 26) Ref: 412163-2 – Floor covering (1/014 Office) – Very Low Risk

The remnant floor covering below cupboards in the Office (Rm 1/14) contains asbestos.

Any change in its appearance should be reported to Property Services.

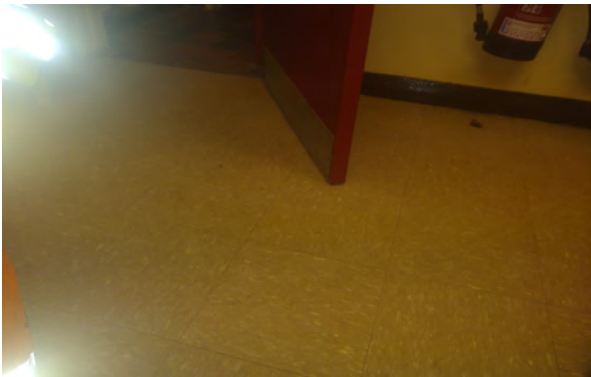
Item 26 Ref: 412163-2

The floor covering in the Office (Rm 1/14) contains asbestos.

Any change in its appearance should be reported to Property Services.

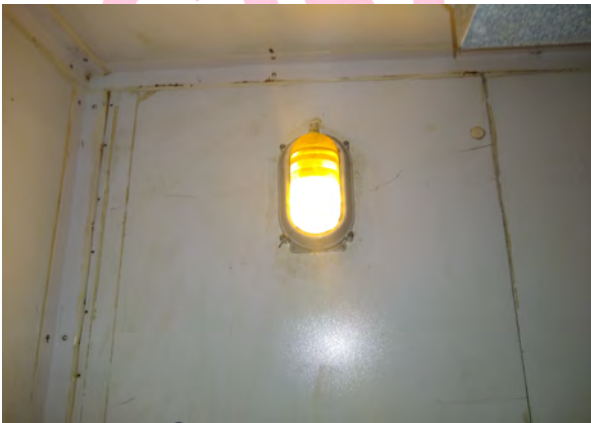
Item 27 Ref: 412163-19

- (Item 27) Ref: 412163-19 – Mastic to light fittings (1/021 Chiller above greengrocer) – Very Low Risk
- (Item 28) Ref: 412163-20 - Seal to expansion joints (External) – No Risk

The mastic to light fittings in the Chiller above greengrocers (Rm 1/21) contains asbestos.

Any change in its appearance should be reported to Property Services.

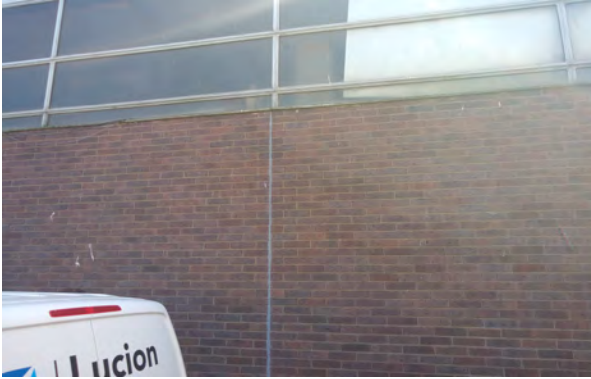
Item 28 Ref: 412163-20

The seal to expansion joints (External) does not contain asbestos.

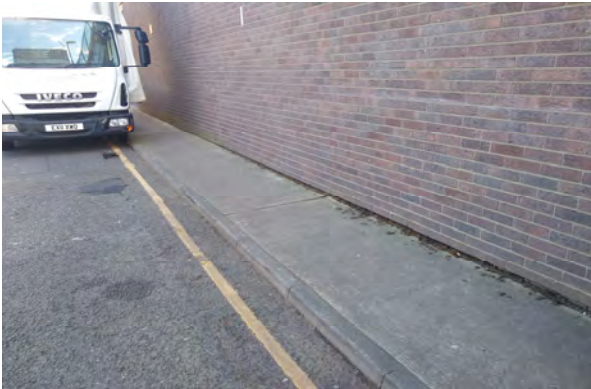
Item 29 Ref: 412163-21

The damp proof course (External) does not contain asbestos.

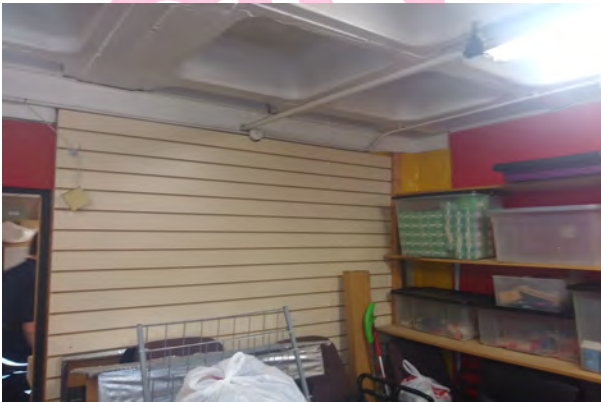
Item 30 Ref: 412163-13

The partition wall in the Store – Former Jewellery Box Outlet (Rm 1/16) does not contain asbestos.

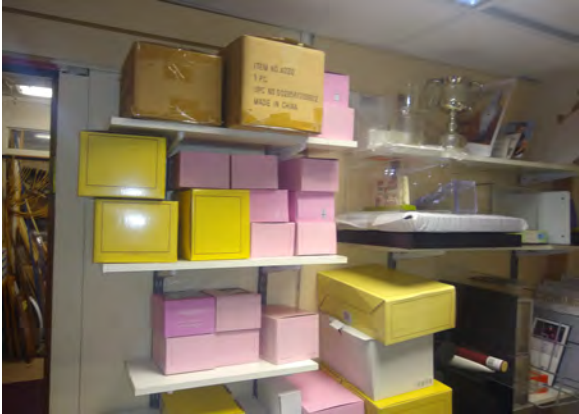
Item 31 Ref:As412163-13

The partition wall in the Store – Former Jewellery Box Outlet (Rm 1/17) does not contain asbestos.

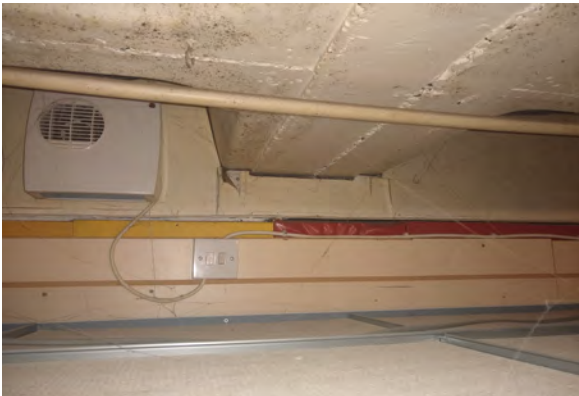
Item 32 Ref:As412163-13

The partition wall in the void above Store – Former Jewellery Box Outlet (Rm 1/17) does not contain asbestos.

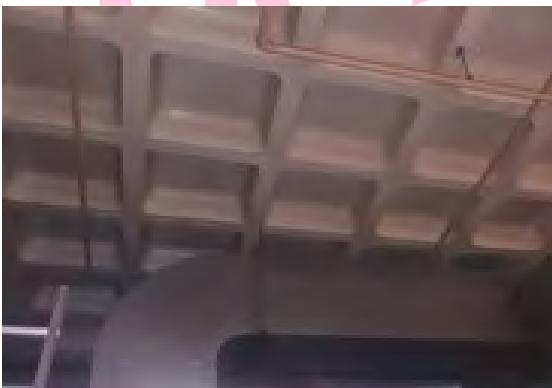
Item 33 Ref: NZ000693

The mastic to joints (G/001 Large Room above market café) does not contain asbestos.

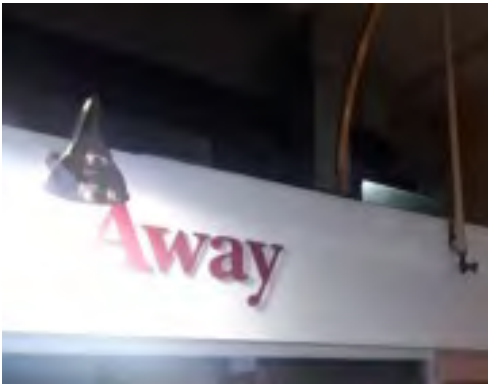
Item 34 Ref: NZ000694

The debris/residue to top of tiles and ductwork (G/001 Large Room above market café) does not contain asbestos.

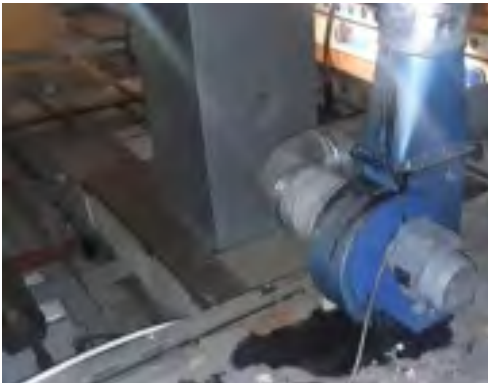
Item 35 Ref: NZ000697

The ductwork gaskets to pump (G/001 Large Room above market café) does not contain asbestos.

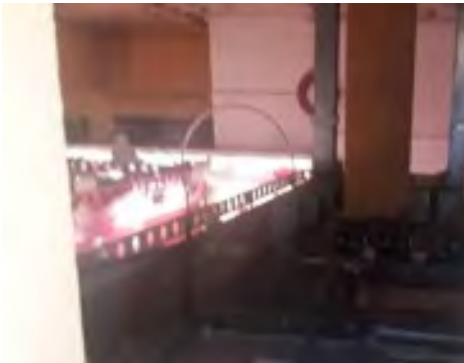
Item 37 Ref: NZ000696

The debris/residue to top of tiles and ductwork (G/002 Large room above Butchers and Seafood stall) does not contain asbestos.

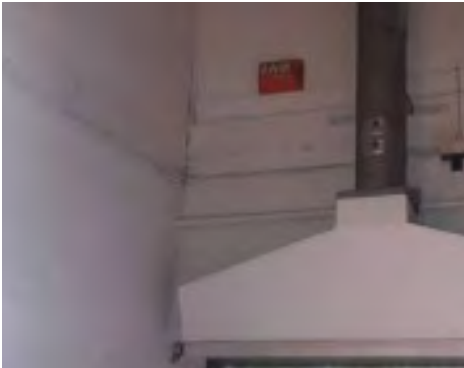
Item 38 Ref: NZ000698

The debris/residue within ductwork (G/002 Large room above Butchers and Seafood stall) does not contain asbestos.

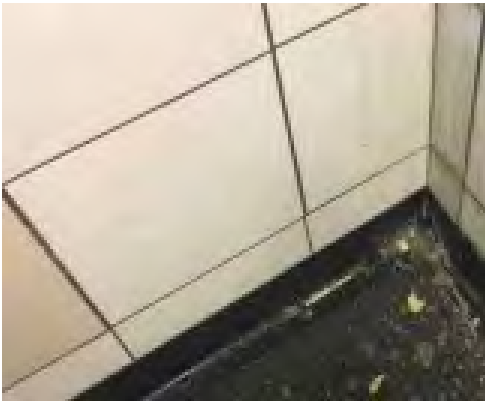
Item 40 Ref: AW005595

The floor debris in the Room Lift Lobby (G/001) does not contain asbestos.

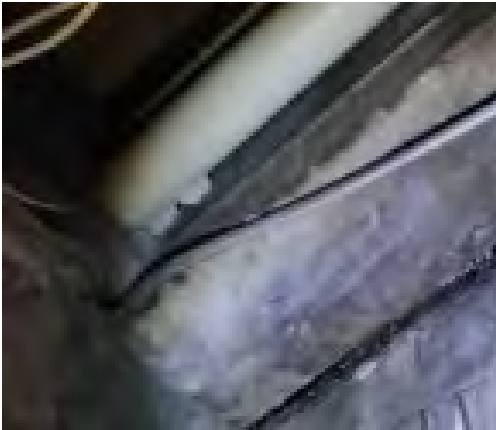
Item 41 Ref: AW005596

The ceiling void panel to expansion joint in the Room Lift Lobby (G/001) does not contain asbestos.

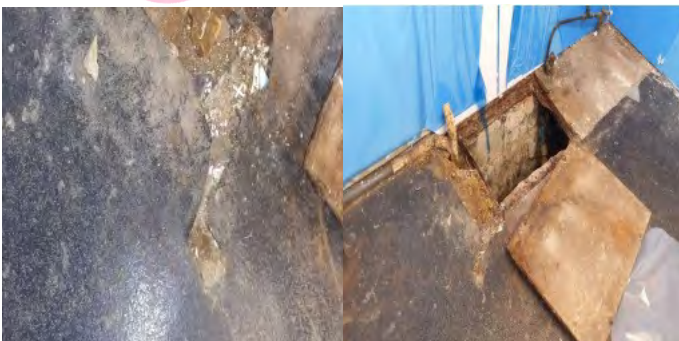
Item 42 Ref: OU001493

The vinyl floor to Unit 71-72 (G/01) does not contain asbestos.

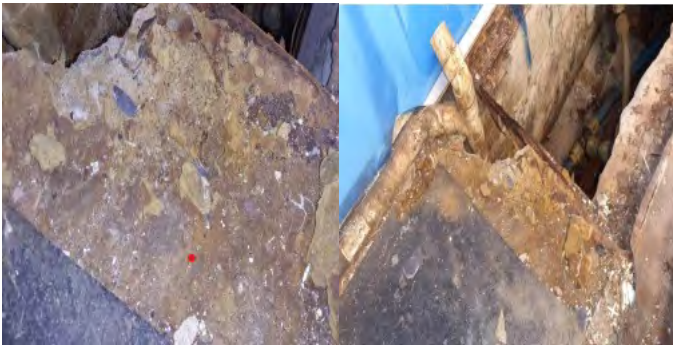
Item 43 Ref: OU001494

The residual adhesive beneath vinyl screed to unit 71-72 (G/01) does not contain asbestos.

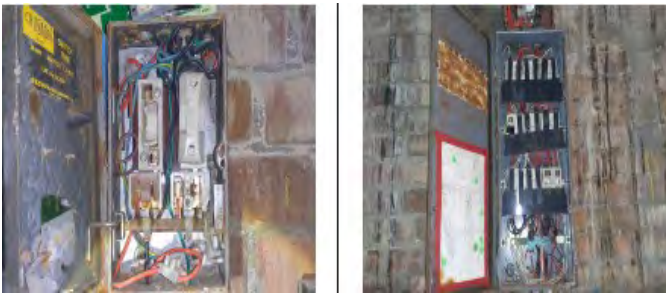
Item 44 Ref: PK002166

- (Item 43) Ref: OU001494 – Residual adhesive beneath vinyl and screed (Unit 71-71 G/01) – No Risk
- (Item 44) Ref: PK002166 – Flash guards electrical switch gear (Store Room G/01) – Low Risk

The flash guards – electrical switch gear in the Store Room (G/01) does contain asbestos.

Any change in appearance should be reported to Property Services.

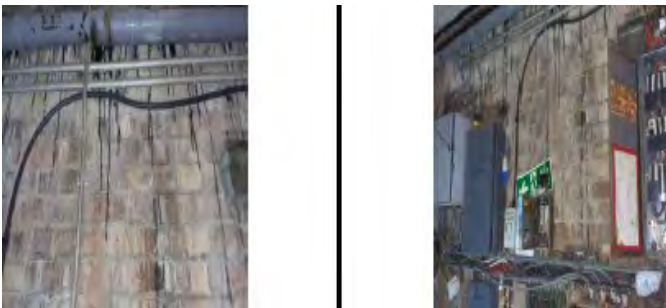
Item 45 Ref: PK002167

The bitumen drip – wall and ceiling in the store room (G/01) does not contain asbestos.
