ASBESTOS SURVEY REPORT FOR DEPTFORD & MILLFIELD CA, SUNDERLAND

Asbestos Register for DEPTFORD & MILLFIELD CA, SUNDERLAND

Date: 26 September 2024

Last updated 26/09/2024 – Depford and Millfield CA – Version 2

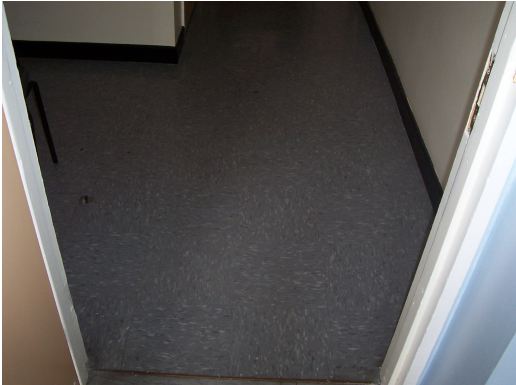
Item 1 Ref: CS06/967

The grey floor tiles to the disabled male WC do not contain asbestos.

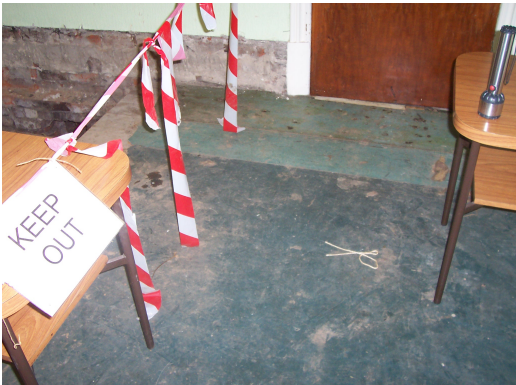
Item 2 - Ref: CS06/969

The blue and grey vinyl flooring over wood in communal room 1 does not contain asbestos.

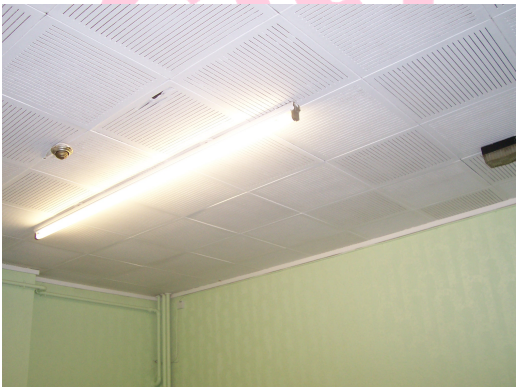
Item 3 - Ref: CS06/970

The coating to the fibreboard ceiling tiles in communal room 1 does not contain asbestos.

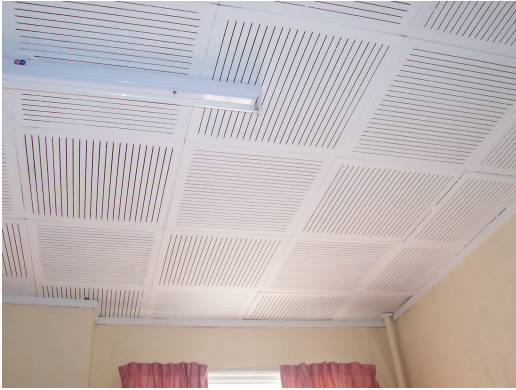
Item 4 - As CS06/970

The coating to the fibreboard ceiling in the office does not contain asbestos.

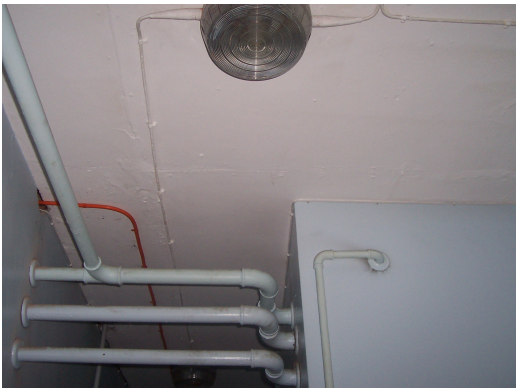
Item 5 - As CS06/972

The cement ceiling panels to area above kitchen door contain asbestos. Any change in its appearance should be recorded, and passed to Property Services.

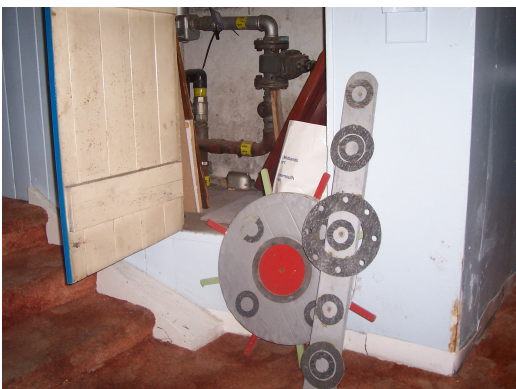
Item 6 - Ref: CS06/971

The redundant gaskets in the under stairs cupboard contain asbestos. Any change in its appearance should be recorded, and passed to Property Services.

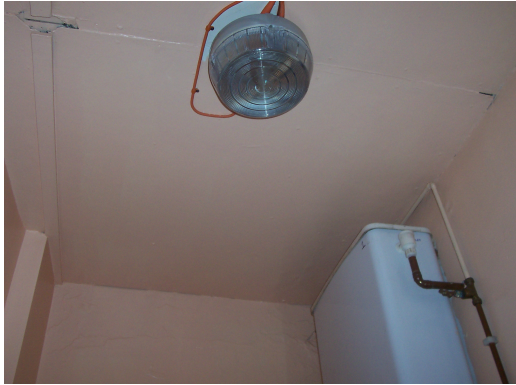
Item 7 - Ref: CS06/972

The cement ceiling panels to the kitchen contain asbestos. Any change in its appearance should be recorded, and passed to Property Services.

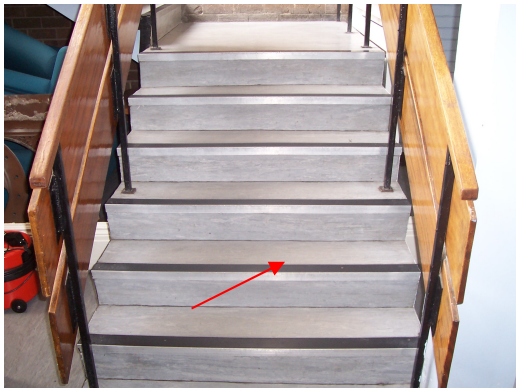
Item 8 - Ref: CS06/973

The stair nosing to the foyer, stairs and lobby does not contain asbestos.

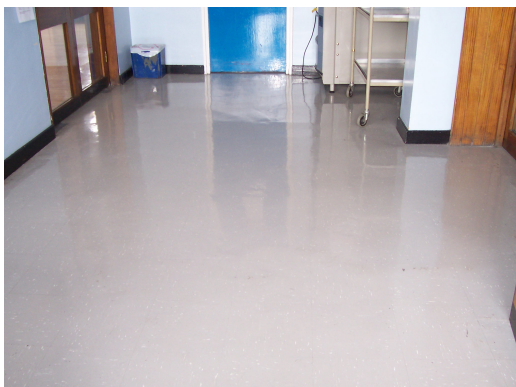
Item 9 - Ref: CS06/974

The grey floor tiles to the foyer, stairs and landing do not contain asbestos.

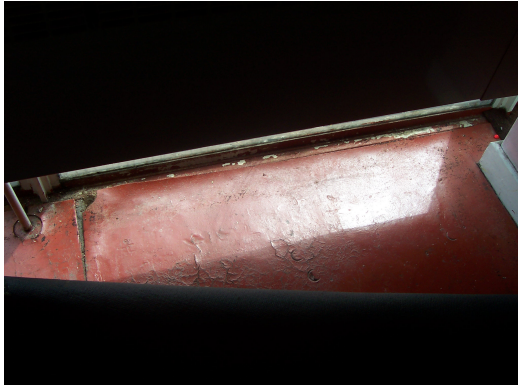
Item 10 - CS06/975

The red vinyl flooring under carpet & adhesive in dressing room 1 does not contain asbestos.

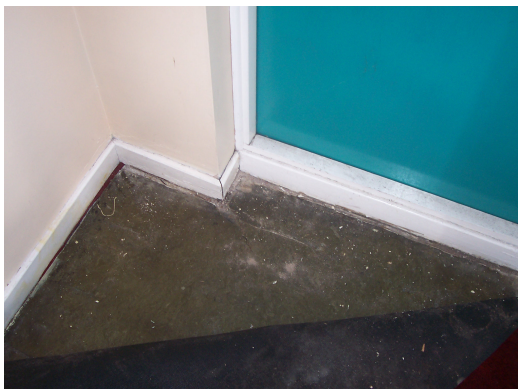
Item 11 - CS06/976

The green vinyl flooring under carpet & adhesive in dressing room 2 does not contain asbestos.

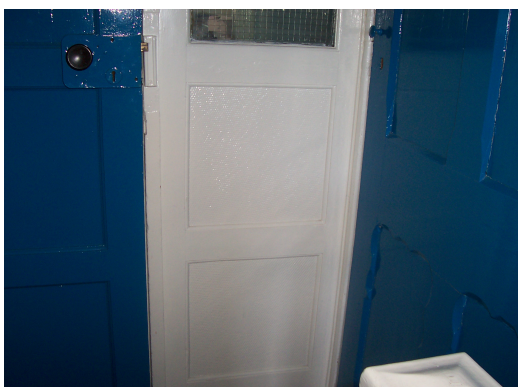
Item 12 - CS06/977

The cement panels to side of door on stairs 2 to second floor and landing does contain asbestos. Any change in its appearance should be recorded, and passed to Property Services.

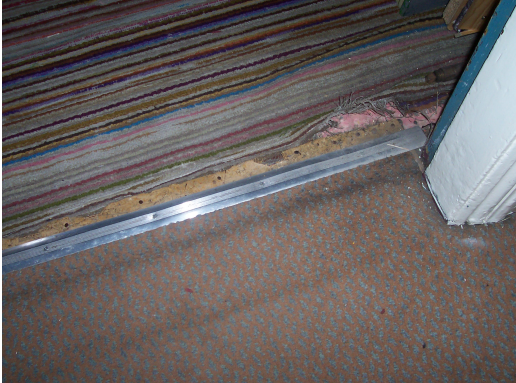
Item 13 - CS06/978

The beige flooring under carpet on corridor 3 does not contain asbestos.

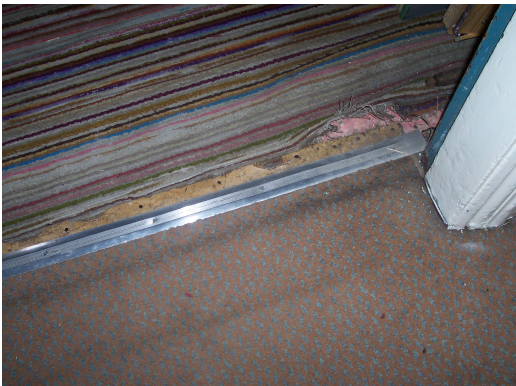
Item 14 - CS06/979

The red vinyl covering under carpet in store 8 does not contain asbestos.

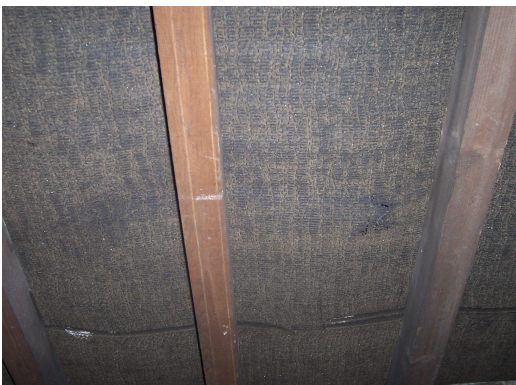
Item 15 - CS06/980

The sarking felt to roof in the loft does not contain asbestos.

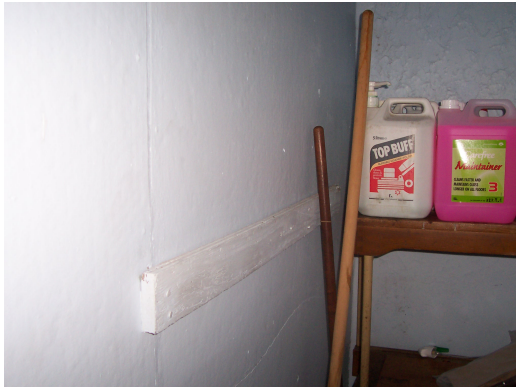
Item 16 - CS06/981

The cement panels to the walls in the cleaners store contain asbestos. Any change in its appearance should be recorded, and passed to Property Services.

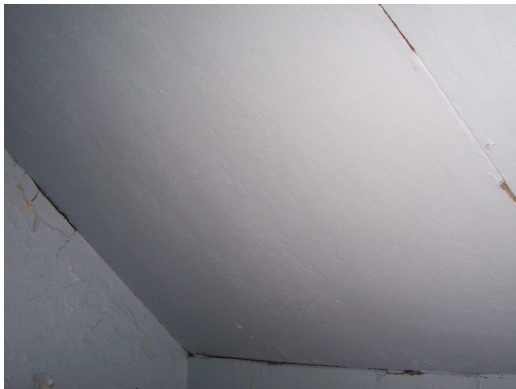
Item 17 - CS06/982

The cement panels to the ceiling angle in the cleaners store contain asbestos. Any change in its appearance should be recorded, and passed to Property Services.

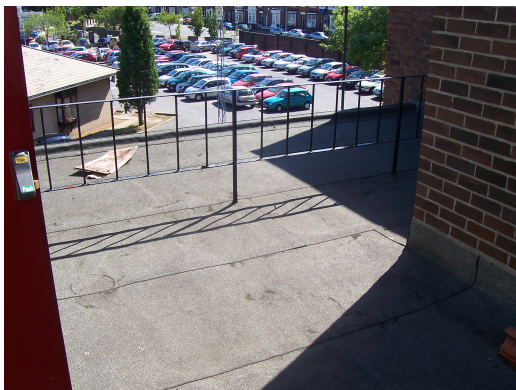
Item 18 - CS06/983

The external flat roof felt does not contain asbestos.

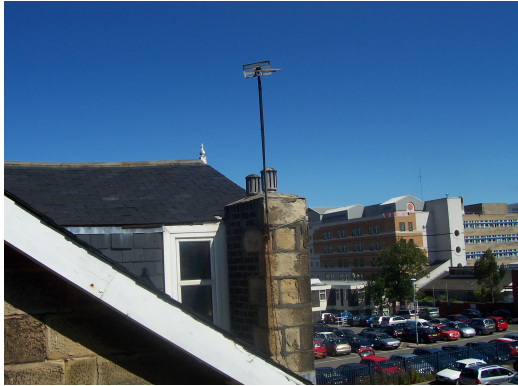
Item 19 – presumed

The four external cement flues are presumed to contain asbestos. Any change in its appearance should be recorded, and passed to Property Services.

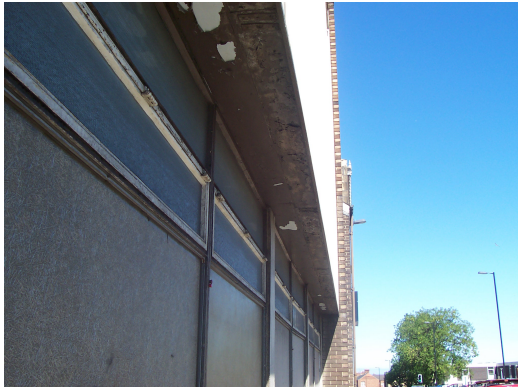
Item 20 - CS06/984

The cement soffits to the ground level contain asbestos. Any change in its appearance should be recorded, and passed to Property Services.

Encapsulated October 2020

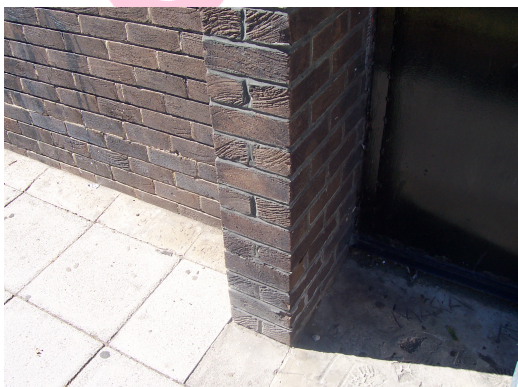
Item 21 - CS06/985

The external damp proof course does not contain asbestos.

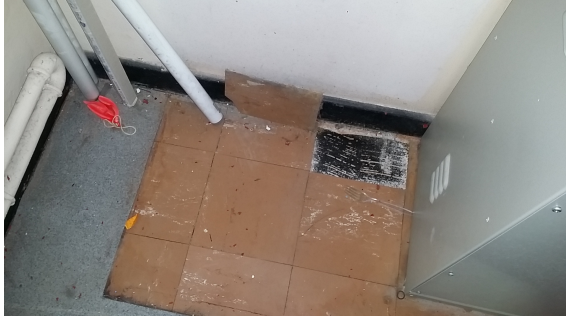
Item 22 – 250834-2

Floor tile with bitumen adhesive in 0/02/female toilets contain asbestos.

Any change in its appearance should be recorded, and passed to Property Services.

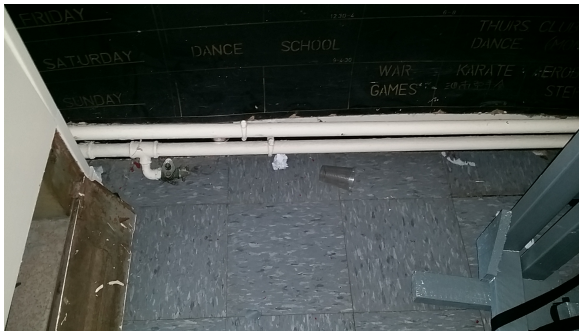
Item 23 – 250834-3

Floor tile with bitumen adhesive in 0/03/male toilets contain asbestos.

Any change in its appearance should be recorded, and passed to Property Services.

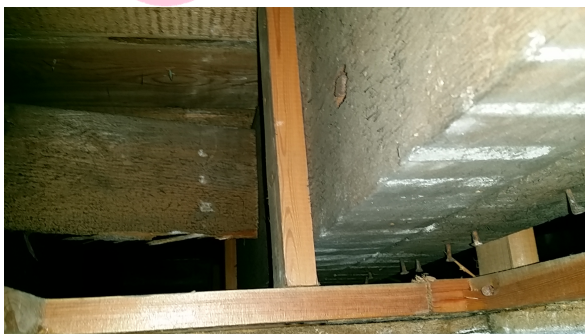
Item 24 – 250834-4

Debris to beams nails & nail holes within beams in 0/04/communal room 1 (void above) do not contain asbestos.

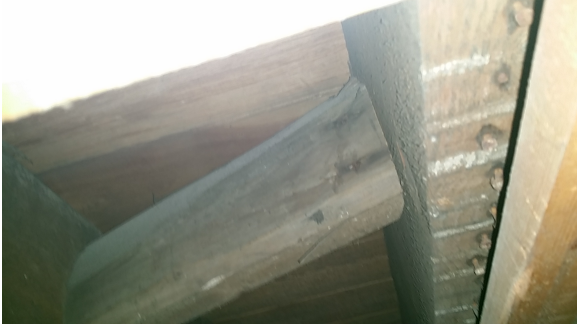
Item 25 – As 250834-4

Debris to beams nails & nail holes within beams in 0/05/office (void above) do not contain asbestos.

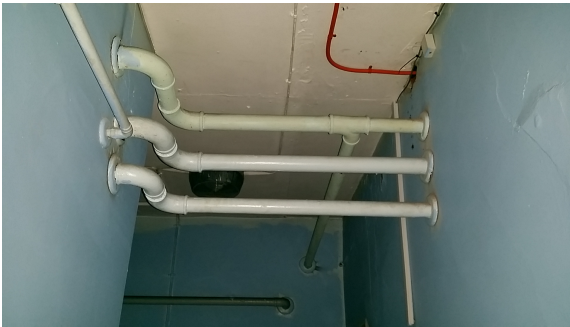
Item 26 – 250834-6

Ceiling in 0/08/corridor contains asbestos.

Any change in its appearance should be recorded, and passed to Property Services.

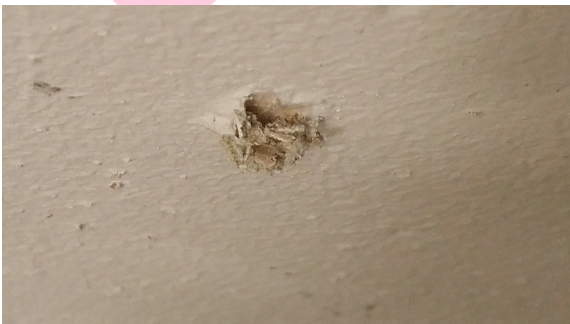
Item 27 – 250834-10

Debris to wall in ground floor boiler room contains asbestos.

Item 27	Debris to wall in ground floor boiler room	Medium	Environmental Clean	Debris removed June 2018
Item 28	Debris to wall in ground floor boiler room	Medium	Environmental Clean	Debris removed June 2018

Environmental clean completed June 2018 – asbestos debris removed

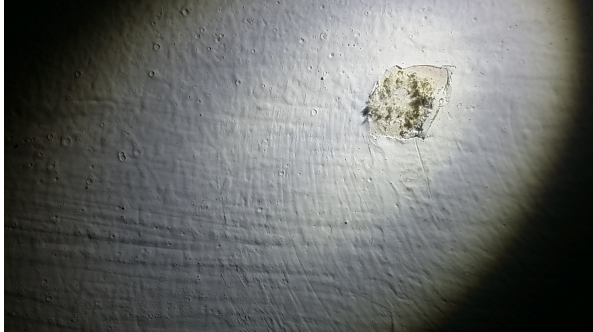
Item 28 – 250834-11

Debris to wall in ground floor boiler room contains asbestos.

Environmental clean completed June 2018 – asbestos debris removed

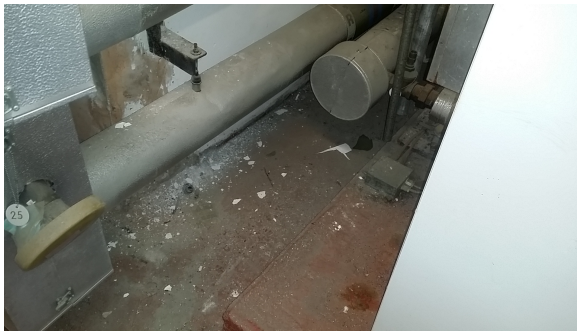
Item 29 – 250834-12

General debris to floor in ground floor boiler room contains asbestos.

Item 29	General debris to floor in ground floor boiler room	Medium	Environmental Clean	Debris removed June 2018
Item 30	General debris to pipe penetration in floor in ground floor boiler room	Medium	Environmental Clean	Debris removed June 2018

Environmental clean completed June 2018 – asbestos debris removed

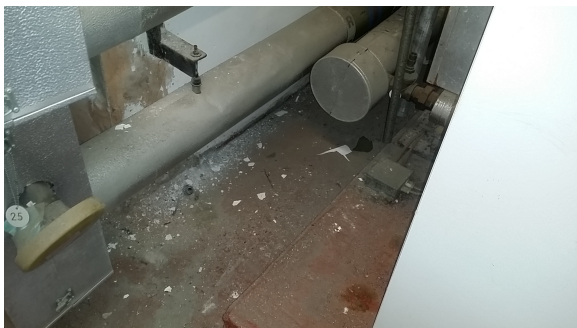
Item 30 – 250834-13

General debris to pipe penetration in floor in ground floor boiler room contains asbestos.

Environmental clean completed June 2018 – asbestos debris removed

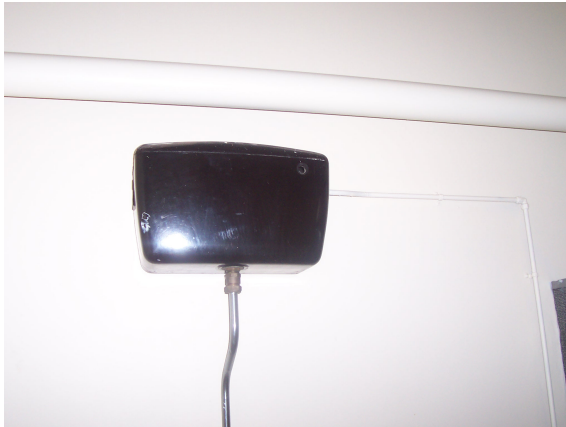
Item 31 – CS06-968

The 2xToilet Cisterns and 1xSeat in the Male WC contains asbestos.

Removed from property but no WCN paperwork.

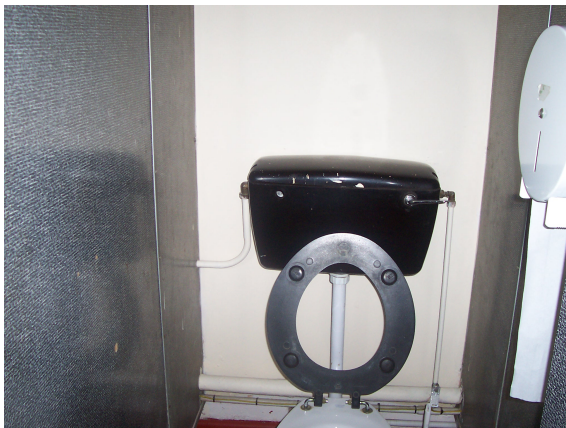
Item 32 – As CS06-968

The 2xToilet Cisterns and 2xSeat in the Female WC contains asbestos.

Removed from property but no WCN paperwork.

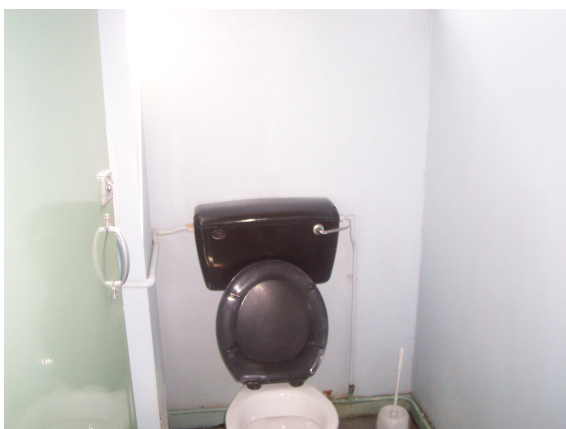
Item 33 – As CS06-968

The Toilet Cistern and Seat in the Male WC contains asbestos.

Removed from property but no WCN paperwork.

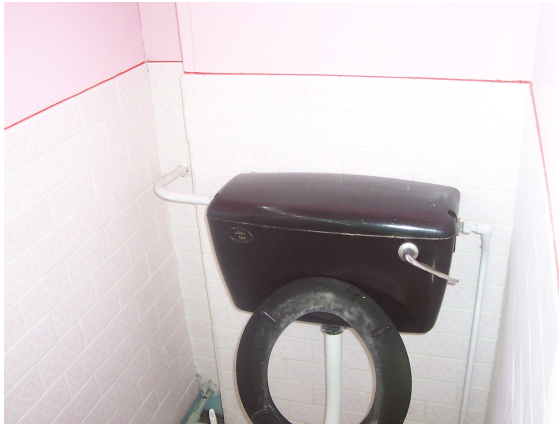
Item 34 – As CS06-968

The Toilet Cistern and Seat in the Ladies WC contains asbestos.

Removed from property but no WCN paperwork.
