ASBESTOS SURVEY REPORT FOR DEPTFORD & MILLFIELD CA, SUNDERLAND

Asbestos Register for DEPTFORD & MILLFIELD CA, SUNDERLAND

TF Ref: CMF006.01

Date: 03 April 2025

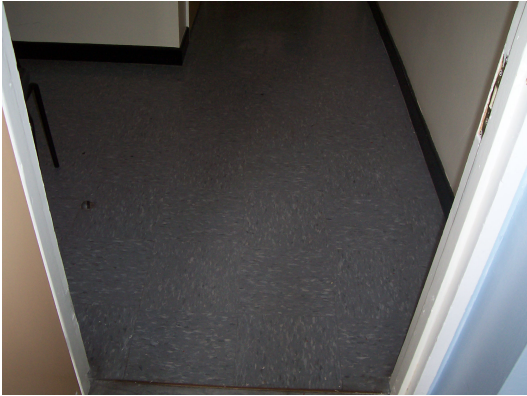
Item 1 Ref: CS06/967

The grey floor tiles to the disabled male WC do not contain asbestos.

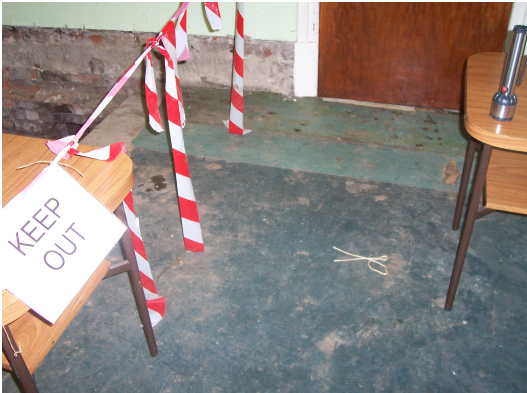
Item 2 - Ref: CS06/969

The blue and grey vinyl flooring over wood in communal room 1 does not contain asbestos.

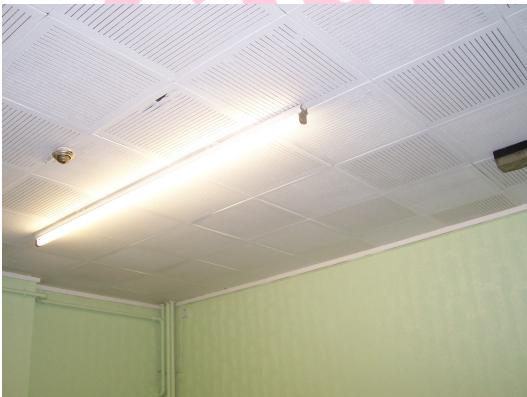
Item 3 - Ref: CS06/970

The coating to the fibreboard ceiling tiles in communal room 1 does not contain asbestos.

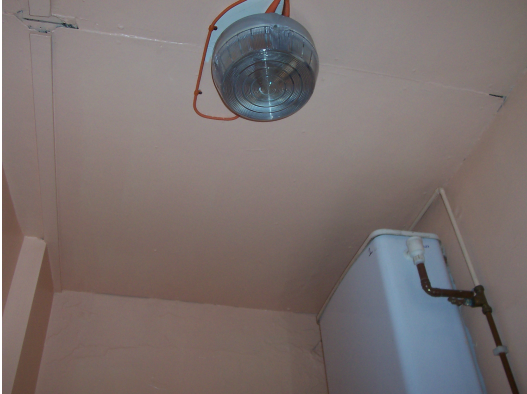
Item 7 - Ref: CS06/972

The cement ceiling panels to the kitchen contain asbestos. Any change in its appearance should be recorded, and passed to Property Services.

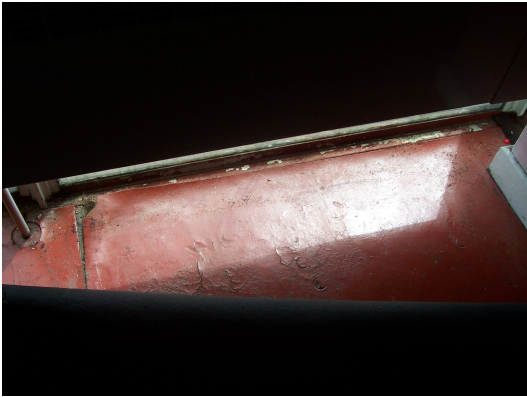
Item 10 - CS06/975

The red vinyl flooring under carpet & adhesive in dressing room 1 does not contain asbestos.

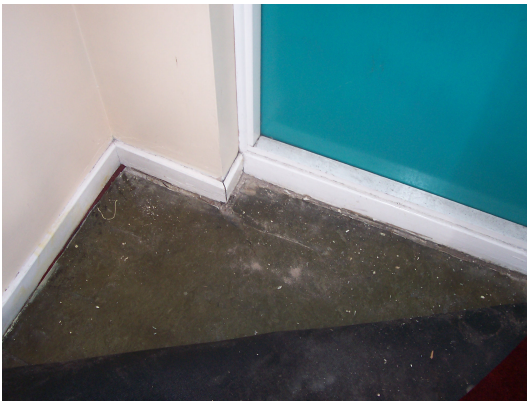
Item 11 - CS06/976

The green vinyl flooring under carpet & adhesive in dressing room 2 does not contain asbestos.

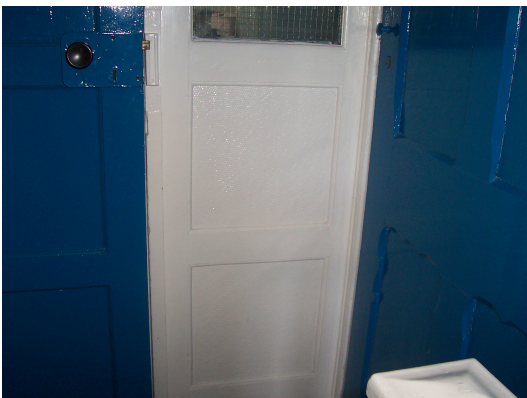
Item 12 - CS06/977

The cement panels to side of door on stairs 2 to second floor and landing does contain asbestos. Any change in its appearance should be recorded, and passed to Property Services.

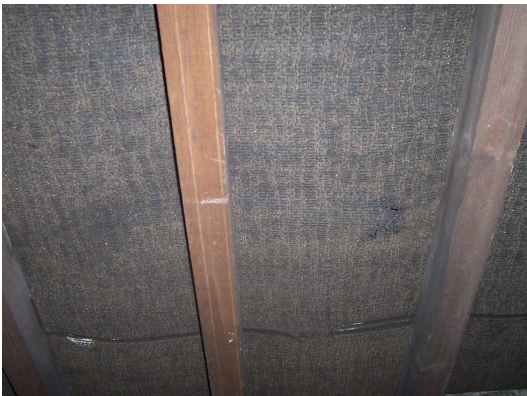
Item 15 - CS06/980

The sarking felt to roof in the loft does not contain asbestos.

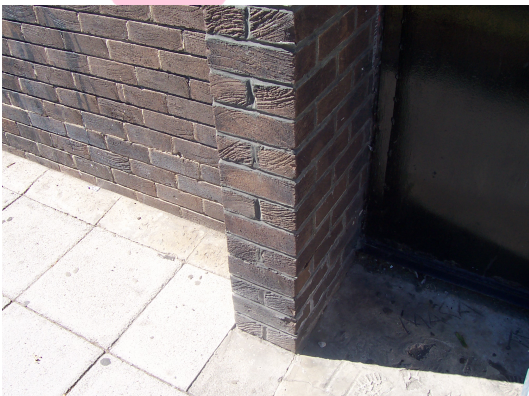
Item 21 - CS06/985

The external damp proof course does not contain asbestos.

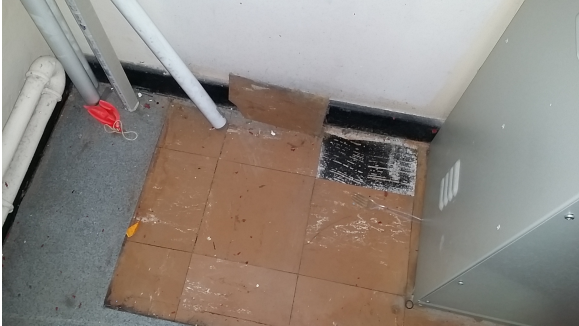
Item 22 – 250834-2

Floor tile with bitumen adhesive in 0/02/female toilets contain asbestos.

Any change in its appearance should be recorded, and passed to Property Services.

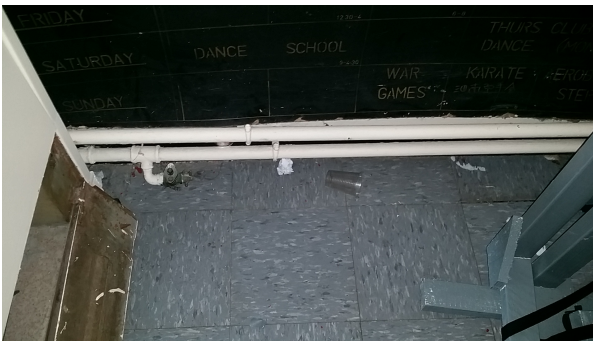
Item 23 – 250834-3

Floor tile with bitumen adhesive in 0/03/male toilets contain asbestos.

Any change in its appearance should be recorded, and passed to Property Services.

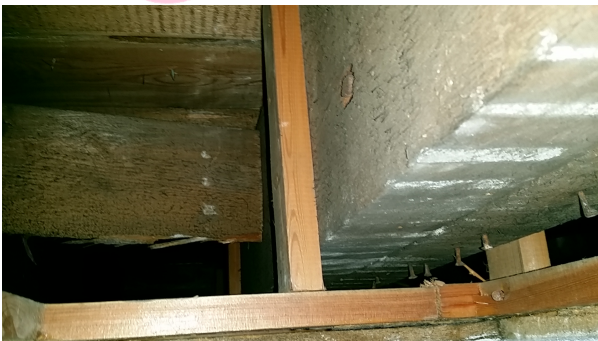
Item 24 – 250834-4

Debris to beams nails & nail holes within beams in 0/04/communal room 1 (void above) do not contain asbestos.

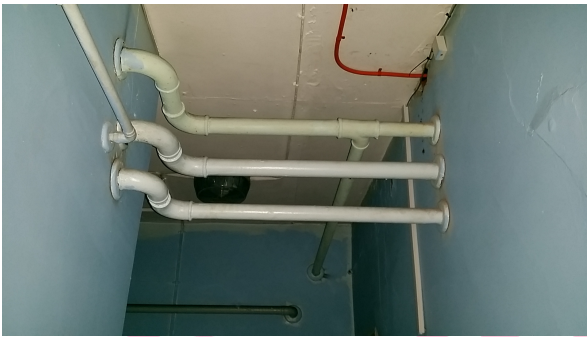
Item 26 – 250834-6

Ceiling in 0/08/corridor contains asbestos.

Any change in its appearance should be recorded, and passed to Property Services.

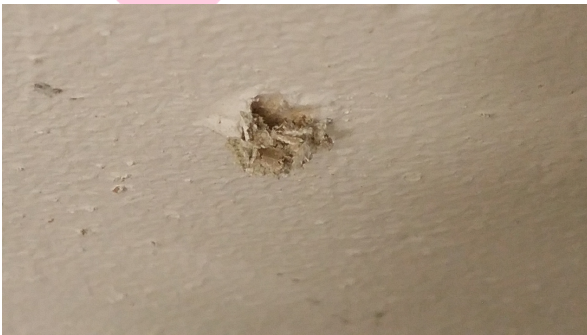
Item 27 – 250834-10

Debris to wall in ground floor boiler room contains asbestos.

***Environmental clean
completed June 2018 –
asbestos debris removed***

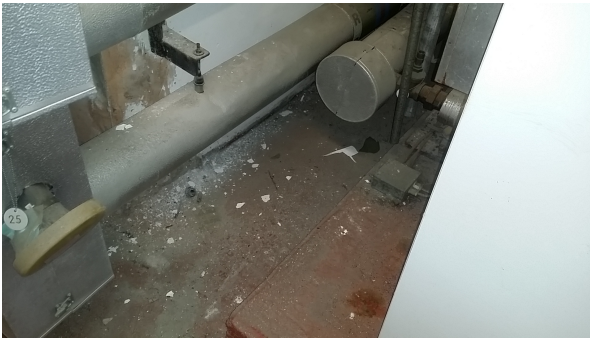
Item 29 – 250834-12

General debris to floor in ground floor boiler room contains asbestos.

Environmental clean completed June 2018 – asbestos debris removed

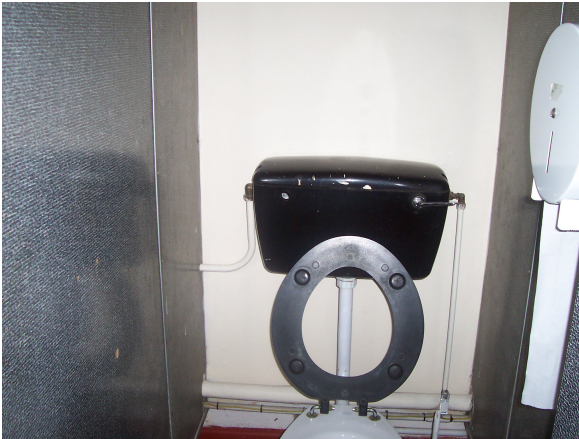
Item 32 – As CS06-968

The 2xToilet Cisterns and 2xSeat in the Female WC contains asbestos.

Removed from property but no WCN paperwork.
