ASBESTOS SURVEY REPORT FOR SUNDERLAND CREMATORIUM,  
CHESTER ROAD, SUNDERLAND, SR4 7RS.

## *Control of Asbestos Regulations 2012*

**Sunderland Crematorium, Chester Road, Sunderland,  
SR4 7RS**

**Date: 06 June 2025**

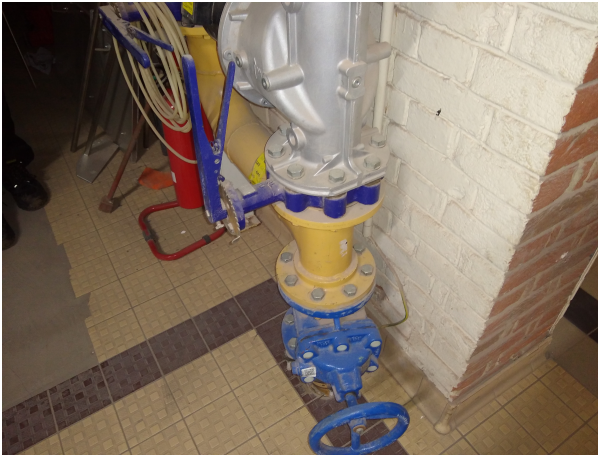
### **Item 1 Ref: As 411588-6**

The pipework flange gasket (0/001/Cremator room 1) does not contain asbestos.

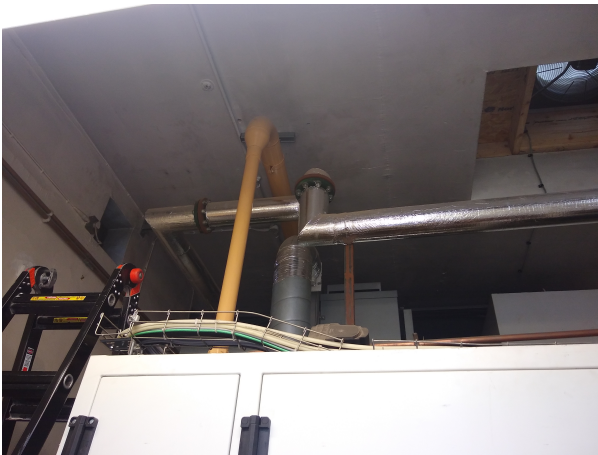
### **Item 2 Ref: 411588-12**

The pipework flange gasket (0/002/Cremator room 2) does not contain asbestos.

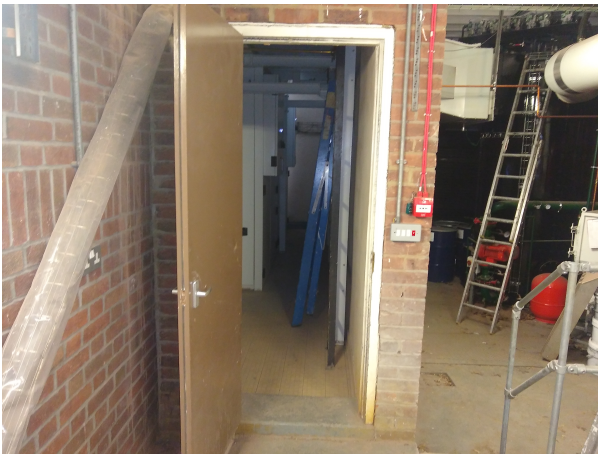
### **Item 3 Ref: 411588-15**

The sealant to door frame (0/003/Plant room containing mercury abatement system) does not contain asbestos.

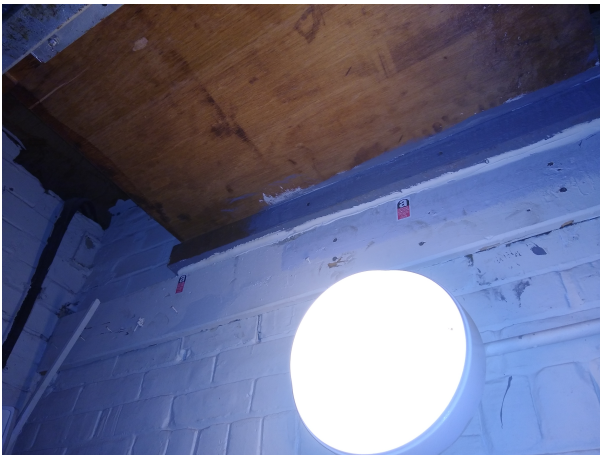
### **Item 6 Ref: Presumed**

The thin fillet above door above wooden fascia (0/004/Boiler Room) is presumed to contain asbestos.

Any change in its appearance should be recorded and passed to Property Services.

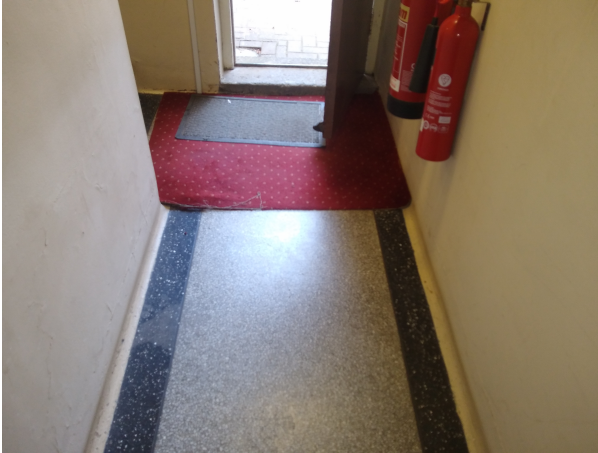
### **Item 10 Ref: 411588-5**

The floor covering (0/009/Corridor) does not contain asbestos.

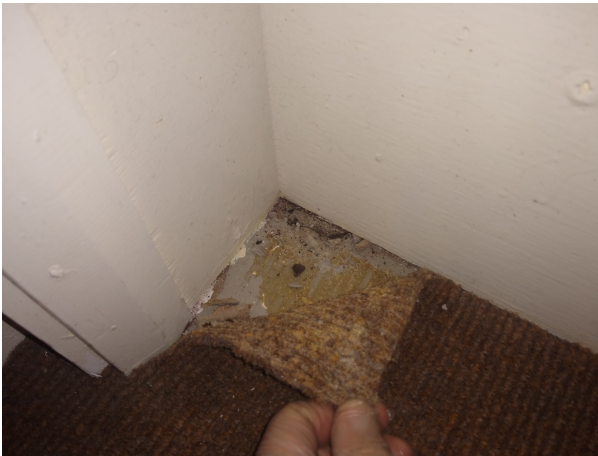
### **Item 11 Ref: 411588-3**

The remnant floor tiles beneath skirting (0/010/Office) contain asbestos.

Any change in its appearance should be recorded and passed to Property Services.

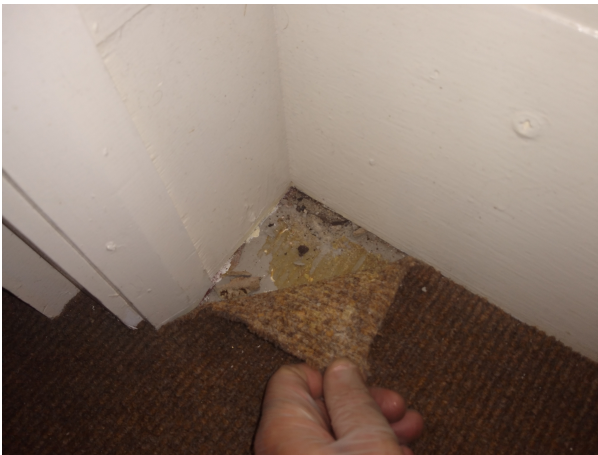
### **Item 12 Ref: 411588-4**

The remnant adhesive to floor beneath screed (0/010/Office) contains asbestos.

Any change in its appearance should be recorded and passed to Property Services.

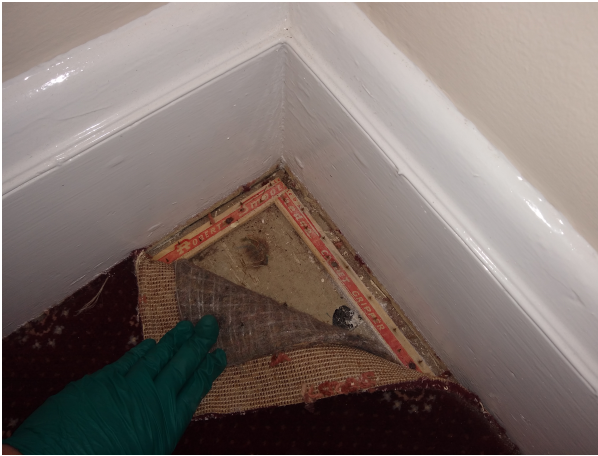
### **Item 16 Ref: 411588-17**

The subfloor (0/21/  
Remembrance corridor)  
contains asbestos.

Any change in its appearance  
should be recorded and  
passed to Property Services.

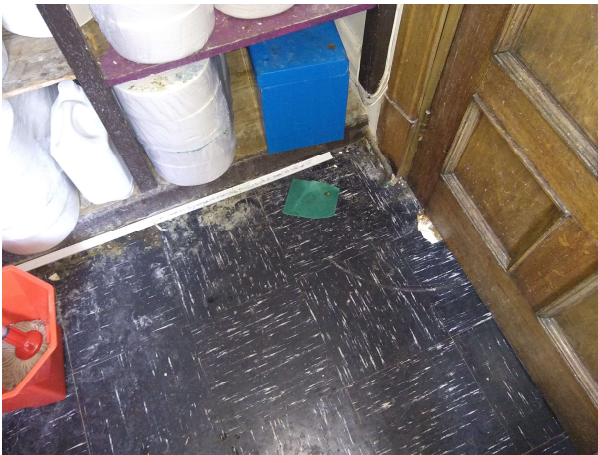
### **Item 17 Ref: 411588-18**

The floor covering  
(0/024/Cleaners store) does  
not contain asbestos.

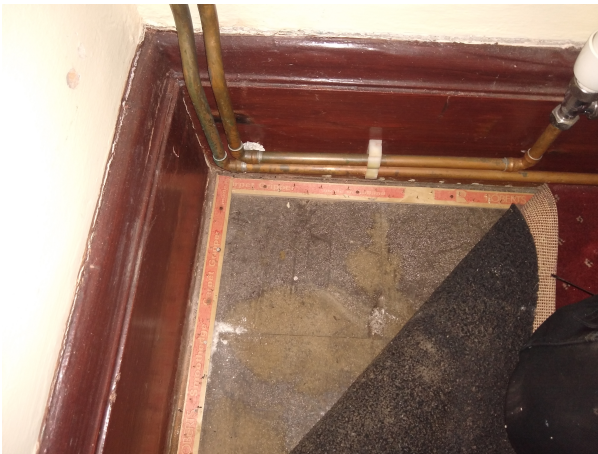
### **Item 18 Ref: 411588-2**

The subfloor (0/025/Lobby)  
contains asbestos.

Any change in its appearance  
should be recorded and  
passed to Property Services.

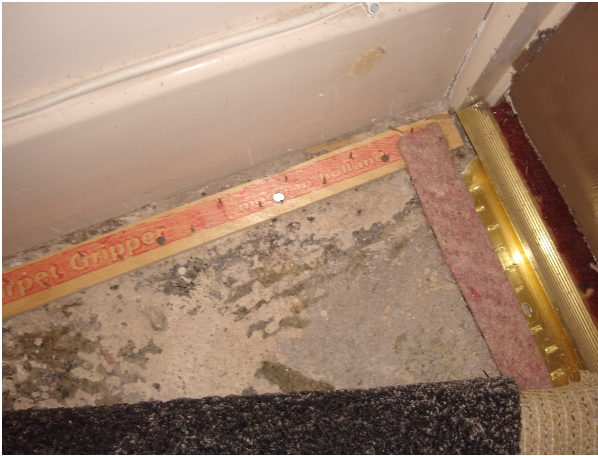
### **Item 19 Ref: As 411588-1**

The remnant adhesive to floor (0/031/Records room) contains asbestos.

Any change in its appearance should be recorded and passed to Property Services.

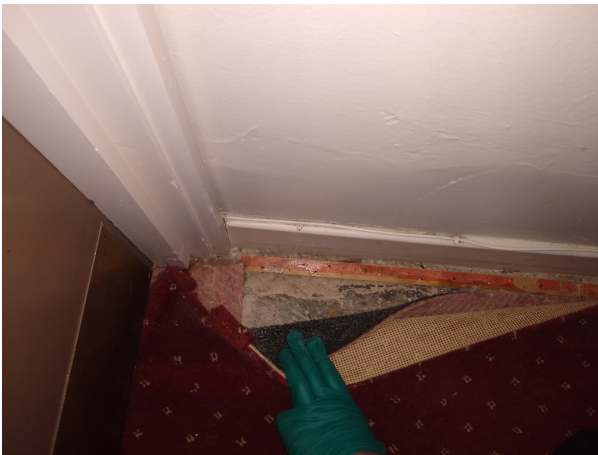
### **Item 20 Ref: As 411588-1**

The remnant adhesive to floor (0/032/Records lobby) contains asbestos.

Any change in its appearance should be recorded and passed to Property Services.

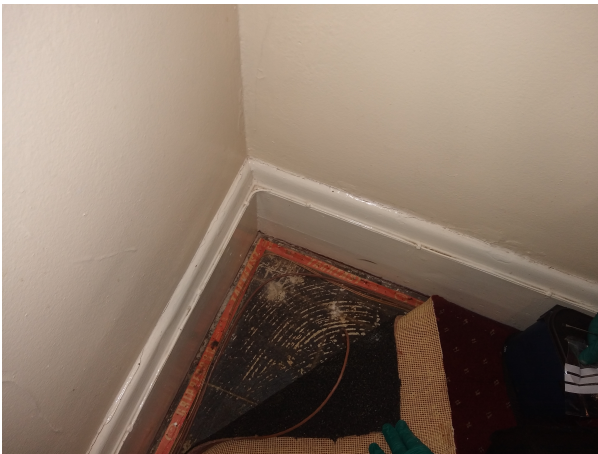
### **Item 21 Ref: 411588-1**

The remnant adhesive to floor (0/033/Lobby) contains asbestos.

Any change in its appearance should be recorded and passed to Property Services.

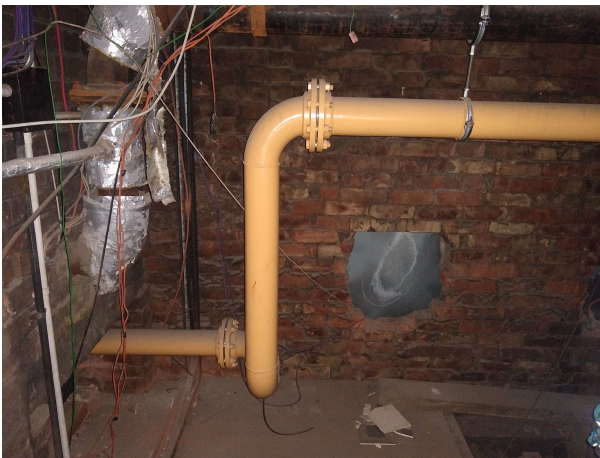
### **Item 23 Ref: 411588-6**

The gas pipework flange gaskets (1/003/loft void) does not contain asbestos.

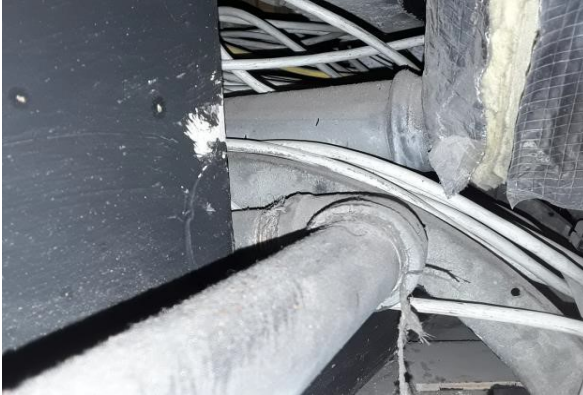
**Item 37 Ref: 20-28162-5**

The walls – cable tray intrusion (debris) in the Cremator Room does not contain asbestos.
