ASBESTOS SURVEY REPORT FOR SUNDERLAND CREMATORIUM,
CHESTER ROAD, SUNDERLAND, SR4 7RS.

Asbestos Register for

**Sunderland Crematorium, Chester Road, Sunderland,
SR4 7RS**

Date: 08 June 2026

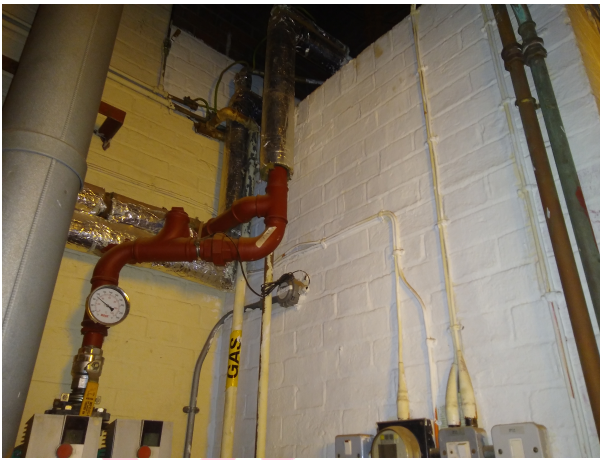
Item 5 Ref: 411588-11

The debris to walls encapsulated (0/004/Boiler room) contain asbestos.

Item 5	Debris to walls encapsulated (0/004/Boiler room)	Low Risk	6 monthly	13.05.2026
Item 6	Thin fillet above door above wooden fascia (0/004/Boiler Room)	Very Low Risk	12 monthly	13.05.2026
<i>Item 7</i>	<i>No asbestos</i>	<i>Is present</i>		
<i>Item 8</i>	<i>No asbestos</i>	<i>Is present</i>		
<i>Item 9</i>	<i>No asbestos</i>	<i>Is present</i>		
<i>Item 10</i>	<i>No asbestos</i>	<i>Is present</i>

Any change in its appearance should be recorded and passed to Property Services.

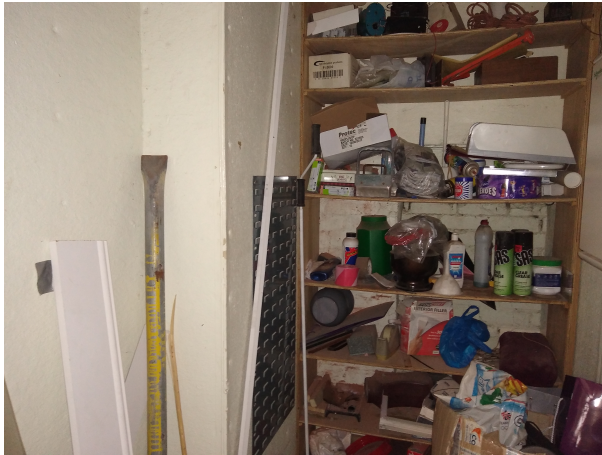
Item 7 Ref: 411588-13

The panels to walls
(0/007/Store room) do not
contain asbestos.

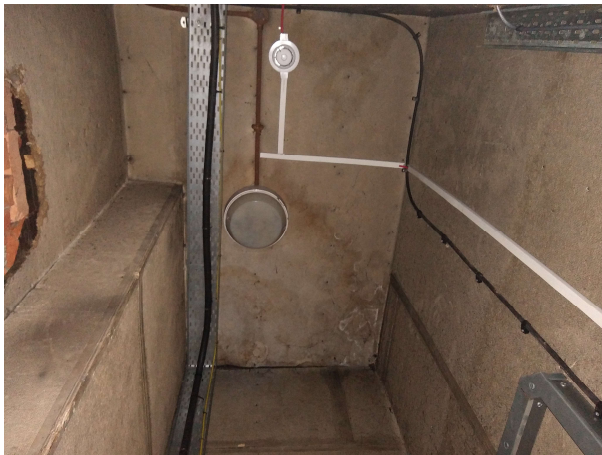
Item 8 Ref: As 411588-13

The panels to ceiling
(0/007/Store room) does not
contain asbestos.

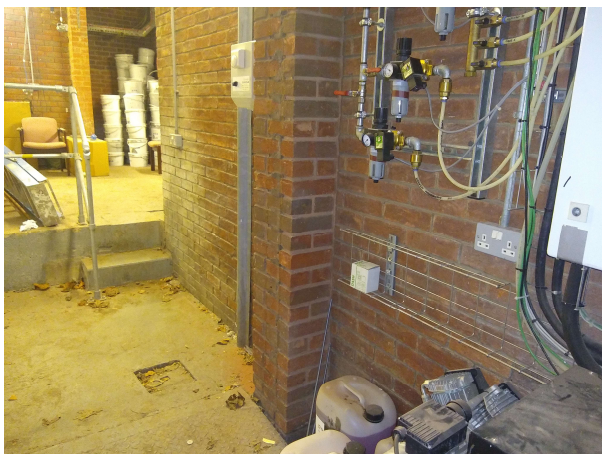
Item 9 Ref: 411588-14

The remnant sealant to brick
pillars (0/008/Plant Room) do
not contain asbestos.

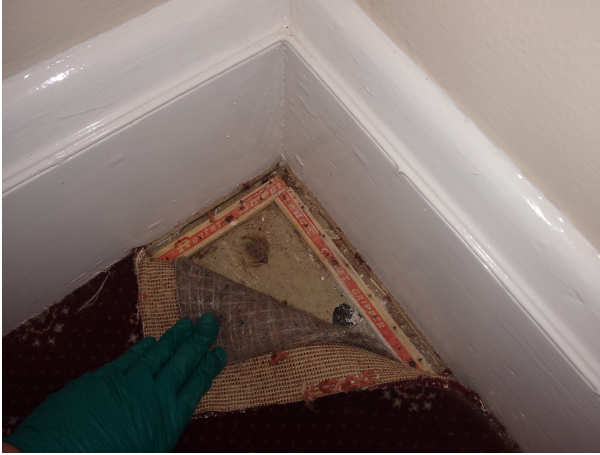
Item 16 Ref: 411588-17

The subfloor (0/21/
Remembrance corridor)
contains asbestos.

Any change in its appearance
should be recorded and
passed to Property Services.

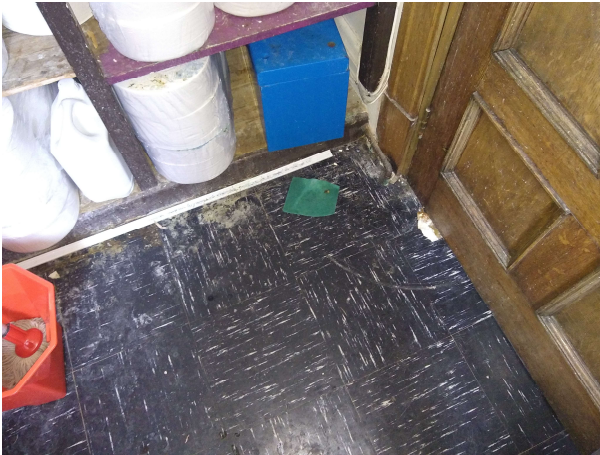
Item 17 Ref: 411588-18

The floor covering
(0/024/Cleaners store) does
not contain asbestos.

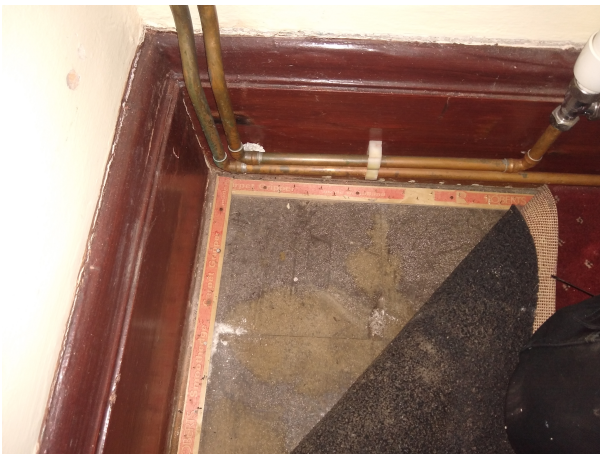
Item 18 Ref: 411588-2

The subfloor (0/025/Lobby)
contains asbestos.

Item 18	Subfloor (0/025/Lobby)	Very Low Risk	12 monthly	13.05.2026
Item 19	Remnant adhesive to floor (0/031/Records room)	Very Low Risk	12 monthly	13.05.2026

Any change in its appearance
should be recorded and
passed to Property Services.

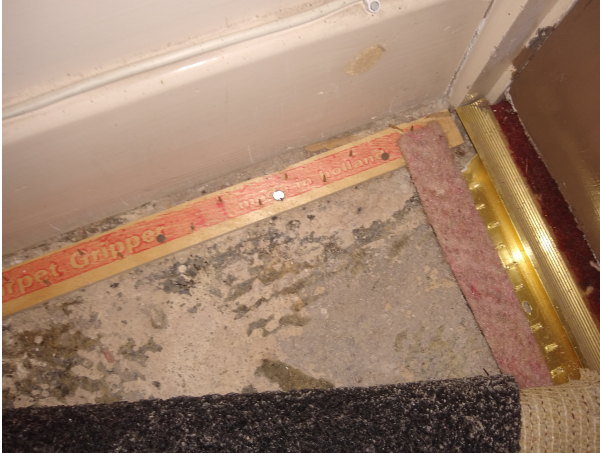
Item 19 Ref: As 411588-1

The remnant adhesive to floor (0/031/Records room) contains asbestos.

Any change in its appearance should be recorded and passed to Property Services.

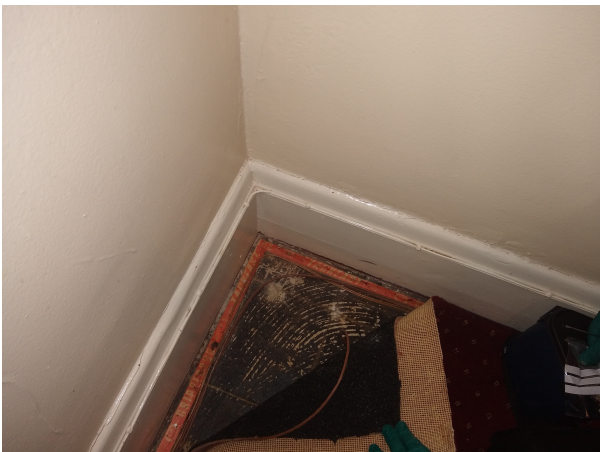
Item 21 Ref: 411588-1

The remnant adhesive to floor (0/033/Lobby) contains asbestos.

Any change in its appearance should be recorded and passed to Property Services.

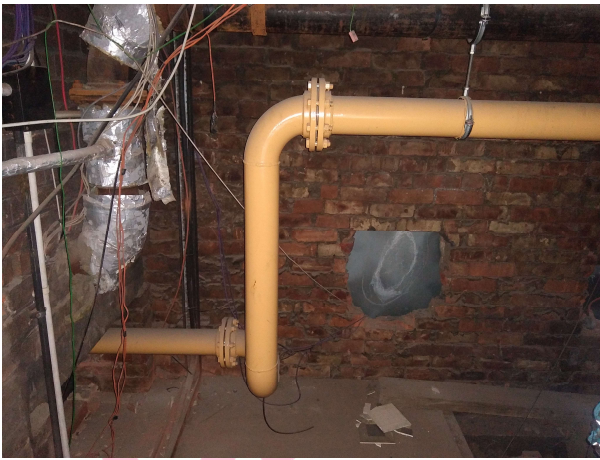
Item 23 Ref: 411588-6

The gas pipework flange gaskets (1/003/loft void) does not contain asbestos.

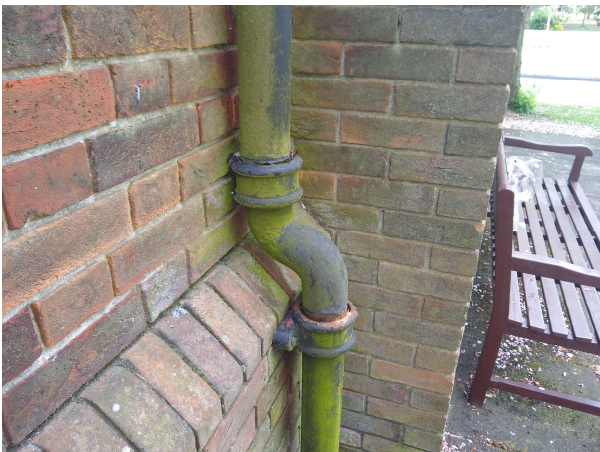
Item 27 Ref: 411588-19

The sealant to downpipe collars (External) does not contain asbestos.

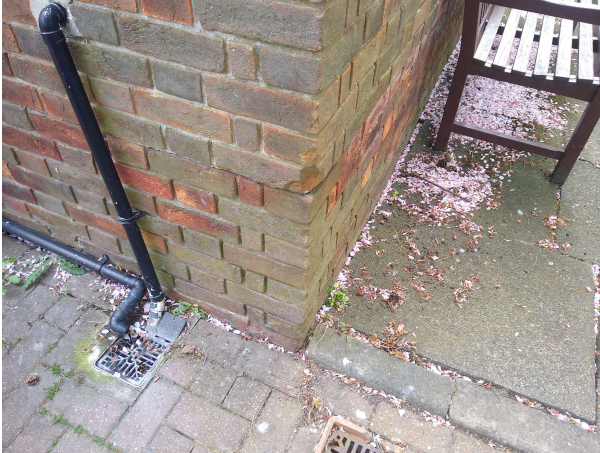
Item 28 Ref: 411588-20

The damp proof course
(External) contains asbestos.

Any change in its appearance
should be recorded and
passed to Property Services.

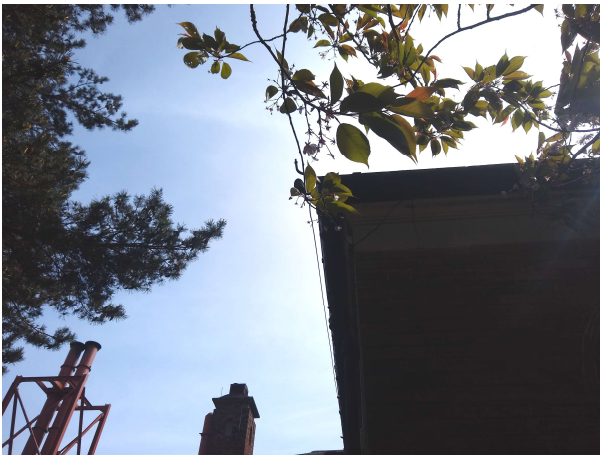
Item 29 Ref: 411588-21

The telephone insulator
(External) contains asbestos.

Any change in its appearance
should be recorded and
passed to Property Services.

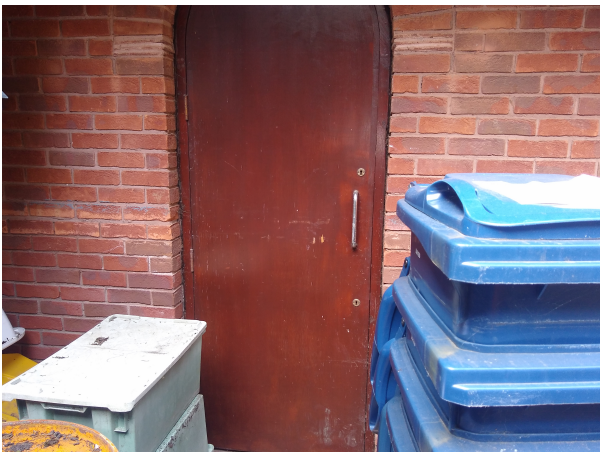
Item 30 Ref: 411588-22

The sealant to door frame
0/011 (External) does not
contain asbestos.

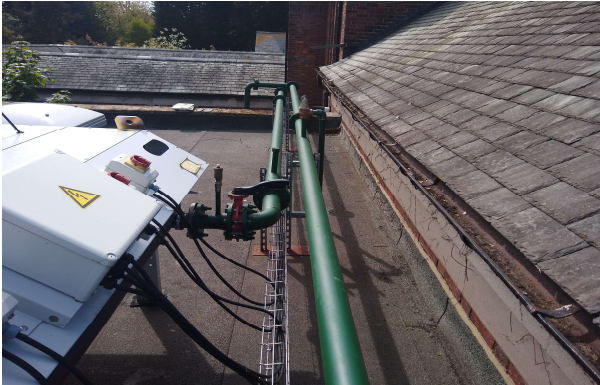
Item 31 Ref: 411588-22

The pipework flange gaskets to flat roof top (External) does not contain asbestos.

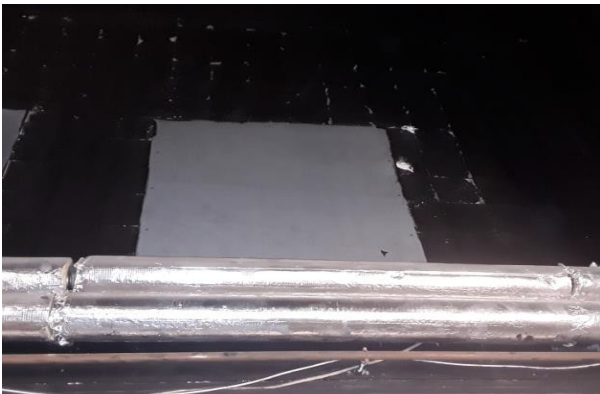
Item 32 Ref: 20-28162-1

The walls (tiles & adhesive) in the Cremator Room do not contain asbestos.

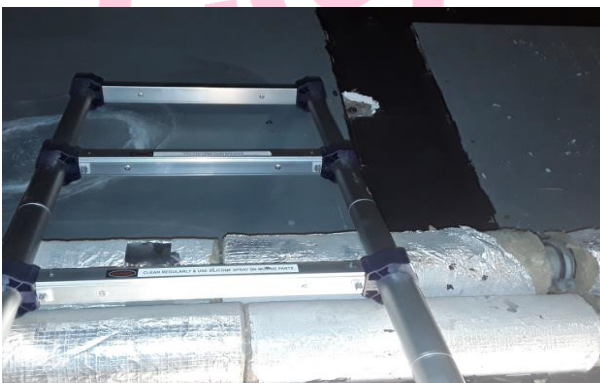
Item 33 Ref: 20-28162-2

The walls (tiles & adhesive) in the Cremator Room do not contain asbestos.

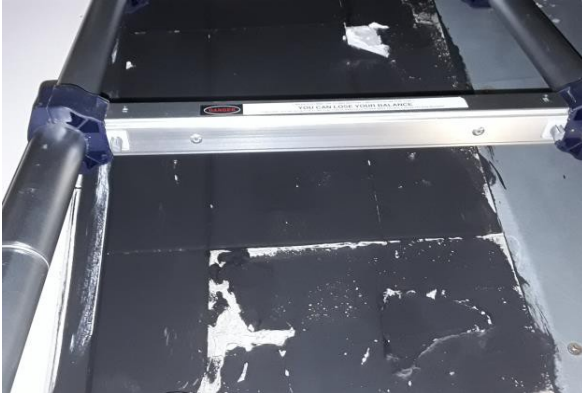
Item 34 Ref: 20-28162-3

The walls (tiles & adhesive) in the Cremator Room do not contain asbestos.

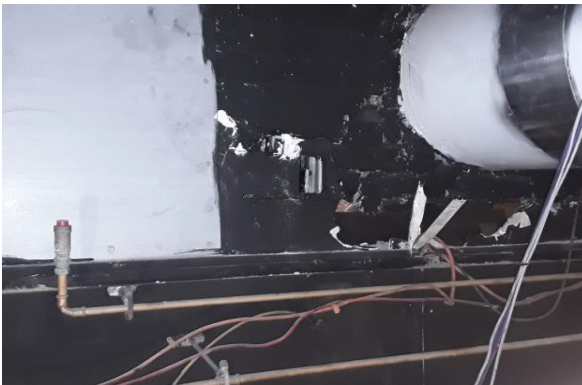
Item 35 Ref: 20-28162-4

The walls (plaster) in the Cremator Room do not contain asbestos.

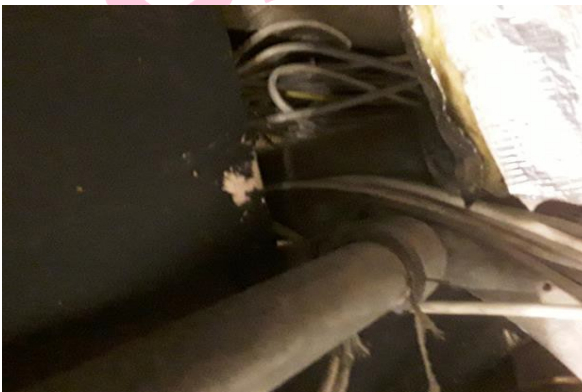
Item 36 Ref: 20-28162-5

The walls – cable tray intrusion (debris) in the Cremator Room does not contain asbestos.

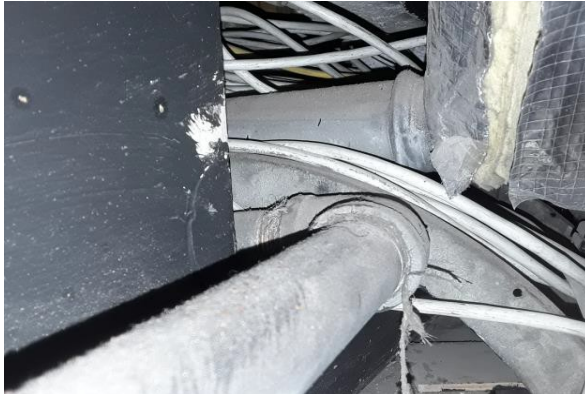
Item 37 Ref: 20-28162-5

The walls – cable tray intrusion (debris) in the Cremator Room does not contain asbestos.
